TURNER RIVER SOLAR HUB SOIL AND LANDFORM ASSESSMENT

Fortescue Limited
December 2024

Project Number: 2211.24b

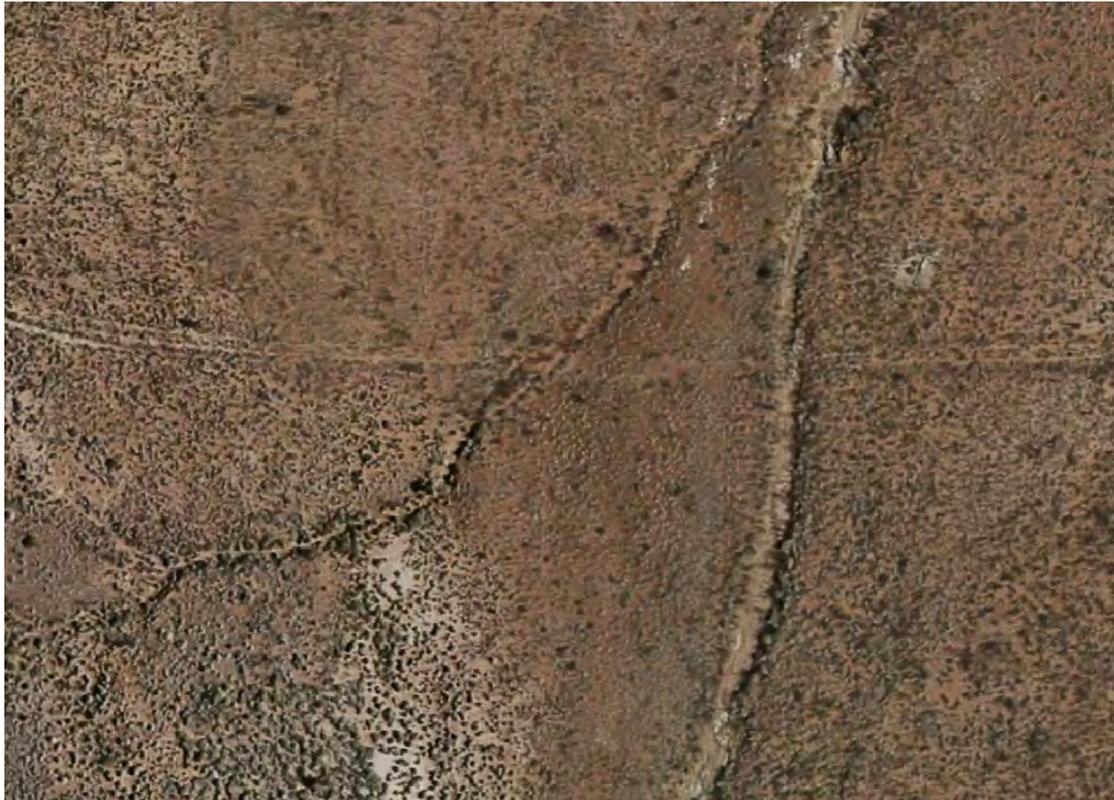
Figure 16: Typical appearance of the drainage floor and channels landform within the Project area, with a major channel running from north-south (image from the northern section of the Project area).

The drainage floors and channels are a relatively minor landform located across the Project area, but at a higher density within the northern section, comprising 21ha (or 1.5%) of the overall area. No imagery of this landform was captured during the field investigation. An aerial image of the typical appearance of the drainage floors and channels is provided in Figure 16.

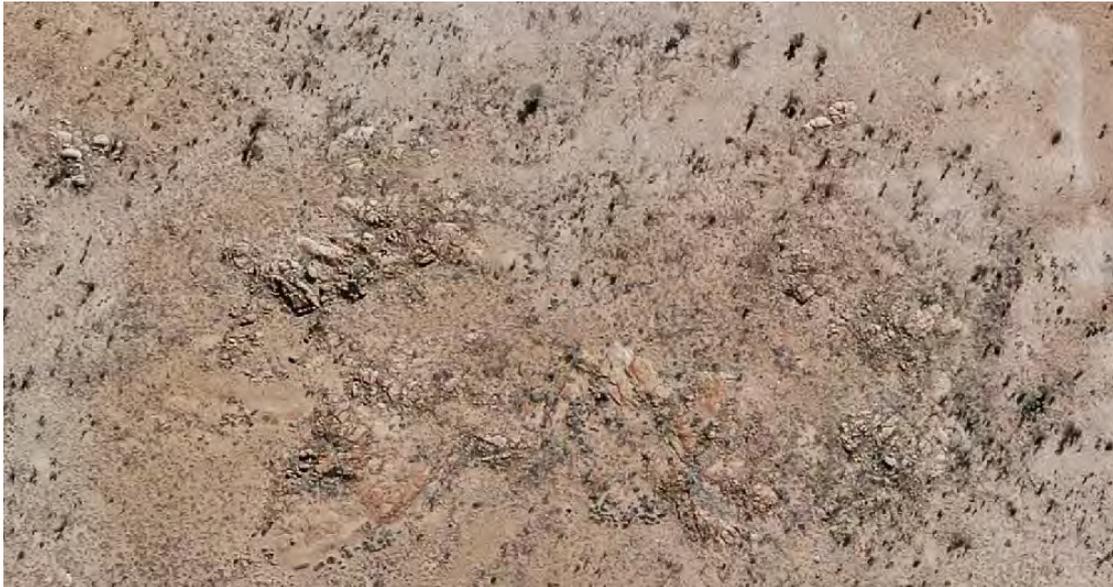
Figure 17: Typical appearance of the low hills and ridges, surrounded by stony plains and interfluves.

No images of the low hills and ridges were captured during the field investigation, as the intent of the survey was to sample the soils of the Project area and these rocky features cannot be excavated. An example of the low hills and ridges located on the southern section of the Project area is provided in Figure 17.

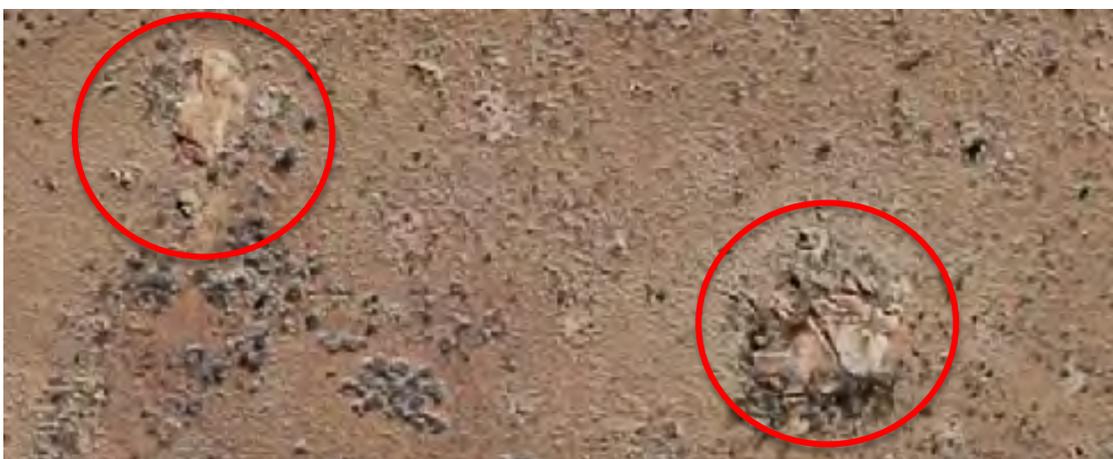
Figure 18: Tor heaps (highlighted with red circle) within southern Project area.

The Tor heaps present within the Project area are typically extremely weathered and in poor condition. They are isolated to a few discrete sections of the southern Project area comprising 3ha (or 0.2%) of the overall Project area. No images of these landforms were captured during the field investigation. However, an example from aerial imagery is provided in Figure 18.

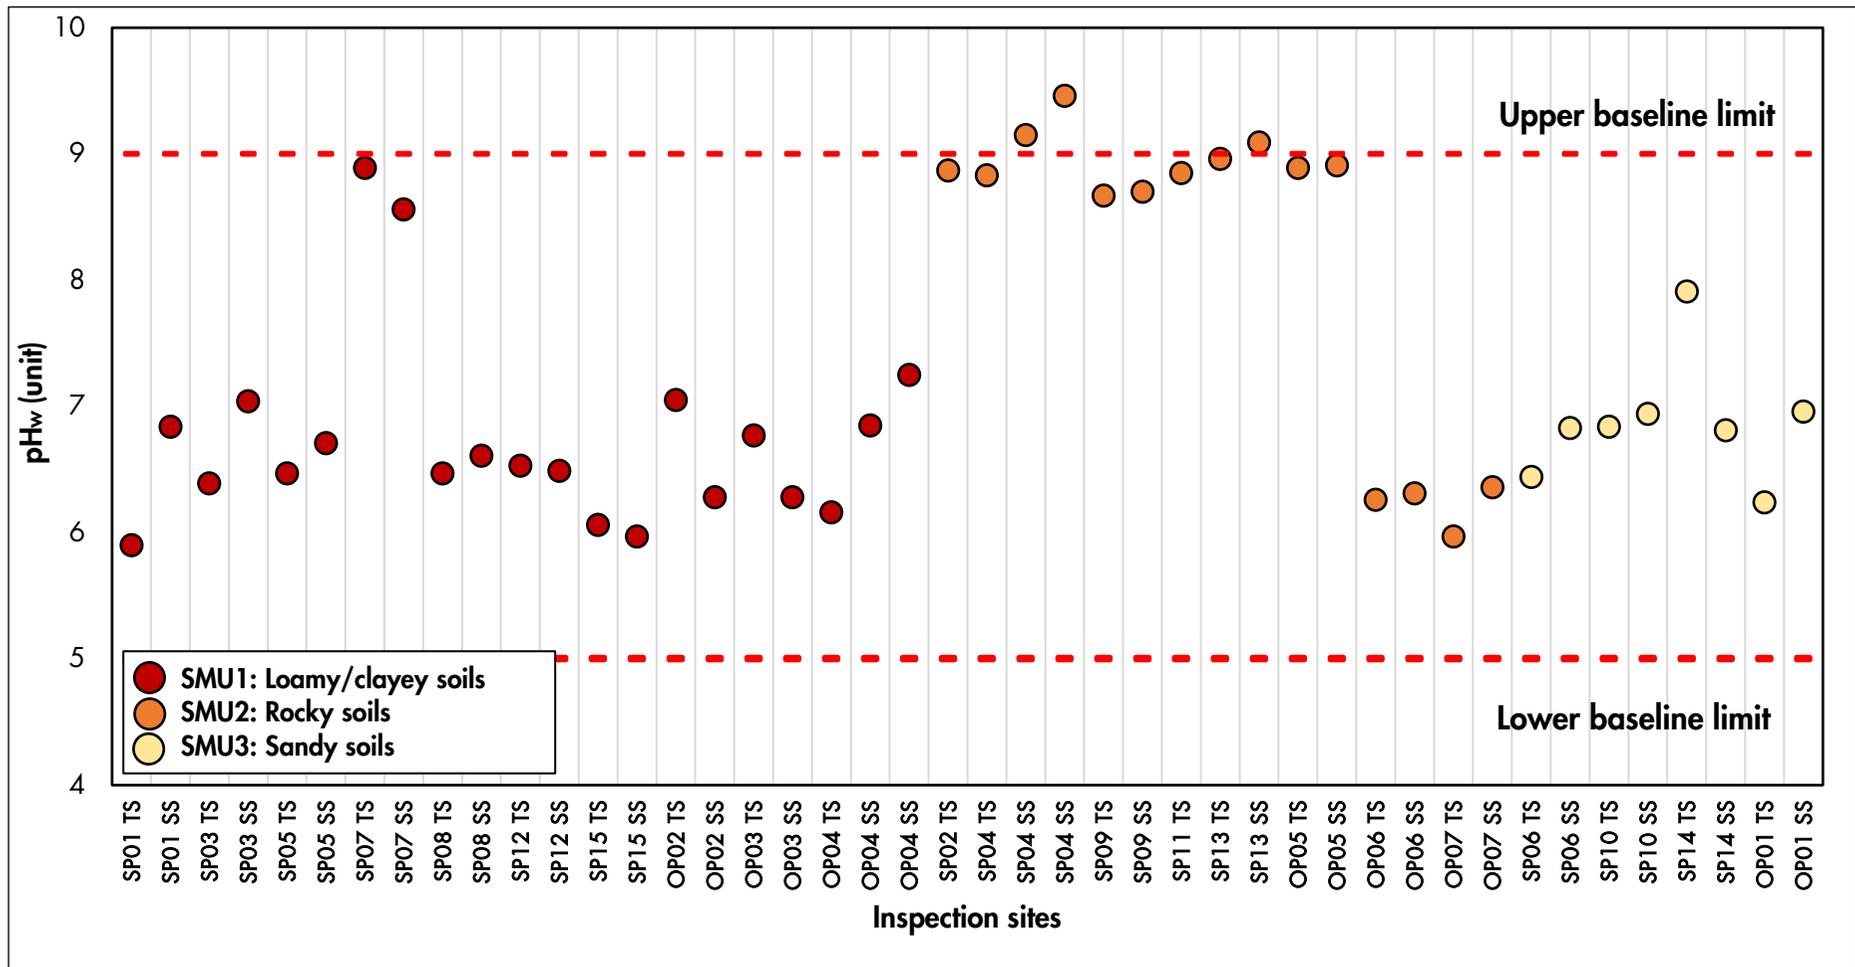
Figure 19: Summary of pH across all sites, grouped by SMU.

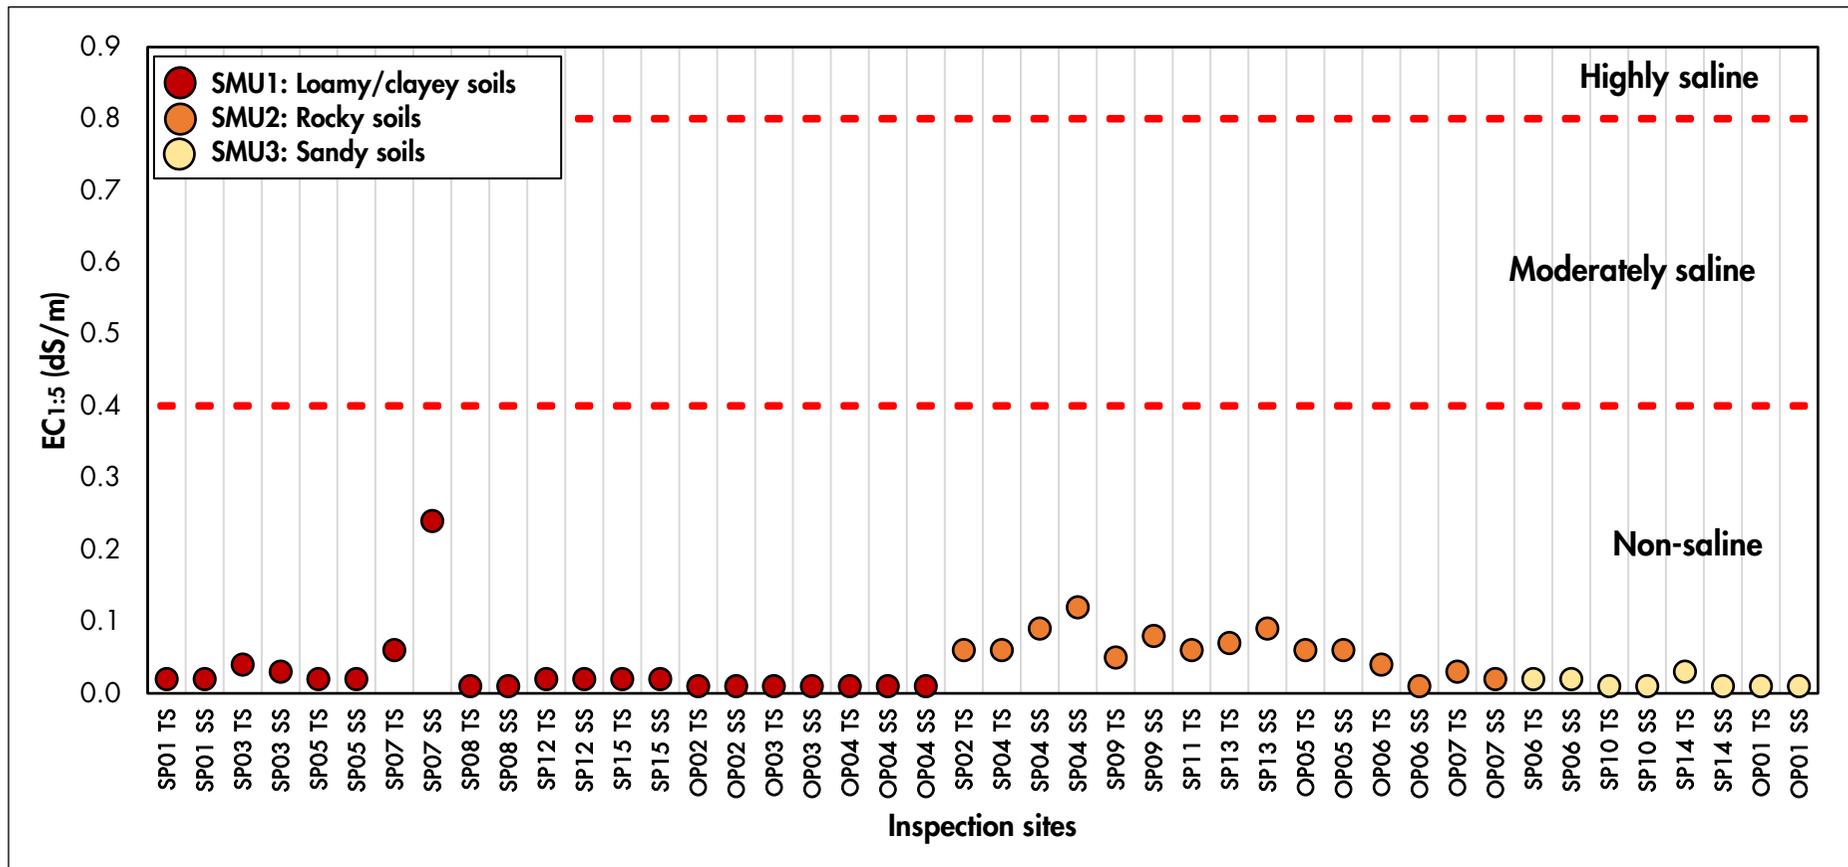
Figure 20: Summary of EC_{1:5} across all sites, grouped by SMU.

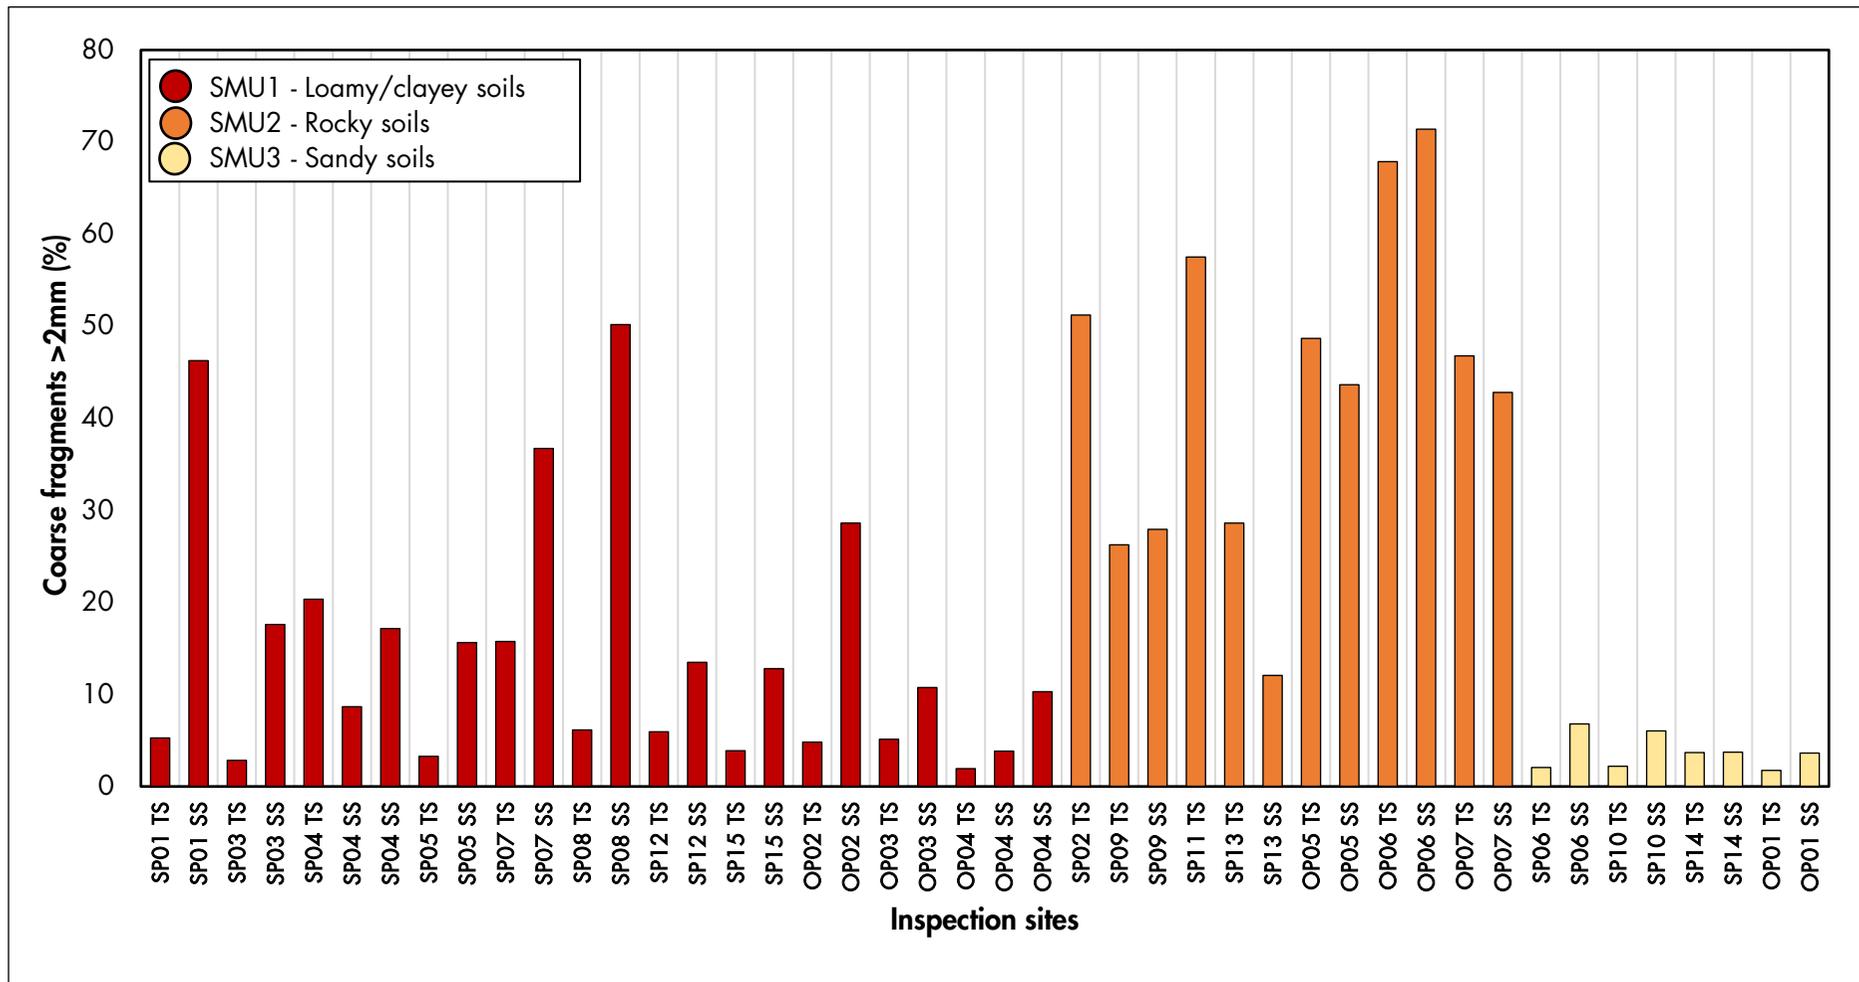
Figure 21: Coarse fragment percentage (>2mm) across all soil inspection sites.

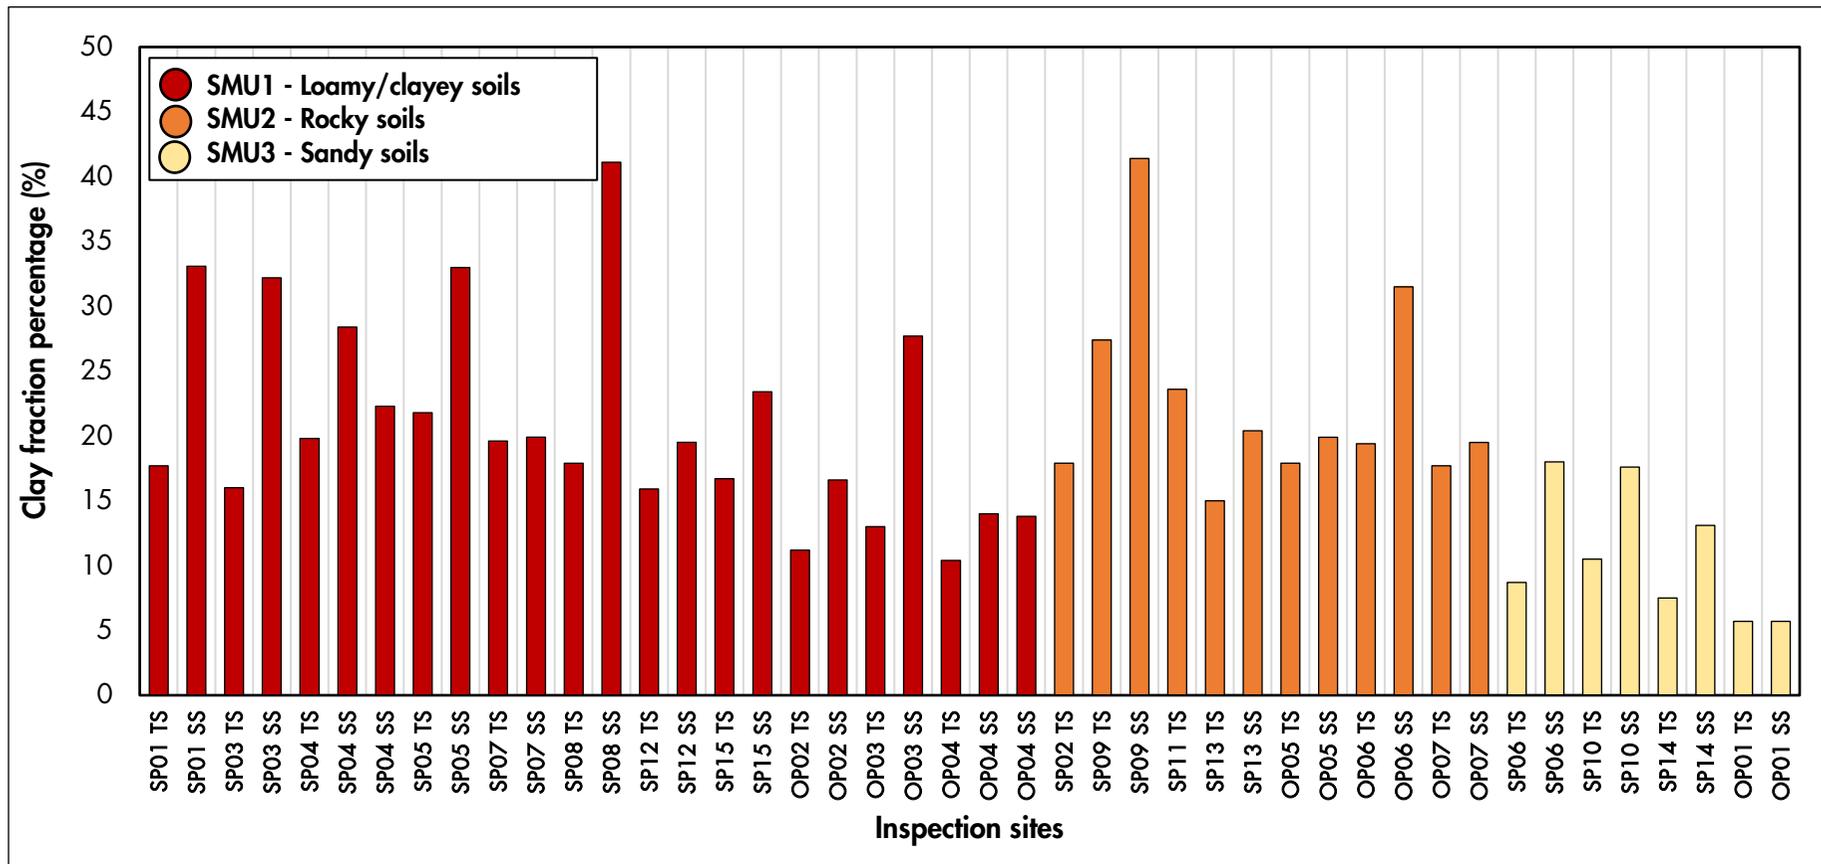
Figure 22: Percentage of clay across all soil inspection sites.

SMU1 (Loamy/clayey soils) typically have a higher abundance of clay in the subsoils, with a median clay content of 17% in the topsoils, and 23% in the subsoils. The Sandy soils had topsoils with a median clay content of 8%, and subsoils with 15%.

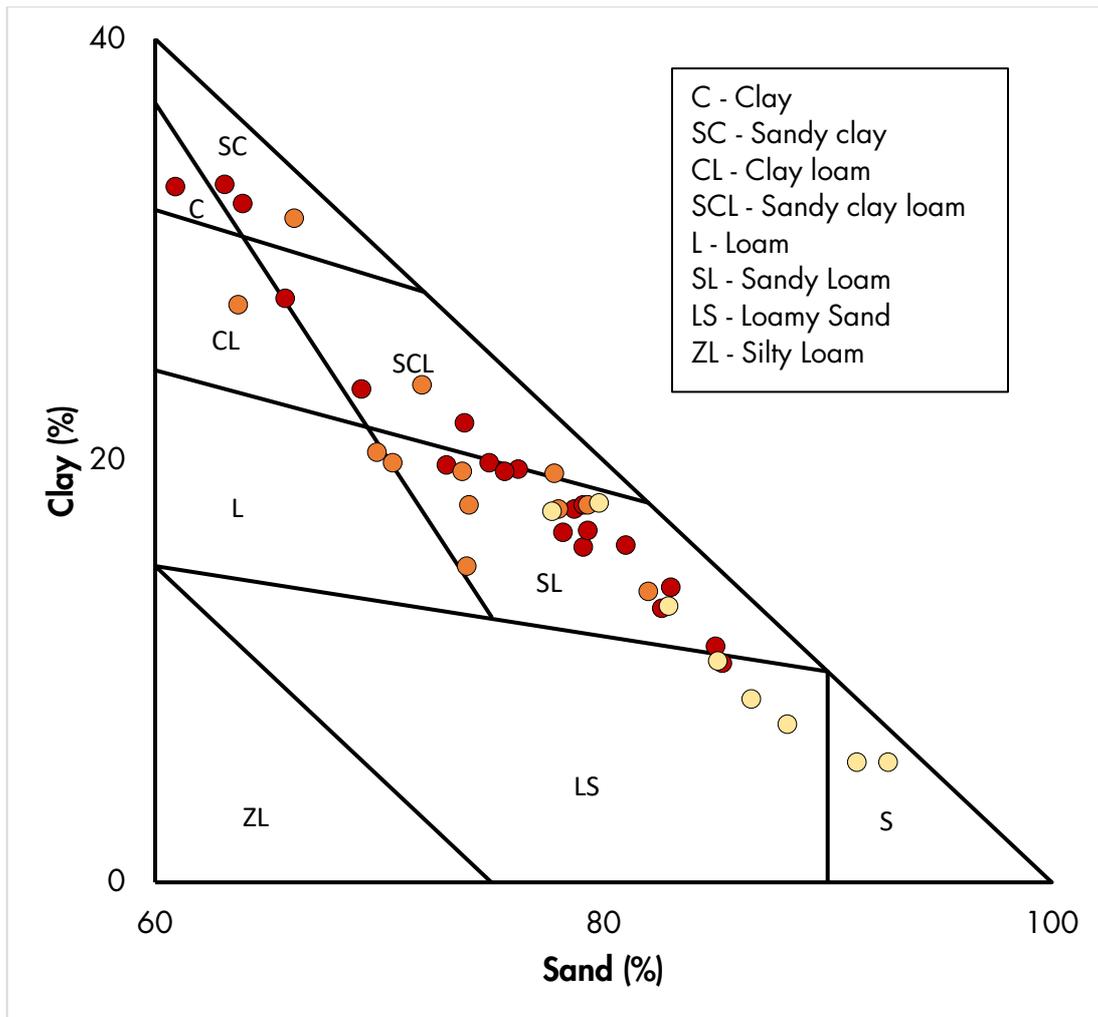
Figure 23: Texture plot with Rocky soil sites shown in dark red, Loamy/clayey soils in orange, and Sandy soils in yellow.

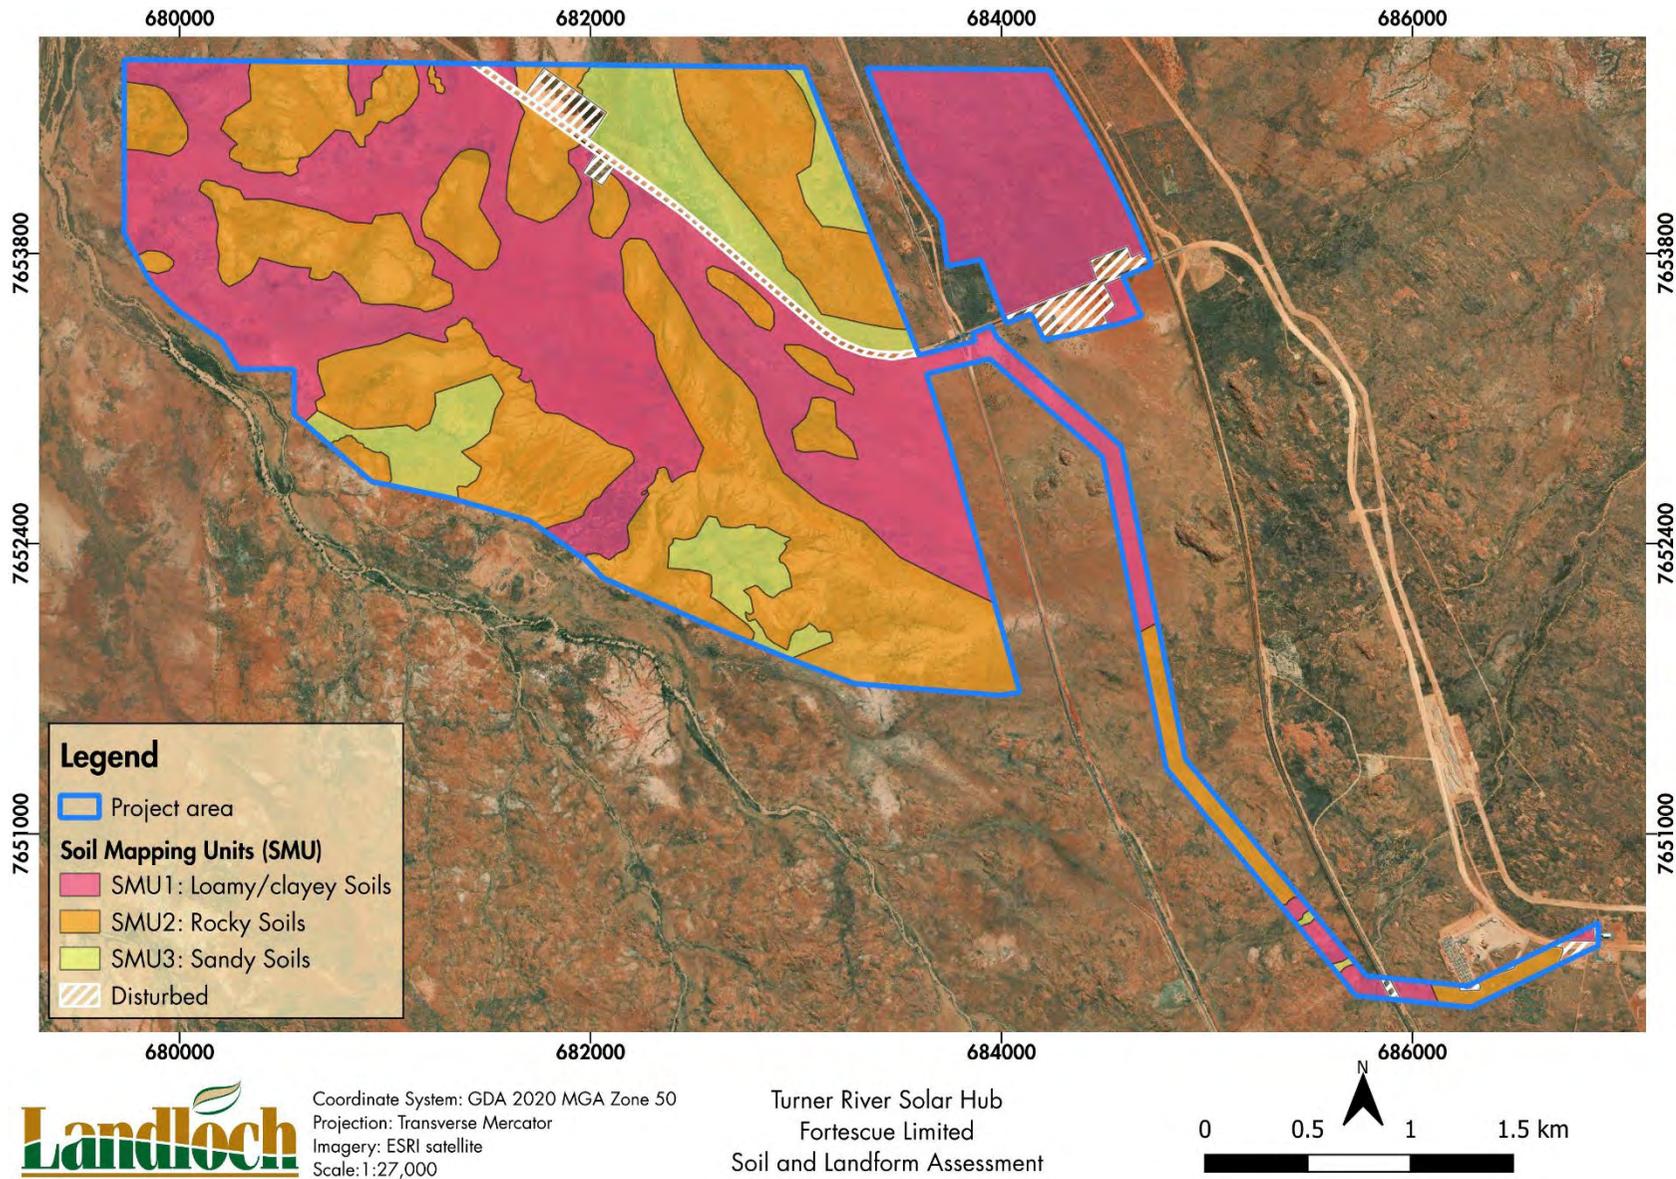
Figure 24: SMU mapping southern section (NSJ West).

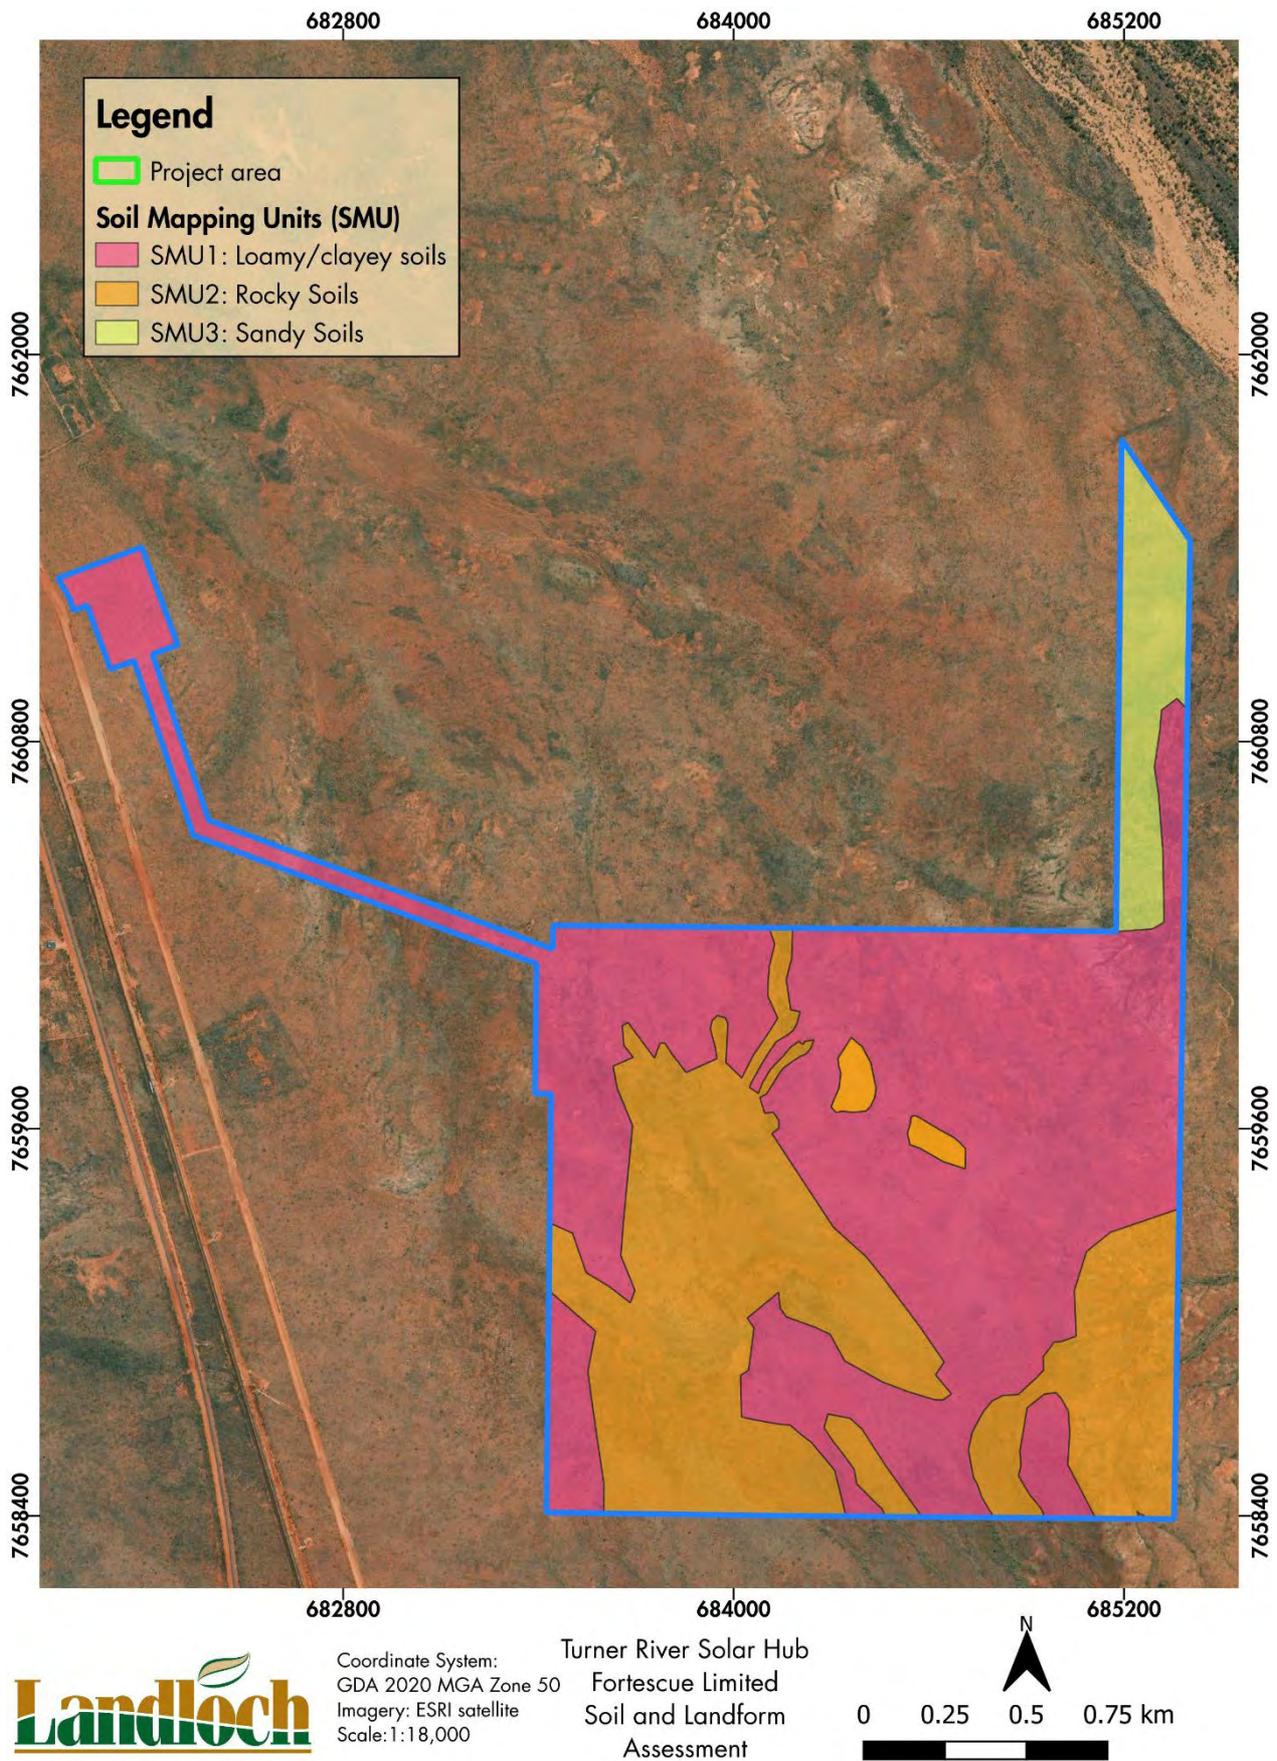
Figure 25: SMU mapping northern section (Wodgina).

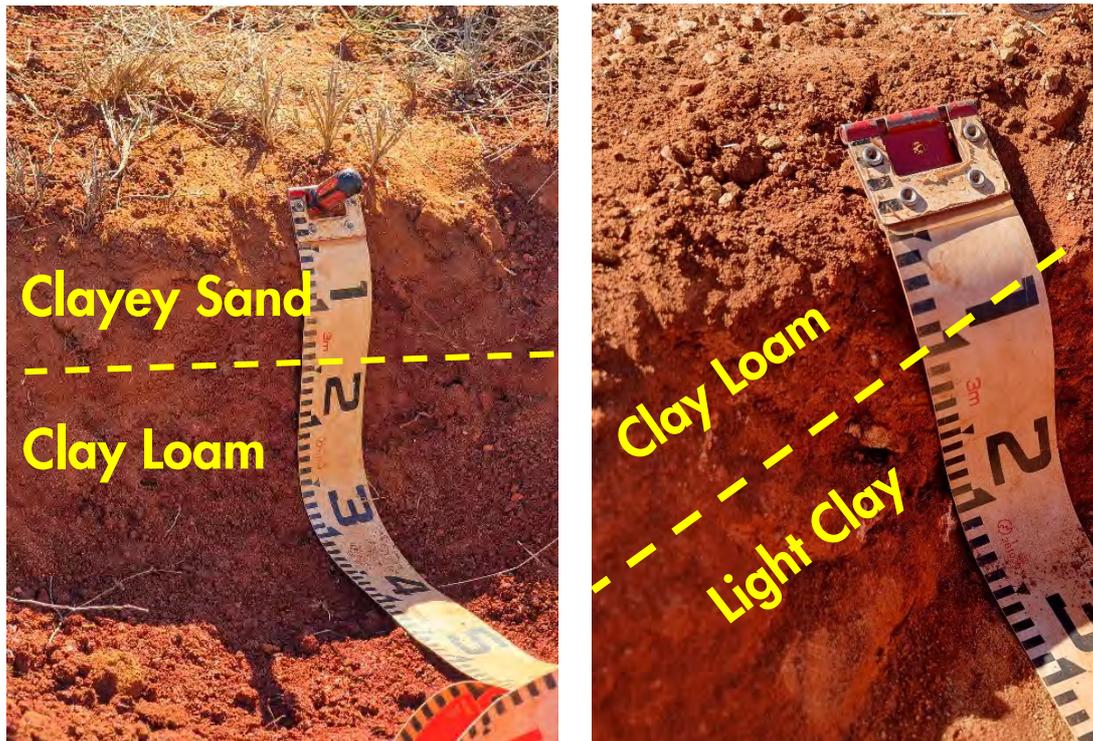
Figure 26: Differences in soil texture, with SP08 (left image) clayey sand topsoils into clay loam subsoils, and SP09 (right image) clay loam topsoils into light clay subsoils.

In general, soils have a sandy or loam texture in the topsoil that increases in clay content to loam or clay in the subsoils. An example of two soil profiles is provided in Figure 26, with SP08 comprised of clayey sand over clay loam, and SP09 clay loam over light clay. No evidence of soil structure was observed, and these soils typically have a very low abundance of coarse fragments.

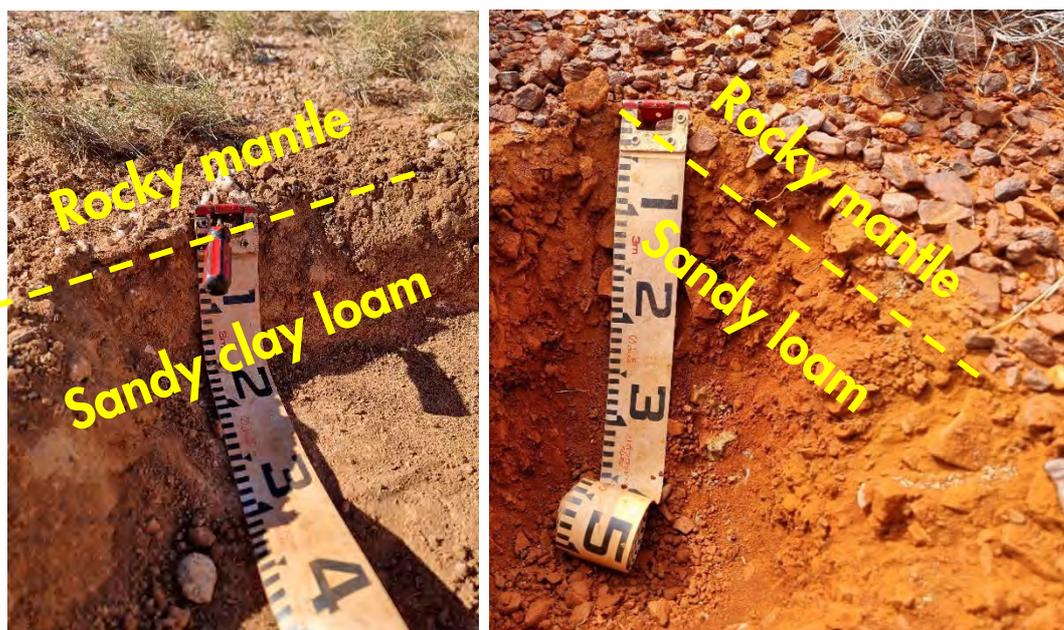
Figure 27: Rocky mantles with SP13 (left image) showing a rocky mantle with sandy clay loam texture underneath, OP06 (right image) comprised of ironstone.

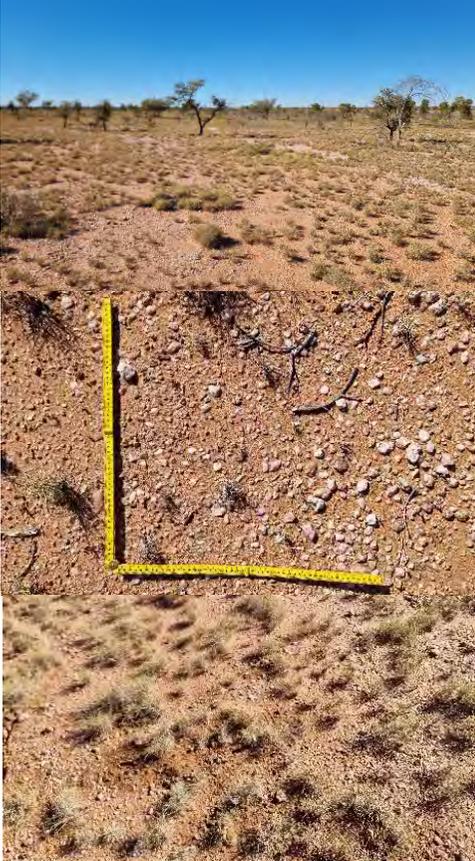
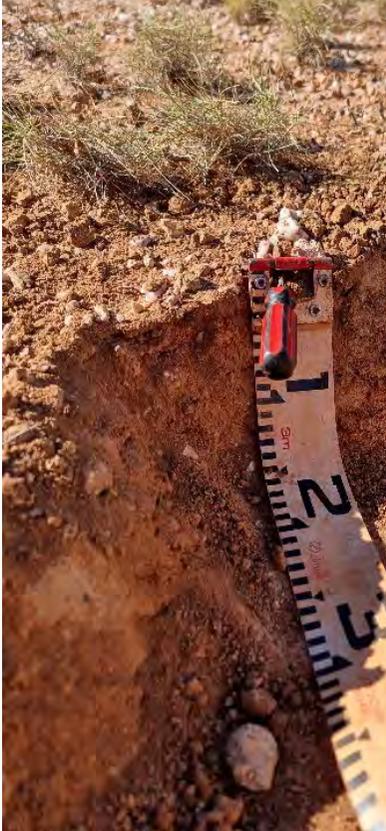
Table 26: Representative inspection site of the Rocky soils

Representative Site No: SP13 Landform: Simple slope Micro-relief: N/A Surface condition: Soft	Dominant Vegetation: Non-woody Surface cover: Sparse (10-30%) Site Drainage: Moderately well-drained	General comments: Surface cover of ~30%, with 20-60mm coarse fragments on the surface. Most the surface rocks are quartz. Profile included smaller coarse fragments in the topsoil (20-50%, 6-20mm, decreasing in size and abundance in the subsoil (10-20%, 2-6mm).						
Landscape Photos	Profile Photo	Horizon (mm)	Moist Colour	Texture	Structure	Consistence	Roots	pH _w & EC _{1:5}

A1 (0-50)	5YR 3/3	Sandy Clay Loam	Weak polyhedral	Firm (dry)	Few (1-10) Fine (2-5mm)	pH: 9.0 EC: 0.07 dS/m
		B (50-150)	5YR 6/6	Sandy Clay Loam	Weak polyhedral	Firm (dry)	None recorded	pH: 9.1 EC: 0.09 dS/m

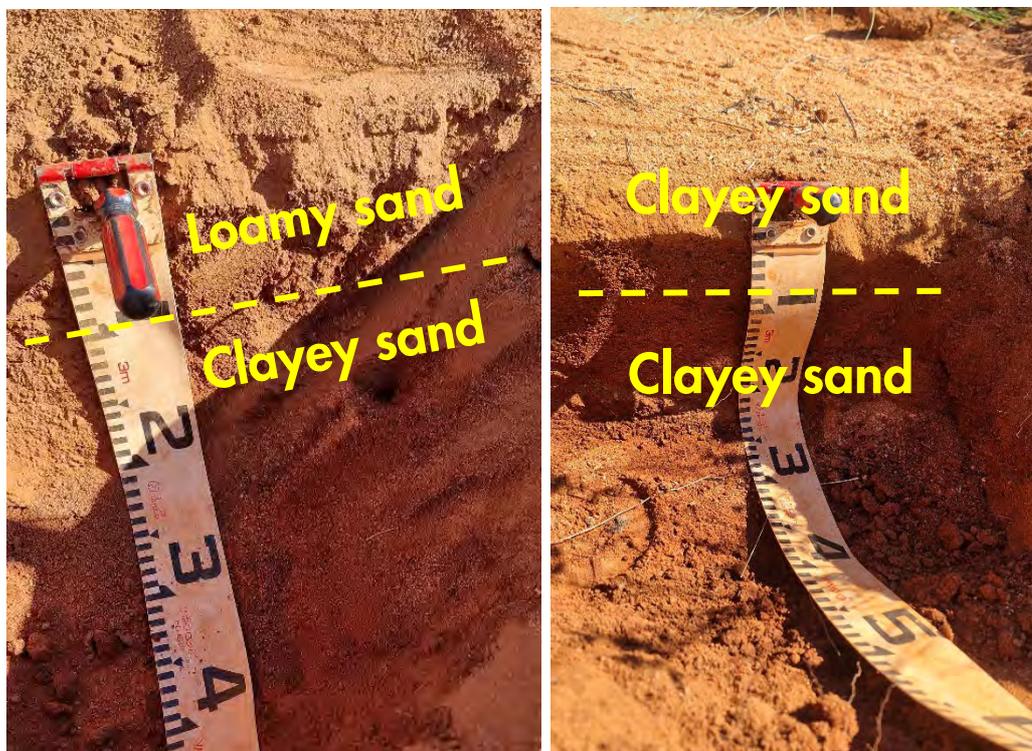
Figure 28: Sandy profiles with SP03 (left image) and SP10 (right image) showing the homogeneity in texture.

In general, this SMU consists of a sandy texture in the topsoil and subsoils. An example of two soil profiles is provided in Figure 28. No evidence of soil structure was observed, and these soils typically have a very low abundance of coarse fragments.
