Site Information

Project 2211.24b	Date 13/06/2024	Scribe M.White	Location SP01	Observation Soil pit	Easting/ Latitude	Zone	ASC Mapped
Dominant Vegetation Form Non-woody		Ground Cover % Sparse (10-30%)		Aspect	Northing/ Longitude	Scale	ASC Ground Truth
Secondary Vegetation Form Woody		Ground Cover % Very sparse (0.2-10%)		Slope %	Rock Outcrop No rock outcrop	Erosion Type None evident	
Vegetation (species) triodia					Drainage (site) Moderately well-drained	Erosion Extent None evident	
Landform Open depression			Soil Surface Condition (dry) Soft		Land Use Grazing	Erosion State None evident	
Landscape Photo (North)

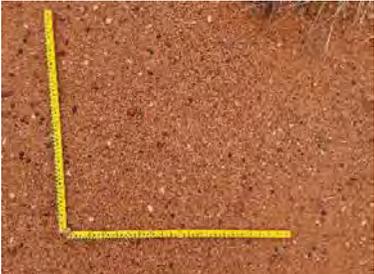
Soil Surface Condition Photo

Microrelief Type Vertical (m) Horizontal (m) Sampled	
Dominant Vegetation Photo 1		Dominant Vegetation Photo 2		Other Vegetation Photo		Other Information: Vegetstion is notably smaller in size than surrounding areas. Surface rock cover 10%, 6-20mm

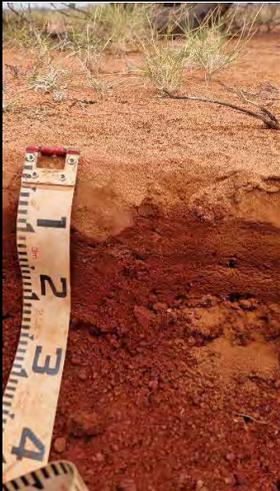
Horizon	Depth (mm)	Profile Photo	Boundary	Texture	Moist Colour	Mottle (colour, abundance)	Segregations (abundance, nature)	Coarse fragments (abundance, size)	Structure (type)	Structure (grade)	Consistence (soil water status)	Roots (abundance, size)	pH	EC (dS/m)	Depth of Sample for Lab (mm)
A	0-100

Clear	Sandy Clay Loam	2.5yr 3/4			2-10 % 2-6 mm							0-100
B	100-250			Clay Loam, Sandy	2.5yr 3/6			20-50 % 6-20 mm							
Other information:

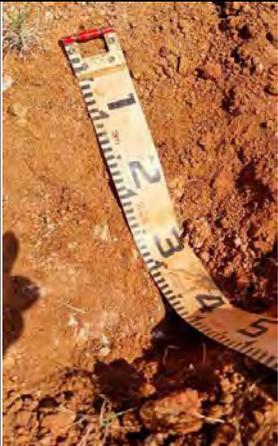
Horizon	Depth (mm)	Profile Photo	Boundary	Texture	Moist Colour	Mottle (colour, abundance)	Segregations (abundance, nature)	Coarse fragments (abundance, size)	Structure (type)	Structure (grade)	Consistence (soil water status)	Roots (abundance, size)	pH	EC (dS/m)	Depth of Sample for Lab (mm)		
A	0-100

Clear	Sandy Clay Loam	2.5yr 2.5/4		Not recorded	20-50 % 6-20 mm								0-100	
B	100-250			Sandy Clay Loam	10R 4/6			50-90 % 20-60 mm									NA

Other information: Depth of refusal 250mm due to increase in rock fraction. B horizon not sampled due to difficulty in digging of rocky material.

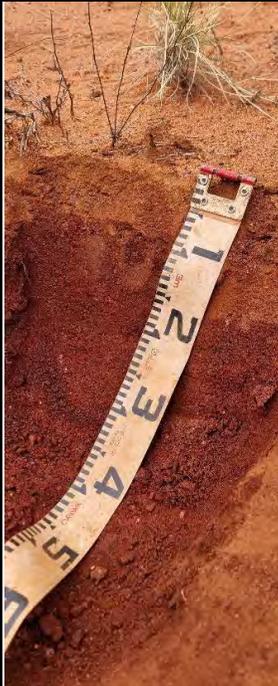
Horizon	Depth (mm)	Profile Photo	Boundary	Texture	Moist Colour	Mottle (colour, abundance)	Segregations (abundance, nature)	Coarse fragments (abundance, size)	Structure (type)	Structure (grade)	Consistence (soil water status)	Roots (abundance, size)	pH	EC (dS/m)	Depth of Sample for Lab (mm)	
A	0-100

Clayey Sand	2.5yr 2.5/3			2-10 % 2-6 mm							0-100	
B	100-300			Sandy Loam	2.5yr 3/6			10-20 % 2-6 mm								200-300

Other information: Depth of refusal 300mm.

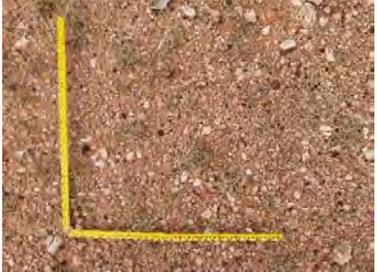
Soil Surface Condition Photo

Project 2211.24b	Date 13/06/2024	Scribe M.White	Location SP04	Observation Soil pit	Easting/ Latitude	Zone	ASC Mapped
Dominant Vegetation Form Non-woody		Ground Cover % Sparse (10-30%)		Aspect	Northing/ Longitude	Scale	ASC Ground Truth
Secondary Vegetation Form Woody		Ground Cover % Very sparse (0.2-10%)		Slope %	Rock Outcrop Slightly rocky	Erosion Type None evident	
Vegetation (species) trioidis					Drainage (site) Imperfectly drained	Erosion Extent None evident	
Landform Upper slope			Soil Surface Condition (dry) Firm		Land Use Grazing	Erosion State None evident	
Landscape Photo (North)

Dominant Vegetation Photo 2		Other Vegetation Photo		Other Information: Surface rock cover 70%, 20-60mm.

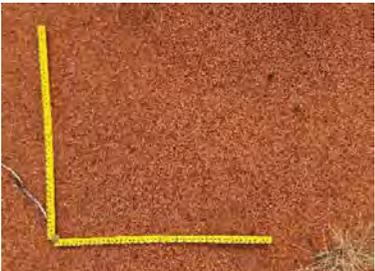
Soil Surface Condition Photo

Project 2211.24b	Date 13/06/2024	Scribe M.White	Location SP05	Observation Soil pit	Easting/ Latitude	Zone	ASC Mapped
Dominant Vegetation Form Non-woody		Ground Cover % Mid-dense (30-70%)	Aspect		Northing/ Longitude	Scale	ASC Ground Truth
Secondary Vegetation Form Woody		Ground Cover % Sparse (10-30%)	Slope %		Rock Outcrop No rock outcrop	Erosion Type None evident	
Vegetation (species) triodia					Drainage (site) Moderately well-drained	Erosion Extent None evident	
Landform Flat		Soil Surface Condition (dry) Firm		Land Use Grazing	Erosion State None evident		
Landscape Photo (North)

Other Photo		Microrelief Type Vertical (m) Horizontal (m) Sampled	
Dominant Vegetation Photo 1		Dominant Vegetation Photo 2		Other Vegetation Photo		Other Information: Very limited surface rock cover.

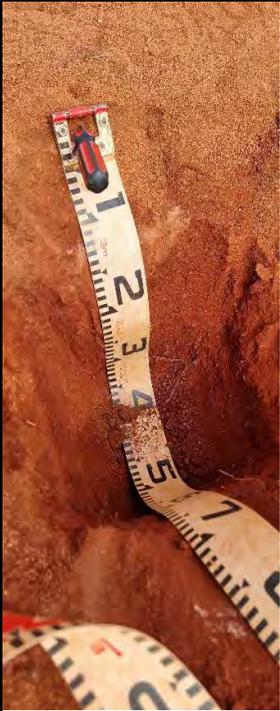
Horizon	Depth (mm)	Profile Photo	Boundary	Texture	Moist Colour	Mottle (colour, abundance)	Segregations (abundance, nature)	Coarse fragments (abundance, size)	Structure (type)	Structure (grade)	Consistence (soil water status)	Roots (abundance, size)	pH	EC (dS/m)	Depth of Sample for Lab (mm)	
A	0-100

Clear	Clayey Sand	10r 3/6			2-10 % 2-6 mm							0-100	
B	100-300			Clay Loam	10r 4/6			10-20 % 6-20 mm								200-300

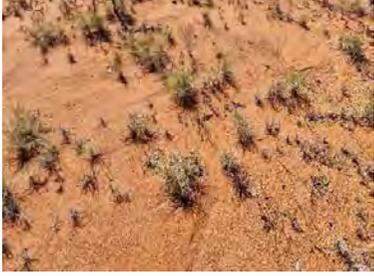
Other Photo

Microrelief Type Vertical (m) Horizontal (m) Sampled	
Dominant Vegetation Photo 1		Dominant Vegetation Photo 2		Other Vegetation Photo		Other Information: Signs of past running water. Negligible surface rock cover.

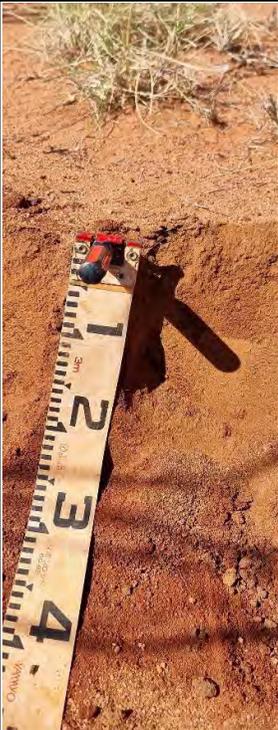
Horizon	Depth (mm)	Profile Photo	Boundary	Texture	Moist Colour	Mottle (colour, abundance)	Segregations (abundance, nature)	Coarse fragments (abundance, size)	Structure (type)	Structure (grade)	Consistence (soil water status)	Roots (abundance, size)	pH	EC (dS/m)	Depth of Sample for Lab (mm)	
A	0-100

Clear	Loamy Sand		10r 3/4		2-10 % 6-20 mm							0-50	
B	100-250			Clayey Sand		10r 4/8		2-10 % 2-6 mm							150-250

Other information: Depth of refusal 250m. Sandier than other similar red earths. B horizon is also a sand.

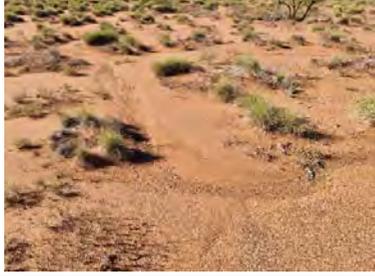
Other Photo

<p>Other Information: Water erosion on surface nearby. Rock covrr 10% 20-60..</p>

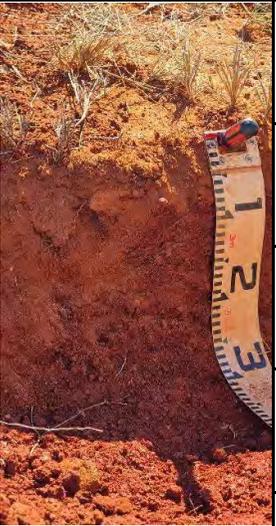
Horizon	Depth (mm)	Profile Photo	Boundary	Texture	Moist Colour	Mottle (colour, abundance)	Segregations (abundance, nature)	Coarse fragments (abundance, size)	Structure (type)	Structure (grade)	Consistence (soil water status)	Roots (abundance, size)	pH	EC (dS/m)	Depth of Sample for Lab (mm)	
A	0-100

Clear	Clayey Sand	2.5yr 3/6		2-10 % 2-6 mm								0-100	
B	100-300			Clay Loam	2.5yr 2.5/4		10-20 % 6-20 mm								200-300	
Other information:

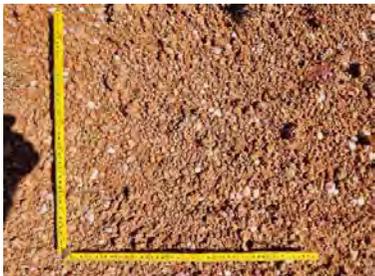
Soil Surface Condition Photo

Site Type Detailed + Sampled for Lab Microrelief Type Vertical (m) Horizontal (m) Sampled Other Information: Undulating are on thr bank of a dry stream. Surface rock cover 70% 20-60mm.
Landscape Photo (South)

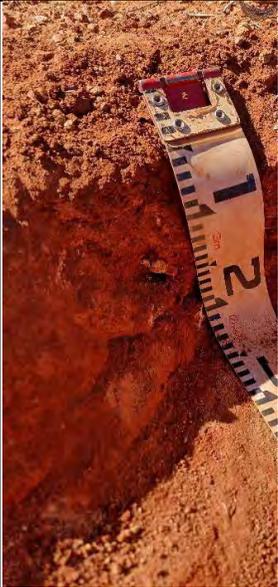
Horizon	Depth (mm)	Profile Photo	Boundary	Texture	Moist Colour	Mottle (colour, abundance)	Segregations (abundance, nature)	Coarse fragments (abundance, size)	Structure (type)	Structure (grade)	Consistence (soil water status)	Roots (abundance, size)	pH	EC (dS/m)	Depth of Sample for Lab (mm)	
A	0-100

Clear	Clay Loam	10R 4/6			2-10 % 2-6 mm							0-50	
B	100-200			Light Clay	10R 5/6			2-10 % 2-6 mm								100-200
Other information:

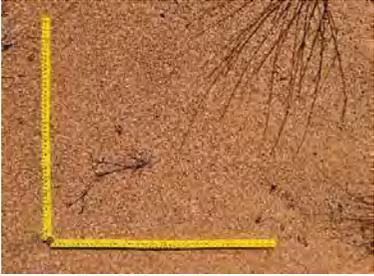
Soil Surface Condition Photo

Sampled Other Information: Evidence of past running water. Negligible surface rock cover. Location moved due to access, still representative of original location.

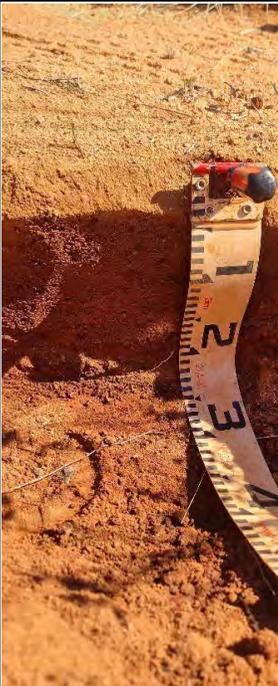
Horizon	Depth (mm)	Profile Photo	Boundary	Texture	Moist Colour	Mottle (colour, abundance)	Segregations (abundance, nature)	Coarse fragments (abundance, size)	Structure (type)	Structure (grade)	Consistence (soil water status)	Roots (abundance, size)	pH	EC (dS/m)	Depth of Sample for Lab (mm)	
A	0-100

Clear	Clayey Sand	2.5yr 3/3			<2 % 2-6 mm							0-50	
B	100-250			Clayey Sand	2.5yr 4/6			2-10 % 2-6 mm								150-250
Other information:

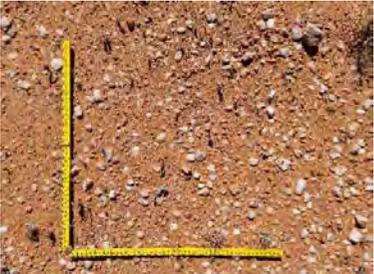
Soil Surface Condition Photo

Other Information: Vegetation is noticeably smaller in size surrounding the inspection site are. Same species are larger in size in adjacent are, 5-10m away. Surface rock cover 50%, 20-60mm quartz.

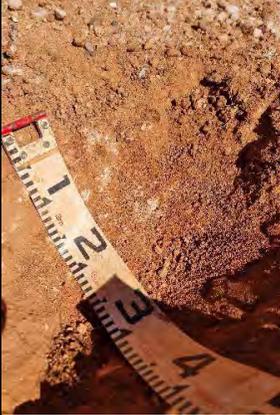
Horizon	Depth (mm)	Profile Photo	Boundary	Texture	Moist Colour	Mottle (colour, abundance)	Segregations (abundance, nature)	Coarse fragments (abundance, size)	Structure (type)	Structure (grade)	Consistence (soil water status)	Roots (abundance, size)	pH	EC (dS/m)	Depth of Sample for Lab (mm)		
A	0-150

Clay Loam	2.5yr 4/6			20-50 % 6-20 mm								0-100

Other information: Depth of refusal 150mm, due to abundance of rocks.

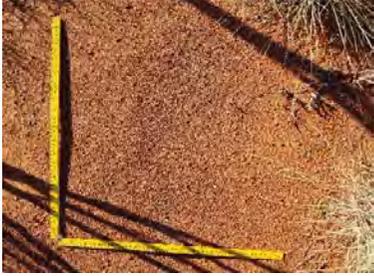
Soil Surface Condition Photo

Microrelief Type Vertical (m) Horizontal (m) Sampled	
Dominant Vegetation Photo 1		Dominant Vegetation Photo 2		Other Information: Surface rock cover 10%. 2-6mm.

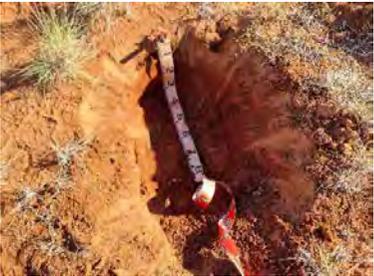
Horizon	Depth (mm)	Profile Photo	Boundary	Texture	Moist Colour	Mottle (colour, abundance)	Segregations (abundance, nature)	Coarse fragments (abundance, size)	Structure (type)	Structure (grade)	Consistence (soil water status)	Roots (abundance, size)	pH	EC (dS/m)	Depth of Sample for Lab (mm)
A	0-100

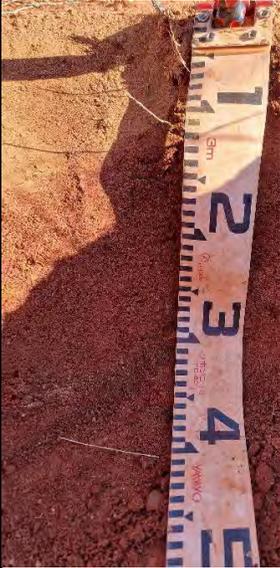
Clear	Loamy Sand		10yr 3/3		2-10 % 2-6 mm							0-50
B	100-350				Sandy Clay Loam		2.5yr 4/8		2-10 % 2-6 mm

Other information: Dug by shovel. depth of refusal 350mm. Area is gently sloping with a few rock outcrops.

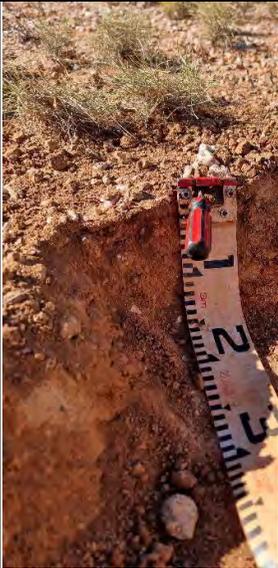
Horizon	Depth (mm)	Profile Photo	Boundary	Texture	Moist Colour	Mottle (colour, abundance)	Segregations (abundance, nature)	Coarse fragments (abundance, size)	Structure (type)	Structure (grade)	Consistence (soil water status)	Roots (abundance, size)	pH	EC (dS/m)	Depth of Sample for Lab (mm)		
A	0-50

Clear	Sandy Clay Loam	5yr 3/3			20-50 % 6-20 mm								0-50	
B	50-150			Sandy Clay Loam	5yr 6/6			10-20 % 2-6 mm									100-150

Other information: Shovel dug. Depth of refusal 150mm

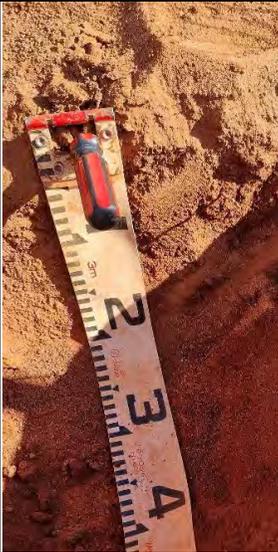
Horizon	Depth (mm)	Profile Photo	Boundary	Texture	Moist Colour	Mottle (colour, abundance)	Segregations (abundance, nature)	Coarse fragments (abundance, size)	Structure (type)	Structure (grade)	Consistence (soil water status)	Roots (abundance, size)	pH	EC (dS/m)	Depth of Sample for Lab (mm)	
A	0-100

Clear	Loamy Sand	2.5yr 2.5/3			2-10 % 2-6 mm							0-50	
B	100-200			Clayey Sand	2.5yr 4/6			2-10 % 2-6 mm								150-200

Other information: Depth of refusal 200mm. Site moved for accesibility.

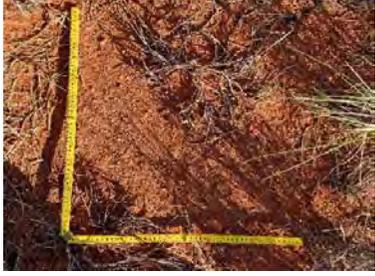
Soil Surface Condition Photo

<p>Other Information: Negligible surface rock cover. Site moved due to density of fegetation restricting vehicle access.</p>

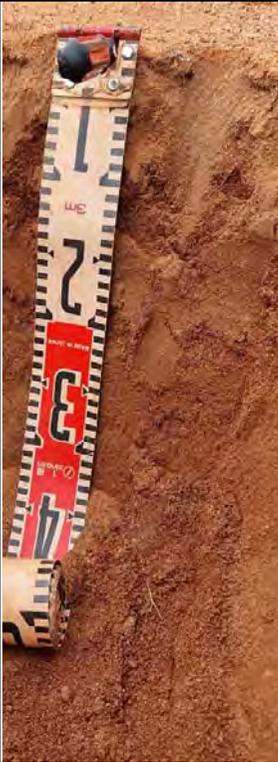
Horizon	Depth (mm)	Profile Photo	Boundary	Texture	Moist Colour	Mottle (colour, abundance)	Segregations (abundance, nature)	Coarse fragments (abundance, size)	Structure (type)	Structure (grade)	Consistence (soil water status)	Roots (abundance, size)	pH	EC (dS/m)	Depth of Sample for Lab (mm)	
A	0-100

Clear				<2 % 2-6 mm								0-100	
B	100-400						<2 % 2-6 mm								300-400

Other information: Depth of refusal 400mm due to soil density.

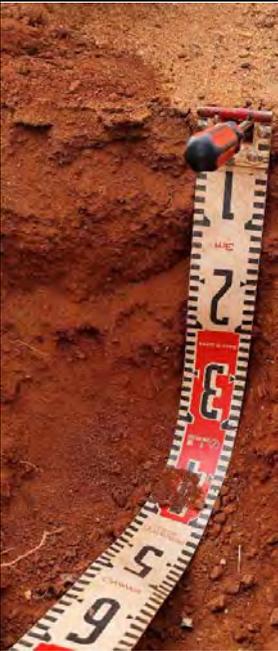
Horizon	Depth (mm)	Profile Photo	Boundary	Texture	Moist Colour	Mottle (colour, abundance)	Segregations (abundance, nature)	Coarse fragments (abundance, size)	Structure (type)	Structure (grade)	Consistence (soil water status)	Roots (abundance, size)	pH	EC (dS/m)	Depth of Sample for Lab (mm)	
A	0-100

Clear				<2 % 2-6 mm								0-100	
B	100-300						2-10 % 2-6 mm								200-300	
Other information:

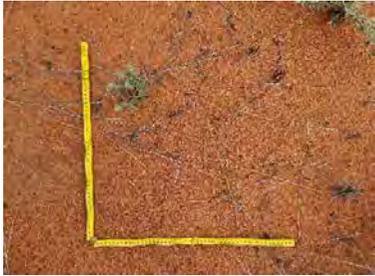
Soil Surface Condition Photo

Other Information: Surface rock cover 5%, 2-6mm.

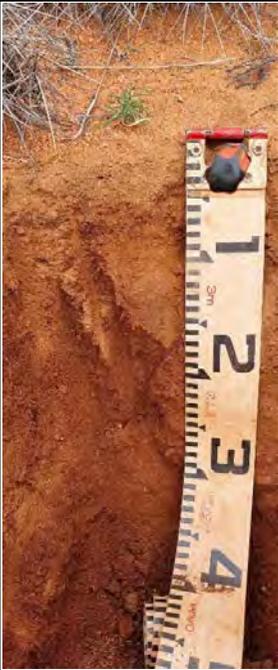
Horizon	Depth (mm)	Profile Photo	Boundary	Texture	Moist Colour	Mottle (colour, abundance)	Segregations (abundance, nature)	Coarse fragments (abundance, size)	Structure (type)	Structure (grade)	Consistence (soil water status)	Roots (abundance, size)	pH	EC (dS/m)	Depth of Sample for Lab (mm)
A	0-100

<2 % 2-6 mm							0-100
B	100-350							<2 % 2-6 mm							250-350
Other information:

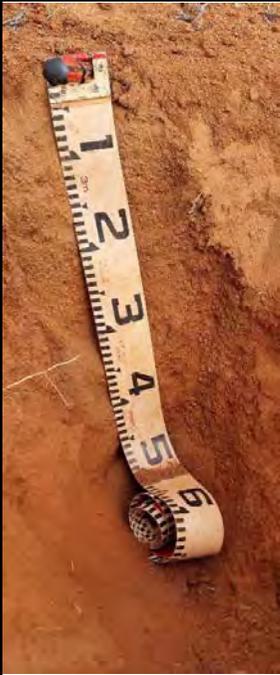
Horizon	Depth (mm)	Profile Photo	Boundary	Texture	Moist Colour	Mottle (colour, abundance)	Segregations (abundance, nature)	Coarse fragments (abundance, size)	Structure (type)	Structure (grade)	Consistence (soil water status)	Roots (abundance, size)	pH	EC (dS/m)	Depth of Sample for Lab (mm)	
A	0-100

Clear					<2 % 2-6 mm							0-100	
B1	100-350							2-10 % 2-6 mm								200-300
B2	350-500							2-10 % 6-20 mm								400-500

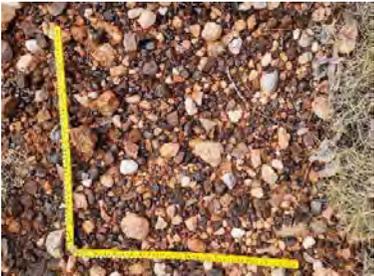
Soil Surface Condition Photo

Other Information: Surface rock cover 80%, 20-60mm.

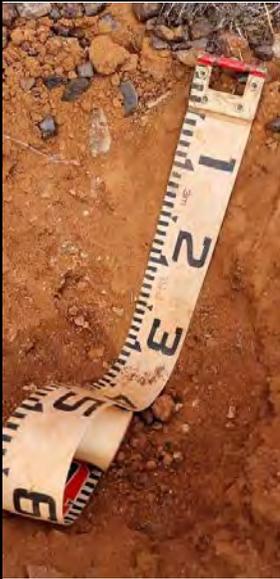
Horizon	Depth (mm)	Profile Photo	Boundary	Texture	Moist Colour	Mottle (colour, abundance)	Segregations (abundance, nature)	Coarse fragments (abundance, size)	Structure (type)	Structure (grade)	Consistence (soil water status)	Roots (abundance, size)	pH	EC (dS/m)	Depth of Sample for Lab (mm)	
A	0-100

Not recorded	20-50 % 20-60 mm							0-100	
B	100-250							20-50 % 20-60 mm							200-250

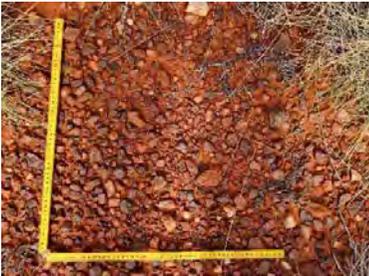
Soil Surface Condition Photo

Other Vegetation Photo		Sampled Other Information: Surface rock cover 60%. 20-60mm

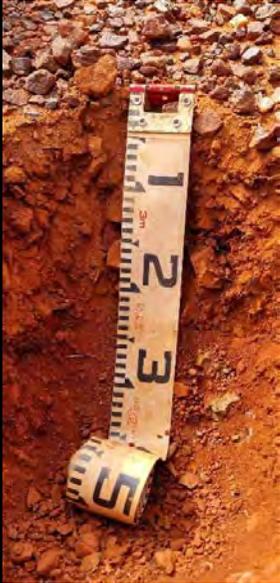
Horizon	Depth (mm)	Profile Photo	Boundary	Texture	Moist Colour	Mottle (colour, abundance)	Segregations (abundance, nature)	Coarse fragments (abundance, size)	Structure (type)	Structure (grade)	Consistence (soil water status)	Roots (abundance, size)	pH	EC (dS/m)	Depth of Sample for Lab (mm)	
A	0-100

50-90 % 20-60 mm								0-100	
B	100-300							50-90 % 20-60 mm								200-300

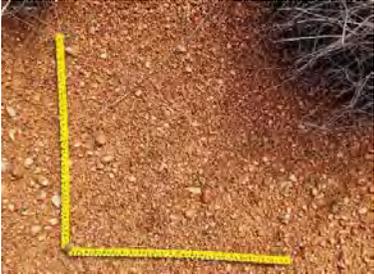
Soil Surface Condition Photo

Other Vegetation Photo		Other Information: Area containing weathered rock. Surface rock cover 70% 6-60mm

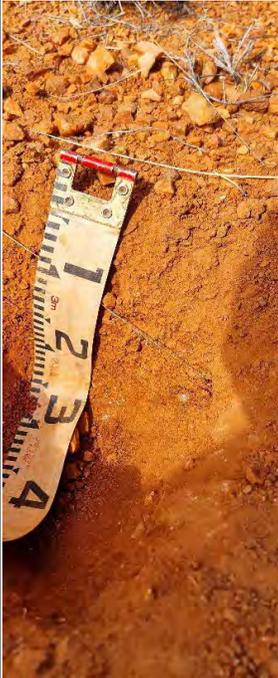
Horizon	Depth (mm)	Profile Photo	Boundary	Texture	Moist Colour	Mottle (colour, abundance)	Segregations (abundance, nature)	Coarse fragments (abundance, size)	Structure (type)	Structure (grade)	Consistence (soil water status)	Roots (abundance, size)	pH	EC (dS/m)	Depth of Sample for Lab (mm)	
A	0-100

20-50 % 20-60 mm							0-100	
B	100-300							20-50 % 6-20 mm							200-300	
Other information:
