**Various Lots Larsen Road & Briggs
Road, Byford**

Local Water Management Strategy

Prepared for

June 2020

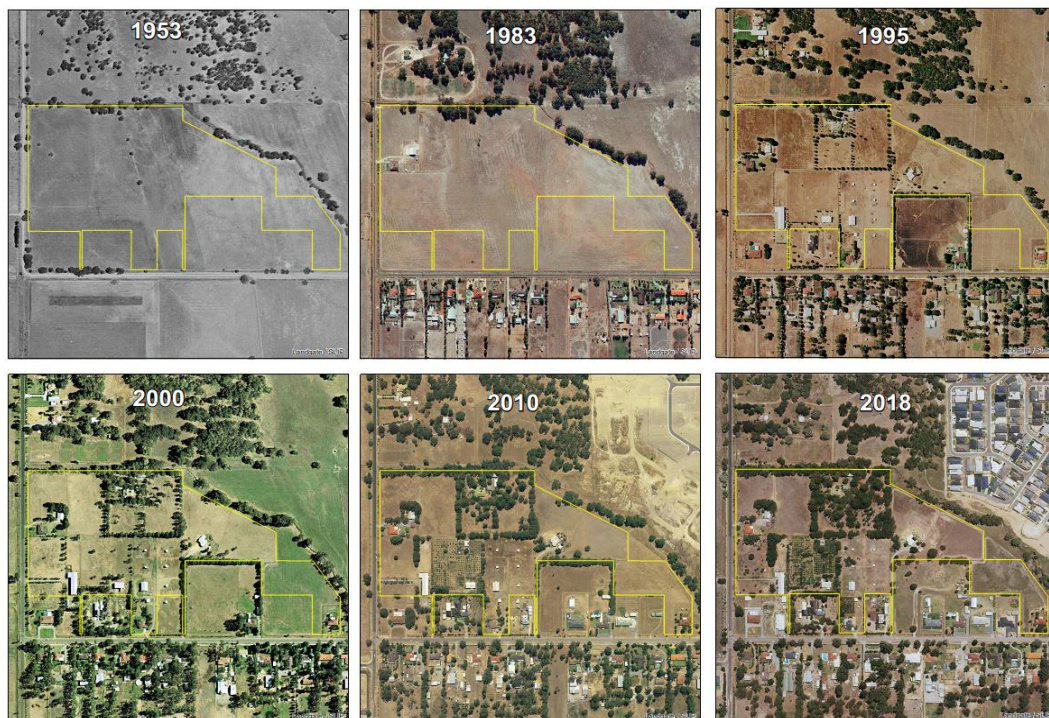
Plate 1: Historical Imagery

Aerial imagery of the site is available from Landgate dated from 1953 (Plate 1). The aerial images show that the land was cleared prior to 1953 and was undeveloped. Only one lot was developed in the western area of the site between 1953 and 1983. The buildings were constructed after 1983 and planting increased vegetation, particularly along property boundaries and fencelines. No additional infrastructure has been built since 1995, and vegetation density in the north and southwestern area increased.

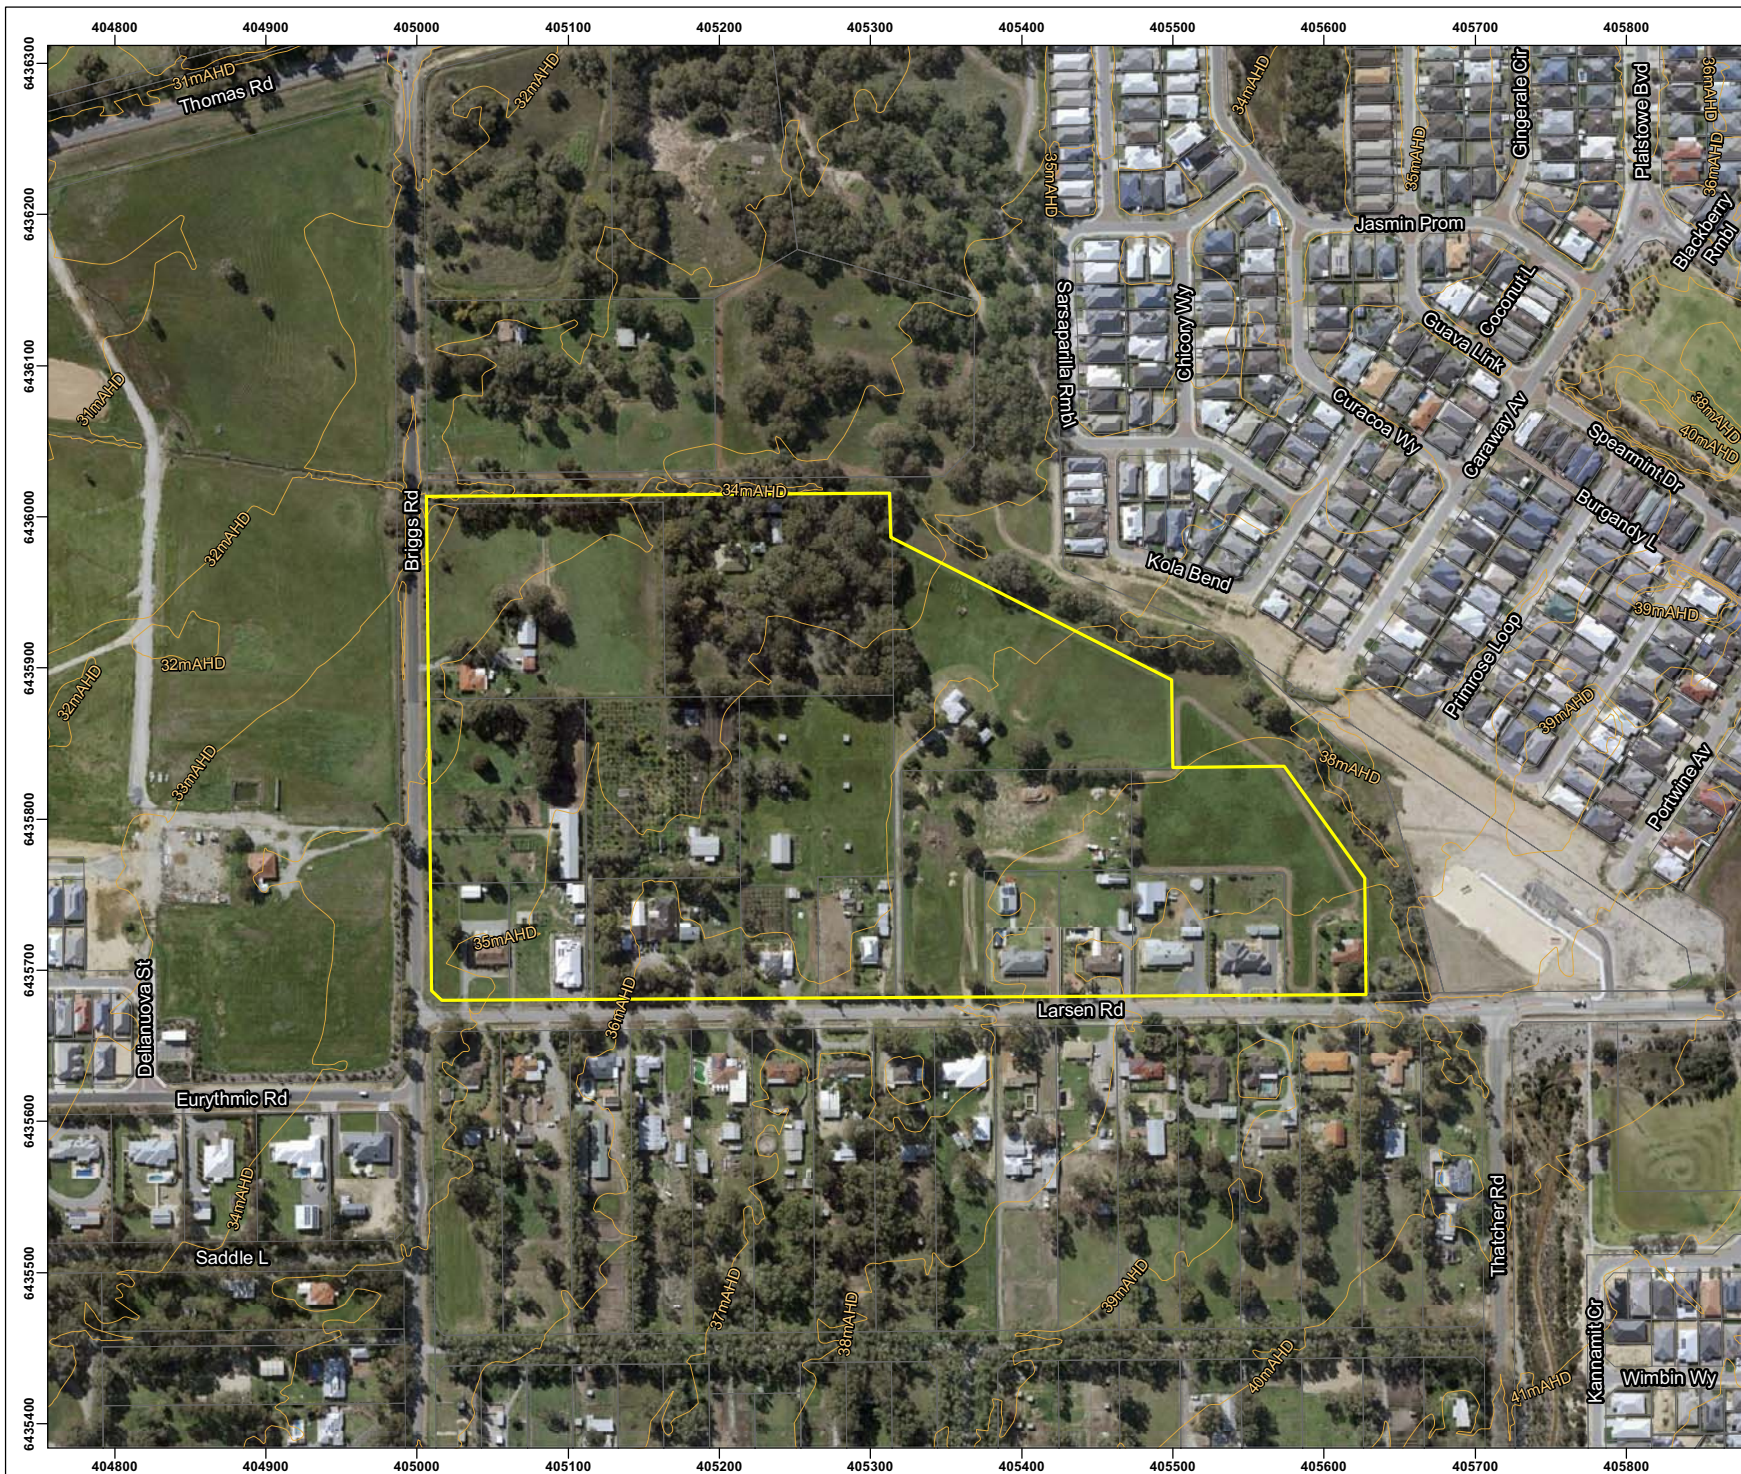
Figure 3 Topography

- Legend**
- Site Boundary
 - Contours 1m
 - Lot Boundaries

Topography Section 2.2	The site varies between 33 and 39 meters Above Height Datum (mAHD) and gently slopes from the south east to the north west (Figure 3). The topography (Section 4.2) indicates that the site drains northwest towards Oaklands Drain located outside the site's northern boundary
Soil Type Section 2.4	The soil landscape subsystem (Department of Primary Industries and Regional Development (DPIRD) 2019) classifies the surface soils onsite as 'Shallow pale sand to sandy loam over very gravelly clay, moderately well drained'.
Wetland Mapping Section 2.6	The site is mapped as a multiple use wetland (UFI 15797)
Groundwater levels Section 2.7.2	<ul style="list-style-type: none"> • A search of the Perth Groundwater Map (DWER, 2019c) was conducted and it is noted that the maximum groundwater level contours were found not to extend to the site • Four boreholes were installed on site to a depth of 5.5m to 7.5 m under the supervision of 360 Environmental staff in July 2019 for the purpose of determining the pre-development groundwater levels

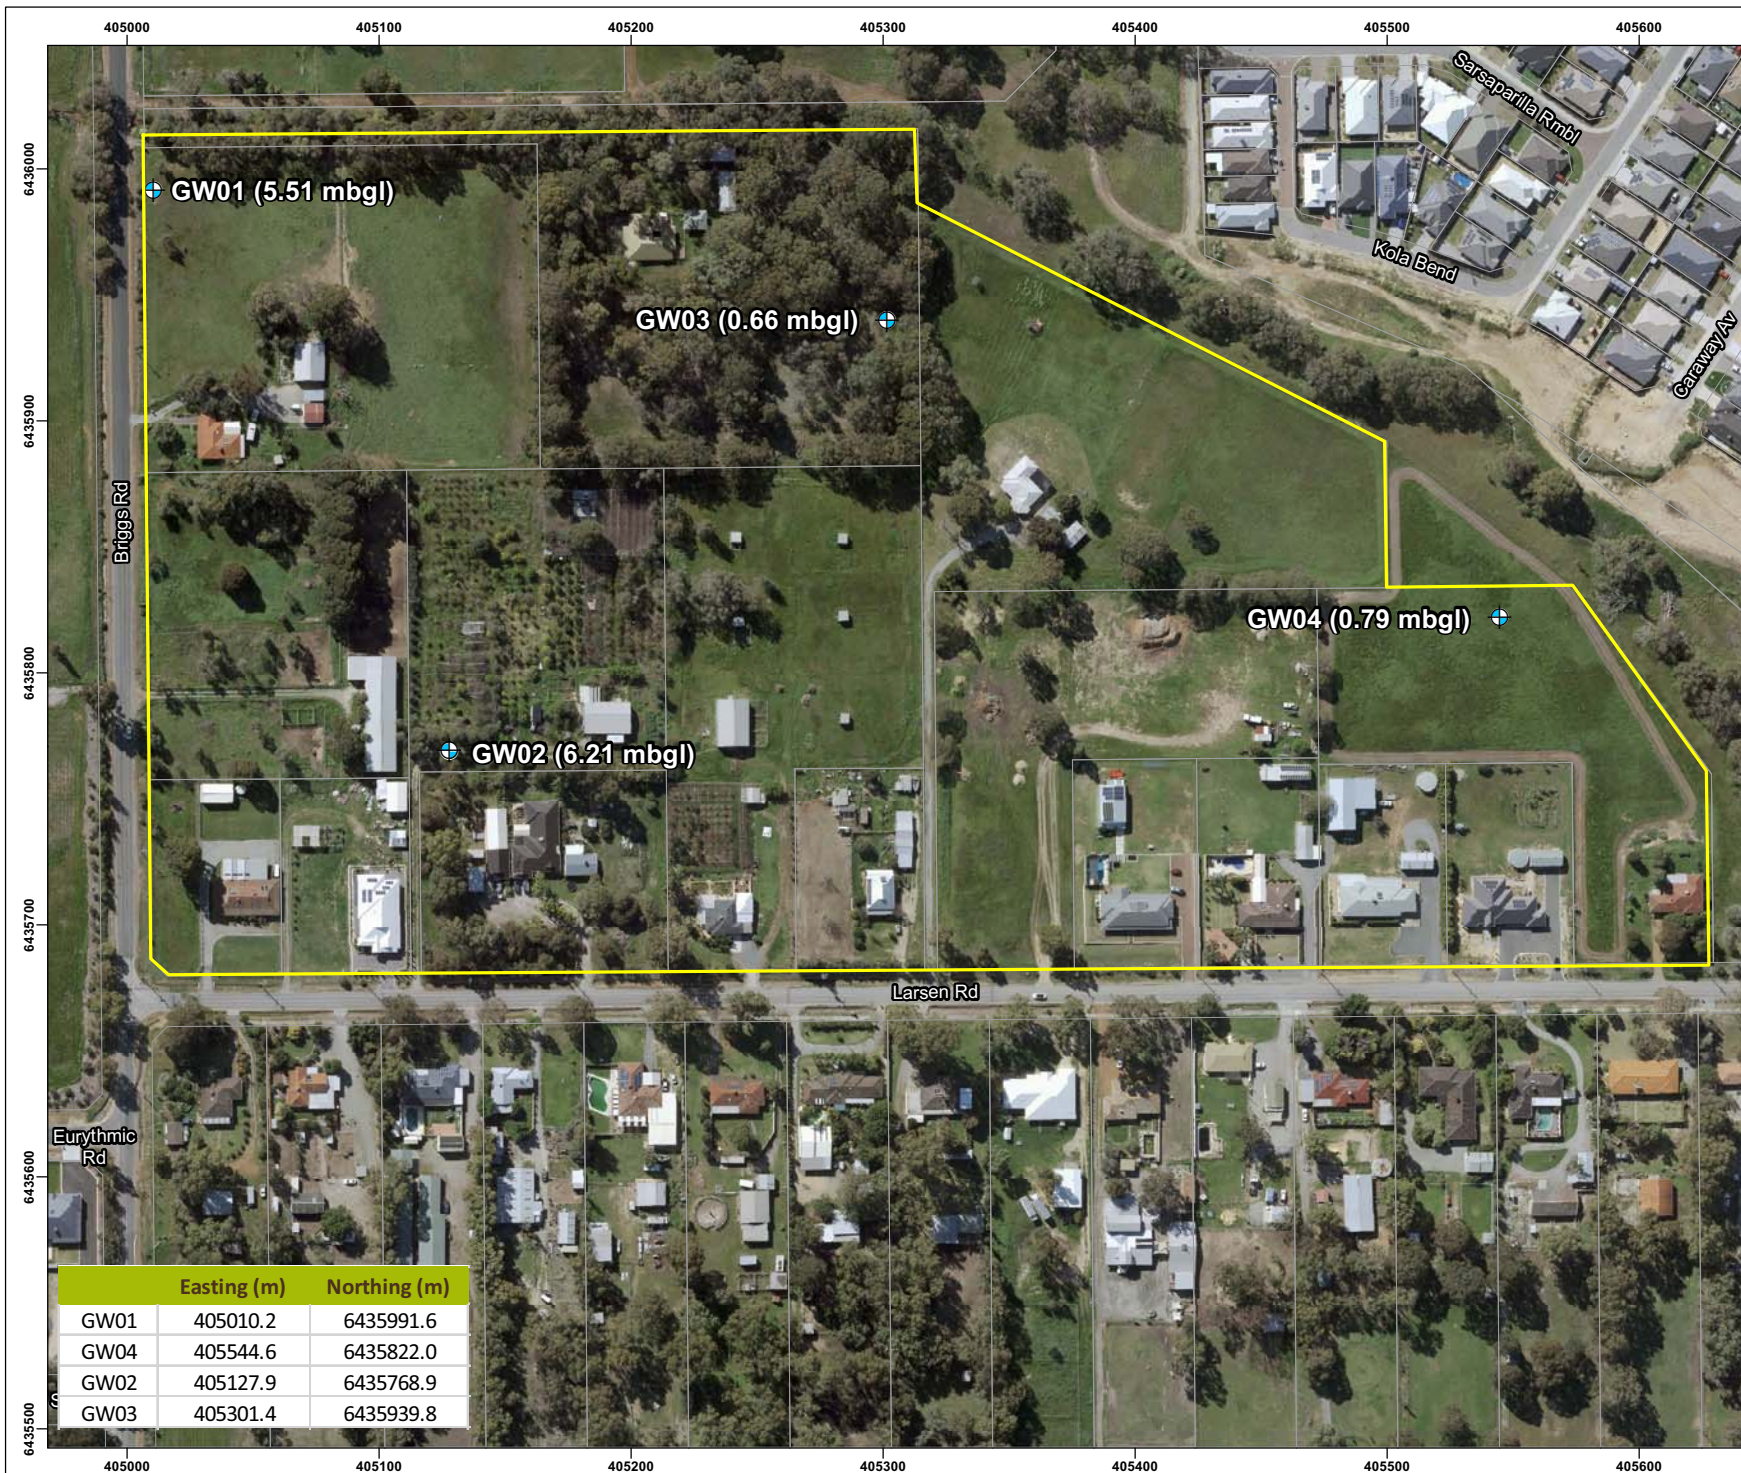
Local Water Management
Strategy
Figure 7 2019 Peak
Groundwater Level

- Site Boundary
- Lot Boundaries
- Groundwater Monitoring Well Locations (2019 max level)

Variability in the clay content found in the soils on site was observed during the drilling and installation of the groundwater monitoring bores which appears to be influencing the groundwater levels recorded on site in 2019. The depth to groundwater significantly varies through the site with peak 2019 groundwater levels in the west and south west being approximately 5.5 m bgl (GW01) to 6.2 m bgl (GW02), while groundwater levels recorded in the east of the site were significantly closer to the natural surface with GW03 recording a peak groundwater level 0.66 m bgl and 0.79 m bgl at GW04.

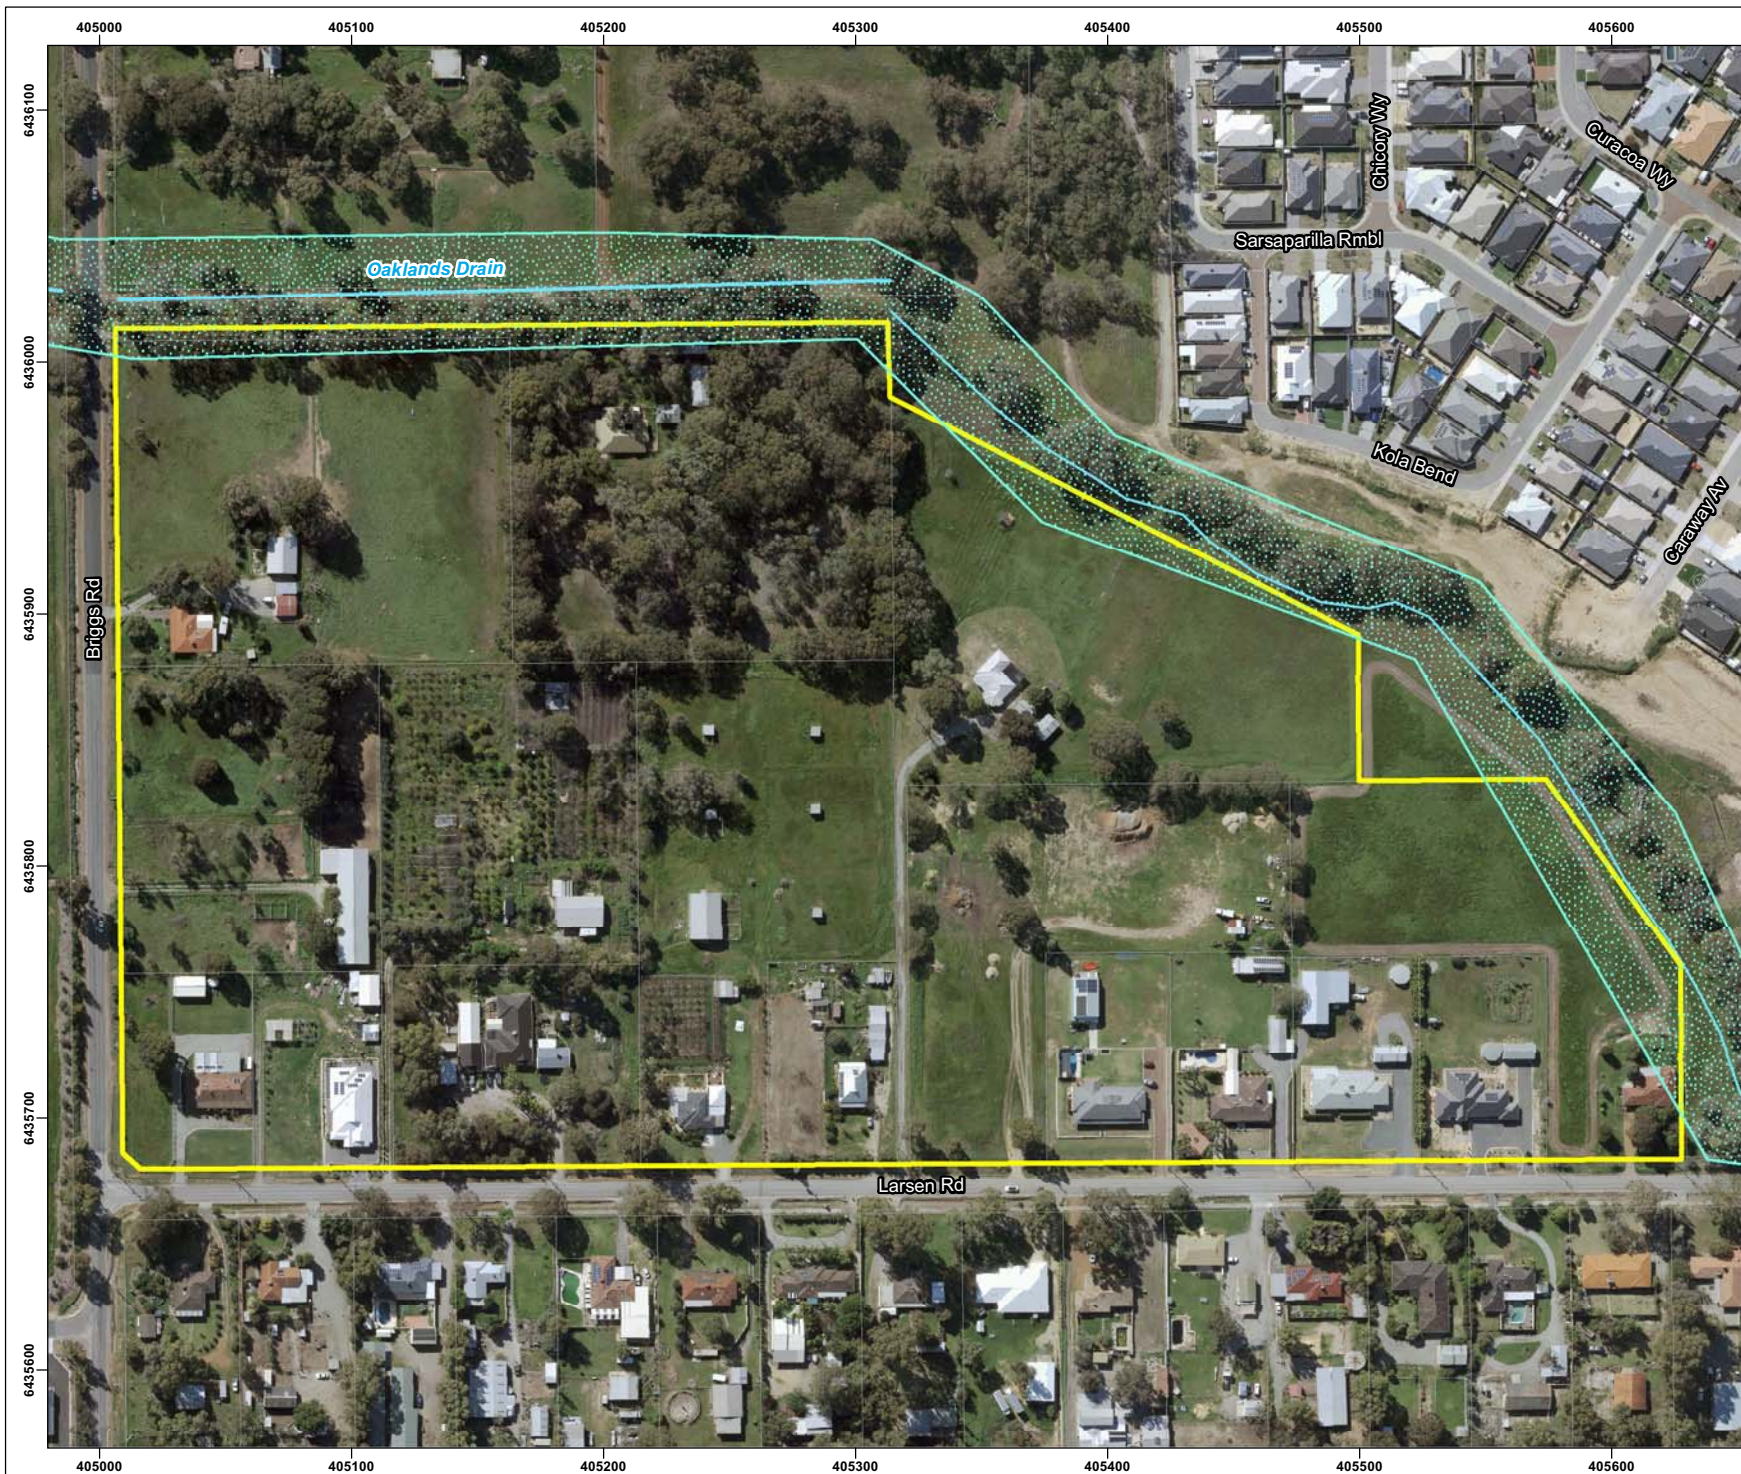
Figure 8 Surface Water Features
and Floodway

- Site Boundary
- Lot Boundaries
- 1% AEP Floodway
- Watercourse - minor
- Drain - major

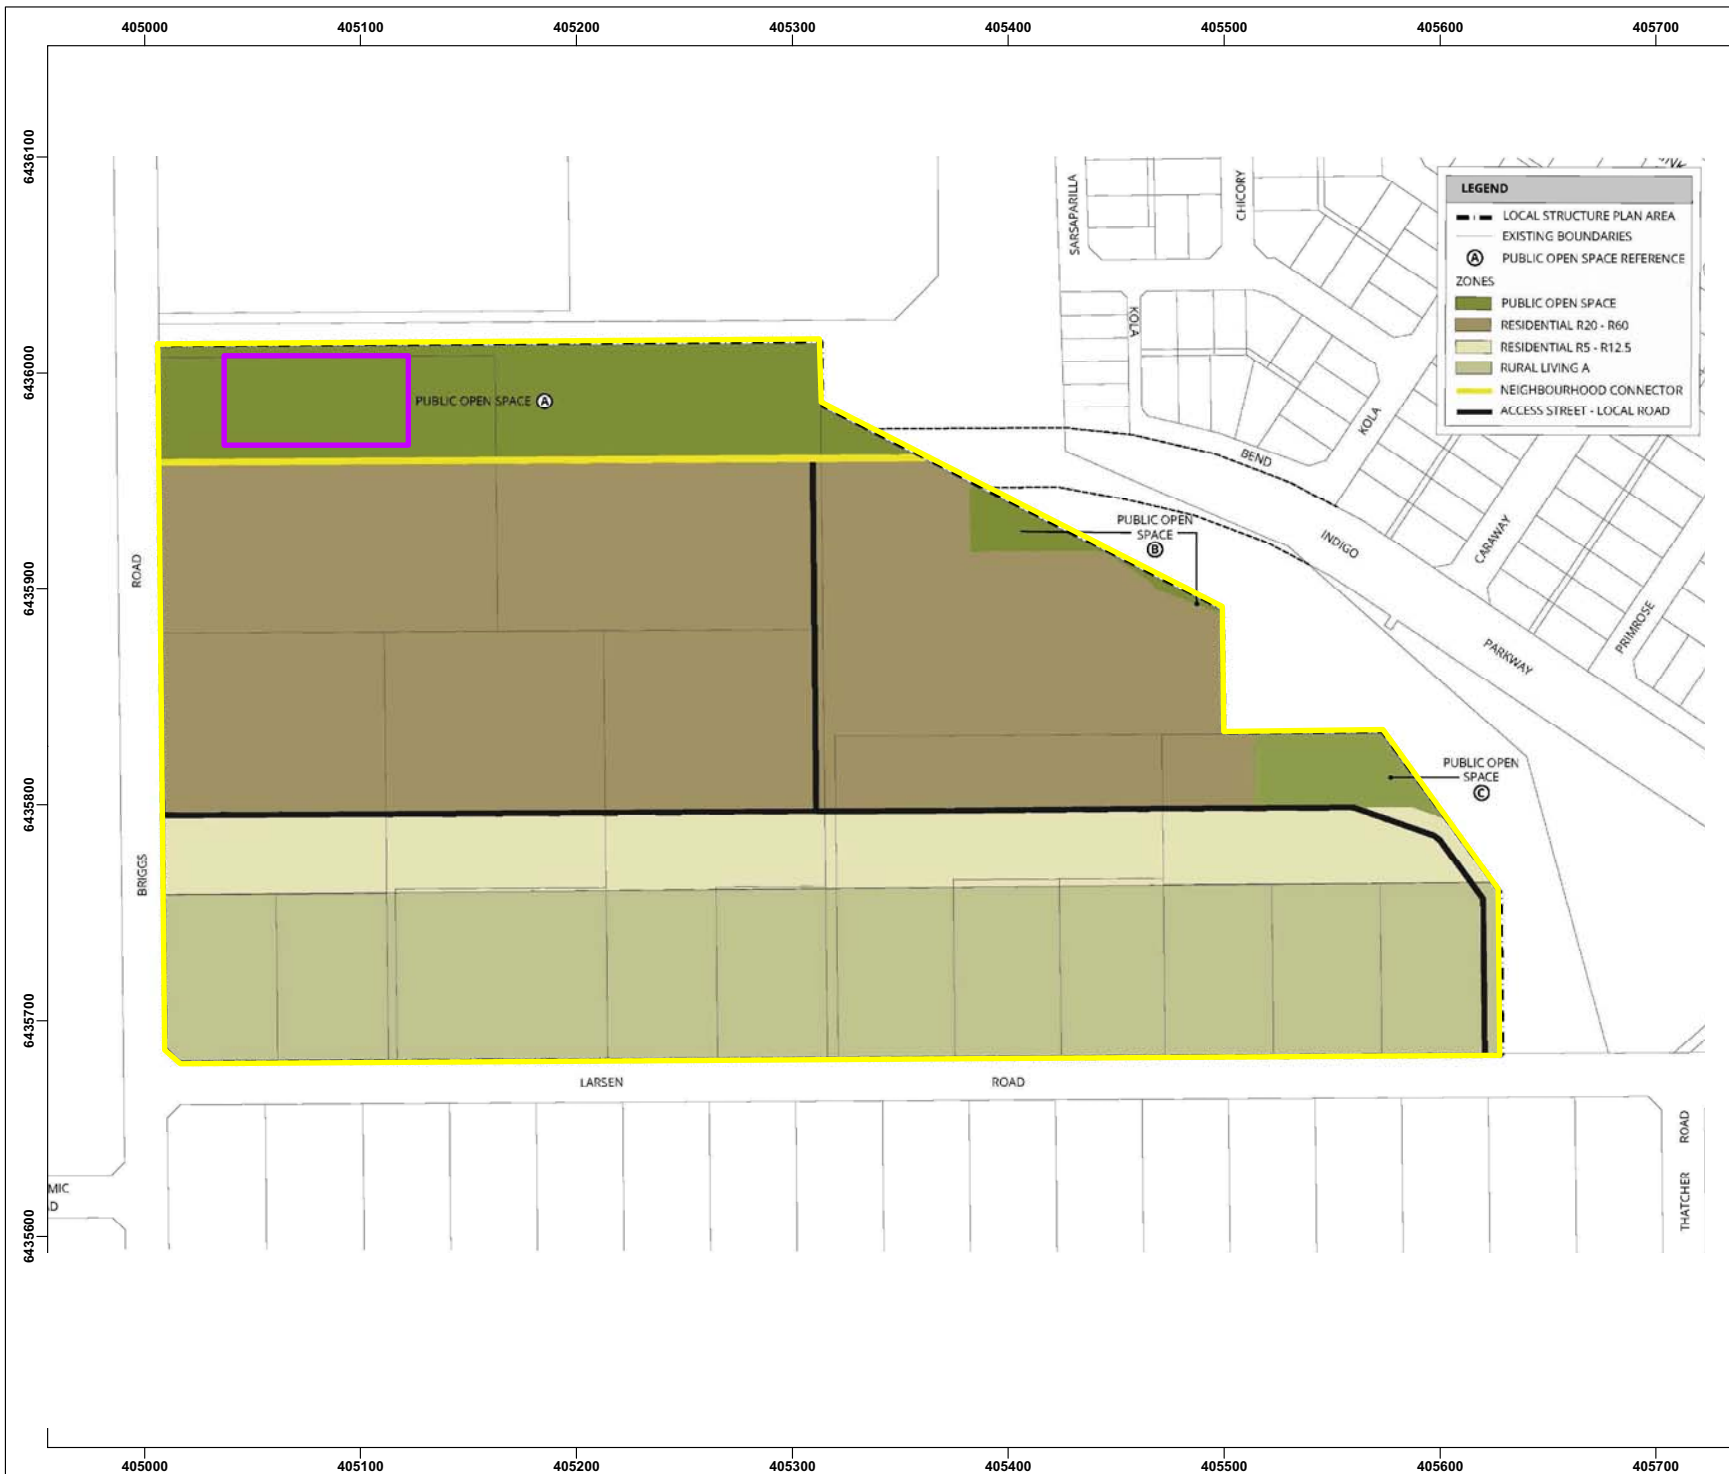
Figure 10 Detention Basin

- ### Legend
- Site Boundary
 - Detention Basin

The discharge pipe will drain water from the basin to Oaklands Drain. A 450 mm diameter pipe located at the basin invert was modelled as the discharge pipe. This is because the soil onsite is clayey and accumulated water is not able to infiltrate within the required timeframe.

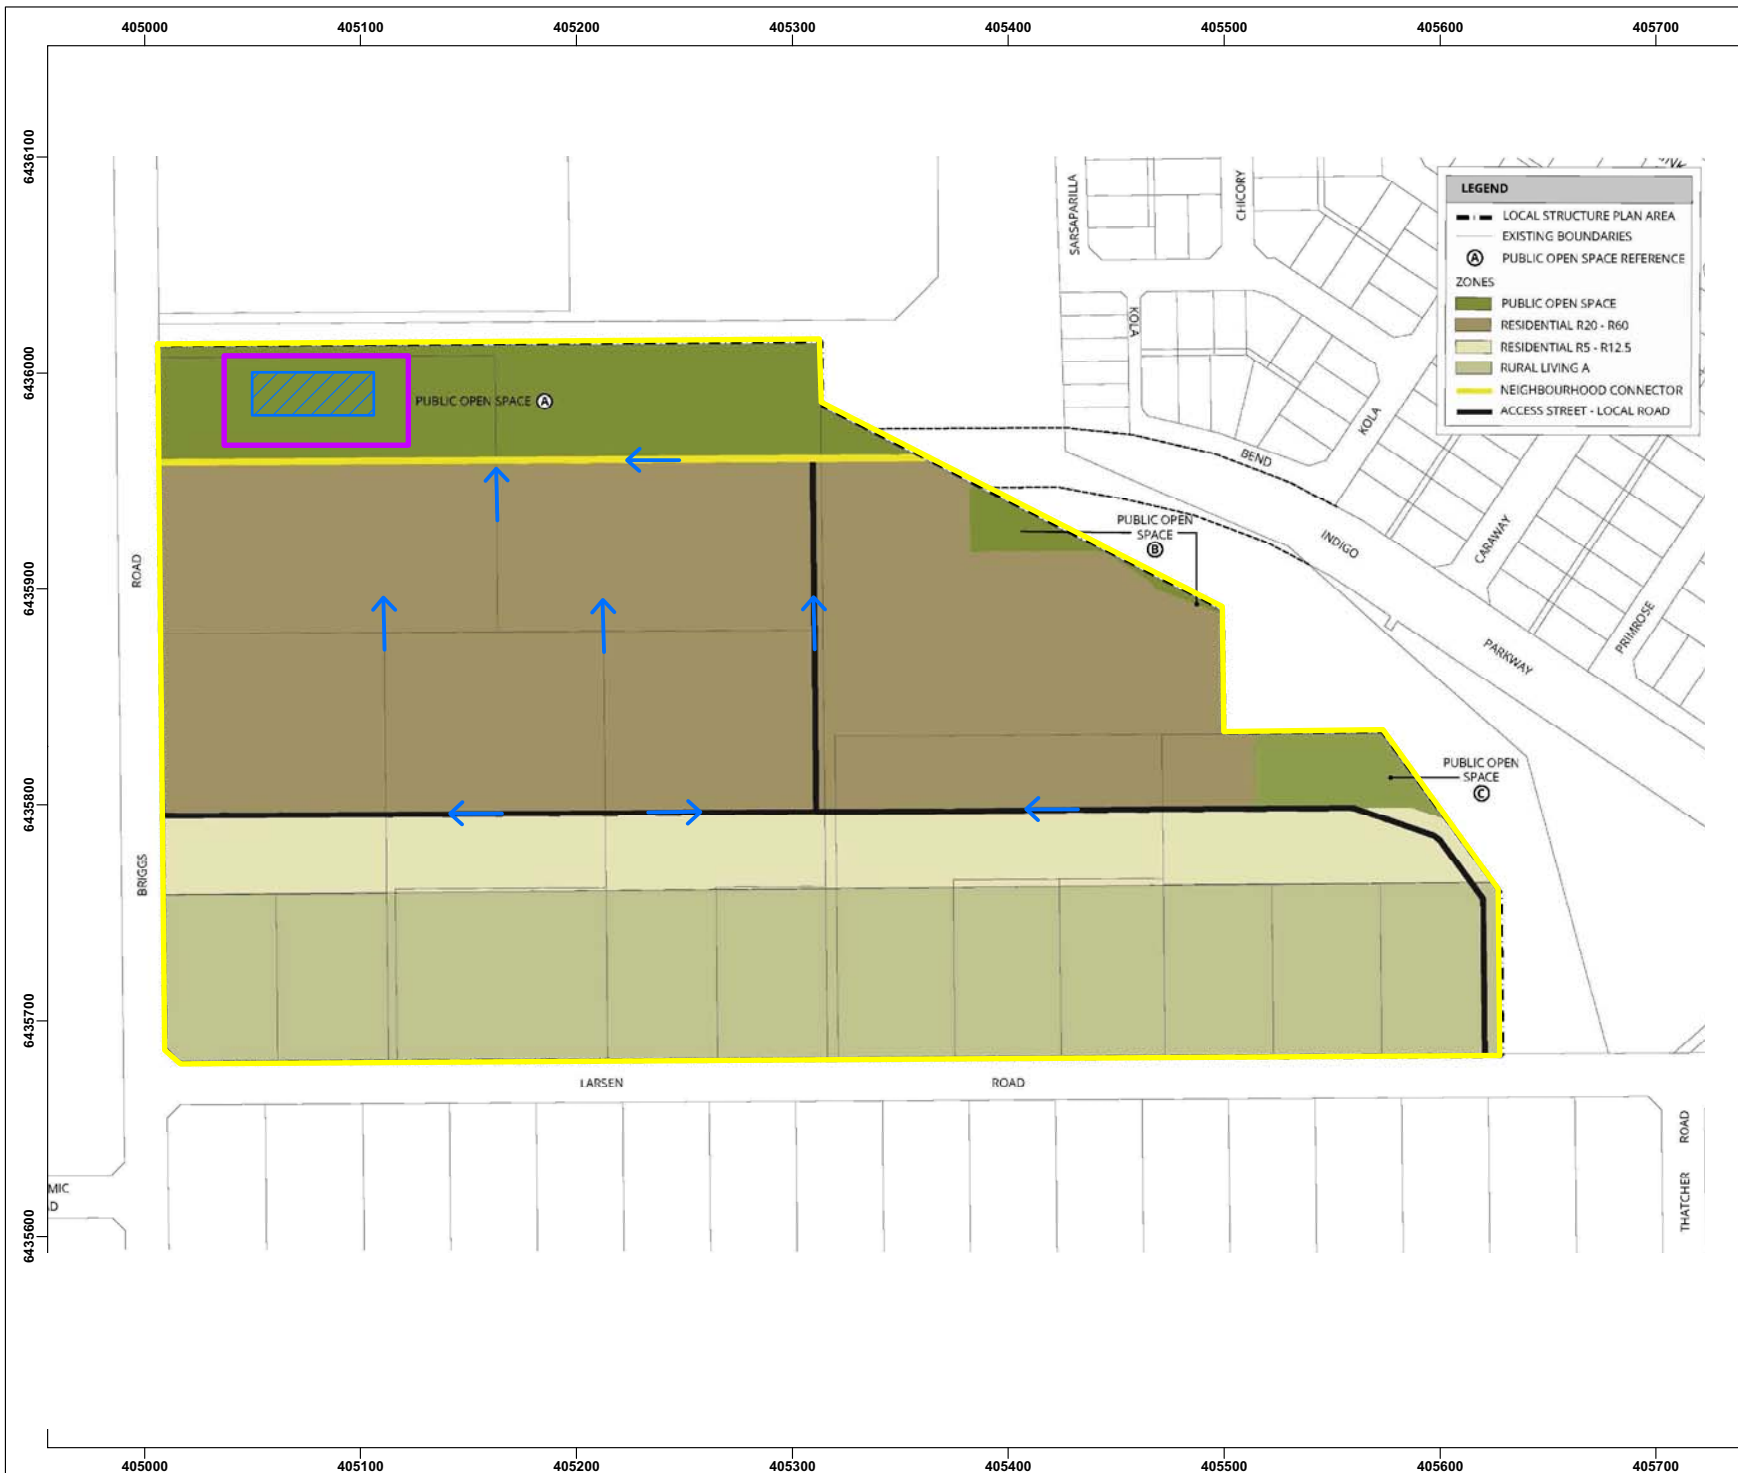
**Figure 11a
 Minor Event Plan**

- Site Boundary
- Detention Basin
(Surface dimension 80m x 30m)
- 20% AEP Inundation Area
(Surface dimension 79m x 29m)
- ← Indicative Flow Path

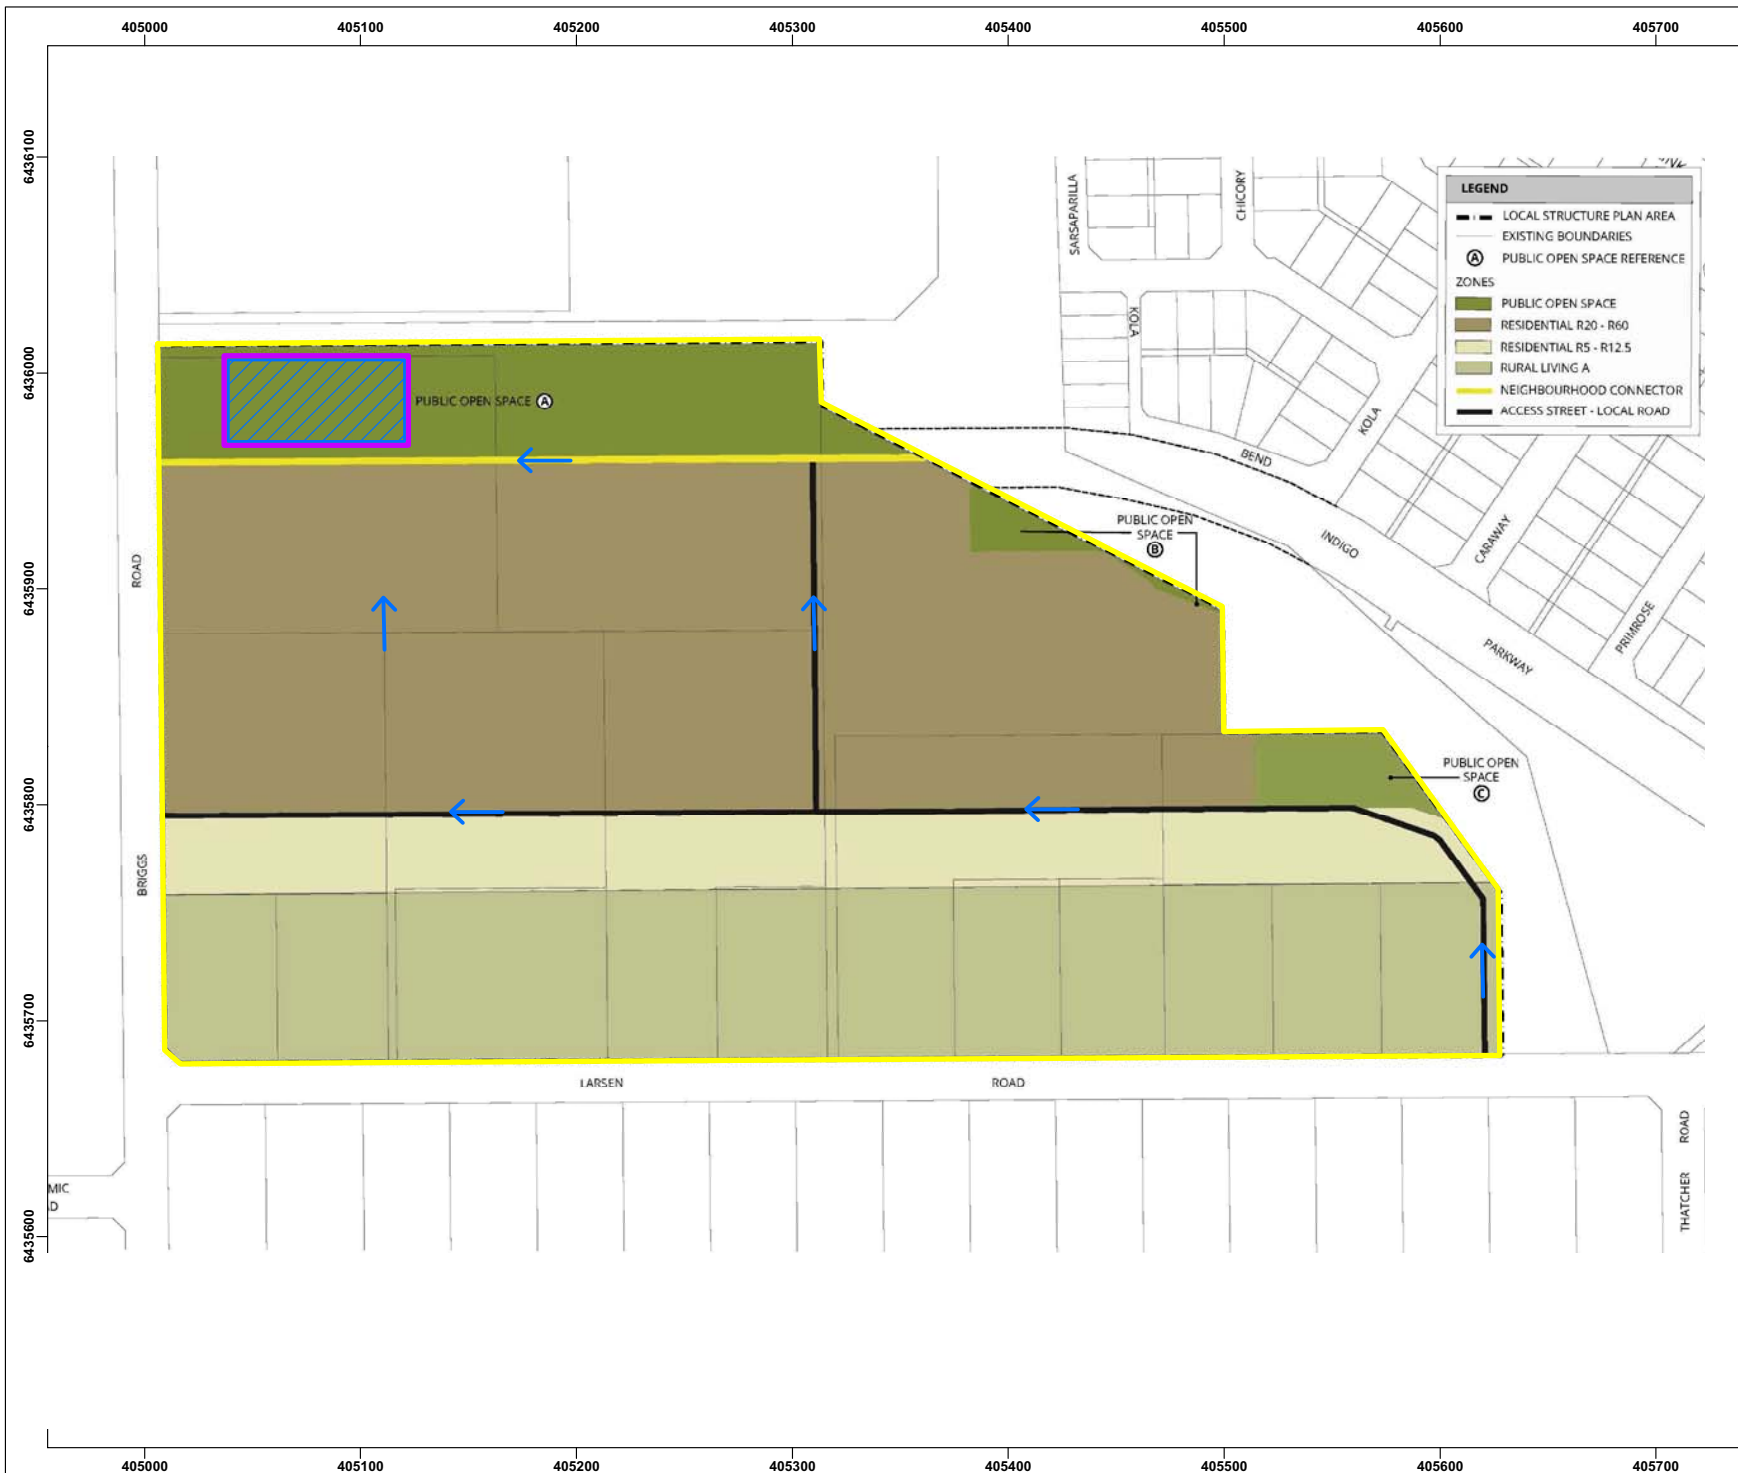
- Site Boundary
- Detention Basin
(Surface dimension 80m x 30m)
- 1% AEP Inundation Area
(Surface dimension 80m x 30m)
- Indicative Flow Path

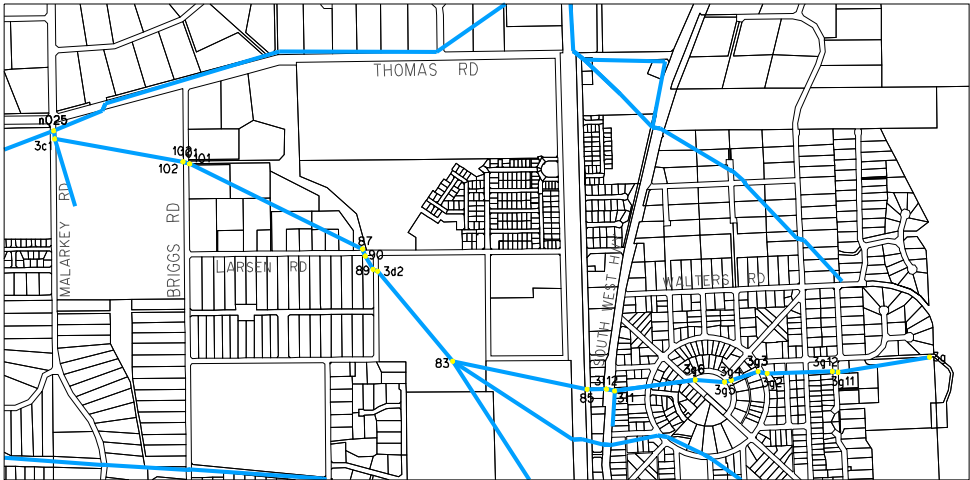
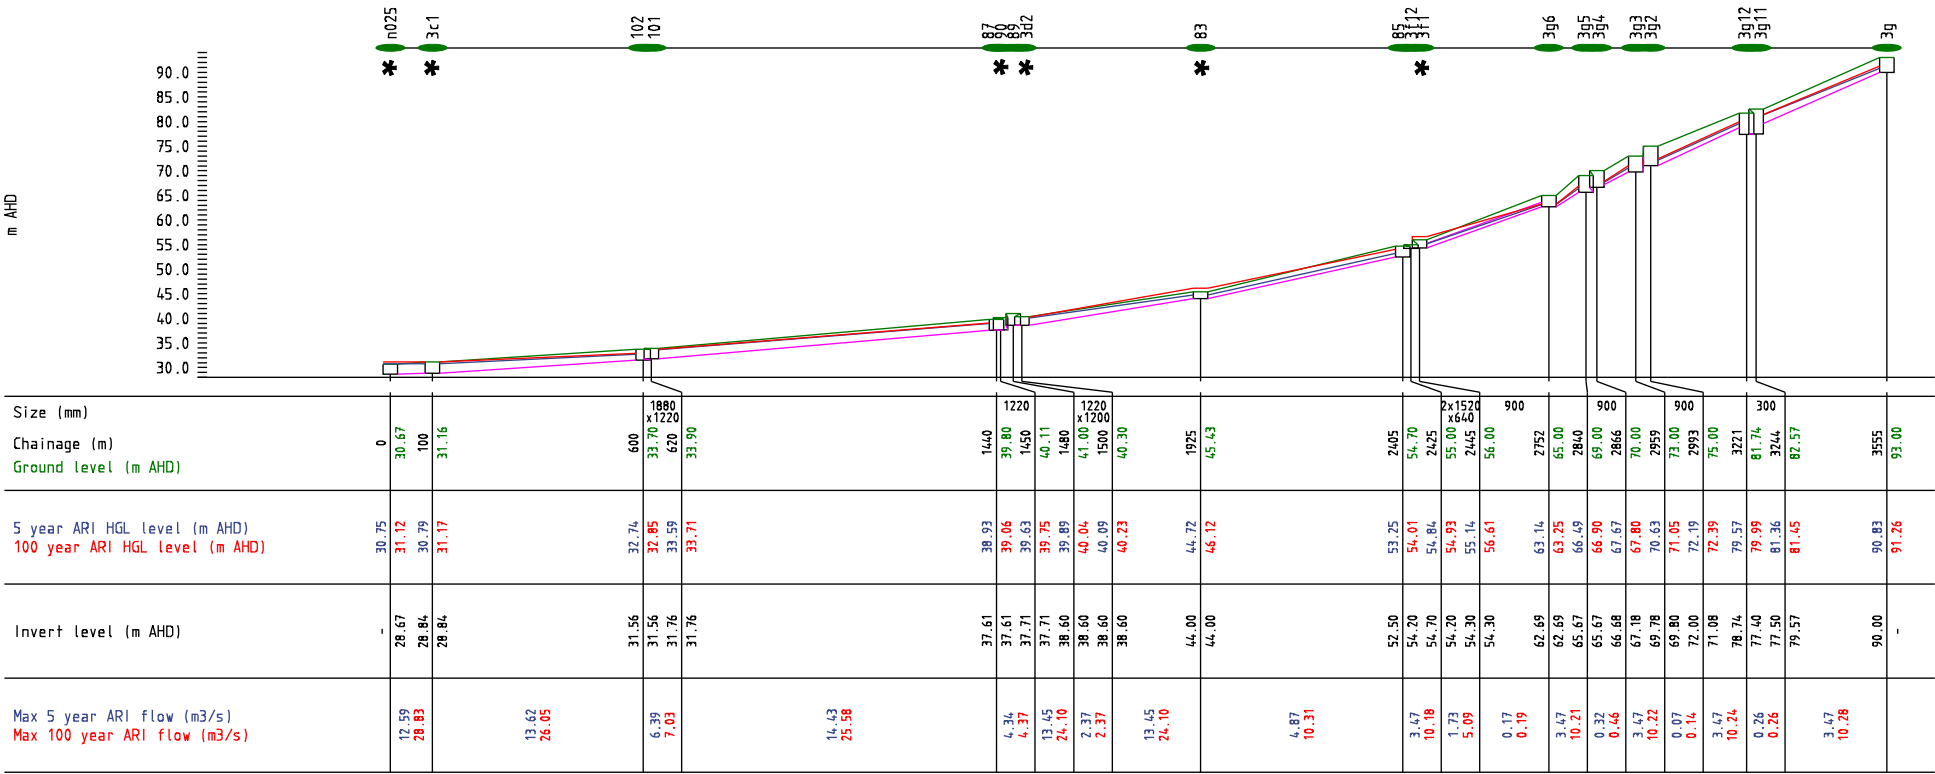
2008 DWMP Oaklands Drain Longitudinal Section

* INDICATES FLOODING DURING 100 YR ARI STORM EVENT

OAKLANDS DRAIN CENTRAL

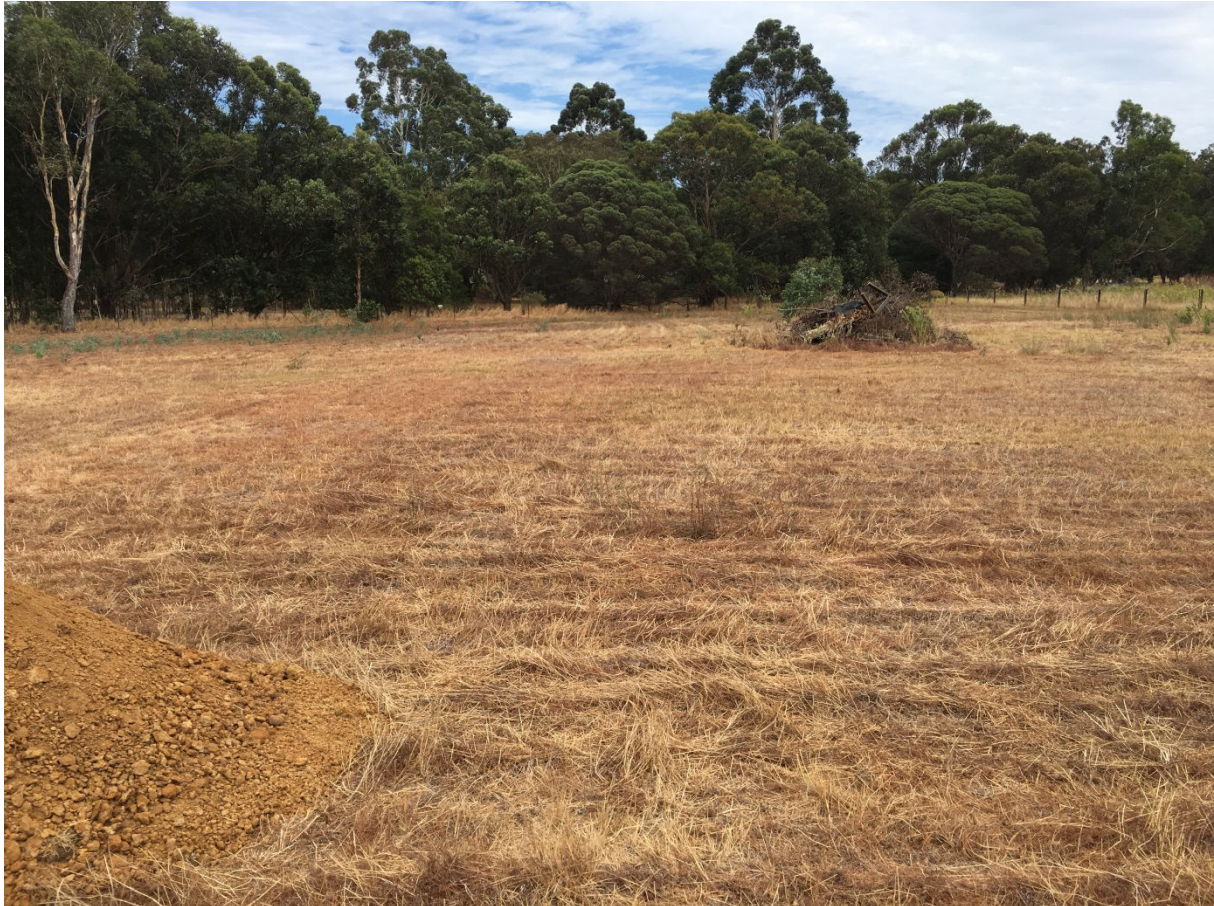
Figure 1: Typical Site Conditions at the time of the Investigation

At the time of the investigation, the site comprised multiple rural residential properties. Test locations were undertaken within grassed areas, away from vegetation and other structures such as sheds and greenhouses.

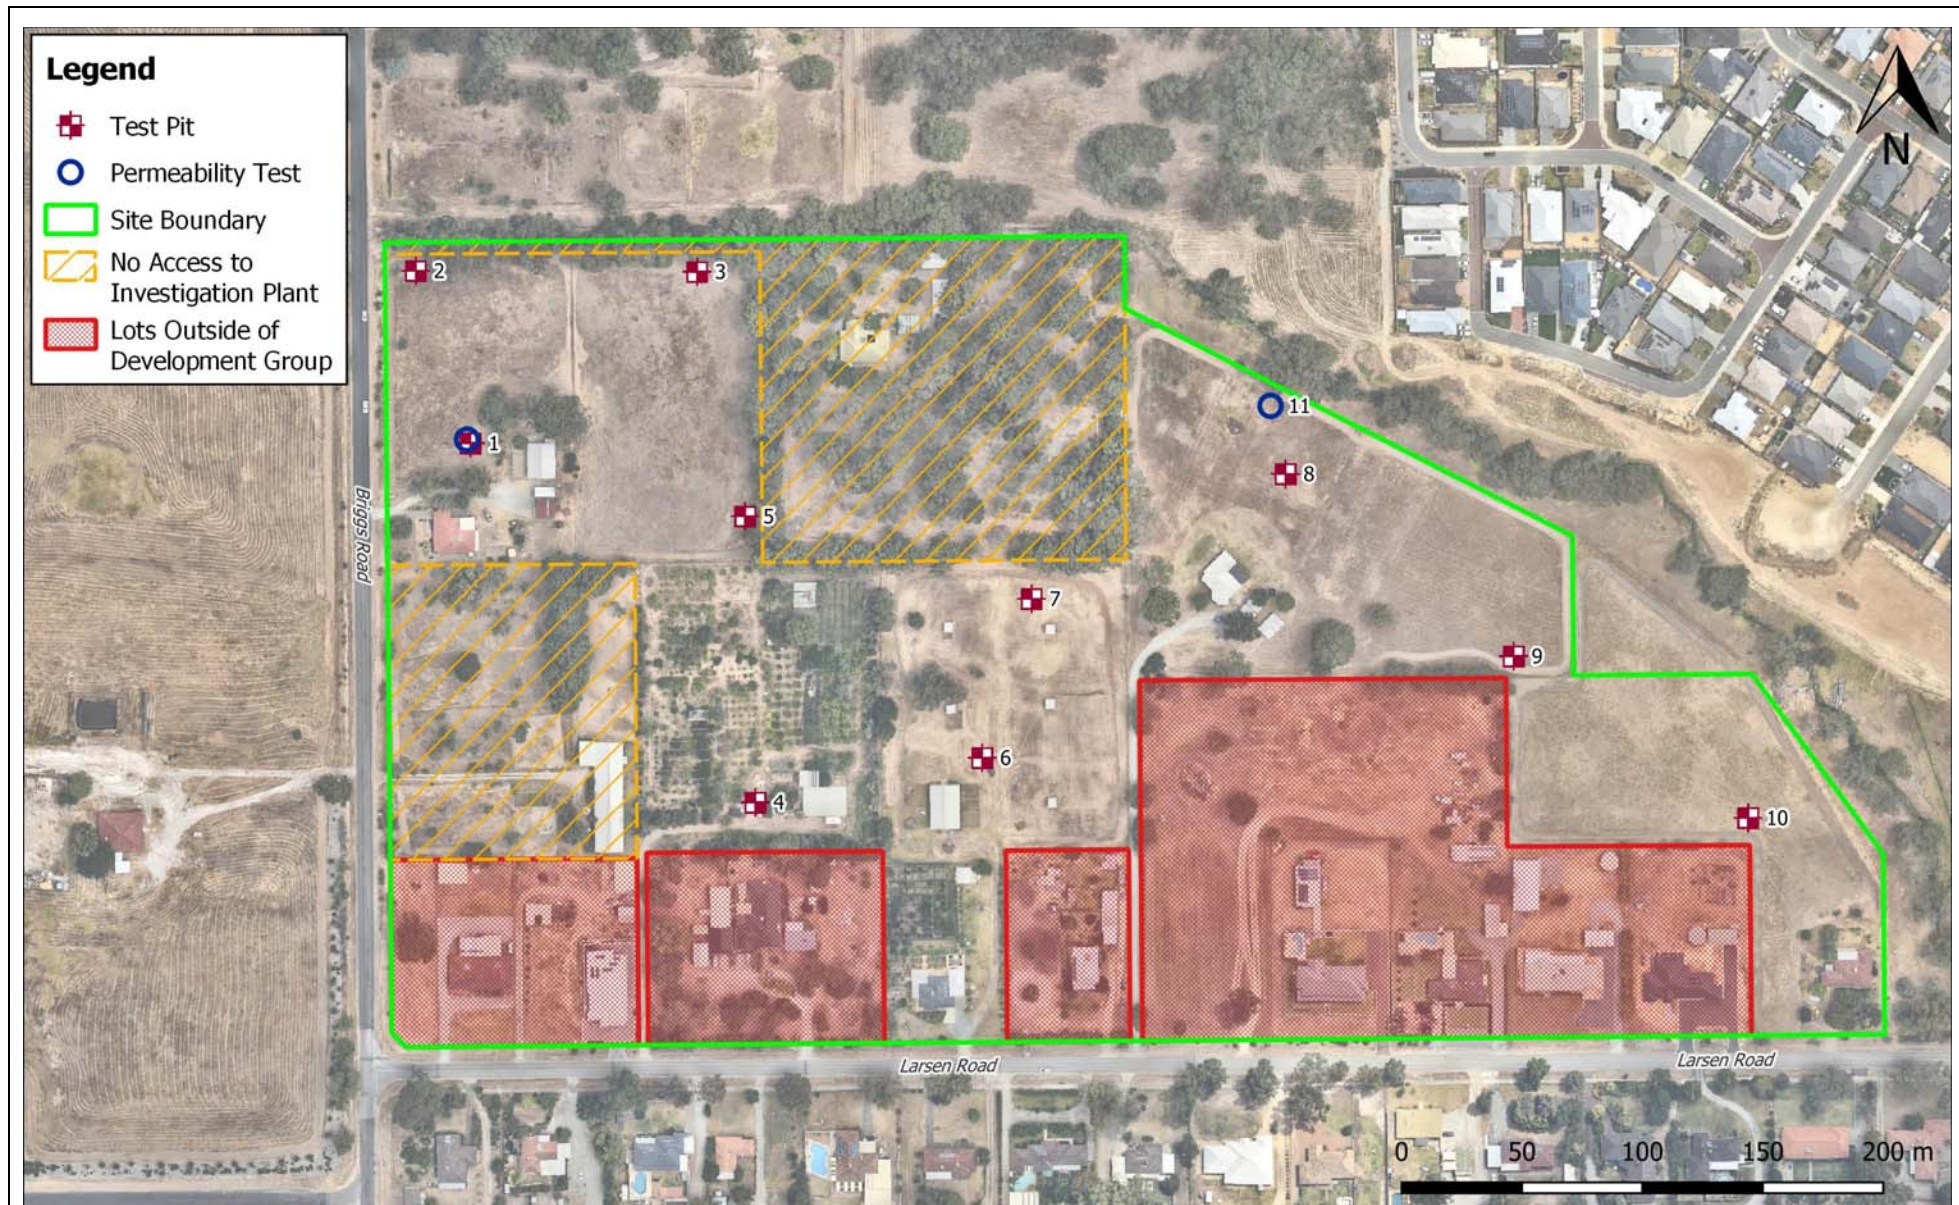
Douglas Partners Geotechnics Environment Groundwater	CLIENT: I.Q Project Management Pty Ltd	Test Location Plan Proposed Local Structure Plan Briggs and Larson Road, Byford, WA	PROJECT No: 96527.00
	OFFICE: Perth		DRAWING No: 1
	DATE: 21-2-2019		REVISION: 0

The investigation included the excavation of ten test pits, in situ permeability testing at two locations and laboratory testing of selected samples. The details of the field work are presented in this report, together with comments and recommendations on the issues listed above.

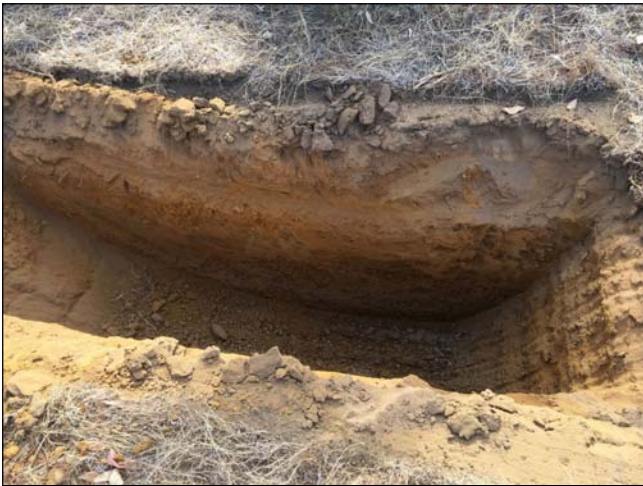
PIT No: 1
PROJECT No: 96527.00
DATE: 22/1/2019
SHEET 1 OF 1

RL	Depth (m)	Description of Strata	Graphic Log	Sampling & In Situ Testing				Water	Dynamic Penetrometer Test (blows per 150mm)			
				Type	Depth	Sample	Results & Comments		5	10	15	20
	0.15	TOPSOIL (SM) - light brown, fine to medium grained, silty sand, trace roots, dry.										
		CLAYEY SAND (SC) - hard, orange brown, fine to medium grained, medium plasticity, clayey sand with gravel, dry.		D	0.6							
	0.9	SANDY GRAVEL (GP-GC) - dense, green-brown, fine to medium sized, sandy gravel with clay, dry. Gravel is laterite. Low plasticity fines.		D	1.1							
	1.3	Pit discontinued at 1.3m *Refusal on hard clay		D	1.3
