**Various Lots Larsen Road & Briggs
Road, Byford**

Local Water Management Strategy

Prepared for

June 2020

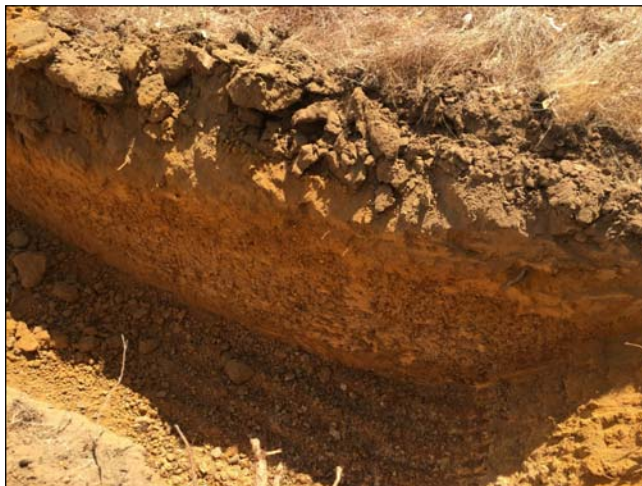
PIT No: 2
PROJECT No: 96527.00
DATE: 22/1/2019
SHEET 1 OF 1

RL	Depth (m)	Description of Strata	Graphic Log	Sampling & In Situ Testing				Water	Dynamic Penetrometer Test (blows per 150mm)			
				Type	Depth	Sample	Results & Comments		5	10	15	20
	0.2	TOPSOIL (SM) - light brown, fine to medium grained, silty sand, trace roots, dry.										
		CLAYEY SAND (SC) - hard, orange brown, fine to medium grained, medium plasticity, clayey sand, dry.										
		- with gravel from 0.5 m.		D	0.6							
		- becoming green/grey mottled orange-brown from 0.7 m.		D	0.95							
	1.1	Pit discontinued at 1.1m *Refusal on hard clay

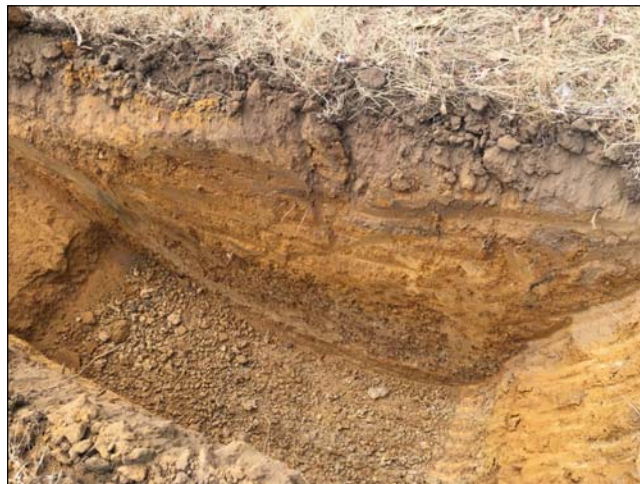
PIT No: 3
PROJECT No: 96527.00
DATE: 22/1/2019
SHEET 1 OF 1

RL	Depth (m)	Description of Strata	Graphic Log	Sampling & In Situ Testing				Water	Dynamic Penetrometer Test (blows per 150mm)			
				Type	Depth	Sample	Results & Comments		5	10	15	20
	0.2	TOPSOIL (SM) - light brown, fine to medium grained, silty sand, trace roots, dry.		D	0.1							
		CLAYEY SAND (SC) - hard, orange brown, fine to medium grained, medium plasticity, clayey sand trace gravel, dry.										
		- with gravel from 0.8 m.		D	0.7							
	1	- becoming green-grey mottled orange-brown from 1.0 m.		D	1.0 1.05		pp = 500					
	1.3	Pit discontinued at 1.3m *Refusal on hard clay		D	1.3

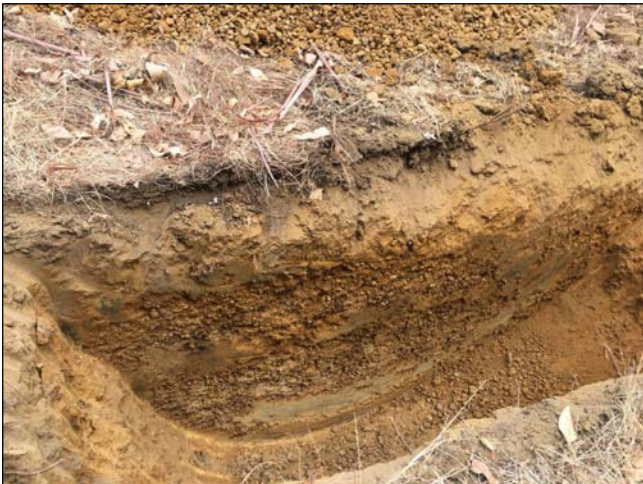
PIT No: 5
PROJECT No: 96527.00
DATE: 22/1/2019
SHEET 1 OF 1

RL	Depth (m)	Description of Strata	Graphic Log	Sampling & In Situ Testing				Water	Dynamic Penetrometer Test (blows per 150mm)			
				Type	Depth	Sample	Results & Comments		5	10	15	20
	0.1	TOPSOIL (SM) - light brown, fine to medium grained, silty sand, trace roots, dry.										
		SANDY CLAY (SC) - hard, orange brown, low plasticity, sandy clay, with gravel, dry.		D	0.3							
	0.4	SANDY GRAVEL (GP-GC) - dense, green-brown, fine to medium sized, sandy gravel with clay, dry. Gravel is laterite. Low plasticity fines.		D	0.9							
	1.3	Pit discontinued at 1.3m *Refusal on hard clay		D	1.3

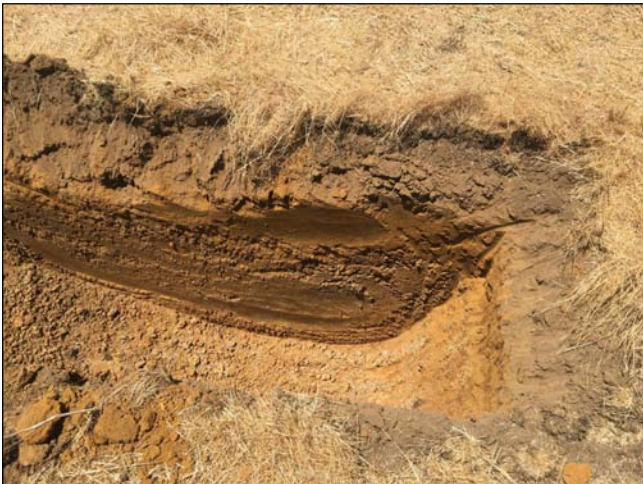
PIT No: 6
PROJECT No: 96527.00
DATE: 22/1/2019
SHEET 1 OF 1

RL	Depth (m)	Description of Strata	Graphic Log	Sampling & In Situ Testing				Water	Dynamic Penetrometer Test (blows per 150mm)			
				Type	Depth	Sample	Results & Comments		5	10	15	20
	0.2	TOPSOIL (SM) - light brown, fine to medium grained, silty sand, trace roots, dry.										
	0.4	SANDY CLAY (CI) - very stiff, orange-brown, medium plasticity, sandy clay, trace gravel, dry		D	0.4							
	0.6	CLAYEY SAND (SC) - hard, orange brown, fine to medium grained, medium plasticity, clayey sand trace gravel, dry. - becoming orange-brown mottled green-grey from 0.8 m.		D	0.7							
	1.2			D	1.2							
	1.3	Pit discontinued at 1.3m *Refusal on hard clay

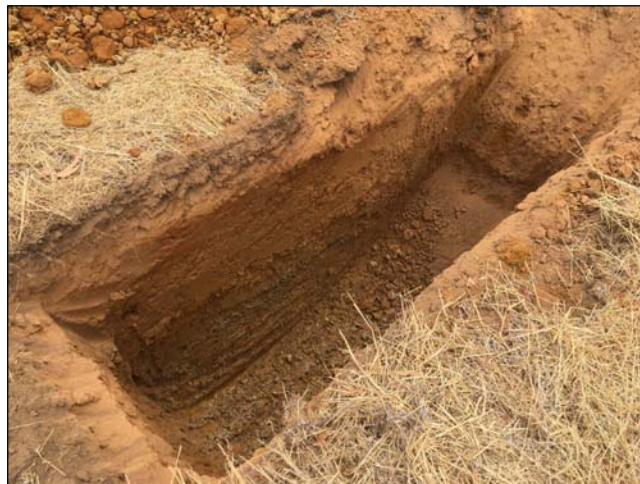
PIT No: 7
PROJECT No: 96527.00
DATE: 22/1/2019
SHEET 1 OF 1

RL	Depth (m)	Description of Strata	Graphic Log	Sampling & In Situ Testing				Water	Dynamic Penetrometer Test (blows per 150mm)			
				Type	Depth	Sample	Results & Comments		5	10	15	20
	0.1	TOPSOIL (SM) - light brown, fine to medium grained, silty sand, trace roots, dry.										
		SANDY CLAY (CI) - stiff, orange-brown, medium plasticity, sandy clay, trace gravel, dry										
		- becoming very stiff from 0.7 m.										
	0.9	CLAYEY SAND (SC) - very stiff, green-grey mottled red-brown, low plasticity, clayey sand trace gravel, dry.										
		- becoming hard from 1.1 m.										
	1.65	Pit discontinued at 1.65m *Refusal on hard clay

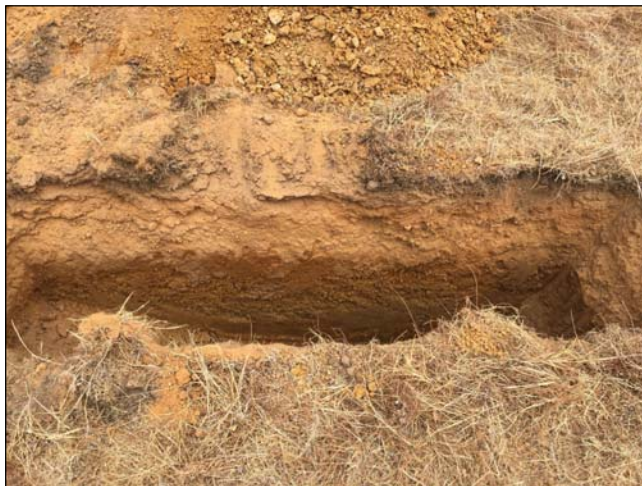
PIT No: 8
PROJECT No: 96527.00
DATE: 22/1/2019
SHEET 1 OF 1

RL	Depth (m)	Description of Strata	Graphic Log	Sampling & In Situ Testing				Water	Dynamic Penetrometer Test (blows per 150mm)			
				Type	Depth	Sample	Results & Comments		5	10	15	20
	0.1	FILL (SILTY SAND, SM) - light brown, fine to medium grained, silty sand, trace roots, dry.										
	0.4	FILL (GRAVELLY CLAY, GC) - stiff, light brown, low plasticity, fine to medium sized, gravelly clay, with sand, dry. Gravel is laterite.										
	0.5	SANDY GRAVEL (GP-GC) - medium dense to dense dense, orange-brown and red, fine to coarse sized, sandy gravel with clay, dry. Gravel is laterite. Low plasticity fines.		D	0.5							
	1.0	CLAYEY SAND (SC) - hard, orange-brown mottled green-grey, low plasticity, clayey sand trace gravel, dry to moist.		D	1.0		pp = 500					
	1.3			D	1.3		pp = 500					
	1.5	Pit discontinued at 1.5m *Refusal on hard clay

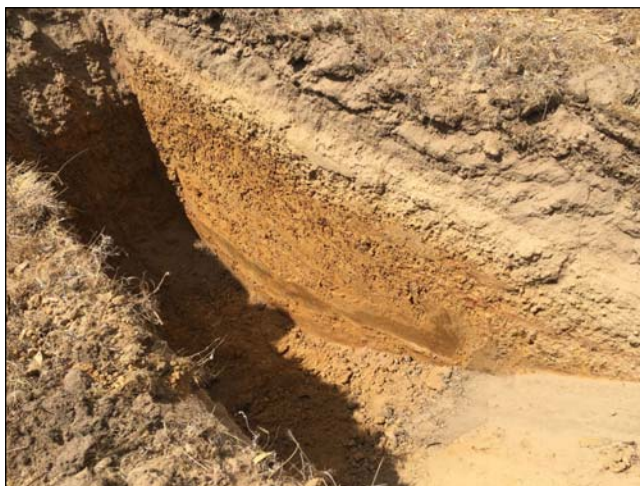
PIT No: 9
PROJECT No: 96527.00
DATE: 22/1/2019
SHEET 1 OF 1

RL	Depth (m)	Description of Strata	Graphic Log	Sampling & In Situ Testing				Water	Dynamic Penetrometer Test (blows per 150mm)			
				Type	Depth	Sample	Results & Comments		5	10	15	20
	0.2	TOPSOIL (SM) - light brown, fine to medium grained, silty sand, trace roots, dry.										
		CLAYEY SAND (SC) - hard, orange-brown and red, low plasticity, clayey sand trace gravel, dry to moist. Gravel is fine to medium sized, laterite.										
		- becoming orange-brown and grey from 0.8 m.										
	0.5			D	0.5		pp = 500					
	1.0			D	1.0		pp = 500					
	1.2	Pit discontinued at 1.2m *Refusal on hard clay

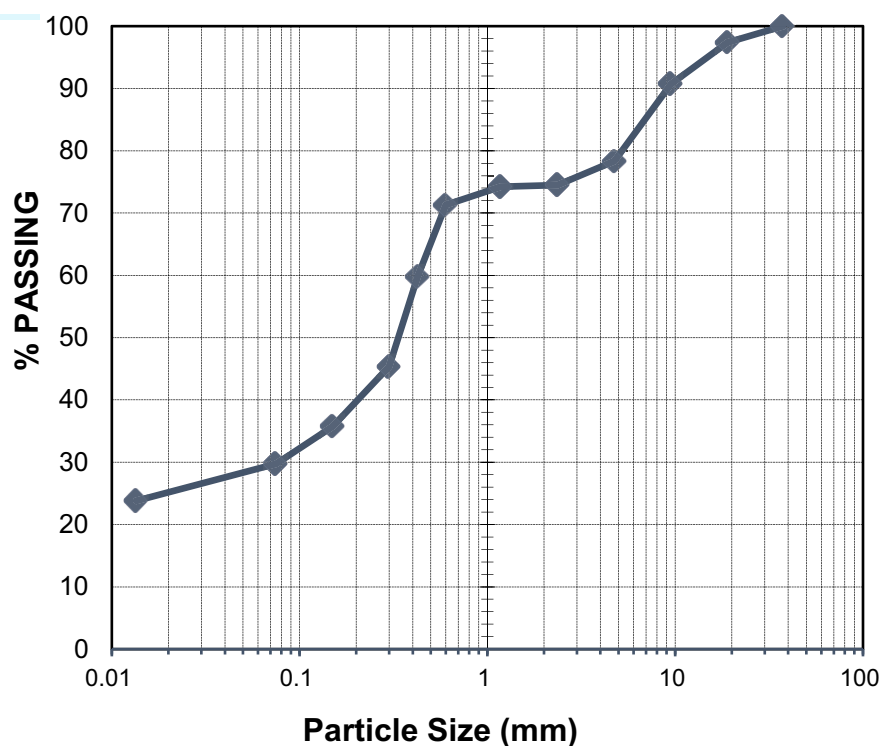
PARTICLE SIZE DISTRIBUTION - ANALYSIS BY SIEVING

Sieve Size (mm)	Percent Passing Sieve (%)
75.0	
37.5	100
19.0	97
9.50	91
4.75	78
2.36	74
1.18	74
0.600	71
0.425	60
0.300	45
0.150	36
0.075	30
0.0135	24

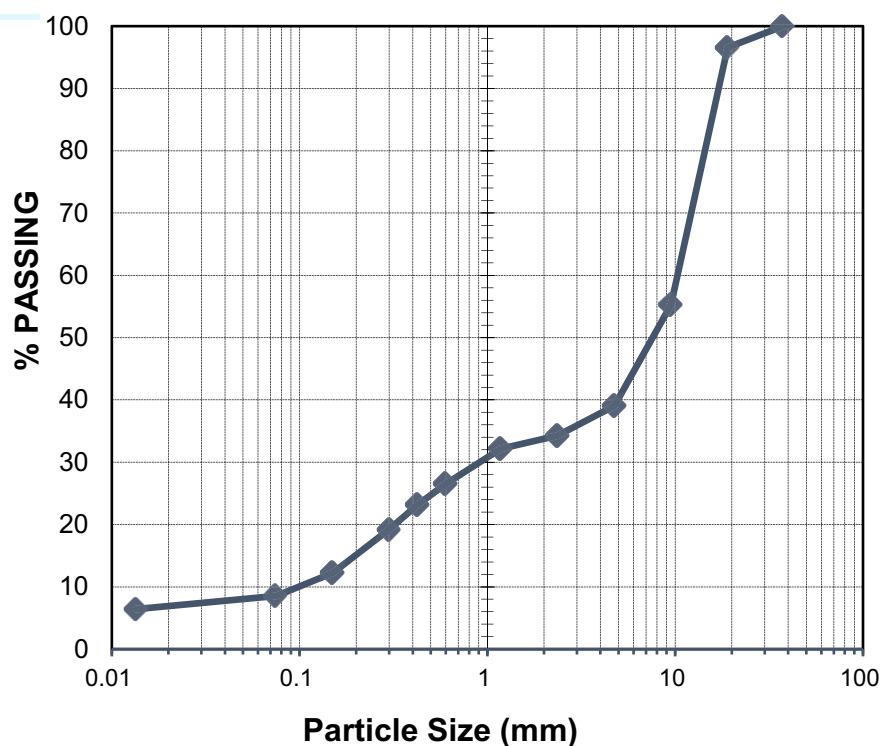
PARTICLE SIZE DISTRIBUTION - ANALYSIS BY SIEVING

Sieve Size (mm)	Percent Passing Sieve (%)
75.0	
37.5	100
19.0	97
9.50	55
4.75	39
2.36	34
1.18	32
0.600	27
0.425	23
0.300	19
0.150	12
0.075	9
0.0135	6

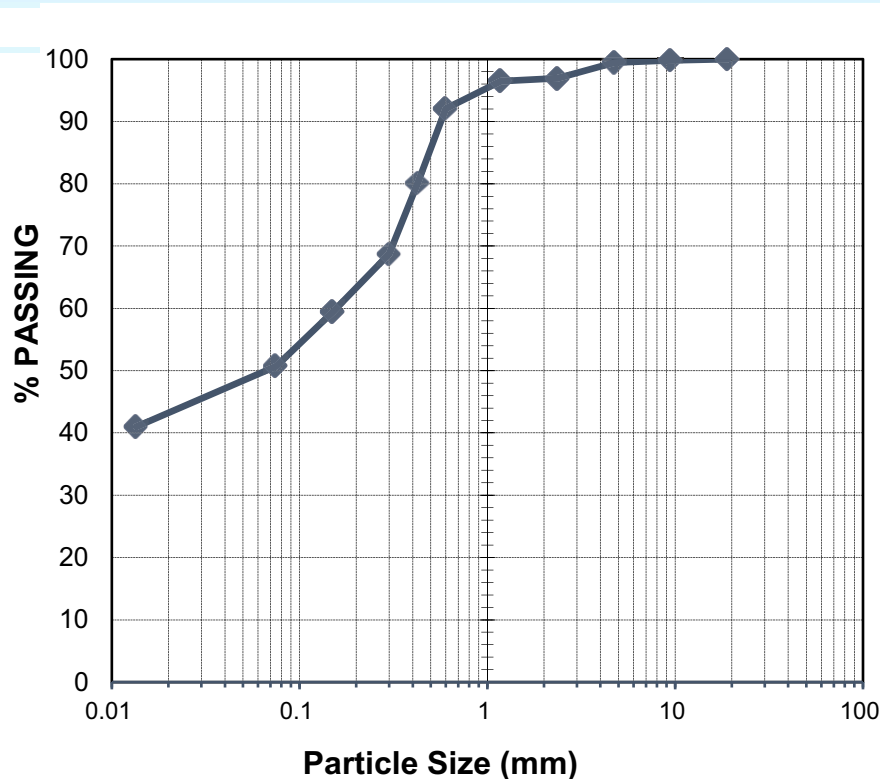
PARTICLE SIZE DISTRIBUTION - ANALYSIS BY SIEVING

Sieve Size (mm)	Percent Passing Sieve (%)
75.0	
37.5	
19.0	
9.50	100
4.75	99
2.36	97
1.18	96
0.600	92
0.425	80
0.300	69
0.150	59
0.075	51
0.0135	41
