**ADDITIONAL INFORMATION**  
**APPLICATION for (Purpose) CLEARING PERMIT 2026**  
**M77/1245- North Pit**

#### 1. HISTORY OF TENEMENT CLEARING INCLUDING PREVIOUS CLEARING PERMITS & TENEMENT OWNERSHIP BY RELATED PARTIES

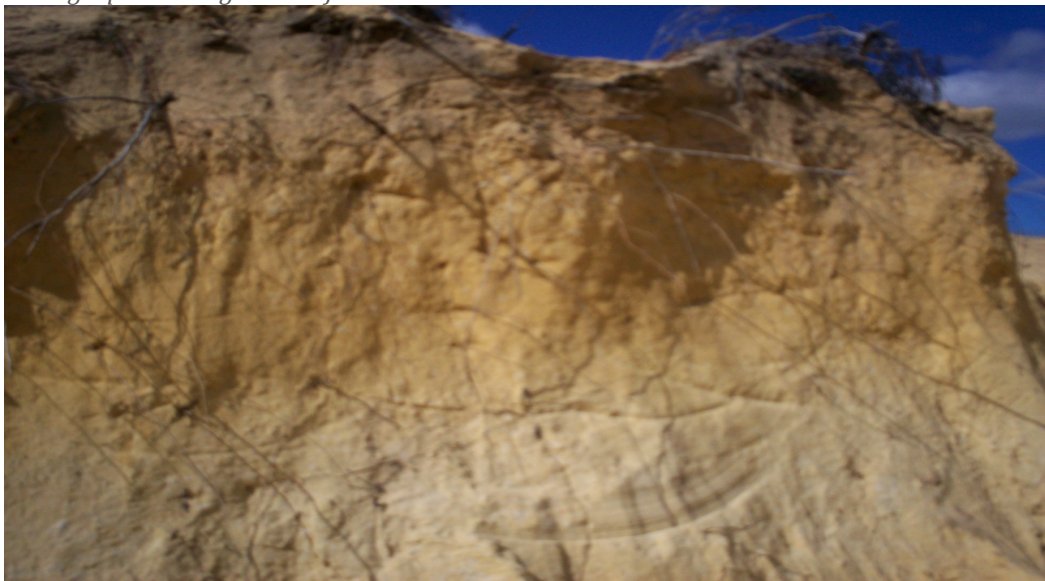
Photograph showing Soil Profile

Page 5 of appendix 1 (Report: *Level 1 Vegetation and Flora Survey*) says :  
“Soils on granite are developed in a catenary arrangement according to their topographic position. On the highest ground in the east are the sandplains of the profile type AC1 [Atlas of Australian Soils] sand soils with weak pedologic development, yellow in colour with an earthy fabric. These tend to be very deep featureless sands, and are without profile differentiation.”

Soil samples show clay and silt at 10% or less. The clay appeared to be kaolinite clay. Sieve size testing showed the following:

Sieve Size	%Passing
2.36	100%
1.18	99%
0.6	84%
0.425	67%
0.300	48%
0.150	18%
0.075	5%

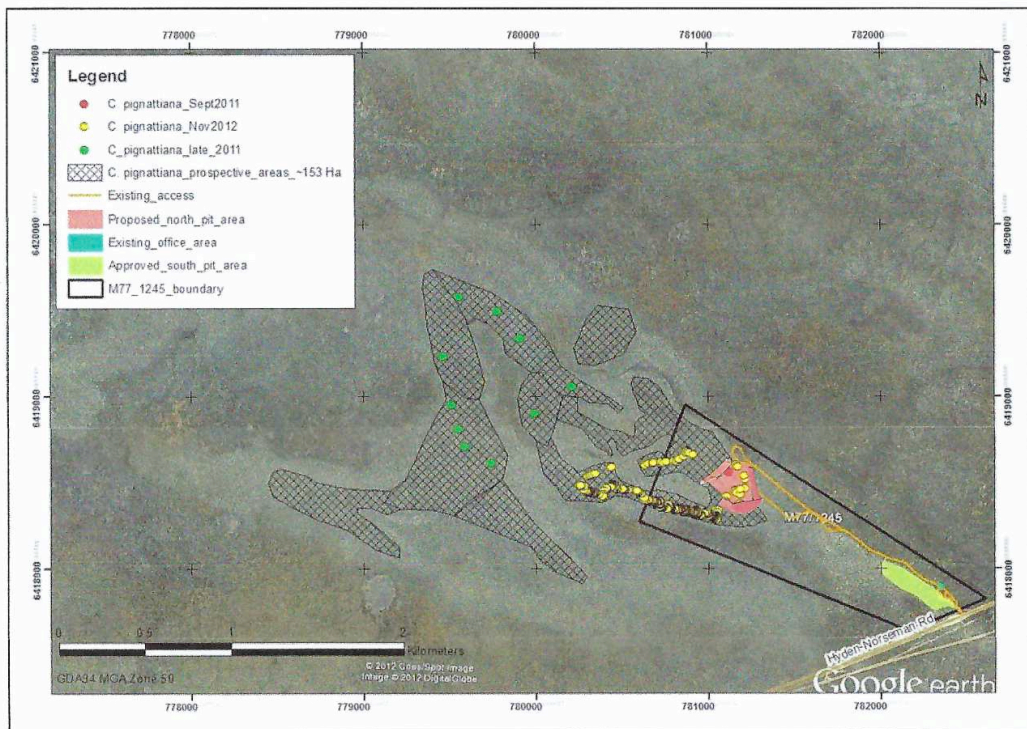
Map 7: Showing Prospective Areas of *Calectasia Pignattiana* and new Proposed Clearing

A thorough search has found only 10 plants in the original 4 hectares of the proposed mining area. The PEF ENVIRO (Environmental Consultant) used a formula based on plant density on the ground to estimate there could be 30 plants in the proposed 4 hectare mining area. The same formula calculates that there could be a possible 300,000 plants in the 153 hectares of similar soil. Therefore, the area is not necessary for the continued existence of rare flora.

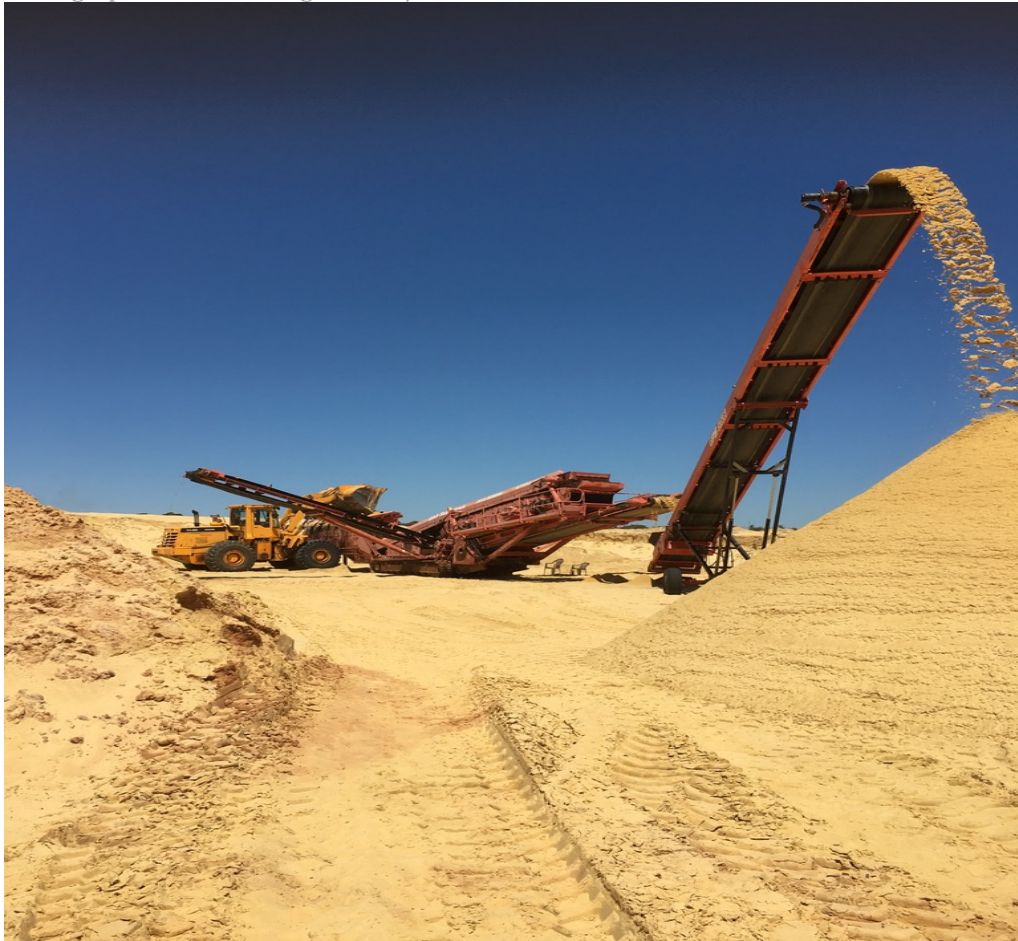
Photograph of Sand Mining on M77/1245

Minimal equipment is needed to mine the sand. Besides a loader, the only other machines are a mobile sand screen and mobile conveyor. See the following photograph.

The lack of a camp decreases any risk of fire starting by human error or electricity generation. As previously mentioned the equipment used to mine is a loader, a mobile screen and a mobile conveyor. This equipment is used in the sand pit which provides a natural 'fire-break'. The trucks do not travel the roads on fire-ban days. Thus it can be seen that the most likely cause of destroying the vegetation is not related to this mining proposal.
