Springhill Rd Clearing Purpose Permit – A Report on Clearing Impact Mitigation and Avoidance by the Shire of Cuballing

Location : Cuballing, WA
Prepared for : Department of Water & Environmental Regulation and the Shire of Cuballing
Date : February 2026

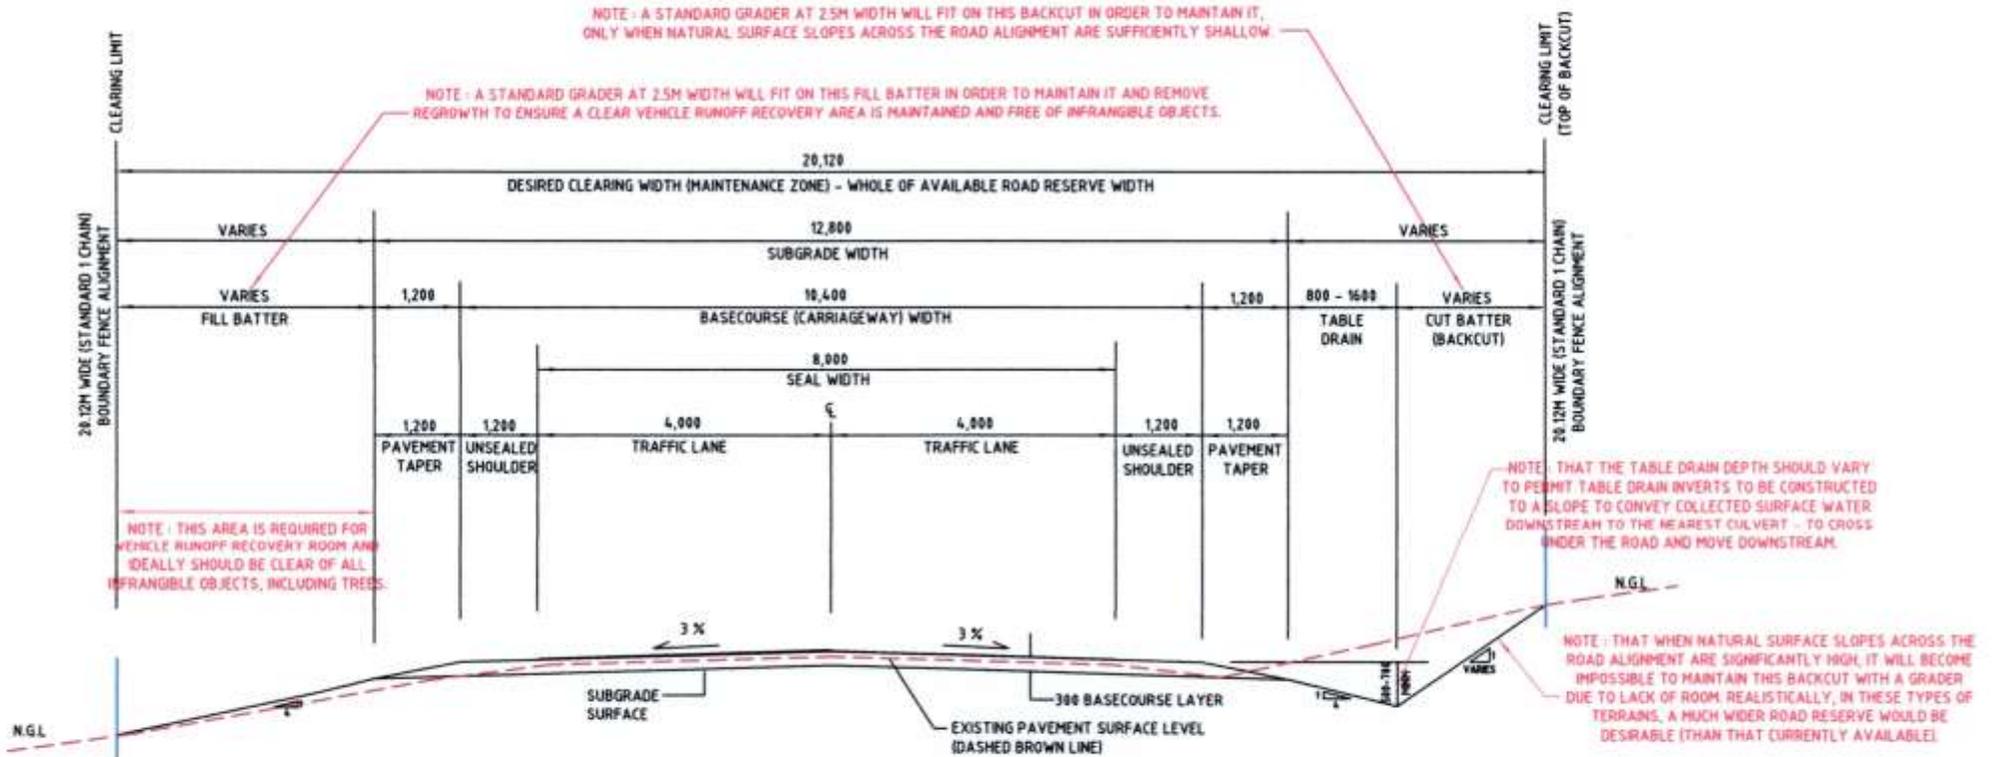
FIGURE 1

DESIRED STANDARD ROAD TYPE 6 PROFILE FOR UPGRADED OVERLAYED & RECONSTRUCTED SECTIONS ON SPRINGHILL RD ON THE TYPICALLY UNDULATING TOPOGRAPHY WITH HIGH NATURAL SURFACE SLOPE ACROSS THE ROAD ALIGNMENT- TANGENT SECTION SHOWN ONLY

- on straight sections, a desired minimum clear width of 20m would generally be required (this is the width of the existing One (1) Chain Road Reserve) – see Figure 1.
- on curved sections where the superelevation slope is opposite to the natural surface slope across the road alignment, a desired minimum clear width of up to 28.5m would generally be required (this is greater than the width of the existing One (1) Chain Road Reserve) – see Figure 2.

The profile for the desired minimum 20.12m Clear Width (the existing Road Reserve width) on Springhill Rd, along straight sections and in less undulating areas, is shown in Figure 1, in Appendix 1 below. As can be seen, this permits a minimum width of 4.86m for each of: the table drain on the upstream verge; and the fill batter on the downstream verge. Given the topography with high natural surface slopes transverse to the road alignment (that is predominantly the case on this road), this clear width would be the bare minimum required to:

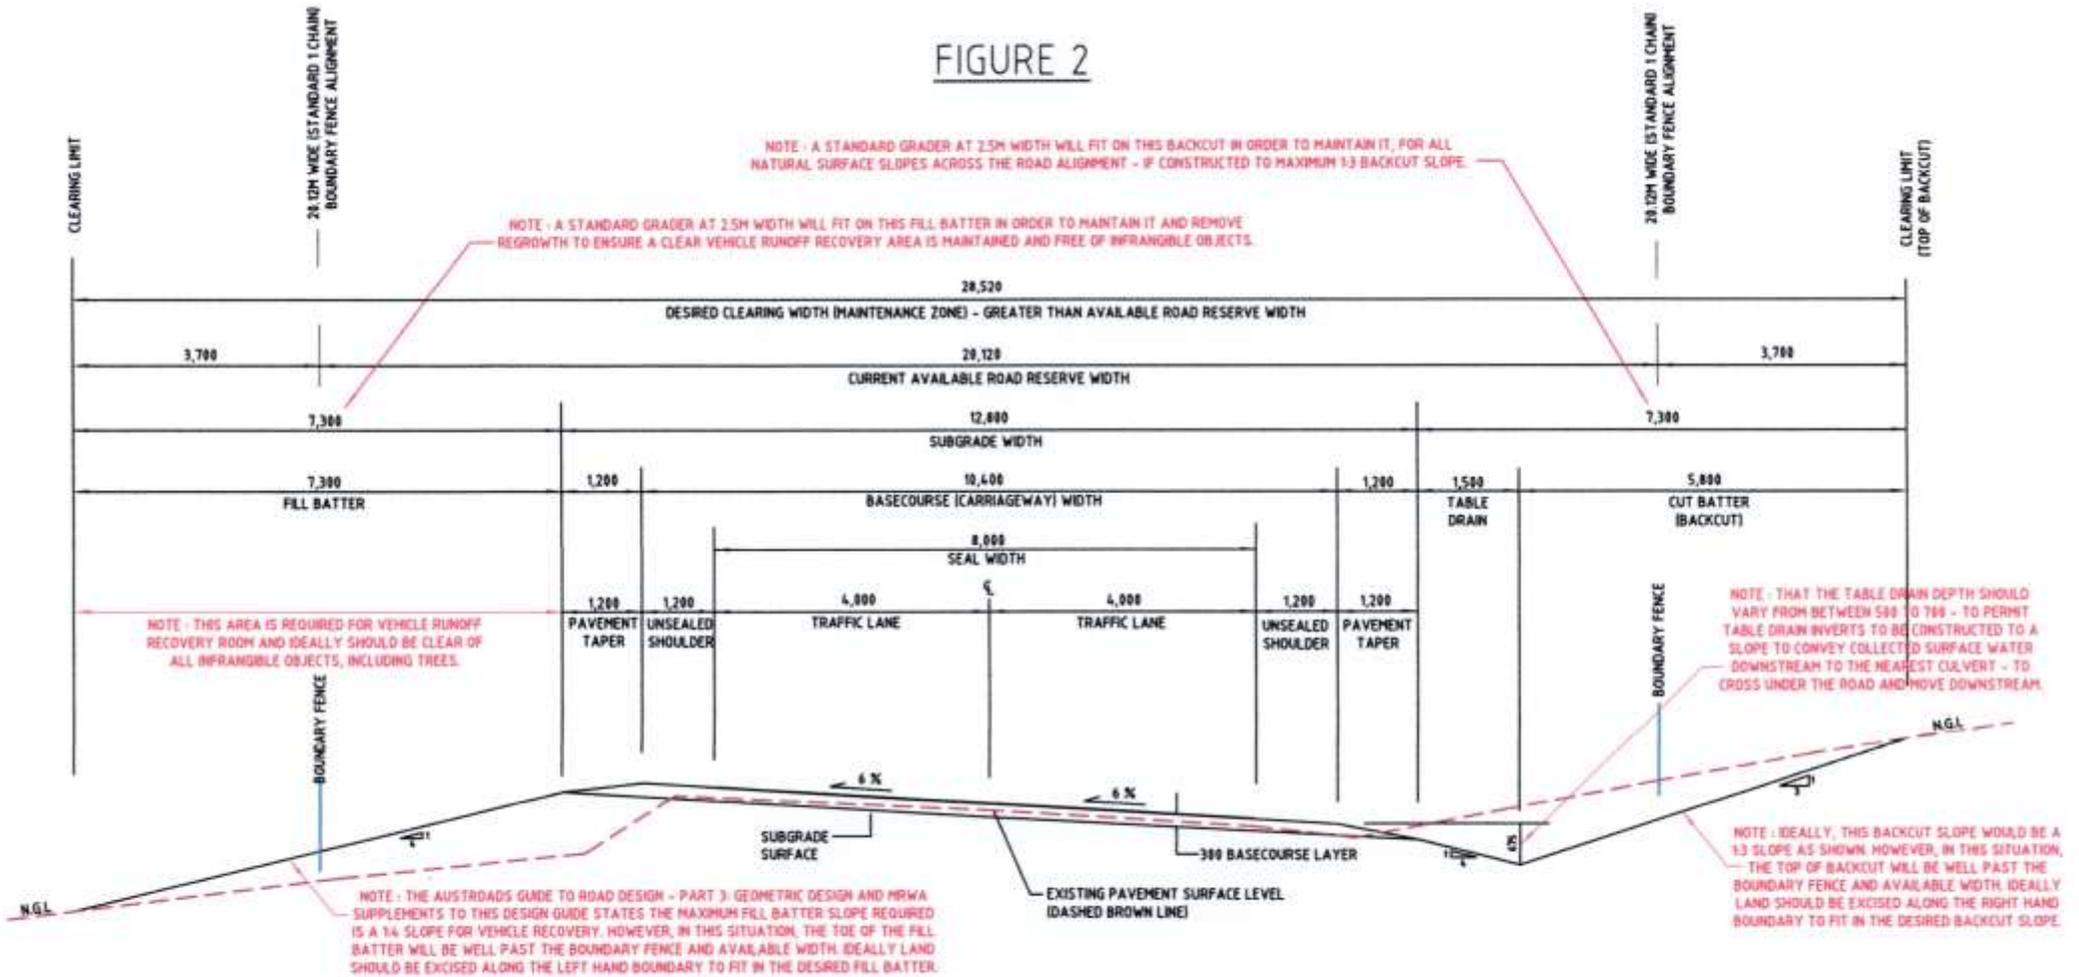
FIGURE 2

DESIRED STANDARD ROAD TYPE 6 PROFILE FOR UPGRADED OVERLAYED & RECONSTRUCTED SECTIONS ON SPRINGHILL RD THROUGH THE CENTRE OF THE RIGHT HAND CURVE AT SLK 1.97 - WITH SUPERELEVATION SLOPE AGAINST THE VERY HIGH NATURAL SURFACE SLOPE ACROSS THE ROAD ALIGNMENT

On those four (4) right hand curved sections along Springhill Rd, where the superelevation slope is opposite to the natural surface slope transverse to the road alignment, a desired minimum clear width of up to 28.5m would generally be required (this is greater than the width of the existing One (1) Chain Road Reserve). The right hand curve from SLK 1.94 to 2.00 is located in an area with extreme natural surface slope transverse to the road alignment, and this is the one section along the road where the most width would be desired to provide the desired carriageway and drainage infrastructure. For this reason, in Figure 2 in Appendix 1, I have included the Road Cross Section at SLK 1.97, to highlight why the extra clear width (to 28.52m width) would be desired – if clearing native vegetation, excising adjacent land and relocating telecom services were not expensive, difficult processes to achieve.

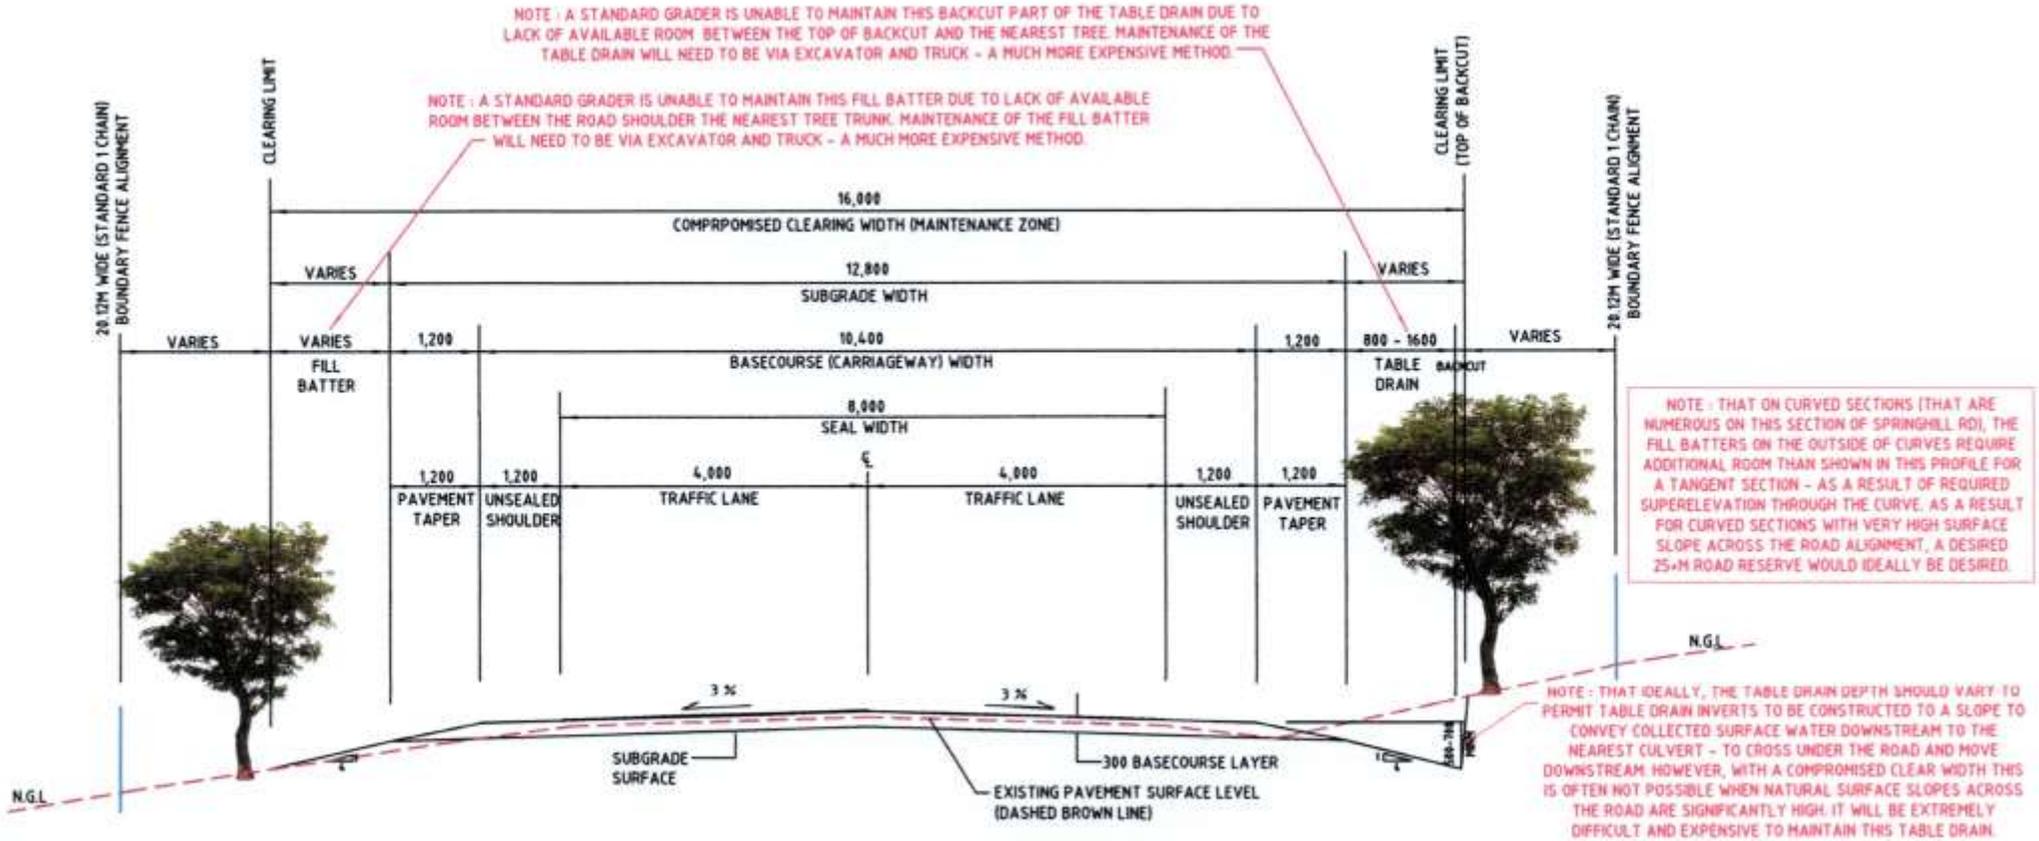
FIGURE 3

COMPROMISED STANDARD ROAD TYPE 6 PROFILE FOR UPGRADED OVERLAYED & RECONSTRUCTED SECTIONS ON SPRINGHILL RD ON THE TYPICALLY UNDULATING TOPOGRAPHY WITH HIGH NATURAL SURFACE SLOPE ACROSS THE ROAD ALIGNMENT- TANGENT SECTION SHOWN ONLY

Despite the above, and as a Strategy to reduce the Clear Width for the Road Upgrade Works, we have compromised the Road Carriageway Upgrade Design to fit within a minimum 16m Clear Width extent. This design Profile is shown in Figure 3 in Appendix 1. As can be seen, this permits a minimum width of only 2.8m for the table drain on the upstream verge and the fill batter on the downstream verge. For the upstream verge, this really only provides enough width for a Pavement Taper / Table Drain batter, with no backcut. These Table Drains will be constructed to a sub-standard at best, and we will be compromising the structural integrity of the road, via much reduced effectual drainage. This cause and effect is explained in section 3 below.

The SoC have only been able to use one (1) strategy to reduce the clearing area impact. This has been to reduce the clearing width from a desired 20.12m (10.06m each way from centre line) to 16m (8.0m each way from road centre line). However, this strategy will add an ongoing additional financial burden to the SoC, via not having desired sufficiently sized table drains that:

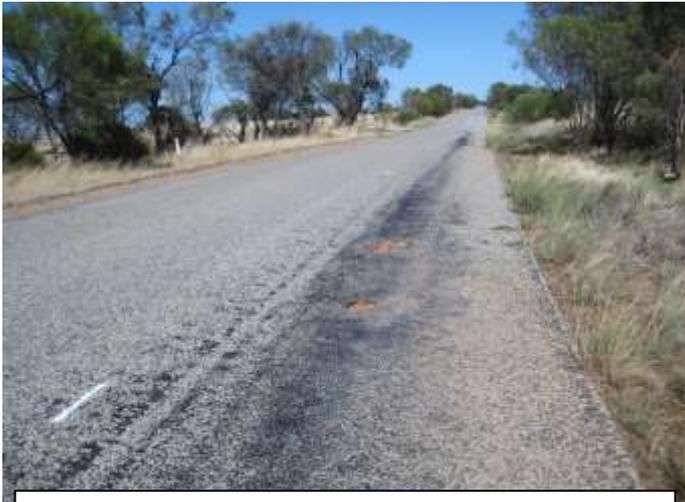
Photo of Pavement Failure on the Goomalling / Calingiri Rd at SLK 5.10 due to non-adequate table drainage and / or subsequent lack of maintenance.

There are many photos of typical similar type sealed Wheatbelt Distributor roads showing accelerated deterioration (than above normal deterioration rate) in Appendix 4 below, as a result of poor, or lack of sufficient Table Drainage.

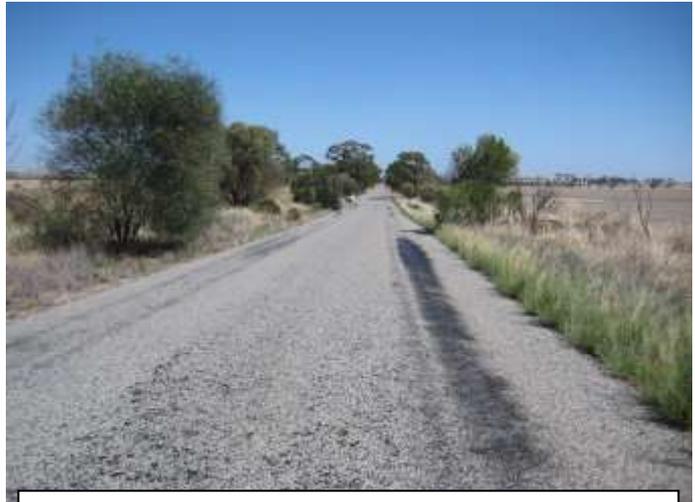
Photo of Pavement Failure on the Goomalling / Calingiri Rd at SLK 6.76 due to non-adequate table drainage and / or subsequent lack of maintenance.

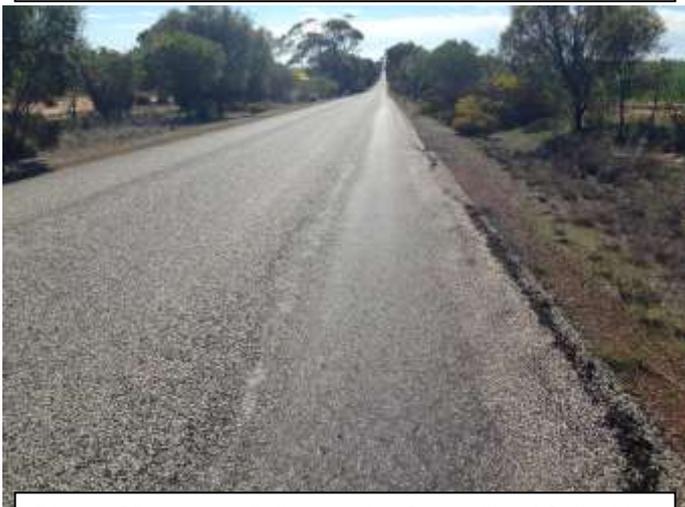
Photo of Pavement Failure on the Goomalling / Calingiri Rd at SLK 10.90 due to non-adequate table drainage and / or subsequent lack of maintenance.

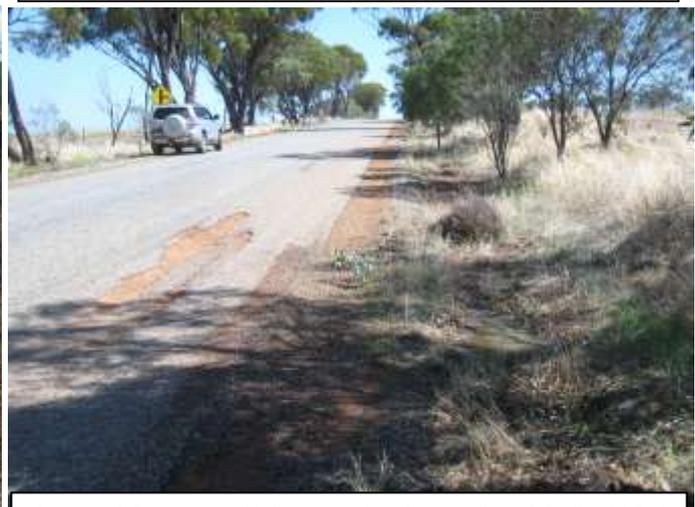
Photo of Pavement Failure on the Goomalling / Calingiri Rd at SLK 11.64 due to non-adequate table drainage and / or subsequent lack of maintenance. Note the surface water sitting in the drain.

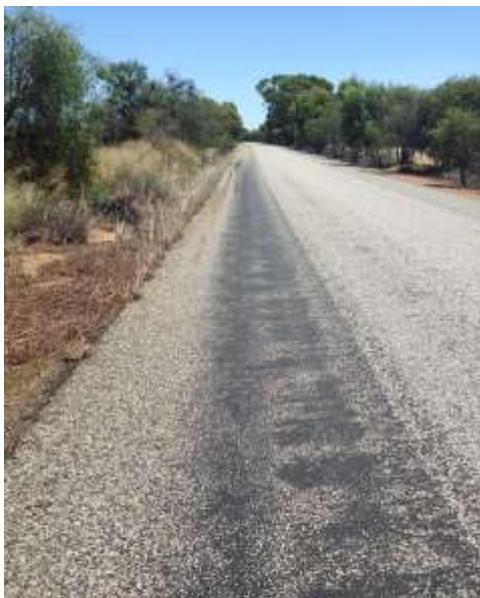
Photo of Pavement Failure on the Goomalling / Calingiri Rd at SLK 24.78 due to non-adequate table drainage and / or subsequent lack of maintenance.

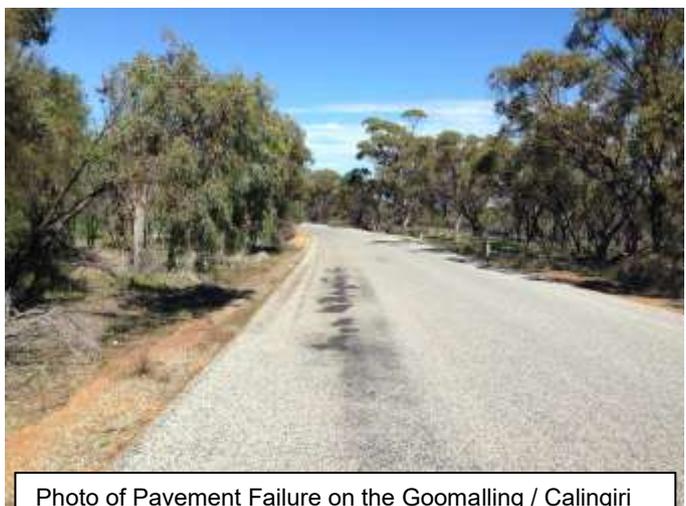
Photo of Pavement Failure on the Goomalling / Calingiri Rd at SLK 26.92 due to non-adequate table drainage and / or subsequent lack of maintenance.

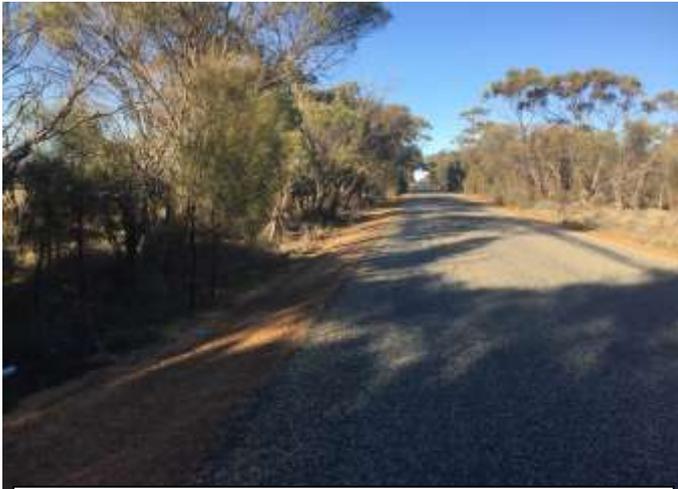
Photo of Pavement Failure on the Kellerberrin / Bencubbin Rd at SLK 13.48 due to non-adequate table drainage and / or subsequent lack of maintenance.

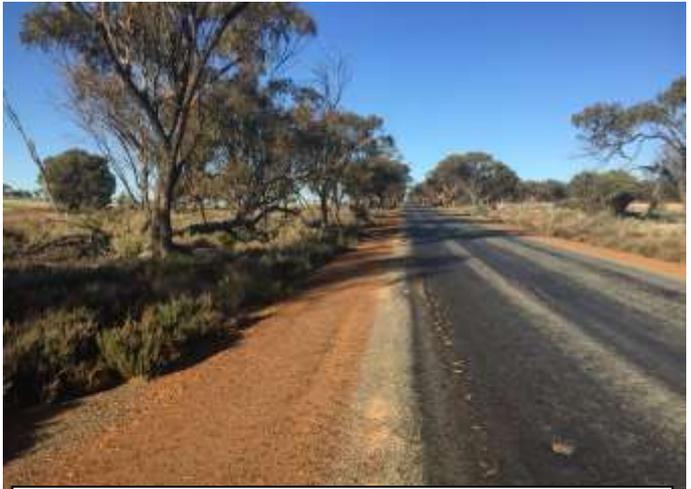
Photo of Pavement Failure on the Kellerberrin / Bencubbin Rd at SLK 16.69 due to non-adequate table drainage and / or subsequent lack of maintenance.

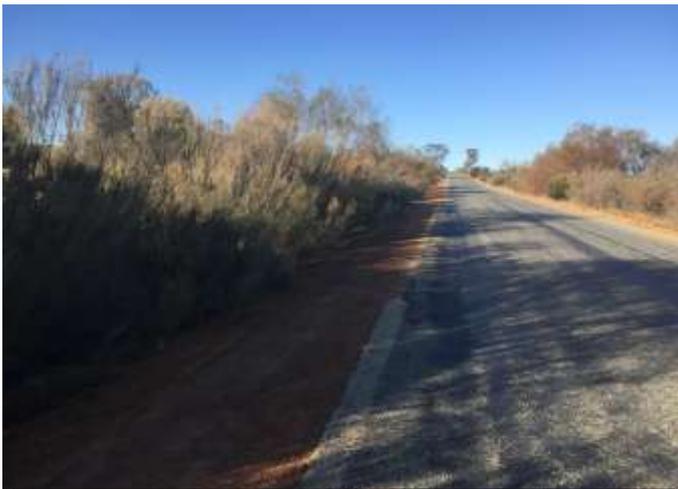
Photo of Pavement Failure on the Kellerberrin / Bencubbin Rd at SLK 22.37 due to non-adequate table drainage and / or subsequent lack of maintenance.

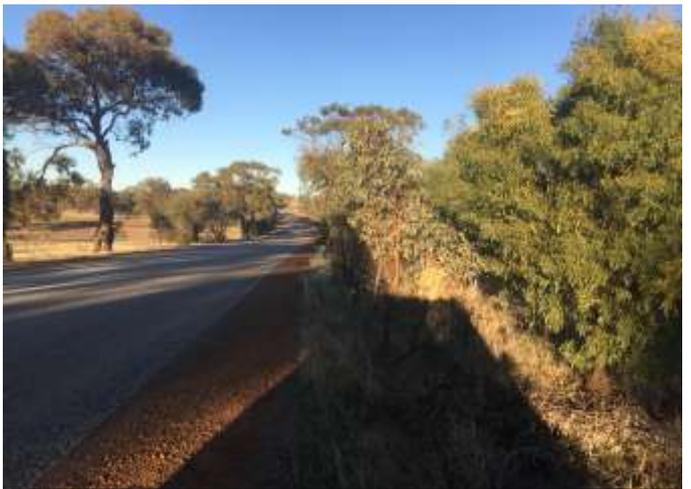
Photo of poorly maintained table drain on the Kellerberrin / Yoting Rd at SLK 17.58 due to insufficient table drain width to allow easy maintenance via Grader. Note this pavement has been upgraded relatively recently and has not had sufficient time to develop potential failure areas.

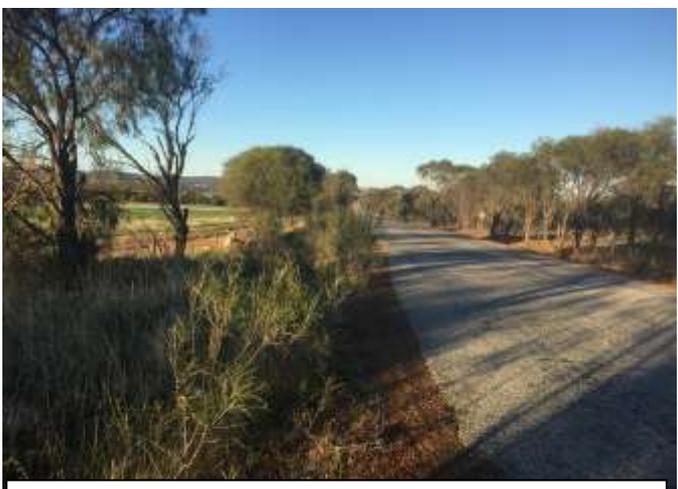
Photo of poorly maintained table drain on the Kellerberrin / Yoting Rd at SLK 19.63 due to insufficient table drain width to allow easy maintenance via Grader. Note this pavement has been upgraded relatively recently and has not had sufficient time to develop potential failure areas.

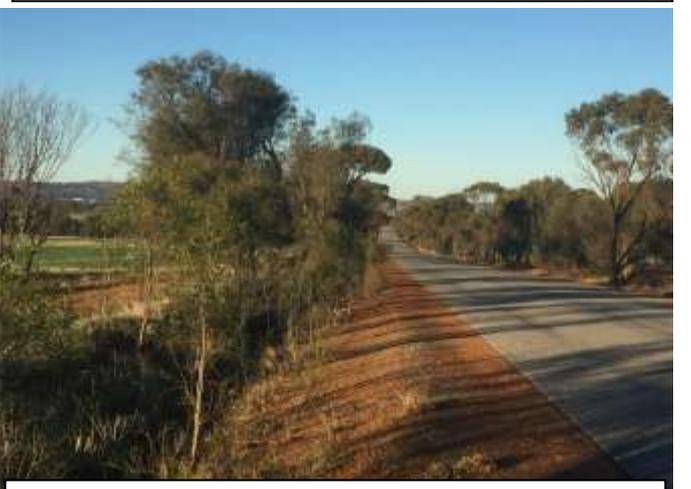
Photo of poorly maintained table drain on the Kellerberrin / Yoting Rd at SLK 19.66 due to insufficient table drain width to allow easy maintenance via Grader. Note this pavement has been upgraded relatively recently and has not had sufficient time to develop potential failure areas.

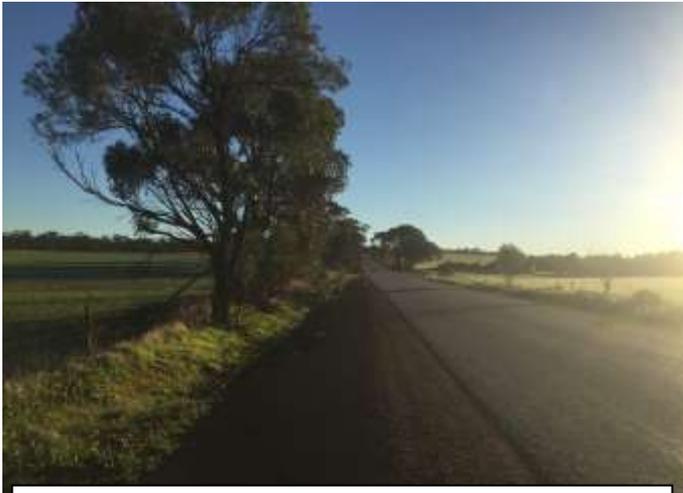
Photo of poorly maintained table drain on the Kellerberrin / Yoting Rd at SLK 20.18 due to insufficient table drain width to allow easy maintenance via Grader. Note this pavement has been upgraded relatively recently and has not had sufficient time to develop potential failure areas.

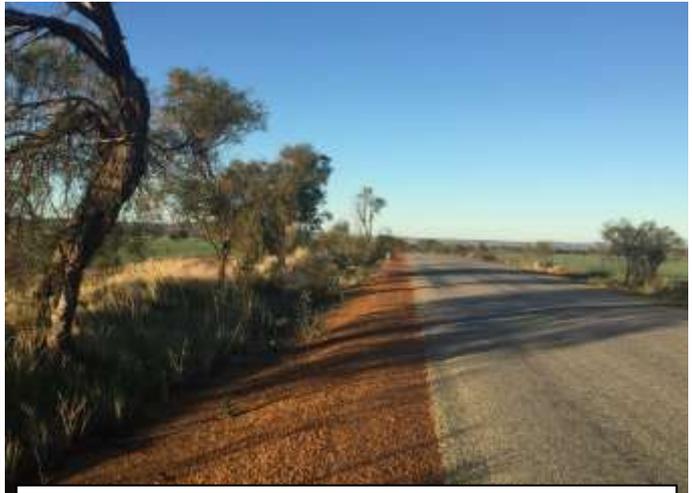
Photo of poorly maintained table drain on the Kellerberrin / Yoting Rd at SLK 20.27 due to insufficient table drain width to allow easy maintenance via Grader. Note this pavement has been upgraded relatively recently and has not had sufficient time to develop potential failure areas.

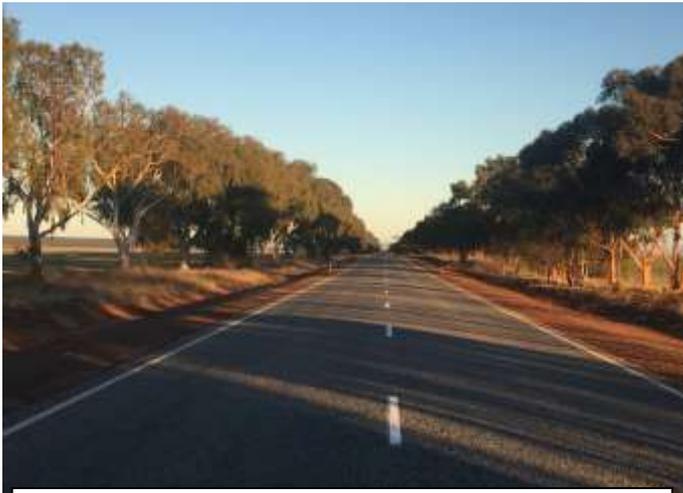
Photo of well shaped road carriageway and table drains on the York / Merredin Rd (MRWA controlled Highway) at SLK 83.66 with well maintained (via Grader) table drains.

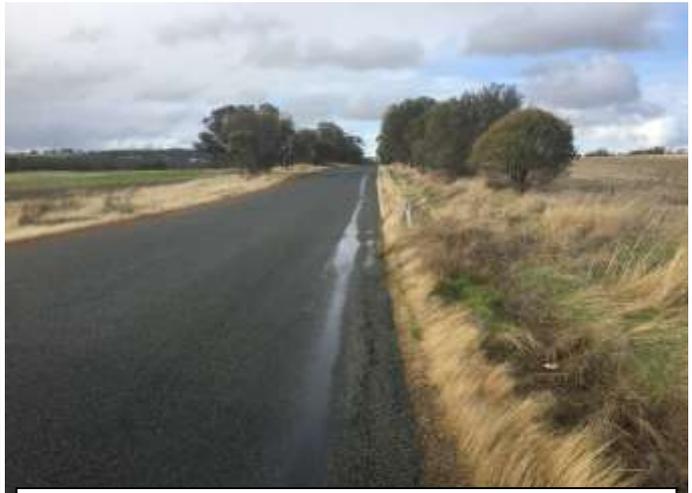
Photo of Pavement Failure on the Pingelly / Alderside Rd at SLK 3.89 due to non-adequate table drainage and / or subsequent lack of maintenance.

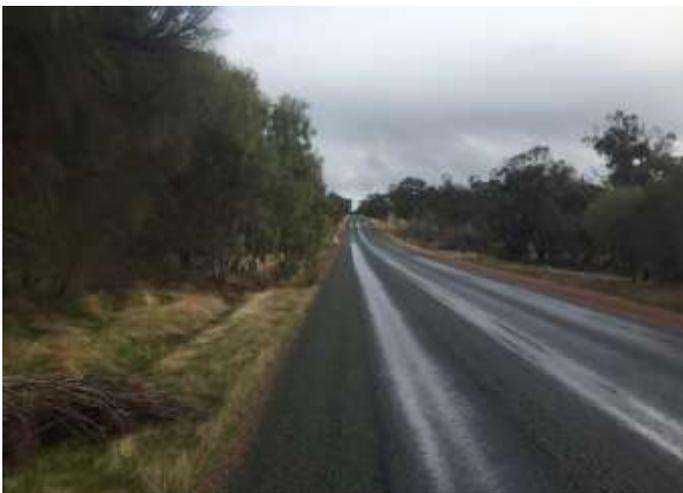
Photo of Pavement Failure on the Pingelly / Alderside Rd at SLK 4.61 due to non-adequate table drainage and / or subsequent lack of maintenance.

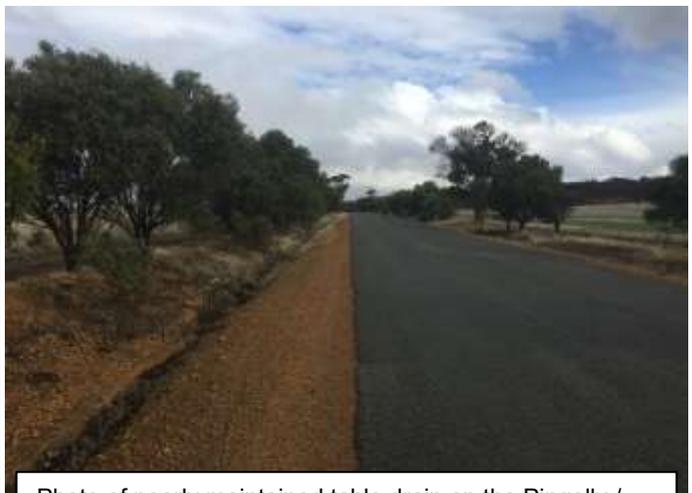
Photo of poorly maintained table drain on the Pingelly / Alderside Rd at SLK 8.53 due to insufficient table drain width to allow easy maintenance via Grader. Note this pavement has no adjacent pavement failures due to the slope on land that is assisting conveying surface water along the table drain. This is evident from the scouring.

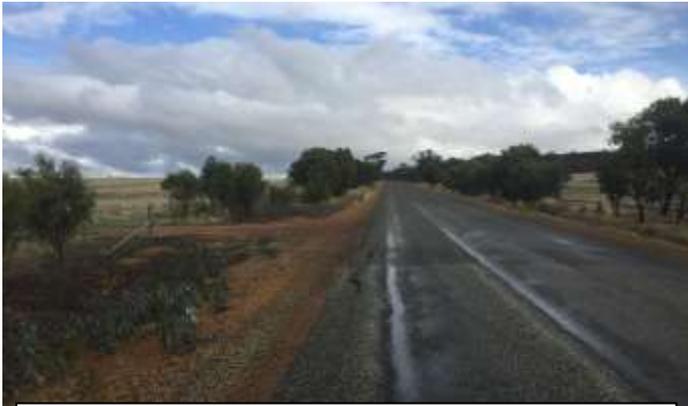
Photo of Pavement Failure on the Pingelly / Alderside Rd at SLK 4.61 due to no adequate table drain and / or lack of maintenance. This pavement failure is the result of no crossover pipe to convey surface water under the crossing and this water has penetrated the underlying soil, resulting in this pavement failure downstream.

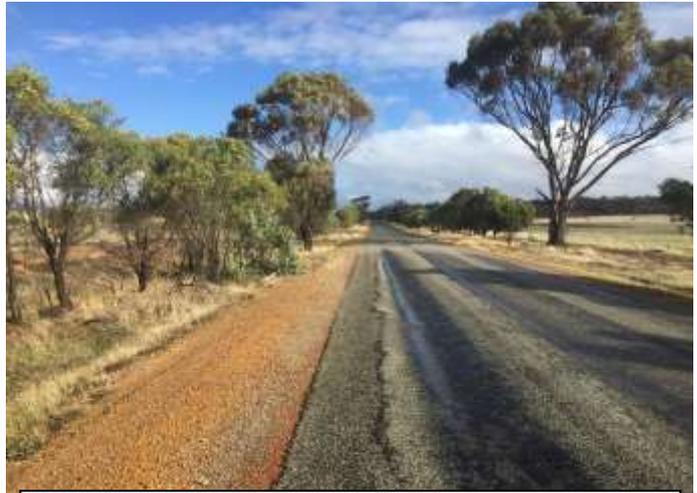
Photo of Pavement Failure on the Pingelly / Alderside Rd at SLK 8.73 due to non-adequate table drainage and / or subsequent lack of maintenance.

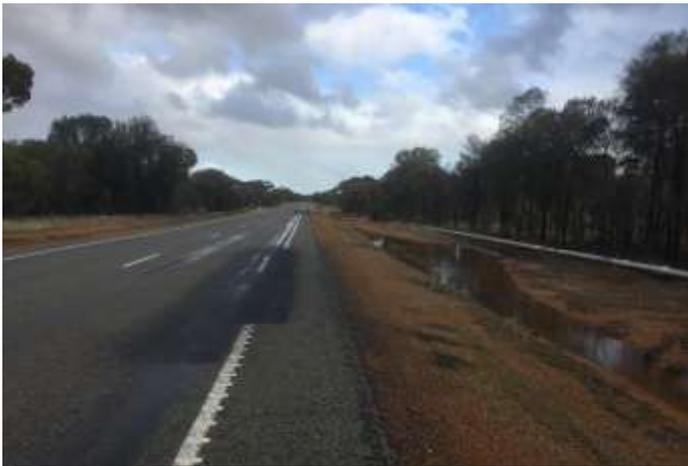
Photo of Pavement Failure on the Great Southern Highway (MRWA Controlled Rd) at SLK 142.53 due ponding of surface water from no downstream drainage to run water away from pavement (above ground water main has hindered either proper downstream drain construction or limited maintenance of).

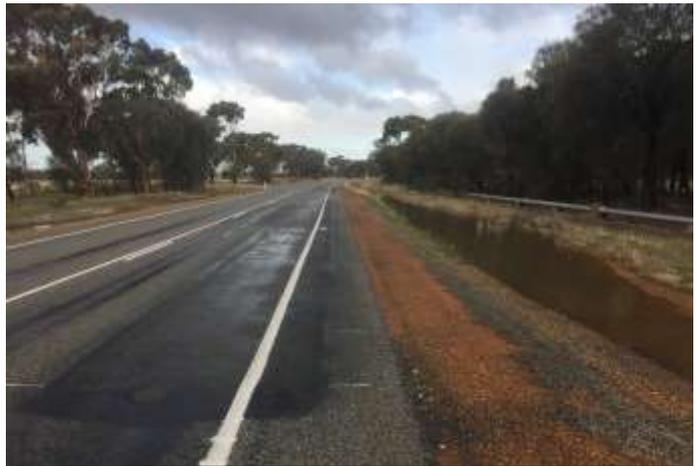
Photo of Pavement Failure on the Great Southern Highway (MRWA Controlled Rd) at SLK 143.15 due ponding of surface water from no downstream drainage to run water away from pavement (above ground water main has hindered either proper downstream drain construction or limited maintenance of).

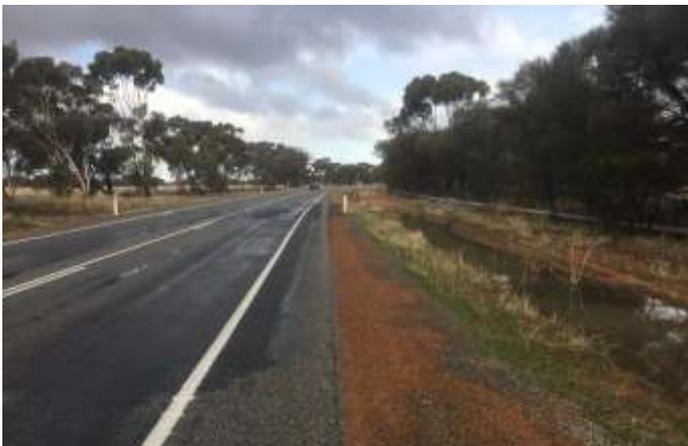
Photo of Pavement Failure on the Great Southern Highway (MRWA Controlled Rd) at SLK 143.20 due ponding of surface water from no downstream drainage to run water away from pavement (above ground water main has hindered either proper downstream drain construction or limited maintenance of).

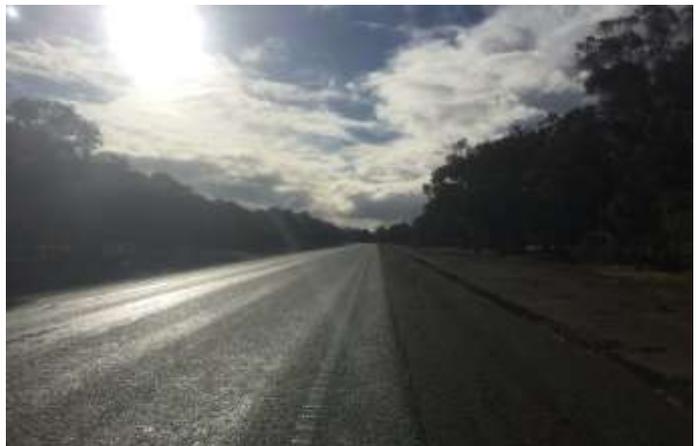
Photo of well shaped road carriageway and table drains on the Great Southern Highway (MRWA controlled Highway) at SLK 148.30 with well maintained (via Grader) table drains. Note the shedding of surface water along the table drain following a large rain event.

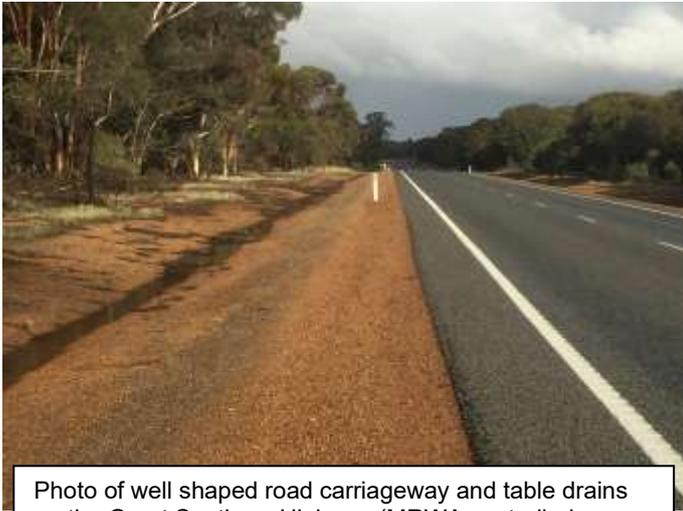
Photo of well shaped road carriageway and table drains on the Great Southern Highway (MRWA controlled Highway) at SLK 149.35 with well maintained (via Grader) table drains. Note the shedding of surface water along the table drain following a large rain event.

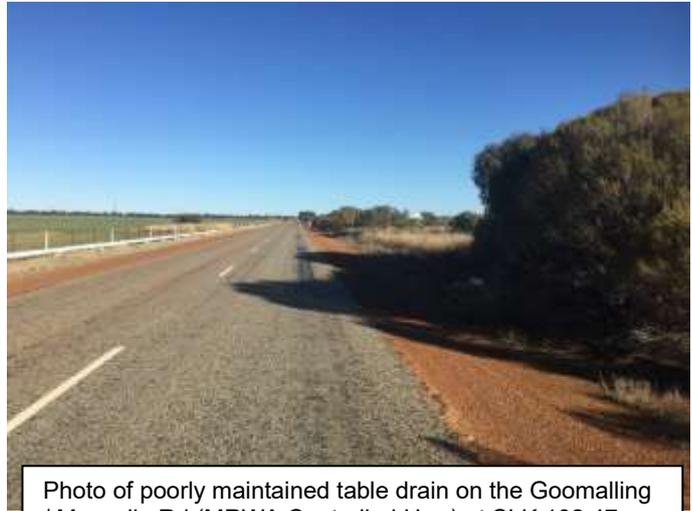
Photo of poorly maintained table drain on the Goomalling / Merredin Rd (MRWA Controlled Hwy) at SLK 102.47 due to insufficient table drain maintenance. Note the surface water sitting in the table drain due to the vegetation in the table drain preventing it from flowing downstream. This has resulted in surface water penetrating the underlying insitu soil, weakening it and causing the adjacent pavement failure.
