## ***TYPHA* DISTRIBUTION IN CITY OF SOUTH PERTH NATURE RESERVES AND PARKS**

September 2020

For City of South Perth

**Report**      **20036RPT001**

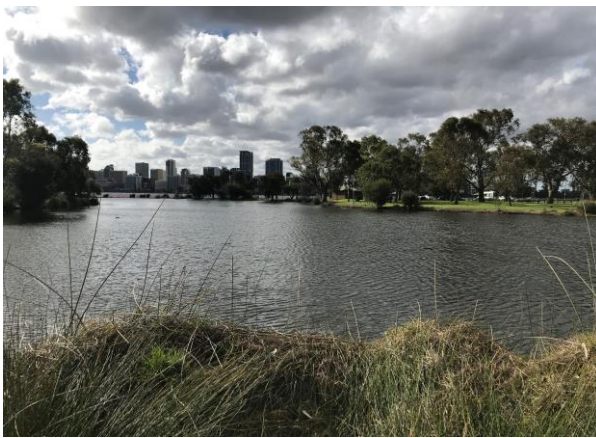
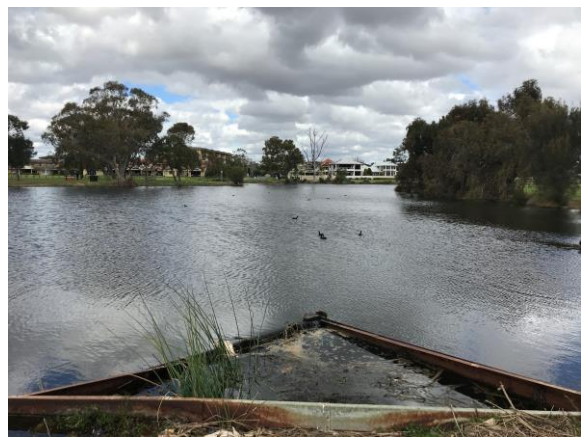
**Plate 1. Lake Hurlingham**

No *Typha* was recorded during the site inspection. Given the size of the waterbody and its use by several water bird species, there is a possibility for *Typha* to be introduced into the lake. Introduction of *Typha* into the wetland without active management would likely result in its permanent establishment, decreasing the lake's capacity to store stormwater runoff, reducing the area required for Swans and other water bird landing and take-off and cause amenity issues with nearby residents. The images showing current lake vegetation are shown in Plate 1.

***Typha* occurrence and distribution:** 0 m<sup>2</sup>

**Percentage of the waterbody covered by *Typha*:** 0 %

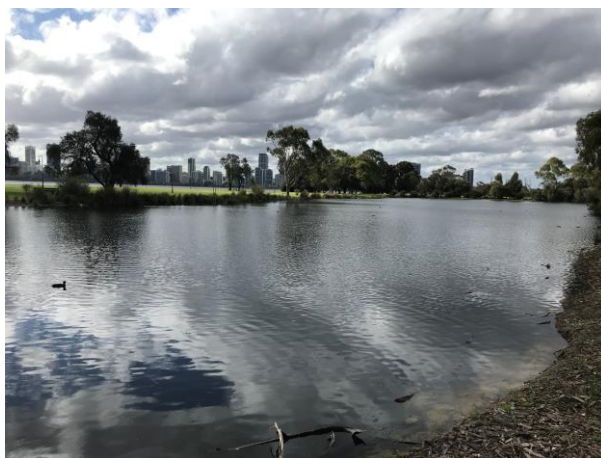
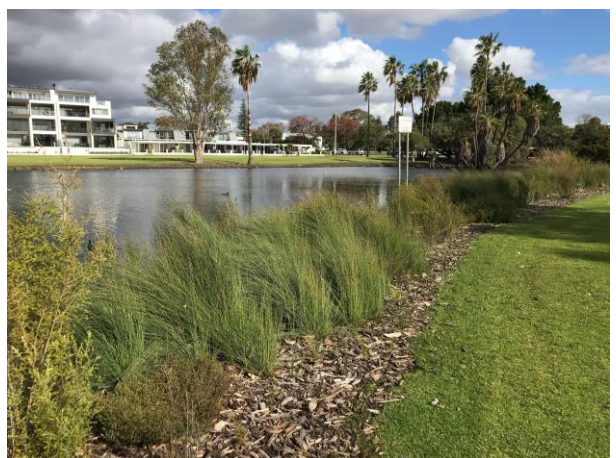
**Plate 2. Lake Douglas**

Largest of the three manmade lakes at Sir James Mitchel Park, Lake Douglas has a very narrow and sparse belt of vegetation on the margins of the lake most of which was planted within the last three years (see Plate 2).

The northern edge of the wetland is more vegetated than the southern edge. Some of the commonly planted species include *Juncus pallidus*, *Baumea juncea* and *Baumea articulata* with scattered shrubs

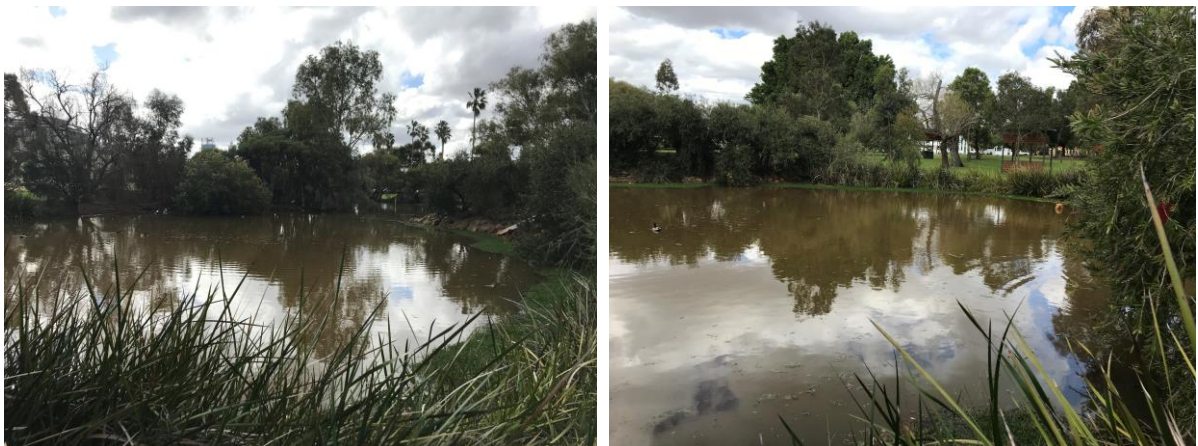
**Plate 3. Lake Tondut vegetation**

The vegetation surrounding this lake is relatively dense, and this is mainly to restrict views to the rusty water which is considered as unsightly by some of the residents. It also masks the artesian bore infrastructure from the parkland beyond. The key species include *Melaleuca raphiophylla*, *Melaleuca cuticularis*, *\*Eucalyptus camaldulensis*, *\*Callistemon* sp. and *\*Phoenix dactylifera* palm. The southern edge of the lake has a dense strand of *Baumea preissii* sedges and to the east *Ficinia nodosa*. The examples of vegetation for Lake Tondut are shown in Plate 3.

No *Typha* was recorded during the survey of the area; however, its introduction is possible. This plant is undesirable in this lake due to its size and function.

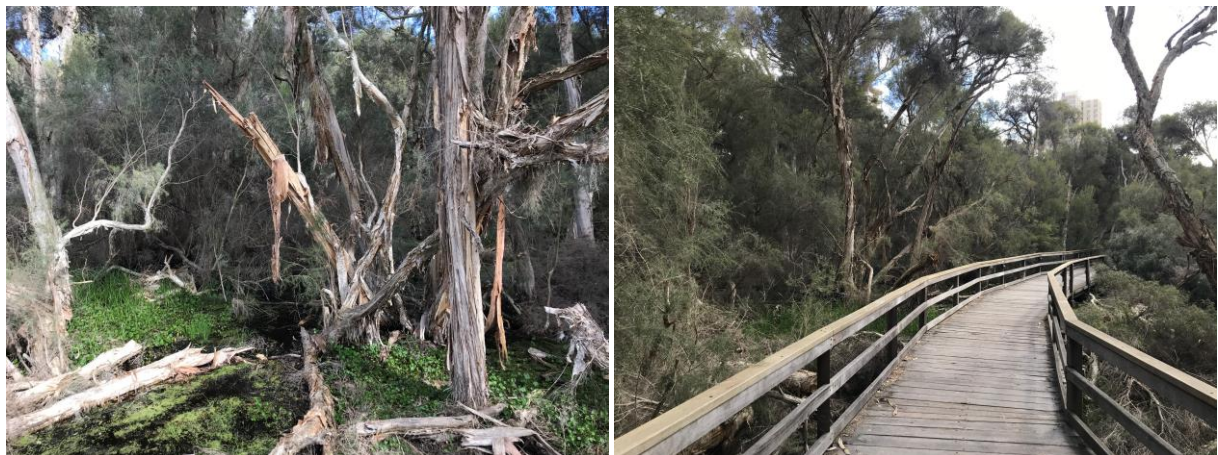
Plate 4. Melaleuca Swamp vegetation

Melaleuca Swamp is a remnant vegetation wetland of good condition containing a dense stand of *Melaleuca raphiophylla* over *Bolboschoenus caldwellii*, *Baumea articulata*, *Centella asiatica*, and *Parietaria debilis*. *Lemna* sp. is found in small patches over water in the areas adjacent to the walkway (Plate 4) where greater access to sunlight is available.

***Typha* occurrence and distribution:** 0 m<sup>2</sup>

**Percentage of the waterbody covered by *Typha*:** 0 %

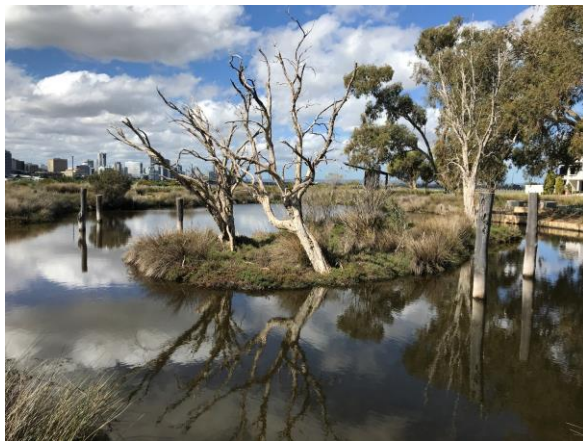
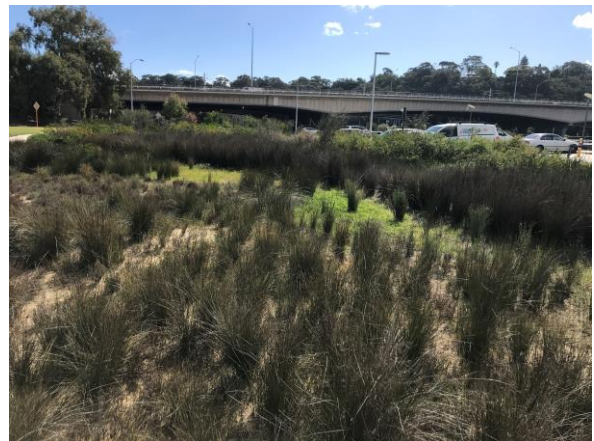
Plate 5. Millers Pool

Vegetation is in very good condition due largely to regular maintenance efforts and the suitable plant selection. While the vegetation surrounding the pool is varied for purposes of providing points of interest and providing diversity in challenging infill conditions, the pool itself has a simpler assemblage comprised of *Juncus kraussii*, *Suaeda australis*, *Salicornia quinqueflora*, *Samolus repens*, and isolated planted trees of *Melaleuca cuticularis*, *Melaleuca raphiophylla* and \**Melaleuca lanceolata*.

No <i>Typha</i> species were recorded at Millers Pool. Given the history of the site and the connectivity between the pool and the Swan River via a pipe, the water conditions within the wetland are largely saline and generally not favourable to establishment of <i>Typha</i> .	
<b>Approximate waterbody size with surrounding vegetation:</b>	0.19 ha
<b><i>Typha</i> occurrence and distribution:</b>	0 m <sup>2</sup>
<b>Percentage of the waterbody covered by <i>Typha</i>:</b>	0 %

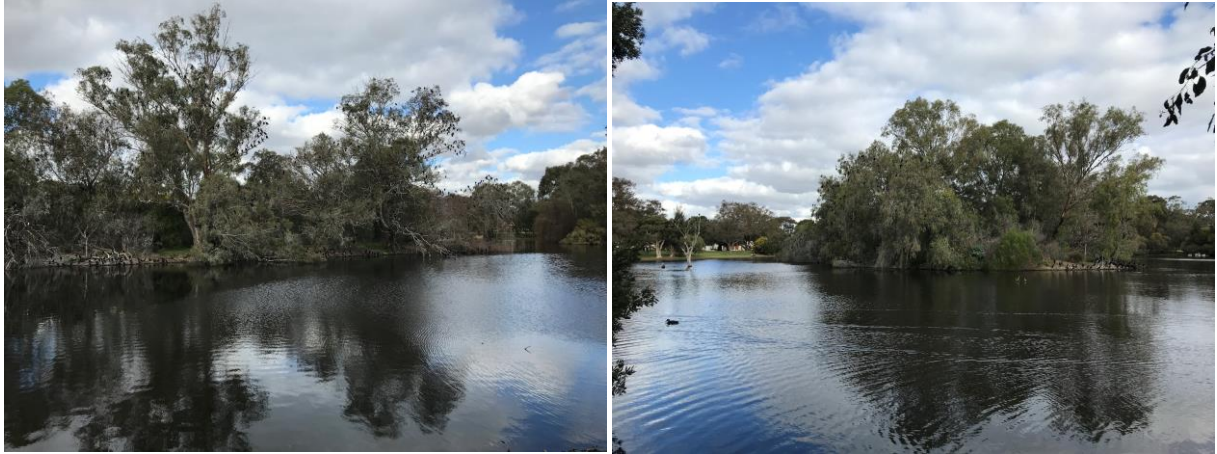
Plate 6. Lake McDougal

While few remnant trees are still found within the parkland, most are planted and include *Eucalyptus rudis* and *Melaleuca raphiophylla* (Plate 6). Intermittent planting of sedges like *Juncus kraussii* and *Baume preissii* was completed in recent years; however, large areas of the lake's edge remain as turf. The northern section of the lake that faces Henley Street shows a greater diversity of planting. In addition to species endemic to site, several introduced species is also present including willows, paperbarks and various shrubs and herbs.

No <i>Typha</i> plants were recorded in the lake. As with other lakes, there is a high likelihood of the <i>Typha</i> introduction. Given that the lake must retain its capacity for stormwater storage and infiltration (it does not have an outlet to other drainage basins or the river), any substantial <i>Typha</i> growth would significantly reduce the capacity of the lake to store stormwater particularly during high rainfall events.
----------------------------------------------------------------------------------------------------------------------------------------------------------------------------------------------------------------------------------------------------------------------------------------------------------------------------------------------------------------------------------------------------------------------------------------------------

<b>Approximate waterbody size including island:</b>	2.28 ha
<b><i>Typha</i> occurrence and distribution:</b>	0 m <sup>2</sup>
<b>Percentage of the waterbody covered by <i>Typha</i>:</b>	0 %

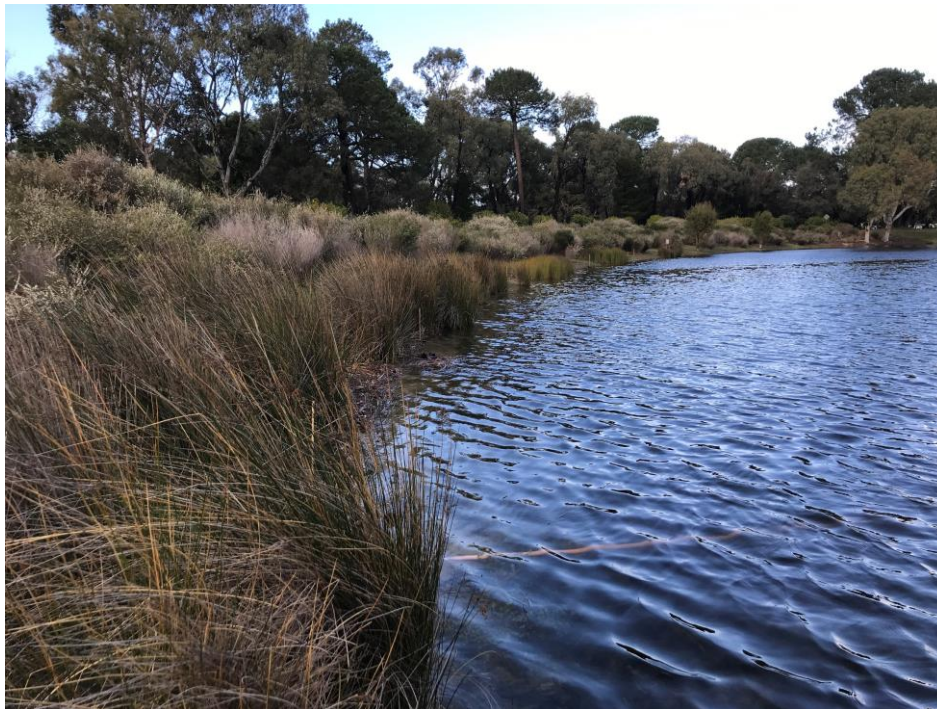
**Plate 7. Collier Park Lake 1 – Entrance Lake (facing south)**

This lake is largely surrounded by turf with the south-eastern side of the lake vegetated with *Baumea juncea* and *Hypocalymma angustifolium / robustum* mix. To the north a small strip of *Baumea articulata*, *Juncus pallidus* and *Ficinia nodosa* are present. The main function of the lake is that of a water compensation basin and entrance amenity statement for the golf course.

No <i>Typha</i> was detected in the lake. Lake has had <i>Typha orientalis</i> (as singular plants) in the past (prior to 2016) at the northern end of the lake, however, these occurrences were managed by timely removal. No <i>Typha</i> species were recorded in the lake since 2016.	
<b>Approximate waterbody size with surrounding vegetation:</b>	0.64 ha
<b><i>Typha</i> occurrence and distribution:</b>	0 m <sup>2</sup>
<b>Percentage of the waterbody covered by <i>Typha</i>:</b>	0 %

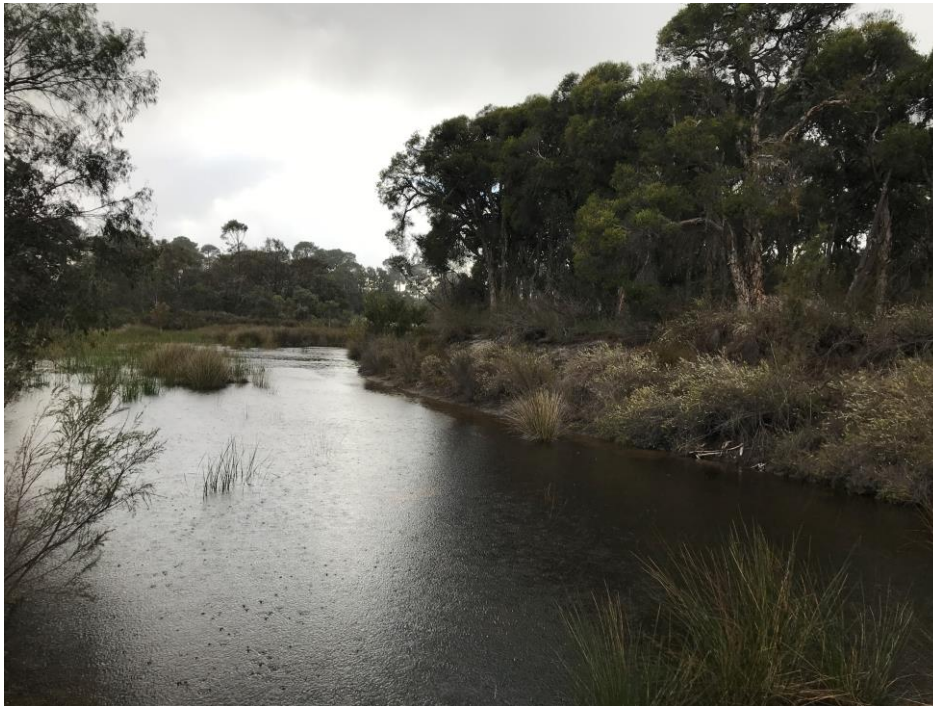
**Plate 8. Collier Park Lake2 – Main Lake**

This is the largest of the three lakes within the Collier Golf Course area and serves as a compensation basin and an irrigation lake. The surrounding vegetation is varied and mostly comprised of planted sedges and trees. The eastern part of the lake forms a large stormwater infiltration area and is densely vegetated whereas the western part is used as water storage for irrigation. The central island contains remnant vegetation dominated by *Melaleuca preissiana* trees and *Astartea scoparia* and *Hypocalymma angustifolium* shrubs. Several groundcover species including orchids are also found on the island. The general appearance of the lake as viewed from the south eastern side is shown in Plate 8.

***Typha* occurrence and distribution:** 0 m<sup>2</sup>

**Percentage of the waterbody covered by *Typha*:** 0 %

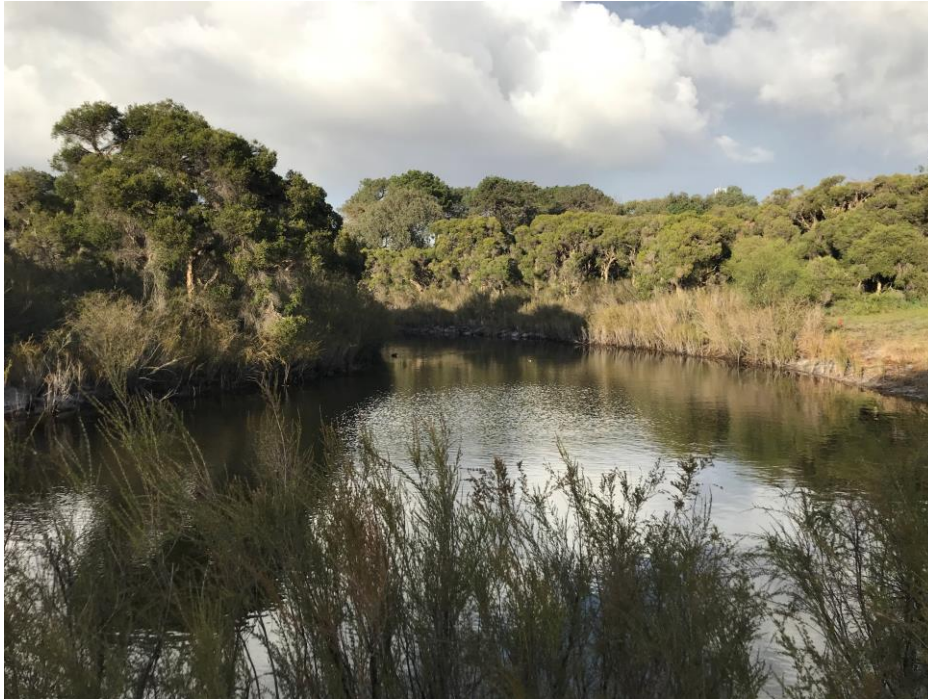
**Plate 9. Collier Park Lake 3 – Small Lake**

***Typha* occurrence and distribution:** 0 m<sup>2</sup>

**Percentage of the waterbody covered by *Typha*:** 0 %

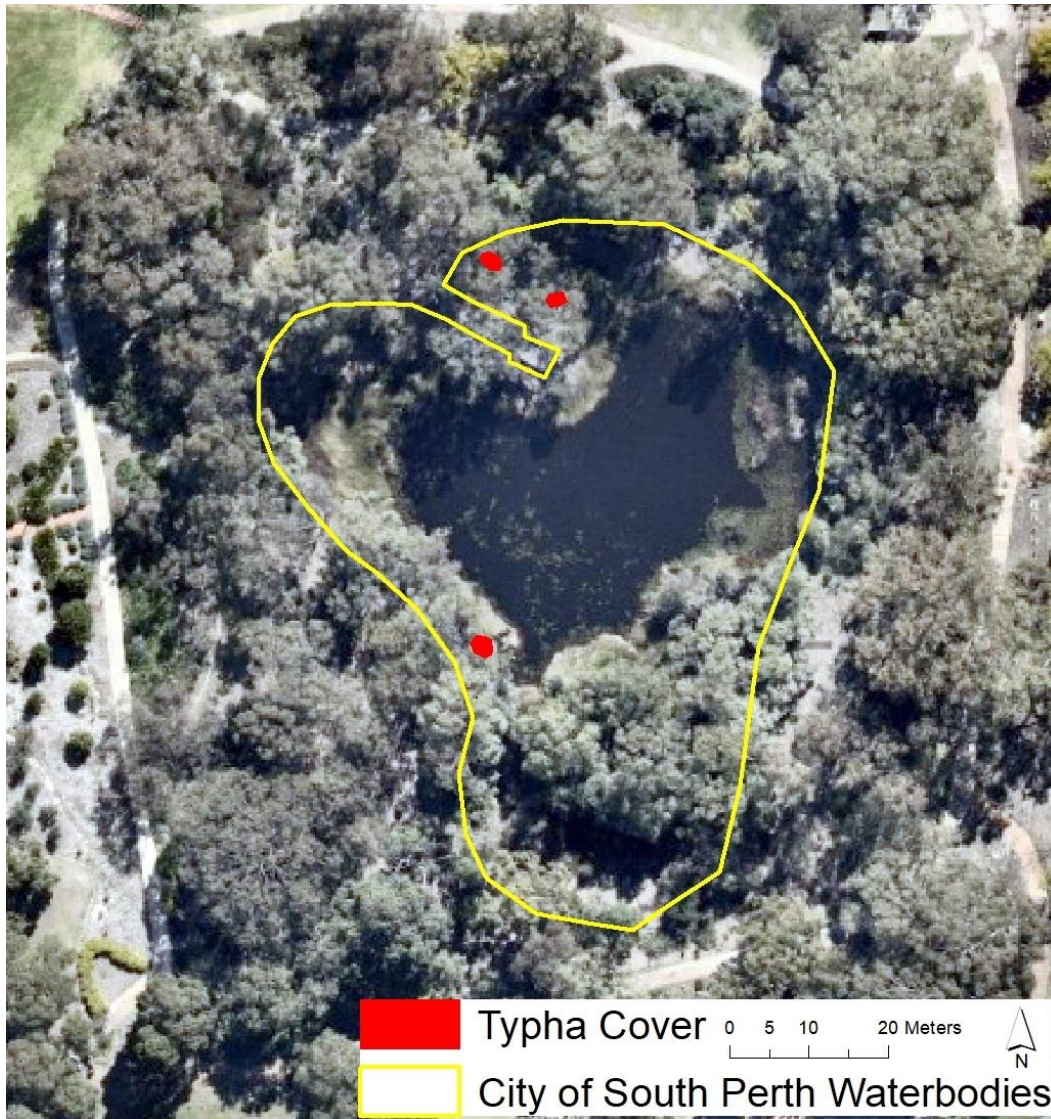
Figure 4. Location and extent of *Typha orientalis* populations within Lake Gillon

*Typha orientalis* was noted in three small patches on the lake margins, as shown in Figure 4 and Plate 10. *Typha* occurred within the lake in the past and was actively managed to maintain its storage capacity and maintain downstream flows.

<b>Approximate waterbody size:</b>	0.41 ha
<b><i>Typha</i> occurrence and distribution:</b>	14 m <sup>2</sup>
<b>Percentage of the waterbody covered by <i>Typha</i>:</b>	0.34 %

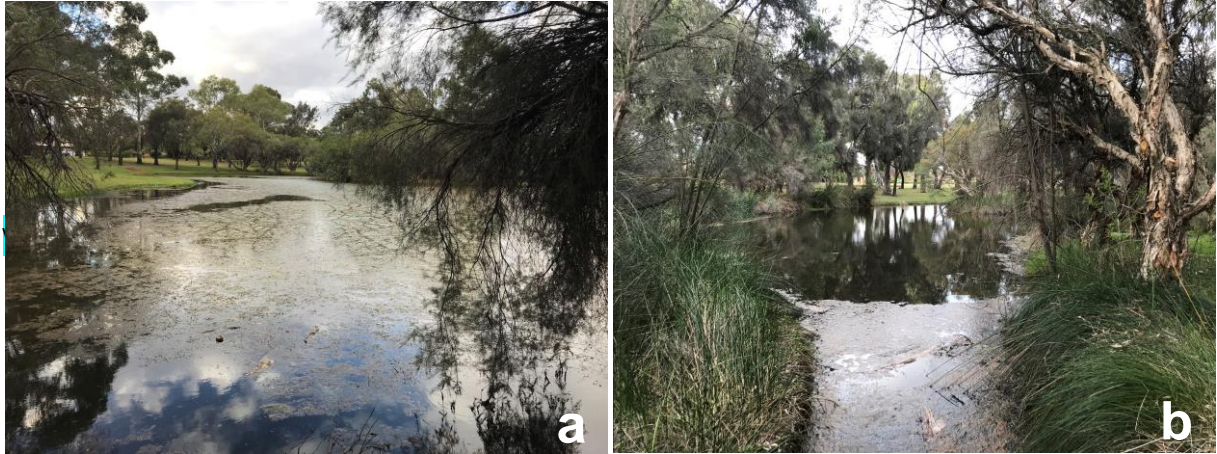
**Plate 12. Bodkin Park Lakes: a) Northern Lake and b) Southern lake**

No *Typha* was recorded within the drain (within the Bodkin Park boundary).

<b>Approximate waterbody size (both wetlands and the drain):</b>	0.69 ha
<b><i>Typha</i> occurrence and distribution:</b>	0 m <sup>2</sup>
<b>Percentage of the waterbody covered by <i>Typha</i>:</b>	0 %

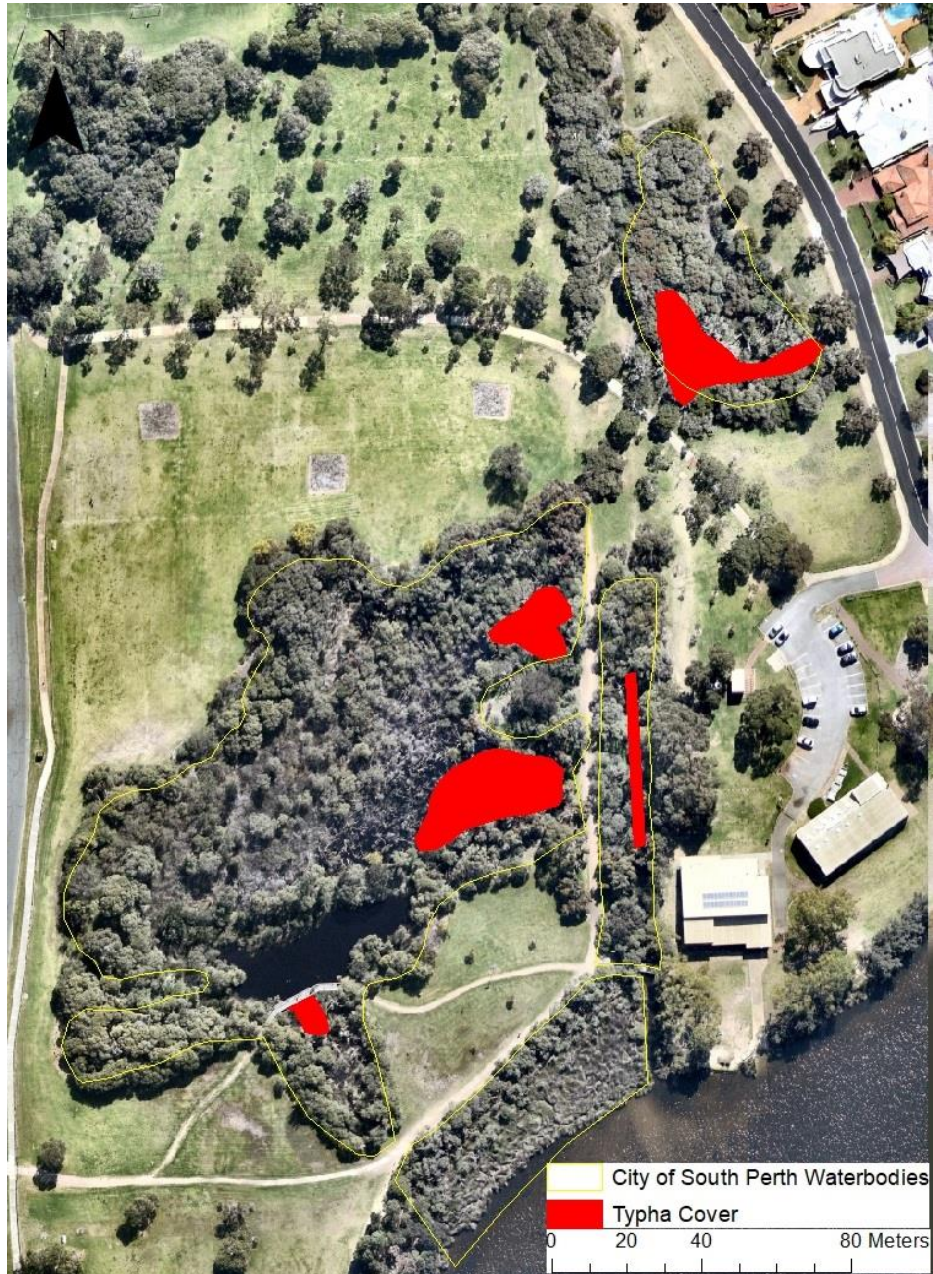
Figure 6. Elderfield Wetlands - areas with *Typha* infestations

The infestations are connected to drainage inflows, and the patches are very dense and starting to impact on other native sedges and rushes.

<b>Approximate wetland size including surrounding vegetation, foreshore and drain:</b>	1.89 ha
<b><i>Typha</i> occurrence and distribution:</b>	1600 m <sup>2</sup>
<b>Percentage of the waterbody covered by <i>Typha</i>:</b>	8 %

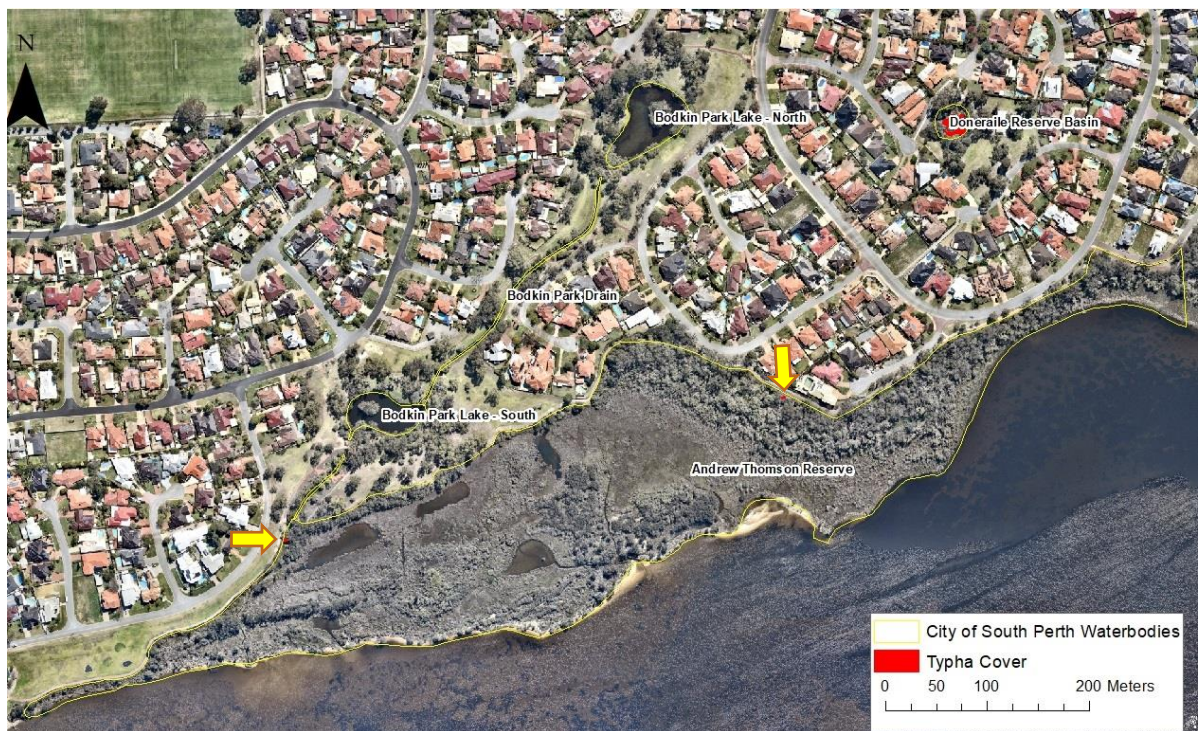
**Figure 7. Location of *Typha orientalis* growth at Andrew Thomson Reserve**

This inspection has noted presence of *T. orientalis* plants at two locations: one associated with the Bodkin Park drain junction and second in the degraded section of Eucalyptus / Melaleuca woodland to the east. Both infestations are small and do not have seeding material. As such, they should be treated/removed to reduce the possibility of further establishment and spread.

<b>Approximate waterbody size:</b>	12 ha
<b><i>Typha</i> occurrence and distribution:</b>	12 m <sup>2</sup>
<b>Percentage of the waterbody covered by <i>Typha</i>:</b>	0.01%

1. Where small and new populations of *Typha* are recorded in remnant vegetation of very good condition like that of Andrew Thompson's Reserve or Cygnia Cove foreshore, these plants should be chemically treated and above ground biomass removed before they take hold and start to seed.

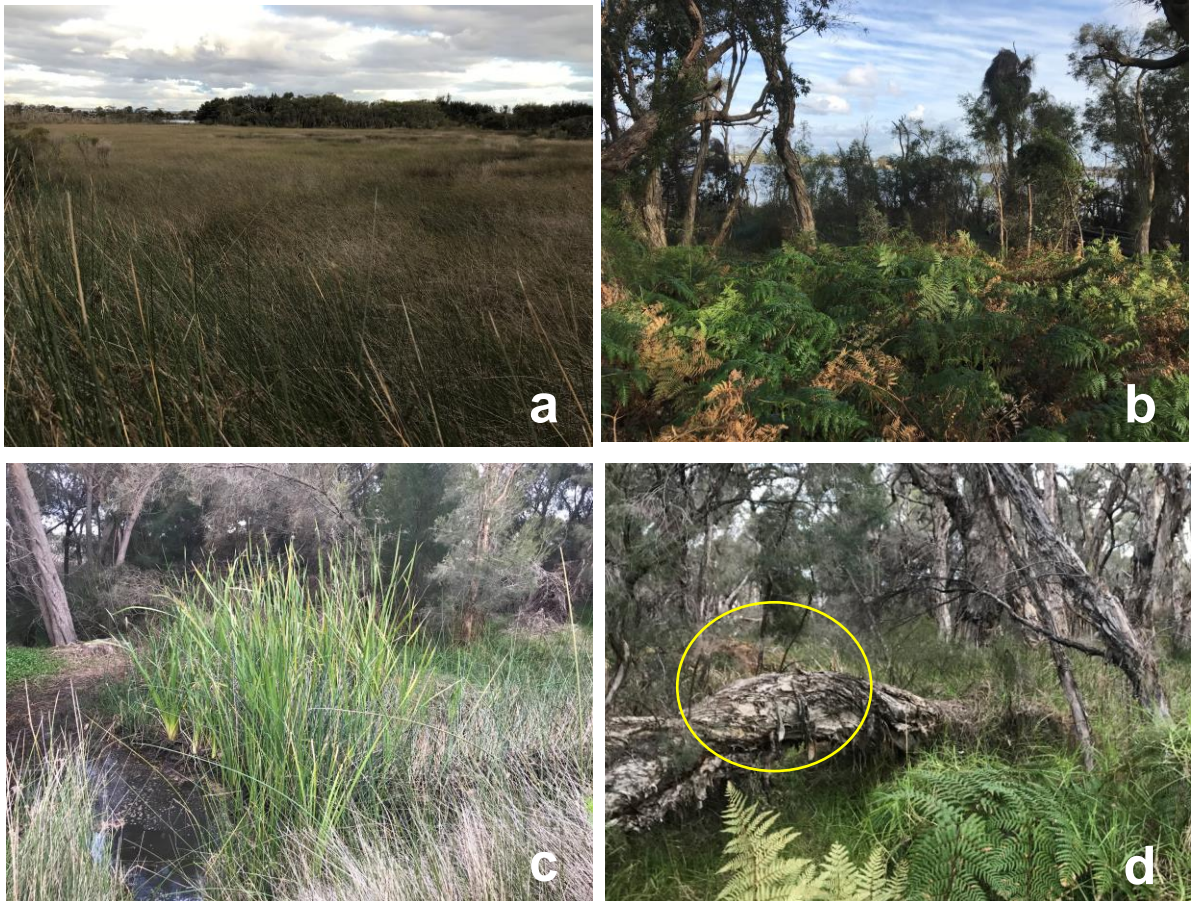
Examples of vegetation present at Andrew Thomson Reserve and photos of the two *Typha* infestations is shown in Plate 14.

**Plate 14. Andrew Thompson Reserve showing remnant vegetation *Juncus kraussii* rushes with *Casuarina obesa* trees (a); *Melaleuca raphiophylla* and *Eucalyptus rudis* with *Pteridium esculentum* (b); and small areas of *Typha* infestation at the end of Bodkin Park drain (c) and eastern section (d)**

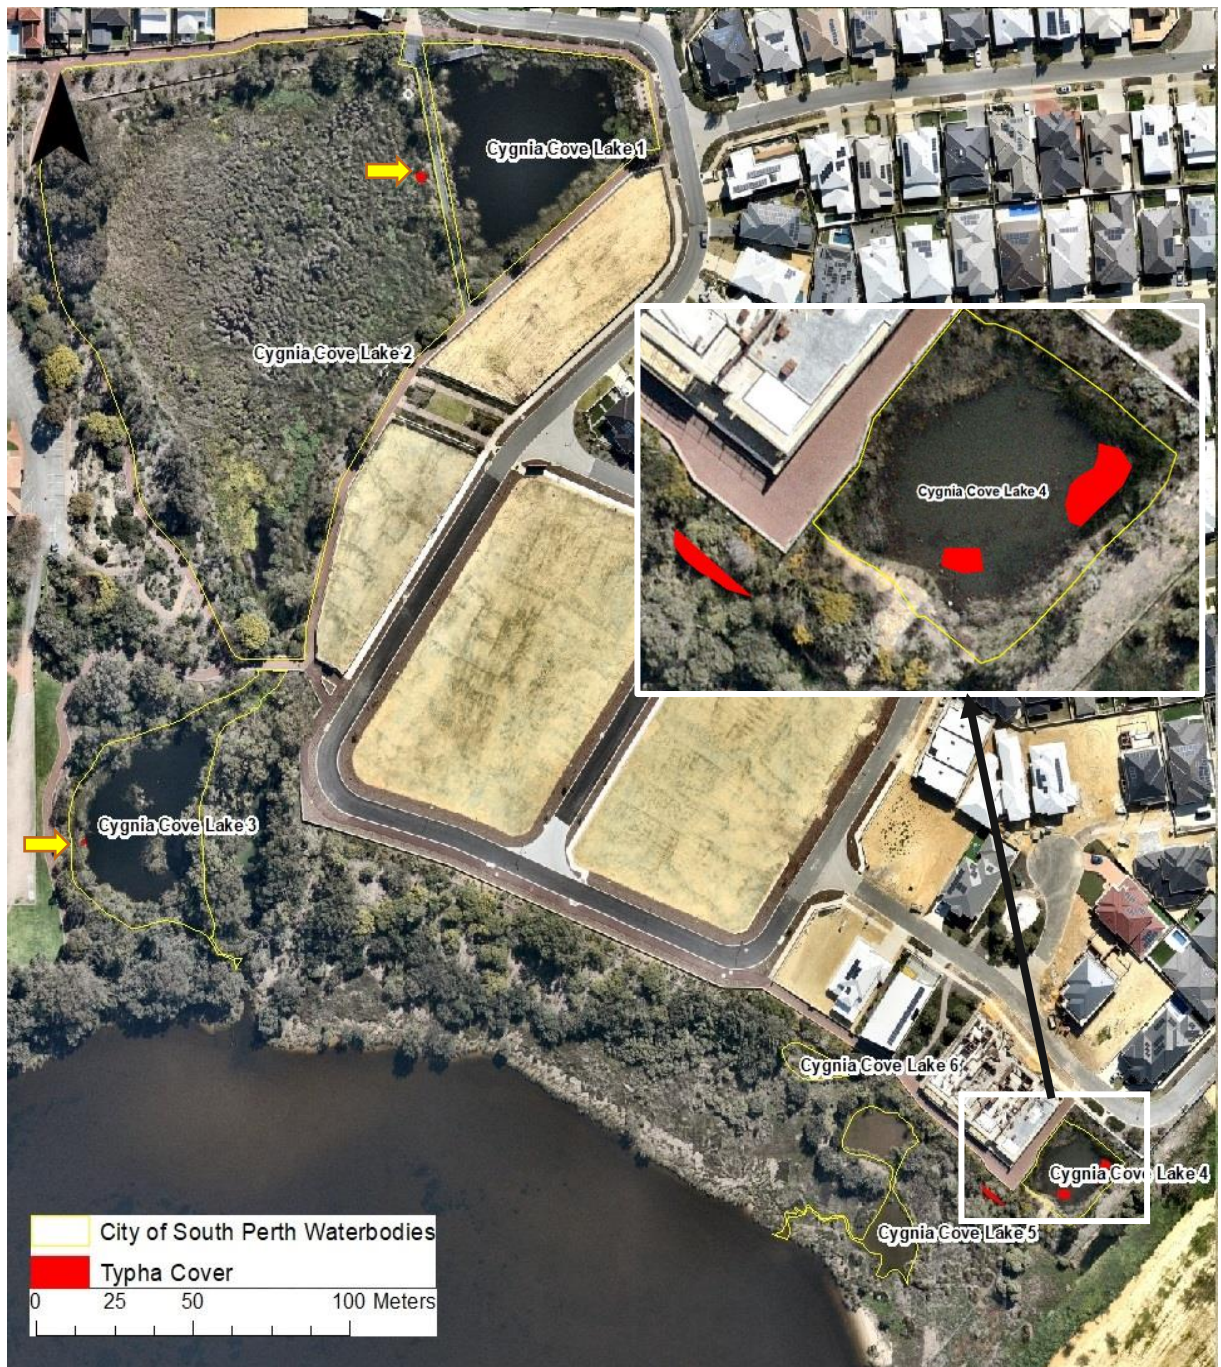
**Figure 8. Location of Cygnia Cove Waterbodies showing *Typha* infestation locations**

*Typha* was recorded in three of the six waterbodies (Lakes 2, 3 and 4) and in the foreshore area where Lake 4 (infested with *Typha*) discharges into remnant foreshore vegetation. Given this area is hydraulically connected to Lake 5 the infestation area has been assigned to this lake. The overall *Typha* infestation compared to the extent of the waterbodies is outlined below and example images of infestations shown in Plate 15

<b>Approximate size of all waterbodies at Cygnia Cove</b>	2.42 ha
<b><i>Typha</i> occurrence and distribution:</b>	36 m <sup>2</sup>
<b>Percentage of the waterbody covered by <i>Typha</i>:</b>	0 %
