**R1947 Rev 2**

**City of Wanneroo**

**Mindarie Tees Ct BAW  
Detailed Design Report**

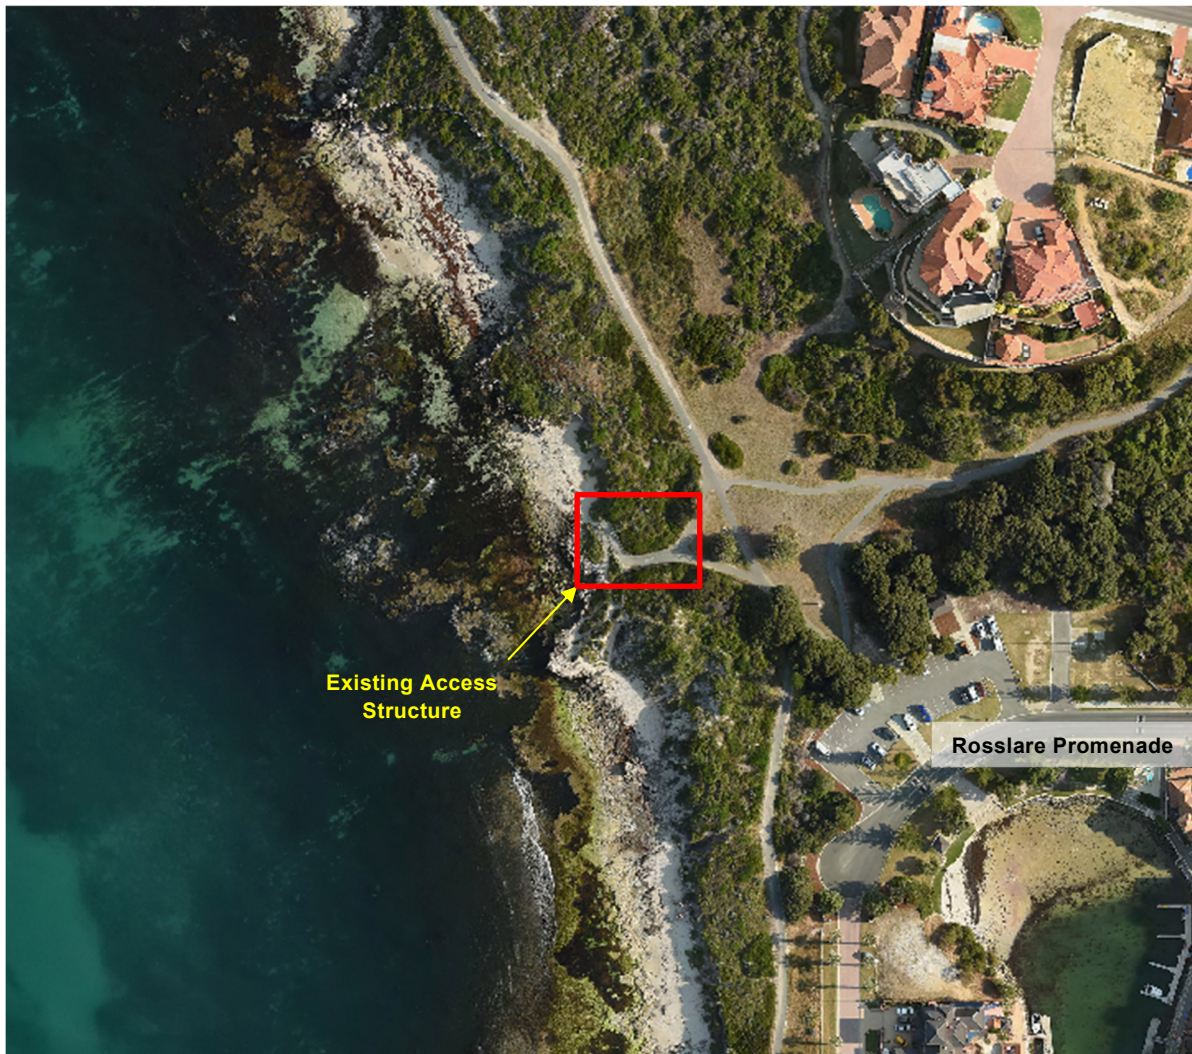
**Figure 1.1 Location Plan**

The location of the BAW is presented in the following figure.

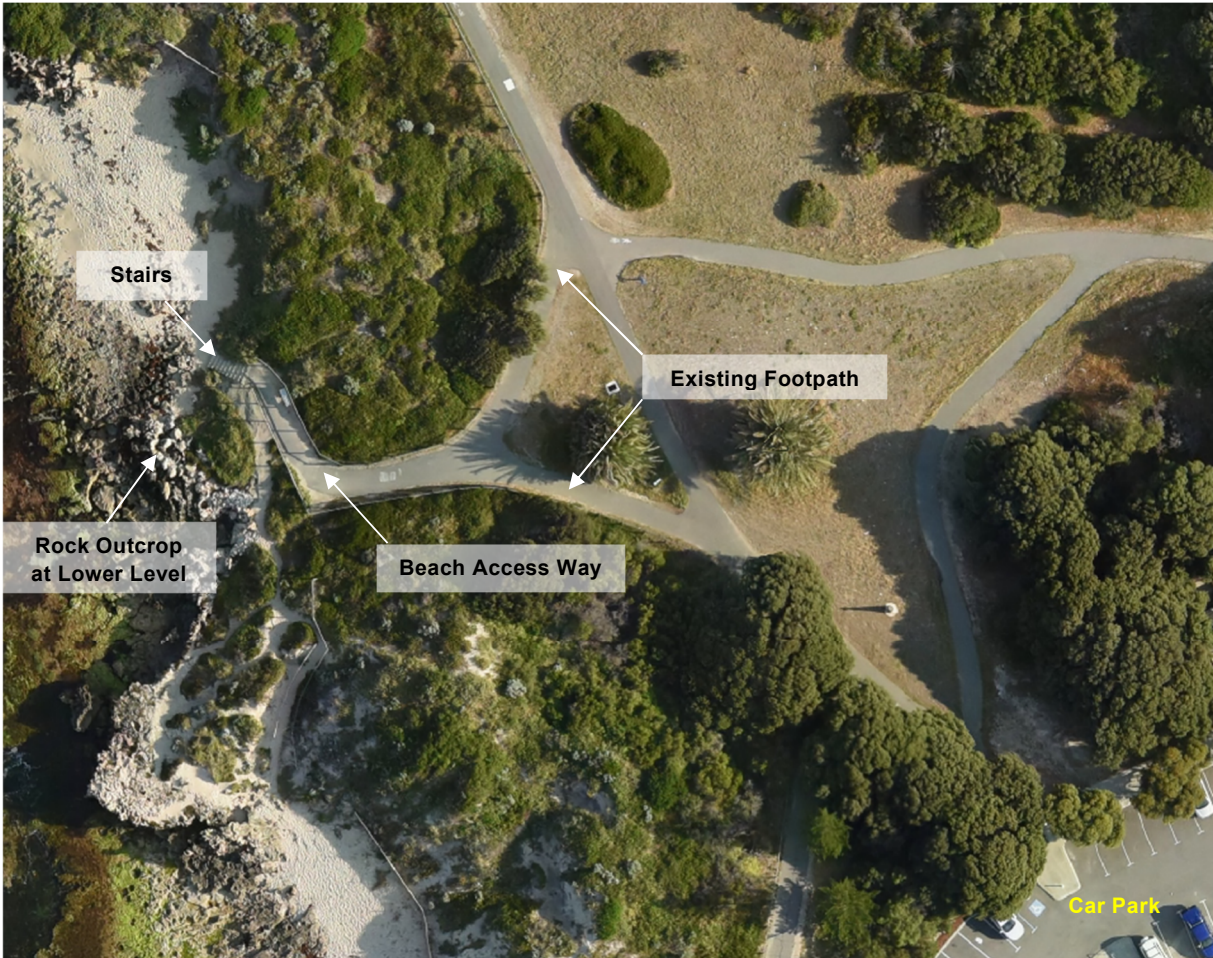
**Figure 1.2 Layout of the Existing Access Structure**

The access structure connects the existing footpath to a small stretch of beach. The footpaths leading to the BAW are generally relatively flat and connect to the BAW which has a steeper gradient. The end of the BAW is a limestone block staircase that leads directly onto the beach. The layout of the existing access structure is shown in the following figure.

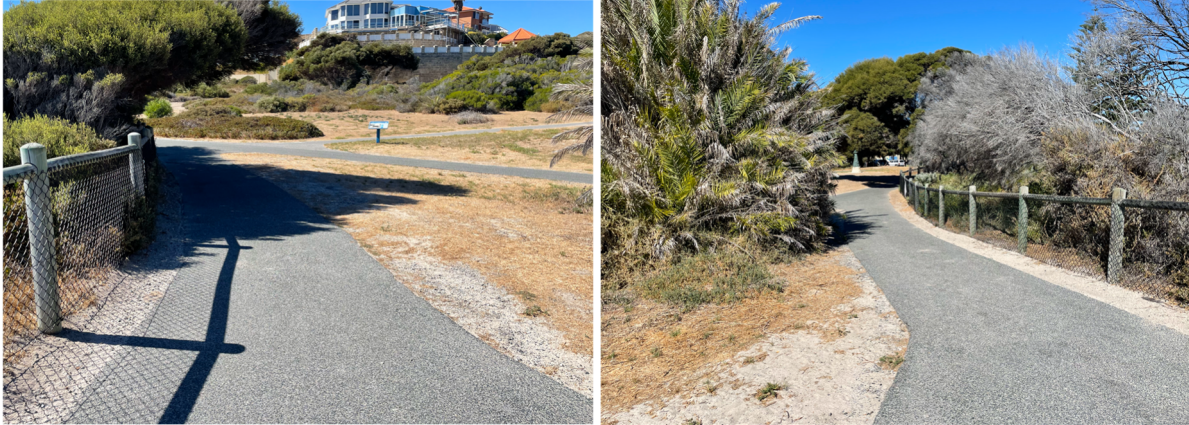
Figure 2.1 Existing Footpaths

There are a number of footpaths that are connected to the BAW and a nearby car park. The footpaths are generally constructed from asphalt, with standard conservation fence on the dune side. The condition of these footpaths generally appears to be reasonable. However, the construction of the replacement BAW is likely to require the use of these footpaths, possibly by machinery.

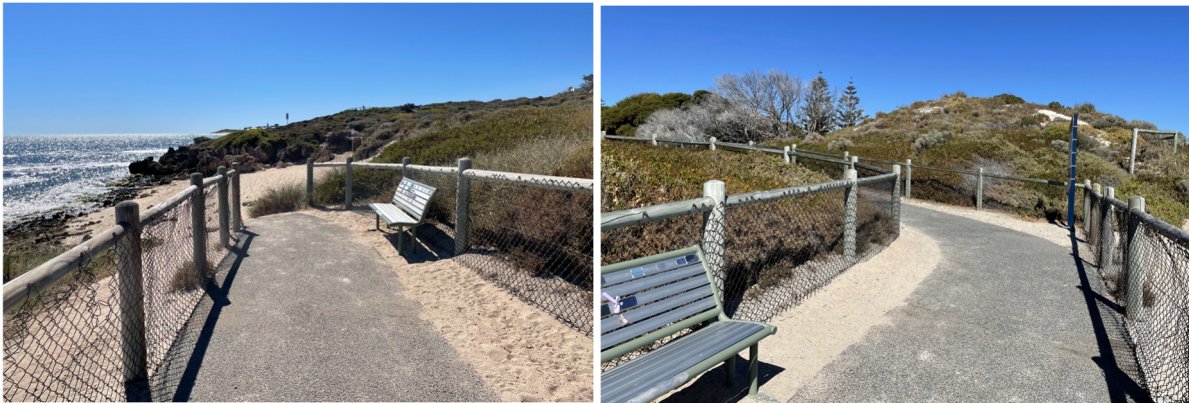
Figure 2.2 Existing BAW

The BAW is generally constructed similarly to the footpath but follows a steeper gradient. The end of the BAW consists of a set of limestone block stairs.

A key requirement for the replacement BAW is to provide improved accessibility to the beach. Given the current relatively steep gradient, this would mean that a longer length of path would be required to accommodate improved accessibility.

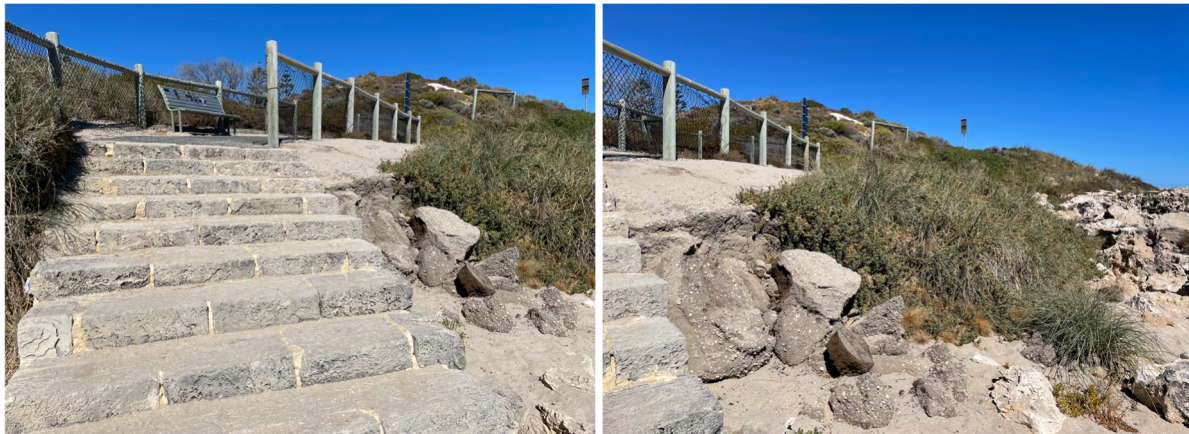
**Figure 2.3 Limestone Block Stairs**

A set of stairs is located at the end of the BAW. The stairs are constructed from reconstituted limestone blocks. There is evidence of erosion (e.g. slumped/unstable dune profile) on the seaward side of the stair. The City has advised that the seaward dune profile adjacent to the BAW and stairs consists of bitumen stabilised limestone that has been placed by the City during previous maintenance repairs. Beach rock and rock outcrop is also visible seaward of the stairs and BAW.

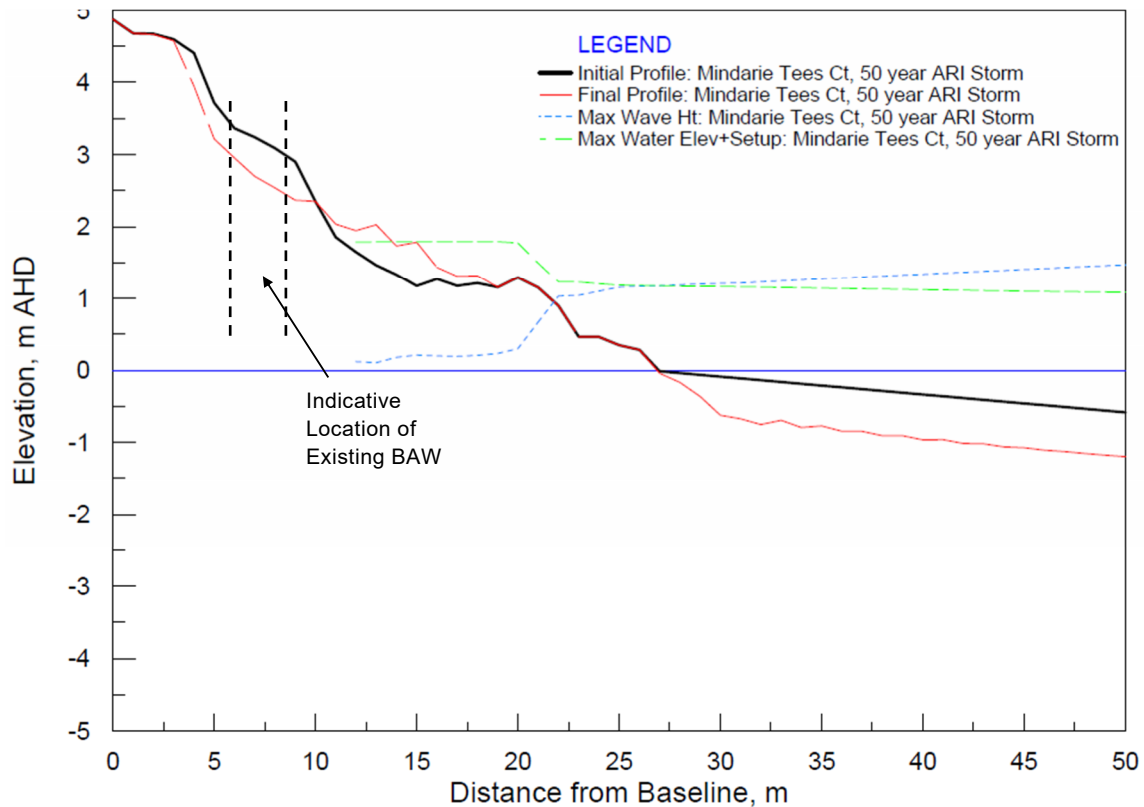
**Figure 3.2 SBEACH Output**

The SBEACH model was setup and run with input beach profiles and storm conditions. Shallow beach rock layers/outcrops are visible at a lower elevation and provides protection for the lower portion of the beach/dune profile, this has been included in the SBEACH modelling. The results from the modelling are presented in the following figure. The model outputs in this figure show the initial (pre-storm) profile, final profile and the maximum wave heights and water levels predicted during the storm.

The SBEACH model indicates that while the lower portion of the dune profile remain relatively stable due to presence of rock, there is still a potential scour in the order of about 0.5 m at the upper portion of the dune profile near the existing BAW. As such, depending on the elevation of the replacement BAW, appropriate scour protection is likely to be required, particularly for the upper portion of the dune. This has been considered in the design.

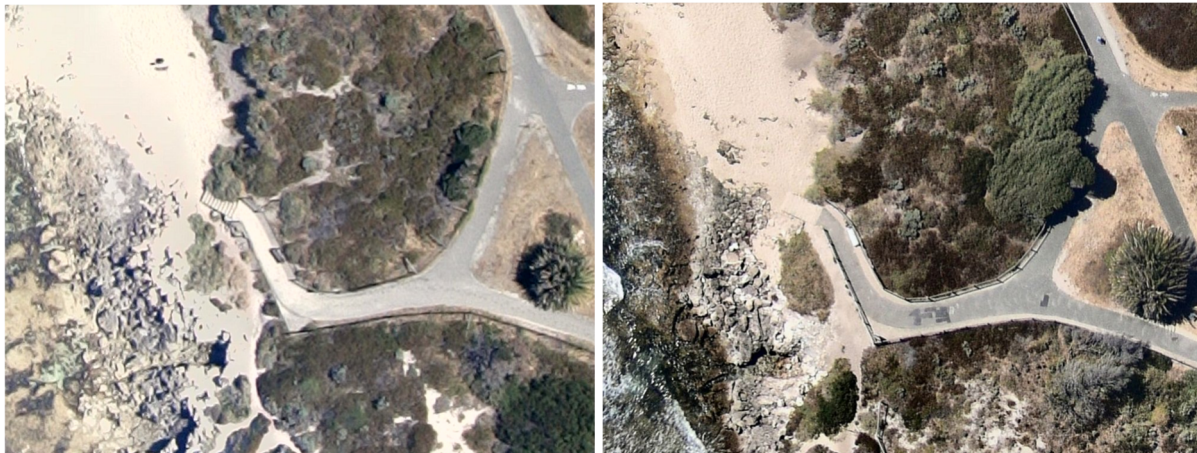
**Figure 3.4 Existing BAW - Left: 2008; Right: 2024**

For design, it is therefore appropriate for the replacement BAW to follow a similar alignment as the existing BAW. However, to maintain functionality over the design life, one or a combination of the following is required at the toe of the replacement BAW.

- Toe to be founded on competent rock layer.
- Appropriate scour protection.

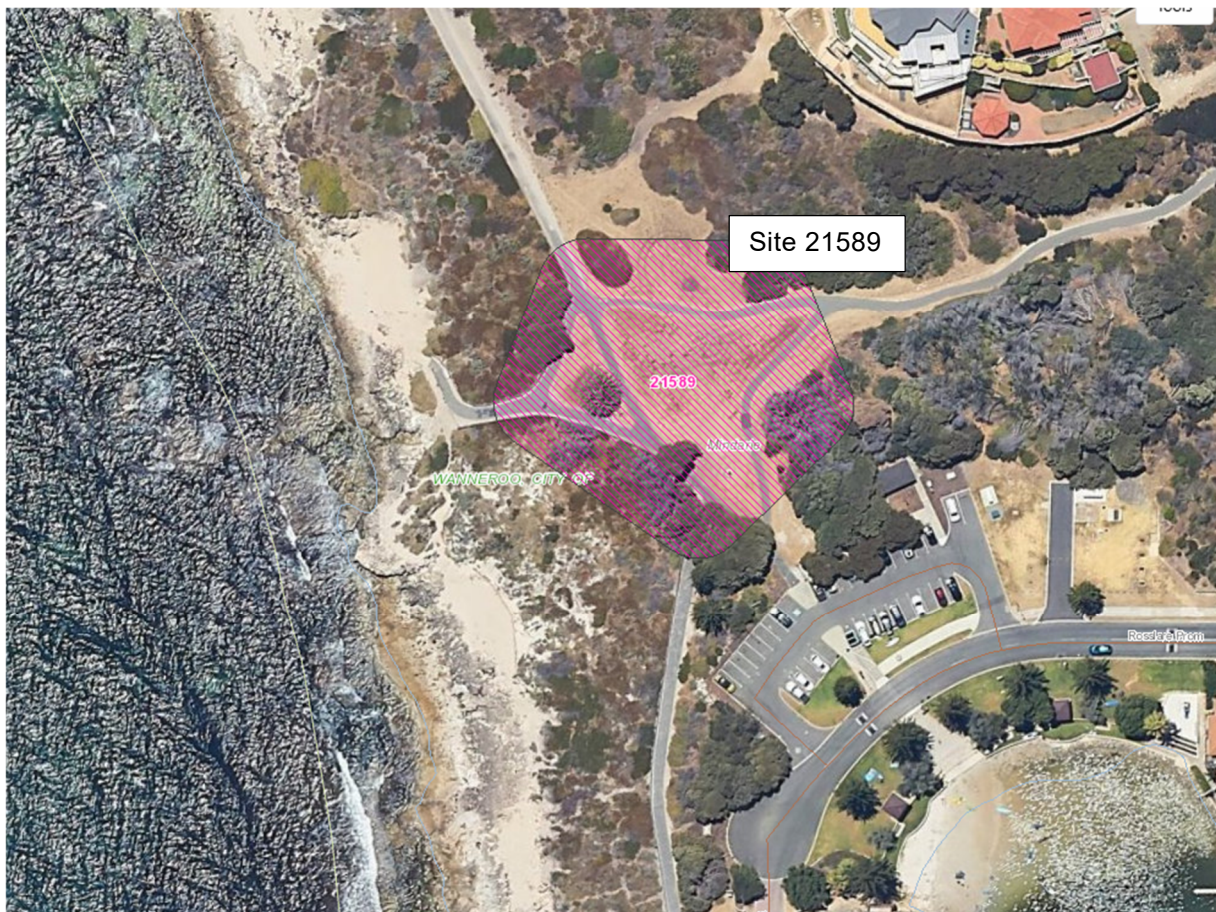
**Figure 3.6 Aboriginal Heritage Places Extract**

Based on the designs presented in Section 4, portions of the works summarised above impact on Aboriginal Registered Site 21589 (Rosslare Soak).
