17 March 2026

Department of Water and Environmental Regulation
Locked Bag 10, Joondalup DC WA 6919
info@dwer.wa.gov.au

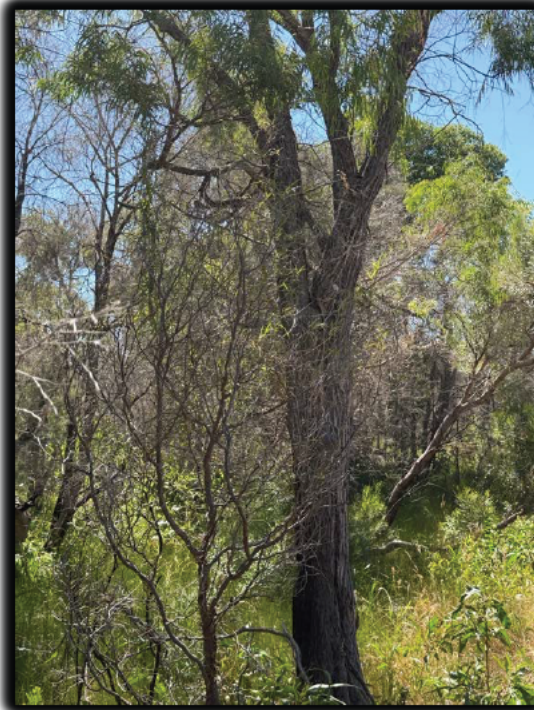
Plate 5. Tree 13, mature Peppermint tree with DBH >30 cm to be removed. Small amount of understorey to be removed. No obvious hollows or dreys were observed.

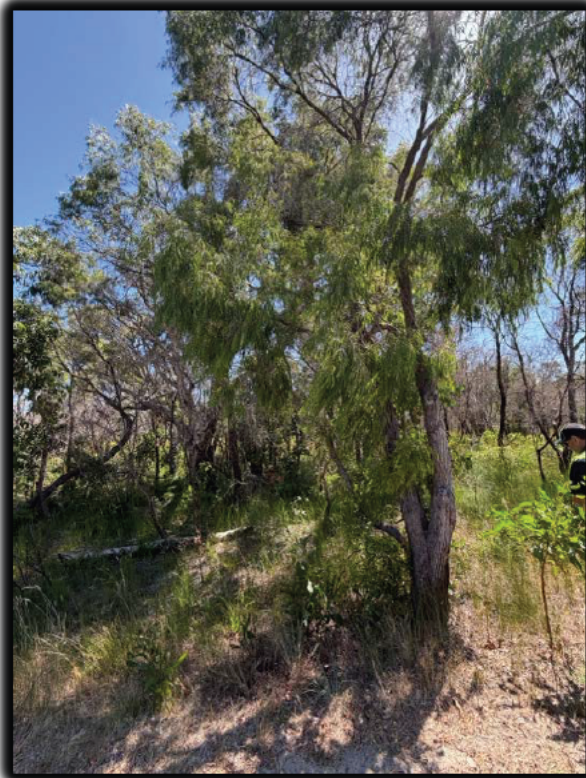
Plate 6. Tree 14, juvenile Peppermint tree to be removed with a DBH <30 cm. Limited native understorey.
