CLEARING PERMIT

Purpose Permit number:	CPS 4860/2
Permit Holder:	Carey Baptist College Inc
Duration of Permit:	21 June 2014– 21 June 2024

Stage 1: Revegetation Plan

Lot 2 Nicholson Road, Forrestdale

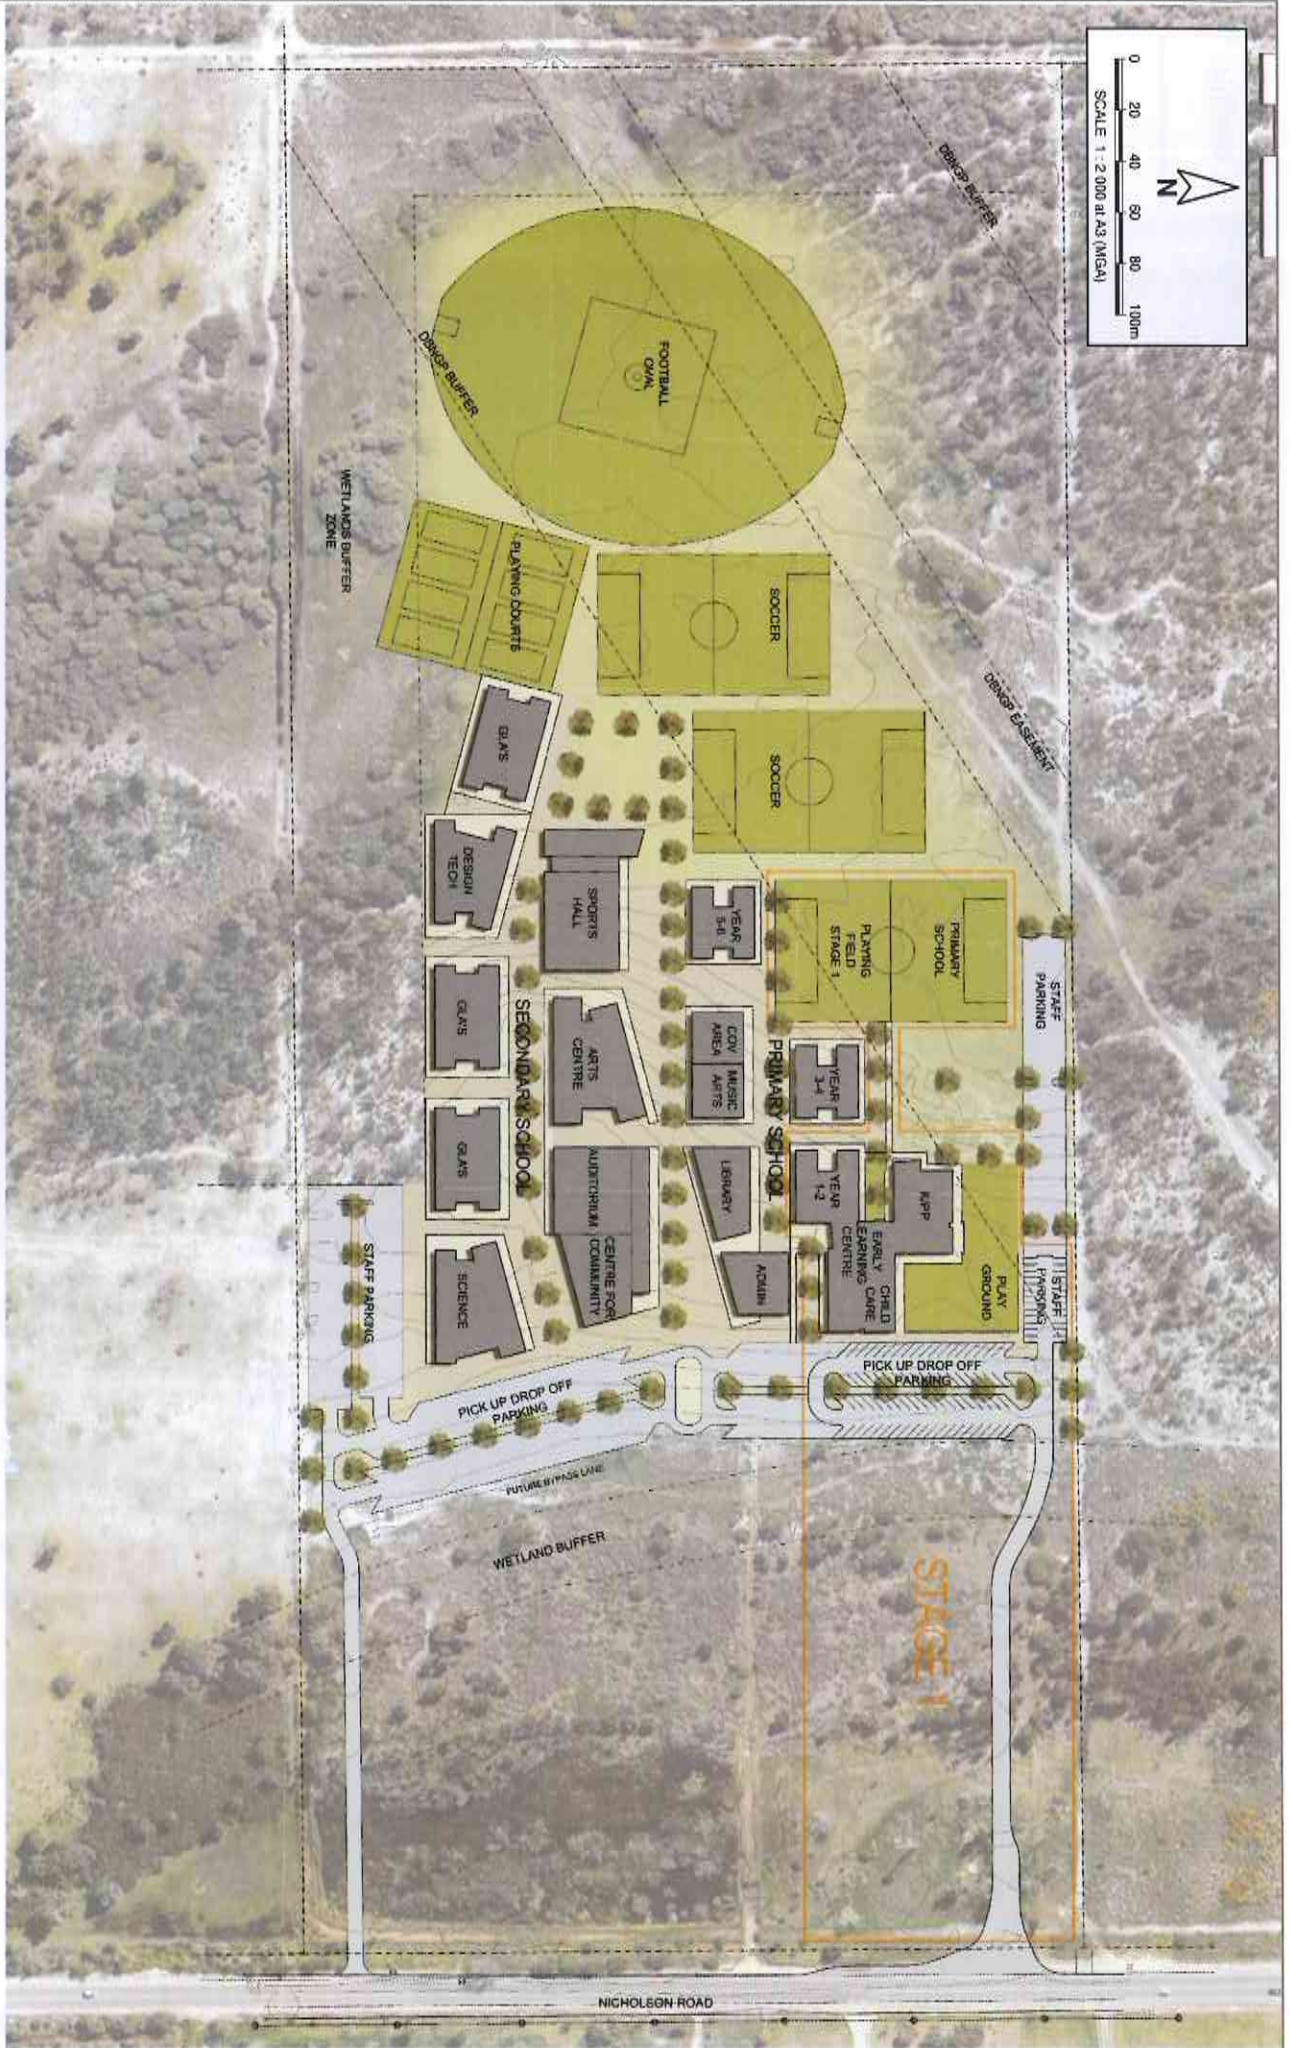
Figure 1

SITE LOCATION

Lot 2 Nicholson Road Forrestdale (the site) is located approximately 24 km south-east of Perth, within the City of Armadale (Figure 1). The site is approximately 22ha in size and is currently zoned 'Rural' under the Metropolitan Region Scheme (MRS) and 'General Rural' under the City of Armadale's Town Planning Scheme 4 (TPS4).

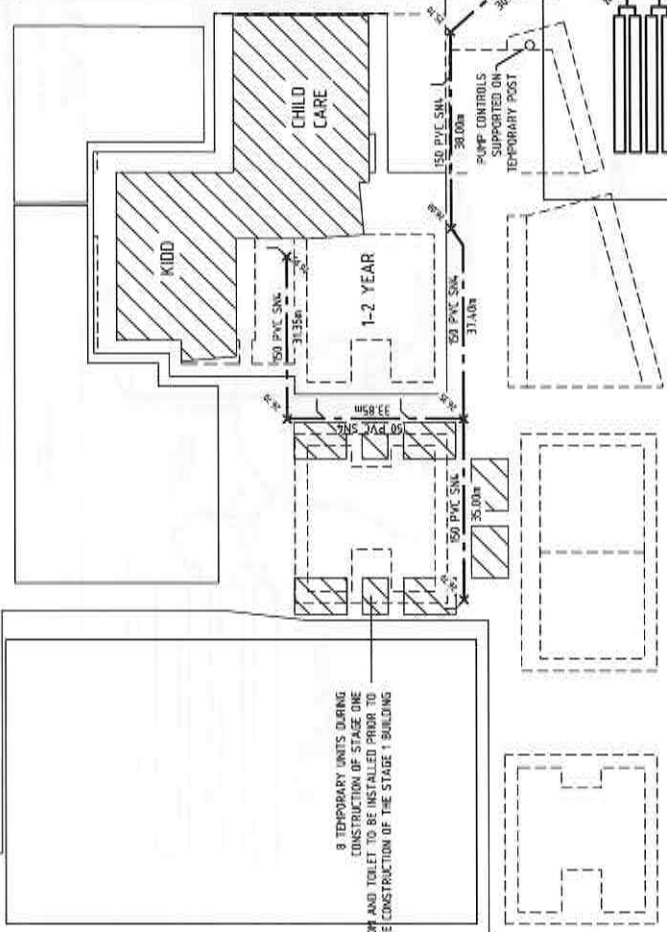
SEE DRAWING 10184-C205

8 TEMPORARY UNITS DURING CONSTRUCTION OF STAGE ONE CLASSROOM AND TOILET TO BE INSTALLED PRIOR TO THE CONSTRUCTION OF THE STAGE 1 BUILDING

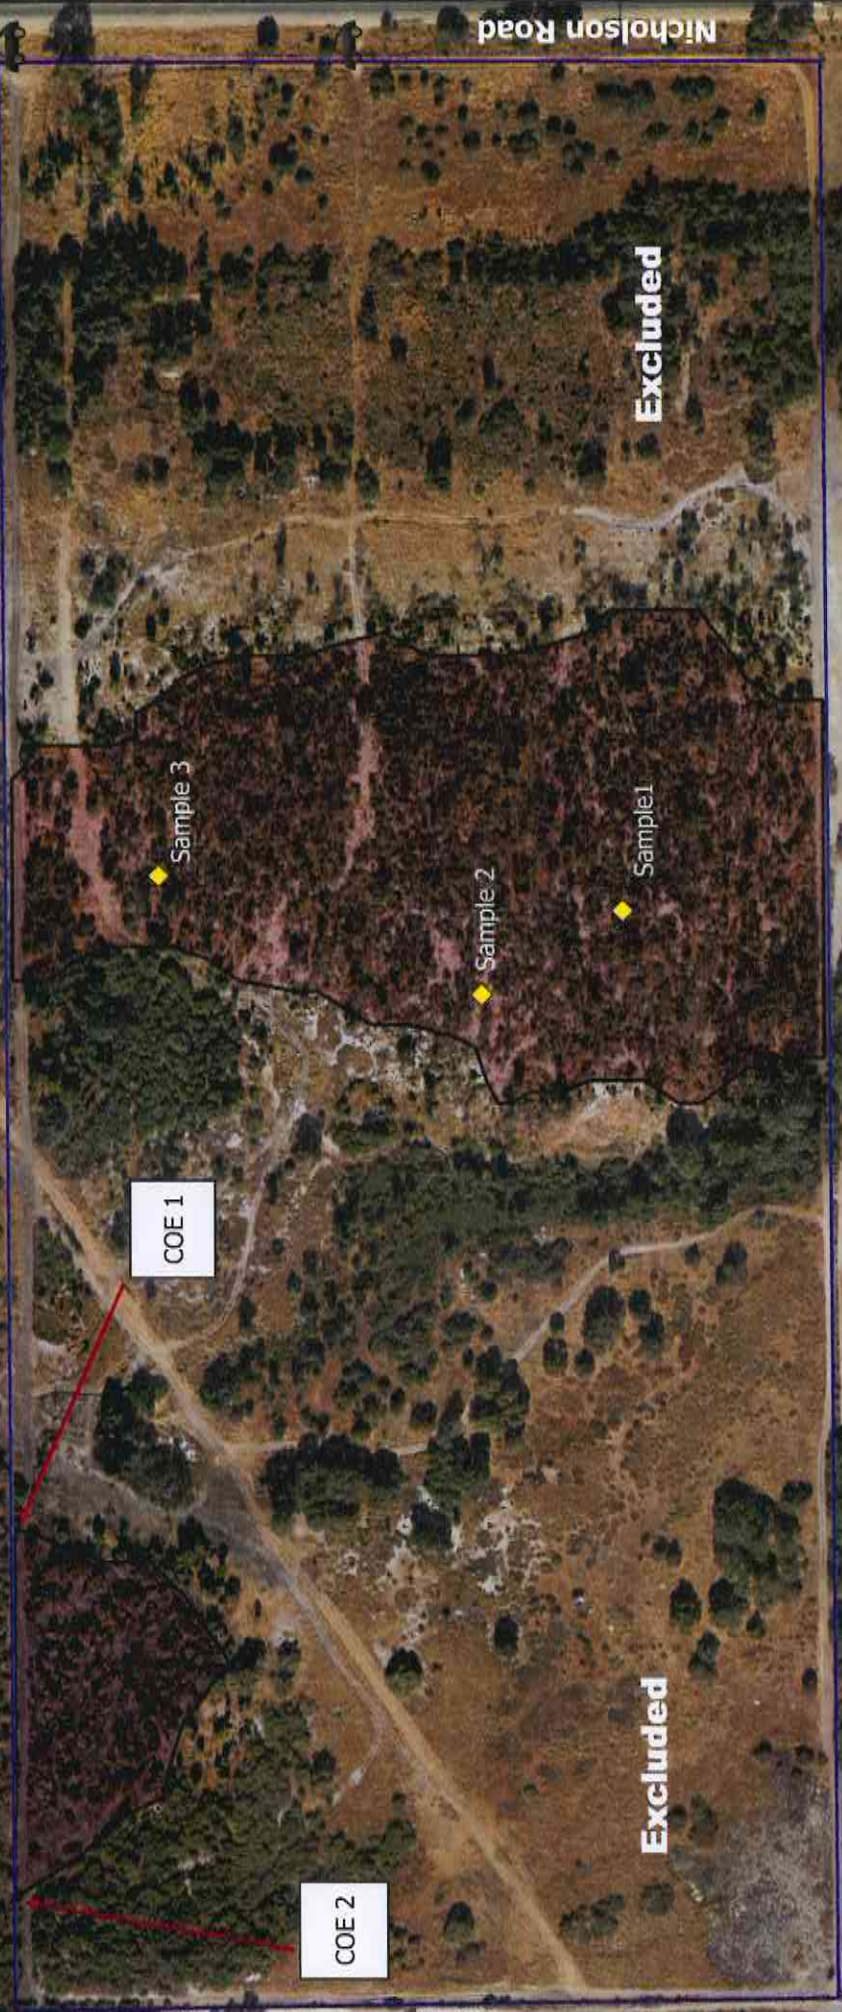
Figure 1

Lot 2 Nicholson Road Phytophthora Dieback Occurrence and Hygiene Management Map

NPC Consulting (2014) discussed that there was a poor to average expression of the disease observed and grasses and weeds were present throughout the site. The impact of the disease was considered variable with significant changes in biomass and biodiversity and the greater presence of non-susceptible species in part particularly within the REW area and areas with little or no vegetation (i.e. paddocks/cleared areas) (refer to Appendix E, Figure 1).

It is recommended that the area categorised as being Temporarily Uninterpretable be protected (Appendix E, Figure 1). The reasons for this are that healthy indicator species appear to be present even though current deaths are fire related and that vegetation outside of Lot 2 immediately to the north may well be free of the disease and possibly protectable. The Concept Plan design for the development has allocated this area for protection including fencing and revegetation (as part of Stage 2A), refer to Figure 9.
