# REHABILITATION MANAGEMENT AND MONITORING PLAN

**LOT 265 QUEELUP ROAD (PREVIOUSLY DUCANE  
ROAD), NORTH BOYANUP**

**MARIO MICHELE GIACCI**

MAY 2024

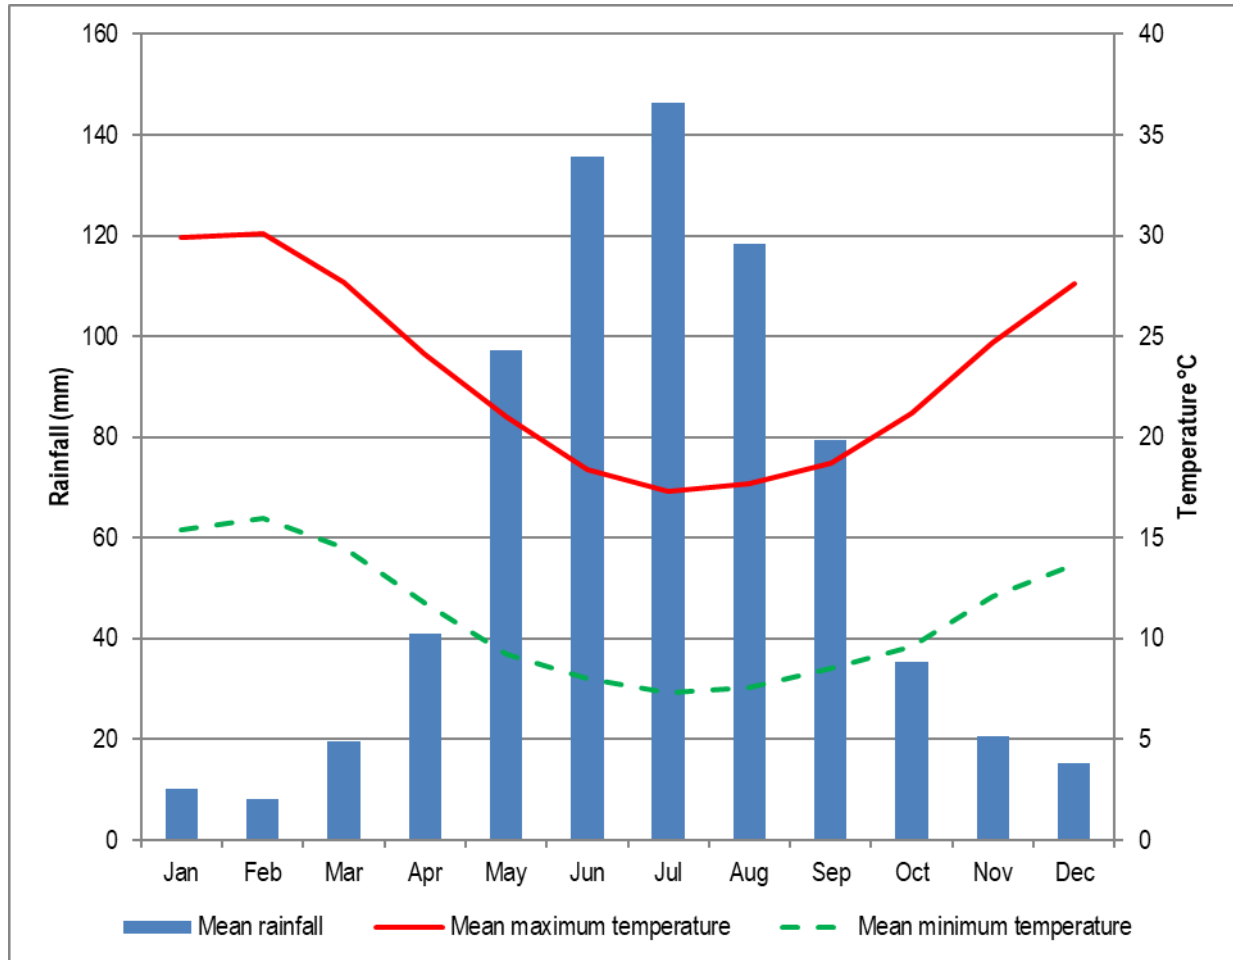
**Figure 4: Long-term Rainfall and Temperature Data (1995-2023) for Bunbury Meteorological Station 9965 (BOM 2024)**

The local climate for Lot 265 is Mediterranean, with cool wet winters and hot dry summers. Bureau of Meteorology (BOM) long-term average climate data for the closest meteorological station (Bunbury – 6 km northwest of the project) is shown in Figure 4. The average annual rainfall is 730.4 mm, mean minimum temperatures between 7°C and 16°C, and mean maximum temperatures between 17°C and 30°C (BOM 2024).

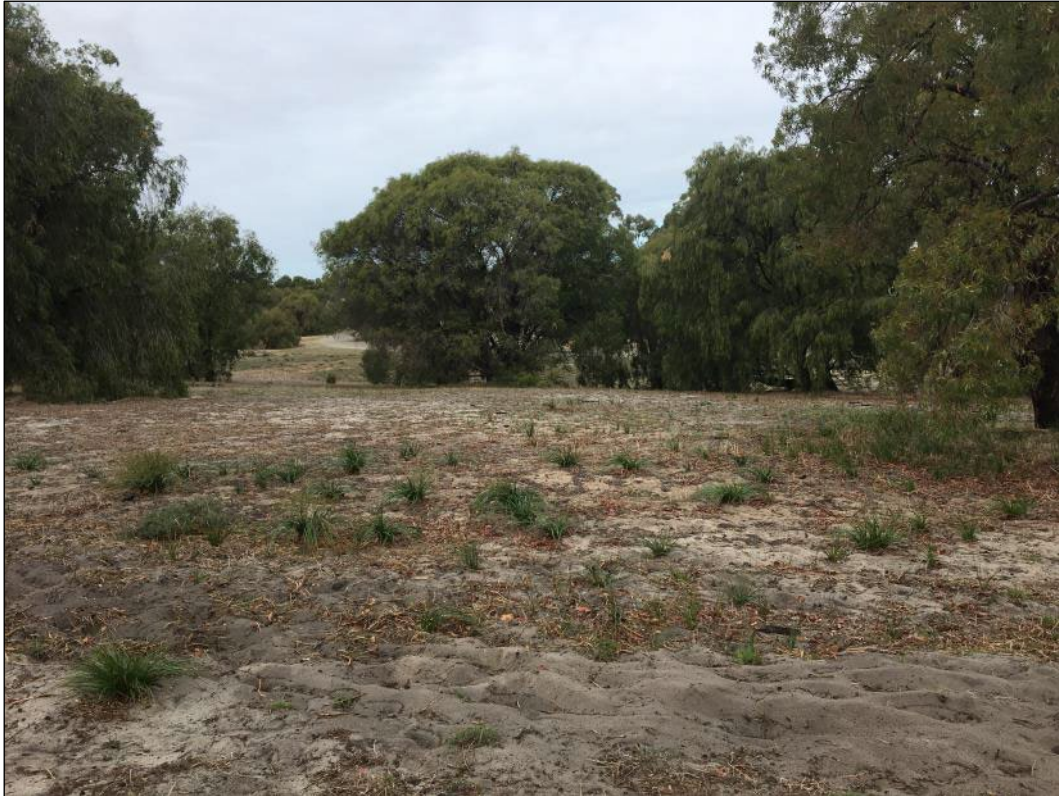
**Plate 1: Example of Remnant Native Vegetation in Extraction Area**

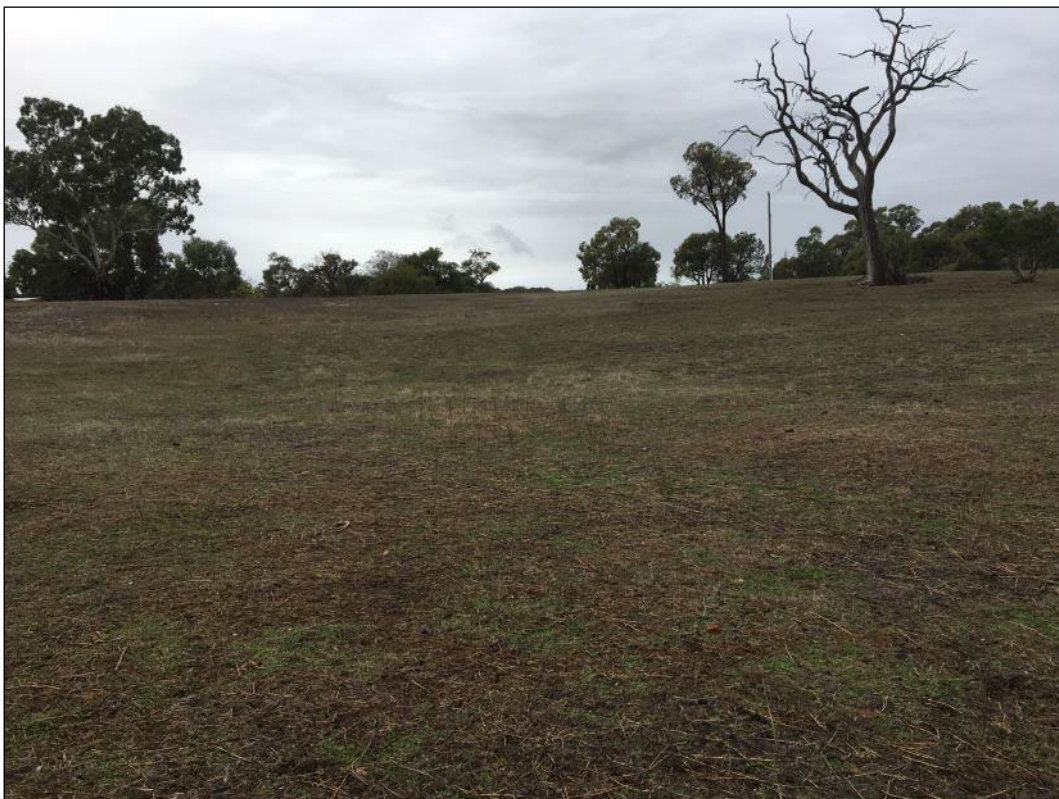
**Plate 2: Example of Bare Area in Extraction Area**

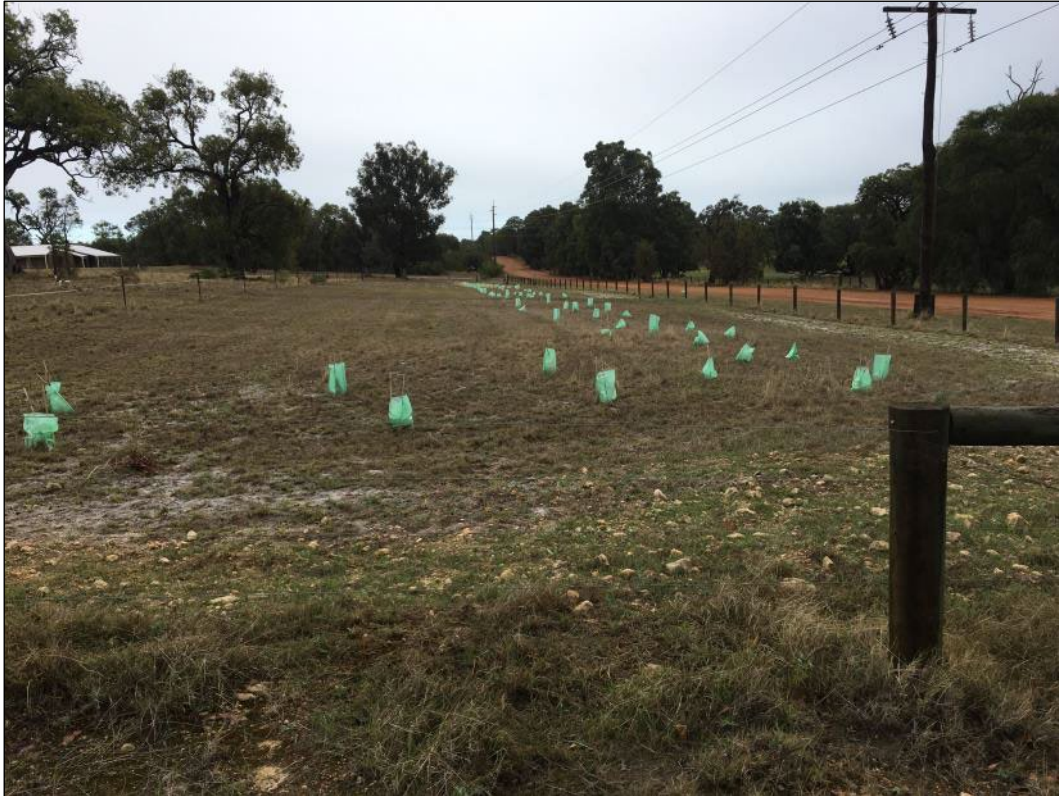
**Plate 3: Part of Northern Native Vegetation Rehabilitation Area**

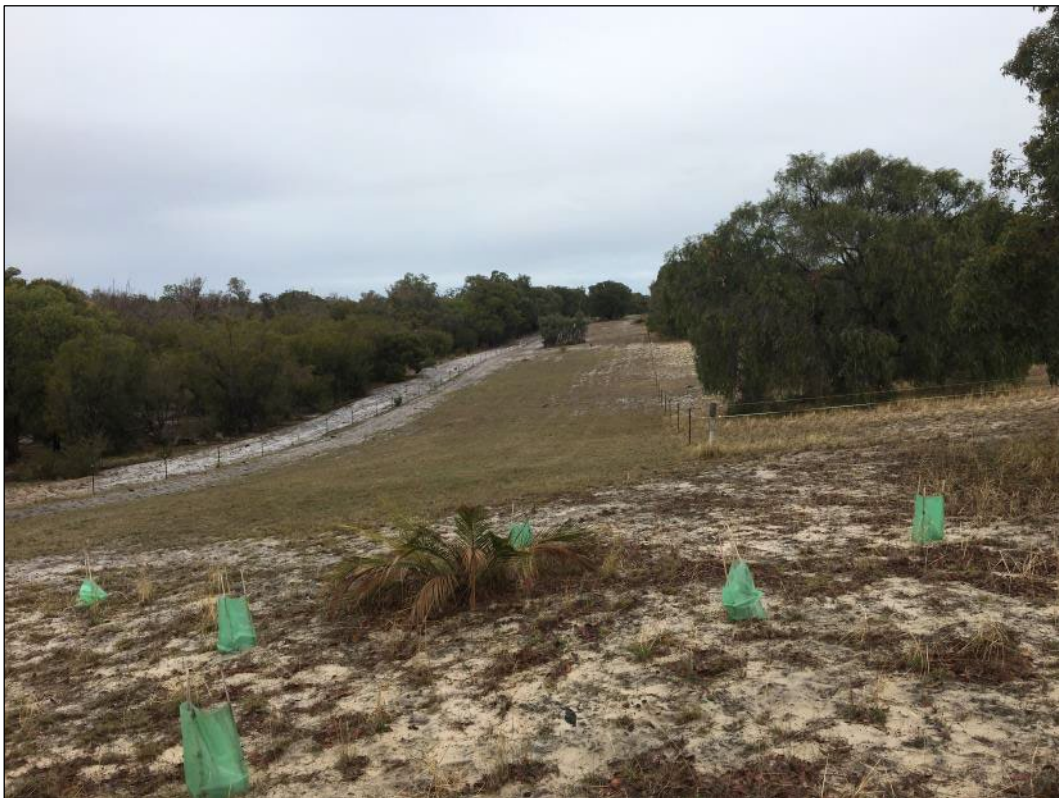
**Plate 4: Part of Eastern Native Vegetation Rehabilitation Area**

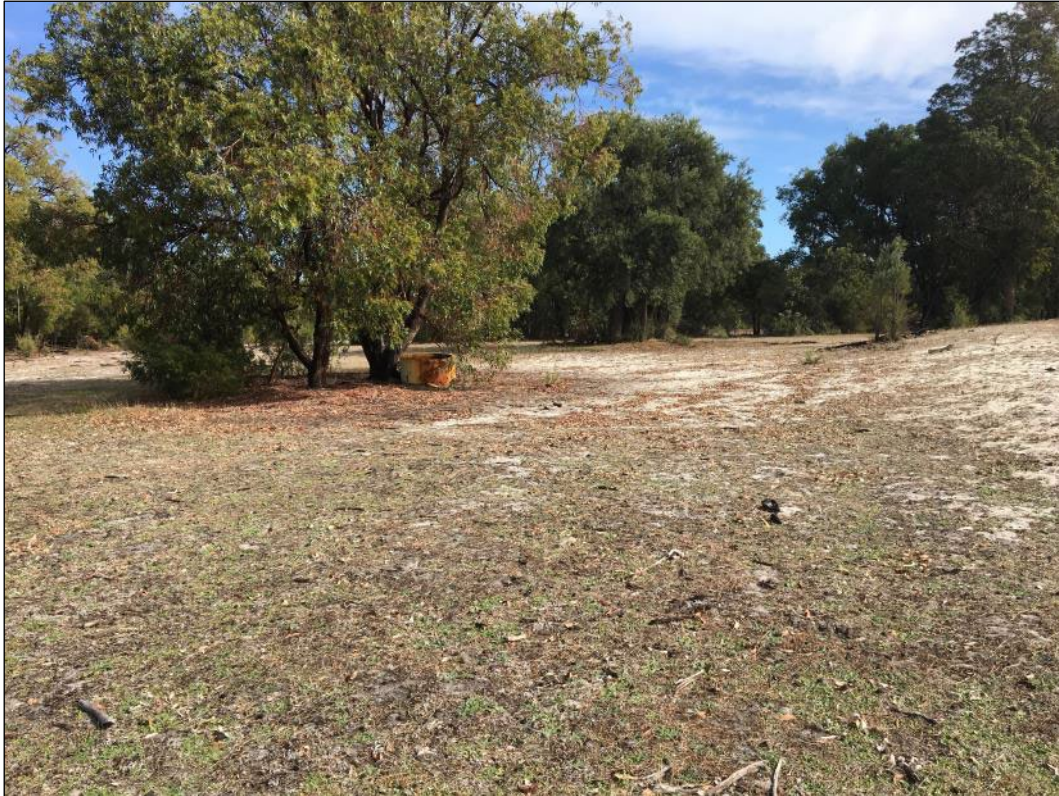
**Plate 5: Part of Southern Native Vegetation Rehabilitation Area**
