CLEARING PERMIT

Purpose Permit number:	CPS 5402/1
Permit Holder:	Cooperative Bulk Handling Ltd
Duration of Permit:	12 October 2013 to 12 October 2019

CBH Gairdner Rehabilitation Plan

Clearing Permit Decision Report

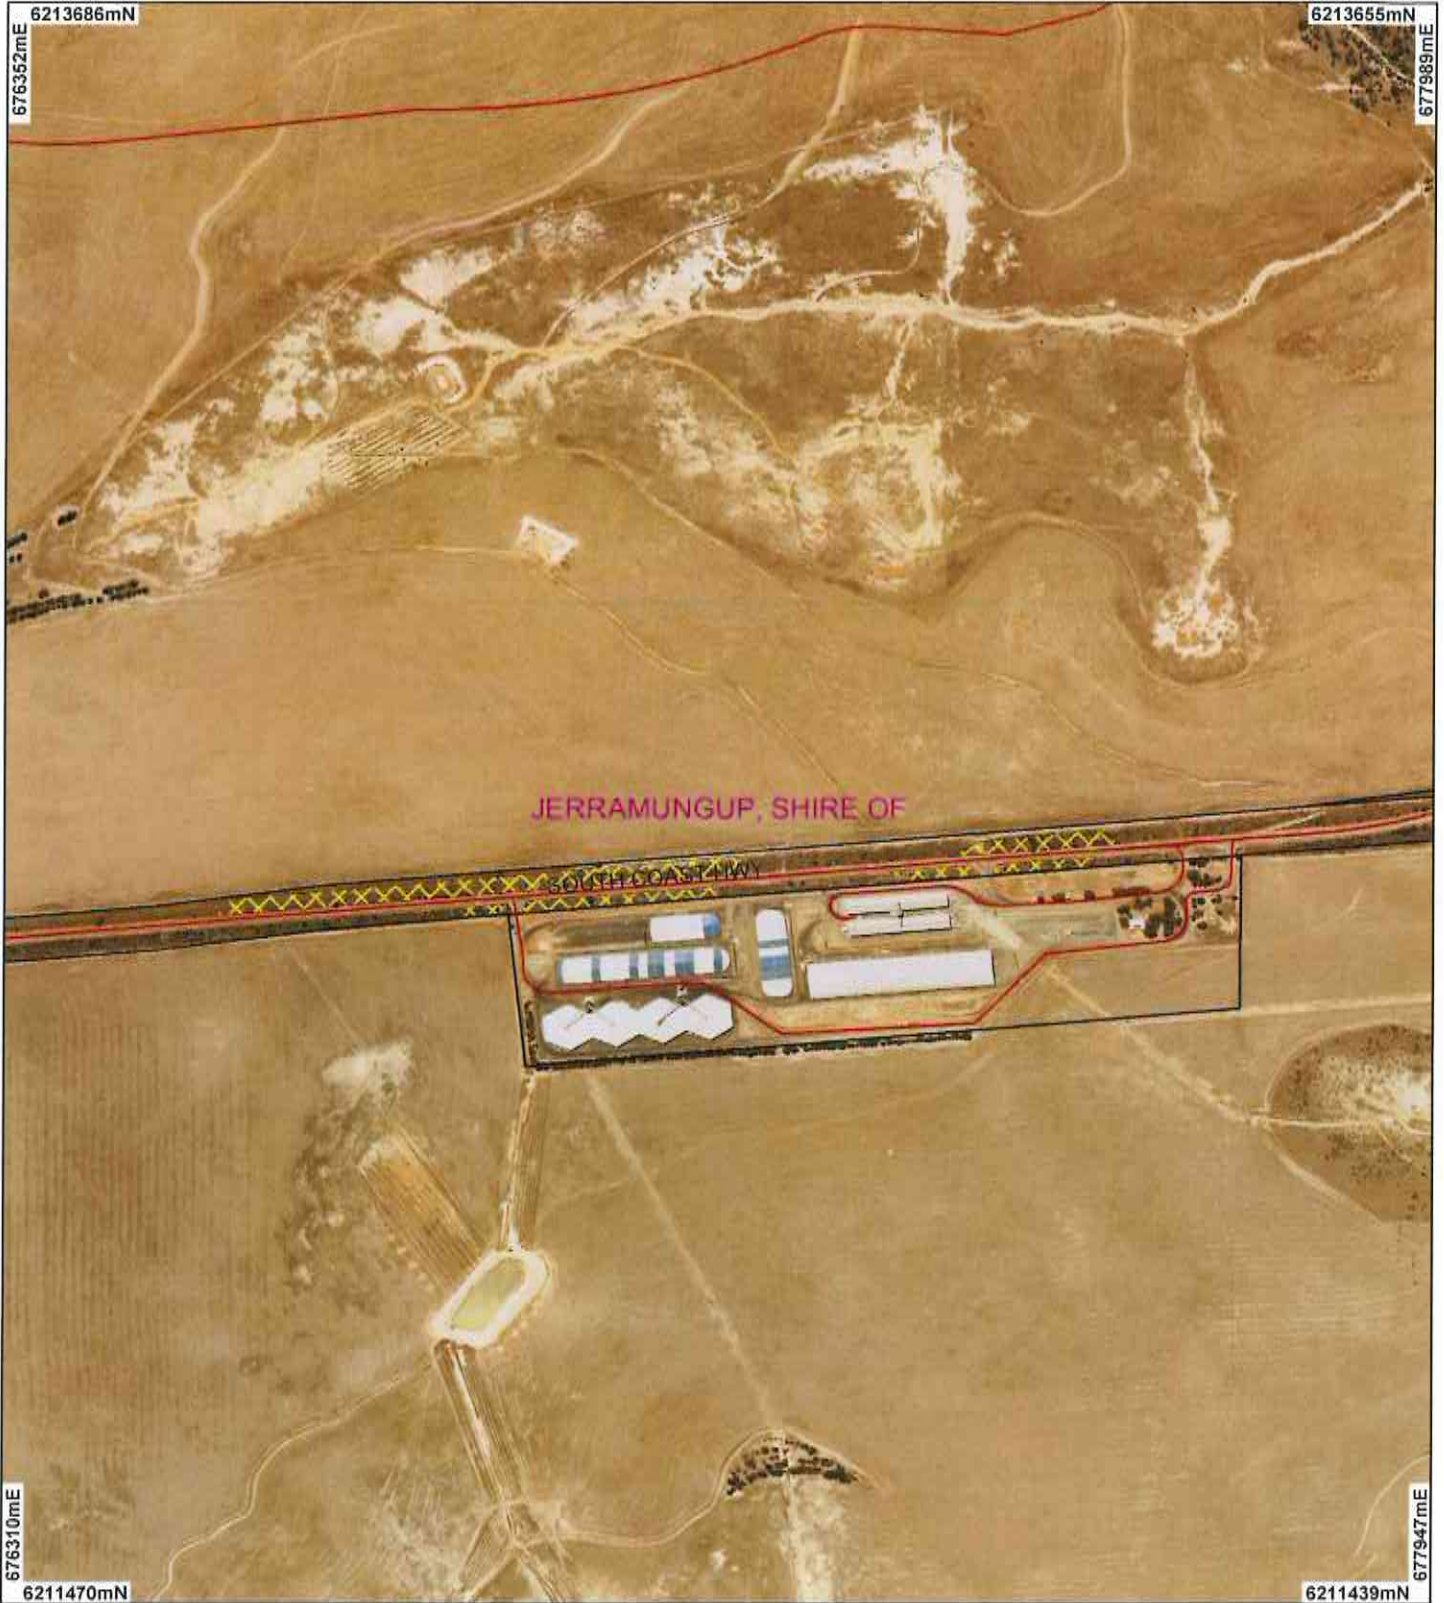
Plan 5402/1a

The Permit Holder must not clear more than 2.15 hectares of native vegetation within the area hatched yellow on attached Plan 5402/1a.

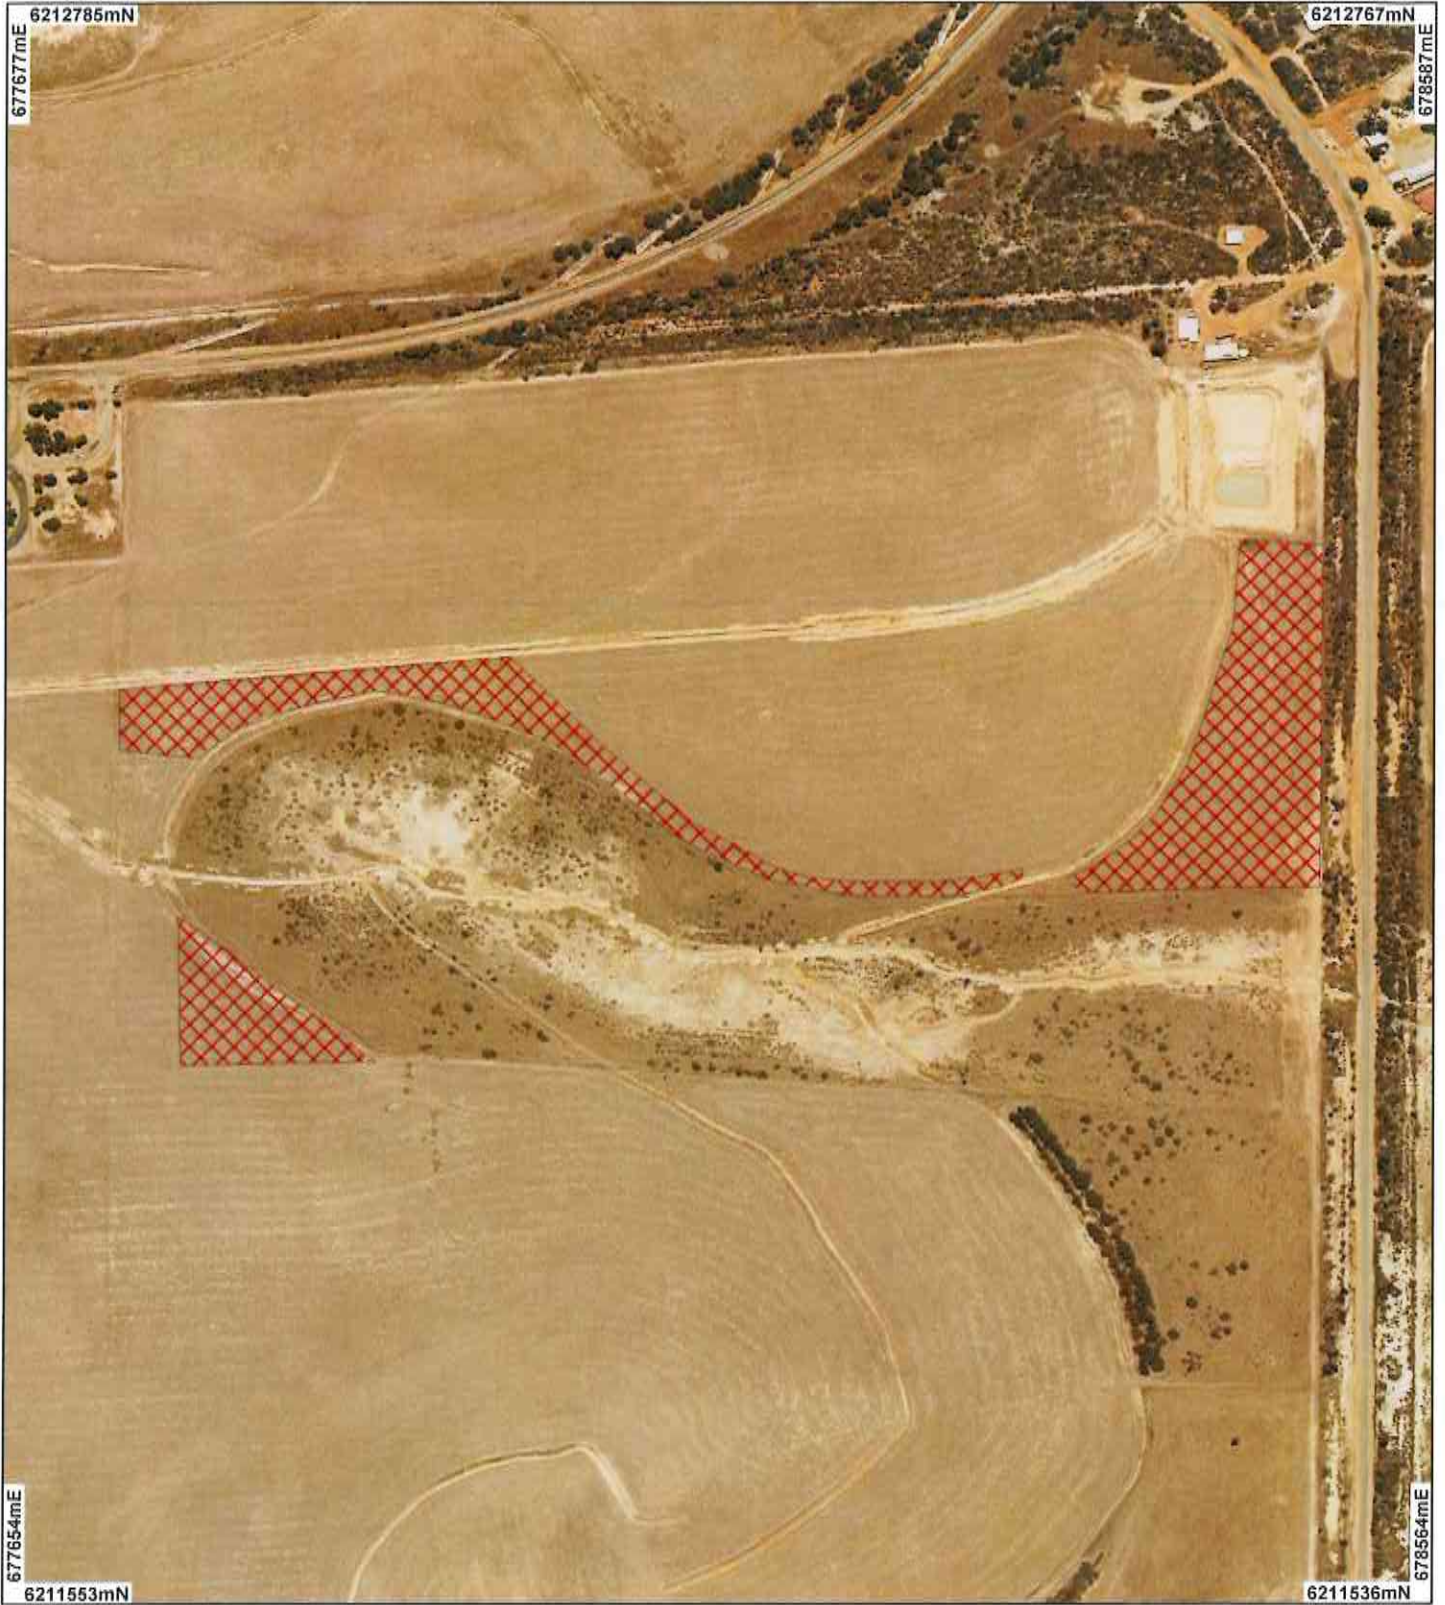
In relation to the areas hatched red on attached Plan 5402/1b the Permit Holder must implement and adhere to the CBH Gairdner Rehabilitation Plan, attached as Appendix A to this permit.

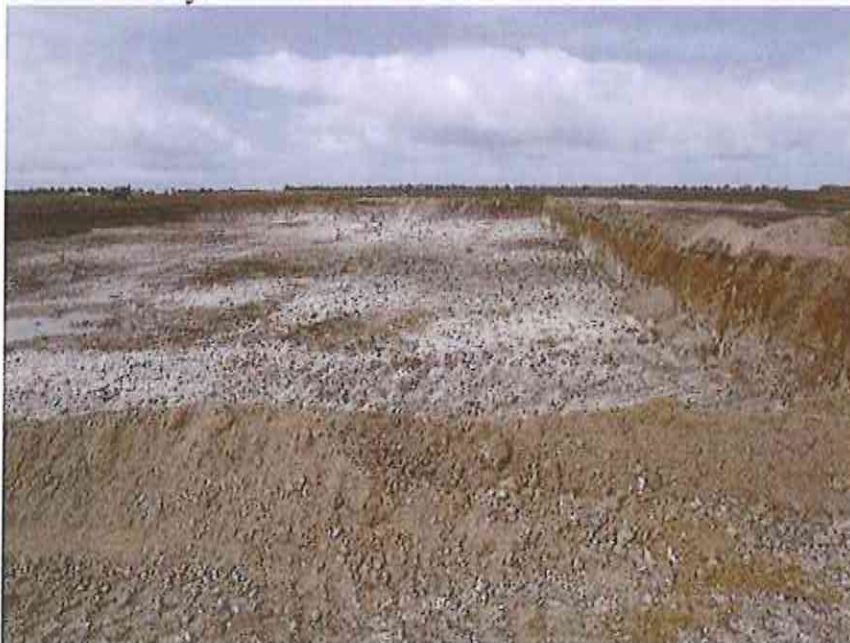
Shallow topsoil and loam over pallid zone clays in main detention basin

1. Main Detention Basin
 - Basin is shallow, as the contractors have stopped at the saline white clay (pallid zone) layer
 - Spoil is piled up alongside the basin and rolled. It is very heavy 'puggy' clay, which will be shaped into a flat topped bank about 10 m wide. The inside batter of the spoil bank will be a continuation of the detention basin batter.

- Topsoil in the area is very thin. Between topsoil and pallid zone clay is a layer of yellow clay.
 - Circumference of the basin is 385m, which accords with the scale shown on the CBH plan.

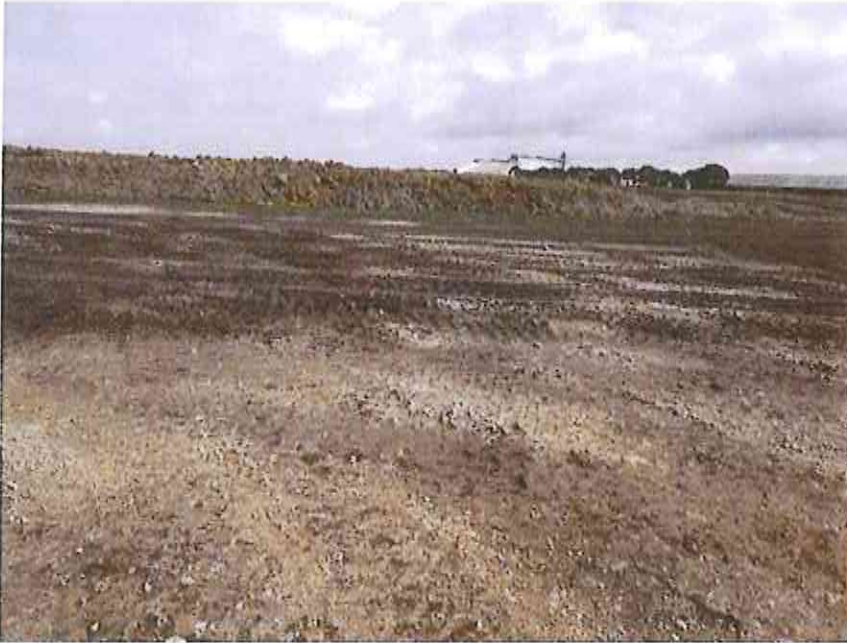
Shallow clays and spoil bank in SE corner of site

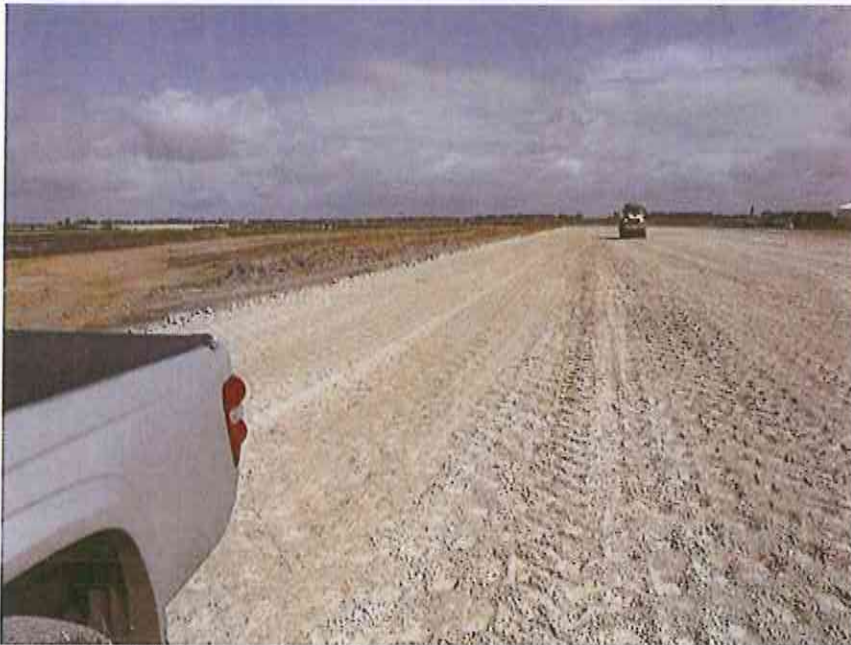
Looking SW from center of site, shallow duplex soil
