CLEARING PERMIT

Purpose Permit number:	CPS 5402/2
Permit Holder:	Cooperative Bulk Handling Ltd
Duration of Permit:	12 October 2013 to 12 October 2019

CBH Gairdner Rehabilitation Plan Revised October 24th 2014

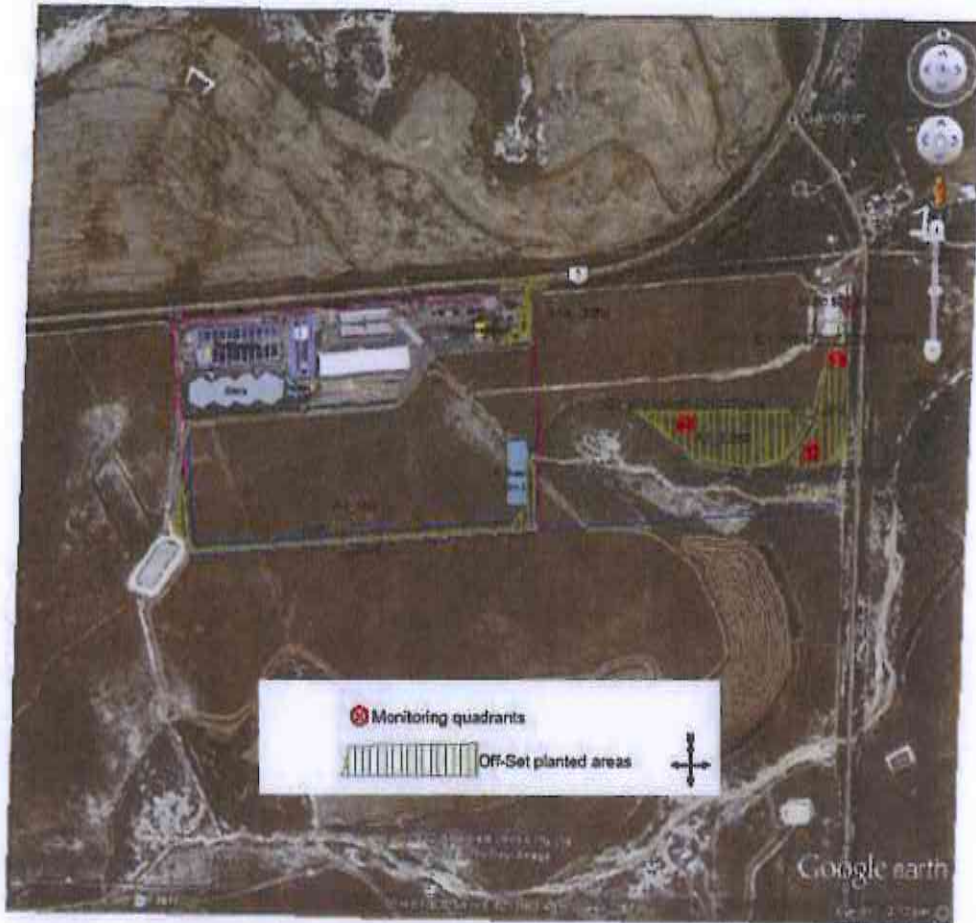
Below: Stylised site image and marked up OFFSET planting areas

NOTE: Target Offset area has been segmented into rehab areas including portion of Rehab area1 [wetlands] and comprises a minimum 4.62ha

Seven potential zones of revegetation have been identified in the plan [see Plan pg6].

3 Monitoring Quadrants Locations (MQL) comprising dimensions 10m x10m are suggested for the OFFSET AREA and are depicted on the Project map as follows:

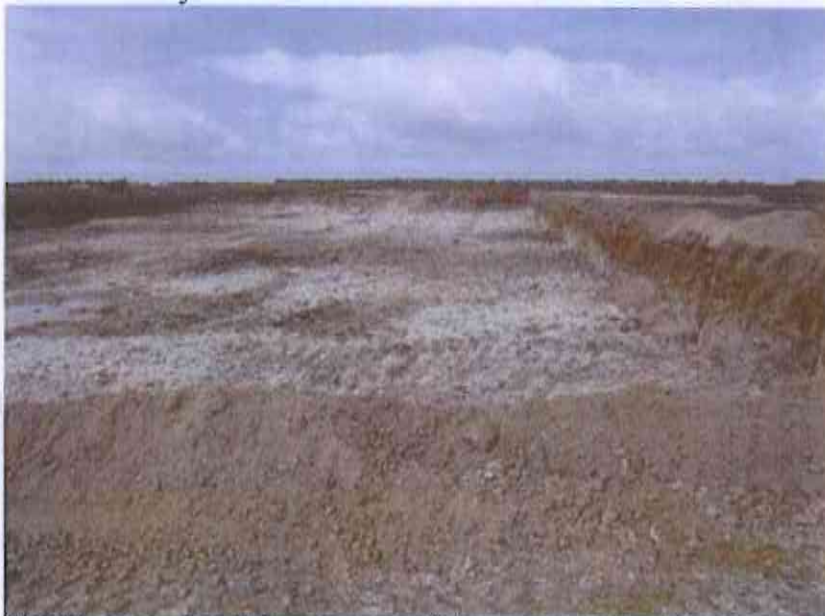
Shallow topsoil and loam over pallid zone clays in main detention basin

- Basin is shallow, as the contractors have stopped at the saline white clay (pallid zone) layer
- Spoil is piled up alongside the basin and rolled. It is very heavy 'puggy' clay, which will be shaped into a flat topped bank about 10 m wide. The inside batter of the spoil bank will be a continuation of the detention basin batter.
- Topsoil in the area is very thin. Between topsoil and pallid zone clay is a layer of yellow clay.
- Circumference of the basin is 385m, which accords with the scale shown on the CBH plan.
- John Ivers queried if topsoil should be spread across spoil bank. I suggested it would be beneficial, although insufficient to impact on soil structure, the micorrhizae will be beneficial.
- The area has low weed burden and no problem weeds were noted in this area. Dominated by *Erodium* sp and grasses.

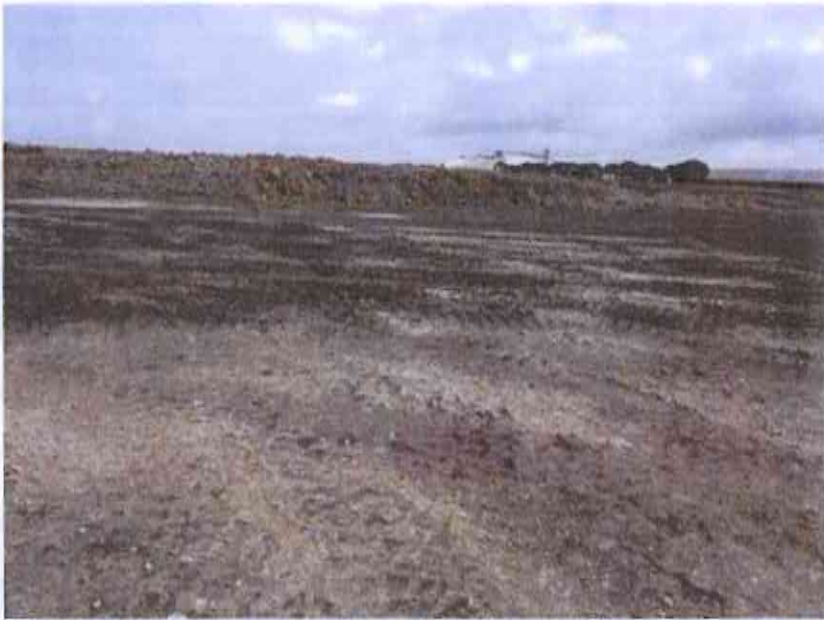
Shallow clays and spoil bank in SE corner of site

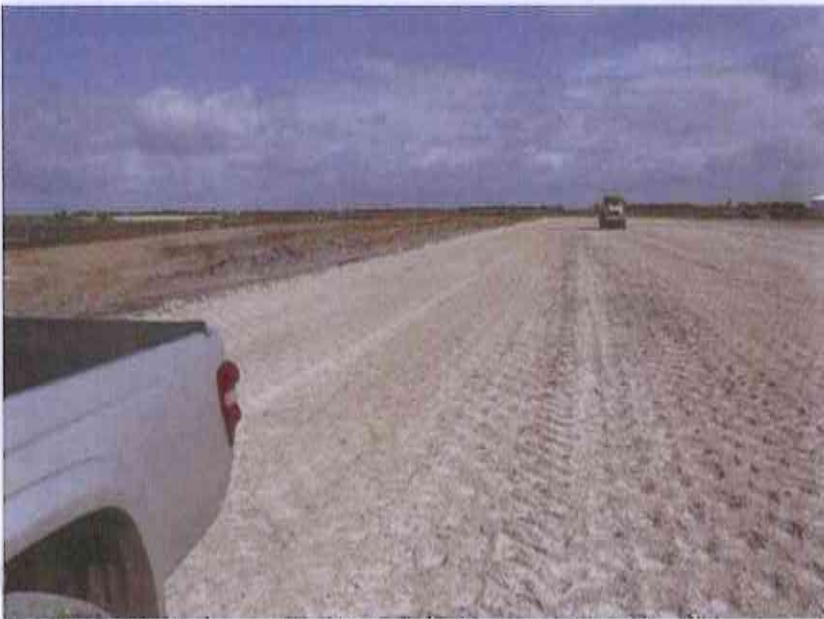
Looking SW from center of site, shallow duplex soil

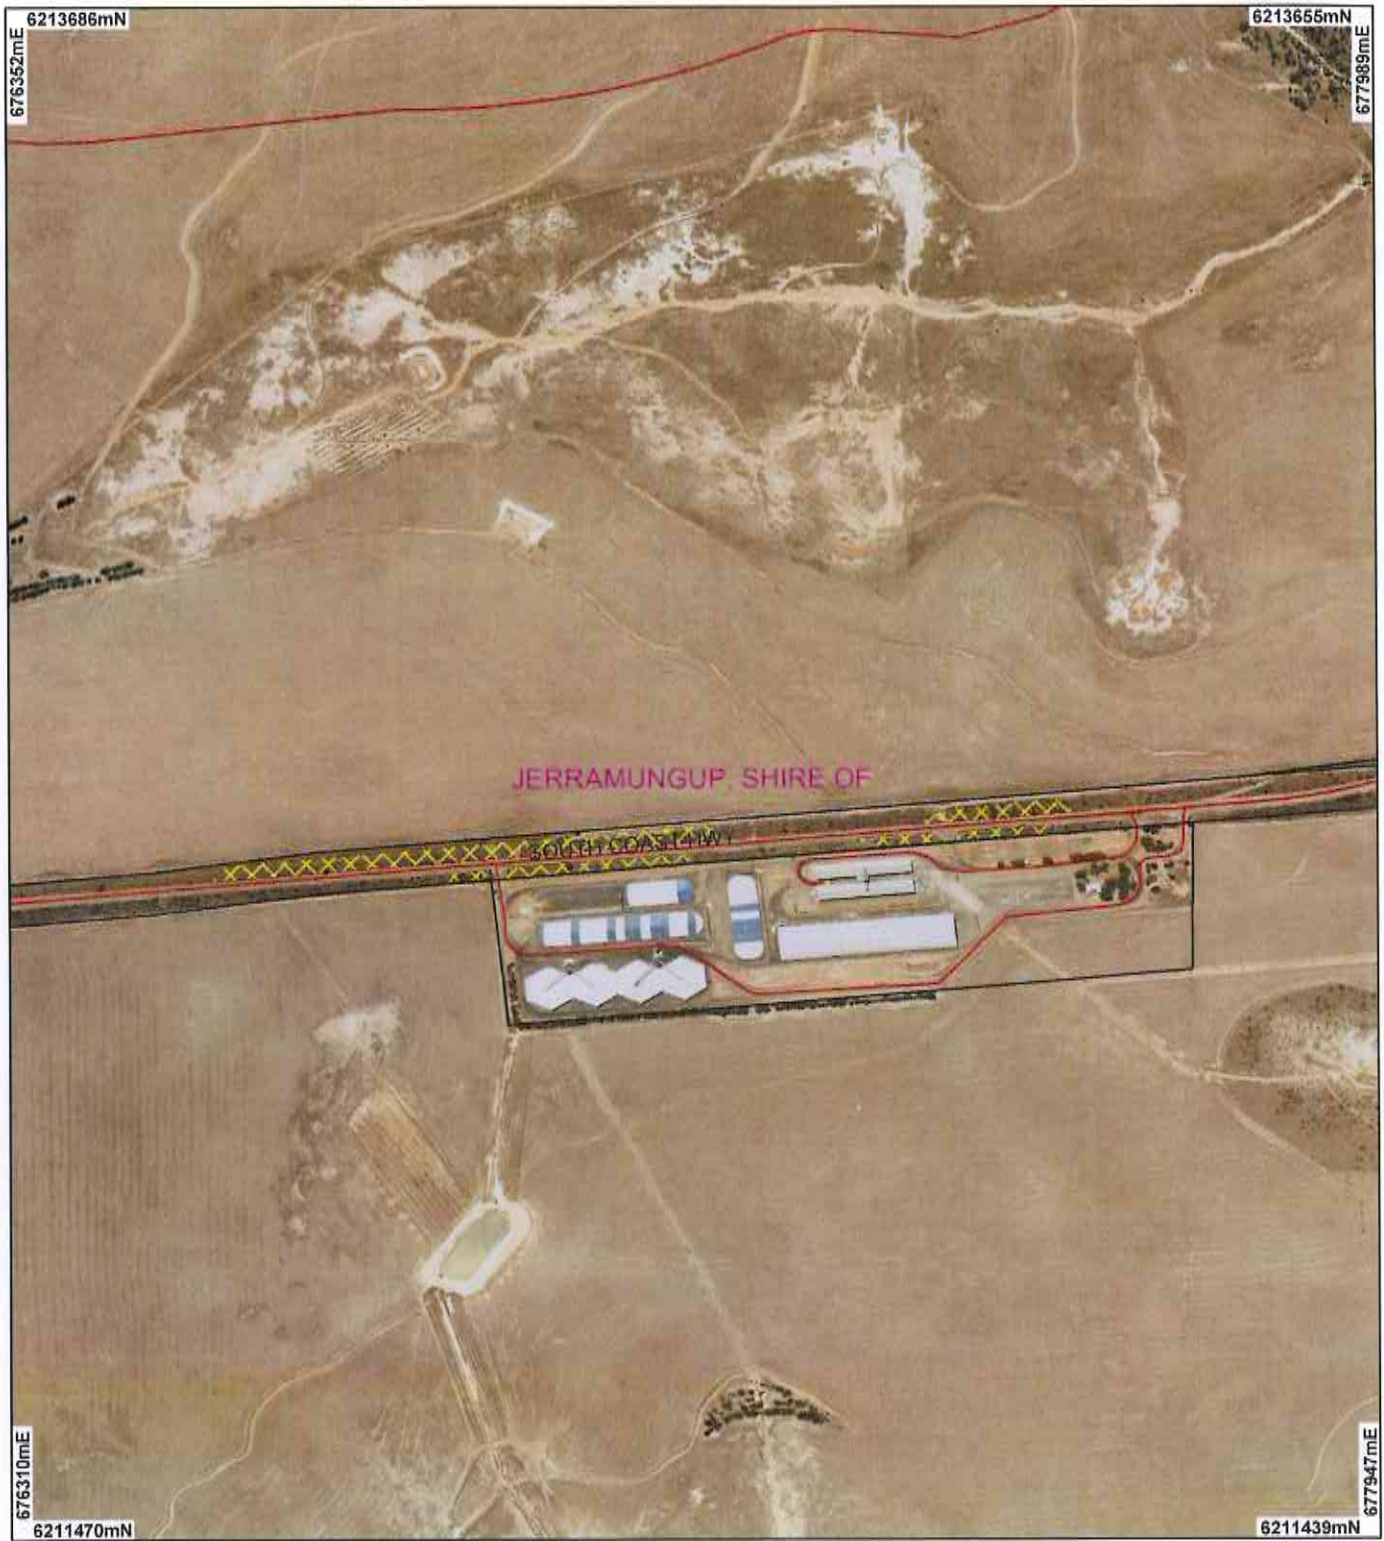
Plan 5402/2a

The Permit Holder must not clear more than 2.15 hectares of native vegetation within the area hatched yellow on attached Plan 5402/2a.

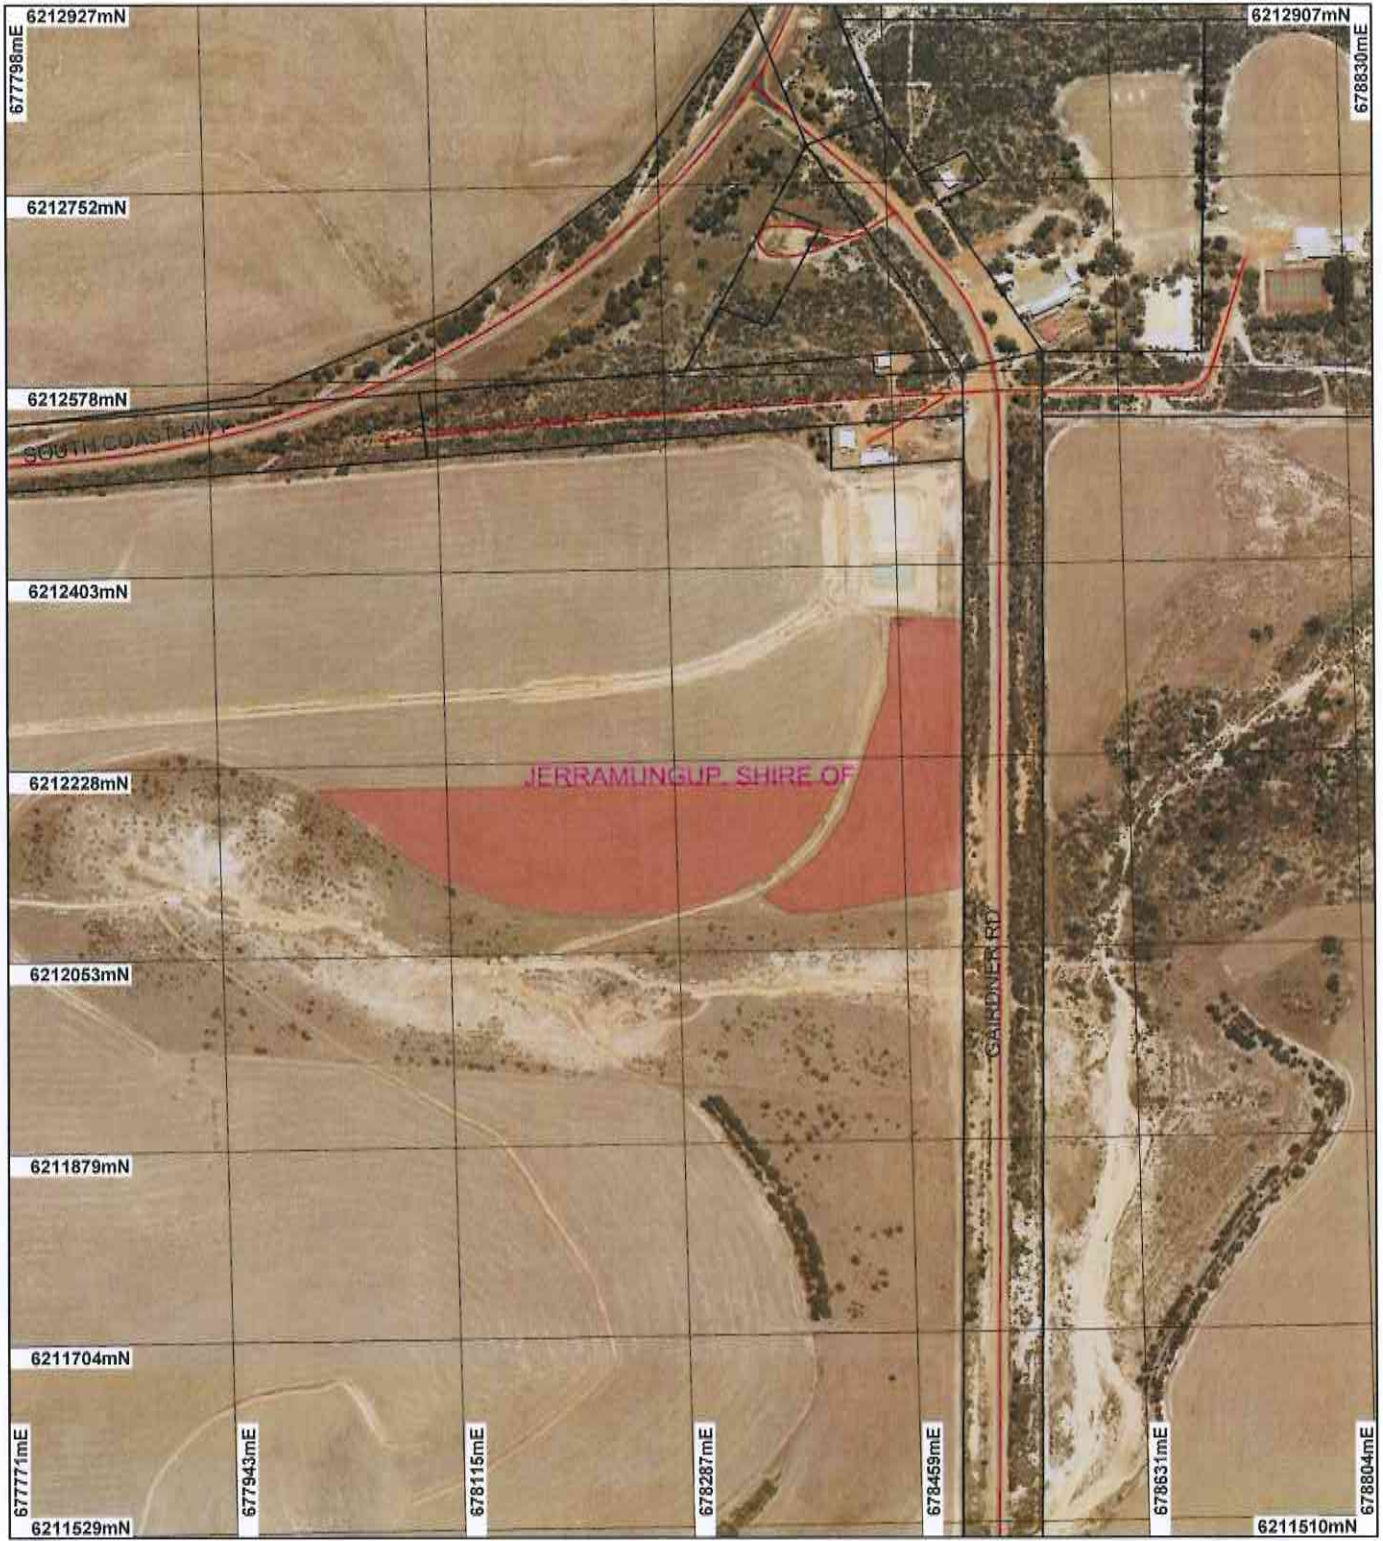
In relation to the areas hatched red on attached Plan 5402/2b the Permit Holder must implement and adhere to the CBH Gairdner Rehabilitation Plan, Revised October 24th 2014, attached as Appendix A to this permit.
