## CLEARING PERMIT

**Purpose Permit number:** CPS 5631/1  
**Permit Holder:** Department of Transport  
**Duration of Permit:** 30 November 2013 to 30 November 2018

# **Carnarvon Fascine Maintenance Dredging Dredging Environmental Management Plan**

301\_02\_001/3\_Rev0  
October 2013

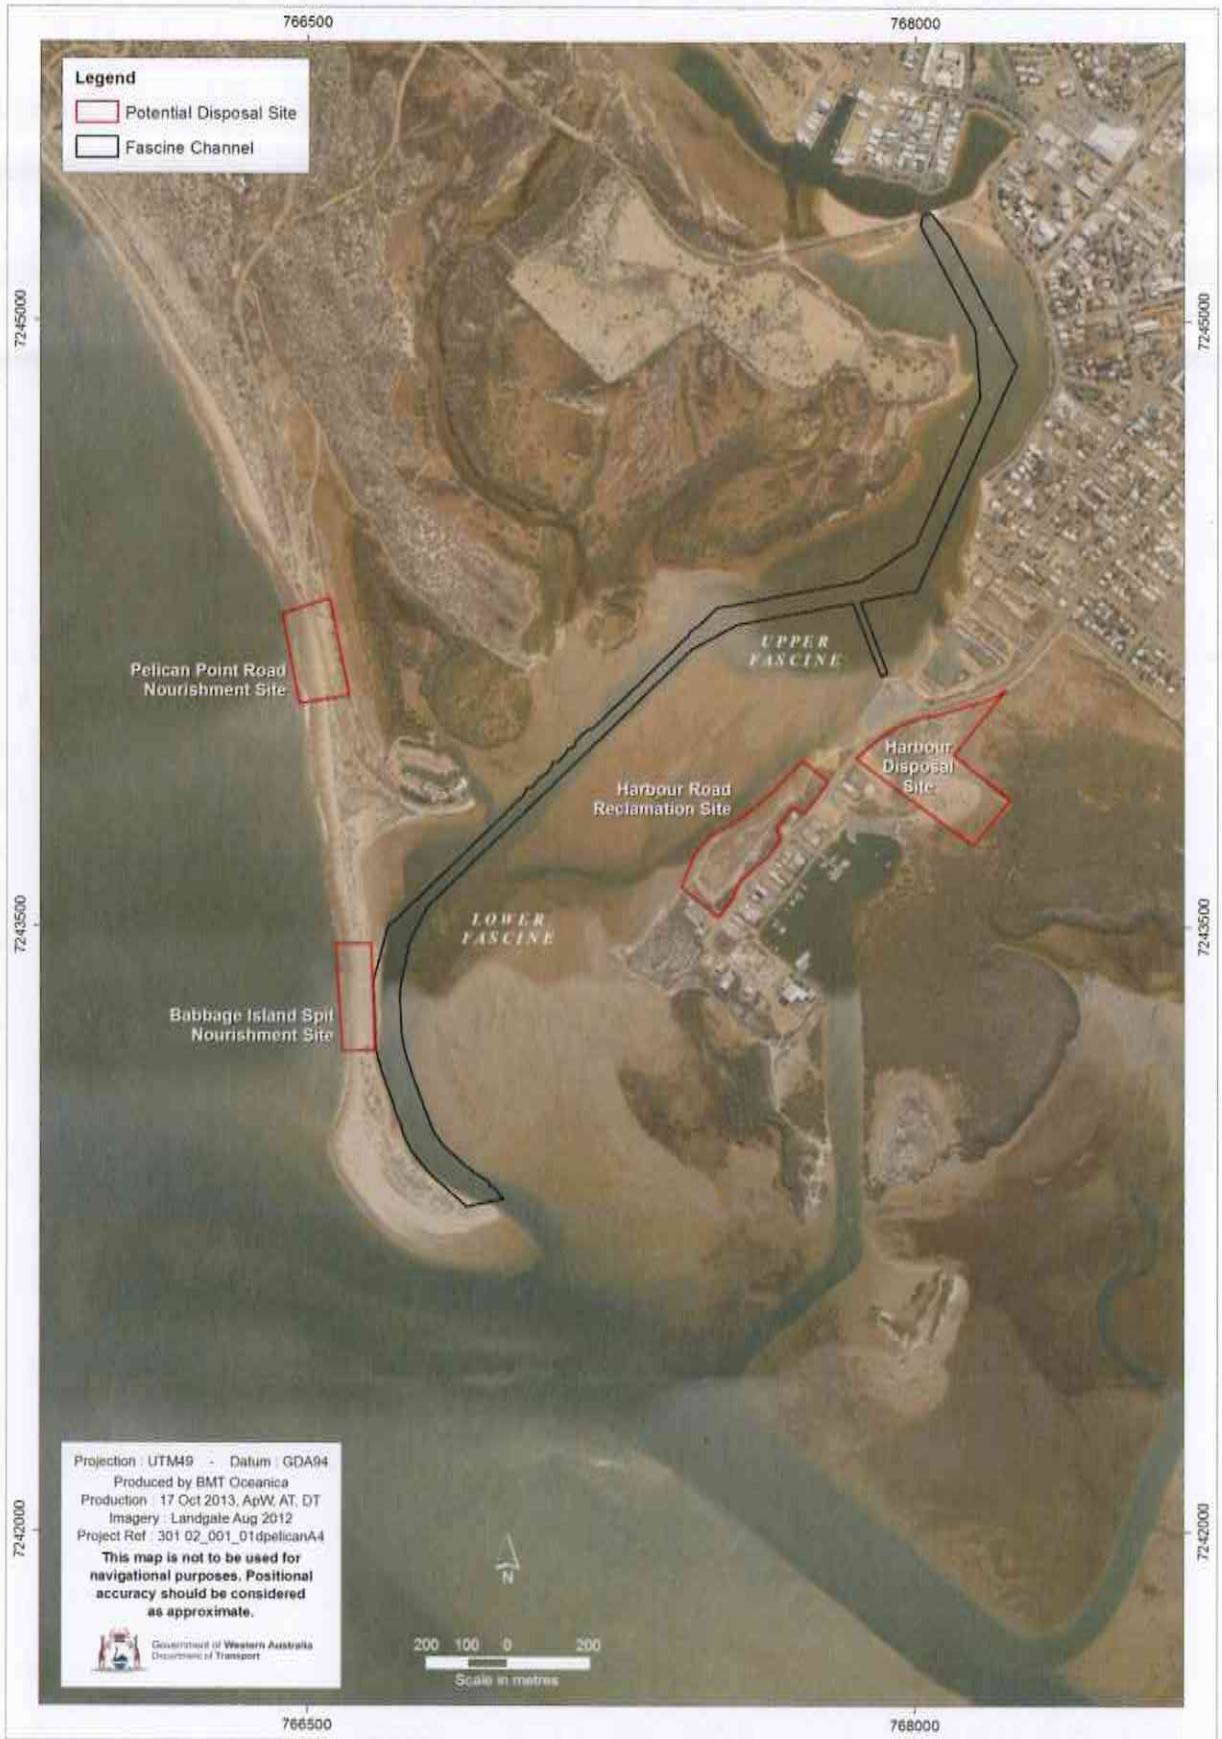
**Figure 1.1 Carnarvon Fascine Channel and disposal sites**

Approximately 15 000 m<sup>3</sup> of material dredged from the Fascine Upper Channel will be disposed of to the Harbour Disposal Site, a 5 ha area of land immediately north of the Carnarvon Boat Harbour, which has been used previously for disposal of dredged material (Figure 1.1). Containment bunds ~3 m high and 20 m wide will be constructed around the site boundaries to create a settlement pond to contain the disposed dredged material (BMT JFA 2013). These bund walls will allow suspended sediment to settle and return water to drain out through a weir box at the southern corner of the site into a mangrove tidal creek. Additionally, an internal bund wall will be present to lengthen the flow path and further decrease turbidity in the return water. It is proposed that this site continue to be used for dredge material disposal over the medium term (i.e. the next 0–5 years) and in the longer term may ultimately be developed by the DoT for use as a commercial area.

Approximately 10 000 m<sup>3</sup> of material dredged from the Fascine Lower Channel will be used to reclaim land at the Harbour Road Reclamation Site, a ~430 m length of shoreline on the eastern side of the Fascine (Figure 1.1). It is anticipated that temporary bunds will be constructed around the site to contain disposed material and allow sediment to settle, and return water will drain through an outlet point into the eastern Fascine. It is expected that this land will be used for harbour/boating infrastructure in the future. The timing for the development of this area will be dependent on economic growth in Carnarvon.

Material dredged from the south-western side of the Fascine (where the channel adjoins the eastern shoreline of Babbage Island spit) may be used to nourish the beach adjacent to Pelican Point Road where erosion issues are currently being experienced. This disposal site is known as Pelican Point Nourishment Site (Figure 1.1). Some material may also be used to re-build the dune at a weak point in the spit known as Babbage Island Spit Nourishment Site (Figure 1.1).

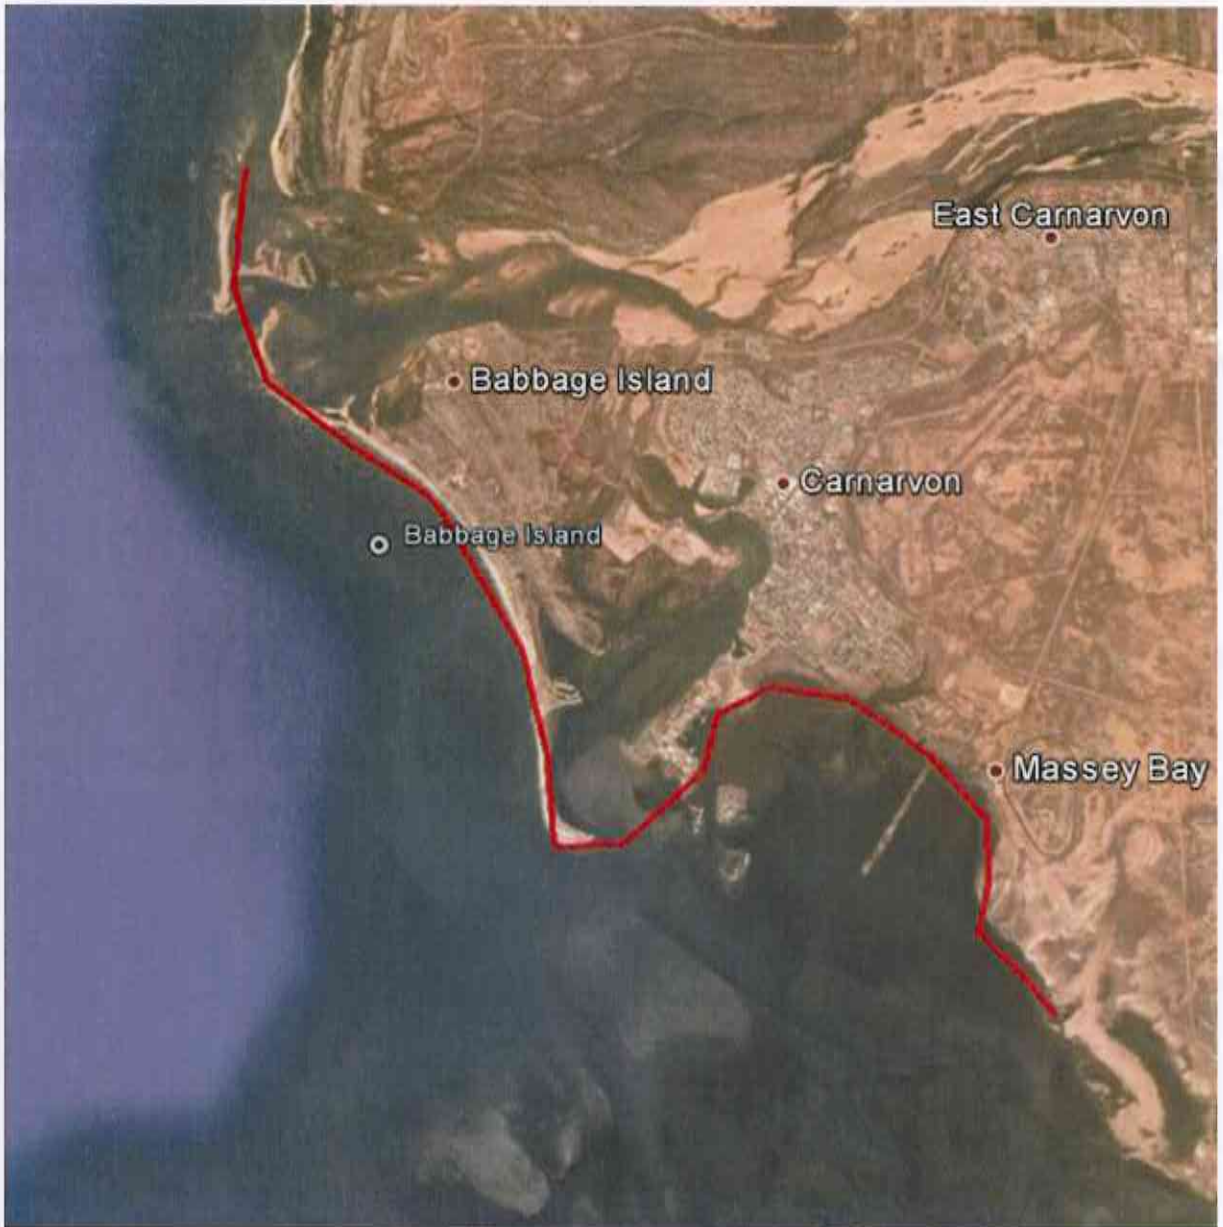
**Figure 1** The ideal aerial flight extent for the coastline either side of Carnarvon

In addition to photographing the dredge and disposal areas, the coastline either side of Carnarvon should be photographed where possible. The ideal aerial flight path extent for the coastline either side of Carnarvon is shown in Figure 1. Where it is not possible to fly the entire length of the path indicated, the flight path should extend as far along the coast either side of the dredge site as possible.

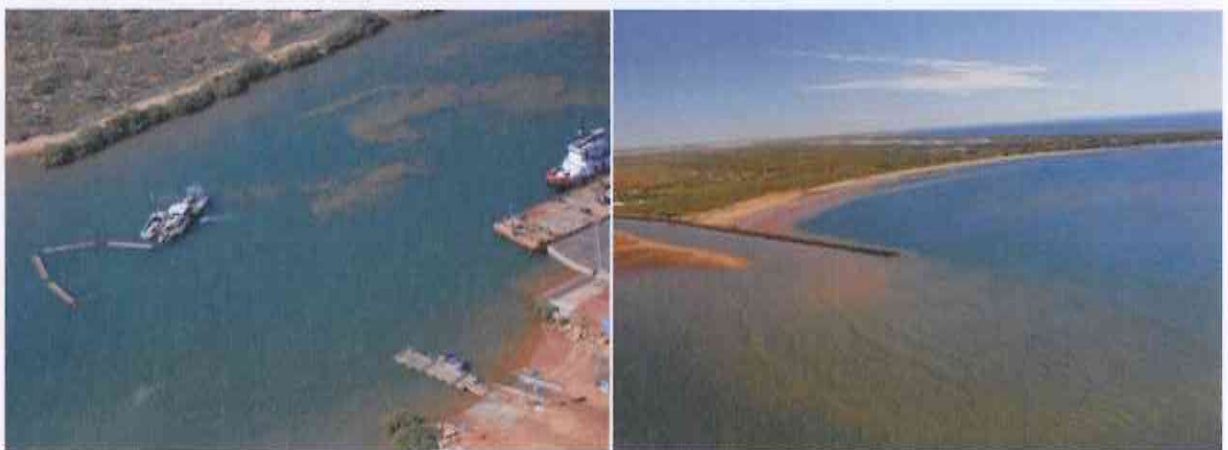
**Figure 1** An example of successful aerial photography: The dredge (left) and disposal site (right) at Beadon Creek, Onslow, 2012

Examples of successful aerial photography during some of DoT's maintenance dredging campaigns are shown in Figure 1, Figure 2, and Figure 3.

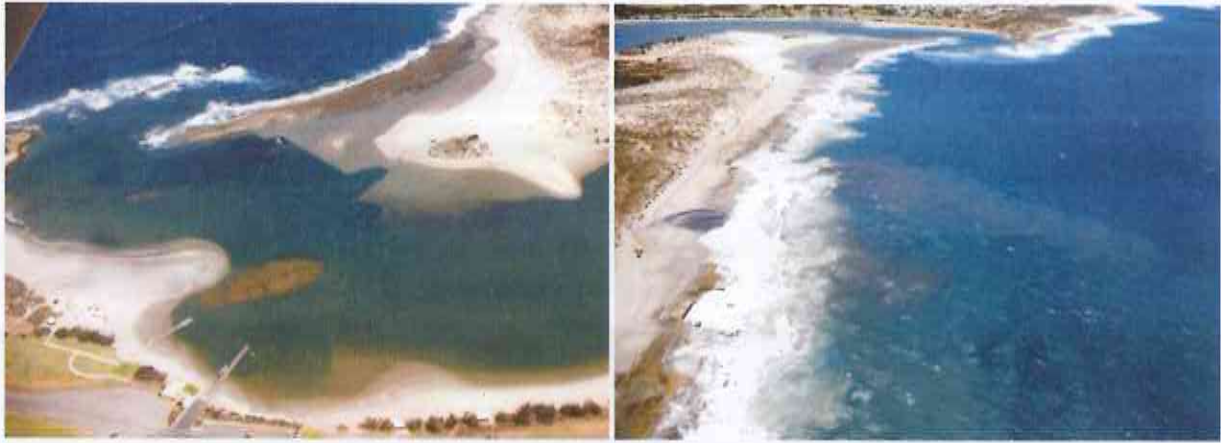
**Figure 2** An example of successful aerial photography: The dredge (left) and disposal site (right) at Kalbarri 2012

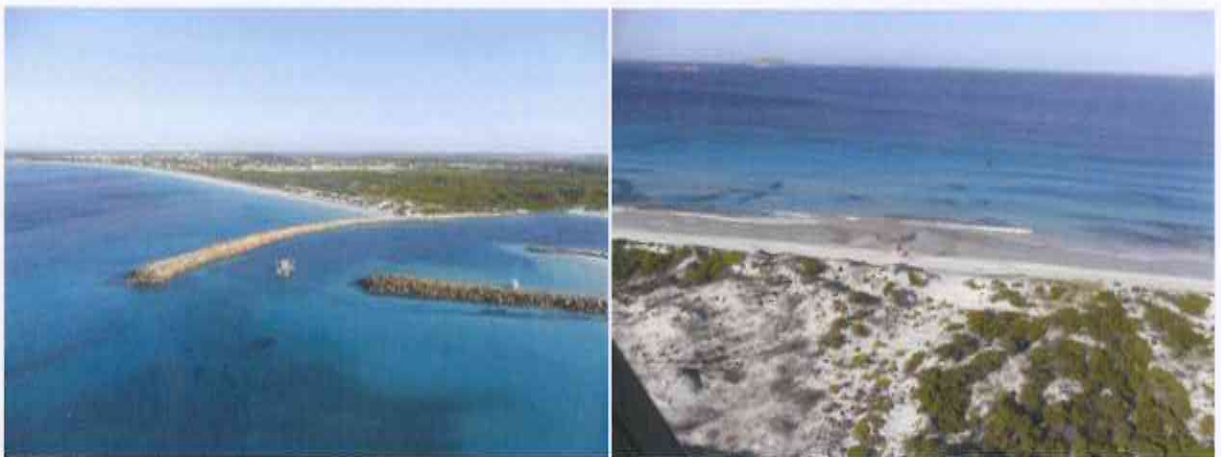
**Figure 3** An example of successful aerial photography: The dredge (left) and disposal site (right) at Bandy Creek Boat Harbour 2007
