Application to amend clearing permit CPS 5947/2

GMA Garnet Pty Ltd (GMA) is a wholly owned subsidiary of Garnet International Resources Pty Ltd. GMA owns and operates the garnet mineral sand mining and processing operations in the Mid-West Region, Port Gregory, Western Australia.

GMA previously submitted a native vegetation clearing permit (NVCP) application to clear native vegetation for mining within M70/968 (Figure 1). A NVCP CPS 5947/2 was granted on 23 April 2015.

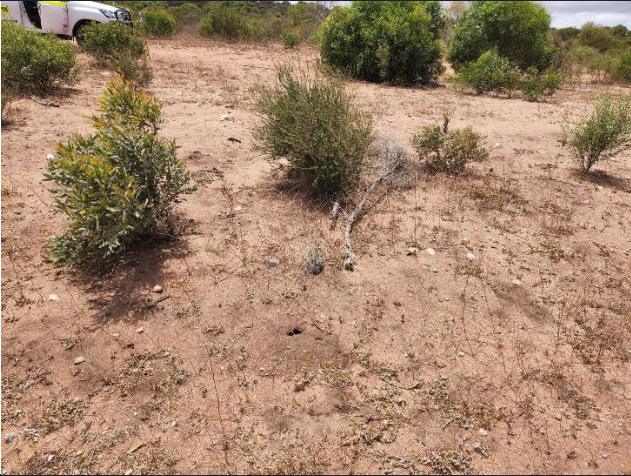
<p>Representative photograph of successful establishment Melaleuca tube stock planted in 2022.</p>

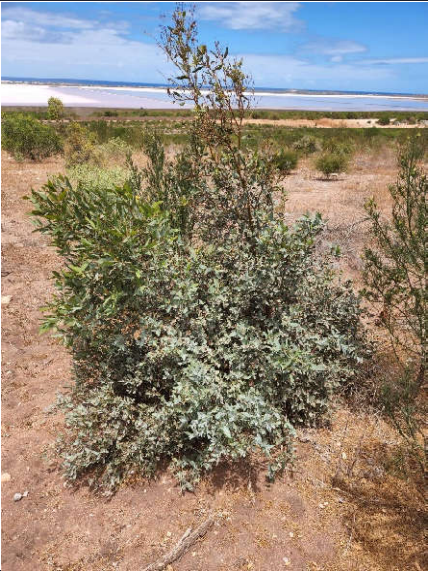
<p>Representative photograph of the successful establishment Eucalyptus seed spread in 2020.</p>

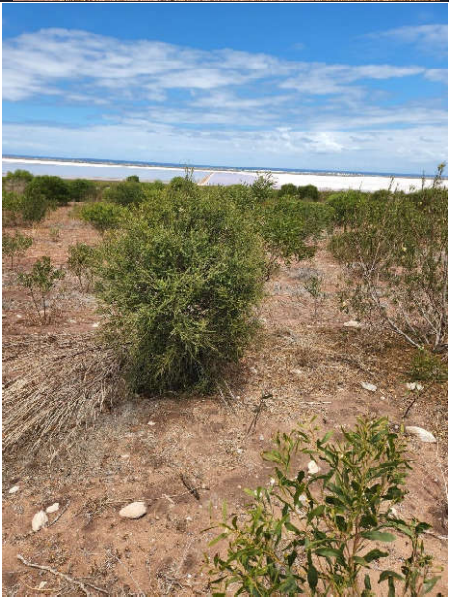
<p>Representative photograph of successful establishment Melaleuca tube stock planted in 2022.</p>

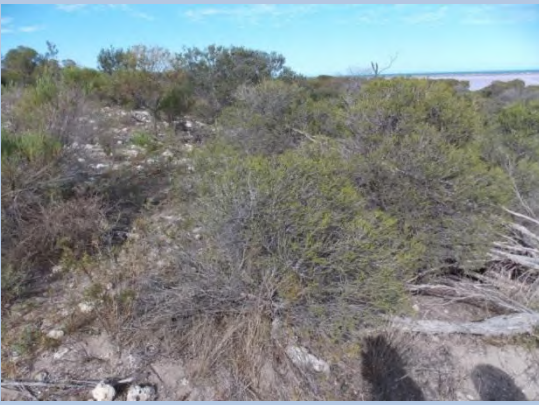
Vegetation Type Number	Short Description	Description	Photograph	Location	Condition	Comparison to Known Associations	Status
1	Mixed Open Heath on Sandy Limestone Ridge	High Open Shrubland of <i>Acacia rostelifera</i> , <i>Melaleuca cardiophylla</i> , <i>Grevillea argyrophylla</i> , over Shrubland of <i>Olearia</i> sp. Kennedy Range, <i>Hibiscus huegelii</i> , over Low Shrubland of <i>Pimelea angustifolia</i> , <i>Diplopeltis petiolaris</i> , <i>Acanthocarpus preissii</i> over Scattered Grasses of <i>Avena barbata</i> , <i>Austrostipa</i> spp., over Mixed Herbs of <i>Lysimachia arvenscens</i> , <i>Goodenia beardiana</i> , <i>Erodium</i> sp. with Scattered Climbers of <i>Cuscuta</i> sp., <i>Dioscorea hastifolia</i> , <i>Commicarpus australis</i>

South and east areas, located on top of the slope	4	Vegetation Association 17	Least Concern
2	<i>Acacia rostelifera</i> Scrub	High Shrubland to Open Scrub of <i>Acacia rostelifera</i> over Shrubland of <i>Rhagodia latifolia</i> , <i>Stylobasium spathulatum</i> , <i>Olearia</i> sp. Kennedy Range over Low Shrubs of <i>Tetragonia implexicoma</i> over Grasses of <i>Ehrharta longiflora</i> , <i>Avena barbata</i> , <i>Austrostipa</i> spp., over Mixed Herbs of <i>Lysimachia arvenscens</i> , <i>Erodium</i> sp. over with Scattered Climbers of <i>Cuscuta</i> sp., <i>Dioscorea hastifolia</i> , <i>Commicarpus australis</i>

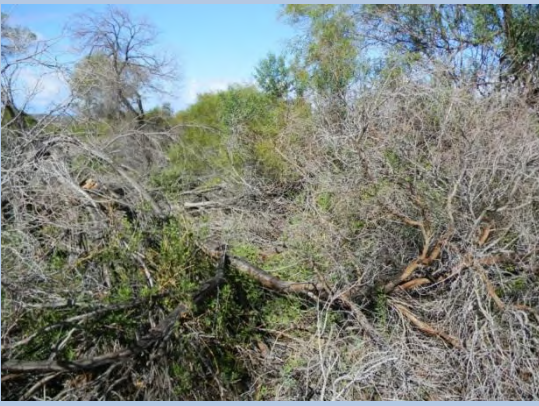
Lower topography areas, on the west side. Often associated with regrowth on old works	5	Vegetation Association 371	Vulnerable

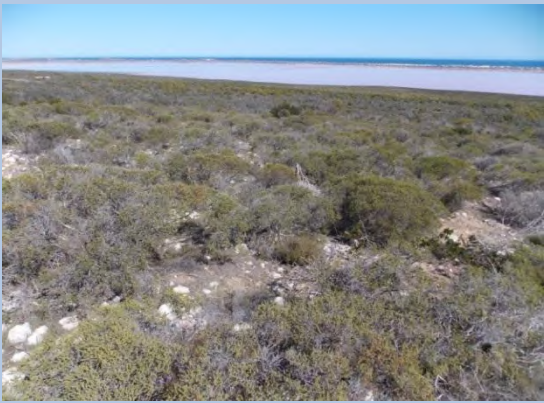
Vegetation Type Number	Short Description	Description	Photograph	Location	Condition	Comparison to Known Associations	Status
3	Low Heath	Low Open Heath to Low Heath of <i>Melaleuca cardiophylla</i> , <i>Diplopeltis petiolaris</i> , <i>Bossiaea spinescens</i> , <i>Pimelea angustifolia</i> , <i>Opercularia vaginata</i> , over Scattered Grasses of * <i>Avena barbata</i> , <i>Austrostipa</i> spp., over Mixed Herbs of * <i>Sisymbrium irio</i> , <i>Zygophyllum billardieri</i> . with Scattered Climbers of <i>Dioscorea hastifolia</i> , with Open Rushes of <i>Desmocladus asper</i>

High Limestone hills in North-east of Lease	3	Uncertain. Possibly Vegetation Association 387	Least Concern
4	Melaleuca Thickets	Closed Scrub of <i>Melaleuca cardiophylla</i> with Mallee of <i>Eucalyptus</i> spp. over Low Shrubs of <i>Rhagodia latifolia</i> , <i>Lasiopetalum angustifolium</i> with Scattered Climbers of <i>Aphanopetalum clematideum</i> , <i>Dioscorea hastifolia</i>

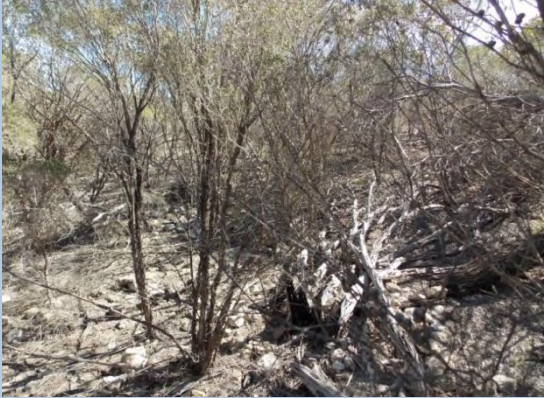
South Facing Slopes	3	Vegetation Association 387	Least Concern

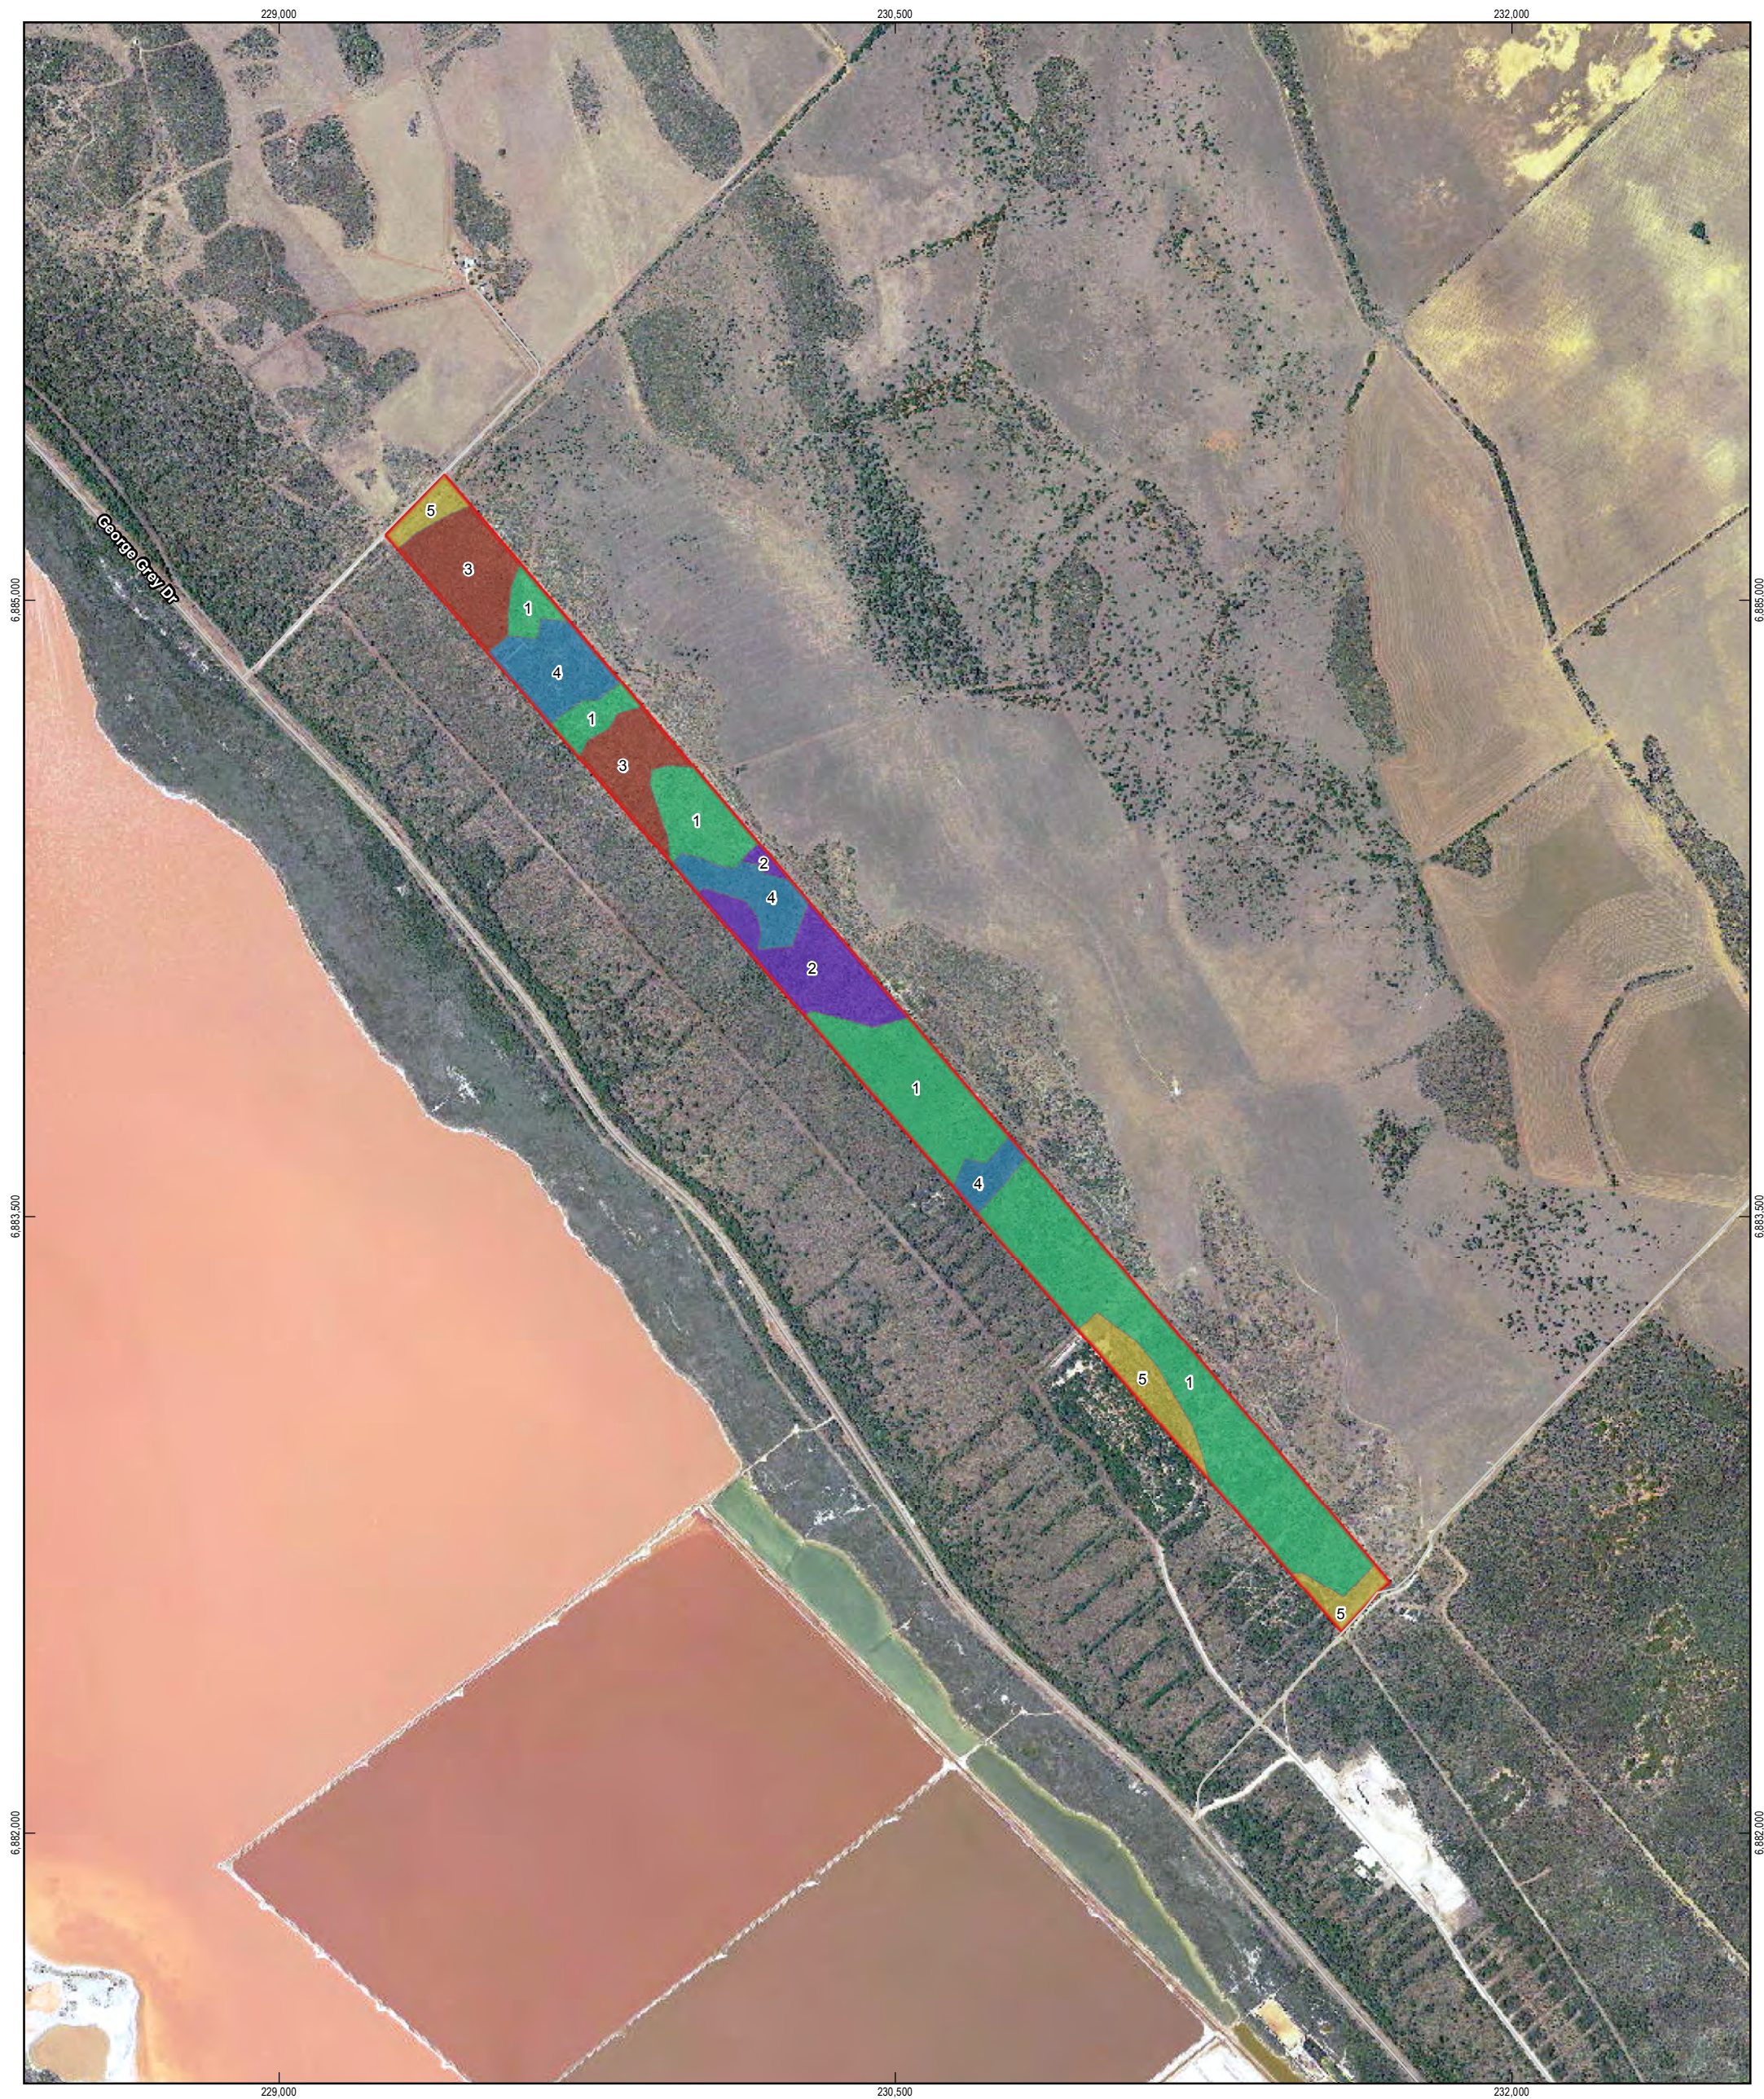
Figure 3

Roads	Vegetation Type		3	
	Project Area		1		4
			2		5

Vegetation Type

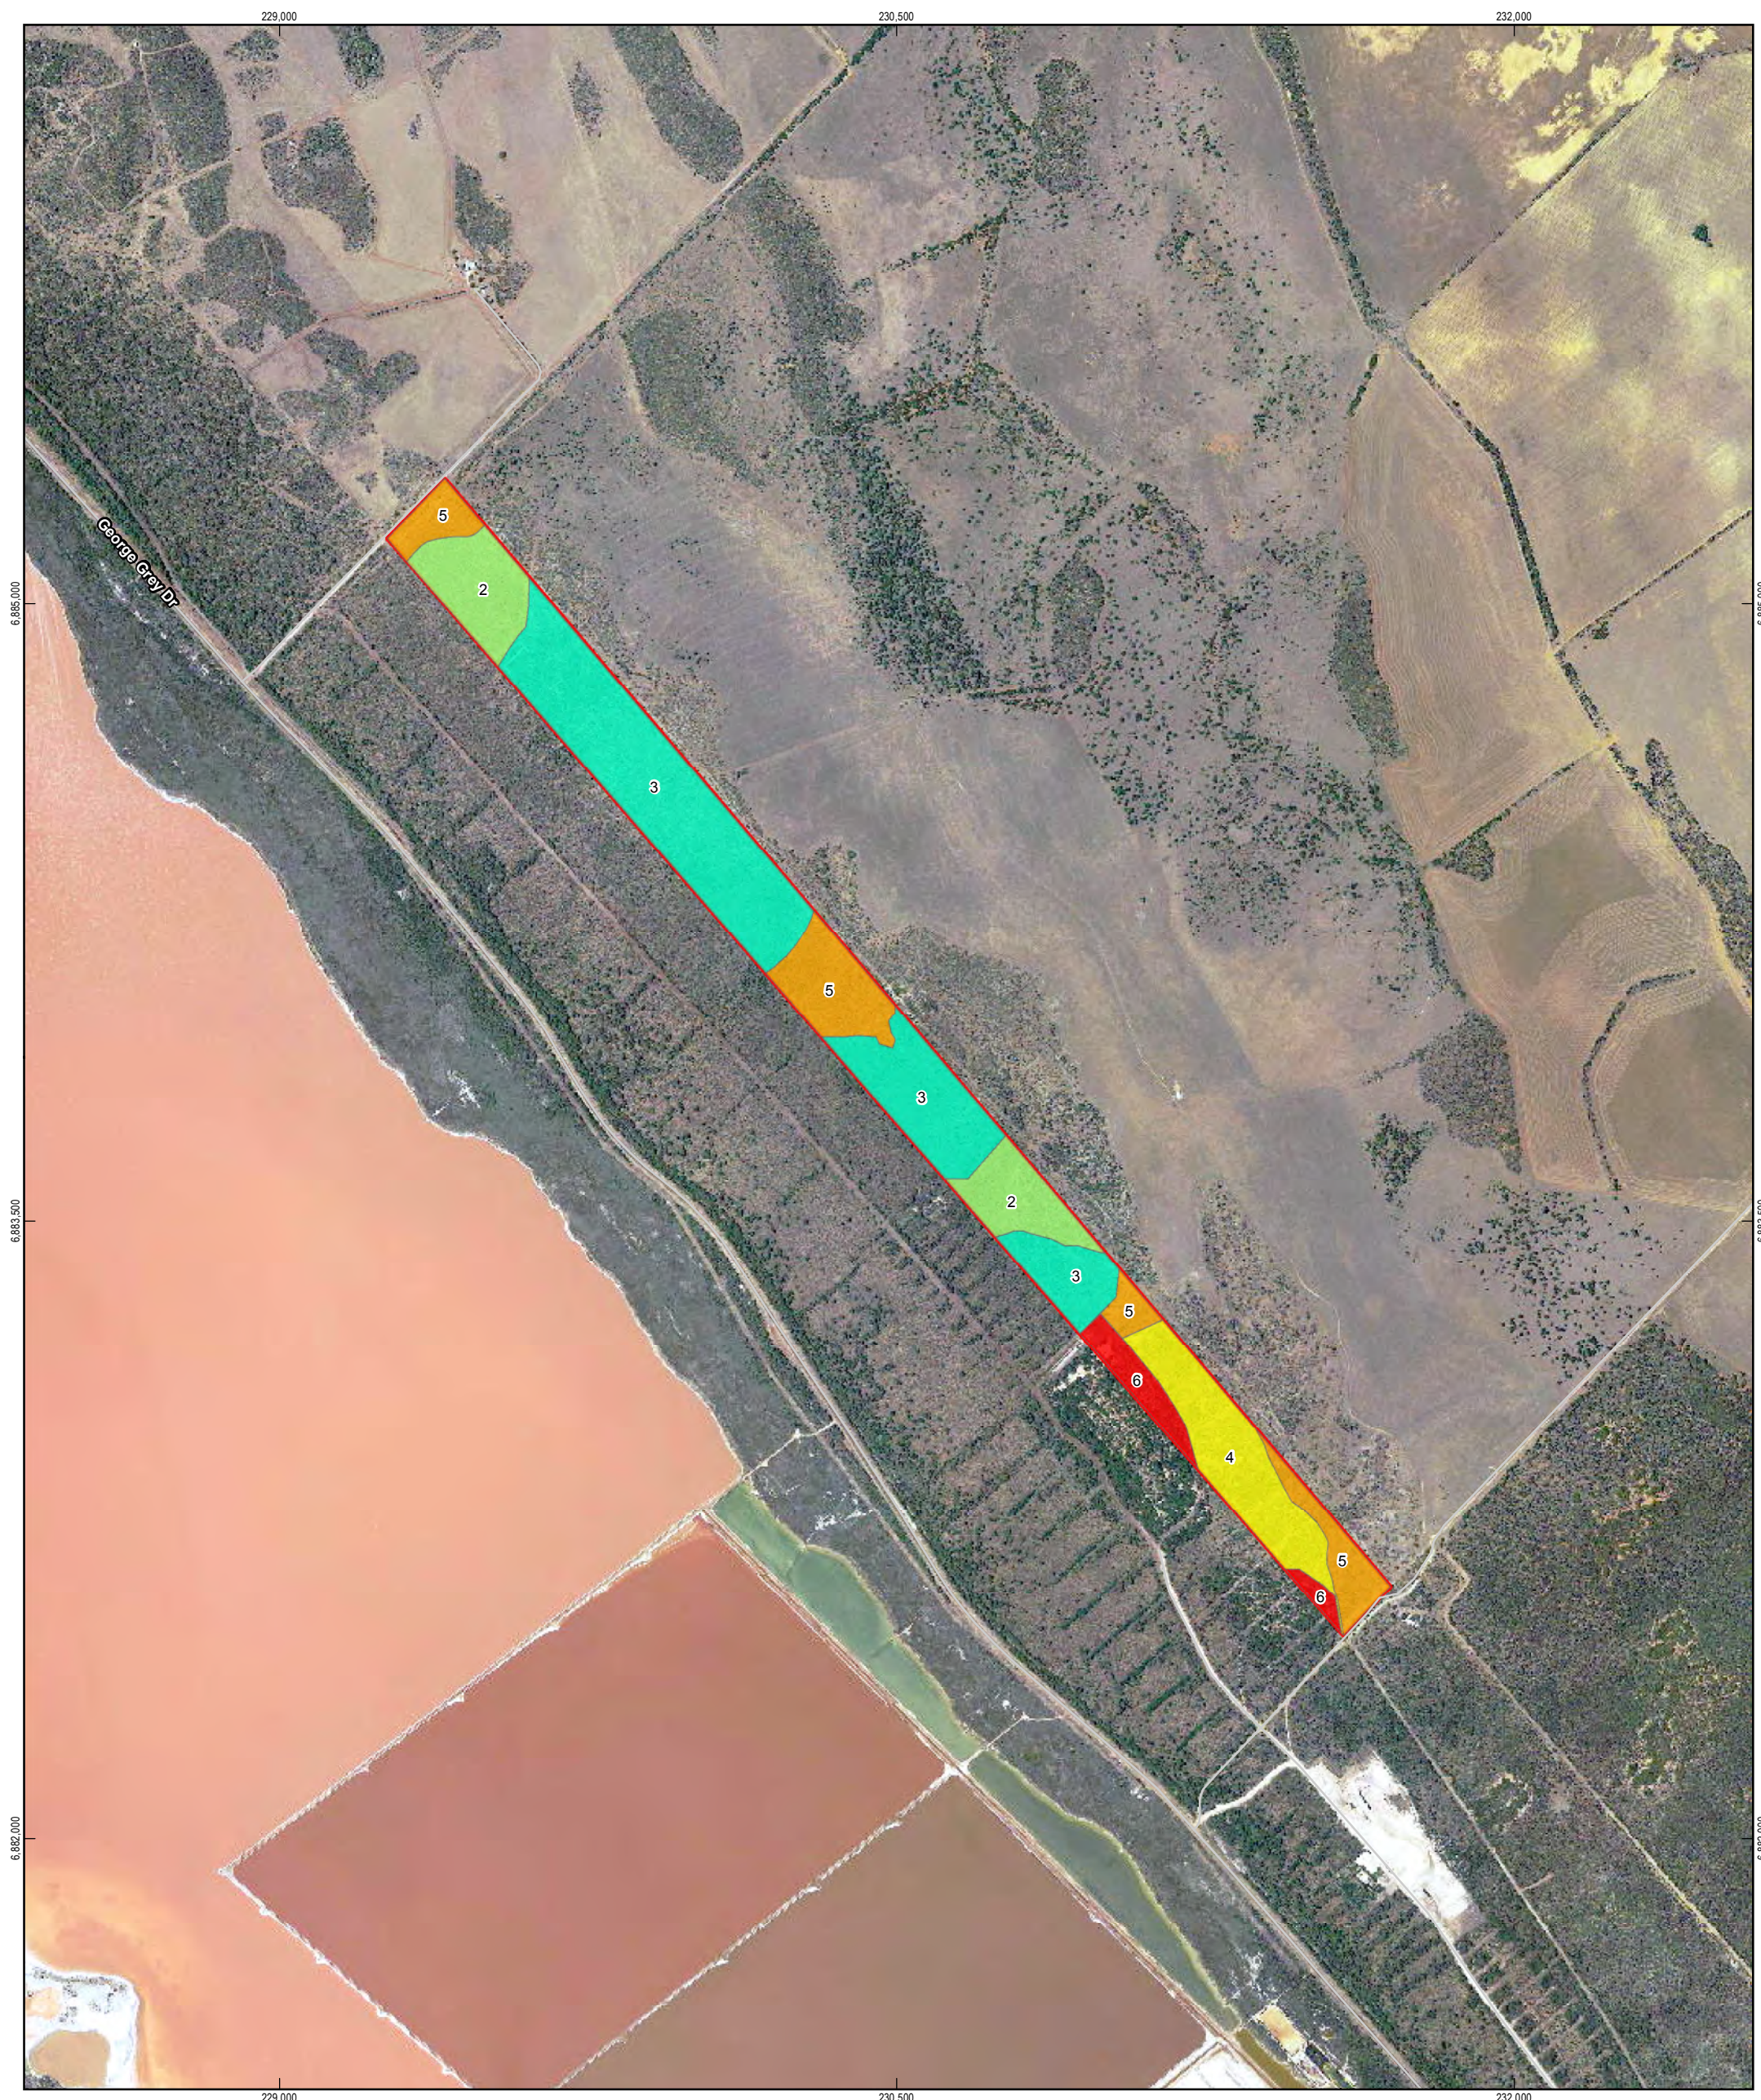
Figure 4

Roads	Vegetation Condition	4. Good
Project Area	2. Excellent	5. Degraded
	3. Very Good	6. Completely Degraded

Vegetation Condition

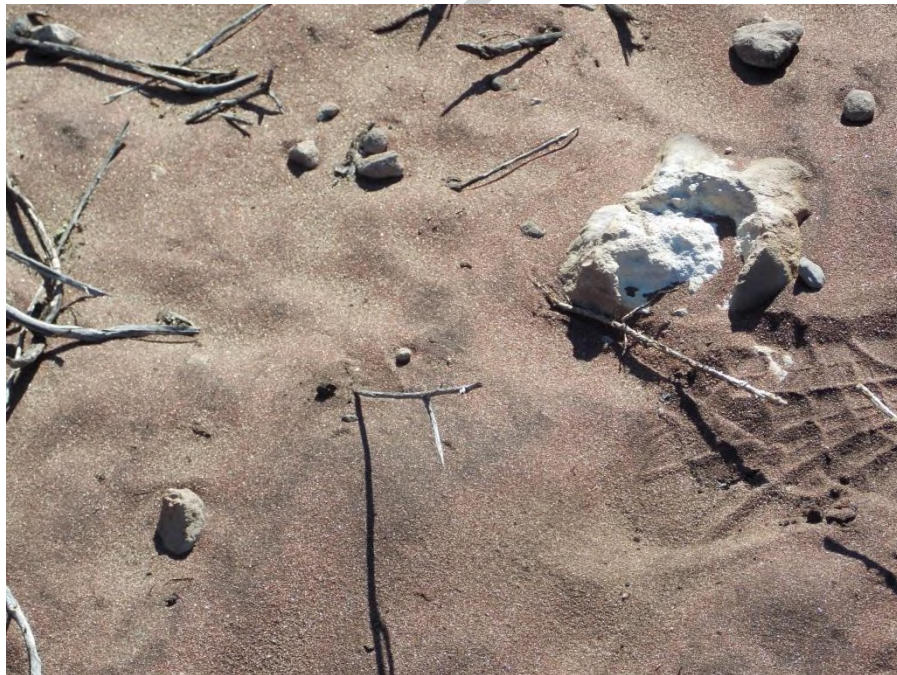
Plate 1 Soil Type

The soil of the Project Area was generally brown sand, sometimes overlying limestone. Plate 1 demonstrates the typical soil type for the area.

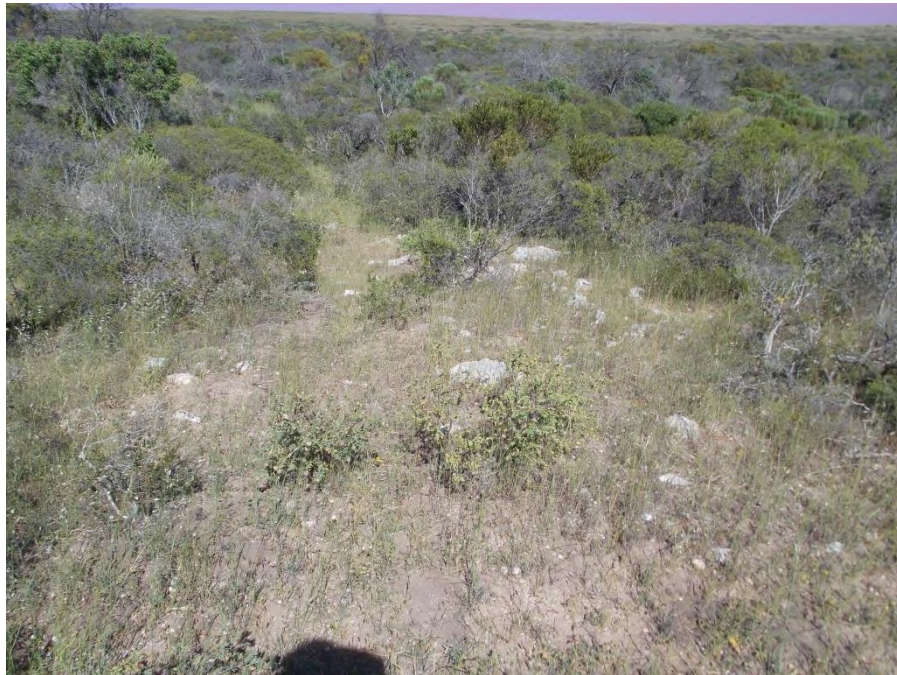
Plate 2 Marginal habitat

Potential habitat was considered extremely marginal because it has been impacted by weeds species and considered unsuitable habitat for *Caladenia bryceana* subsp. *cracens*. Plate 2 demonstrates the habitat found within the Project Area.

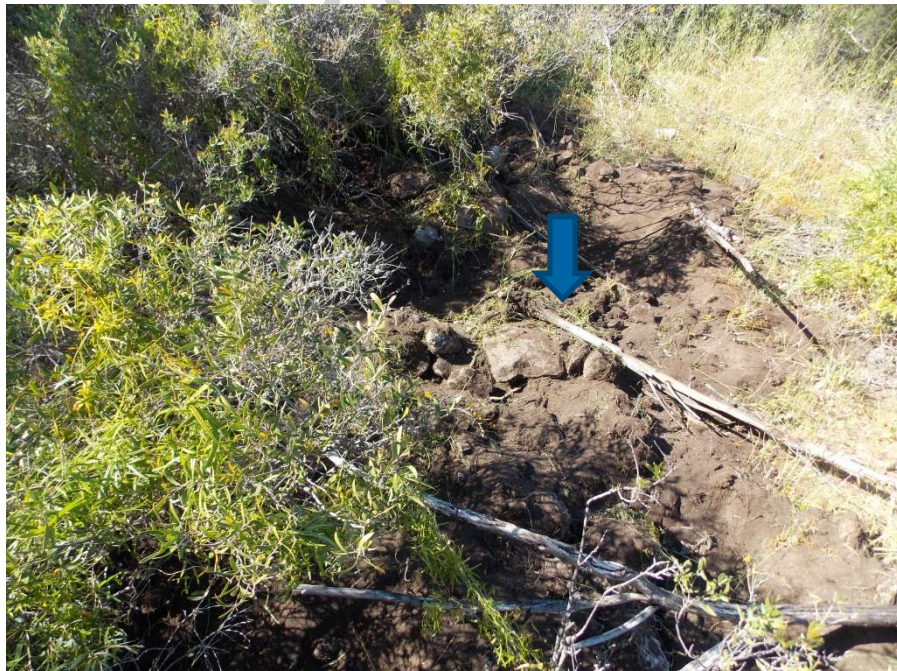
Plate 3 Pig Impact

GHD noted evidence of wild pigs impacting Project Area (Plate 3). Such an impact indicates threats posed to extremely marginal habitat with the Project Area.

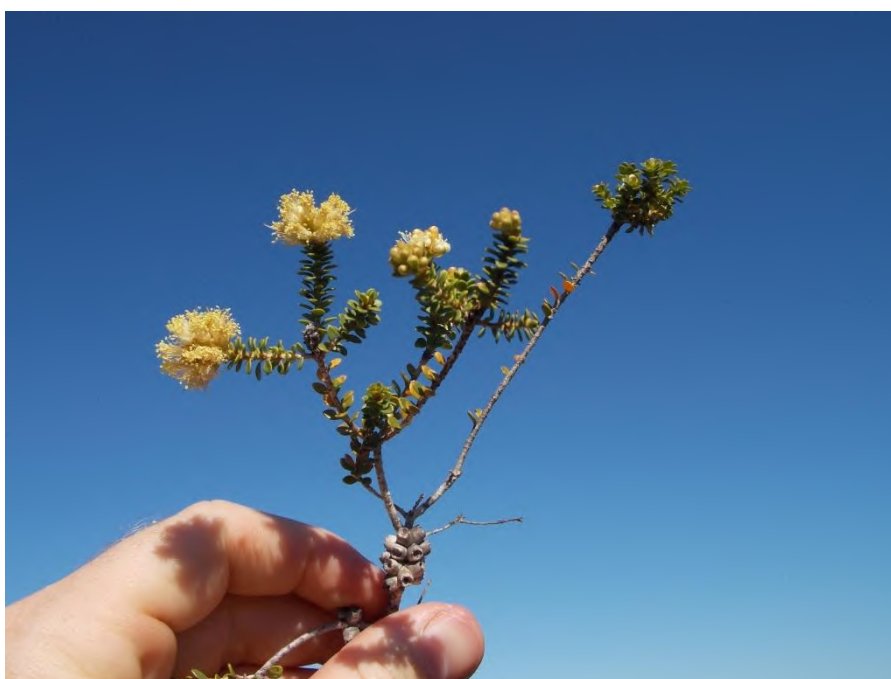
Plate 4 *Melaleuca huttensis*

Melaleuca huttensis is a listed DPaW Priority 1 flora taxon. It is described as an upright shrub that grows to approximate height of three metres. This species flowers cream to yellow during June and July, sometimes September. *M. huttensis* is typically found growing along lower slopes of undulating plains and sandplains overlain by light yellow or beige sand (DPaW, 1998a-).

In 2014 GHD recorded approximately 23 individual plants from three locations within the Project Area. The plants were recorded growing along the middle to lower slope of the sanddune. GHD traversed the entire Project Area by foot to identify any additional plants, no plants were identified. The locations of these plants are provided in Table 2 and Figure 2.

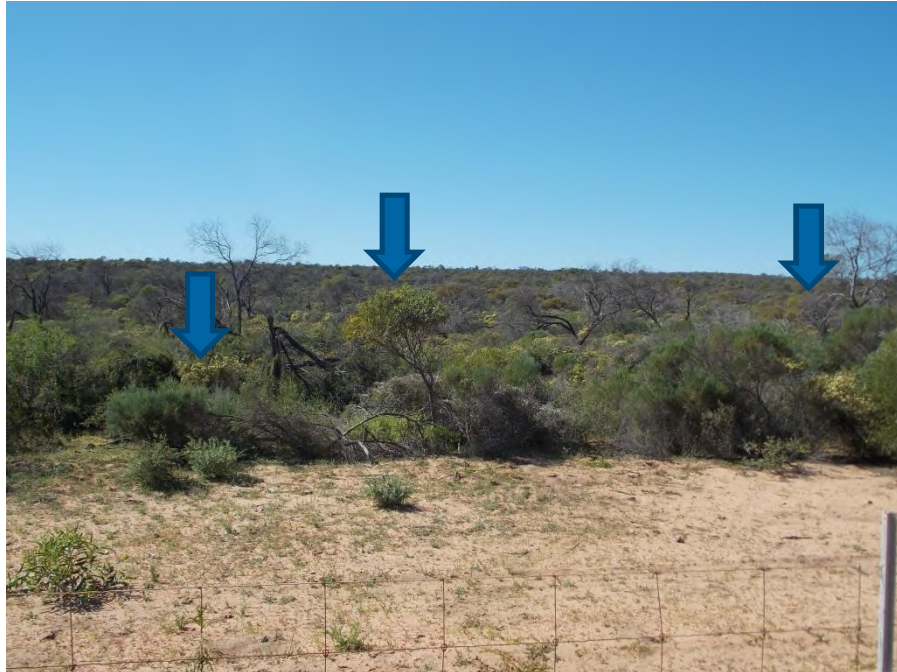
Plate 5 Population of <1000 individual plant of *M. huttensis* in adjacent area.

Road West (DPaW, 2007-). In 2014, GHD conducted a survey on behalf DPaW along Horrocks Road, located approximately 10 km from the Project Area. GHD recorded between 21,000 and 740,000 plants within an area of 106 hectares.

The removal of these species is likely to impact only >0.003% of the population within 10 km of the Project Area. It is unlikely that the removal of these plants will impact on the status of this species within the local area.

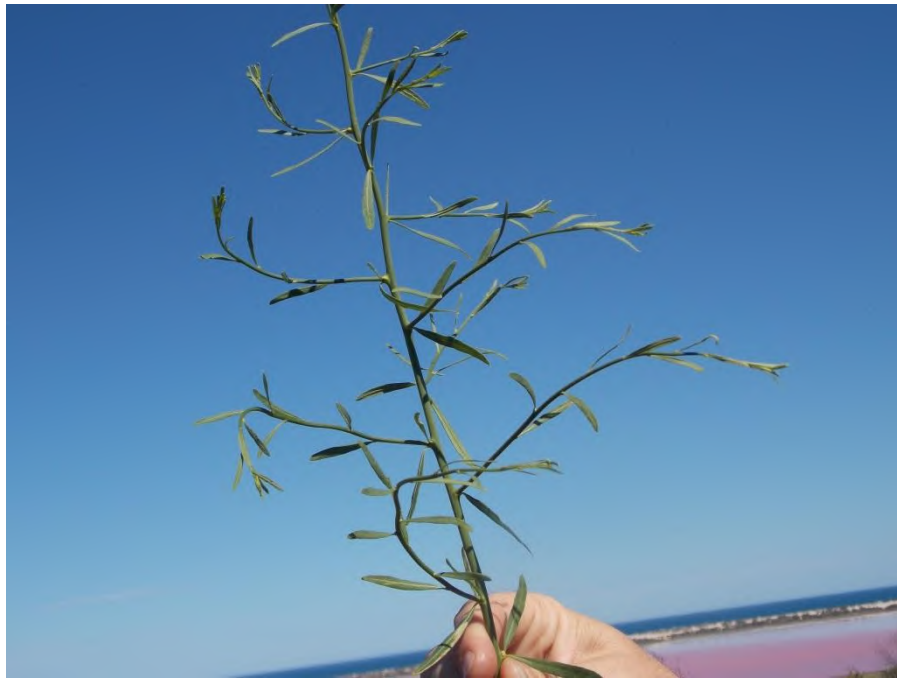
Plate 6 *Anthocercis intricata*

Anthocercis intricata is a DPaW listed Priority 3 flora taxon. It is described as a dense, spinescent shrub, growing to approximate height of between 0.9 to 3.0 m high. It has white to cream flowers occurring between June and September (Plate 6). This species typically occurs on sand or loam over limestone, associated with consolidated sand dunes (DPaW, 1998-). This is a wide-ranging coastal species with records known from Shark Bay in the north to Leeman in the south.

In 2014, GHD recorded approximately 54 individual plants from three locations were recorded from the Project Area. This species was associated with previous disturbances and was recorded growing along existing firebreaks track. GHD traversed the entire Project Area by foot to identify any additional plants, no plants were identified. The locations of these plants are provided in Table 3 and Figure 3.

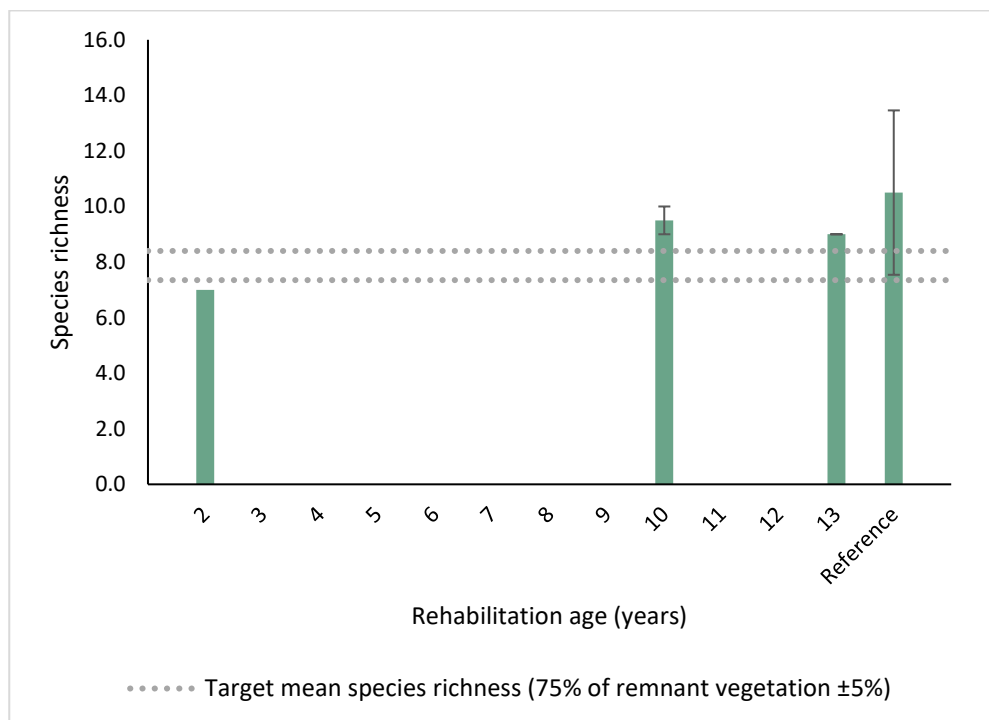
Species diversity from *Acacia rostellifera* scrub rehabilitation areas is compared against the completion criteria derived from the reference quadrats in **Plate 1**.

Plate 1: Mean species richness (\pm standard errors) for 2023 monitoring of quadrats in *Acacia rostellifera* rehabilitation areas and reference sites presented against completion criteria (native vegetation)

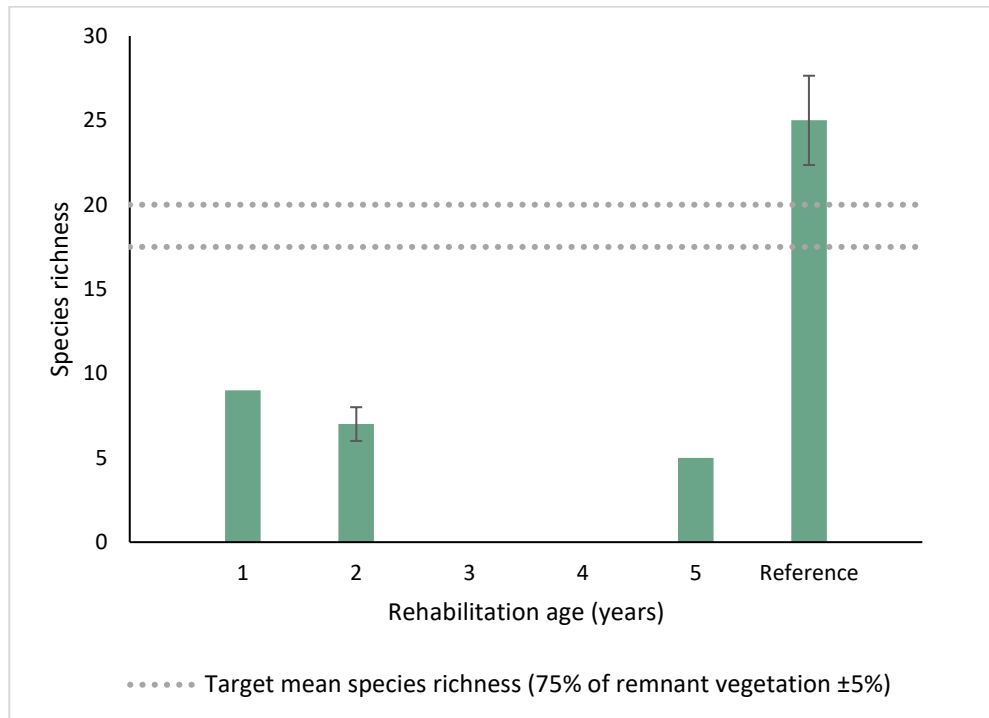
Plate 2: Mean species richness (\pm standard errors) for 2023 monitoring of quadrats in mixed open heath on sandy limestone ridge rehabilitation areas and reference sites presented against completion criteria (native vegetation)

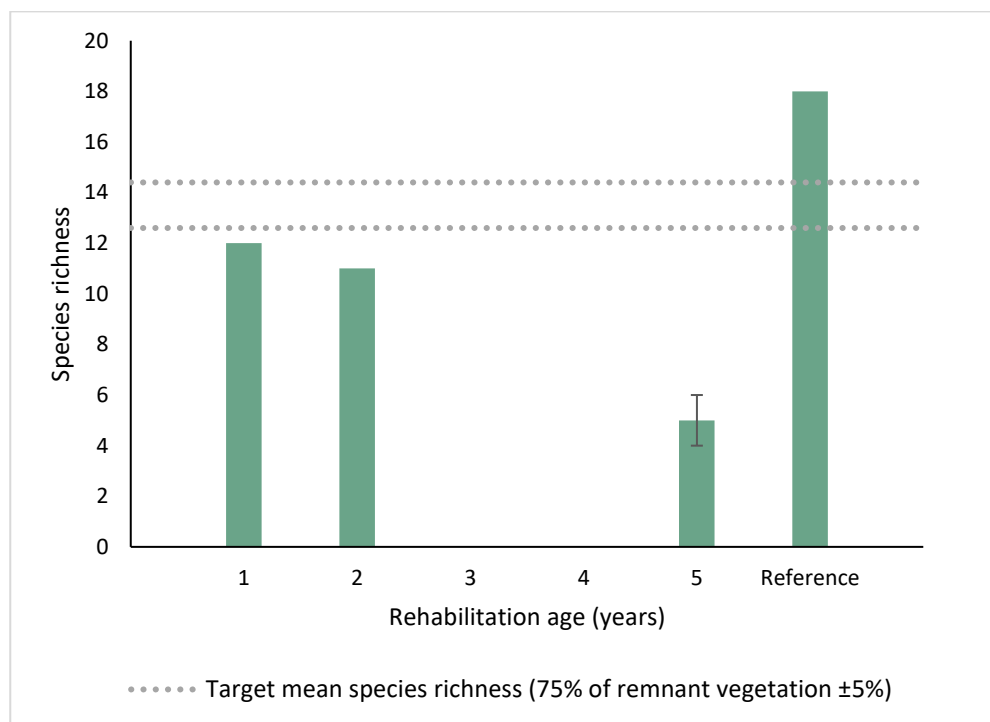
Species diversity from the *Melaleuca* thickets rehabilitation areas is compared against the completion criteria derived from the reference quadrats in **Plate 3**.

Plate 3: Mean species richness (\pm standard errors) for 2023 monitoring of quadrats in *Melaleuca* thicket rehabilitation areas and reference sites presented against completion criteria (native vegetation)

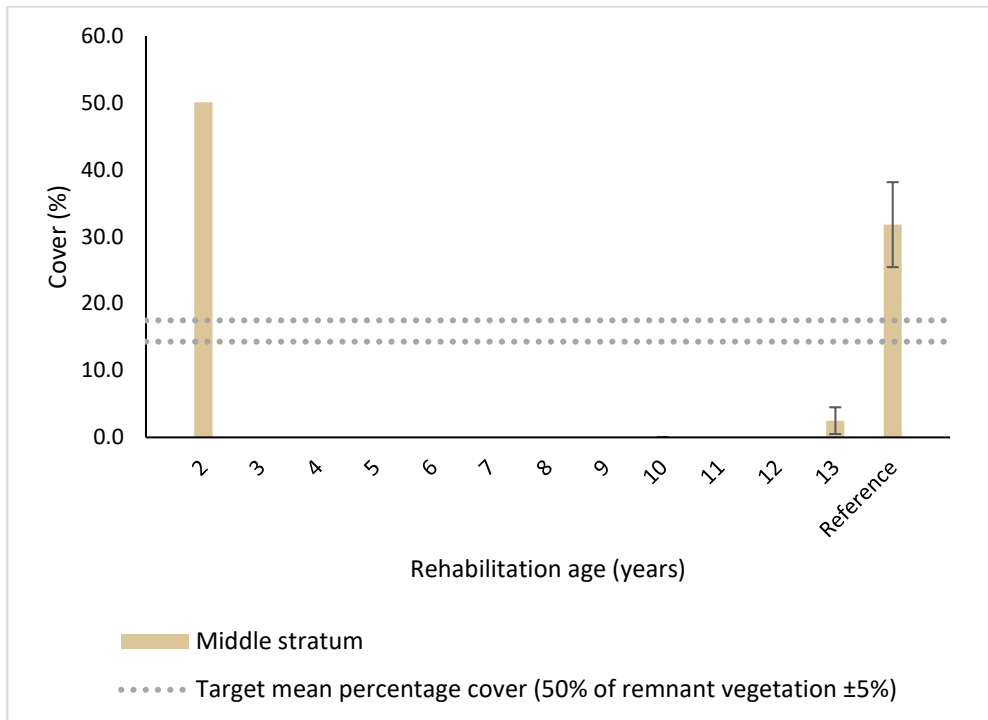
Plate 4: Mean percentage cover (\pm standard errors) for 2023 monitoring of *Acacia rostellifera* scrub quadrats in rehabilitation areas and reference sites presented against completion criteria for middle stratum (native vegetation)

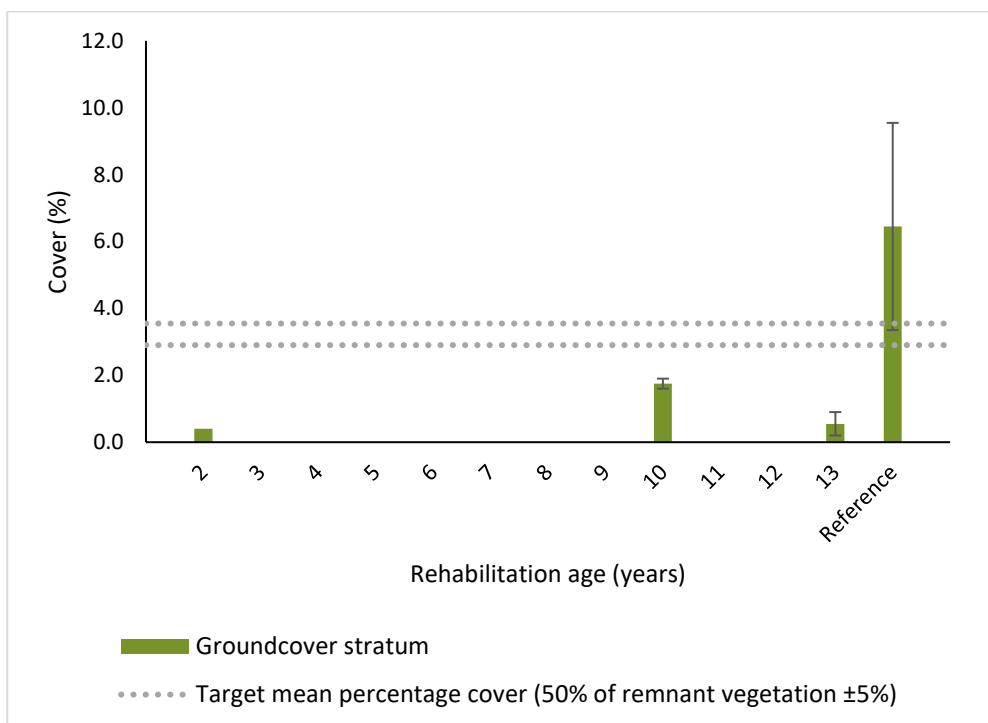
Plate 5: Mean percentage cover (\pm standard errors) for 2023 monitoring of *Acacia rostellifera* scrub quadrats in rehabilitation areas and reference sites presented against completion criteria for ground stratum (native vegetation)

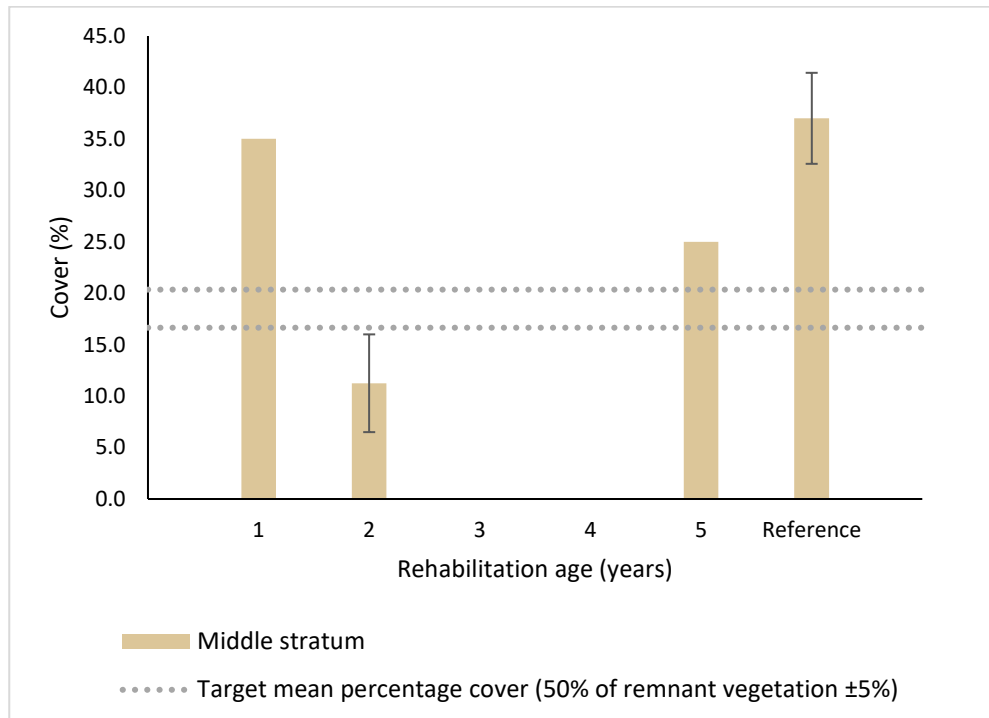
Plate 6: Mean percentage cover (\pm standard errors) for 2023 monitoring of mixed open heath on sandy limestone ridge quadrats in rehabilitation areas and reference sites presented against completion criteria for middle stratum (native vegetation)

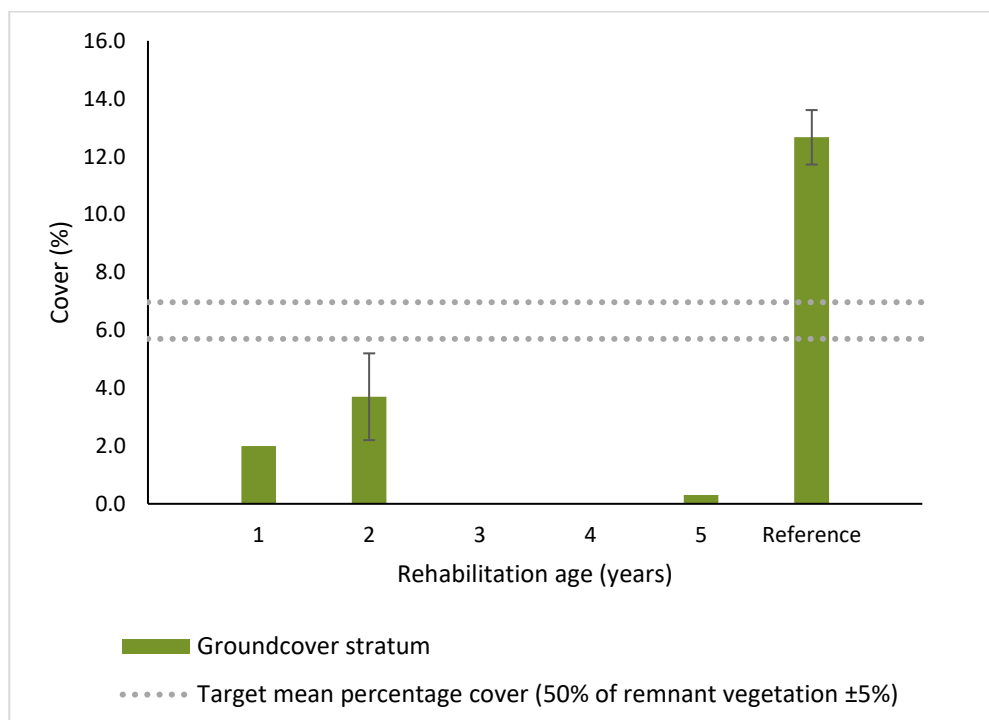
Plate 7: Mean percentage cover (\pm standard errors) for 2023 monitoring of mixed open heath on sandy limestone ridge in rehabilitation areas and reference sites presented against completion criteria for groundcover stratum (native vegetation)

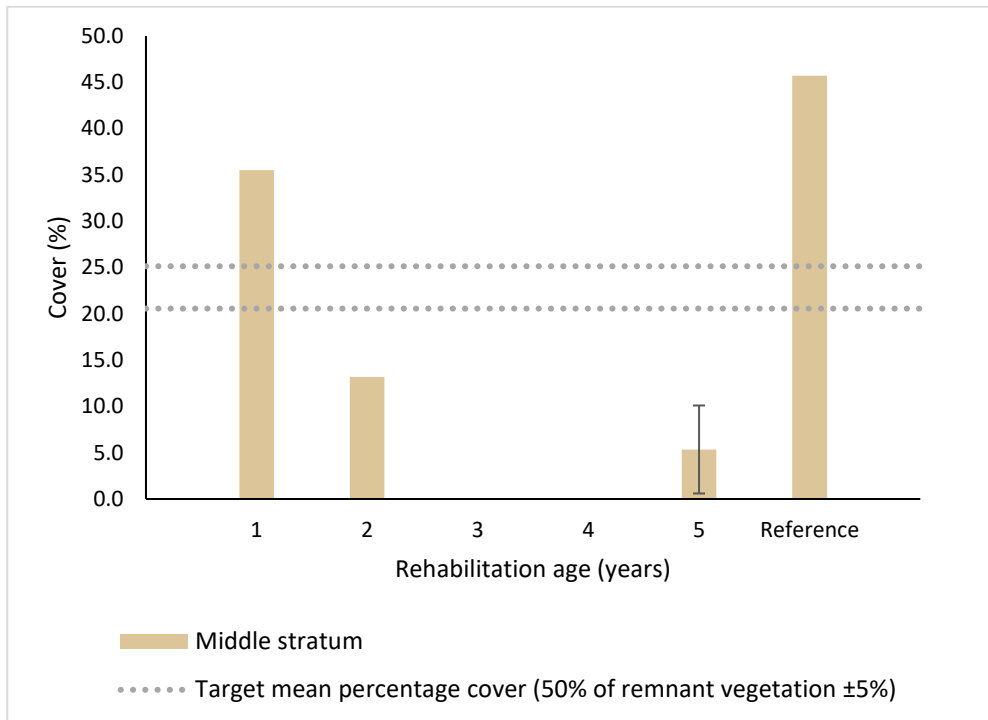
Plate 8: Mean percentage cover (\pm standard errors) for 2023 monitoring of *Melaleuca* thickets quadrats in rehabilitation areas and reference sites presented against completion criteria for middle stratum (native vegetation)

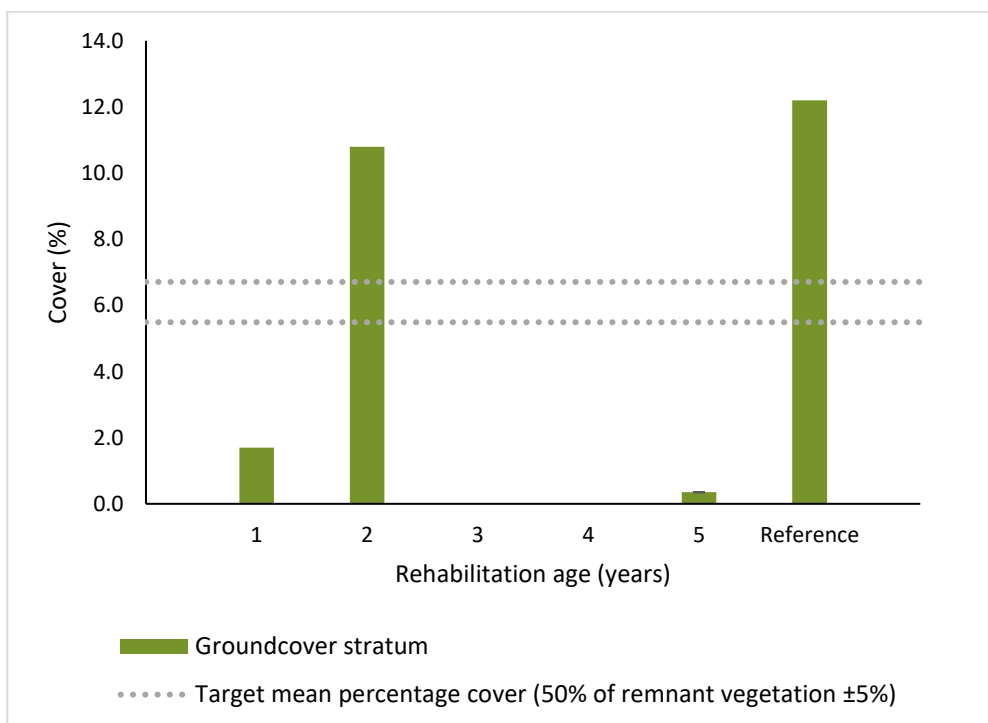
Plate 9: Mean percentage cover (\pm standard errors) for 2023 monitoring of *Melaleuca* thickets quadrats in rehabilitation areas and reference sites presented against completion criteria for ground stratum (native vegetation)
