# PROPOSED BRIDGE AND ROAD UPGRADE, RAILWAY PARADE, UPPER SWAN

## ENVIRONMENTAL ASSESSMENT

Prepared for: City of Swan  
Report Date: 8 February 2013  
Version: 1  
Report No. 2012-78

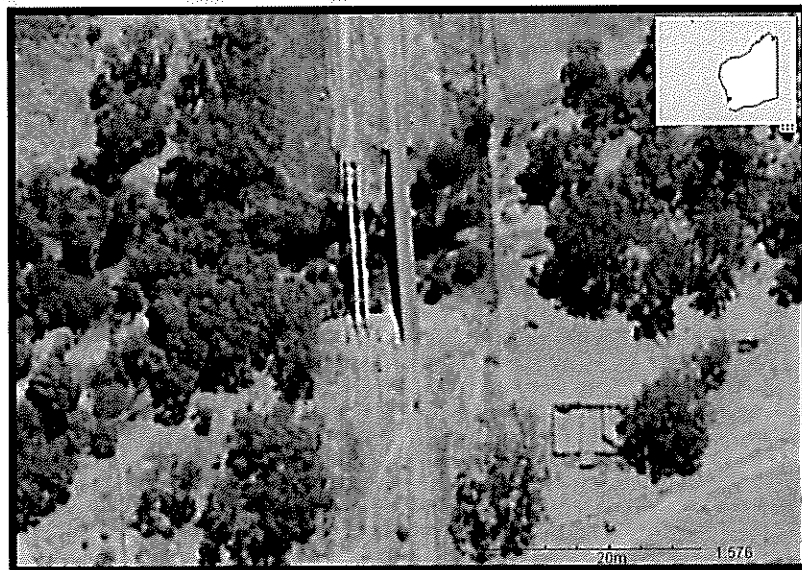
Plate 2: Aerial Photography from 1965 showing the bridge over the Ellen Brook (Landgate 2012b).

The 1965 aerial photograph shows the remains of a small bridge over Ellen Brook as well the rail bridge on the right hand side (Plate 2).

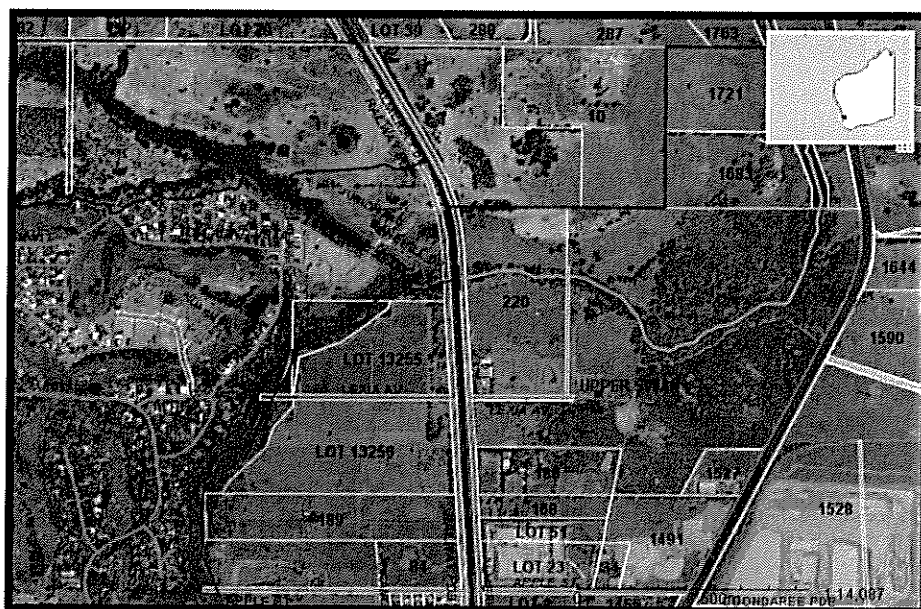
**Plate 3: Aerial Photography from 1979 showing land that was cleared (Landgate 2012b).**

Between 1977 and 1979 the vegetation to the north of Ellen Brook was cleared up to Maralla Road (Plate 3).

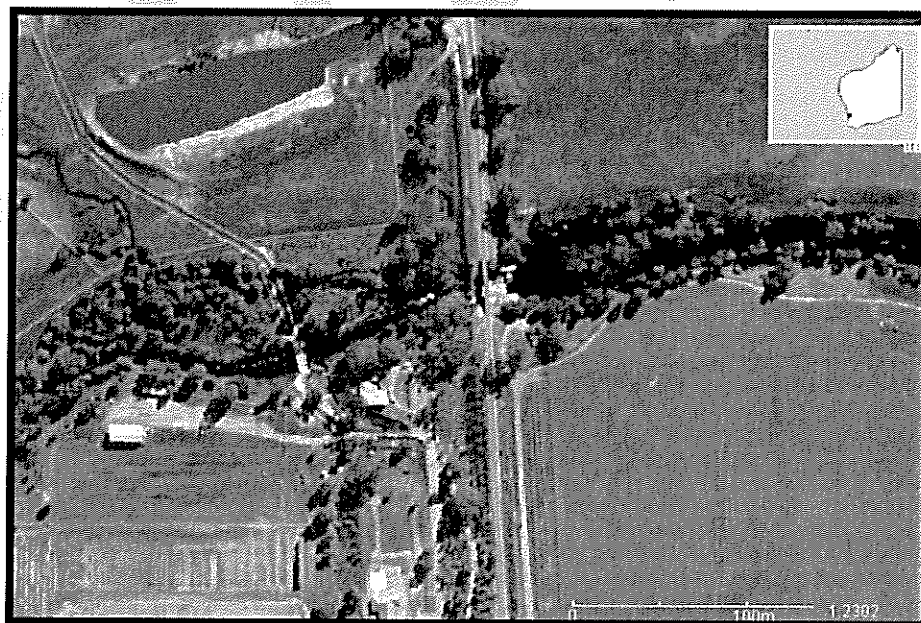
**Plate 4: Aerial Photography from 1981 showing new buildings and a dam (Landgate 2012b).**

Between 1979 and 1981 there has been some development commenced in close proximity to the Ellen Brook. To the south a dwelling has been established on the site. To the north of Ellen Brook an area has been excavated to form a dam (Plate 4).

The small bridge is still evident in 1981 however has been removed by 1985 (Plate 5).

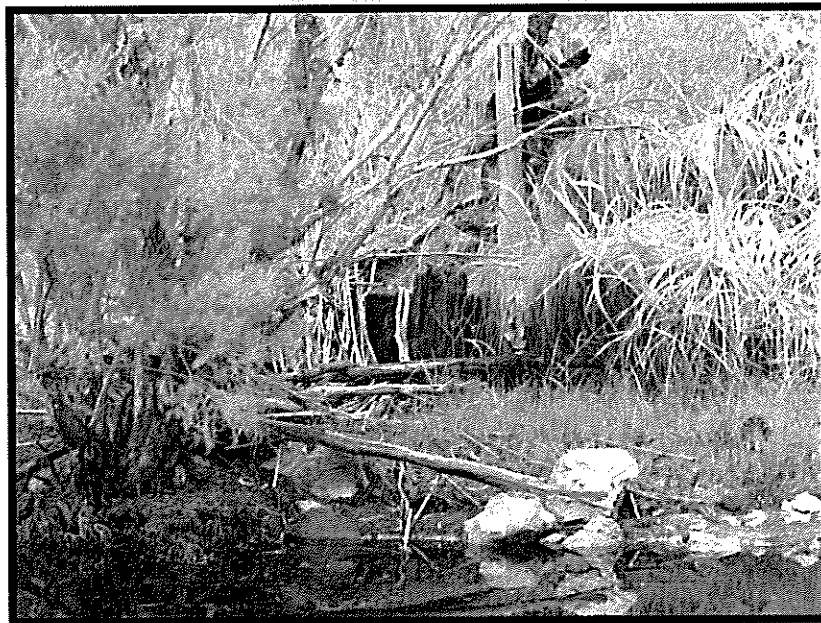
**Plate 6: Old Footings of the Bridge**

There is evidence of the old bridge on the site in 2012 (Plate 6).

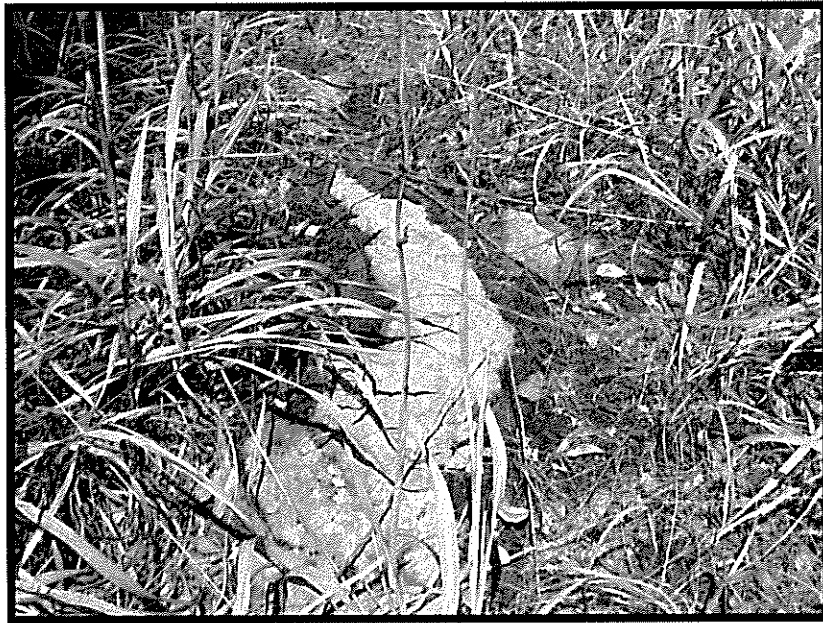
**Plate 7: Granite located to the South of Ellen Brook**

During the site visit it was noted that the south side of the banks of Ellen Brook had some outcropping of what is assumed to be granite (Plate 7). It is possible that the granite was placed on the site to stabilise the footings for the old bridge.

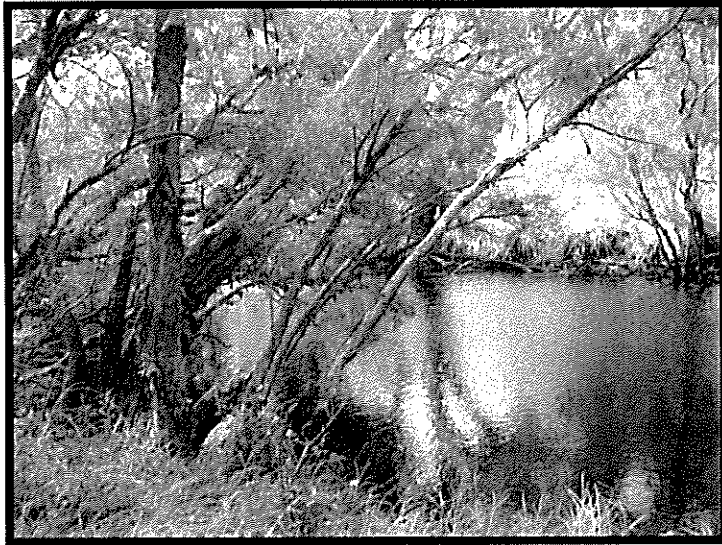
**Plate 8: Ellen Brook with some Trees and a Weedy Understorey**

A site visit conducted by PGV Environmental in November 2012 confirmed that this part of Ellen Brook is degraded with very little understorey other than weeds (Plate 8). There was some evidence of bank erosion.

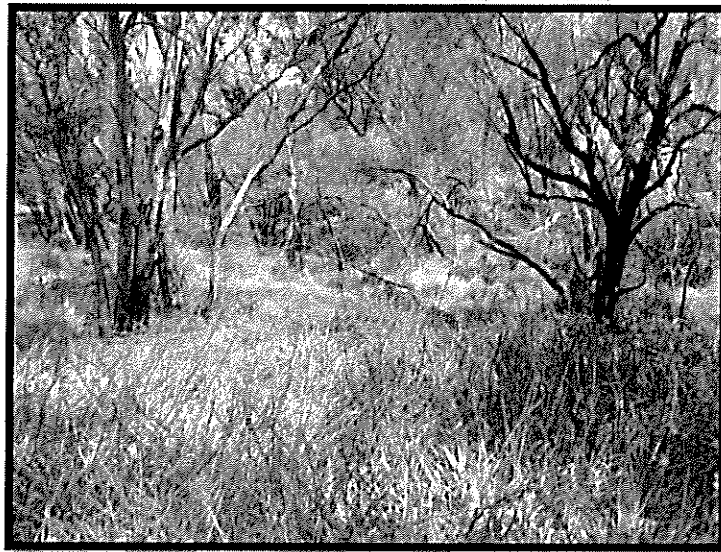
**Plate 10: Degraded Vegetation in the Resource Enhancement Wetland (UFI 15733)**

A Resource Enhancement Palusplain (UFI 15733) occurs to the north of Ellen Brook and adjacent to the western side of the rail reserve (Figure 6). This wetland is degraded and the vegetation consists of trees over weeds (Plate 10).

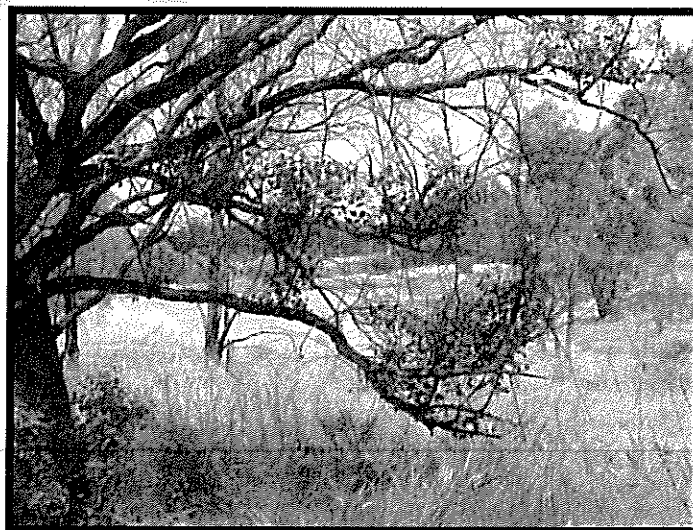
**Plate 11: Excavated Area near Resource Enhancement Wetland**

To the west of the Resource Enhancement Wetland is an area that has been excavated to create a man-made dam and is likely to hold water for most of the year (Plate 11).

It is likely that the construction of this dam has impacted on the hydrology of the Resource Enhancement wetland by diverting surface water.

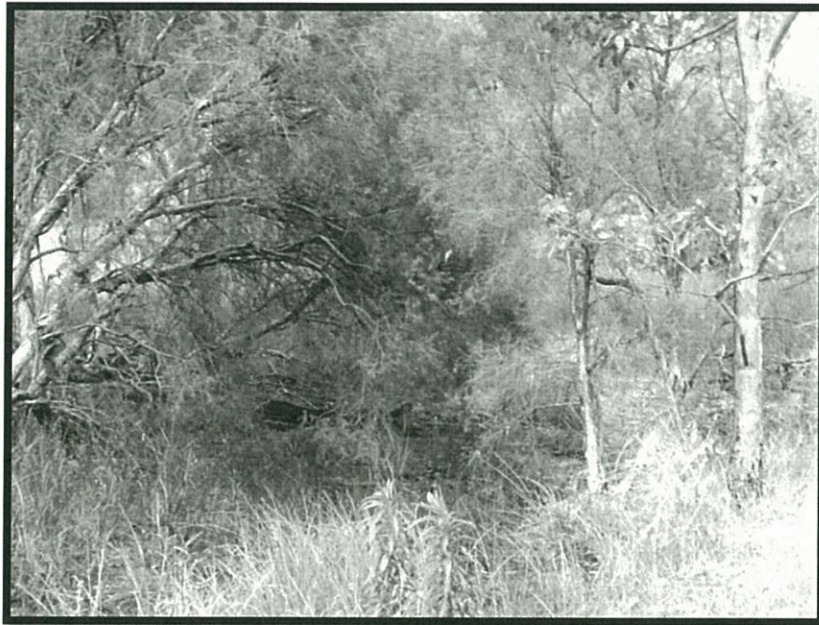
**Plate 12: Weedy Vegetation in the Vicinity of Ellen Brook**

Riparian vegetation exists on the banks of the Ellen Brook and other low-lying areas (Plate 12). The vegetation consists of Flooded Gum (*Eucalyptus rudis*) and Paperbarks (*Melaleuca raphiophylla*) with an understorey consisting of weeds such as Watsonia (*Watsonia bulbifera*), (*Typha orientalis*), Arum Lily (*Zantedeschia aethiopica*) and Wild Oats (*Avena fatua*). The upper banks of the Ellen Brook on the southern side contain some Marri trees over weeds with Cornflag dominant (Plate 13). The southern side of Ellen Brook contains scattered Flooded Gums and planted Tasmanian Blue Gums (*Eucalyptus globulus*) (Plate 14).

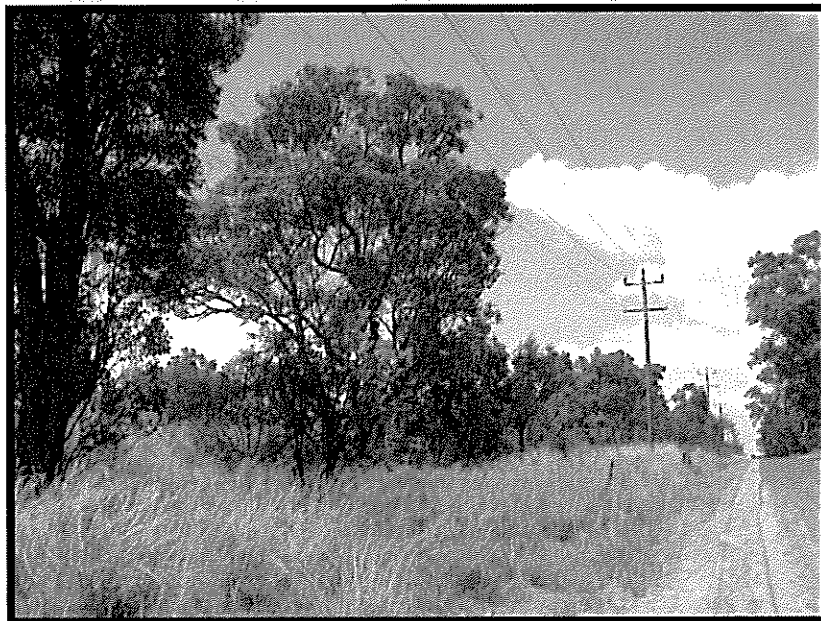
**Plate 15: Roadside vegetation along the southern part of Railway Parade**

A section of the eastern road reserve south of Ellen Brook contained Marri vegetation with some native heath understorey including *Jacksonia sternbergiana*, *Xanthorrhoea preissii* and *Hakea prostrata* (Plate 15). While the area contained numerous weeds, especially Lovegrass (*Eragrostis curvula*), the site may contain conservation significant flora species or ecological communities. A spring flora and vegetation survey is recommended for this area.

The highly degraded vegetation was considered not likely to represent any of the TECs and PECs listed. The vegetation on the eastern side of the road reserve south of Ellen Brook was in slightly better condition and could potentially represent one of the Ecological Communities in Table 4. A spring flora and vegetation survey is recommended in this area to identify the community type.
