RAILWAY PARADE BRIDGE OVER ELLEN BROOK PRELIMINARY DESIGN REPORT

Preliminary Design Report

Options Assessment

Report No A5001-AA007882-AAR-00

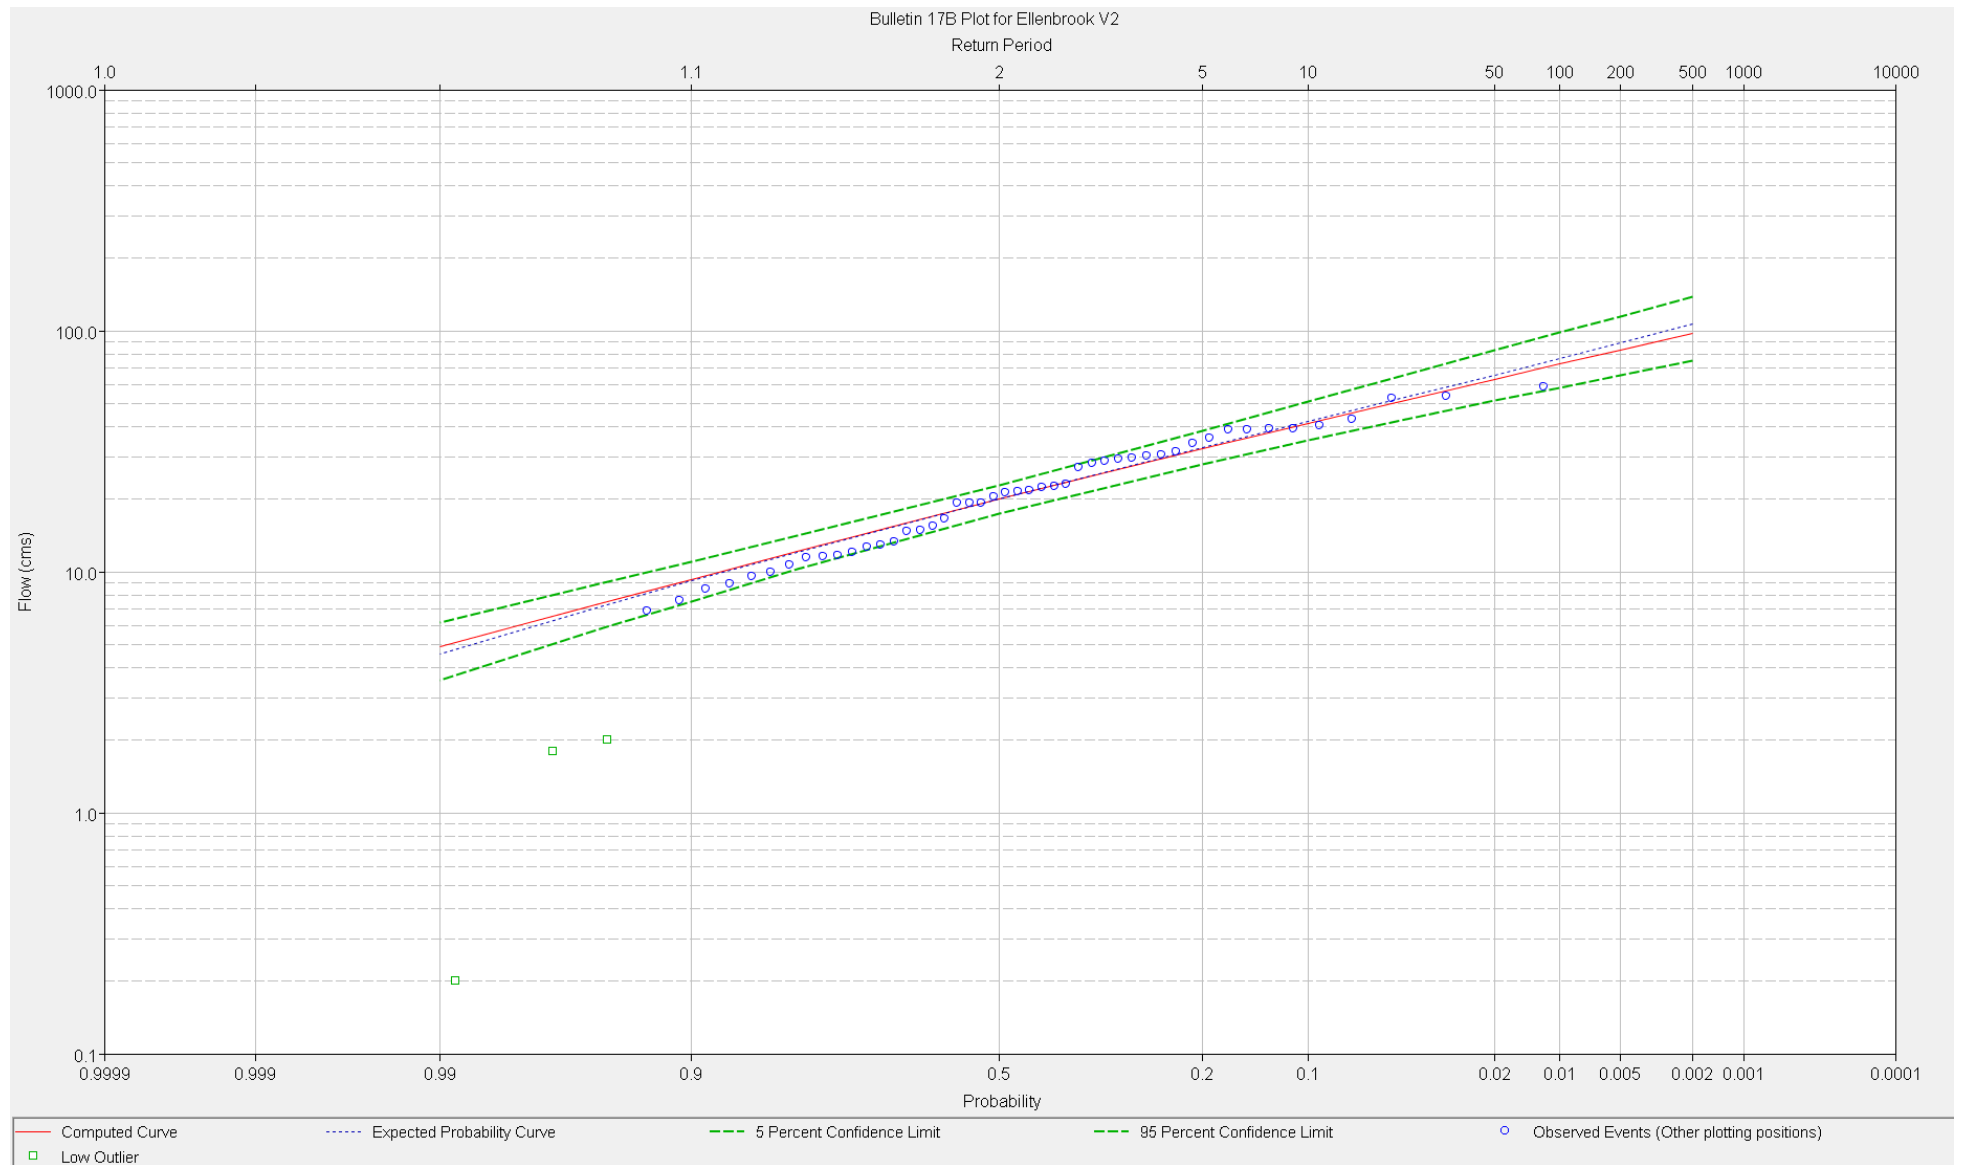
Figure 2.6: FFA Final Peak Flows Curve

ARI (years)	FFA Final Peak Flows (m ³ /s)
100	72.9
50	63.0
20	50.5
10	41.3
5	32.3
2	20.0

The XP-RAFTS model was calibrated for each ARI event to match these FFA outputs as closely as possible. This was done by adjusting the proportional loss values, with no adjustments to the Manning's n or storage coefficient required to match peak flows. Upon completion of this Stage 1 calibration, the calibrated loss parameters were comparable to those recommended by AR&R and used in the initial model run, as shown in Table 2.5 below.

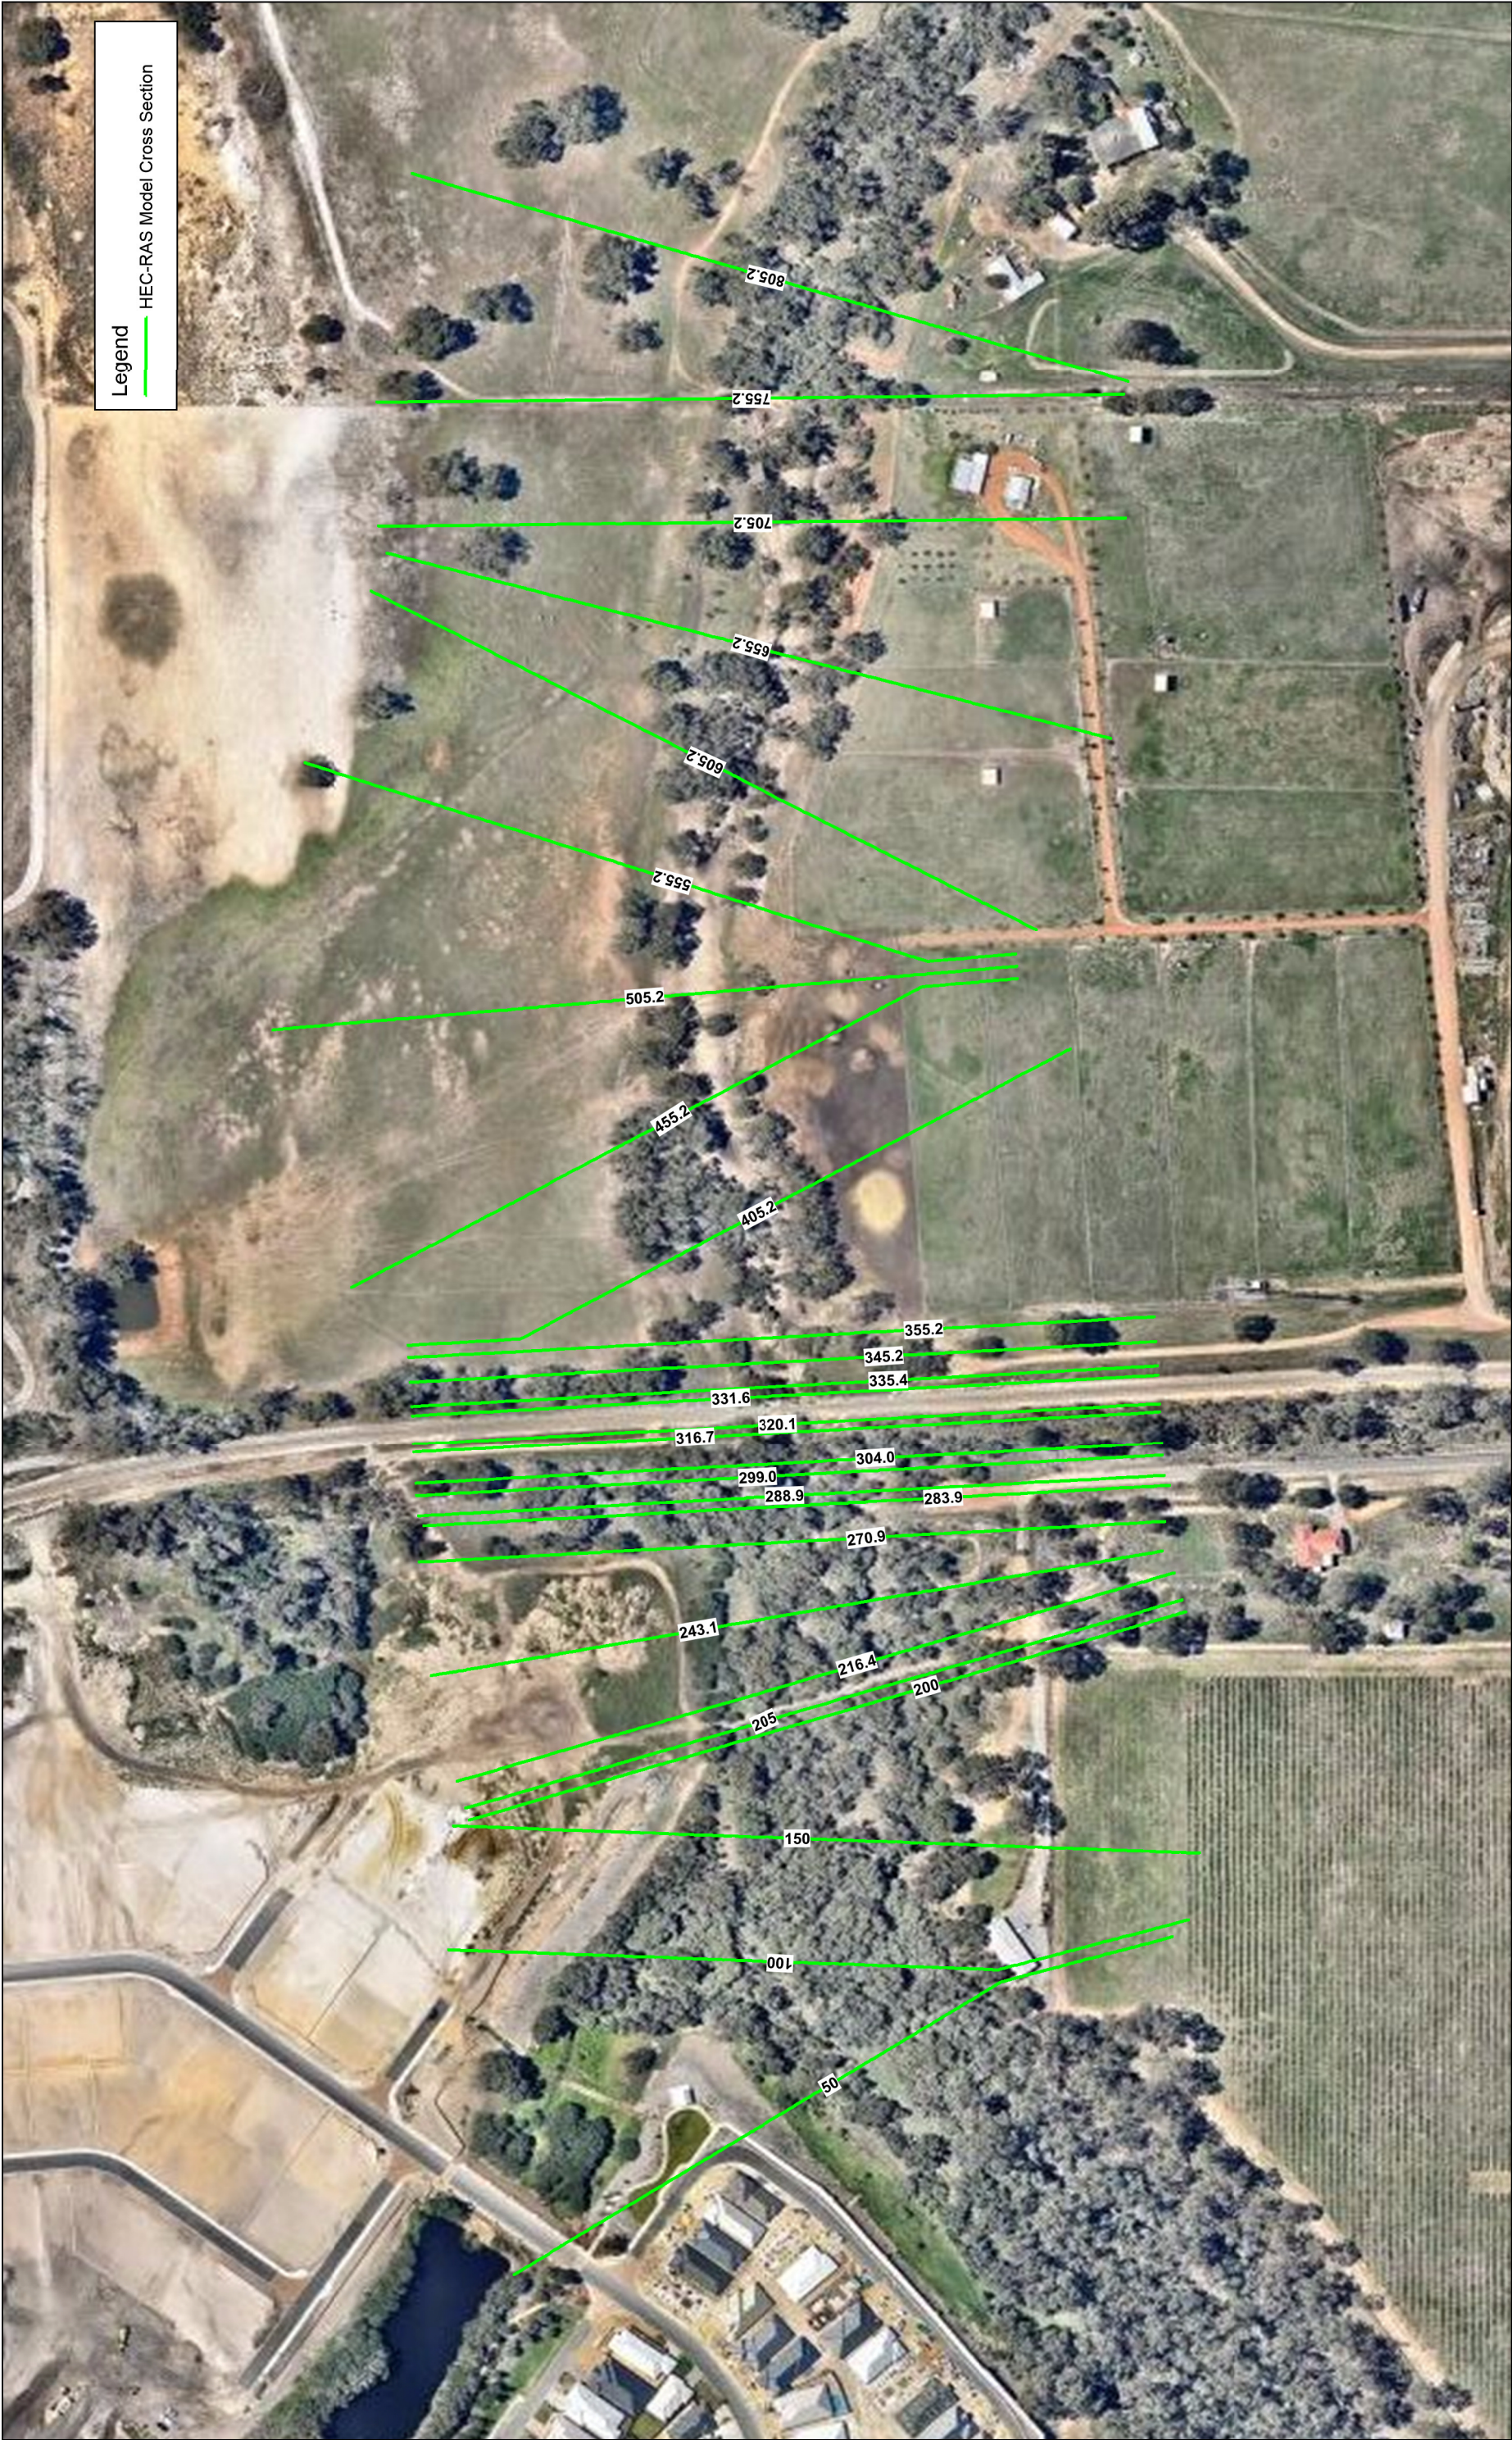
Legend
HEC-RAS Model Cross Section

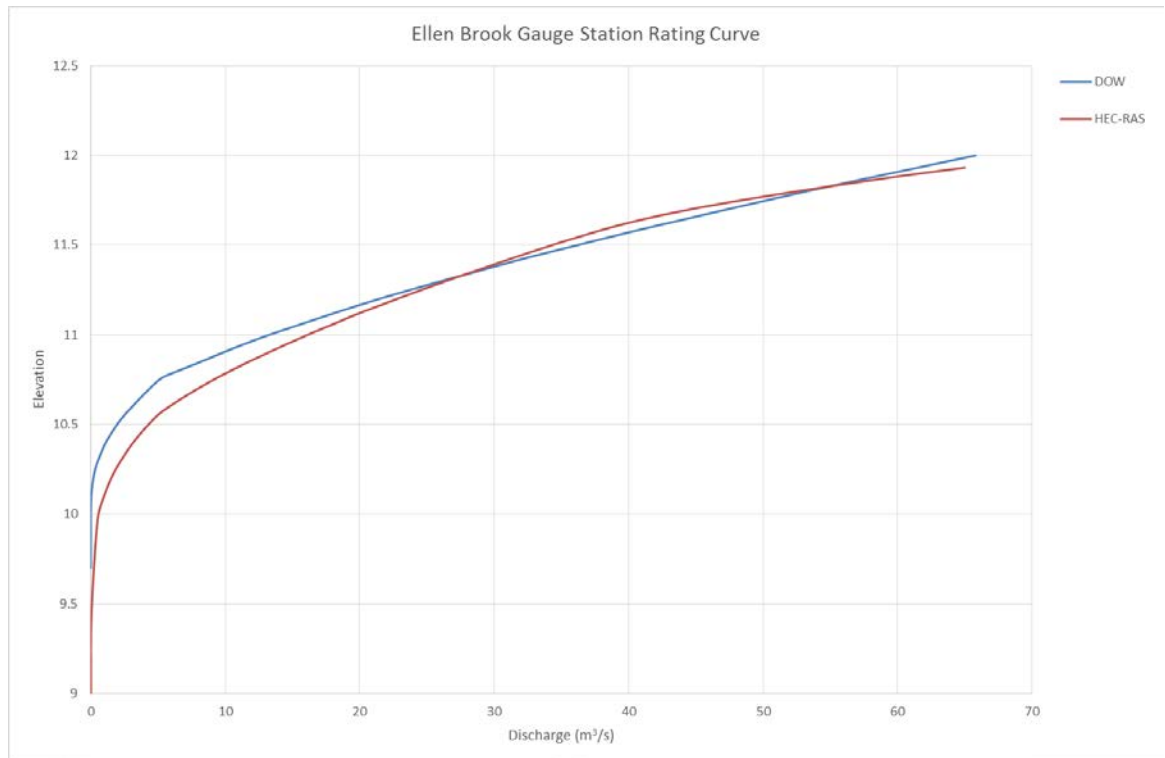
Figure 4.1: Ellen Brook Gauge Station Rating Curve

It should be noted that the supplied rating curve from DoW is based on the local elevation and for the purposes of the calibration, the model output rating curve was adjusted to the local elevation. Figure 4.1, shows a comparison between the rating curves provided by DoW and that produced in the calibrated HEC-RAS model.

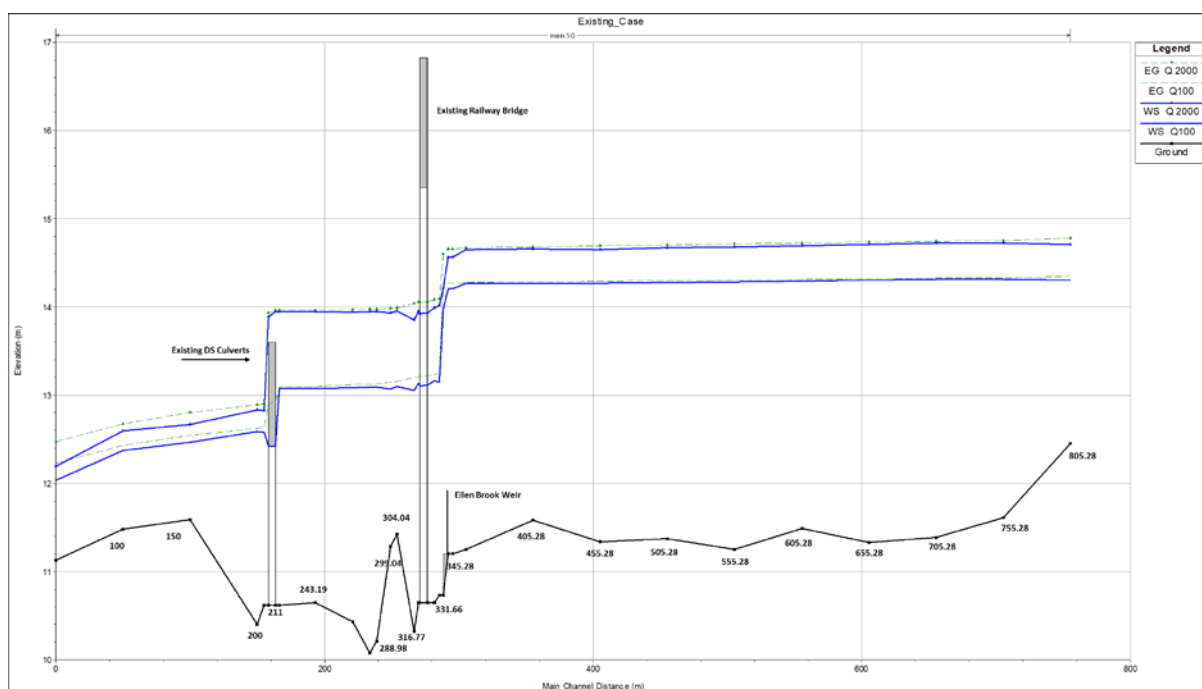
Figure 4.2: Ellen Brook Longitudinal Profile- Existing Condition

Complete results from the hydraulic modelling of the existing condition are presented in Appendix C. The following figure shows the longitudinal profile of Ellen Brook in its existing condition.

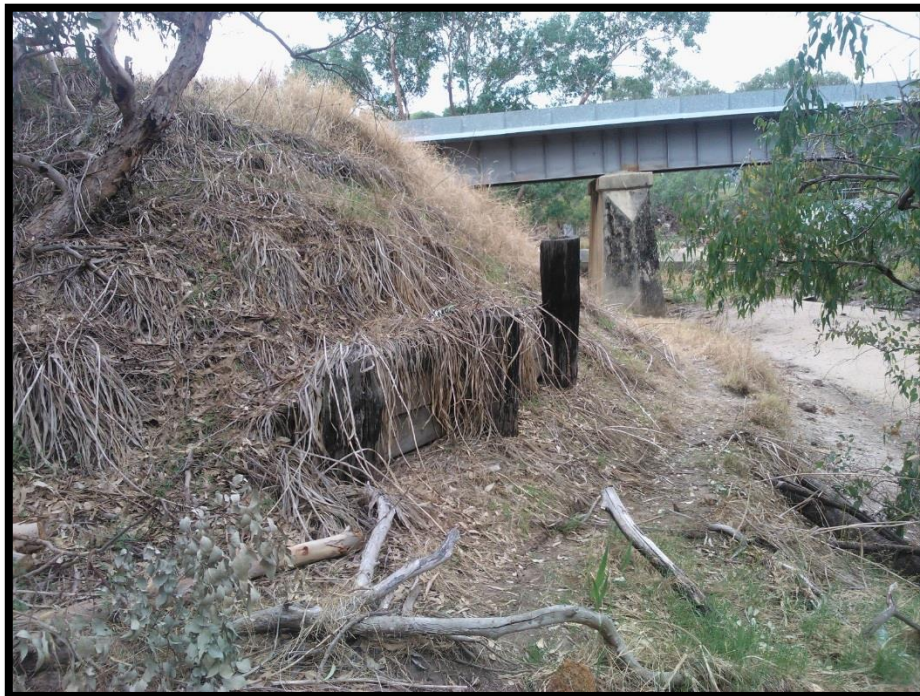
Plate 6: Old Footings of the Bridge

There is evidence of the old bridge on the site in 2012 (Plate 6).

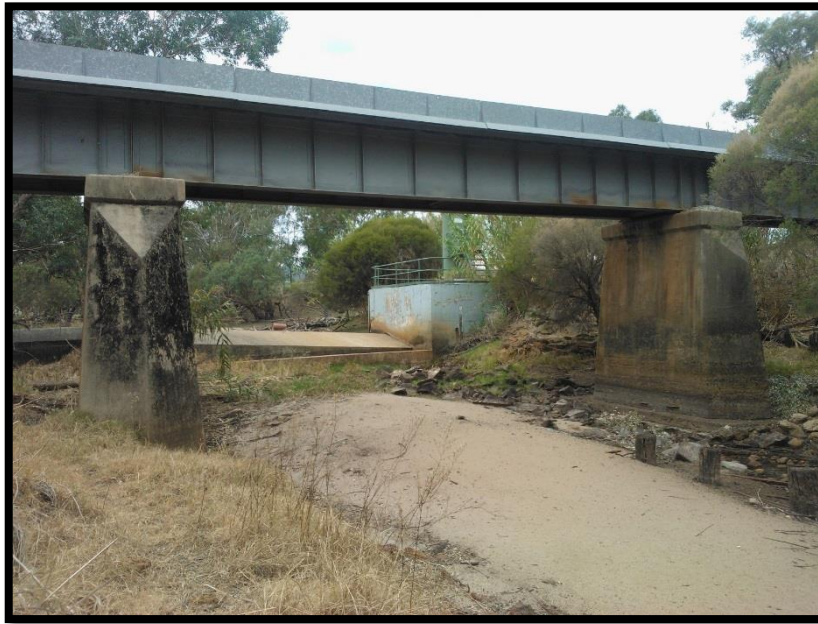
Plate 7: Existing Railway Pylons in Ellen Brook

The existing railway bridge has two large pylons in the Ellen Brook as shown in Plate 7.

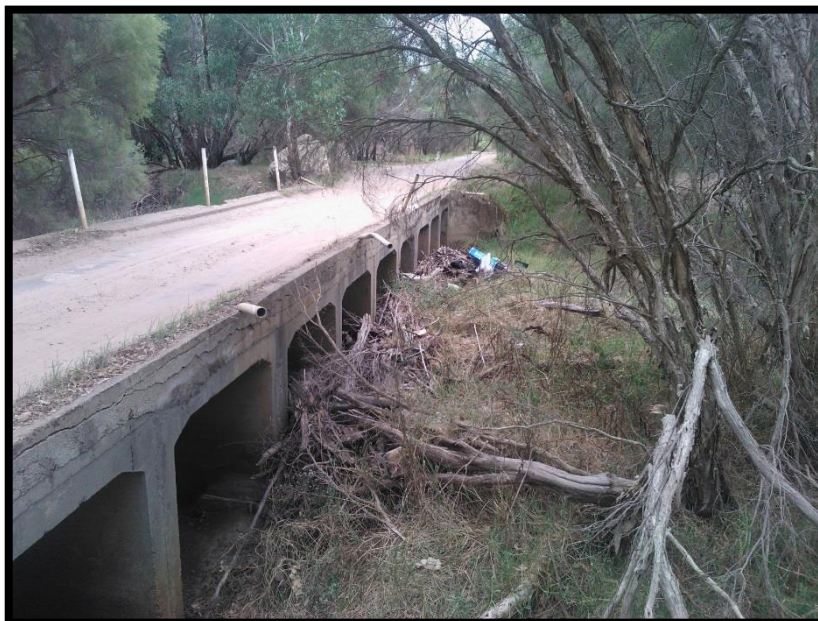
Plate 8: 'Occupational Crossing' of Ellen Brook

Approximately 75m downstream from the proposed crossing of Ellen Brook is an 'Occupational Crossing' (Appendix 1) consisting of 9 barrels of 1.53 x 1.53 RC box culverts (DoW, Pers comm, 2013) (Plate 8).

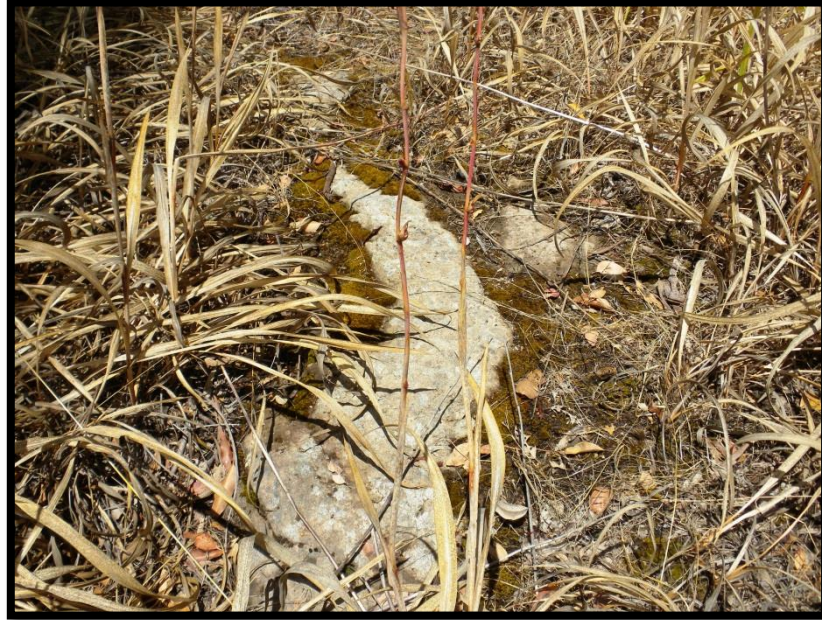
Plate 9: Granite located to the South of Ellen Brook

During the site visit it was noted that the south side of the banks of Ellen Brook had some outcropping of what is assumed to be granite (Plate 9). It is possible that the granite was placed on the site to stabilise the footings for the old bridge.

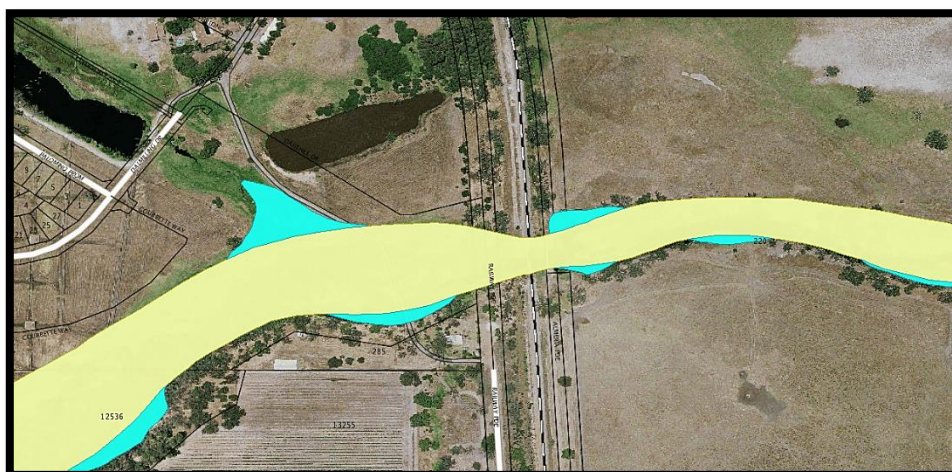
Plate 11: 100 Year ARI Floodway Mapping

Floodplain mapping supplied by the Department of Water shows the extent of a 100 year ARI event and the floodplain limit to be one and the same (Appendix 1). Digitised mapping as shown below also shows the 100 Year ARI Floodway (yellow) and the Flood Fringe (blue) to have the same extent at the site of the proposed crossing (Plate 11).

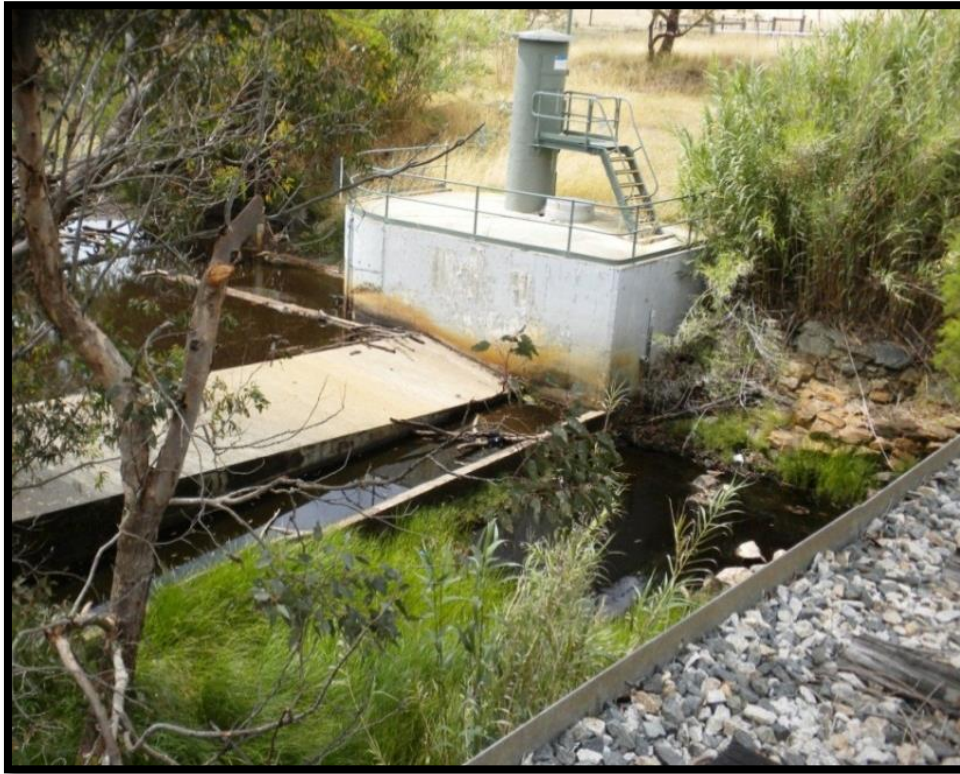
Plate 12: Ellen Brook Flow Gauging Station

The Ellen Brook Flow Gauging Station is located on the southern bank of Ellen Brook a short distance to the east of the railway bridge (Plate 12). The station was established in 1965 and contains a

tower which is linked to a telemetered pressure gauge. The station can measure water flow as well as water quality factors such as salinity, nitrogen and phosphorus levels.

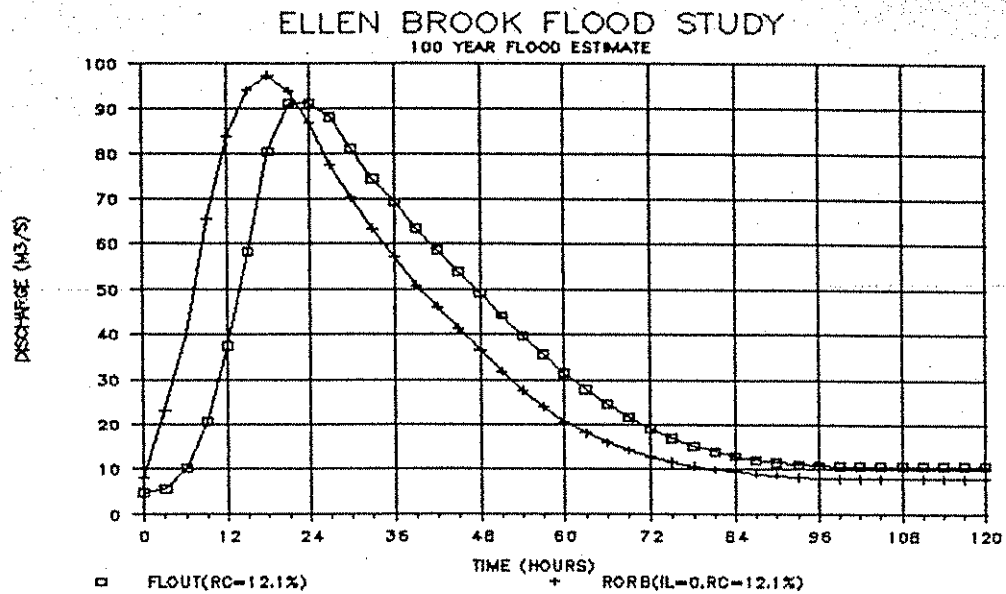
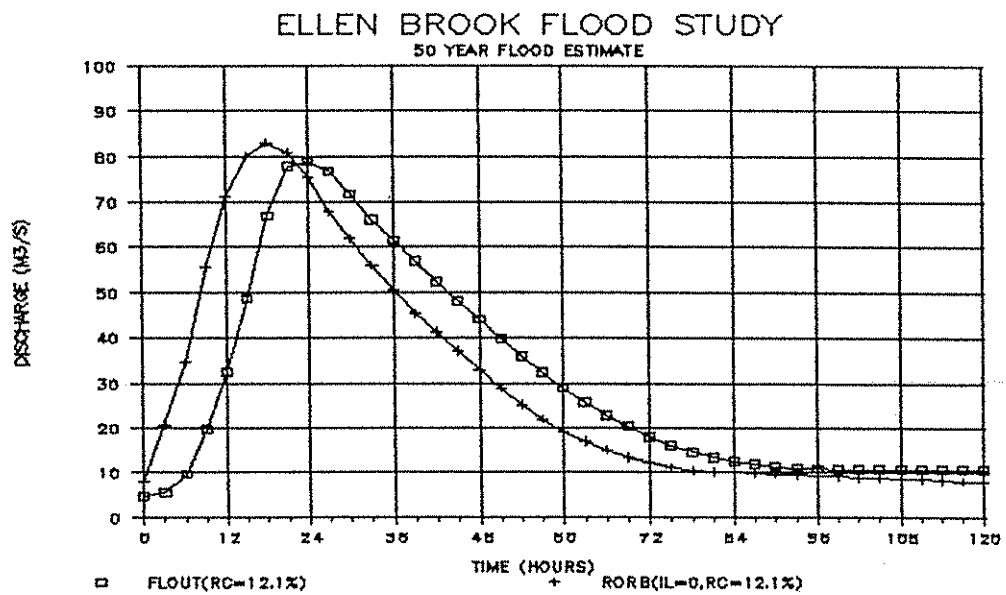
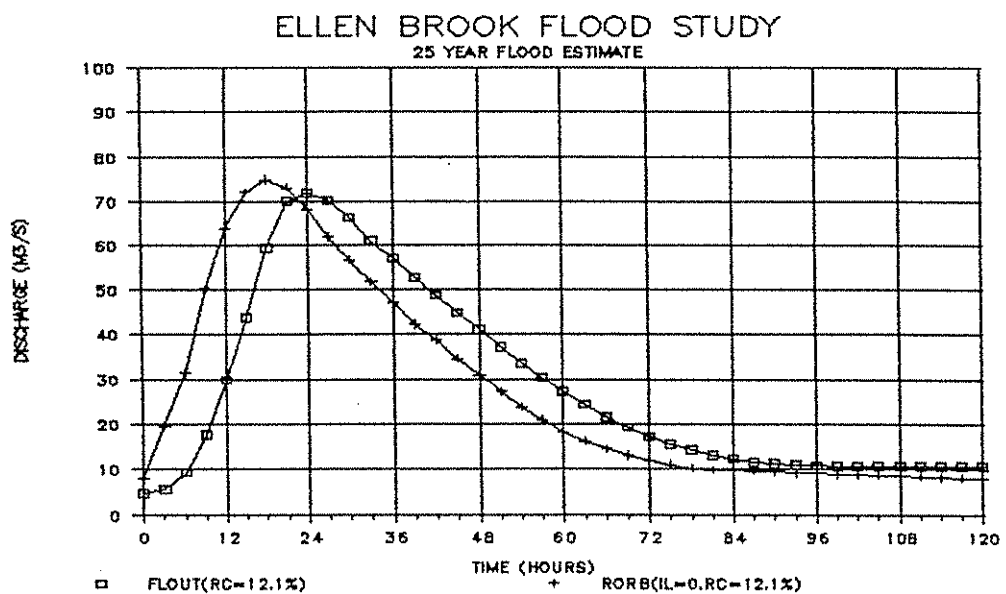
ELLEN BROOK
Design Hydrographs Comparisons

In this study a flood frequency analysis has been used as a method of deriving an appropriate runoff coefficient for design. Being a more direct method, flood frequency analysis eliminates the need to consider catchment conditions and percentage runoff values since these are already implied in the flood estimate. The main limitation of this method is that only relatively short periods of record are available for rivers in the South West. In this study the flood frequency analysis based on only 16 years of streamflow record includes a ten year period of dry years and small floods. The adjustment made in this case to account for the low flow period relies on modelling of the Avon River with the development of a flood frequency curve based on long term

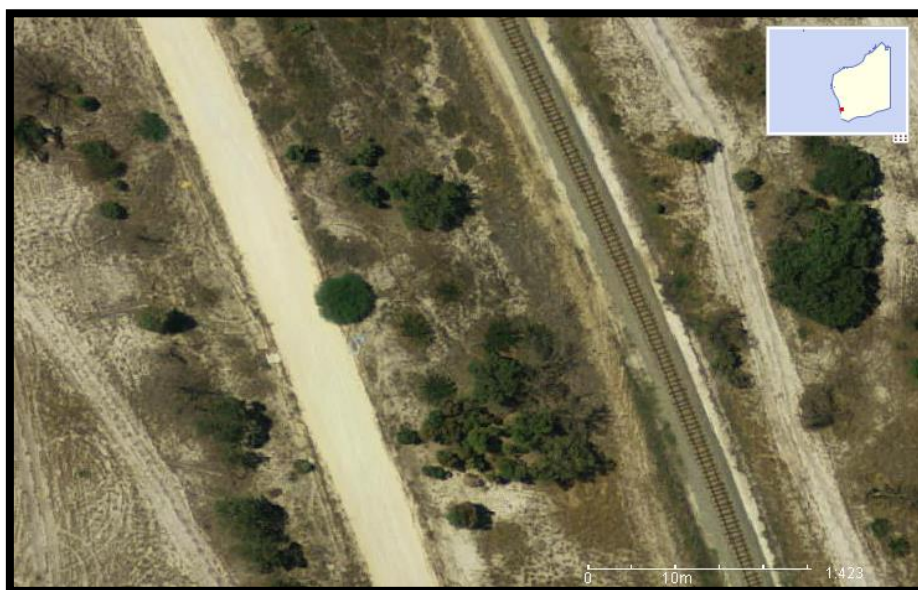
Plate 1: Aerial Photography from January 2013 (Landgate, 2014)

The area to the north of Ellen Brook was burnt on 27 February 2013 which has impacted on the vegetation (Plate 1 and 2).
