RAILWAY PARADE BRIDGE OVER ELLEN BROOK PRELIMINARY DESIGN REPORT

Preliminary Design Report

Options Assessment

Report No A5001-AA007882-AAR-00

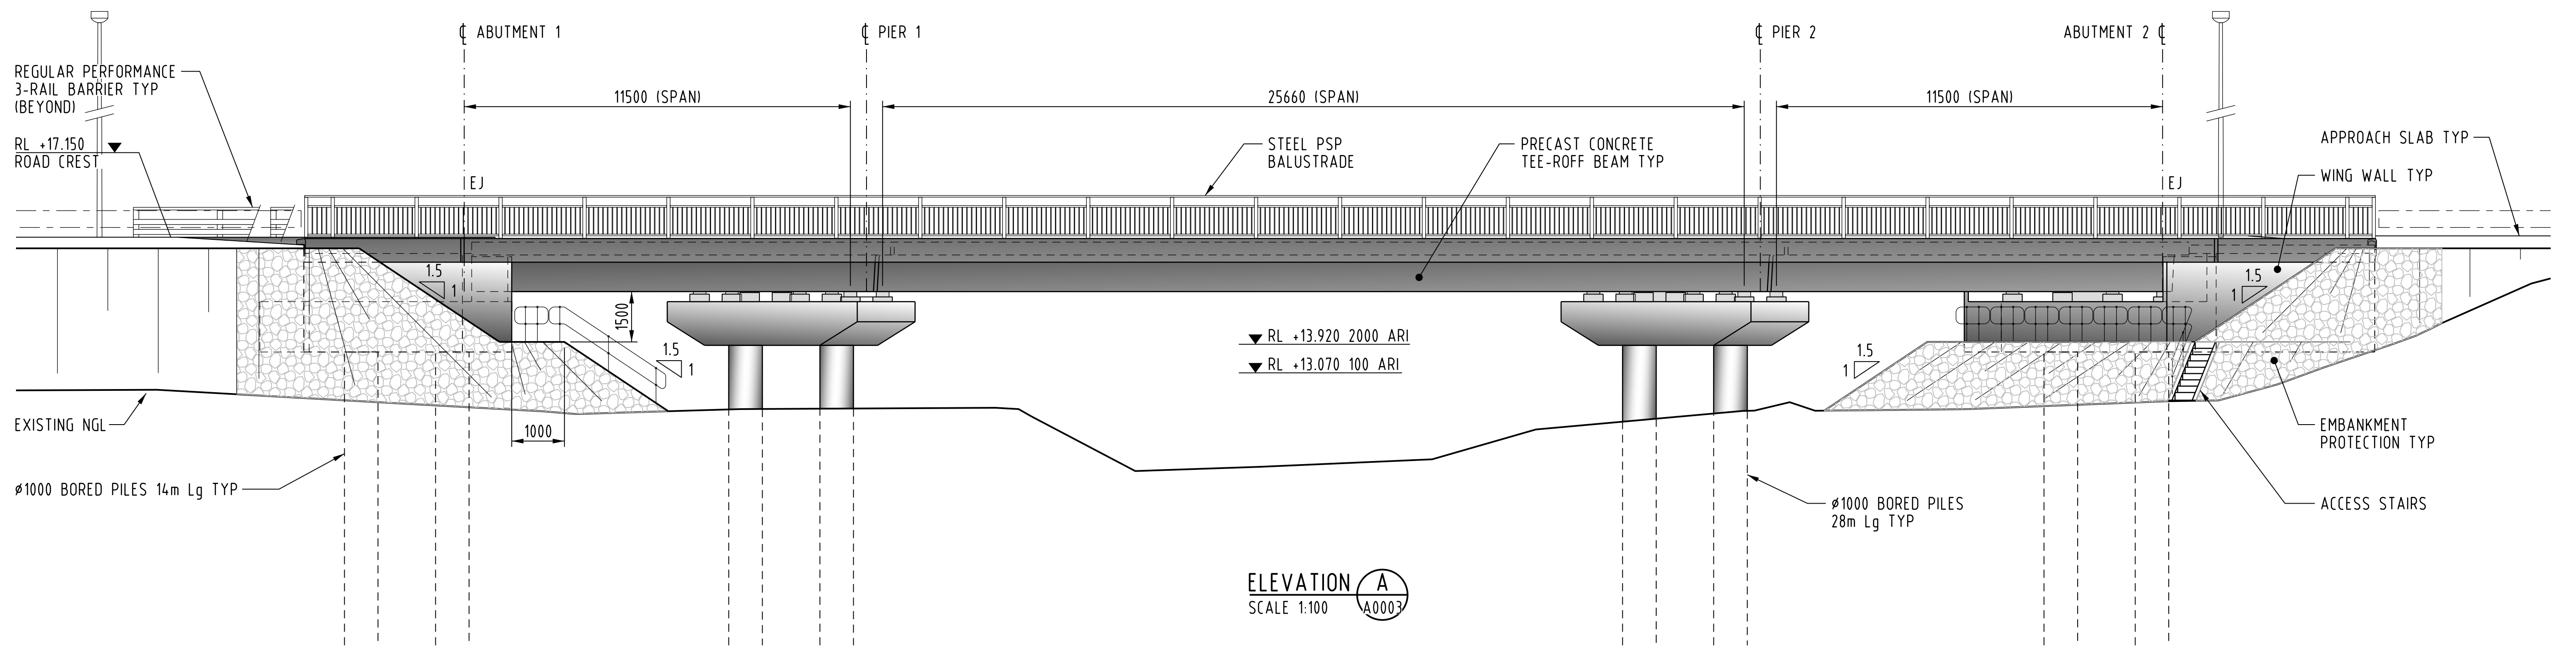
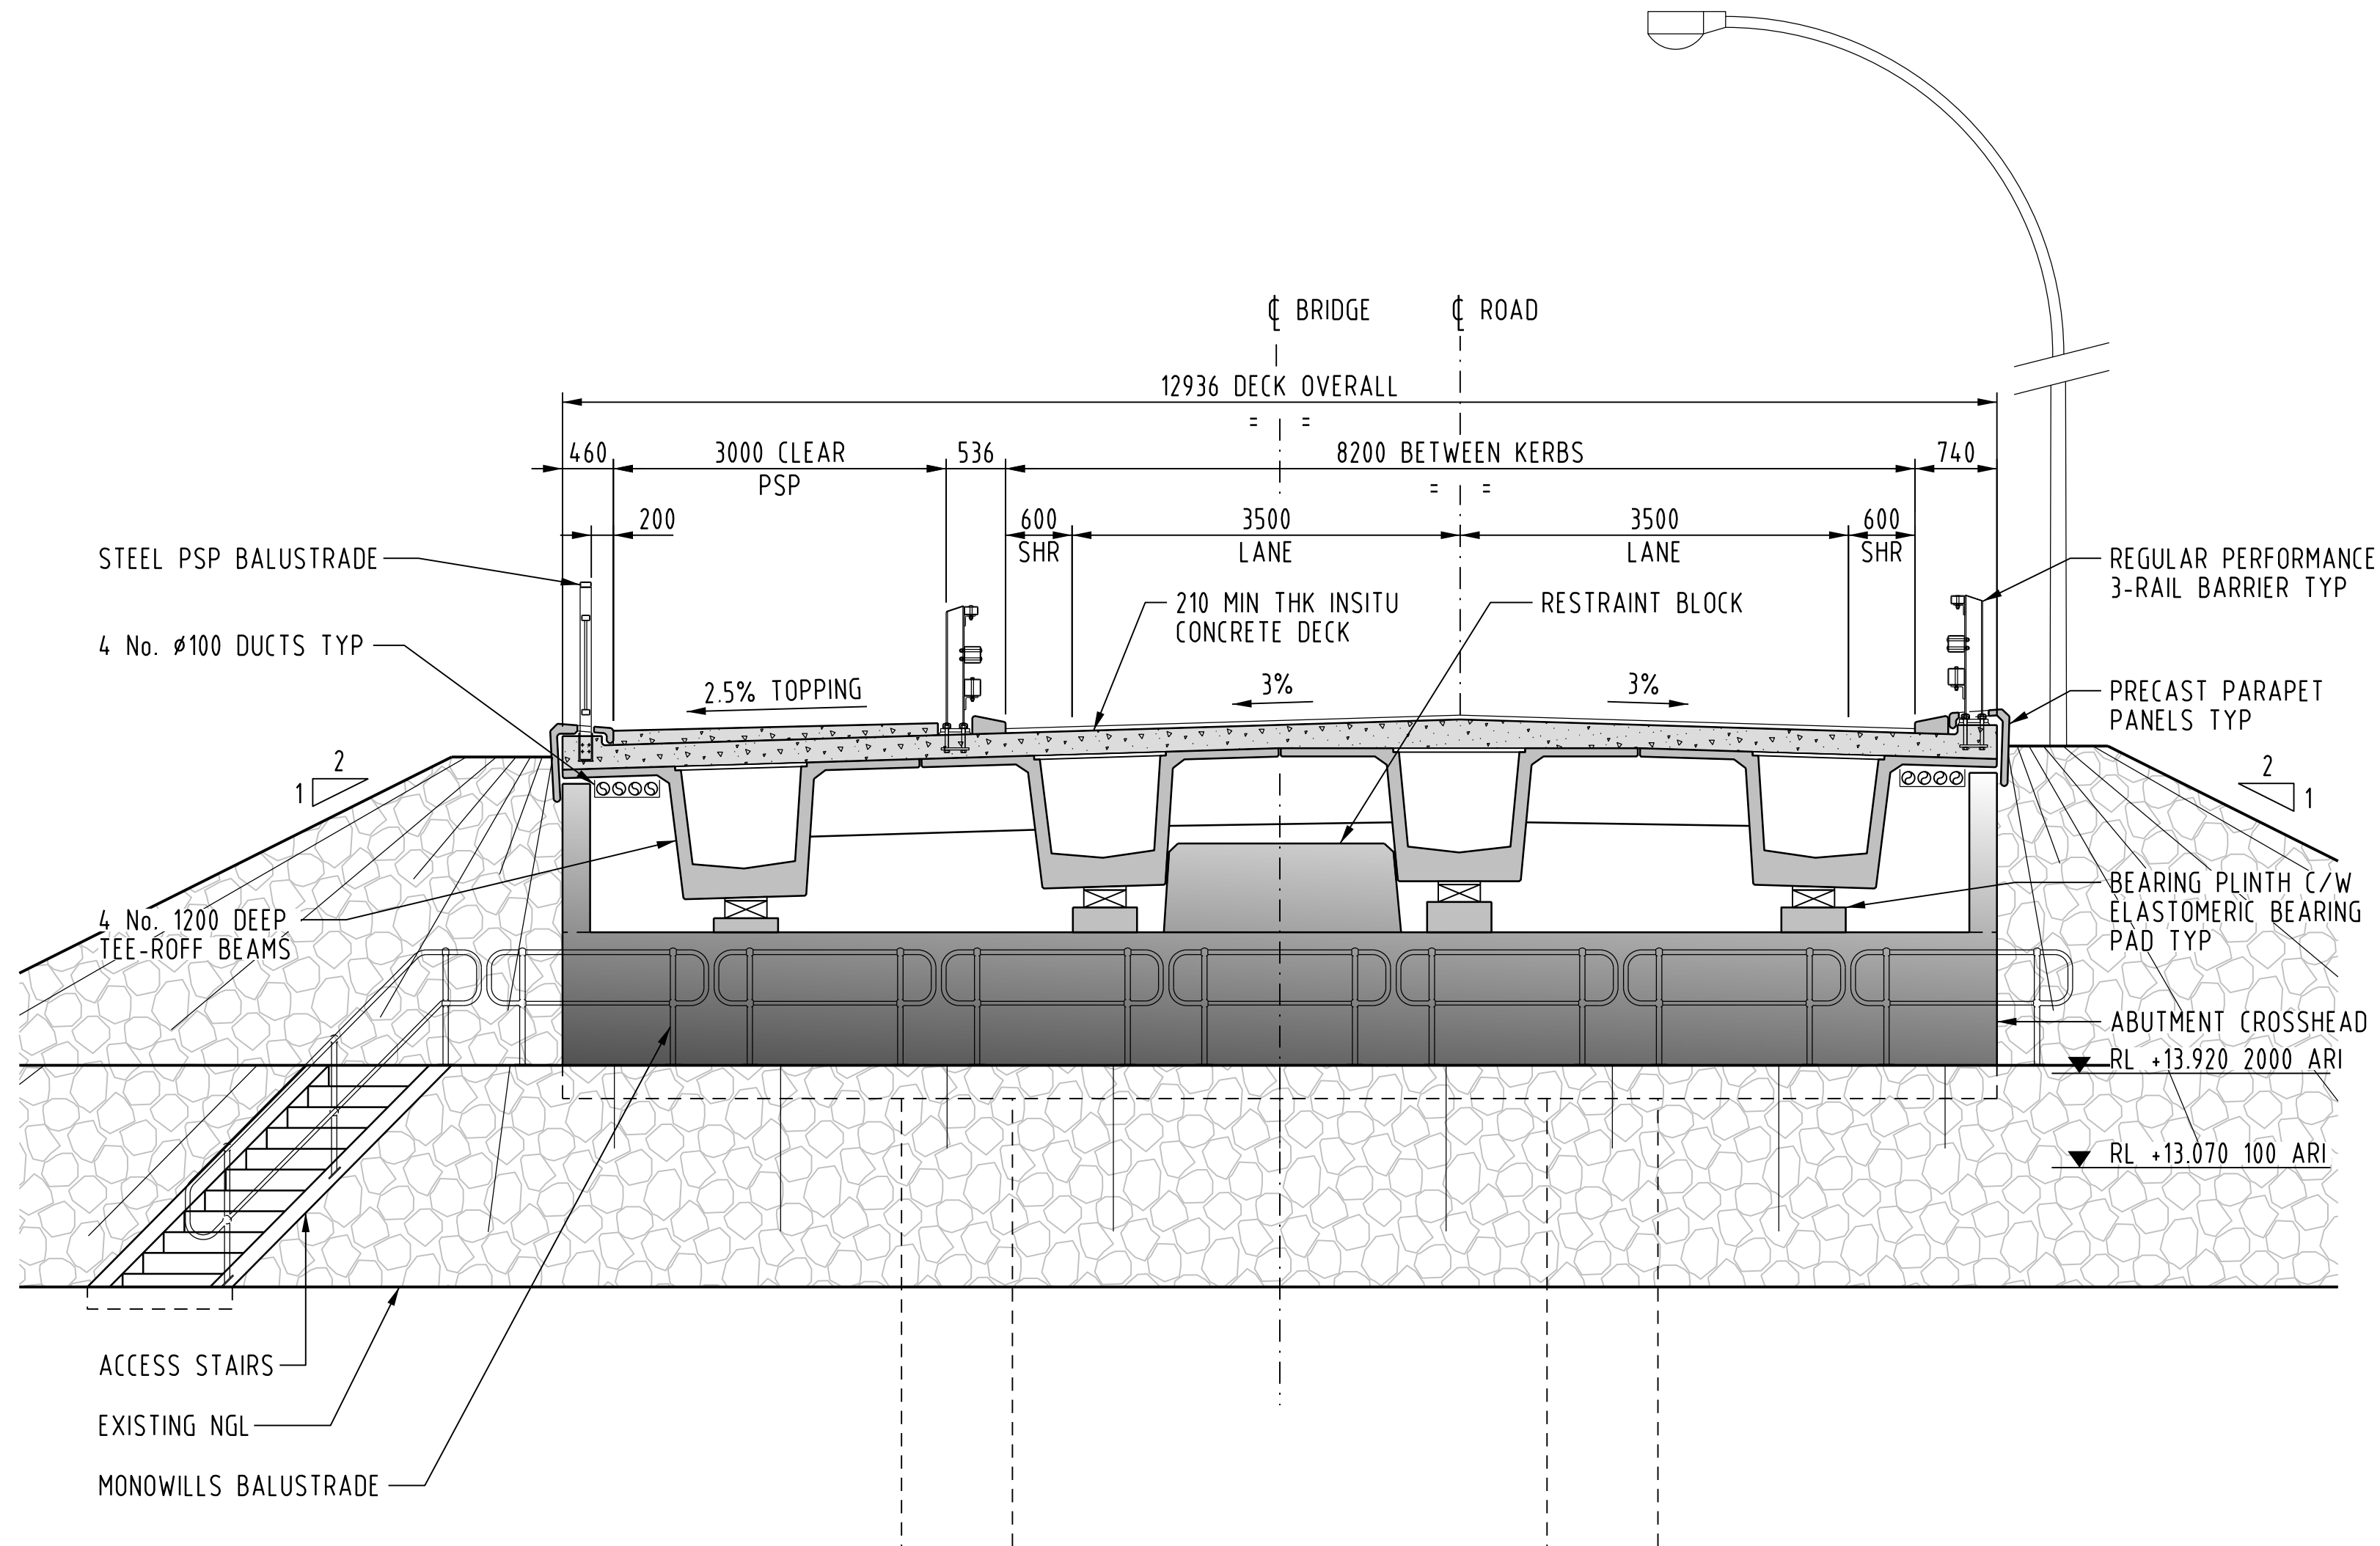
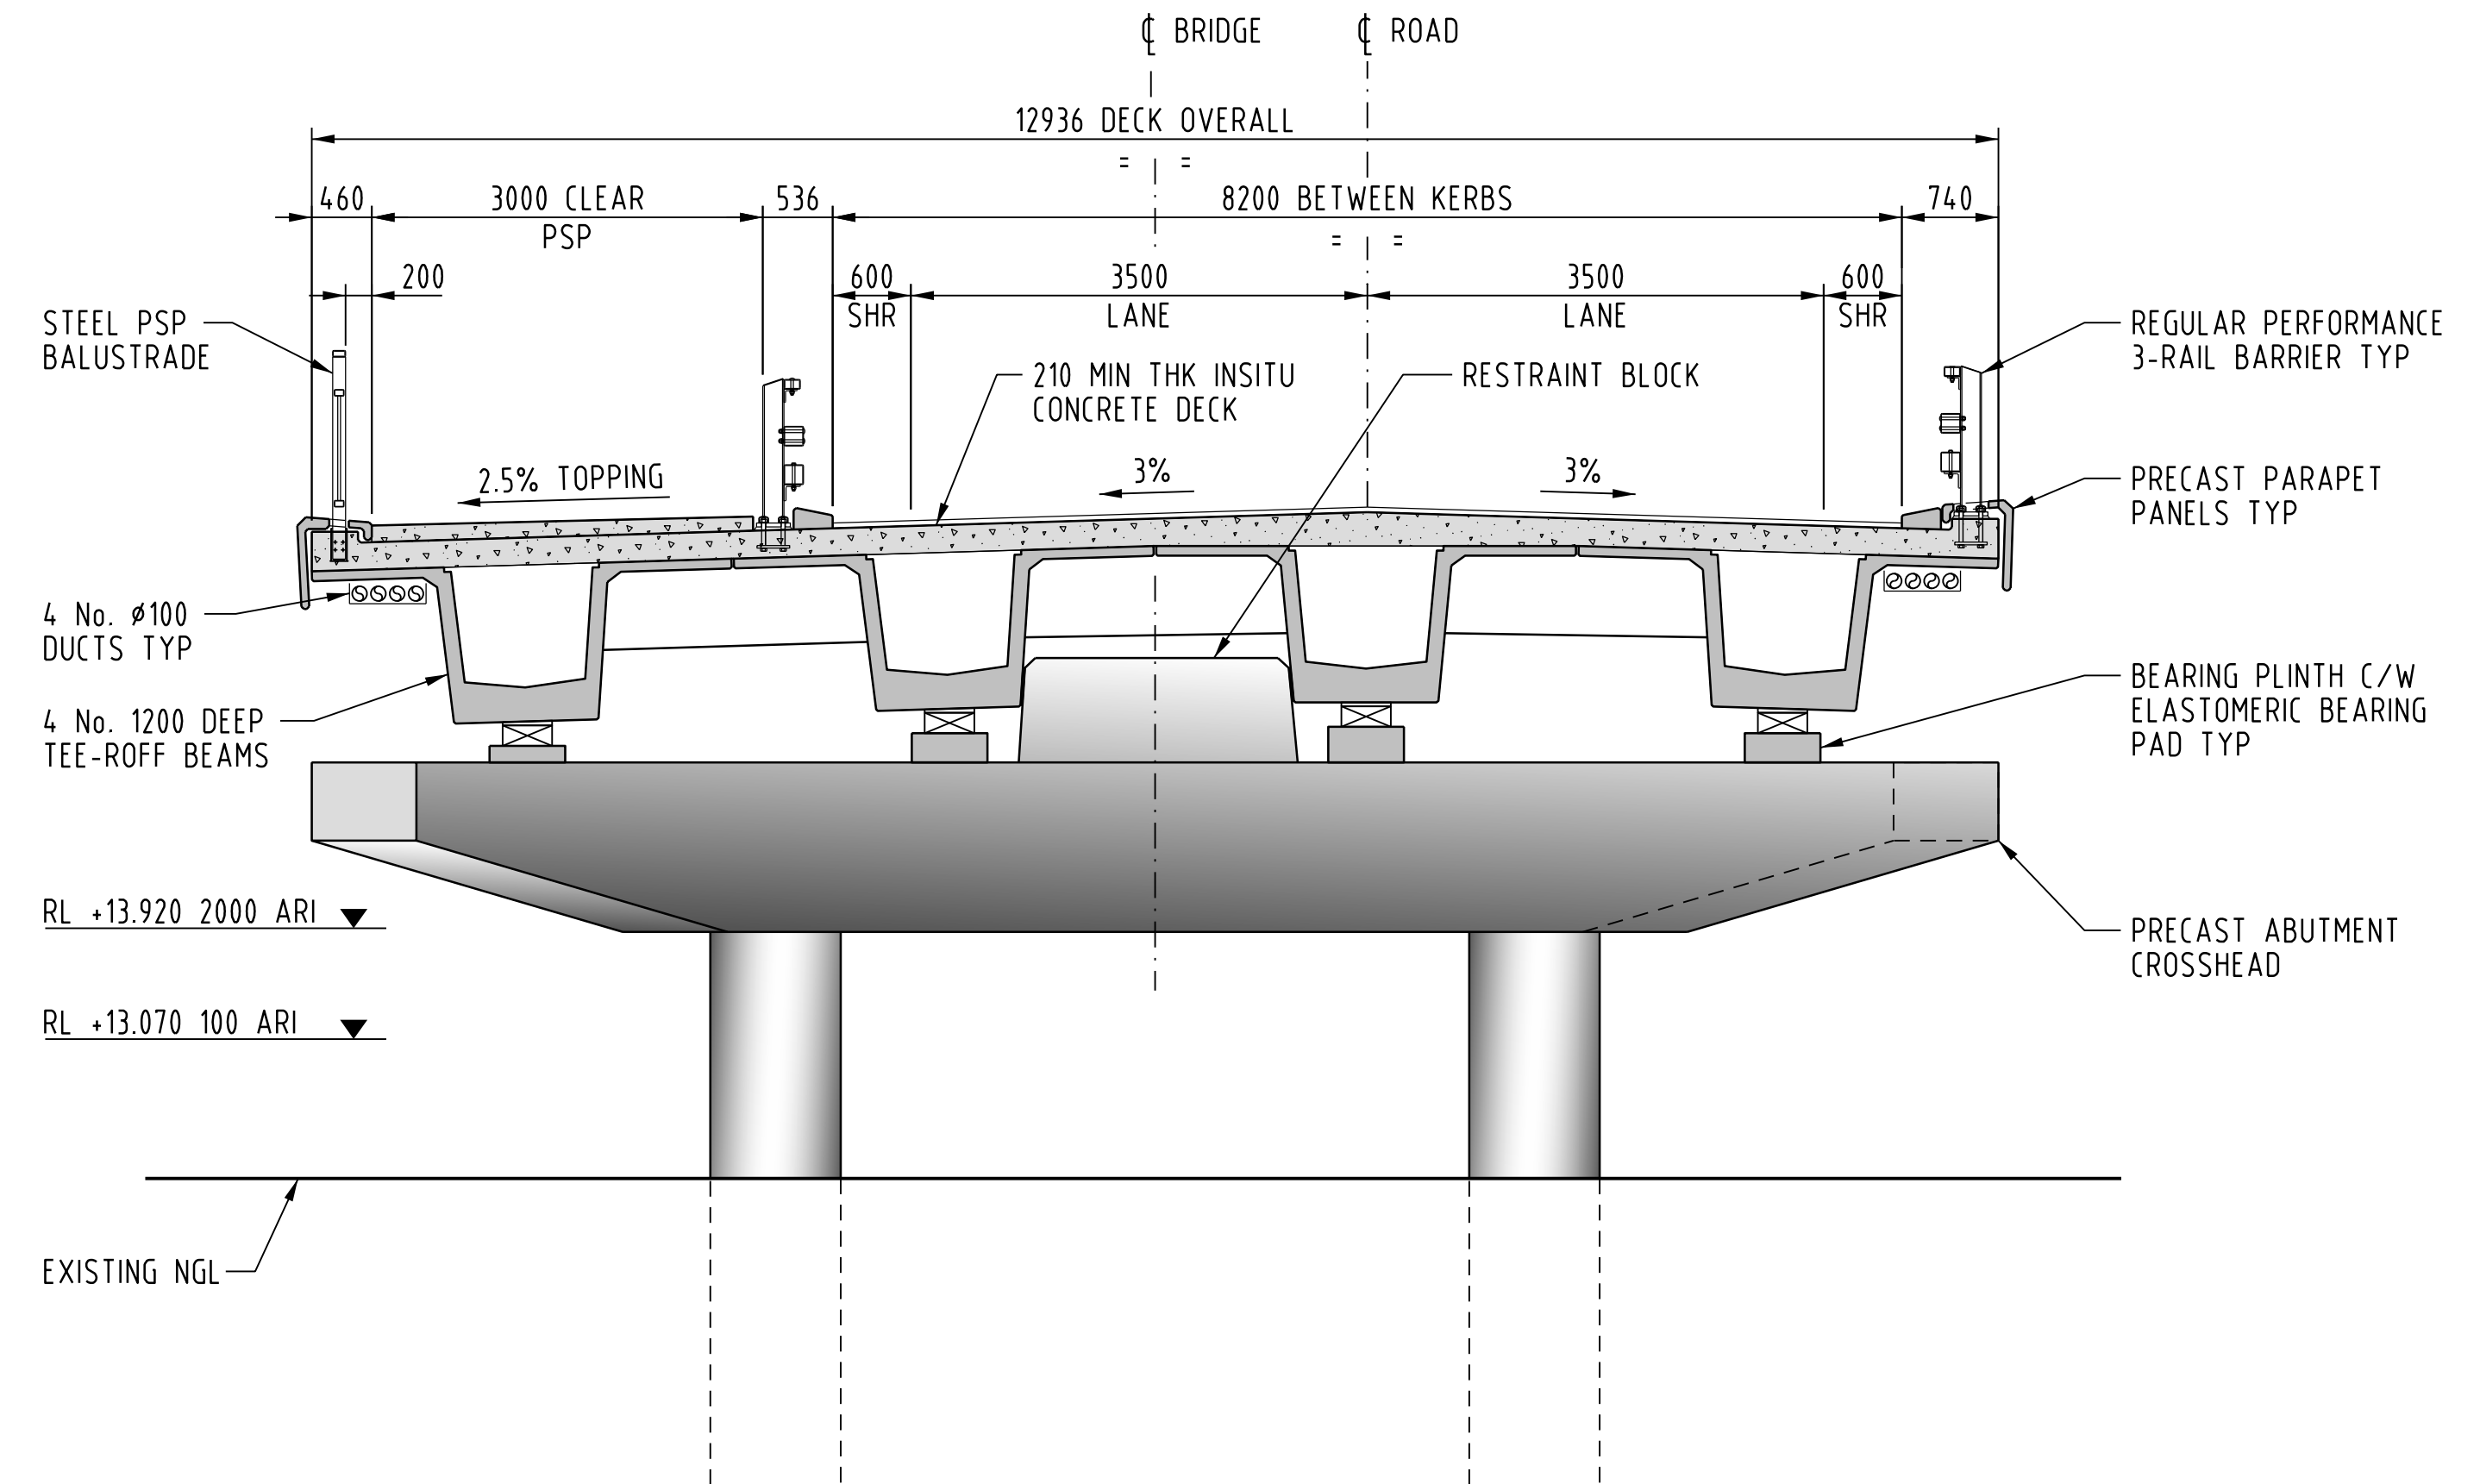
RAILWAY PARADE BRIDGE
OPTION 2 - THREE SPAN TEE-ROFF BEAM
ELEVATION & SECTION

In order to ensure that the new bridge crossing will not cause an adverse effect on the water flow the piers are positioned outside the brook. The position of the south abutment was established at the toe of the existing batter which in turn determined the length of the south side span. The north side span is kept of the same length for the symmetrical and more balanced visual appearance.

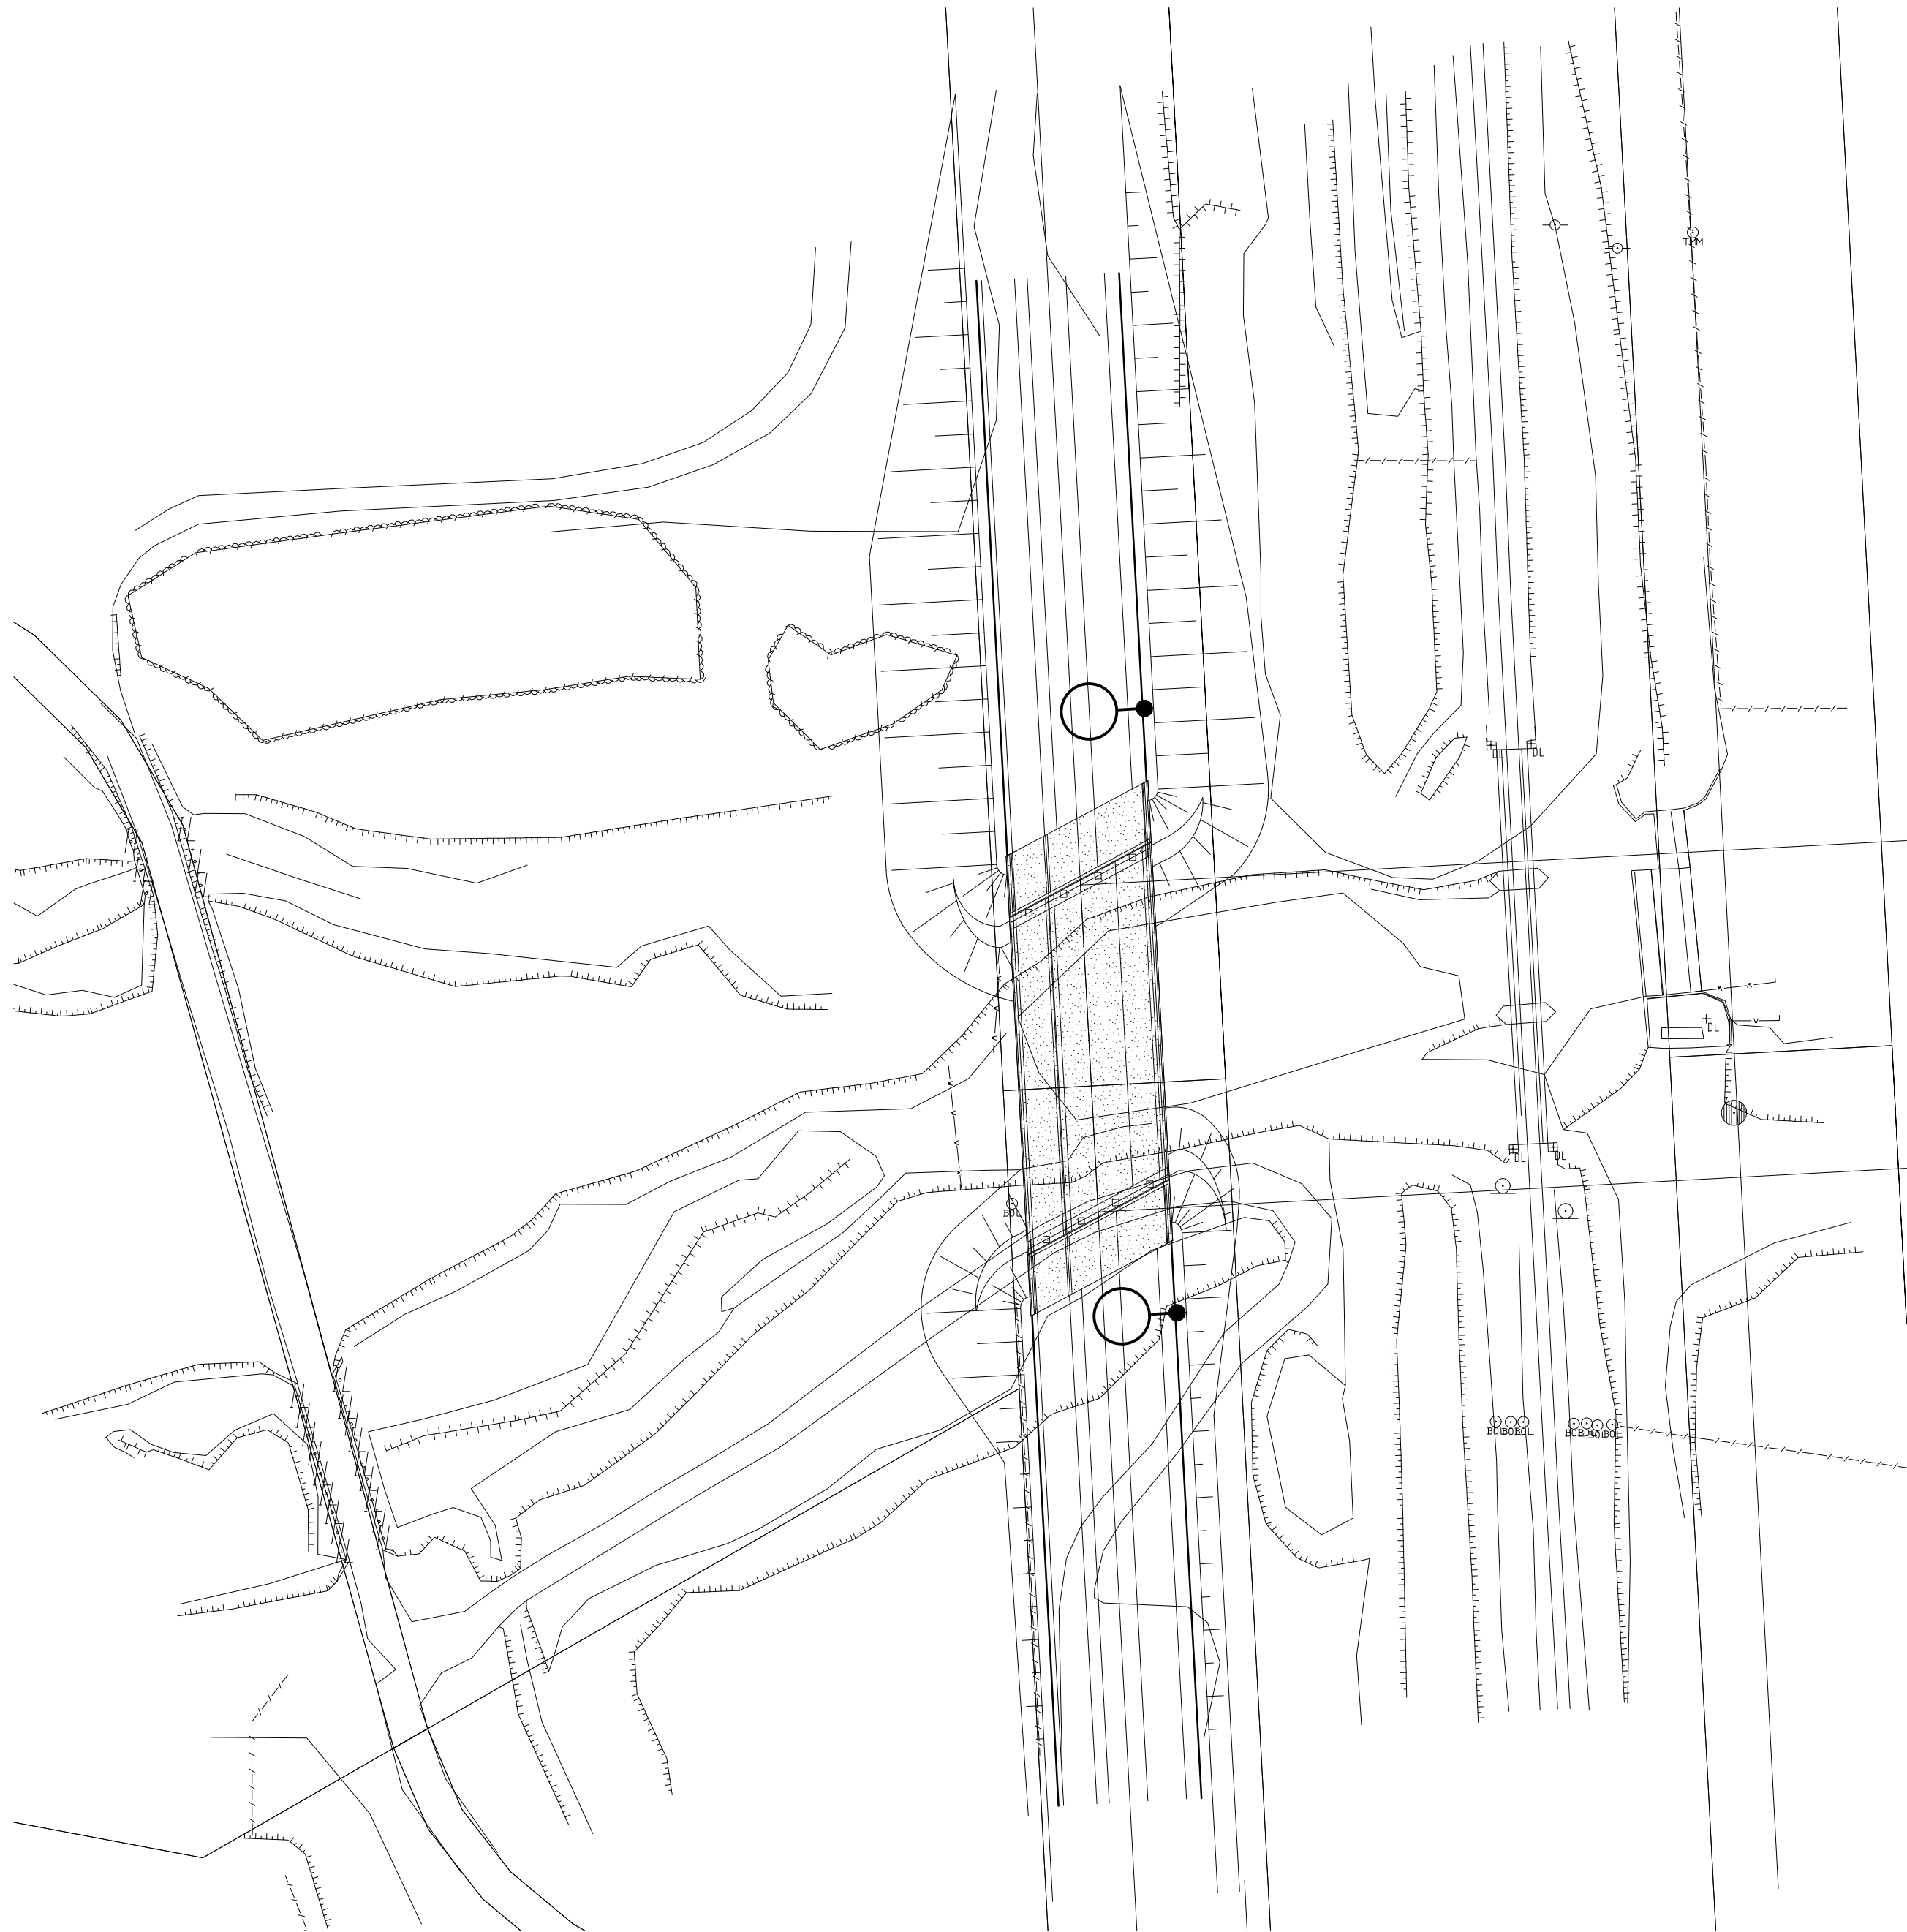
SITE PLAN
SCALE 1:500 @ A1

PRELIMINARY LIGHTING DESIGN
