REHABILITATION AND DECOMMISSIONING
PROGRAMME
LOT 393 SOUTH WESTERN HIGHWAY, GWINDINUP

LOT 393 LOWRIE ROAD, GWINDINUP REHABILITATION AND DECOMMISSIONING PROGRAMME

LOT 393 LOWRIE ROAD GWINDINUP NATIVE VEGETATION REHABILITATION PLAN

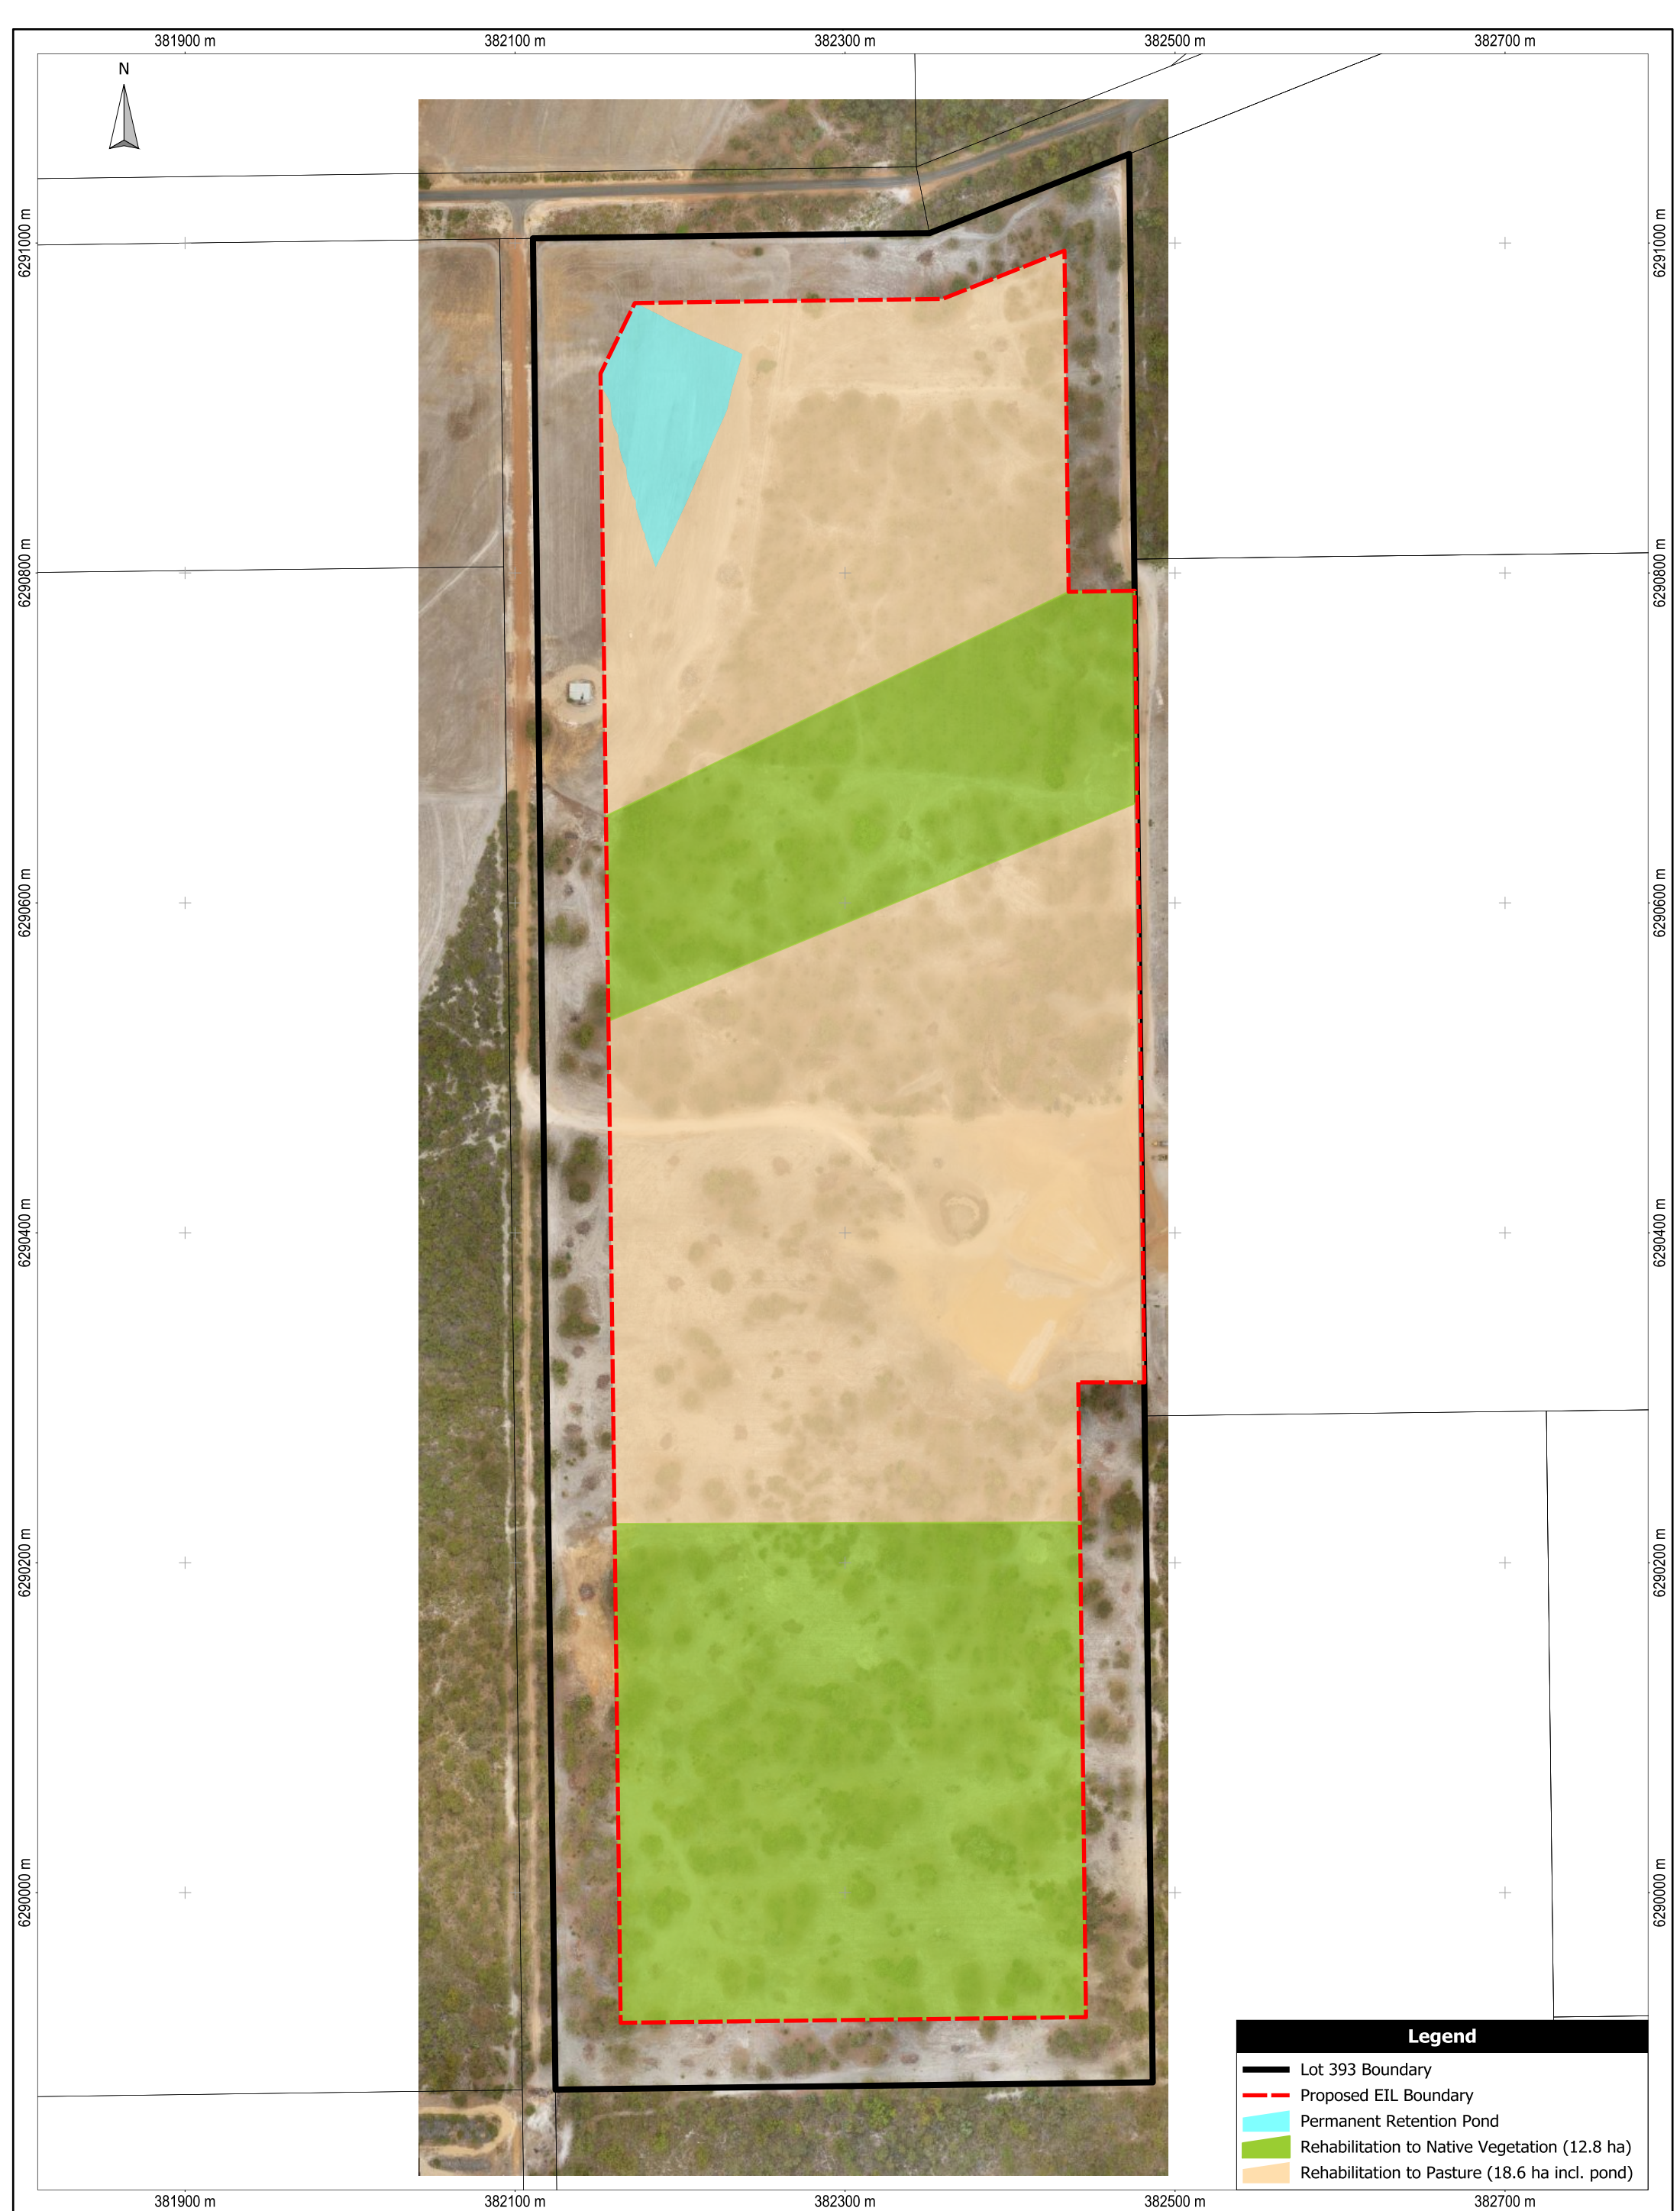
Figure 1
Site Layout

Lot 393 covers total of 52 ha in two parts (40.94 ha and 10.94 ha). The proposed extraction area (also referred to as the site) covers 31.4 ha (Figure 1). The property used to be covered in mostly blue gums (Plate 1) that were harvested in 2018. There are some patches of remnant native vegetation (Plate 2) and some sporadic individual native trees or shrubs that are described in more detail in Appendix 1. The proponent holds a current clearing permit (CPS 7171/1) from Department of Water and Environmental Regulation to remove remaining native vegetation within the previously approved EIL area and has applied to modify this permit to include all native vegetation within the current EIL application area.

Legend	
	Lot 393 Boundary
	Proposed EIL Boundary
	Permanent Retention Pond
	Rehabilitation to Native Vegetation (12.8 ha)
	Rehabilitation to Pasture (18.6 ha incl. pond)

The site is planned to be worked in 2.0 ha stages. Once excavation of sand and gravel has been completed, the stage will be rehabilitated as excavation moves forward. Rehabilitation to native vegetation will cover 12.8 ha and rehabilitation to pasture the remaining of the extraction area (approximately 18.6 ha). These rehabilitation areas are shown in Appendix 1 that describes in detail the native vegetation rehabilitation. The following sections will describe general rehabilitation measures applicable to all areas or specifically to pasture areas. It is noted that some of these works will be undertaken already prior to or during the extractive operations in preparation for rehabilitation.

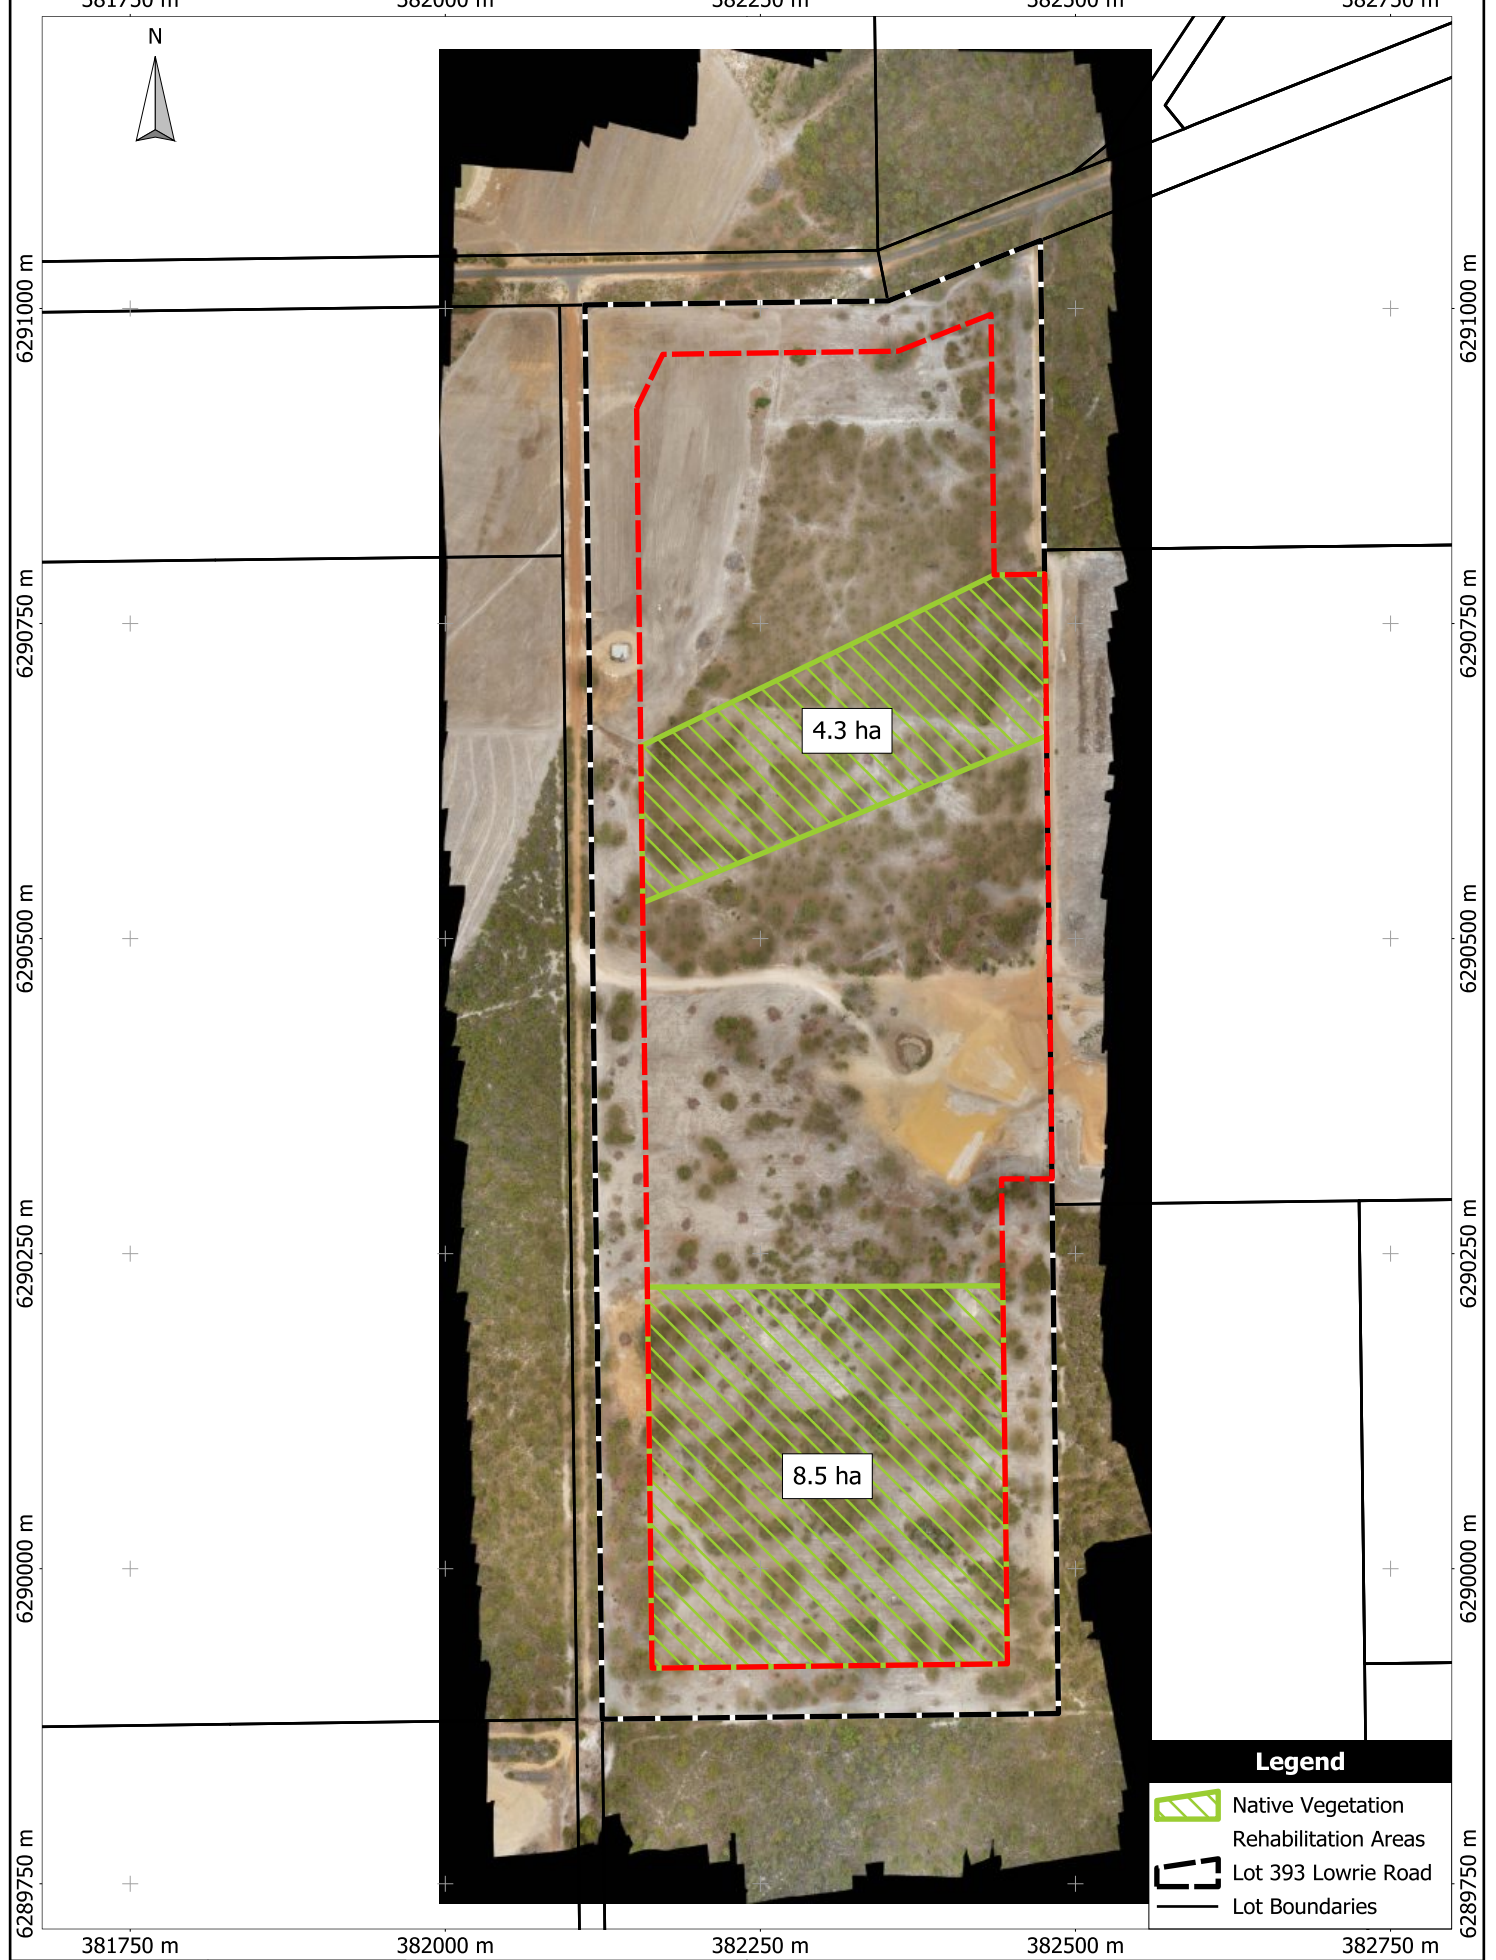
Figure 2
Native Vegetation Rehabilitation Areas

This Native Vegetation Rehabilitation Plan (NVRP) has been prepared to address conditions of the EIL. The original version (June 2018) was developed in consultation with DBCA and then approved by Shire of Capel. This NVRP Rev1 (April 2019) has been prepared to address a change in the clearing and extraction area. The areas on Lot 393 that are subject to this NVRP Rev1 are shown in Figure 2 and total 12.8 ha (northern 4.3 ha, southern 8.5 ha). Other parts of the extraction area will be rehabilitated to pasture.

Vegetation – Condition	Vegetation is self-sustaining.	Potential threats to establishing self-sustaining vegetation are identified and mitigated.
Vegetation – Extent	Revegetation covers the areas specified in Figure 2 (northern 4.3 ha, southern 8.5 ha).	Progressive rehabilitation follows gradual completion of extraction.

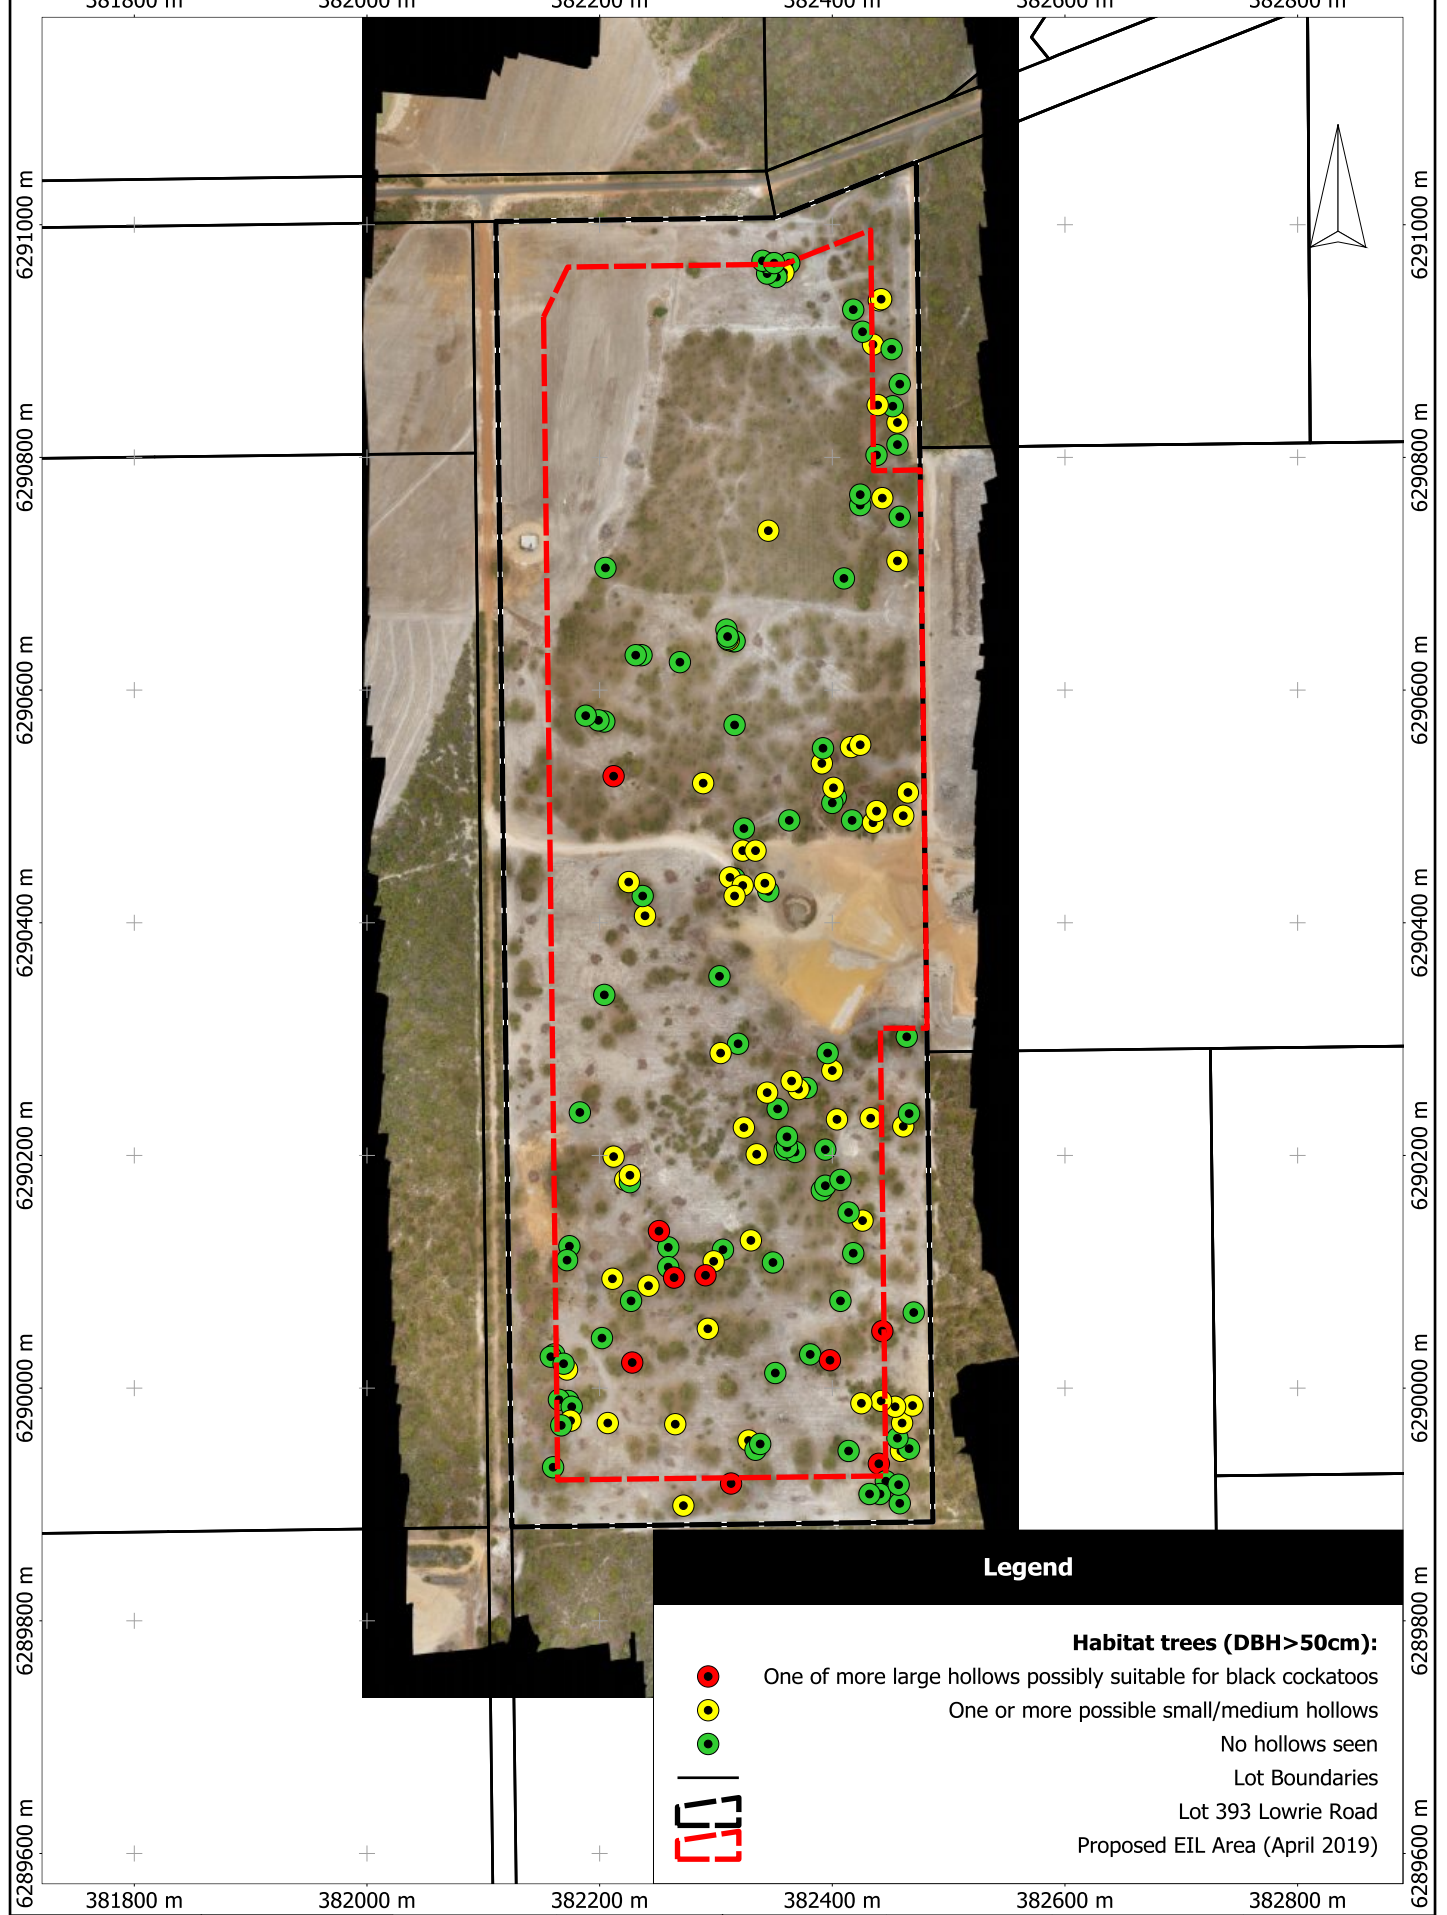
The survey found following (Figure 3):

- One of more large hollows possibly suitable for black cockatoos
- One or more possible small/medium hollows
- No hollows seen
- Lot Boundaries
- Lot 393 Lowrie Road
- Proposed EIL Area (April 2019)

This condition is assumed to apply to the eight trees to be removed that have large hollows possibly suitable for black cockatoos, as none of the hollows were actually inspected on the inside to determine whether they are being used for nesting.

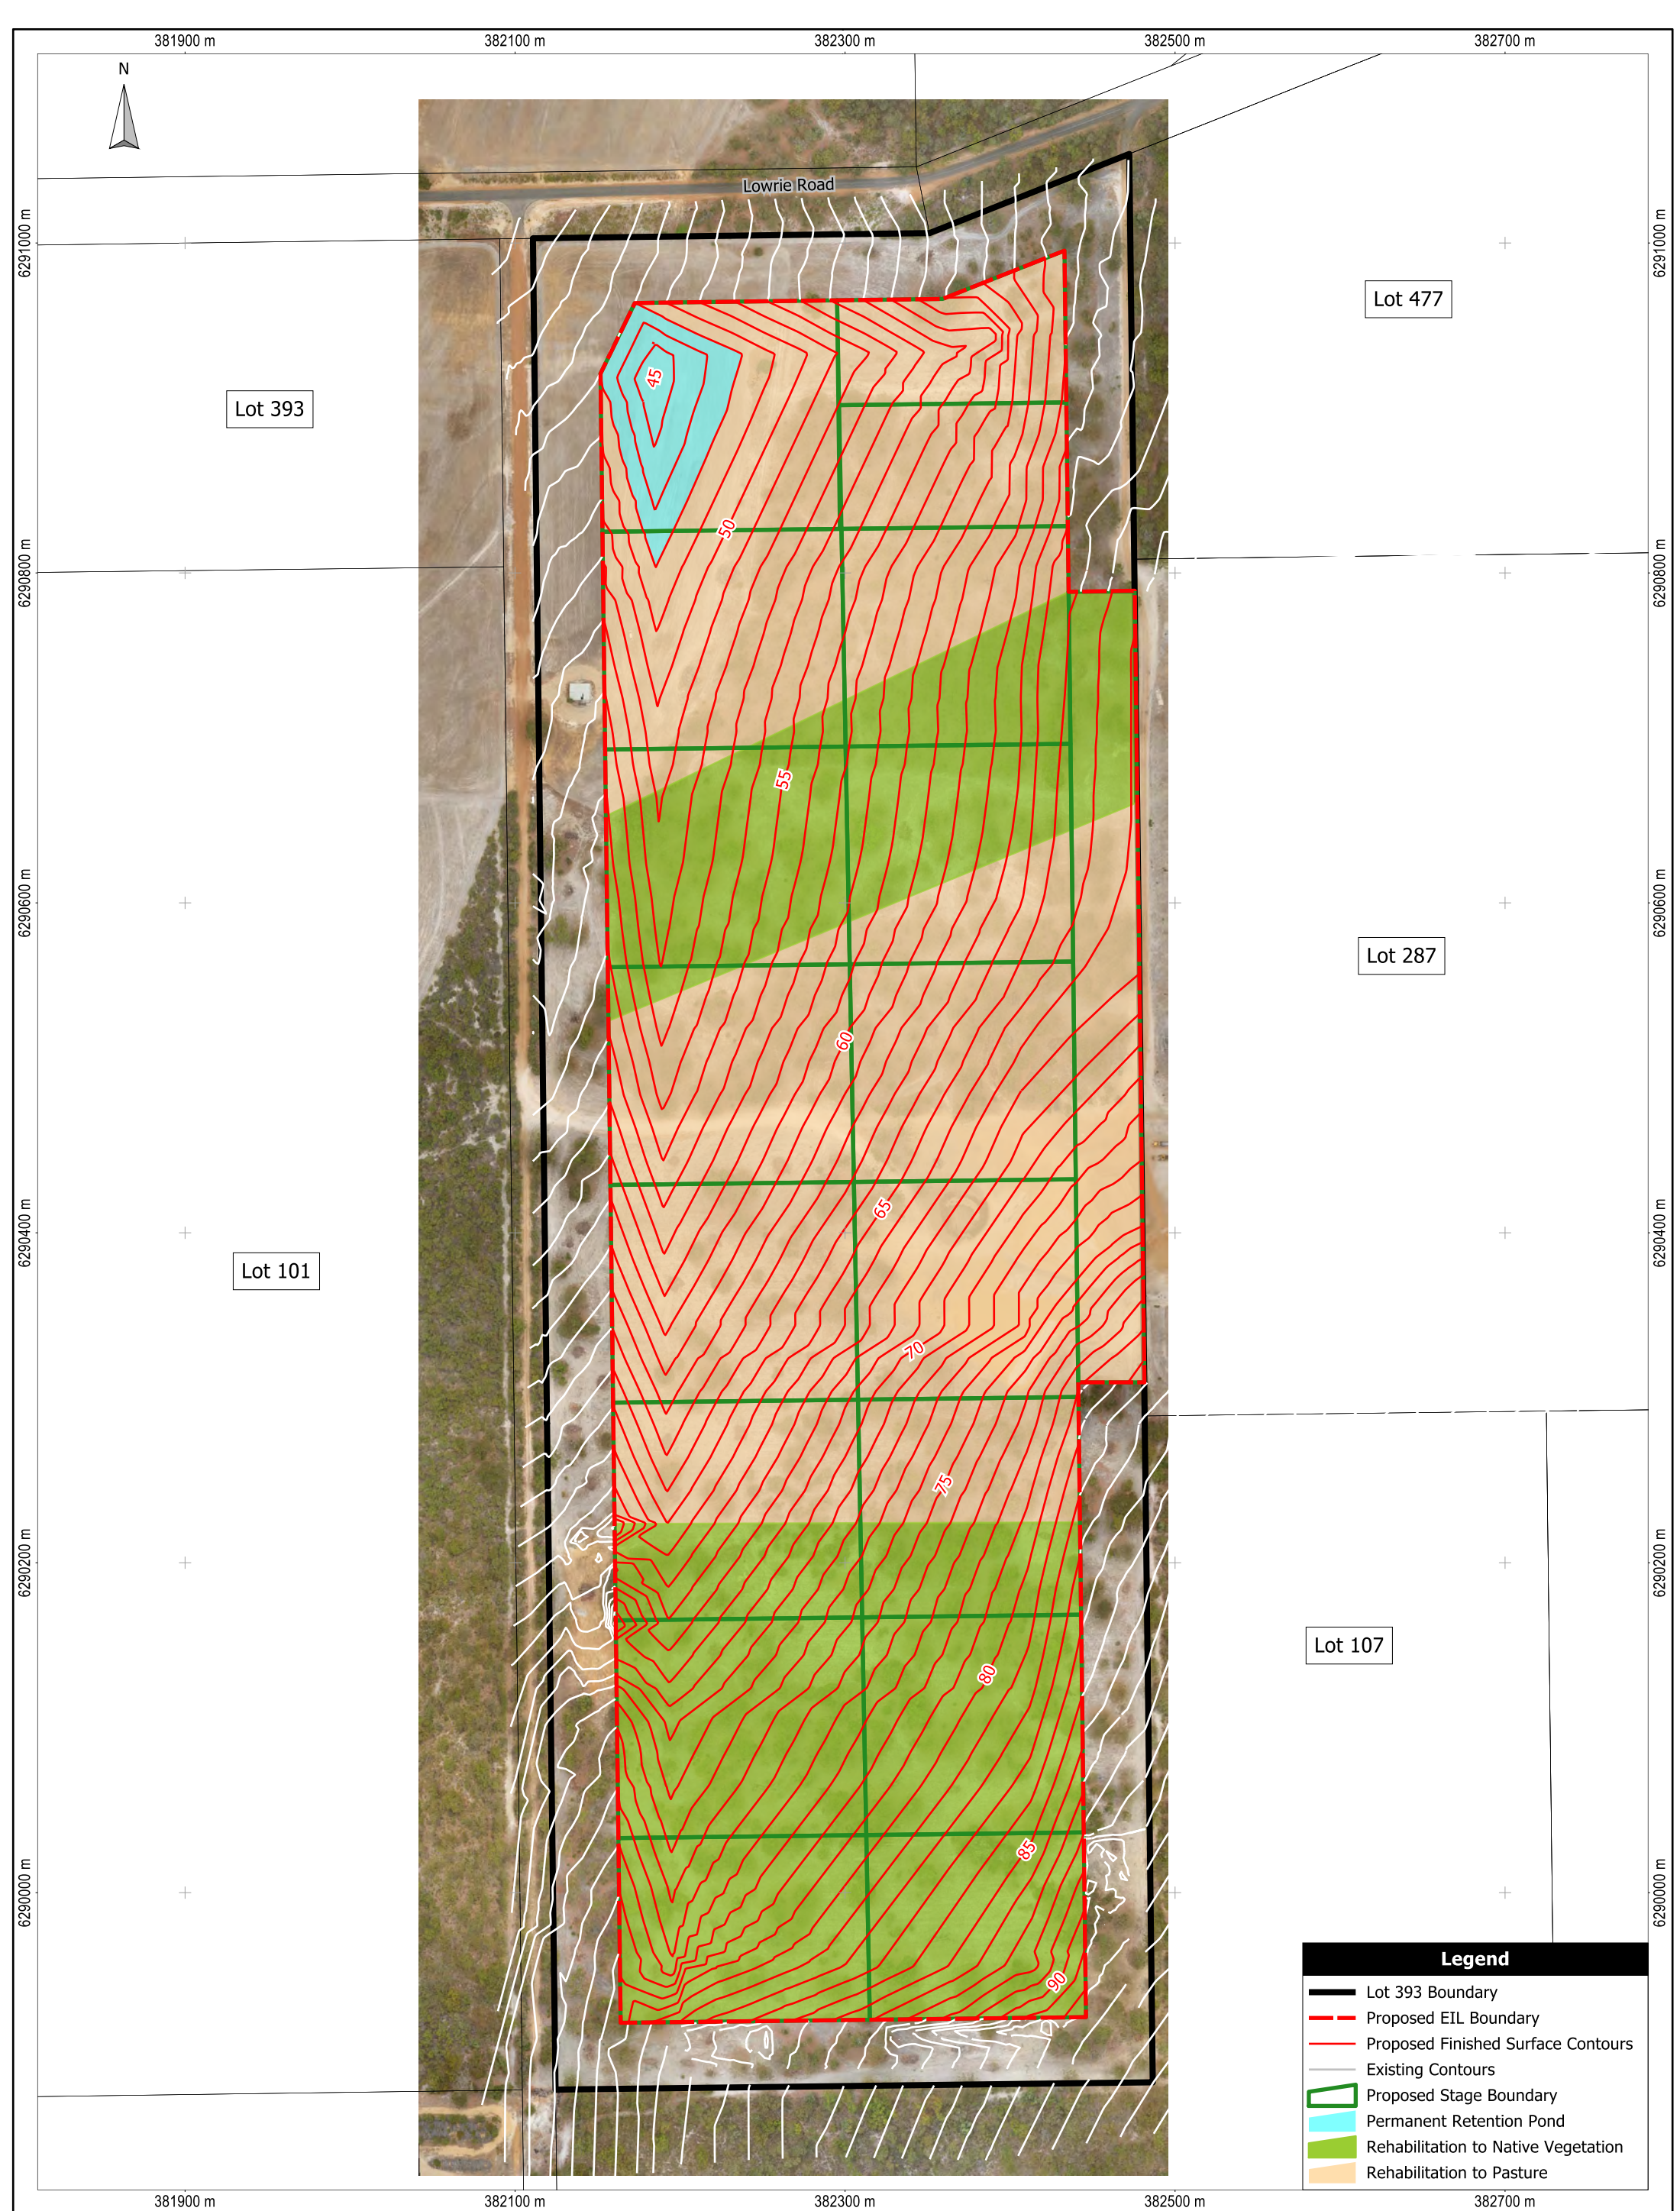
APPENDIX 3: PROPOSED FINISHED DEVELOPMENT PLAN

Following completion of sand and gravel extraction, the final landform will be established as per Appendix 3. Ripping along the contour will be undertaken to remove soil compaction, improve runoff infiltration and root penetration. Topsoil will be respread following ripping.
