LOT 2602 MCDONALD ROAD, KARRIDALE

Flora and fauna assessment

Title: **PROPOSED DAM DEVELOPMENT PLAN - J. PATTON**
LOT 2602 McDONALD ROAD, KARRIDALE

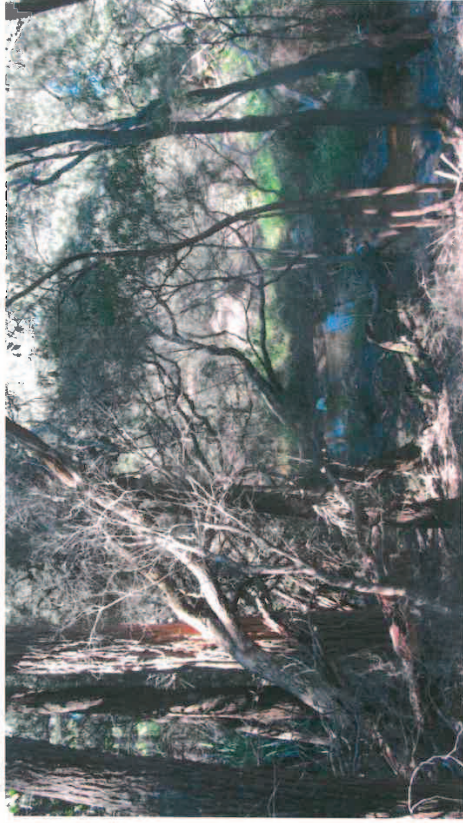
FIGURE 12: OPEN STREAMBED SOUTH OF THE DENSE VEGETATION THAT IS SUBJECT TO THE CLEARING PROPOSAL

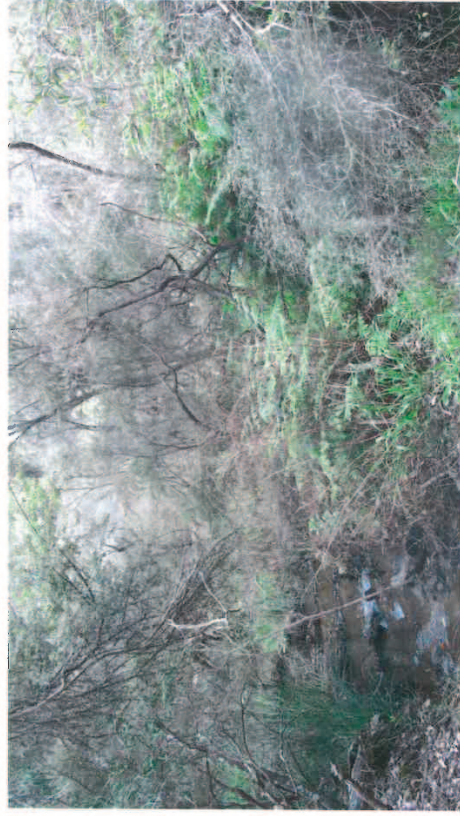
FIGURE 13: OPEN STREAMBED SOUTH OF THE DENSE VEGETATION THAT IS SUBJECT TO THE CLEARING PROPOSAL

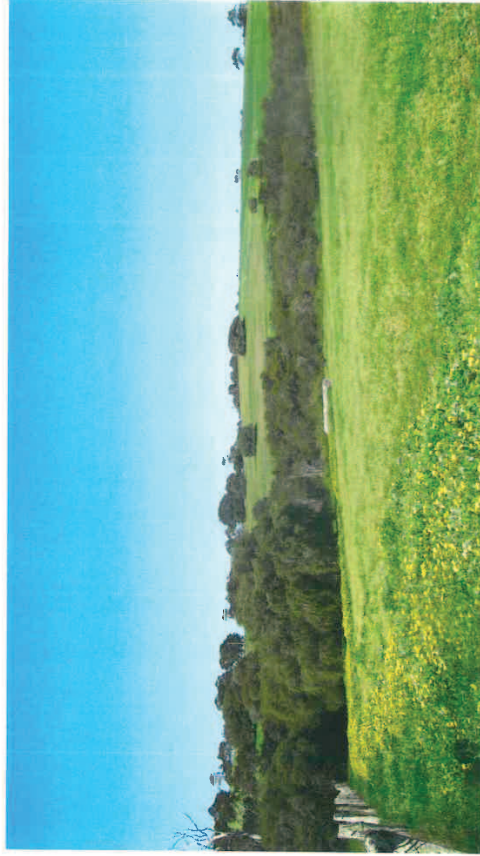
FIGURE 9: OPEN GRASSED Paddock FRINGING THE REMNANT STREAMLINE VEGETATION

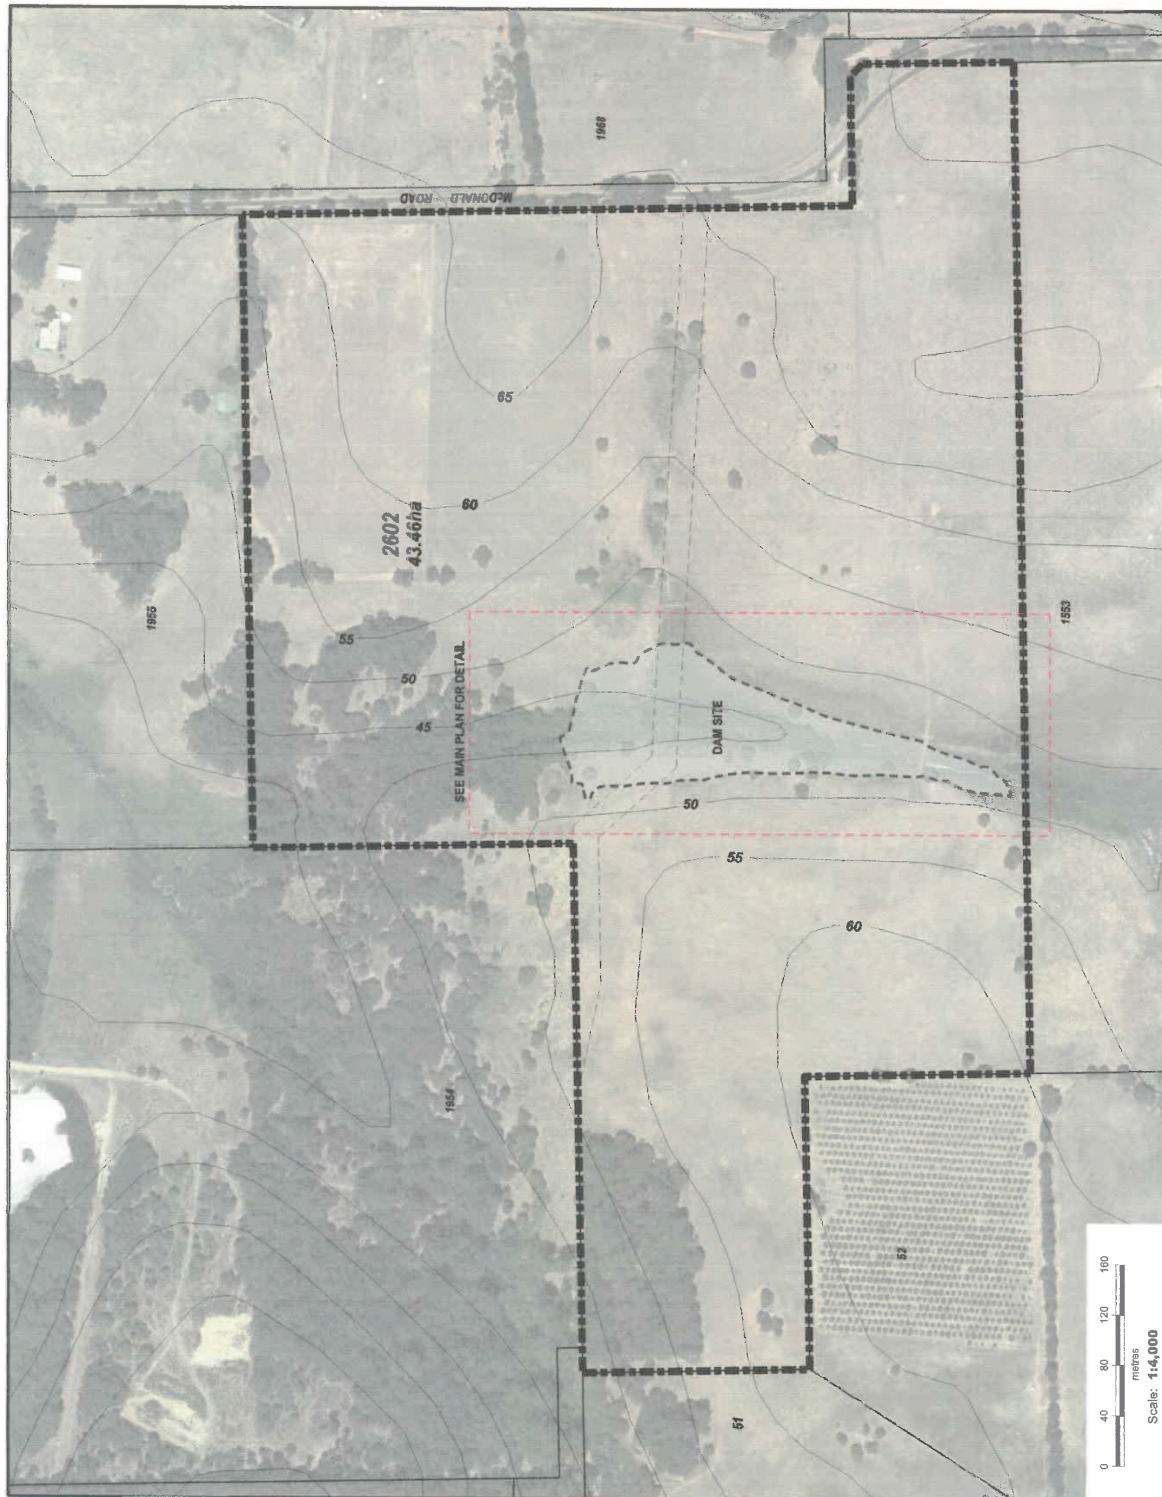
Figure: **1** Scale: **AS SHOWN** Revision No: **A**
 Date: **DECEMBER 2017** Designer: **W.S.** Job No: *****

DAM :
 WALL - HEIGHT 5.0m (45.0 - 40.0)
 - LENGTH 105m
 - CREST R.L. 45.0
 - FULL SUPPLY LEVEL - R.L. 44.5 (WEIR TOP)
 - UPSTREAM BATTER 1V: 3h
 - DOWNSTREAM BATTER 1V: 2.5h

Lot 2602 McDonald Road, Karridale ('the site') is currently used for pasture and grazing. The current owners plan to plant tree crops on the site and will require dam water for irrigation. The proposal is to construct a dam on the streamline that passes in a north-south direction through the centre of the site.

The construction of the new dam will require the clearing of approximately 1.4 hectares of remnant vegetation. A further 2.8 hectares of vegetation will be retained downstream of the remnant that will be affected by the dam proposal. Other small remnants are found on other parts of the property. These remnants mostly occur on rocky outcrops and consist of groves of marri and willow peppermint trees with a degraded understorey.
