Water Corporation - Greenbushes to Kirup Link

Phytophthora Dieback occurrence assessment – Version 0.4

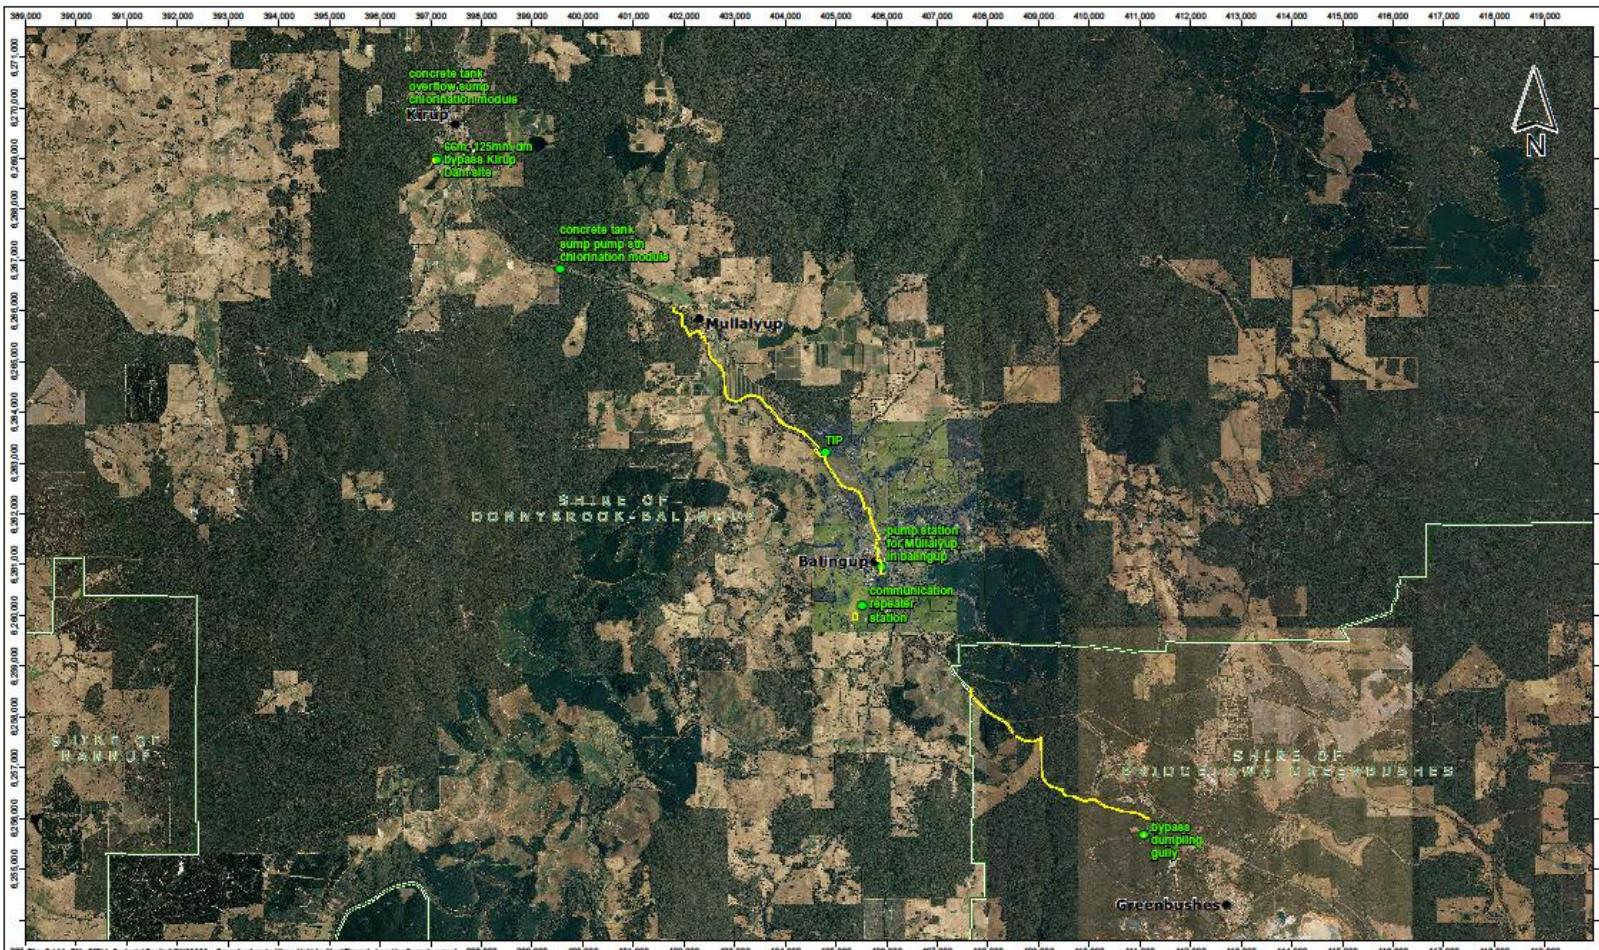
Figure 1 - Project overview (supplied by GHD)

One project as part of this program, is the Greenbushes to Kirup Link, a twenty-three kilometre link between Greenbushes and Kirup (Figure 1). Glevan Consulting assessed the vegetation within and adjacent to this corridor (the Project Area) for the presence of the disease caused by Phytophthora Dieback. The Project Area covered 16.49 hectares, of which 5.14 hectares was assessable.

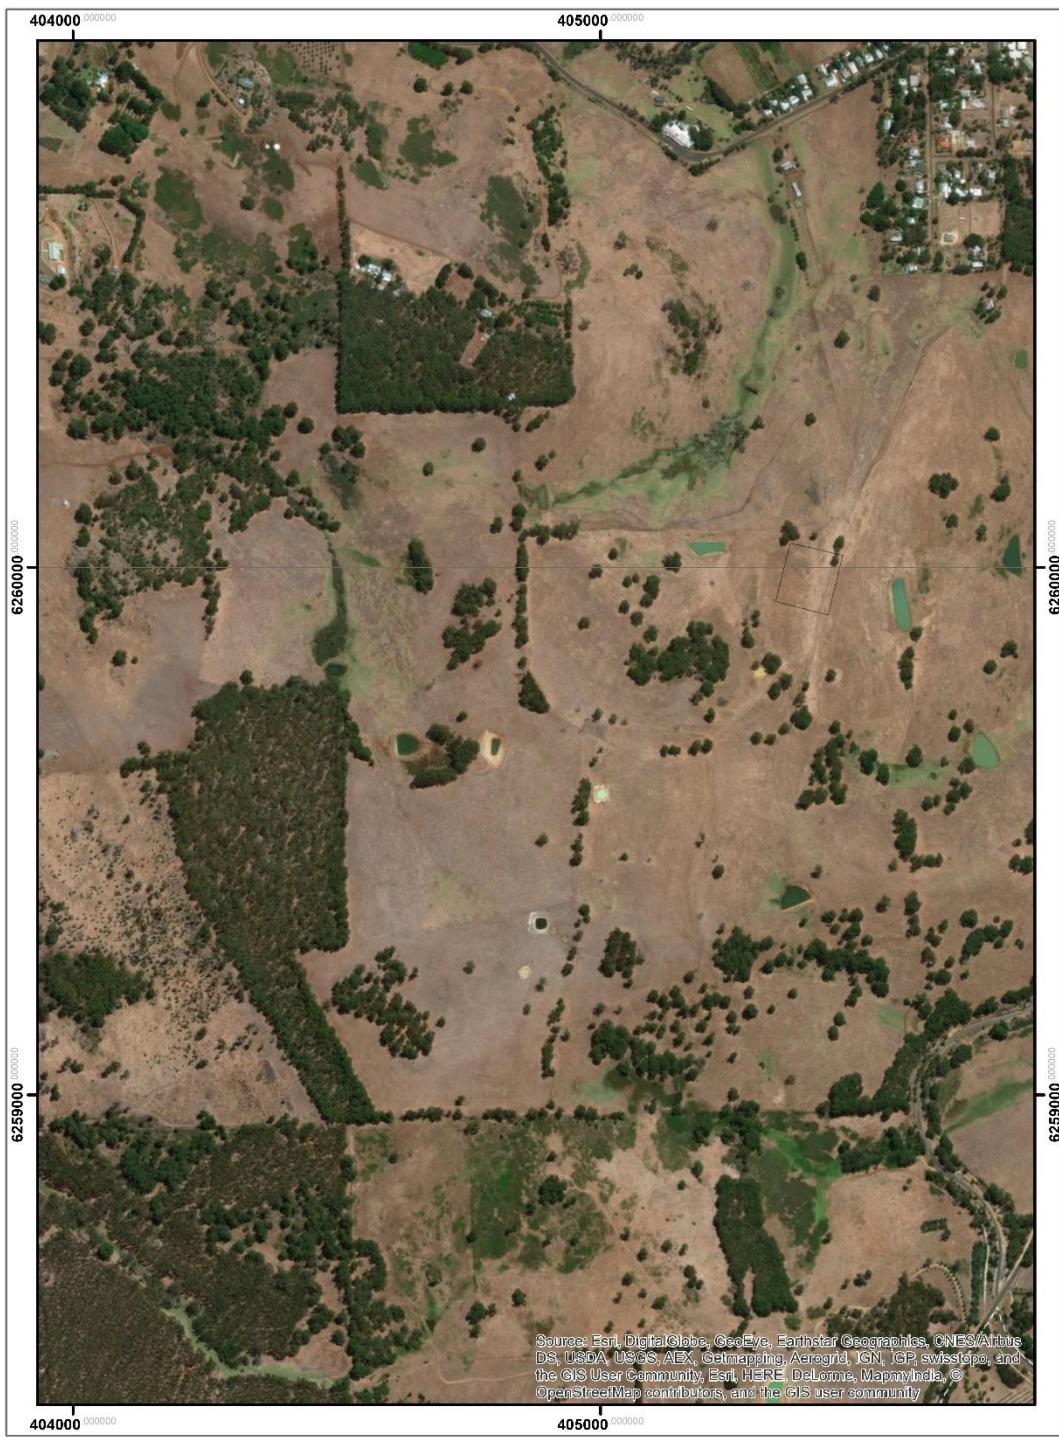
Map 1 - Balingup Tank Site

The Balingup Tank Site (Map 1) contains no assessable vegetation and has been classified as Excluded.

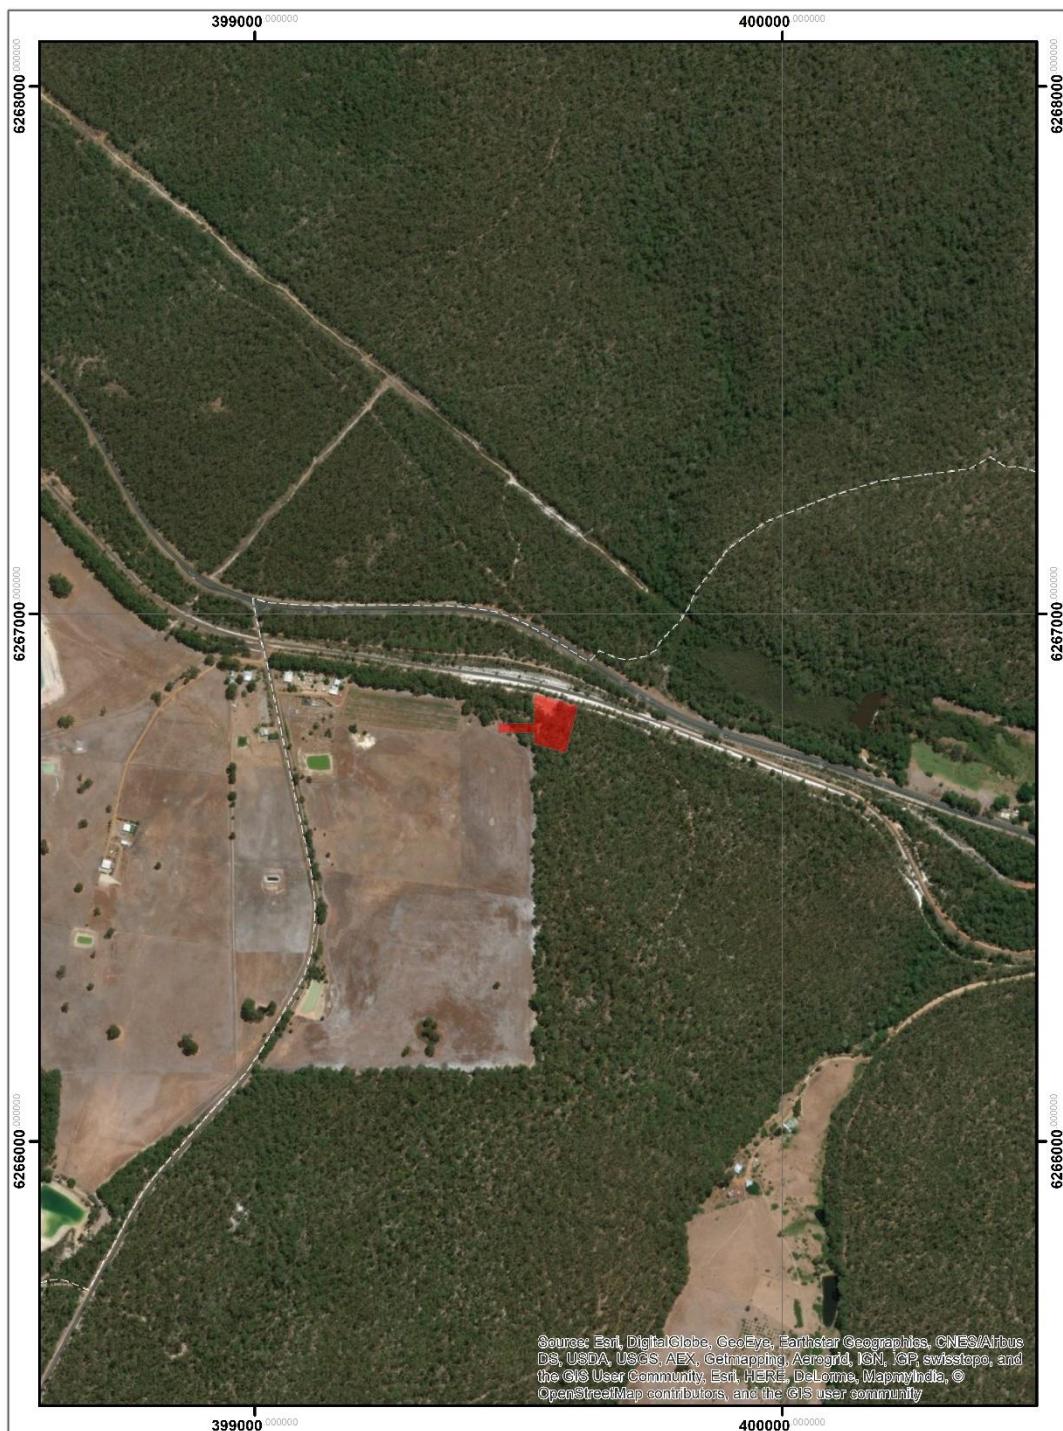
Map 2 - Mullalyup Tank Site

The Mullalyup Tank Site (Map 2) contains vegetation that is displaying the symptoms of Phytophthora Dieback and is classified as Infested.

- Soil and plant material of infested or unknown dieback status should not be introduced to uninfested or unmappable sections of the study area.
- Soil and plant material should not be transported from the infested or unmappable sections of the study area for use at any other protectable area site.

- Soil movement within each category is permissible, but should not occur across category boundaries, except where the source is uninfested.
- Vehicles and machinery should be clean upon entry into any of the site categories (except infested), and when moving across category boundaries. Moving from uninfested areas into other categories does not require clean down measures.

- Restrict access, where possible, to dry soil conditions only. Where vehicles or machinery are required to access the area during, or shortly after rainfall, they must carry clean down equipment, and remove any soil or plant material at designated hygiene points.

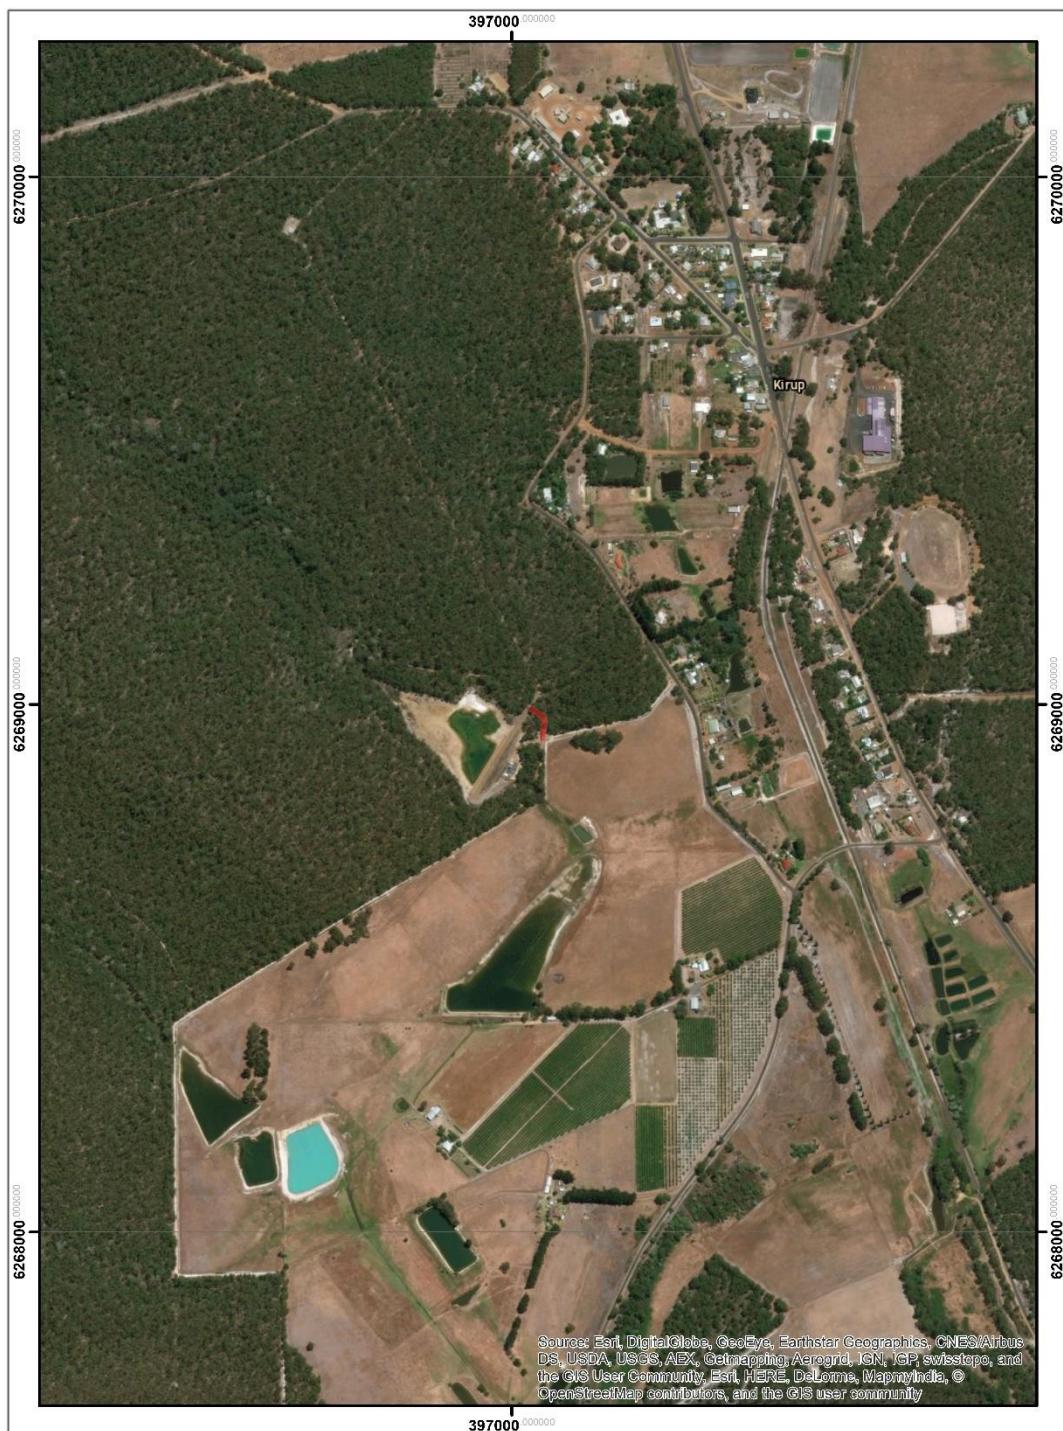
Map 3 - Kirup Dam Bypass

The Kirup Dam Bypass (Map 3) contains vegetation that is displaying the symptoms of Phytophthora Dieback and is classified as Infested.

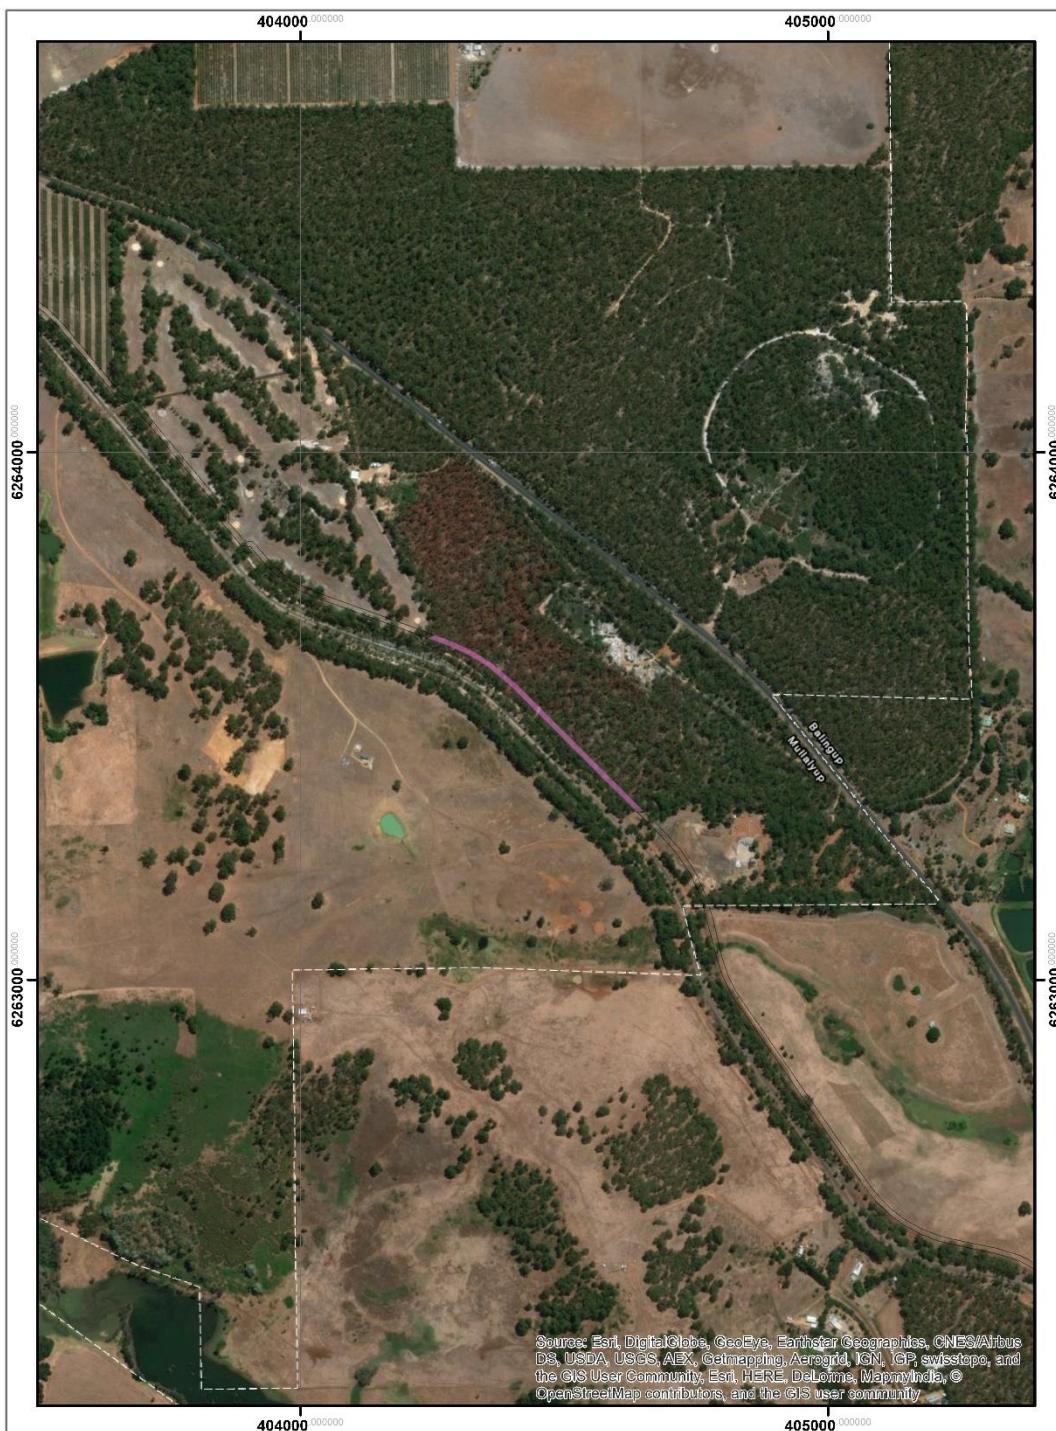
Map 4 - Northern Alignment

The Northern Alignment (Map 4) extends from just north of Mullalyup to the southern end of the Balingup townsite.

One section of the route is vegetated however this vegetation did not contain a sufficient density of species to allow the confident assessment for the presence of Phytophthora Dieback and has been classified as Uninterpretable. The remainder of this section is Excluded.

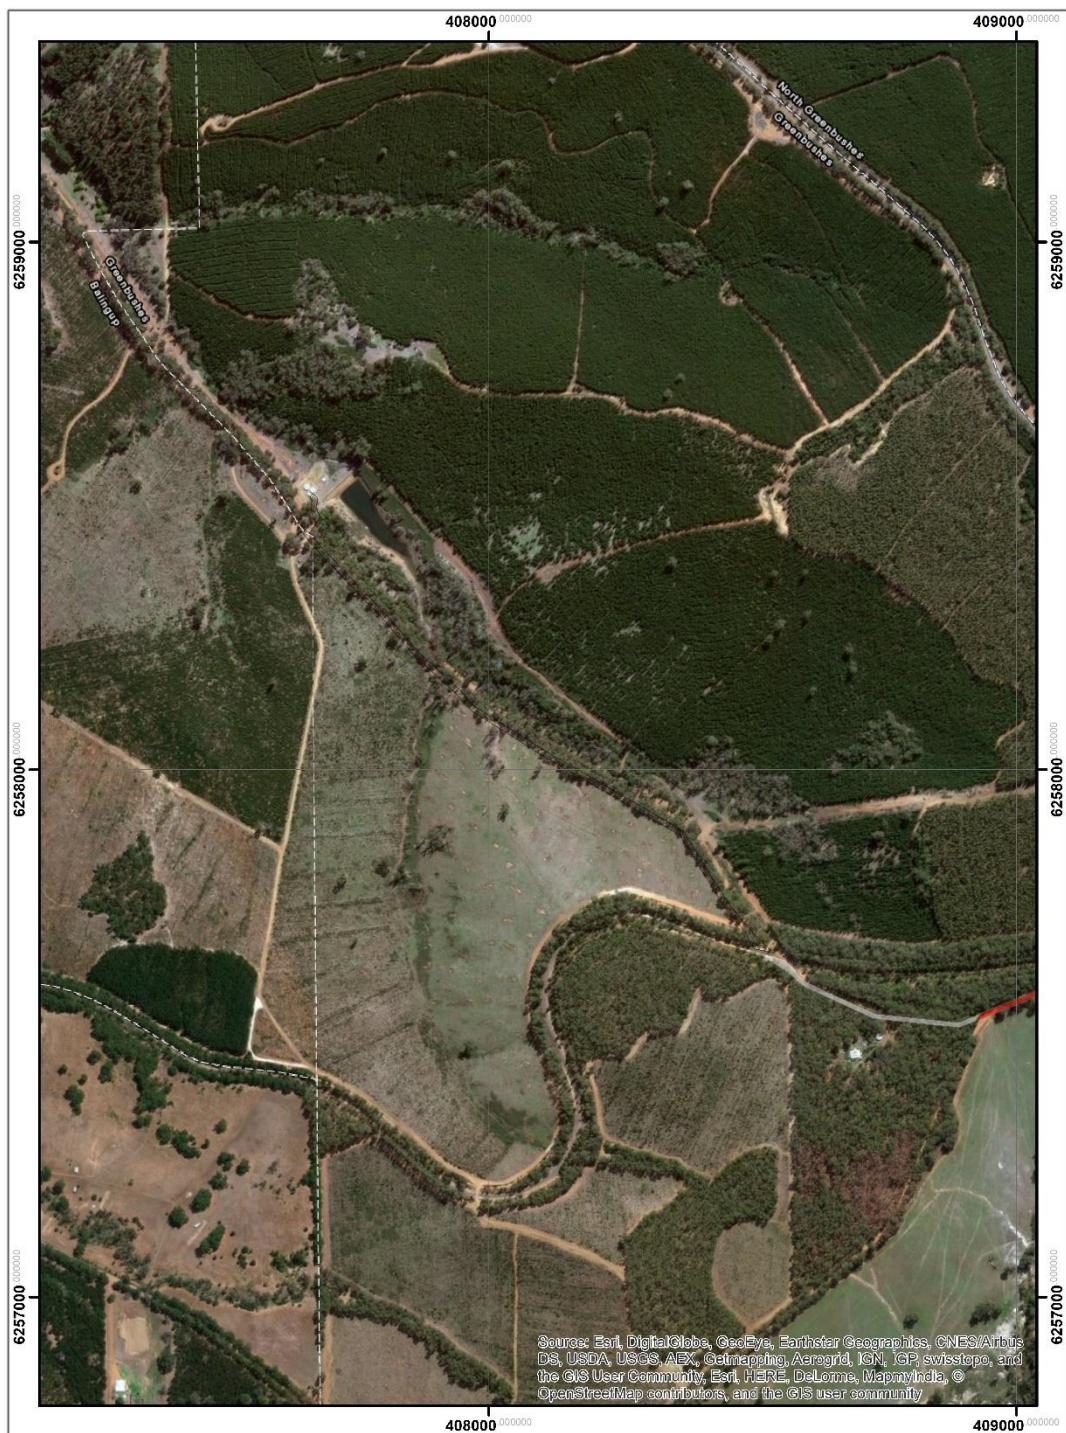
Map 5 - Southern Alignment Part A

The Southern Alignment Part A (Map 5) extends south from the Padbury Reservoir and follows Padbury Road to the rail reserve, just west of Hay Road.

The entire section is Excluded as there is no assessable vegetation along the route. The majority of the route has been given to plantations and cleared road reserve.

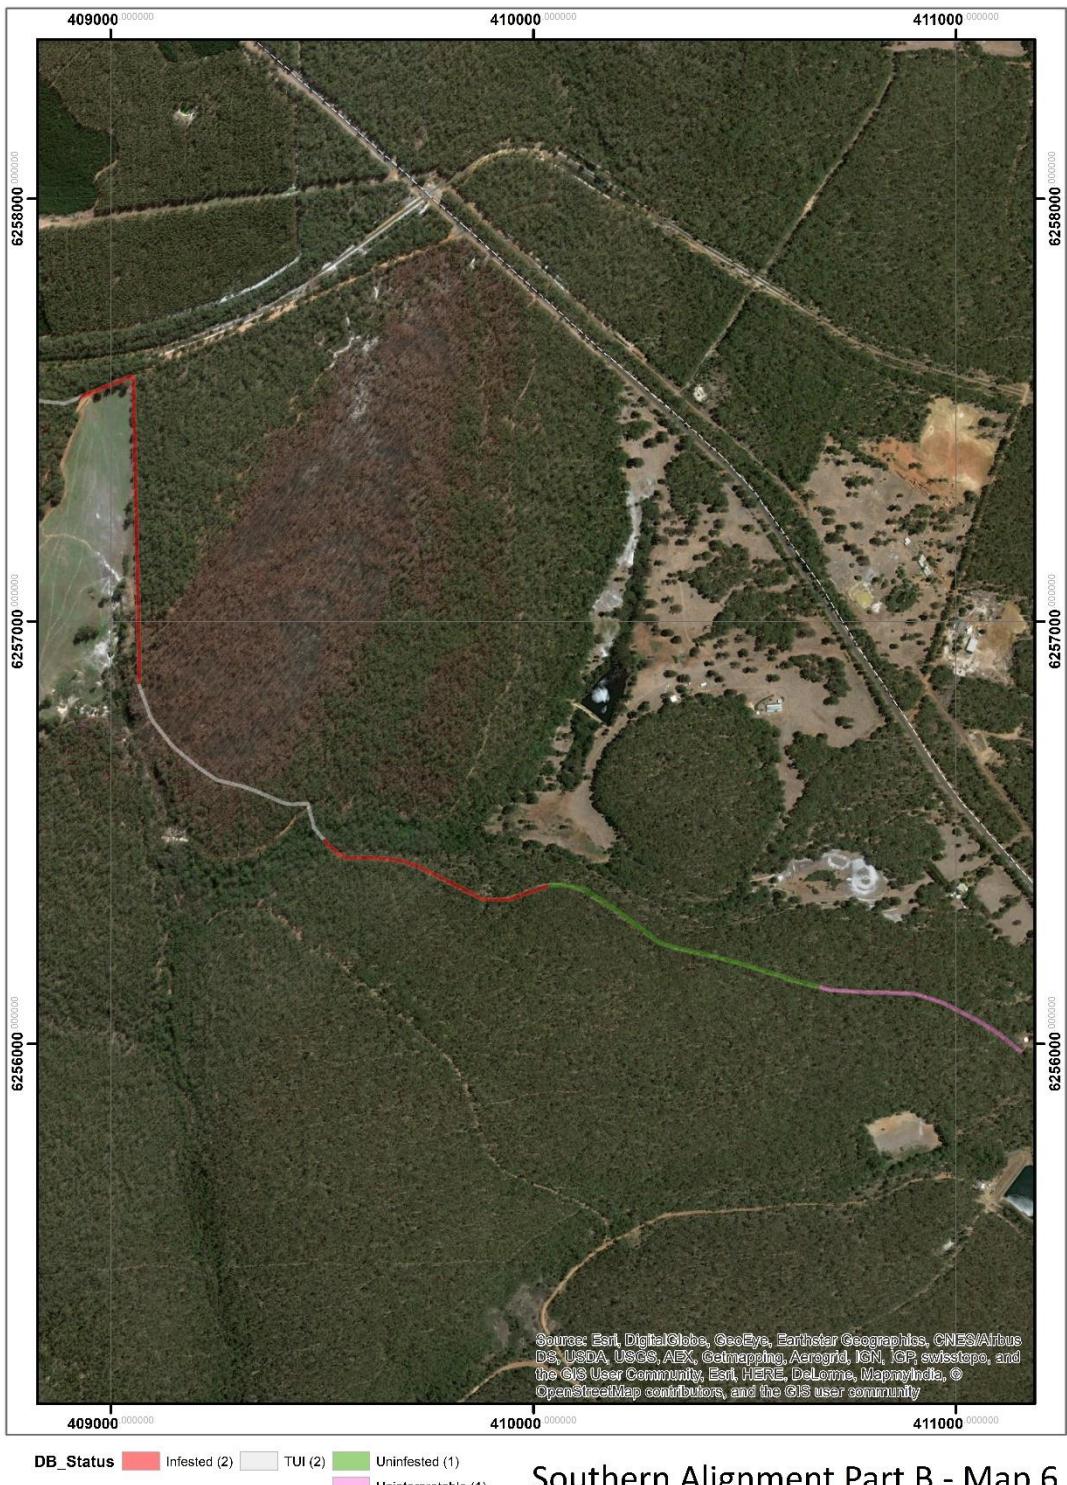
Map 6 - Southern Alignment Part B

The Southern Alignment Part B (Map 6) extends from just west of Hay Road, through Greenbushes forest block and terminates at Reserve R6890.

The section from the rail reserve to Hay Road has recently been burnt and has been classified as Temporarily Uninterpretable.

From Hay Road and south along the western edge of the Greenbushes forest block are numerous deaths of Phytophthora Dieback indicating species, particularly within the *Banksia* and *Xanthorrhoea* families. This section has been classified as Infested.

A section from just west of the Bibbulmun Track to the creek just west of Greenbushes Loop has been classified as Temporarily Uninterpretable as it had been recently burnt.

A small section of infested vegetation has been demarcated adjacent to the creek that flows in from the east, on the northern side of Greenbushes Loop.

The southern end has been classified as Uninterpretable. Although pockets of vegetation exist with Phytophthora Dieback indicating species present, their location is sporadic and discontinuous.
