## **1. BACKGROUND**

Pilbara Ports Authority (PPA) intends to undertake rehabilitation works to the Utah Road pavement. Utah Road connects the Great Northern Highway with the Utah Point Bulk Handling Facility (Utah Point) and was constructed in 2009. The alignment was altered in 2014 to accommodate the realignment of the Great Northern Highway. The Utah Road is approximately 9km in length, 8.1km of which is a PPA asset.

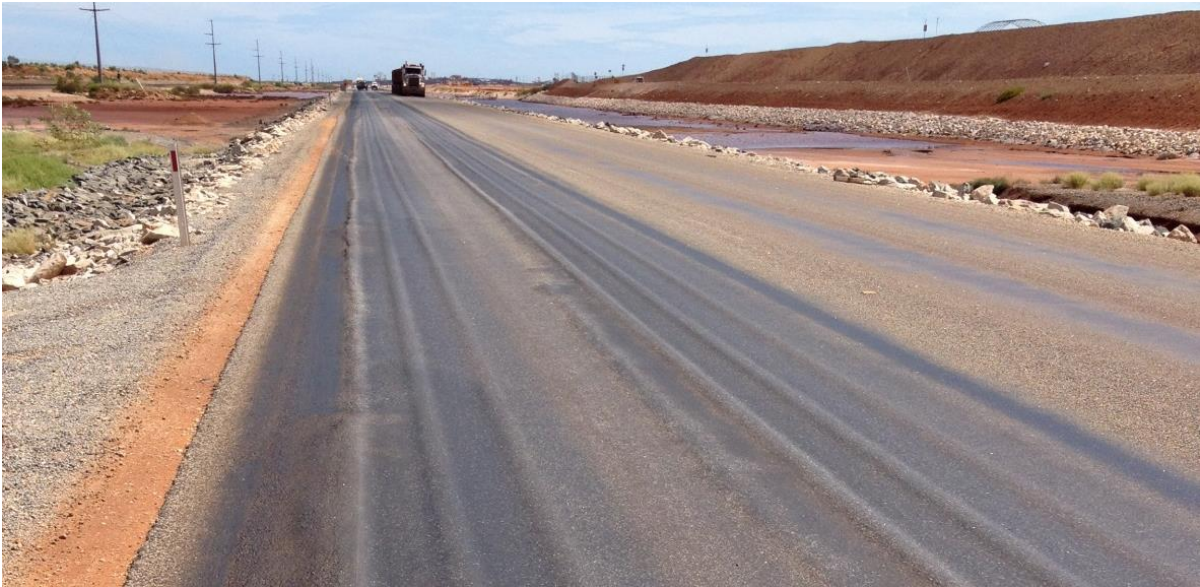
**Figure 1:** Typical pavement rutting on Utah Road.

The Utah Road pavement is inadequate to accommodate the current traffic loading and will not meet its design life. The throughput at Utah Point has increased significantly from what was originally envisaged for the facility during its design. As such, the pavement is carrying well in excess of its design traffic loading. This has caused rapid deterioration and pavement failures (Figure 1). Significant reconstruction and maintenance works have been undertaken since 2009, but major defects persist which will manifest as further failures without intervention.
