GARDEN STREET, SOUTHERN RIVER

REVEGETATION MANAGEMENT PLAN

Prepared for: City of Gosnells

Report No. 2017-314

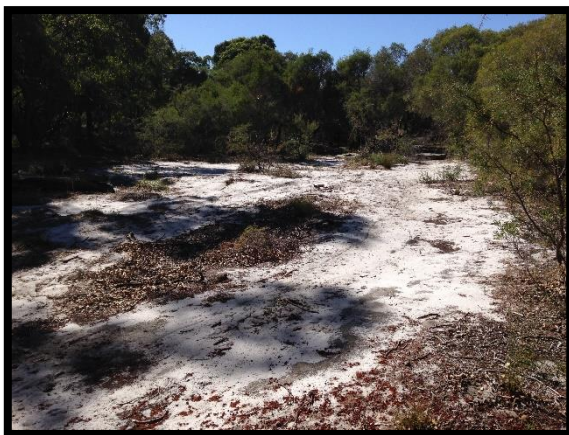
Plate 1: Bare area on the Hume Road site

Each of the offset sites contains large Completely Degraded areas that have very little native vegetation (Plates 1,2,3 and 4).

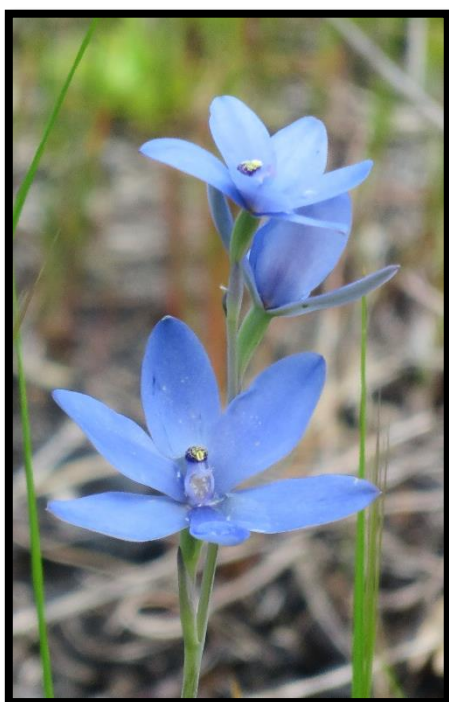
Plate 5: *Thelymitra crinita*

The soil on some of the tracks that are designated for revegetation is compacted. In these areas holes will be augured for each revegetation stem. The Hume Road Site contains two orchid species (*Thelymitra crinita* and *Caladenia paludosa* – Plate 5 and 6) and as these plants are not able to be seen in autumn, auguring on the edge of tracks should be avoided to ensure no orchid tubers are damaged or removed.

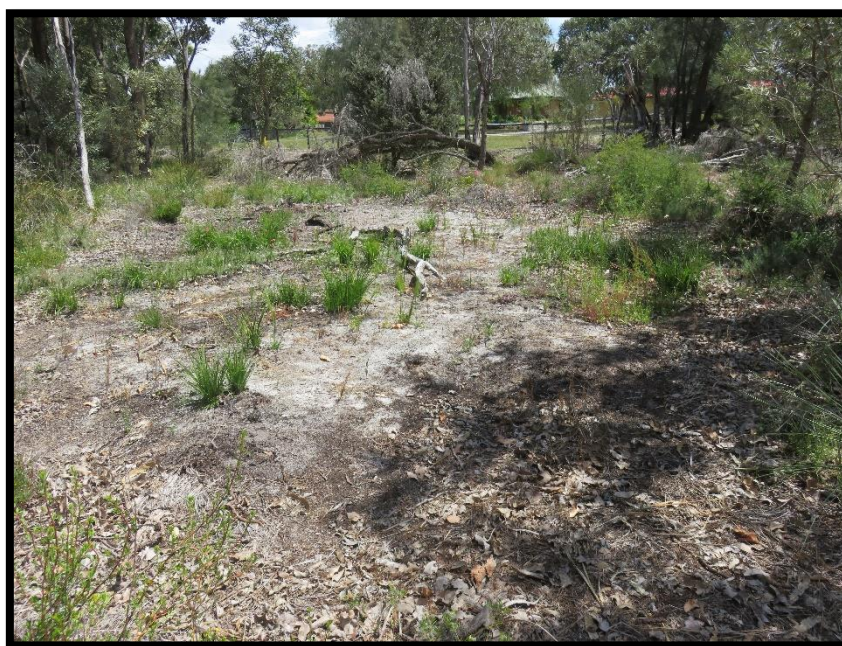
Plate 7: Area H1

Area H1 is located on the central part of the northern boundary of the site and is 765m² in size. Area H1 as shown on Figure 6 is a sparsely vegetated area in the northern part of the site (Plate 7). Weed control has been undertaken by the City previously. Currently the large part of the site is bare, with some natural recruitment. The vegetation was most likely dryland vegetation prior to being degraded.

Area H1 will have infill planting of an overstorey containing Black Cockatoo foraging habitat and an understorey that will improve the habitat values in the area and connect other more vegetated parts of the Reserve.

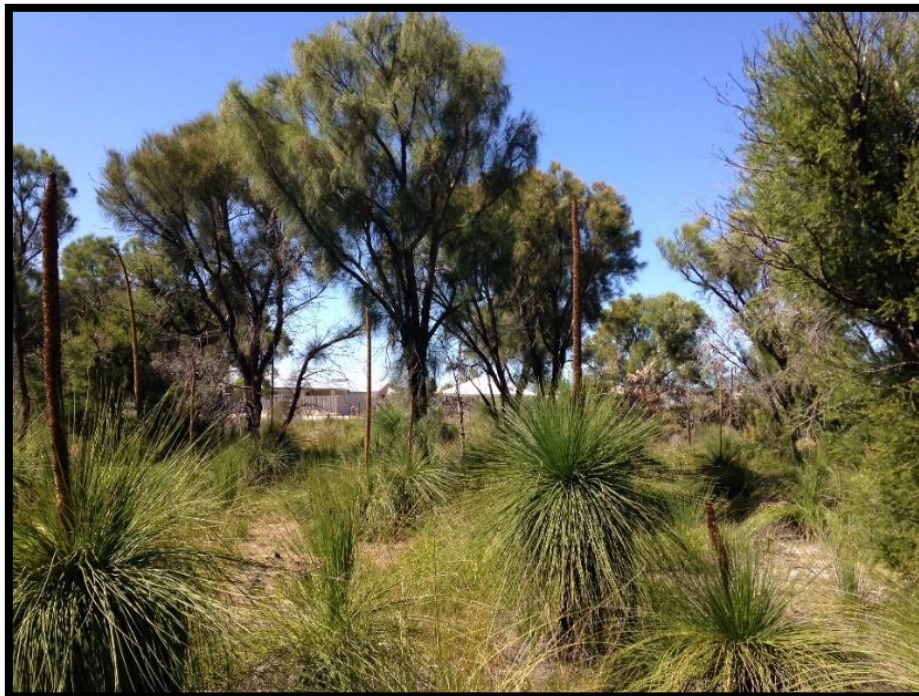
Plate 8: Nicholson Road Vegetation

The vegetation on the Nicholson Road site is mostly scattered *Melaleuca preissiana* over a low heath of *Patersonia occidentalis*, *Dasyogon bromeliifolius*, *Hypocalymma angustifolium*, *Lyginia barbata* and *Xanthorrhoea preissii*. Several Christmas Trees (*Nuytsia floribunda*) also occur on the site. The vegetation types indicate that vegetation is transitional between a Dampland and a dryland. The southern part of the site contains Banksia (*Banksia attenuata*) and Sheoak (*Allocasuarina fraseriana*) over Grass Trees (*Xanthorrhoea preissii*) with some Christmas Trees present (Plate 8).

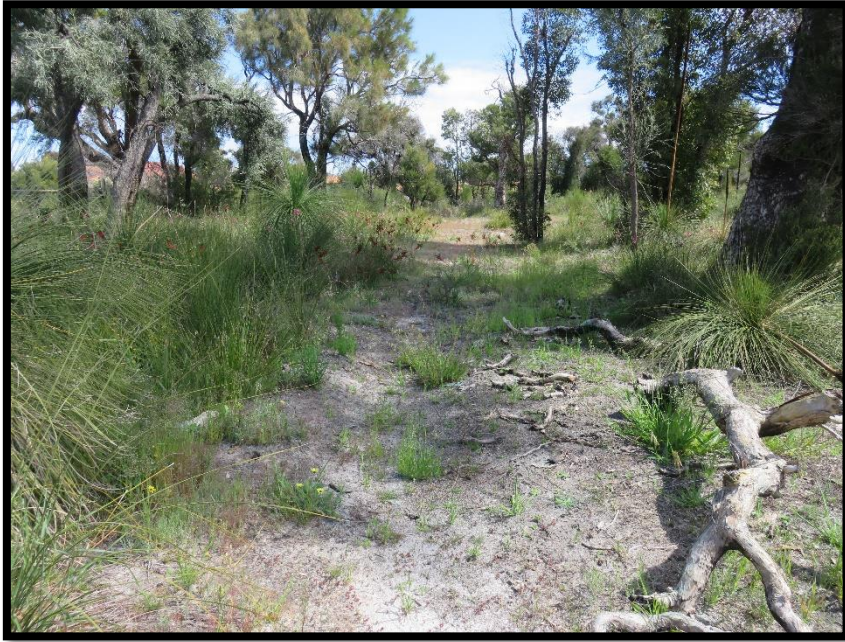
Plate 10: Area N2

There is a redundant fire access track on the southern boundary of the site that comprises Area N2 (1573m²) (Figure 7). The site is sparsely vegetated in areas due to some natural recruitment (Plate 10) and bare in others.

Area N2 will be revegetated to reflect upland vegetation. The revegetation of the site will provide an additional 1573m² of foraging habitat for Black Cockatoos and improved environmental values.

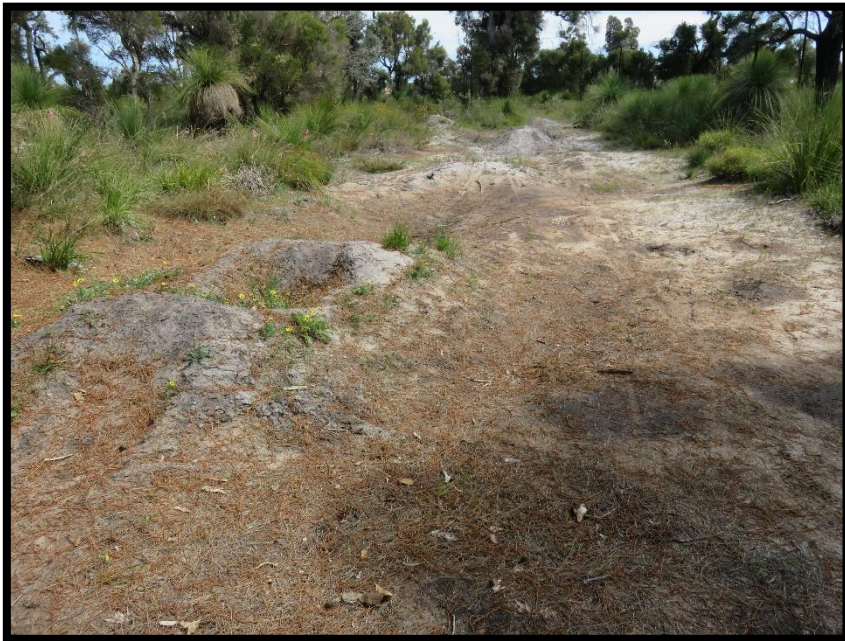
Plate 11: BMX track on the Nicholson Road site

Area N2 contains an informal BMX track that has been constructed to include small jumps (Plate 11).

The presence of the BMX track on the south-western boundary will mean that Area N2 will require further access restriction. If the revegetation is being impacted by access, star-picket and ringlock fencing will be installed on the perimeter of the revegetation area to try and discourage access that damages the establishing plants.

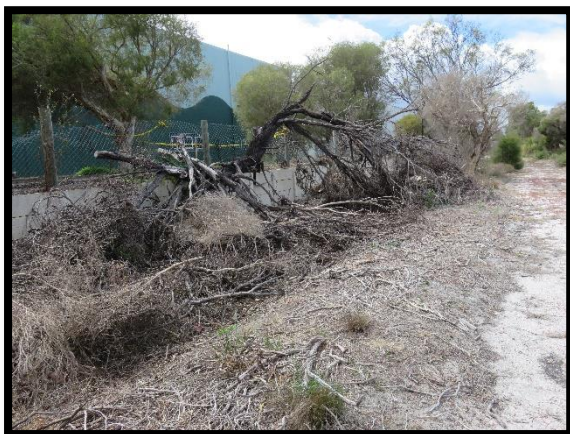
Plate 12: Dead Tree in Area N1

The Nicolson Road site in Area N1 has a large amount of debris including dead tree matter and rubbish (Plate 12 and 13).

The debris will be removed prior to the commencement of revegetation activities.

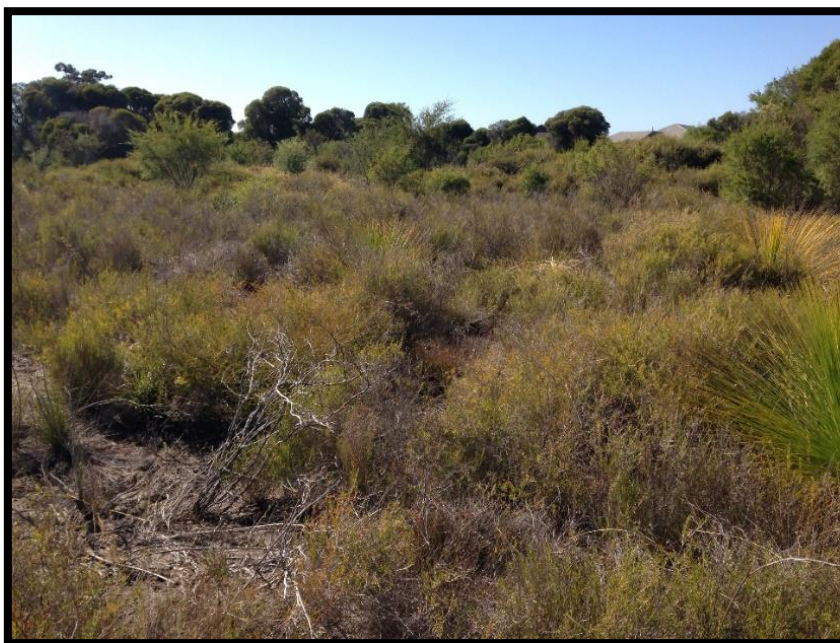
Plate 14: Sandmartin Drive Vegetation.

The Sandmartin Drive site mostly contains wetland vegetation with an inner area of *Hypocalymma angustifolium* Heath (Plate 14) surrounded by taller thickets of Spearwood (*Kunzea glabrescens*) and Paperbark (*Melaleuca preissiana*). Dense *Acacia saligna* stands occur along the northern boundary.

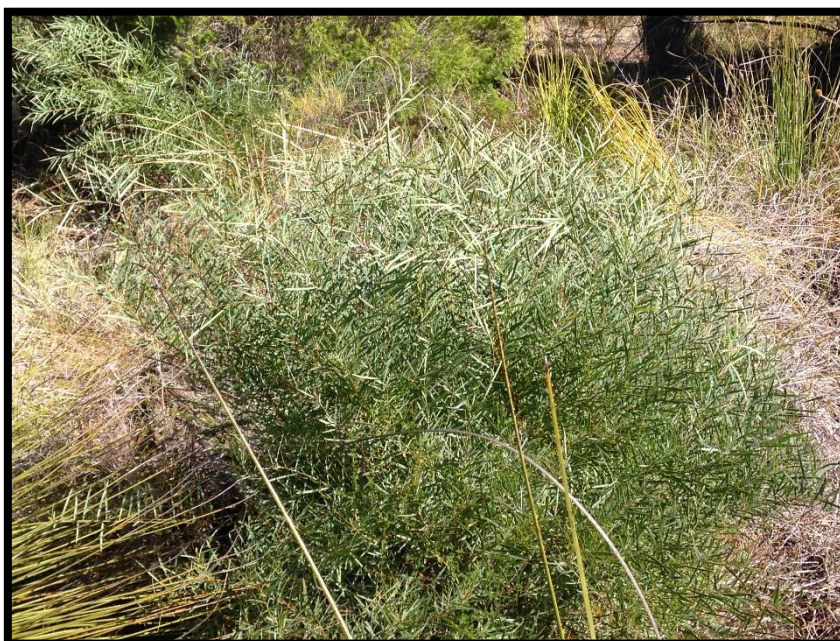
Plate 15: Flinders Range Wattle (*Acacia iteaphylla*) on the Sandmartin Drive site

Weeds occur along tracks and next to the drain that runs through the southern part of the site. Weeds include Fleabane, Blackberry Nightshade (*Solanum nigrum*), Prickly Lettuce (*Lactuca serriola*), Melon (*Citrullus lanatus*), Bushy Stinkwort (*Dittrichia graveolens*), and the woody weeds Flinders Range Wattle (*Acacia iteaphylla*) (Plate 15), Sydney Golden Wattle (*Acacia longifolia*) and Victorian Teatree *Leptospermum laevigatum*.

The Sydney Golden Wattle (*Acacia longifolia*) on the site will be removed by hand pulling seedlings. The mature shrubs will be felled and treated with 250 ml Access® in 15 L of diesel to basal 50 cm of trunk, or cut and paint or drill and fill with 50% glyphosate as recommended by Parks and Wildlife Service (PaWS) on Florabase (PaWS, 2017). The Flinders Range Wattle (*Acacia iteaphylla*) does not sprout or produce root suckers so this species requires only felling (PaWS, 2017). All branches from felled shrubs will be removed from the site.

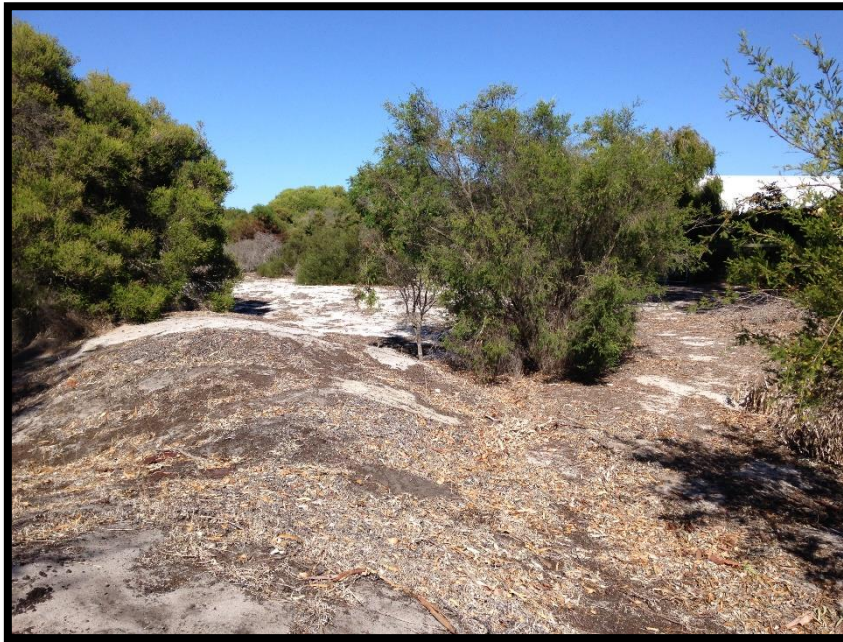
Plate 16: Sand pile on the Sandmartin Drive site

The northern part of the site contains several piles of sand that are not naturally occurring. The areas are Completely Degraded and generally bare (Plate 16). The piles will be recontoured prior to revegetation activities to resemble the natural ground level. Soil may be removed from the site if it is not able to be redistributed to areas that have been excavated in the past. The recontouring will be executed by small machinery such as a Kanga or Bobcat to ensure the surrounding native vegetation is not impacted by the works.

M29 Recontour filled areas prior to revegetation activities to resemble the natural ground level

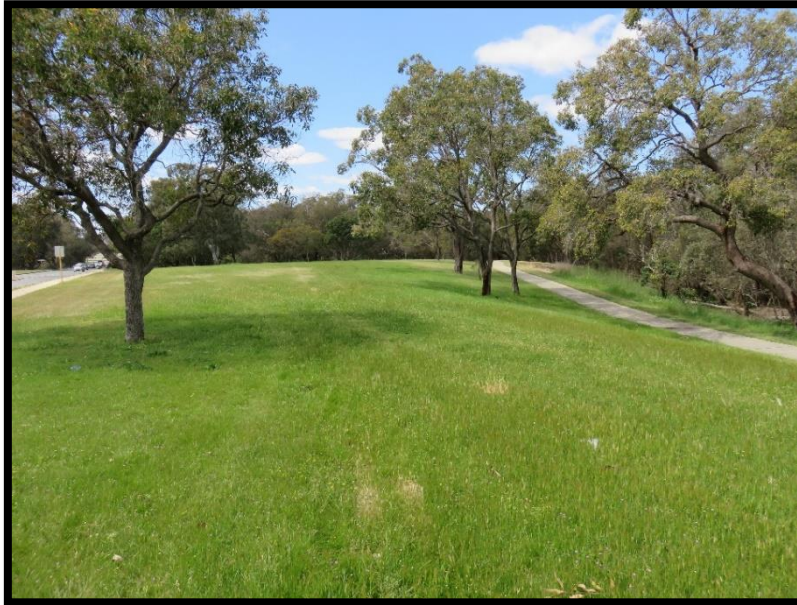
Plate 17: Area B1

The Burslem Drive site consists of two areas. Area B1 is Completely Degraded lawn area (Plate 17) located in the northern part of the site adjacent to Burslem Drive (Figure 9). The B1 grassed area contains scattered Marri trees.

Area B1 (Figure 9) in the Burslem Drive site is Completely Degraded. The parkland setting will be enhanced with the planting of an overstorey consisting of native endemic tree species that will provide habitat for Black Cockatoos. The grass will be partially maintained under the trees, with mulched areas

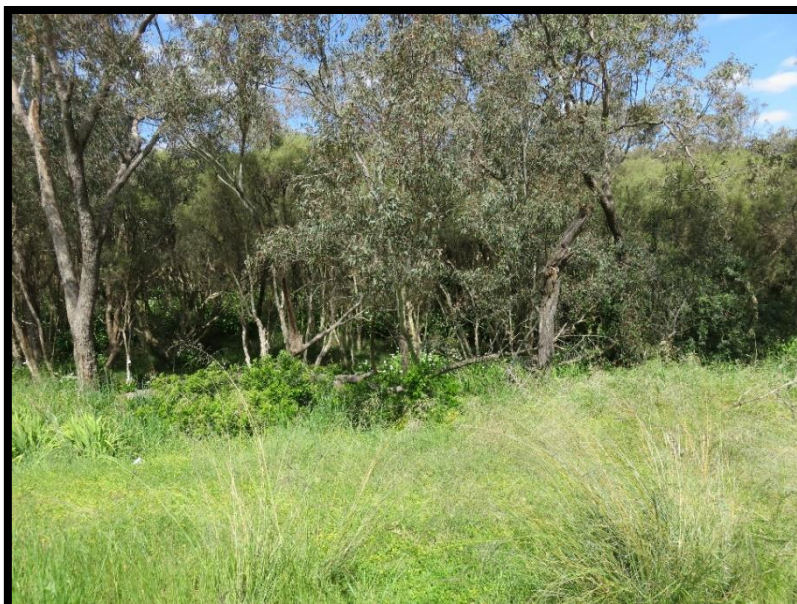
Plate 18: Flooded Gum overstorey over weeds on the Burslem Drive site

Vegetation in the riverbank part of the Burslem Drive site (Area B2) (Figure 9) is dominated by an overstorey of Flooded Gum (*Eucalyptus rudis*) and Paperbark (*Melaleuca raphiophylla*) but has a high coverage of weeds, including Declared weeds and woody weeds in the understorey (Plate 18).

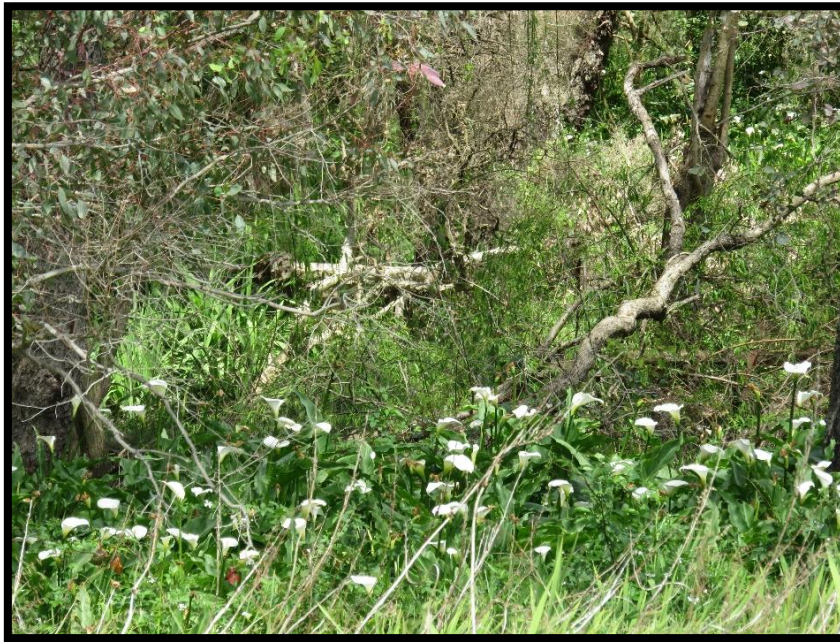
Plate 19: Arum Lily in Area B2

Area B2 has a dense understorey of weeds, particularly Arum Lily (Plate 19) and some woody weeds make up part of the canopy (Table 12).

- M35** Area B1 to be treated with a topical application of appropriate selective herbicides to ensure the retention of the Kikuyu.
- M36** Area B2 to have priority weeds managed in accordance with PaWS recommendations.
- M37** Woody weeds will be treated as per PaWS recommendations and the biomass will remain *in situ*.

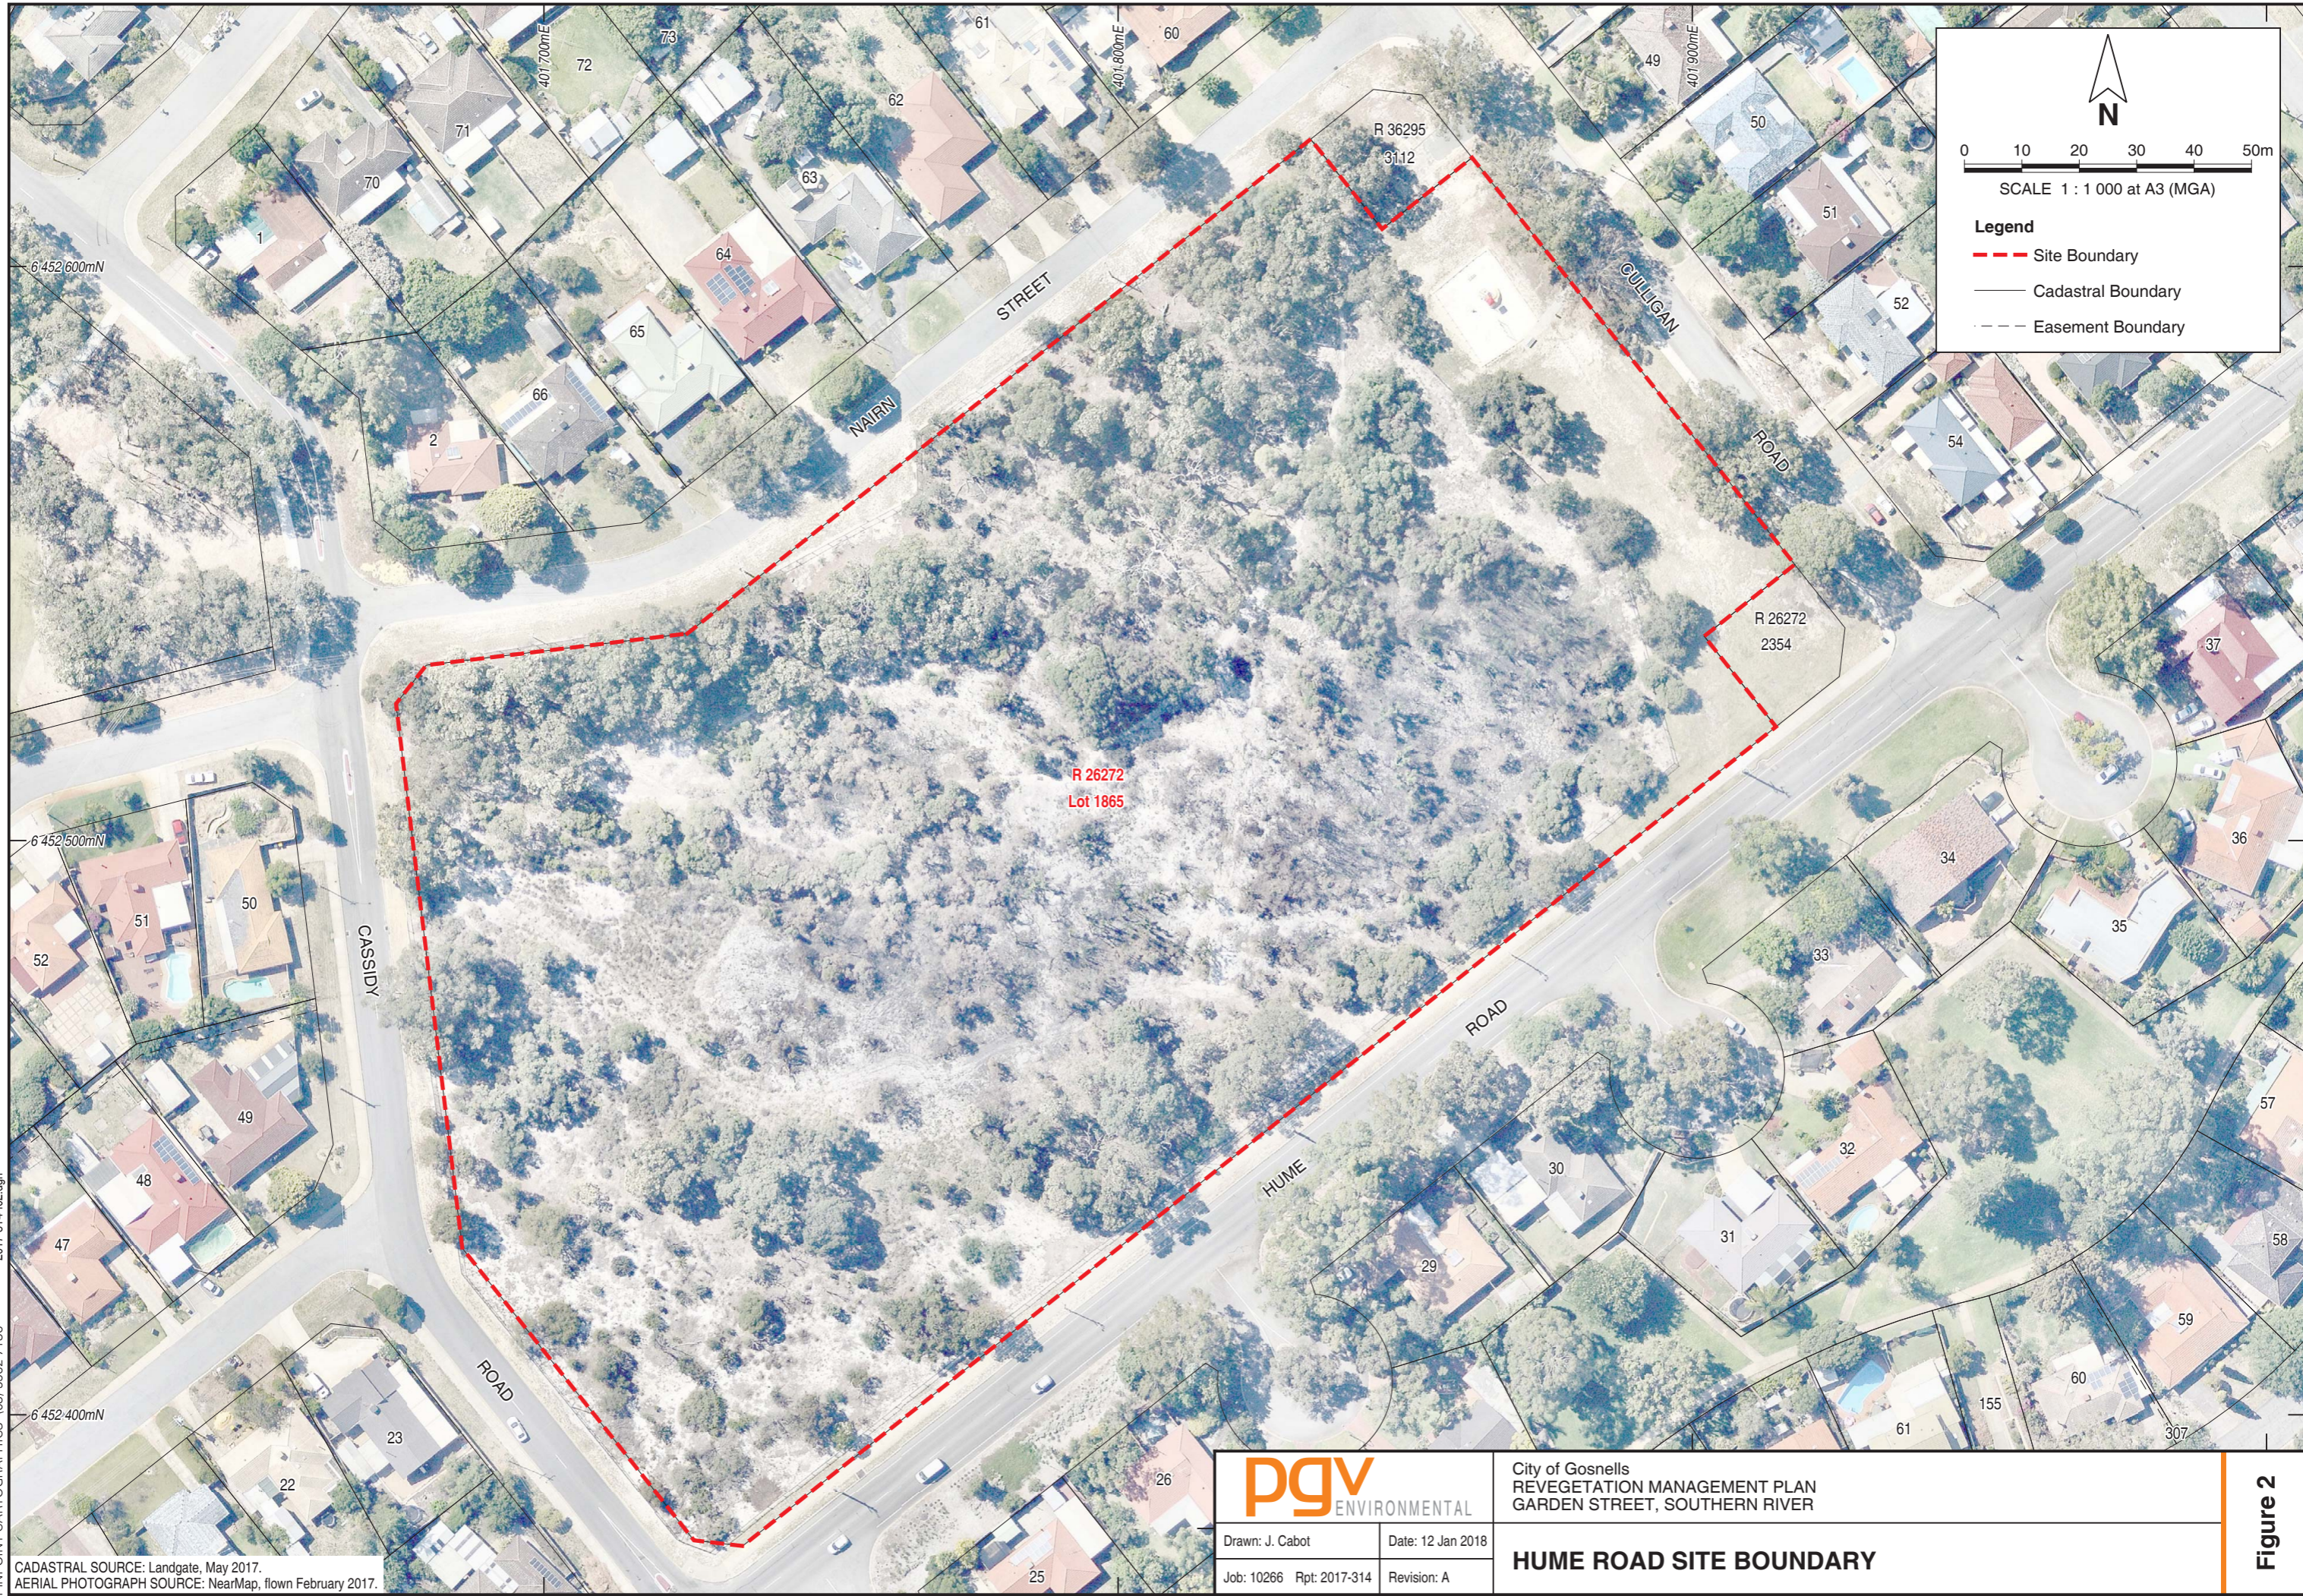
Figure 1

City of Gosnells REVEGETATION MANAGEMENT PLAN GARDEN STREET, SOUTHERN RIVER	
		SITE LOCATIONS	
Drawn: J. Cabot	Date: 12 Jan 2018		
Job: 10266 Rpt: 2017-314	Revision: A

The revegetation areas are all within a 3.6km radius of where the clearing is to be undertaken for the purposes of extending Garden Street (Figure 1). Revegetation is proposed in four sites, including:

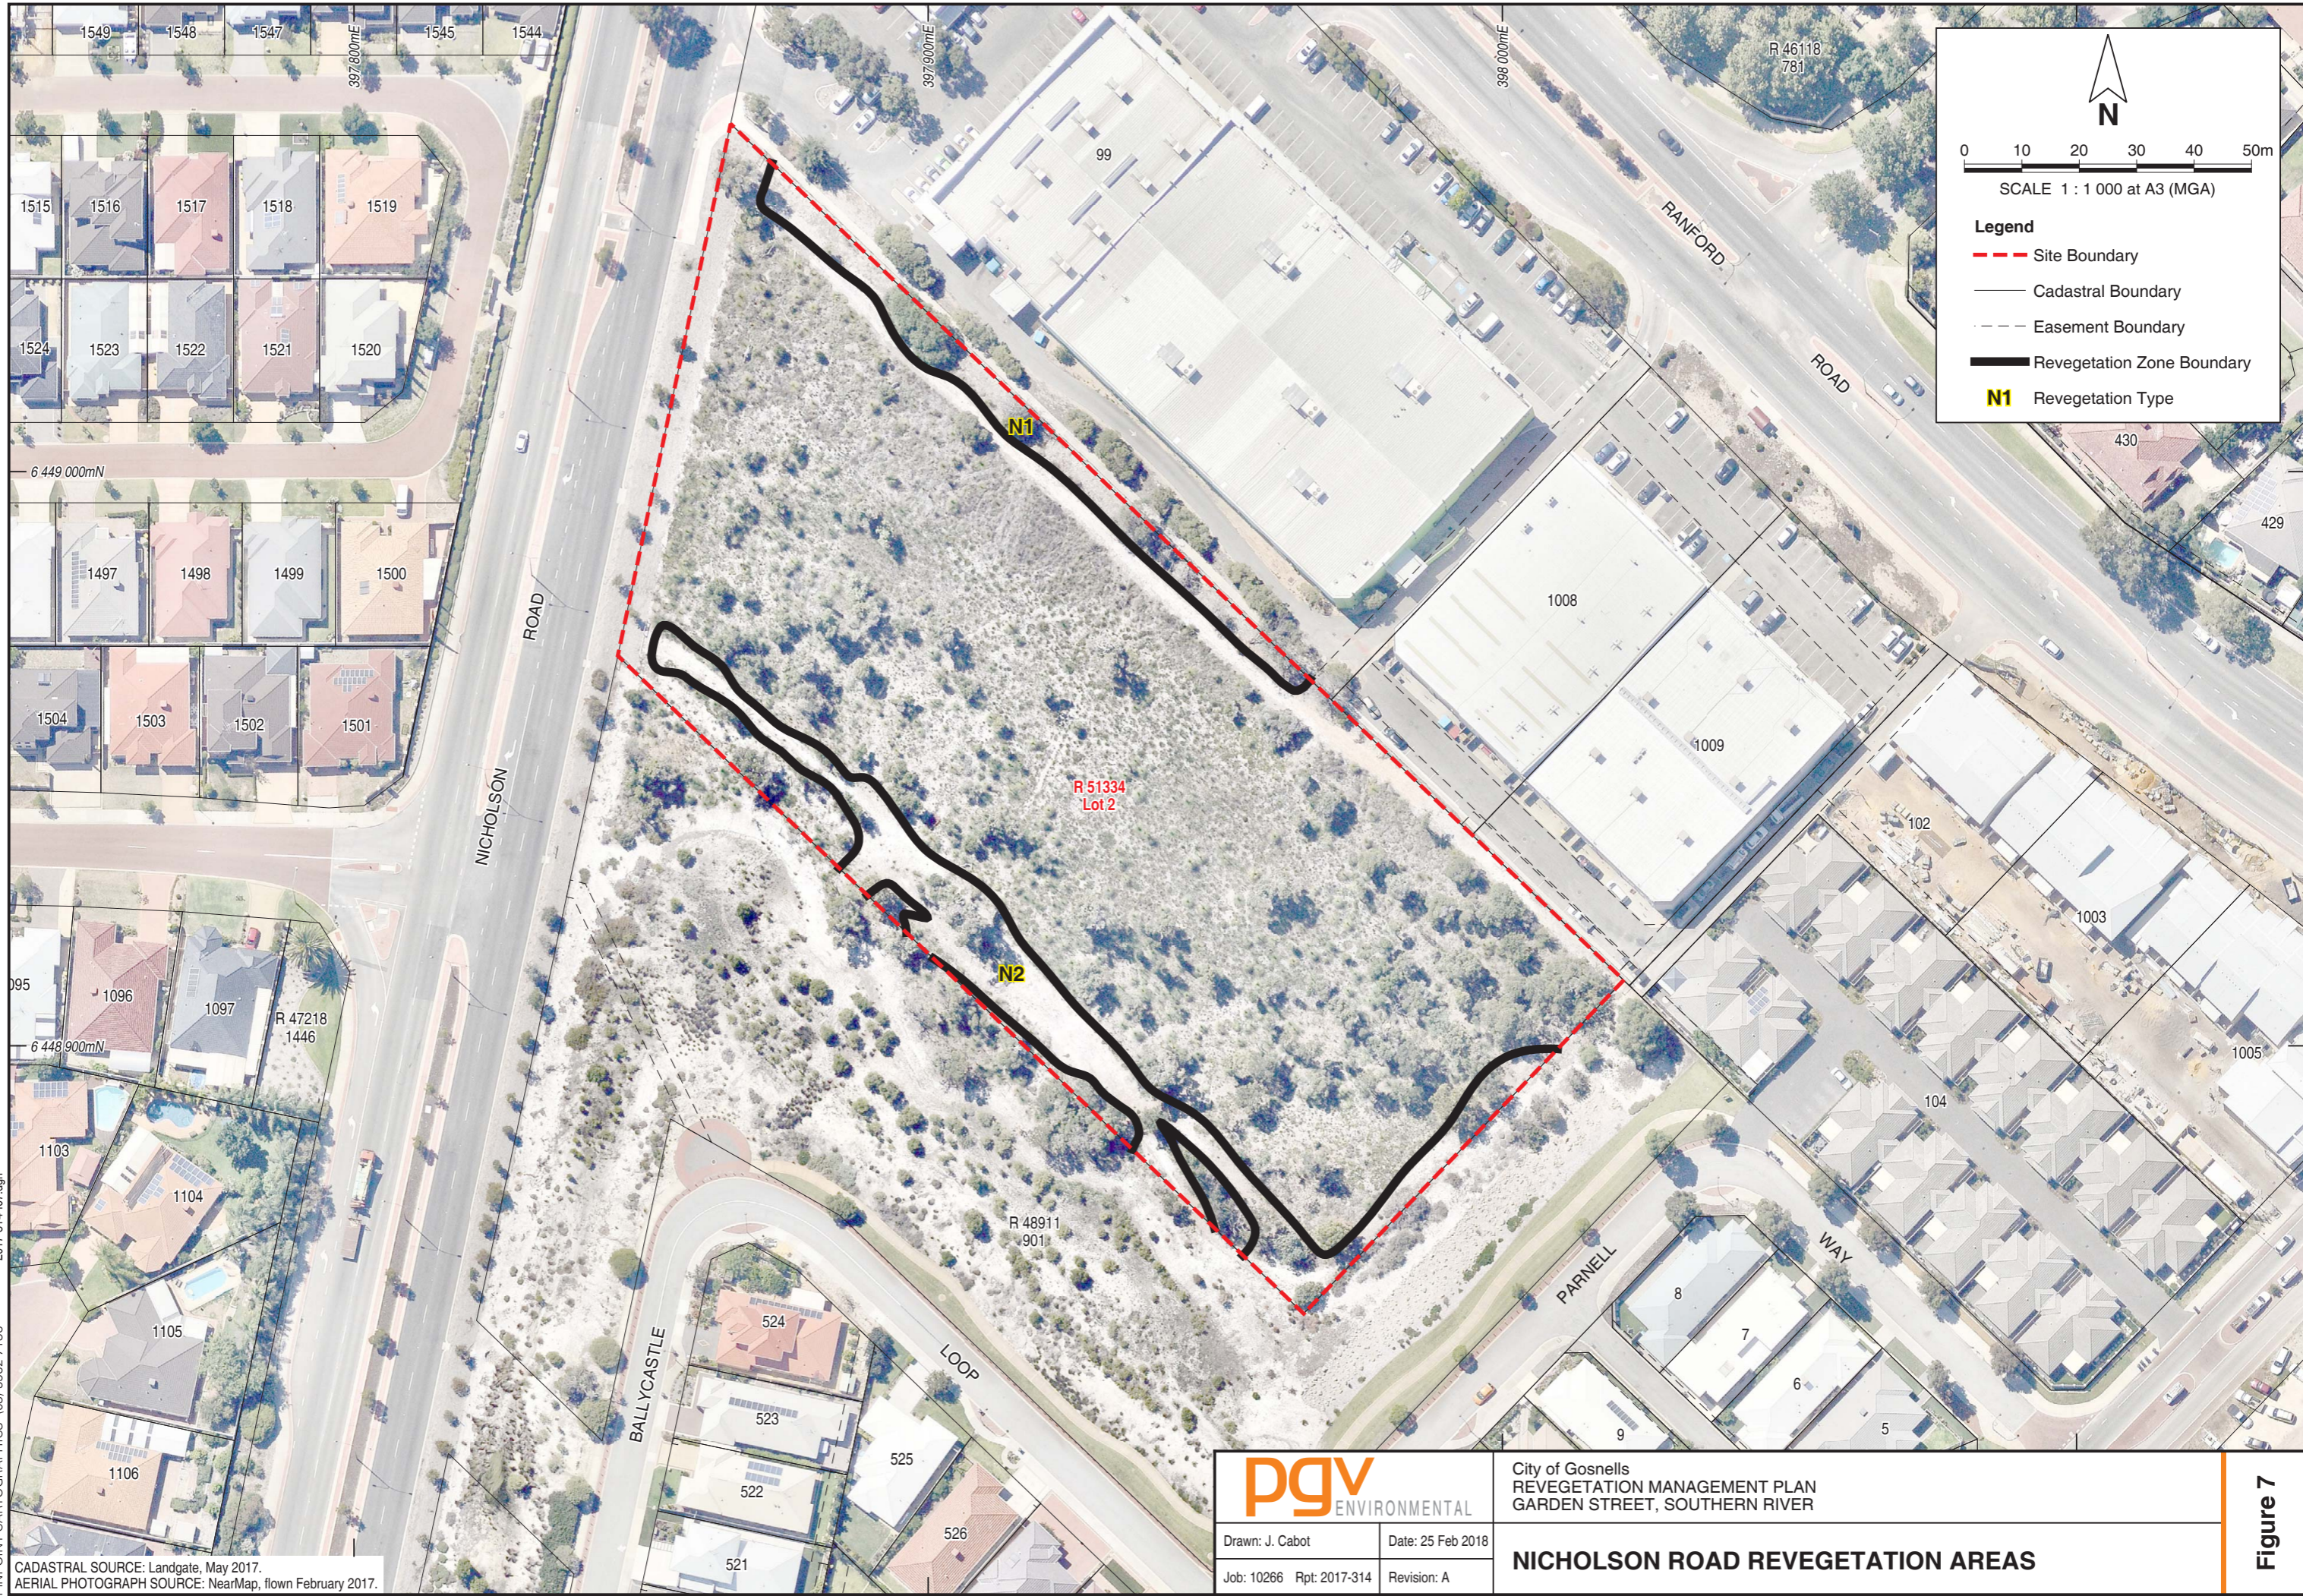
Figure 6

City of Gosnells REVEGETATION MANAGEMENT PLAN GARDEN STREET, SOUTHERN RIVER	
Drawn: J. Cabot	Date: 1 Mar 2018	<h2 style="margin: 0;">HUME ROAD REVEGETATION AREAS</h2>	
Job: 10266 Rpt: 2017-314	Revision: A

Area H2 is 207m². Area H3 (263m²) is to the south (Figure 6). Areas H4 and H5 (286m²) are two areas that will have the same treatment. Areas H4, H5 and H6 are located within low-lying parts of the site and the existing vegetation has wetland characteristics. The revegetation in these areas will enhance the wetland environments by establishing an understorey in Degraded areas and thereby improving habitat values. All three areas will be planted with species that provide habitat for Black Cockatoos. Area H6 (171m²) contains drainage infrastructure that will remain cleared.

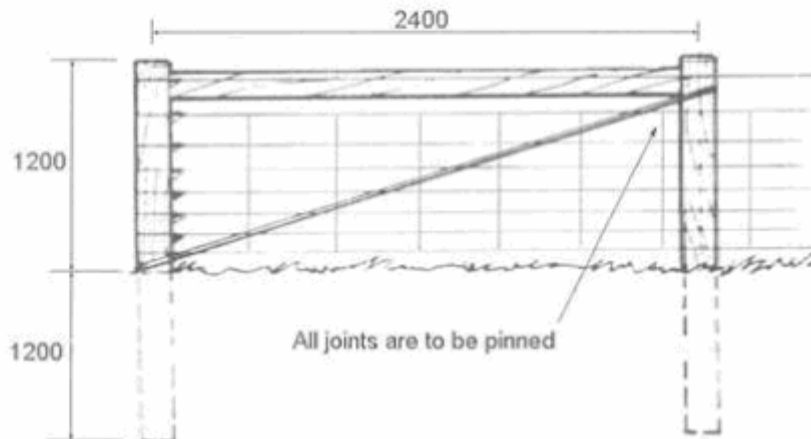
CONSTRUCTION – BOX STRAINER

- Fence to smoothly follow the overall contours of the land (Not to have sudden dips and rises),
- Use 10 mm x 900 mm long High Tensile locking chain (non rusting) for Agricultural Gates,

- Do not over tension fence, ensuring all vertical wires are in line,
- Pedestrian Access ways to be 800mm wide and be boxed
