TRIESTE 3D SEISMIC SURVEY Environment Plan

Review record

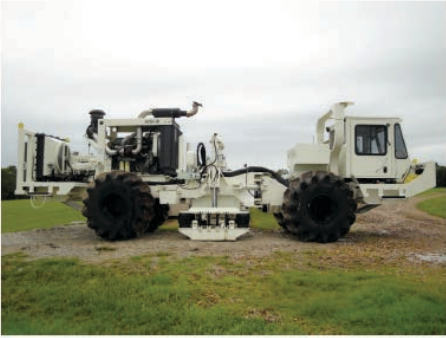
Shaker Model:	P-Wave Vibrator; PLS-364	Filtration:	3-micron absolute servo filter;
Peak Force:	275 kN (61,800 lb)		3.5-micron absolute, high and
Piston Area:	132.9 sq cm (20.6 sq in)		low pressure, triple element
Mass Weight:	4,998 kg (11,020 lb)	Accumulators:	2 x 19 L (5 gal); bladder-type
Driven Weight:	2,027 kg (4,469 lb)	Heat Exchanger:	Steel core; multi-wing fan;
Useable Stroke:	9.83 cm (3.87 in)		hydraulically-driven
Frequency Limit:	1 Hz to 250 Hz	Reservoir:	170 L (45 gal)
Mass Accumulators (2):	3.8 L (1.0 gal.) Servo Manifold	Baseplate Type:	Reinforced rectangular
Lift Stroke:	97 cm (38 in)	Baseplate Area:	2.5 m ² (3,864 in ²)
Balance Method:	Airbags	Baseplate Clearance:	46 cm (18 in) - Tires
Isolation Method:	Airbags	Winch Capacity:	13,608 kg (30,000 lb)
Hydraulic System:	Closed-loop		
Hydraulic System Pumps:	2 x 119 cc (7.25 in ³); Denison P-7		
Servo Valve:	Atlas 240H (with DR modification)

Pilot Valve:	M00G

AHV-IV Commander

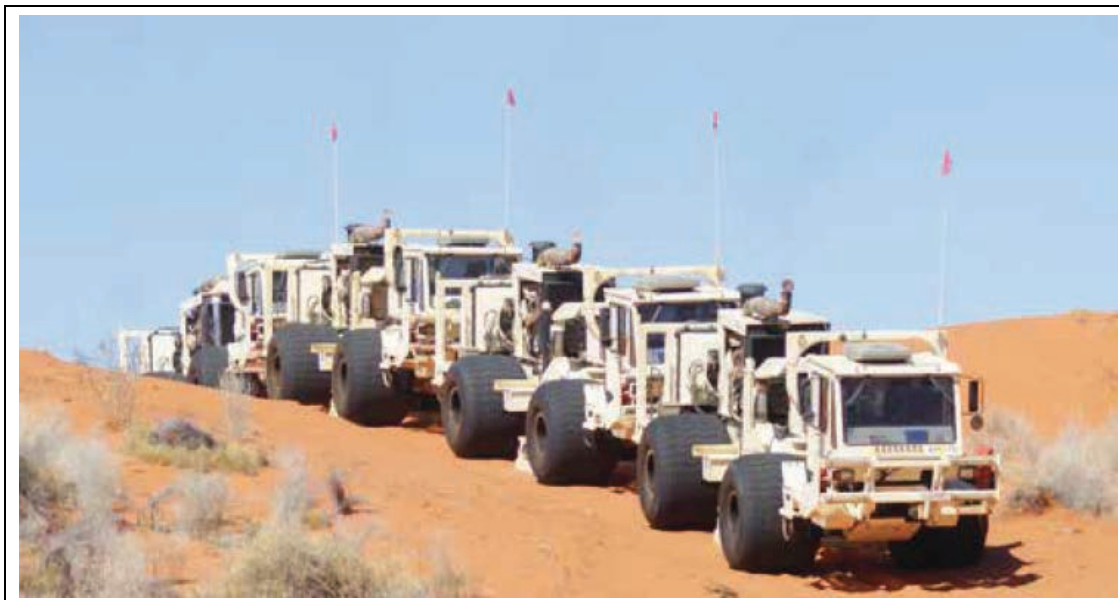
Plate 3.2. Typical vibroseis buggy nose-to-tail acquisition process (note the balloon tyres)

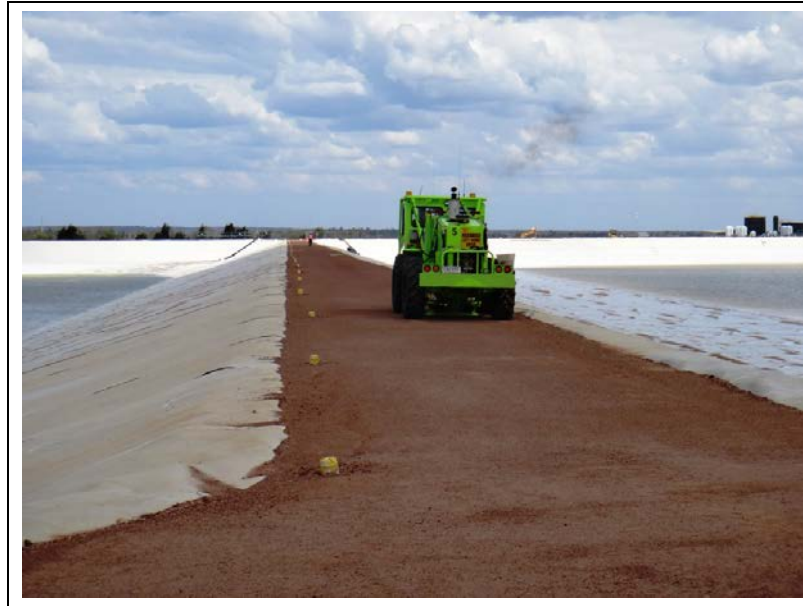
Plate 3.4. Vibroseis vehicle working in an active group of nodes

The buggies acquire survey data by operating centrally to a rectangular group of nodes known as an active patch (Plate 3.4).

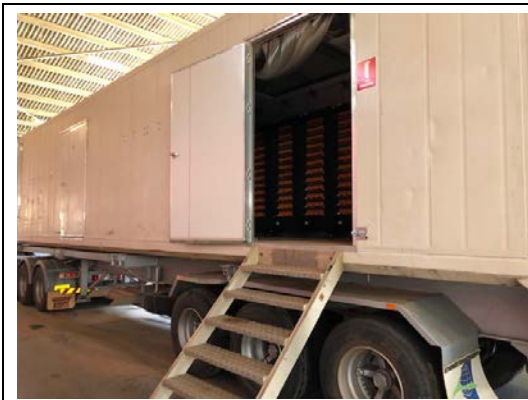
Plate 3.5a. Harvester truck

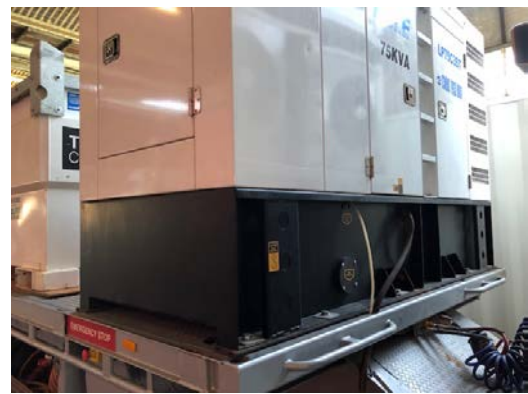
Plate 3.5b. Harvester and generator set

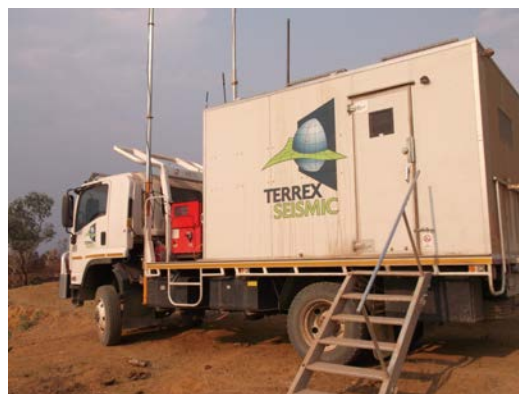
Plate 3.6. Recording truck

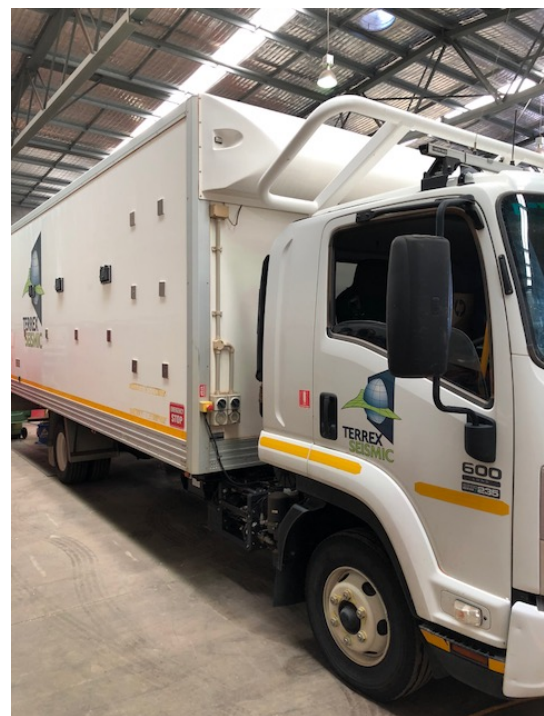
Plate 3.7. QC truck

QC truck (Plate 3.7)	1	Quality control and seismic processing field office
Energy sources		
Vibroseis (see Plate 3.1)	7	AHV-IV PLS-364 60,000lb "Commander" vibroseis buggy fitted with balloon tyres
Source control	1	Seismic source - Universal Encoder II
Vibrator control	7	Seismic source - Force III

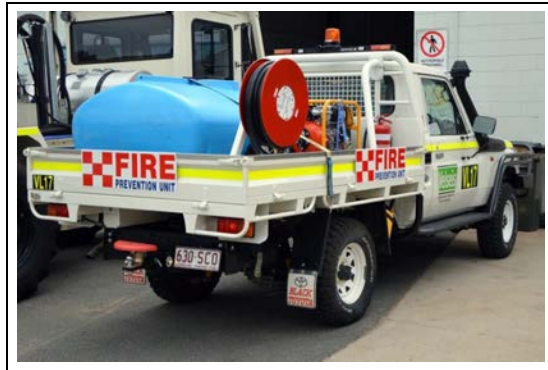
Plate 3.8. Fire tender vehicle

- 4WD tractor fitted with balloon tyres (to reduce soil compaction) with a front attachment to push or move small obstacles;
- Fire tender vehicle (Gator/Mule equivalent) fitted with a minimum 200-litre water capacity fire-fighting unit fitted with a high-pressure pump, hoses and nozzle in order to extinguish any fires that may be ignited (Plate 3.8). The fire tender unit will be present and operational at all times; and
- Tilt tray or equivalent truck to move the machinery to and from properties via the designated wash down facility.

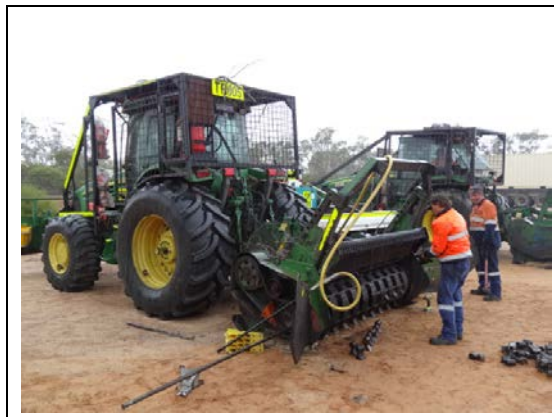
Plate 3.9. Forestry mulcher vehicle

- Rootstock is much more likely to stay in place than rolling as the plant stem is cut rather than pushed over (particularly true for sandy environments).

- The mulched debris breaks down quickly to return nutrients to the soil.
- Terrex has employed this technique on several seismic surveys in the Perth Basin in the recent past, including the West Erregulla survey and Arrowsmith survey, while government agencies including DPaW and DFES use this technique to create firebreaks and access tracks within parks and reserves. Mulching is also used to maintain vegetation on the Dampier to Bunbury Natural Gas Pipeline (DBNGP) easement.

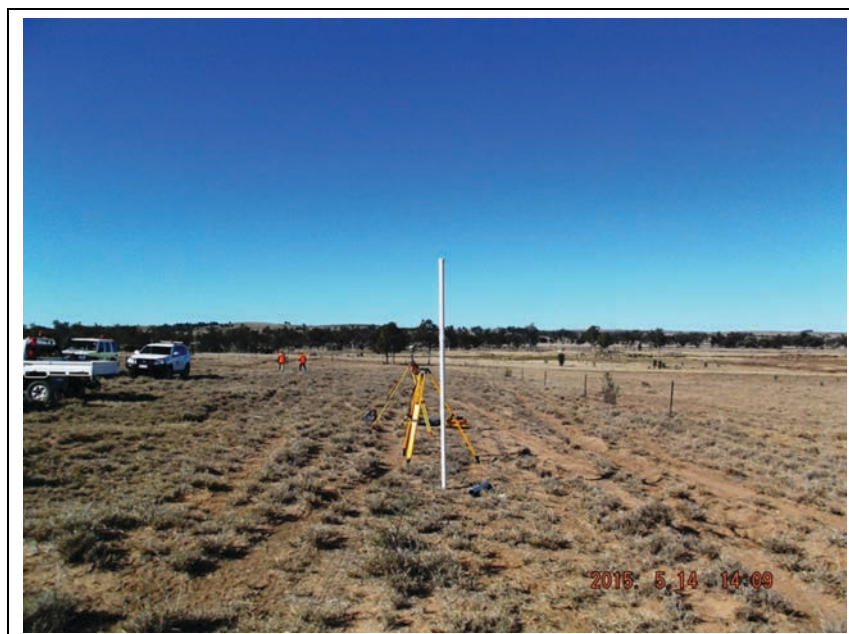
Plate 3.10. GPS base station

To achieve source and receiver accuracy for the survey operations, a global positioning system (GPS) base station will need to be established within the proposed survey area (Plate 3.10). This will be established in an area that does not require any vegetation clearing. Such a site is typically no more than a few square meters in size and equipment will be removed at completion of the survey. The base station will not be erected within 10 m horizontally of any electric power cables and only non-conductive poles will be used.

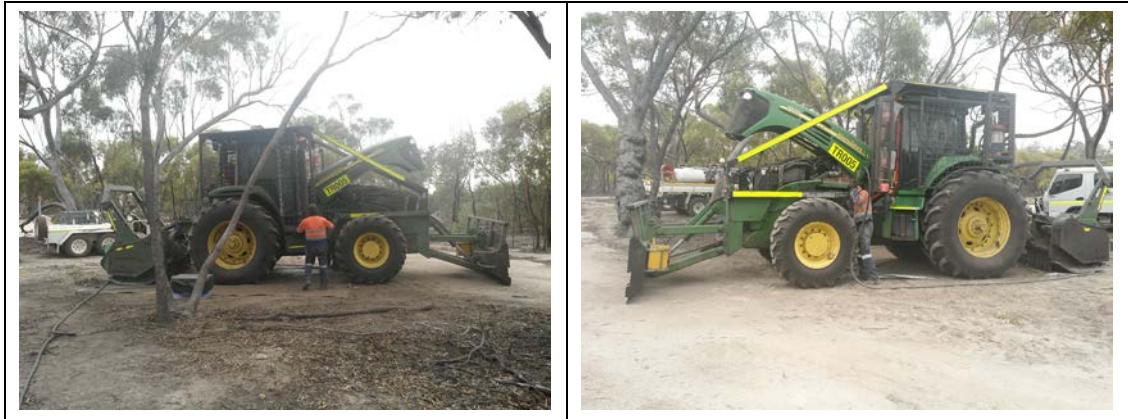
Plate 3.13. Weed blowdown process

- Eneabba North wash down pad – Terrex will provide a water truck and high-pressure cleaner, as the water tank is not in use. The pad is available for use seven days a week.
- Mine site operations centre - once a vehicle is on the wash pad, high-pressure sprays of water from nozzles located under and beside the vehicle are activated and continue for 60 seconds. There is also a manual wash pad (that utilises high-pressure hoses and sumps) beside the automated pad.

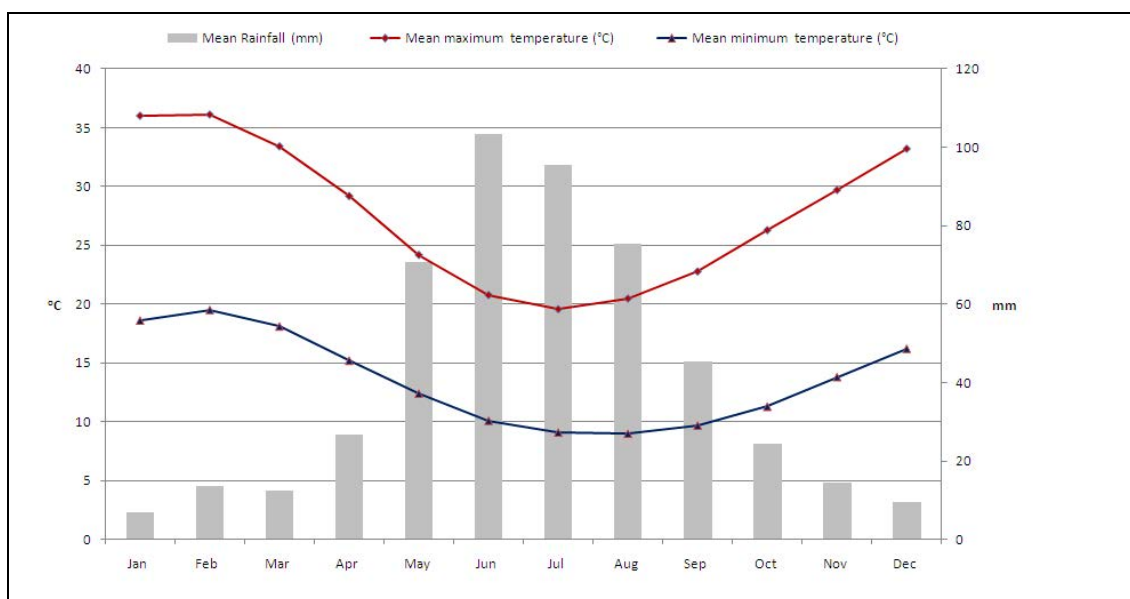
Figure 5.1. Summary of meteorological data for Eneabba

Mean monthly temperature and rainfall data from the Eneabba meteorological station (008225), the nearest to the proposed survey area (~14 km south) and which commenced observations during 1964, are presented in Figure 5.1. The average annual rainfall is around 500 mm, with the majority of rainfall occurring during the winter months. Summer is typically dry with scattered and irregular thunderstorms that approach from the north-west. The average daily relative humidity is between 40% and 80% with the most humid months being May to September (BoM, 2017).
