Excavation and Rehabilitation
Management Plan

EXTENSION
AGRICULTURAL LIME
QUARRY

Lot 502
MURRAY ROAD, QUALLILUP
Shire of Esperance

Triple M Transport (WA) Pty Ltd

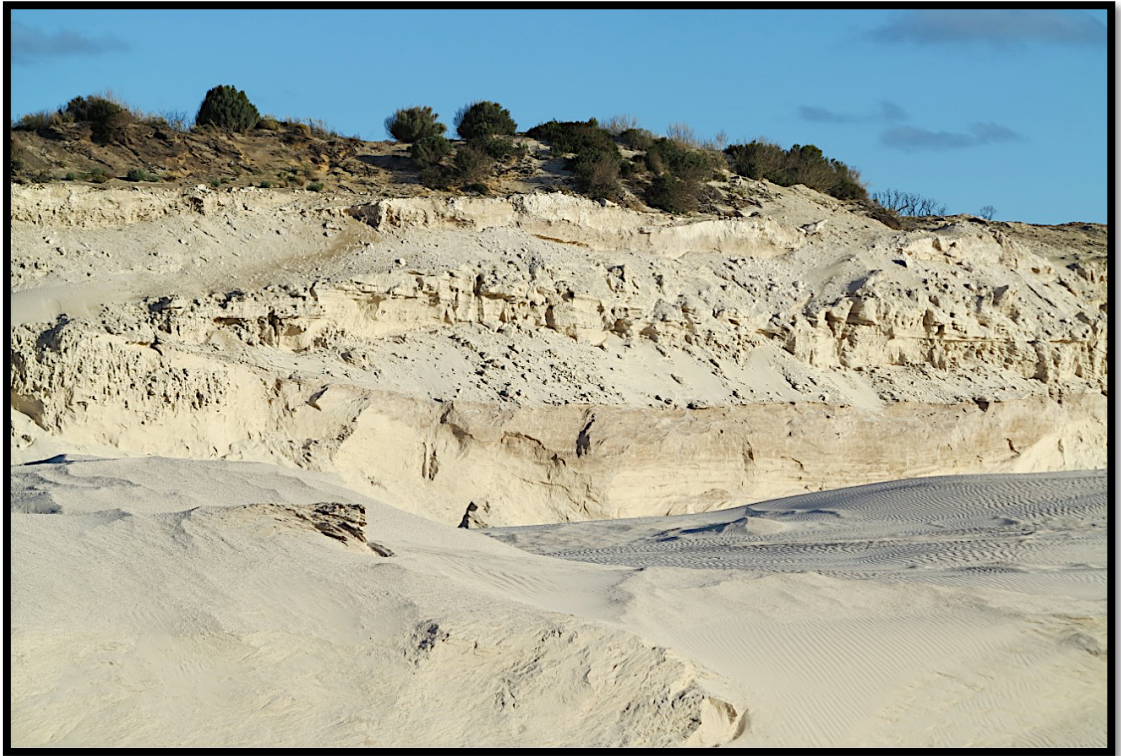
Figure 2 Limestone resource

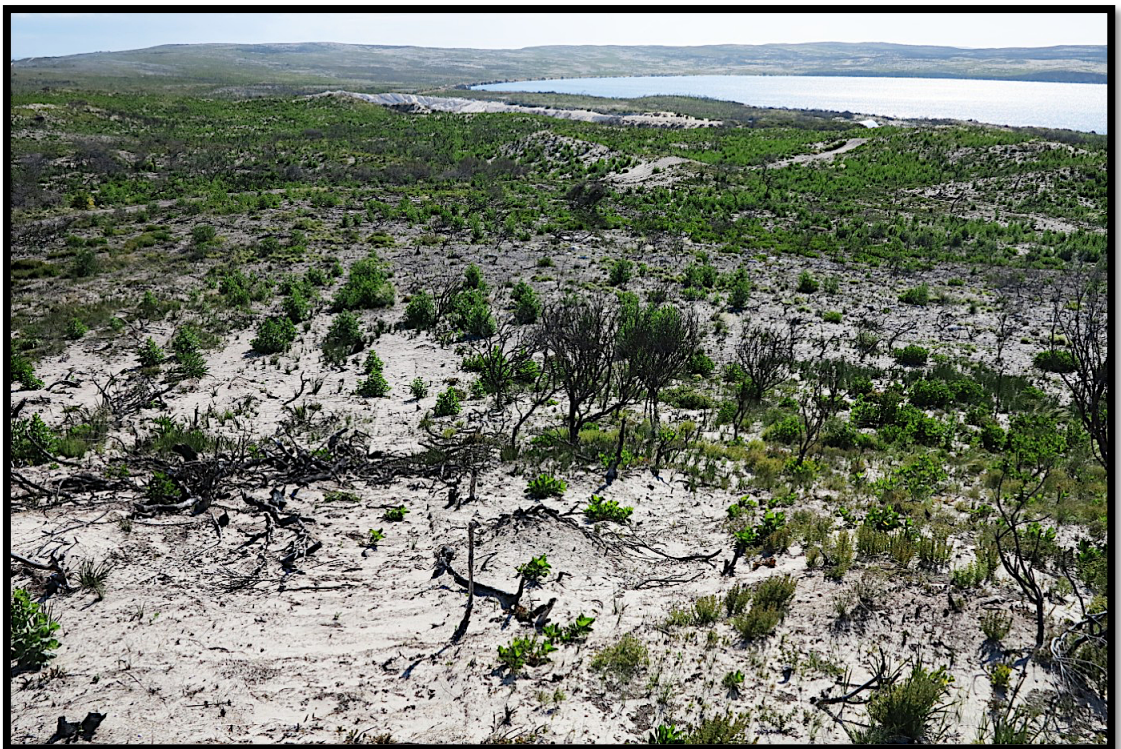
Figure 3 View west across the proposed quarry in the foreground and the existing operations in the middle distance

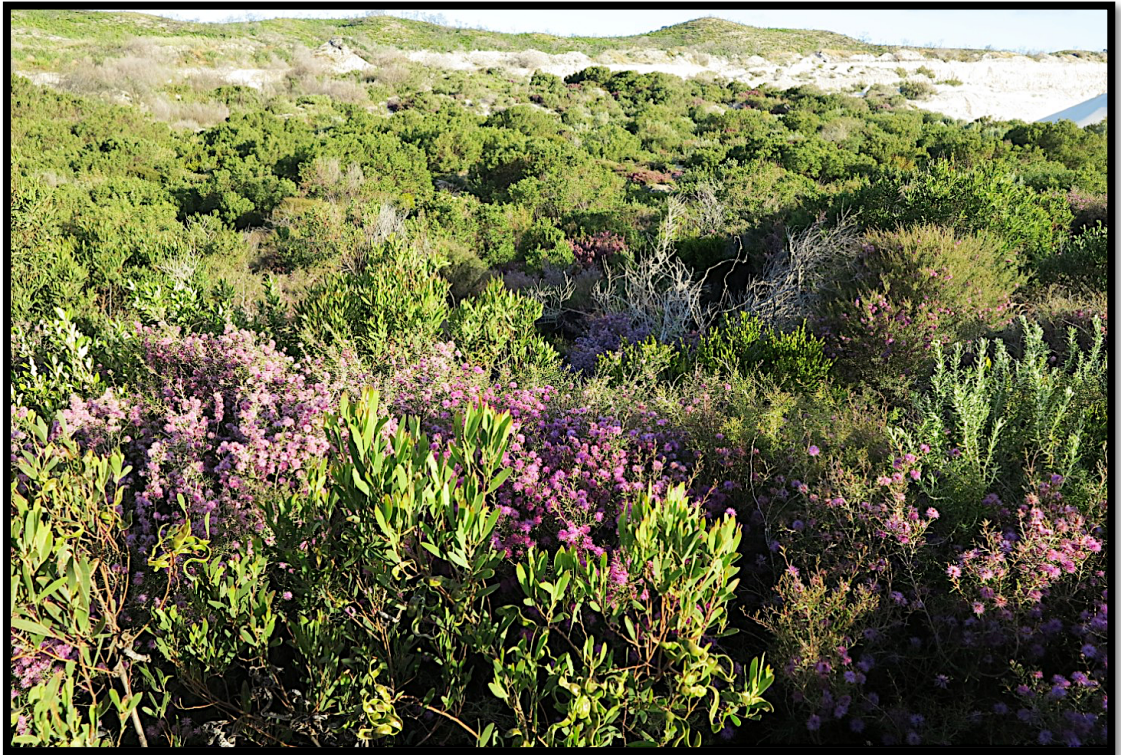
Figure 7 Rehabilitation at the existing pit

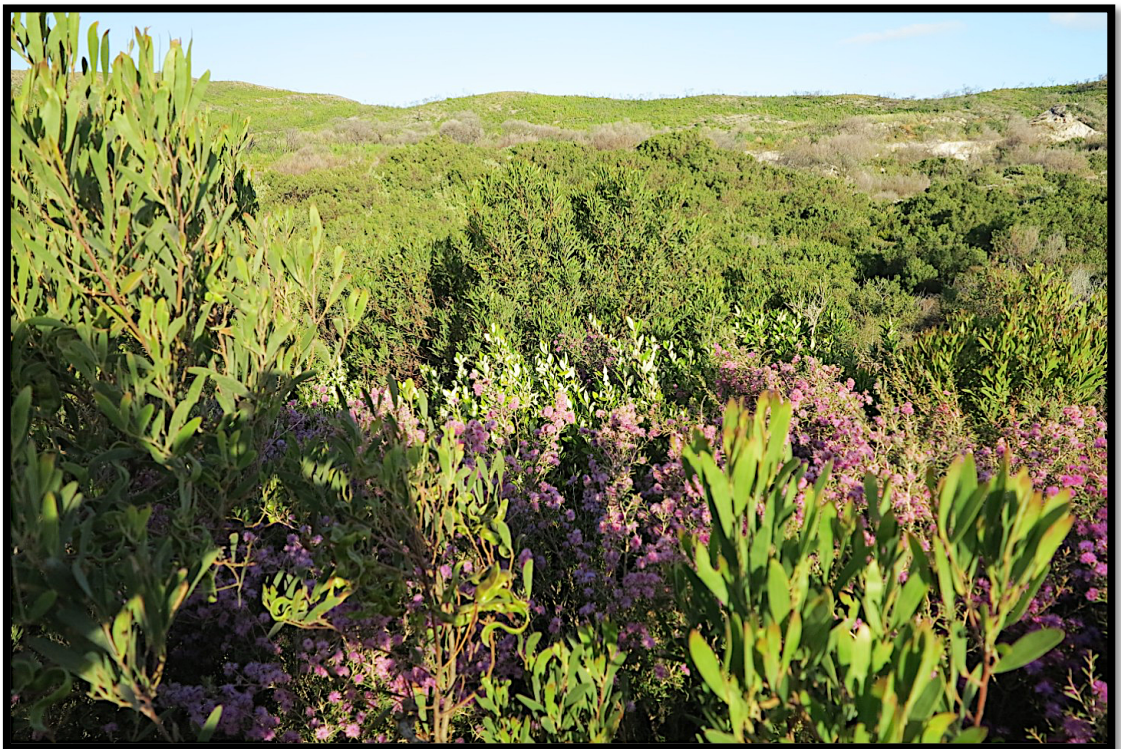
Figure 8 Rehabilitation at the existing pit

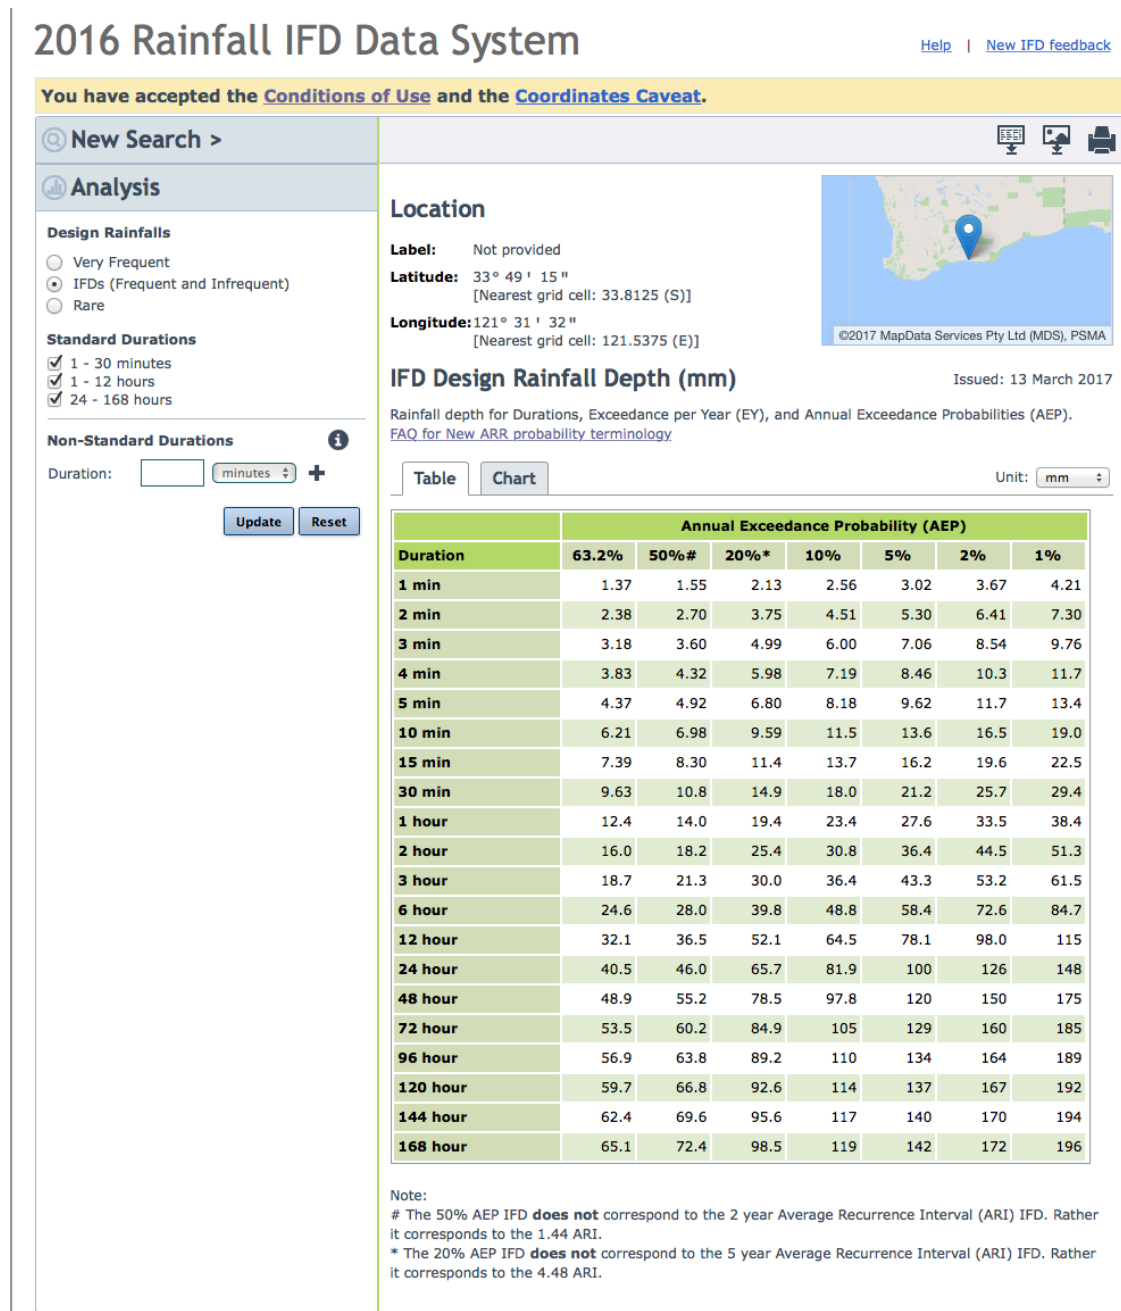
Figure 1 Rainfall Exceedance Chart

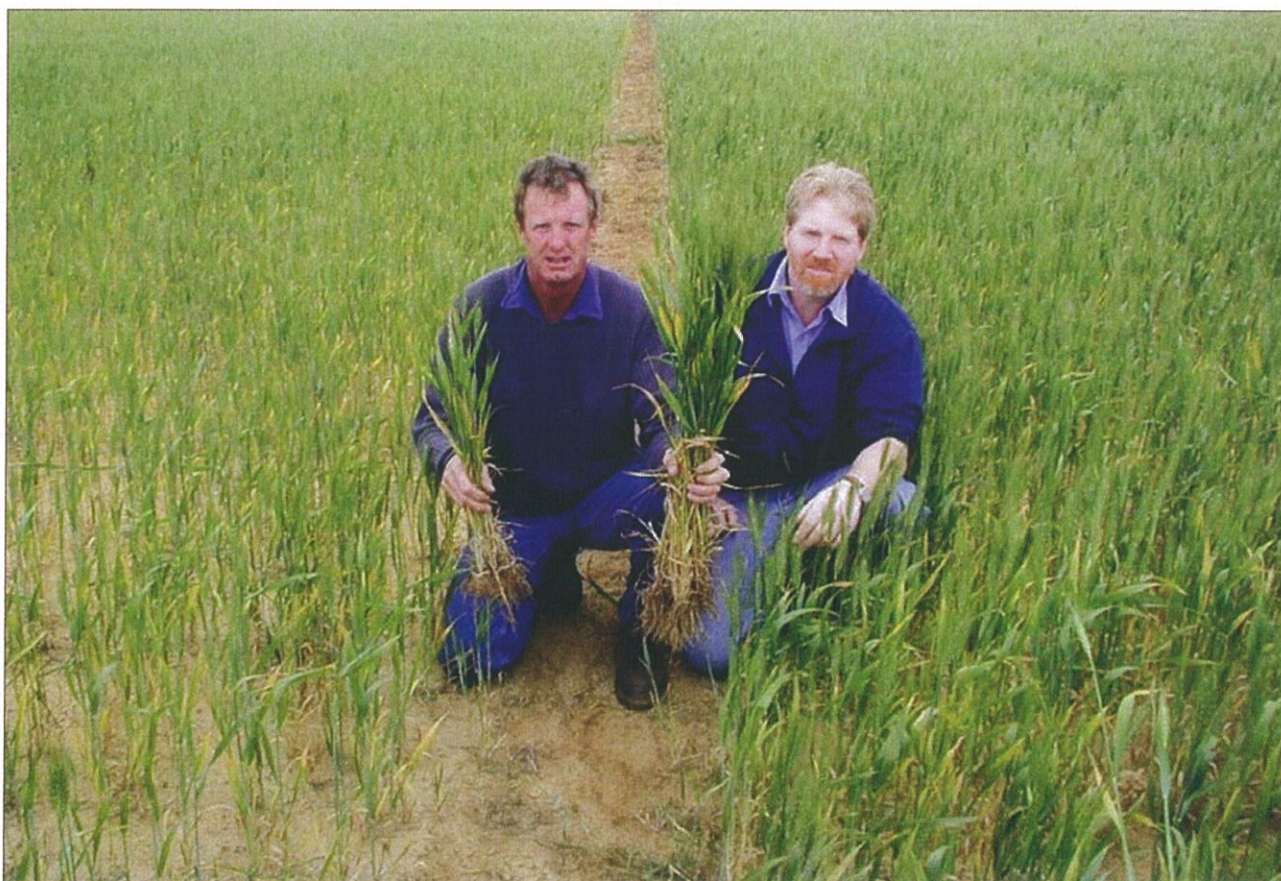
Figure 7 **Liming trial at South Bodallin. When enough lime is applied to treat an acidic soil profile significant plant growth and production responses can be achieved.**
