Water Corporation
Vasse Diversion Drain
Proposal Variation Summary Report

May 2018

Water Corporation
Vasse Diversion Drain Upgrade

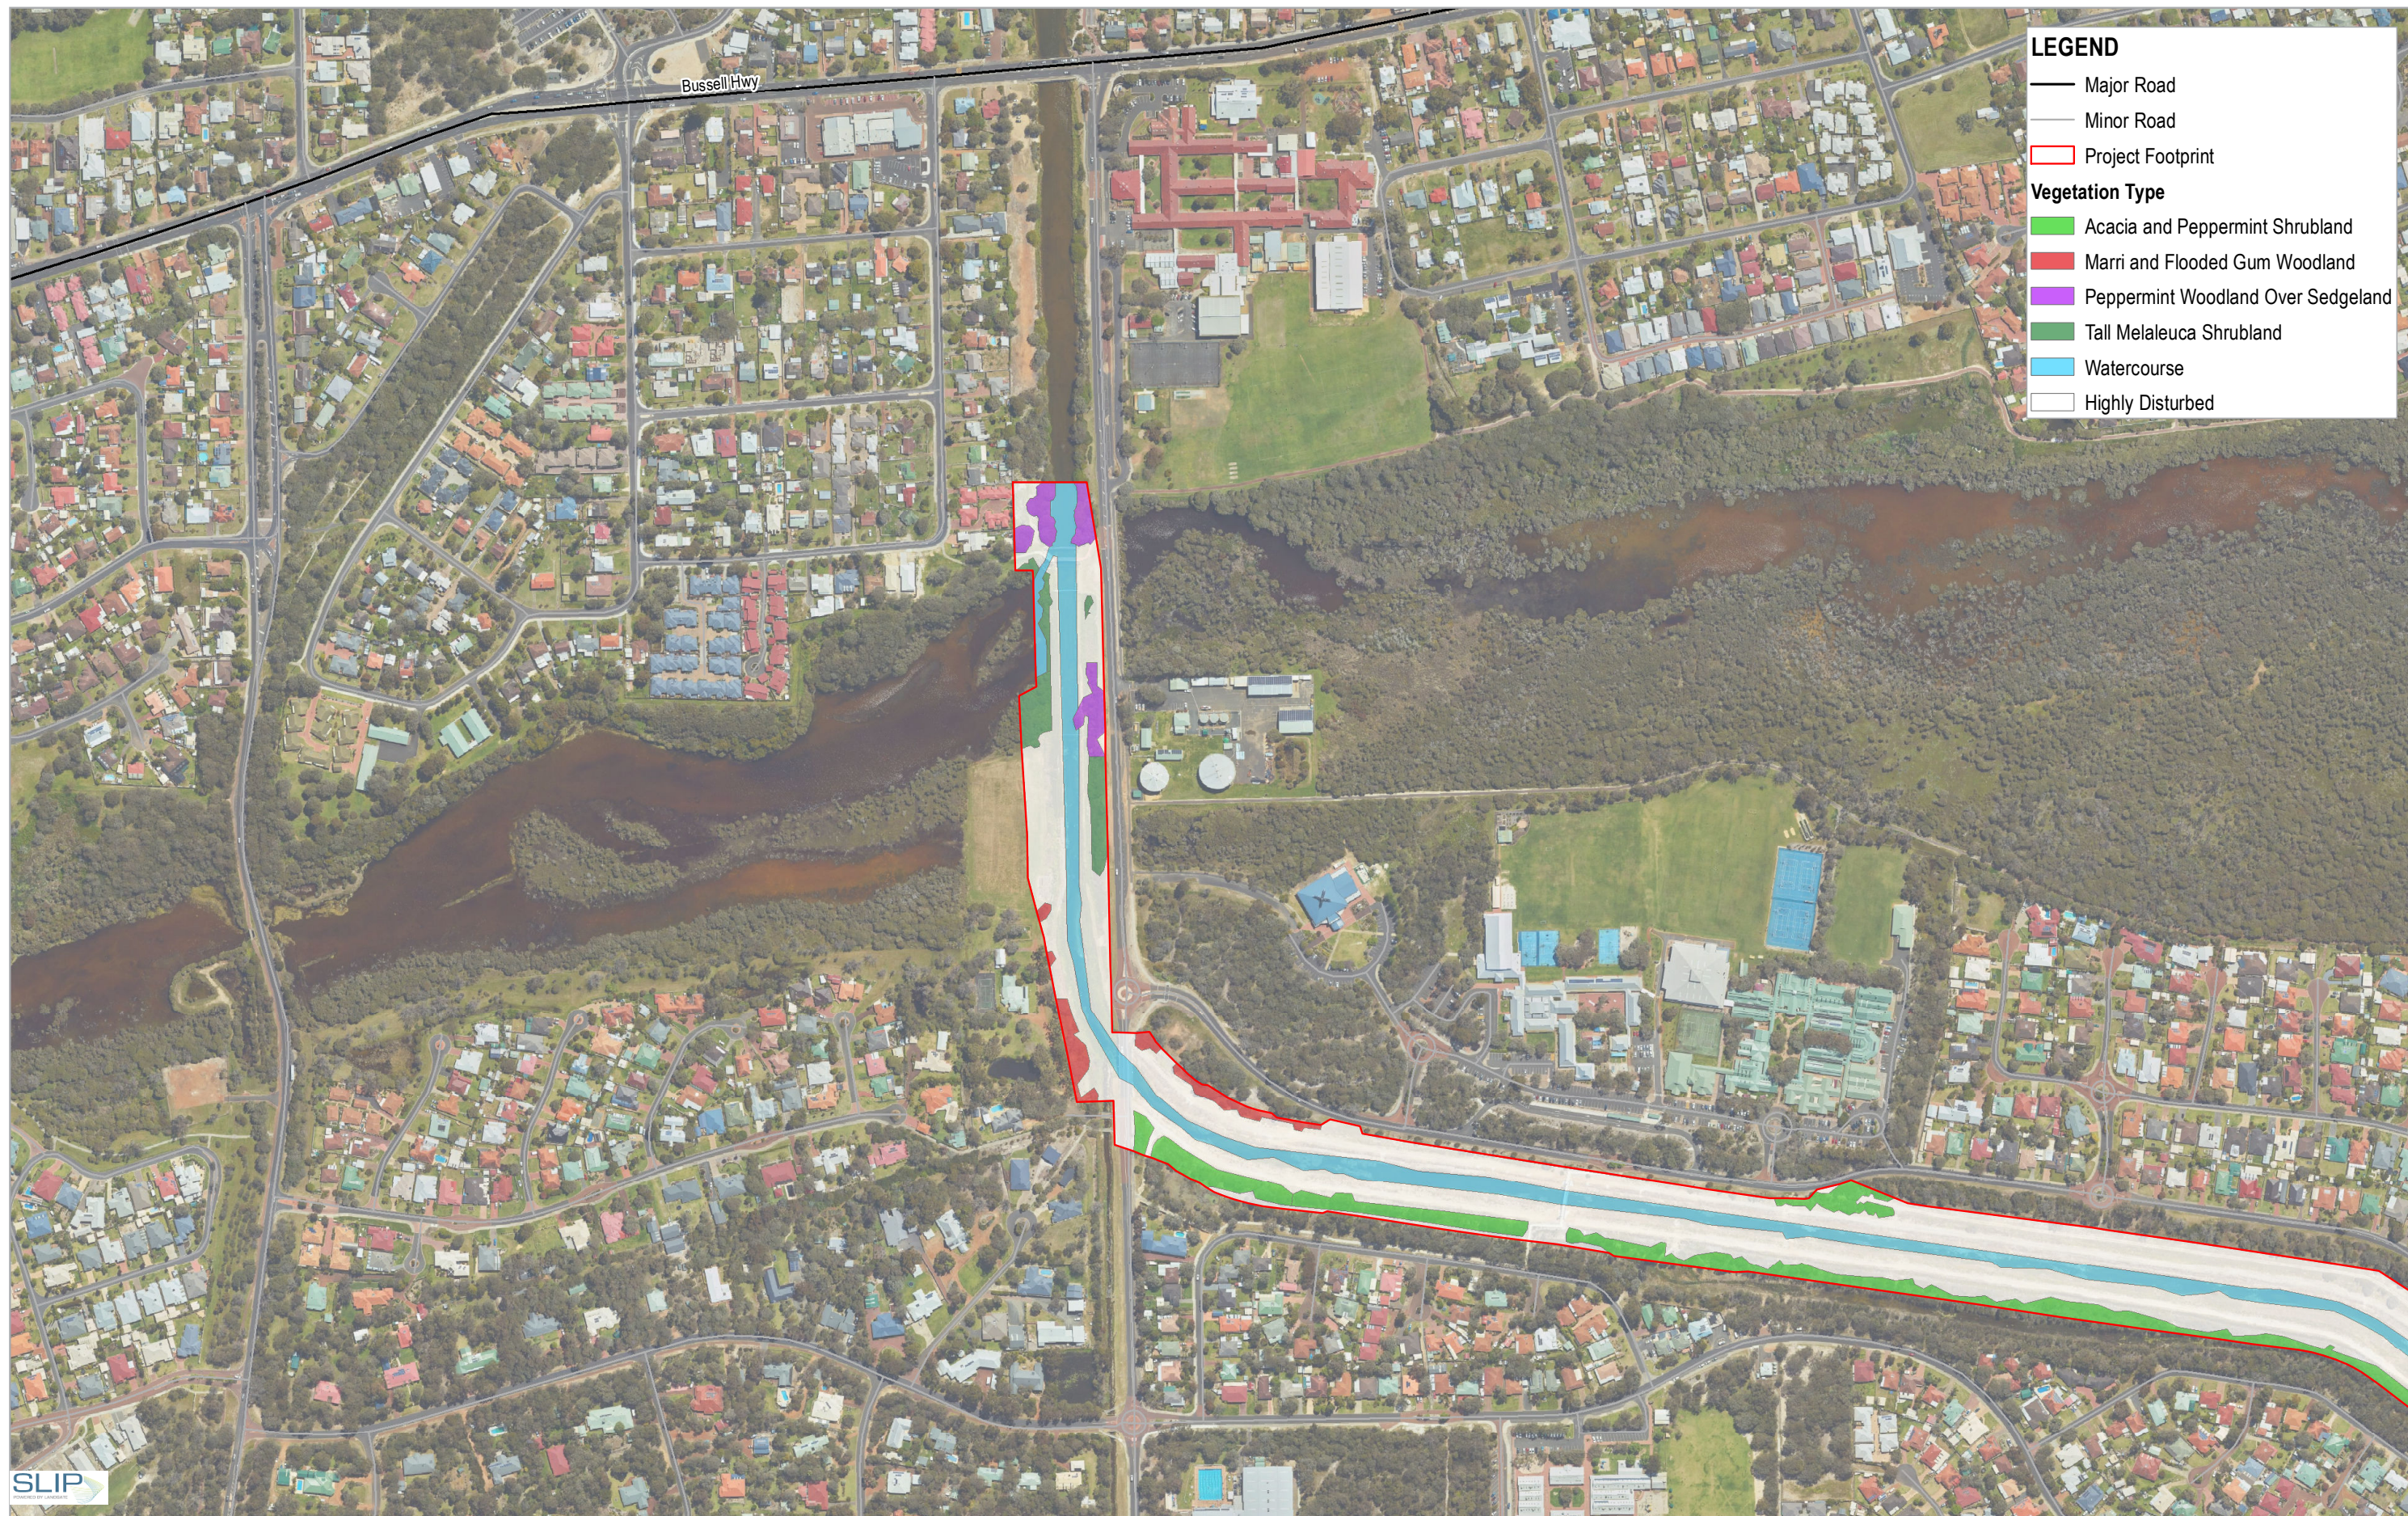
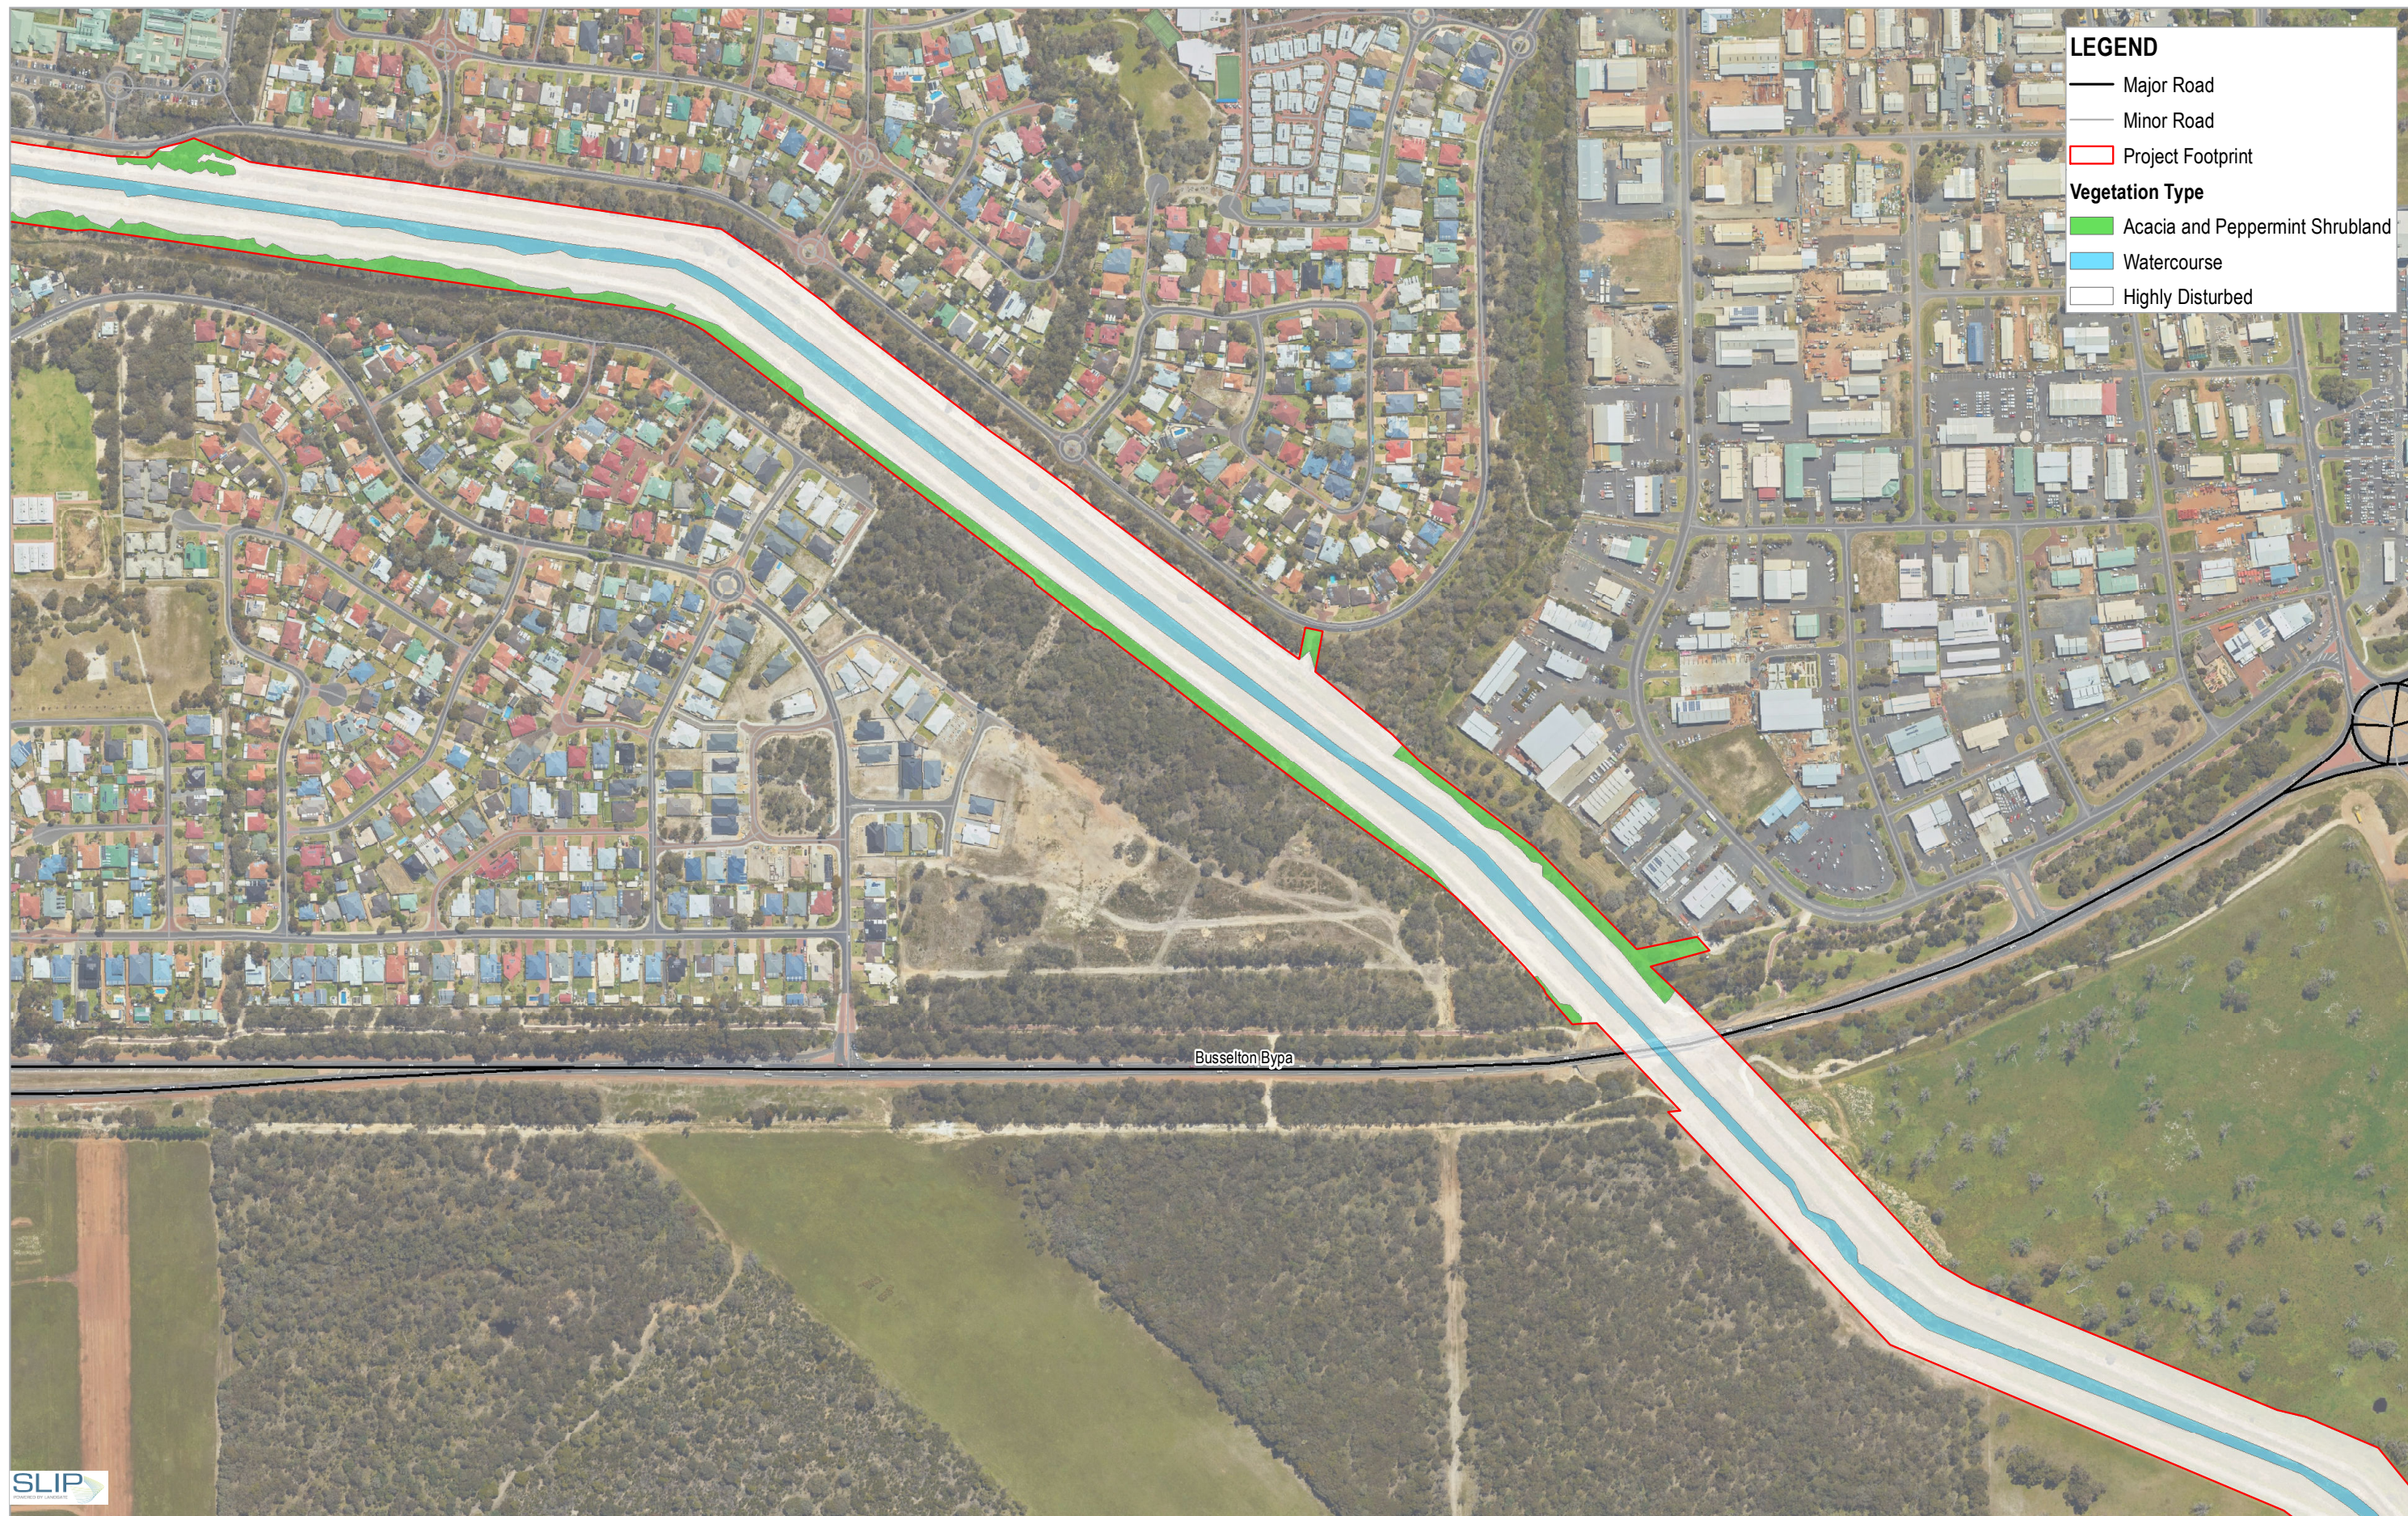
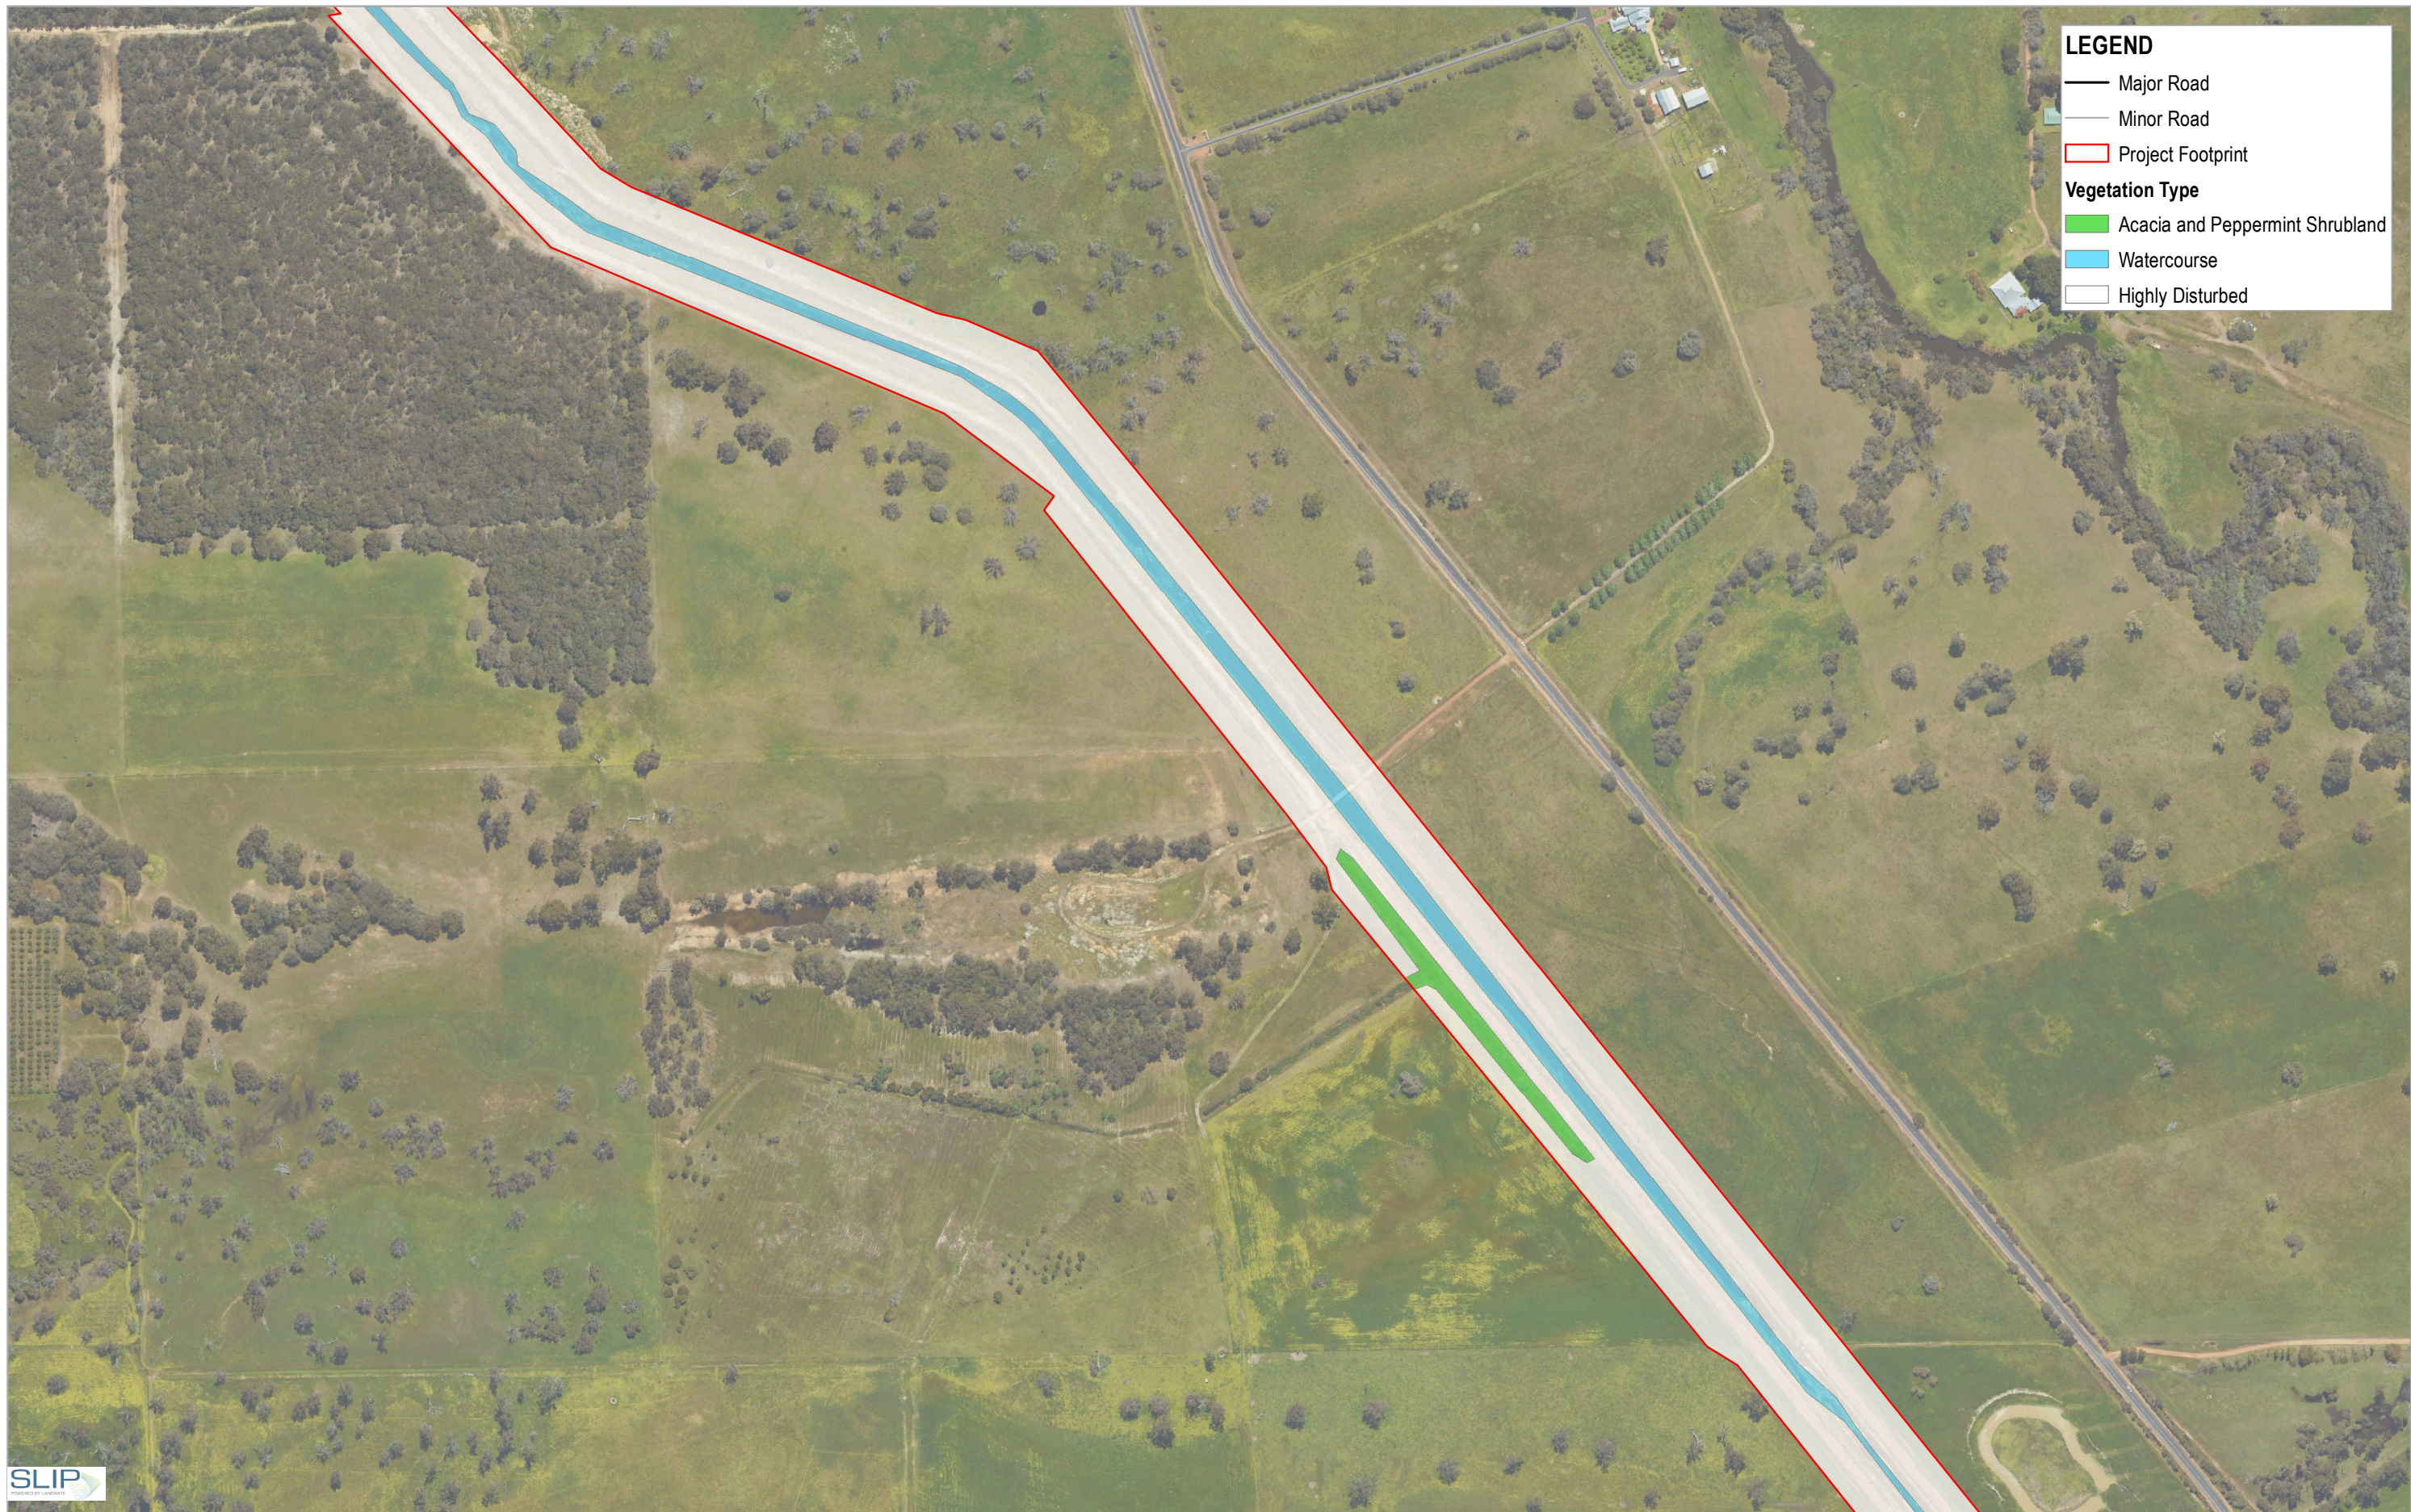
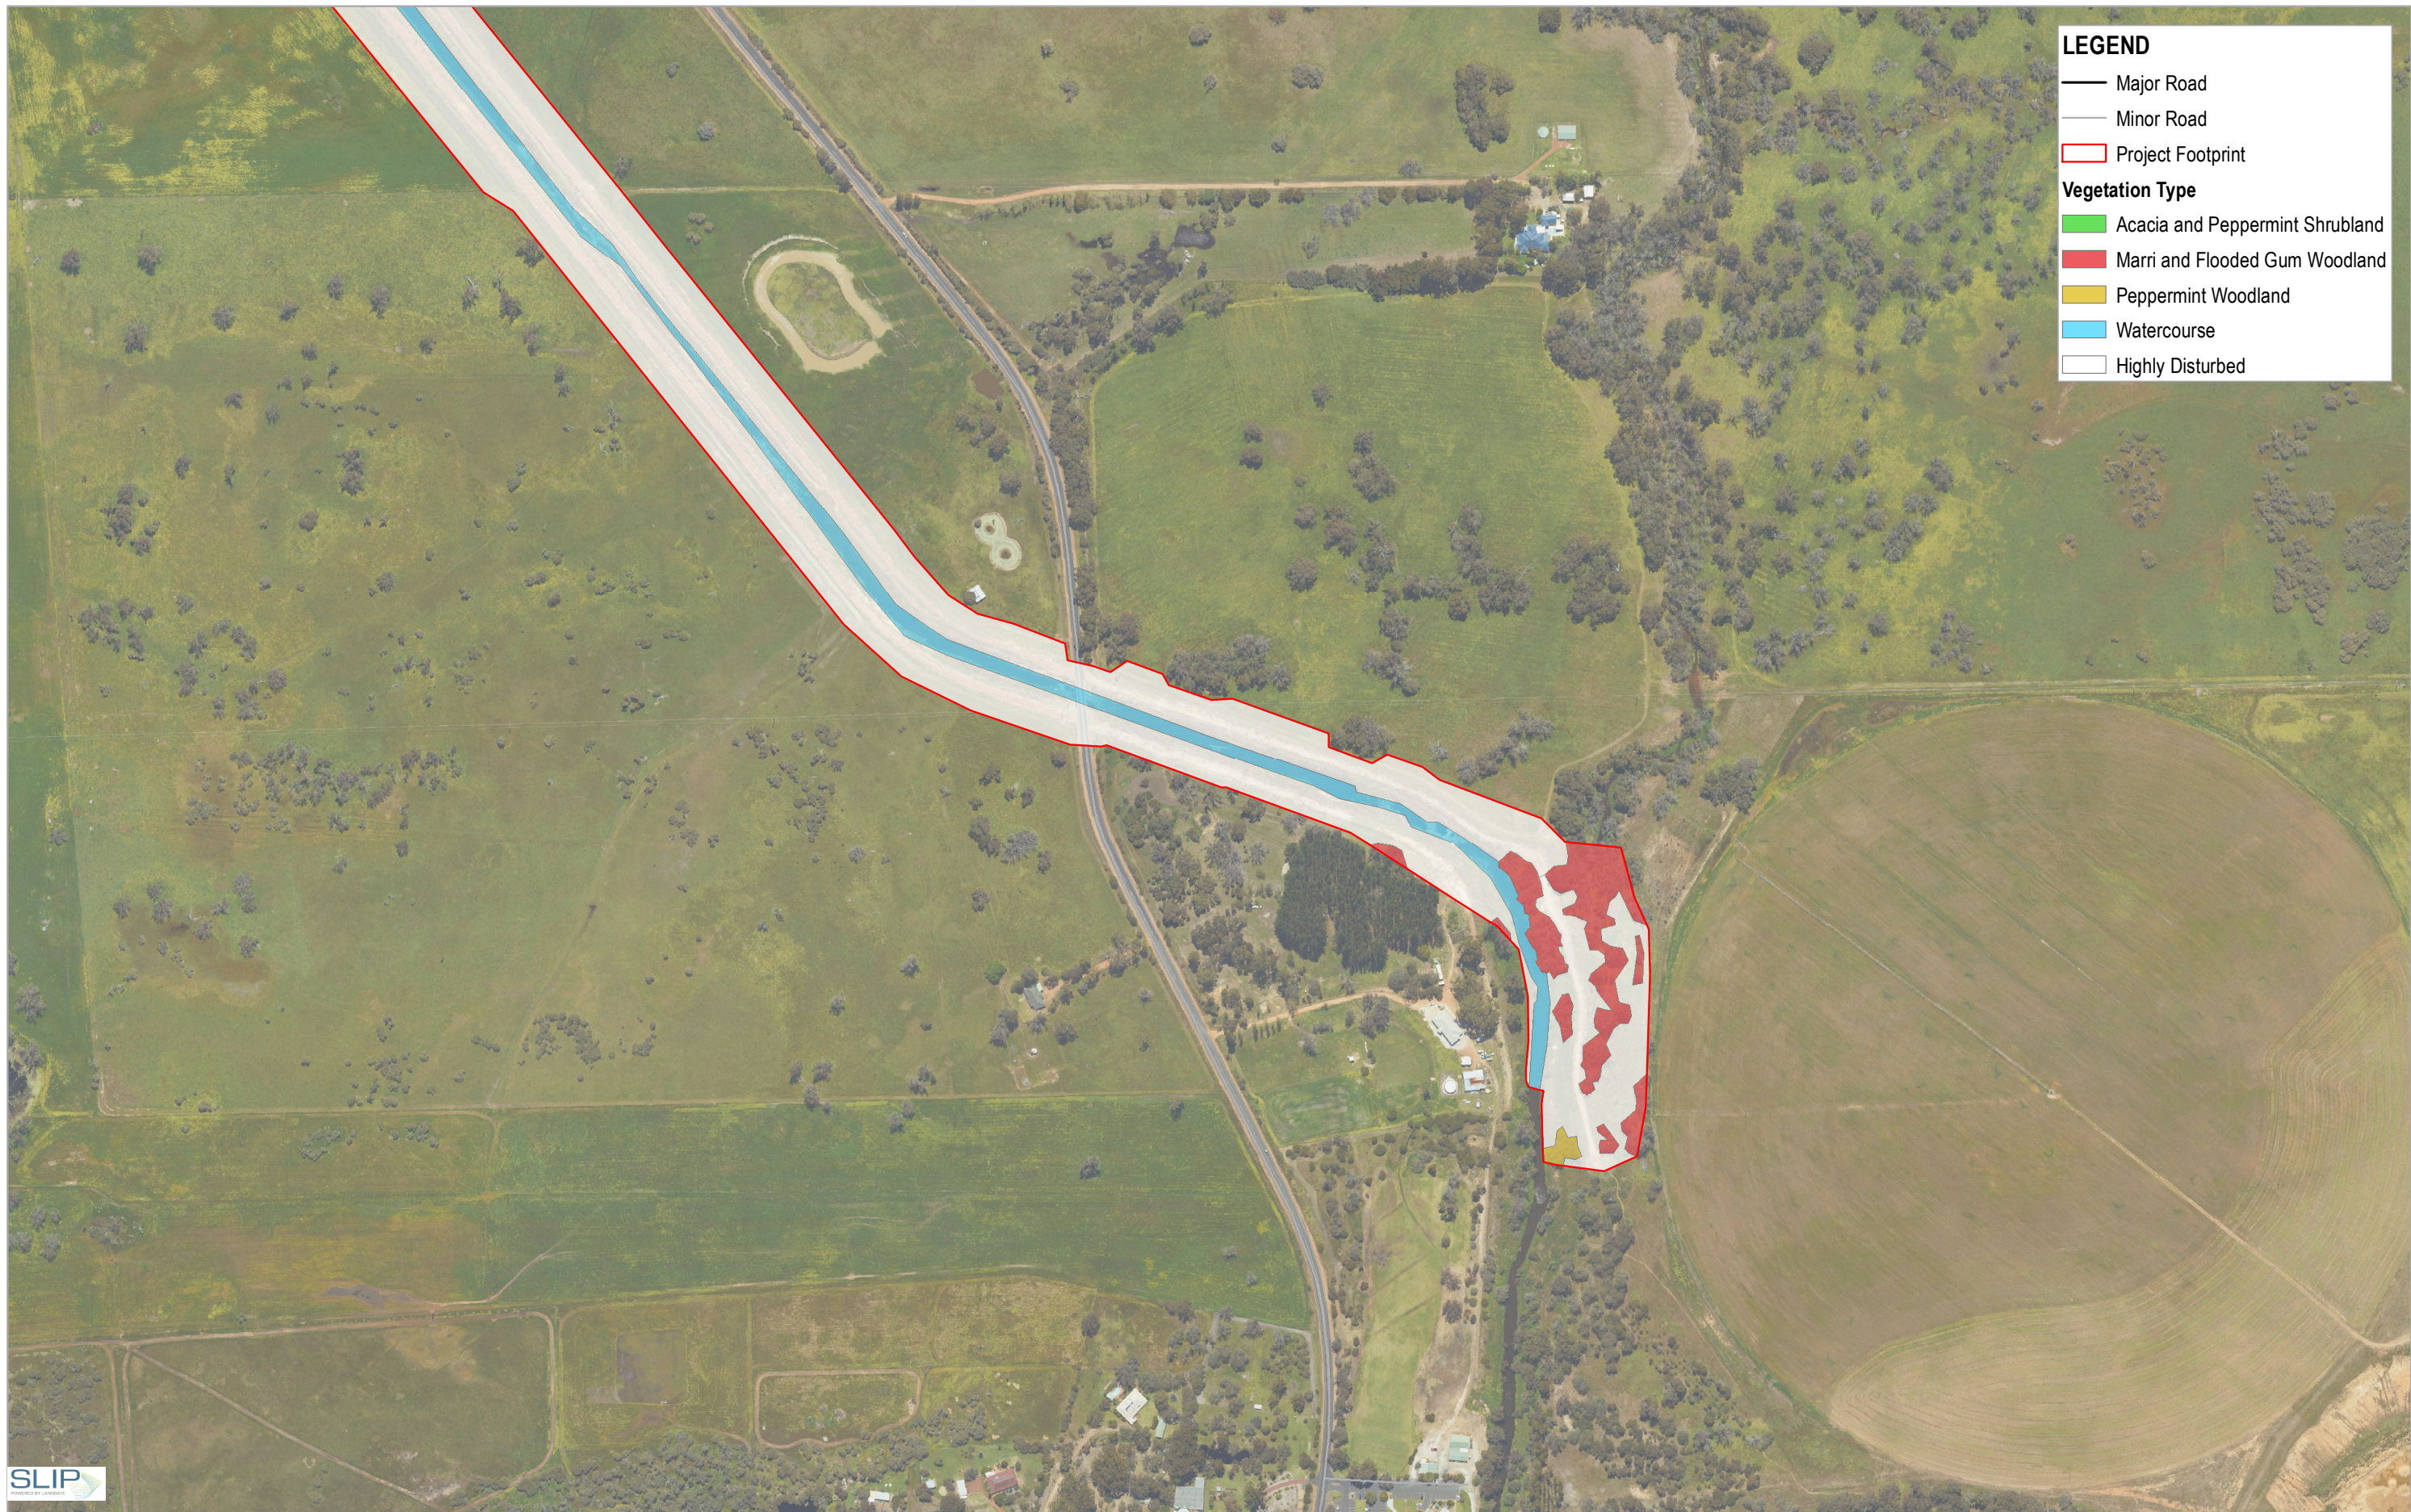
FIGURE 2

A summary of the vegetation types recorded in the revised project footprint is provided in Table 2 with updated mapping provided in Figure 2, Appendix A.

Vegetation Type

Five vegetation types have been mapped within the project footprint, as well as the Vasse drain (watercourse) and highly disturbed vegetation. Although the total project footprint has increased by 2.41 ha, the clearing of remnant native vegetation has reduced, with the majority (74%) of the project footprint consisting of highly disturbed (or cleared) vegetation.
