Water Corporation
Vasse Diversion Drain
Proposal Variation Summary Report

May 2018

Water Corporation
Vasse Diversion Drain Upgrade

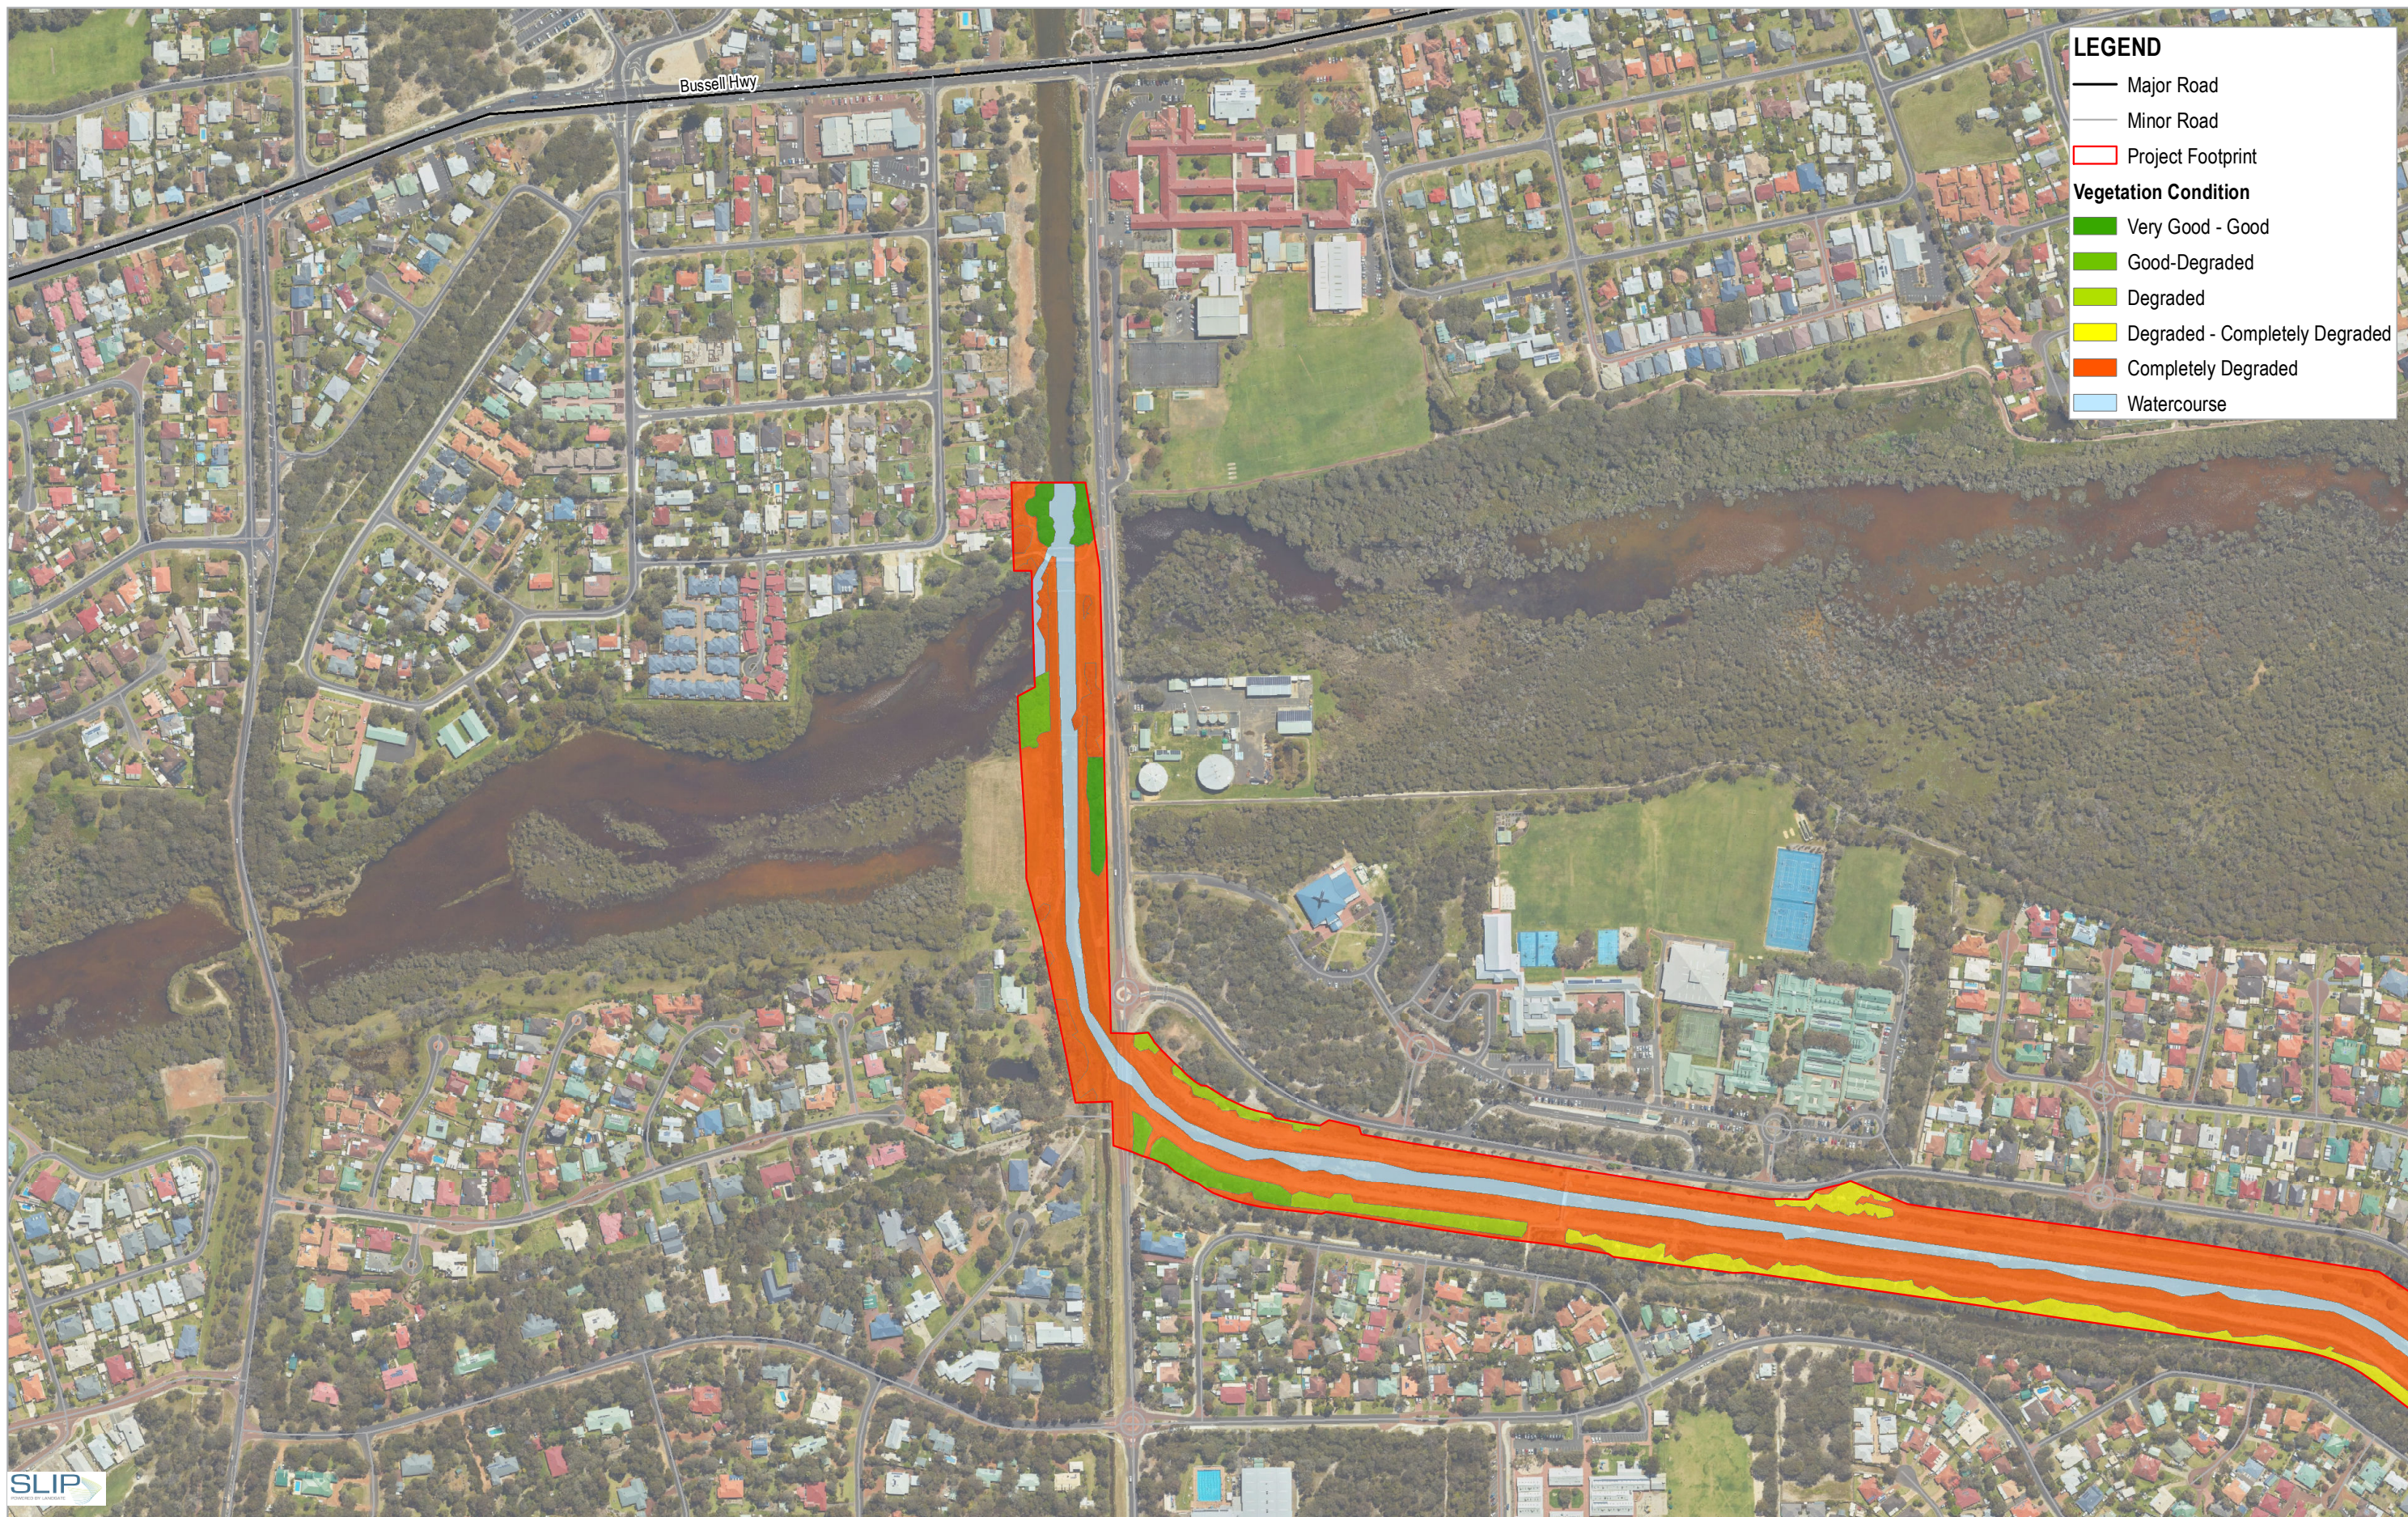
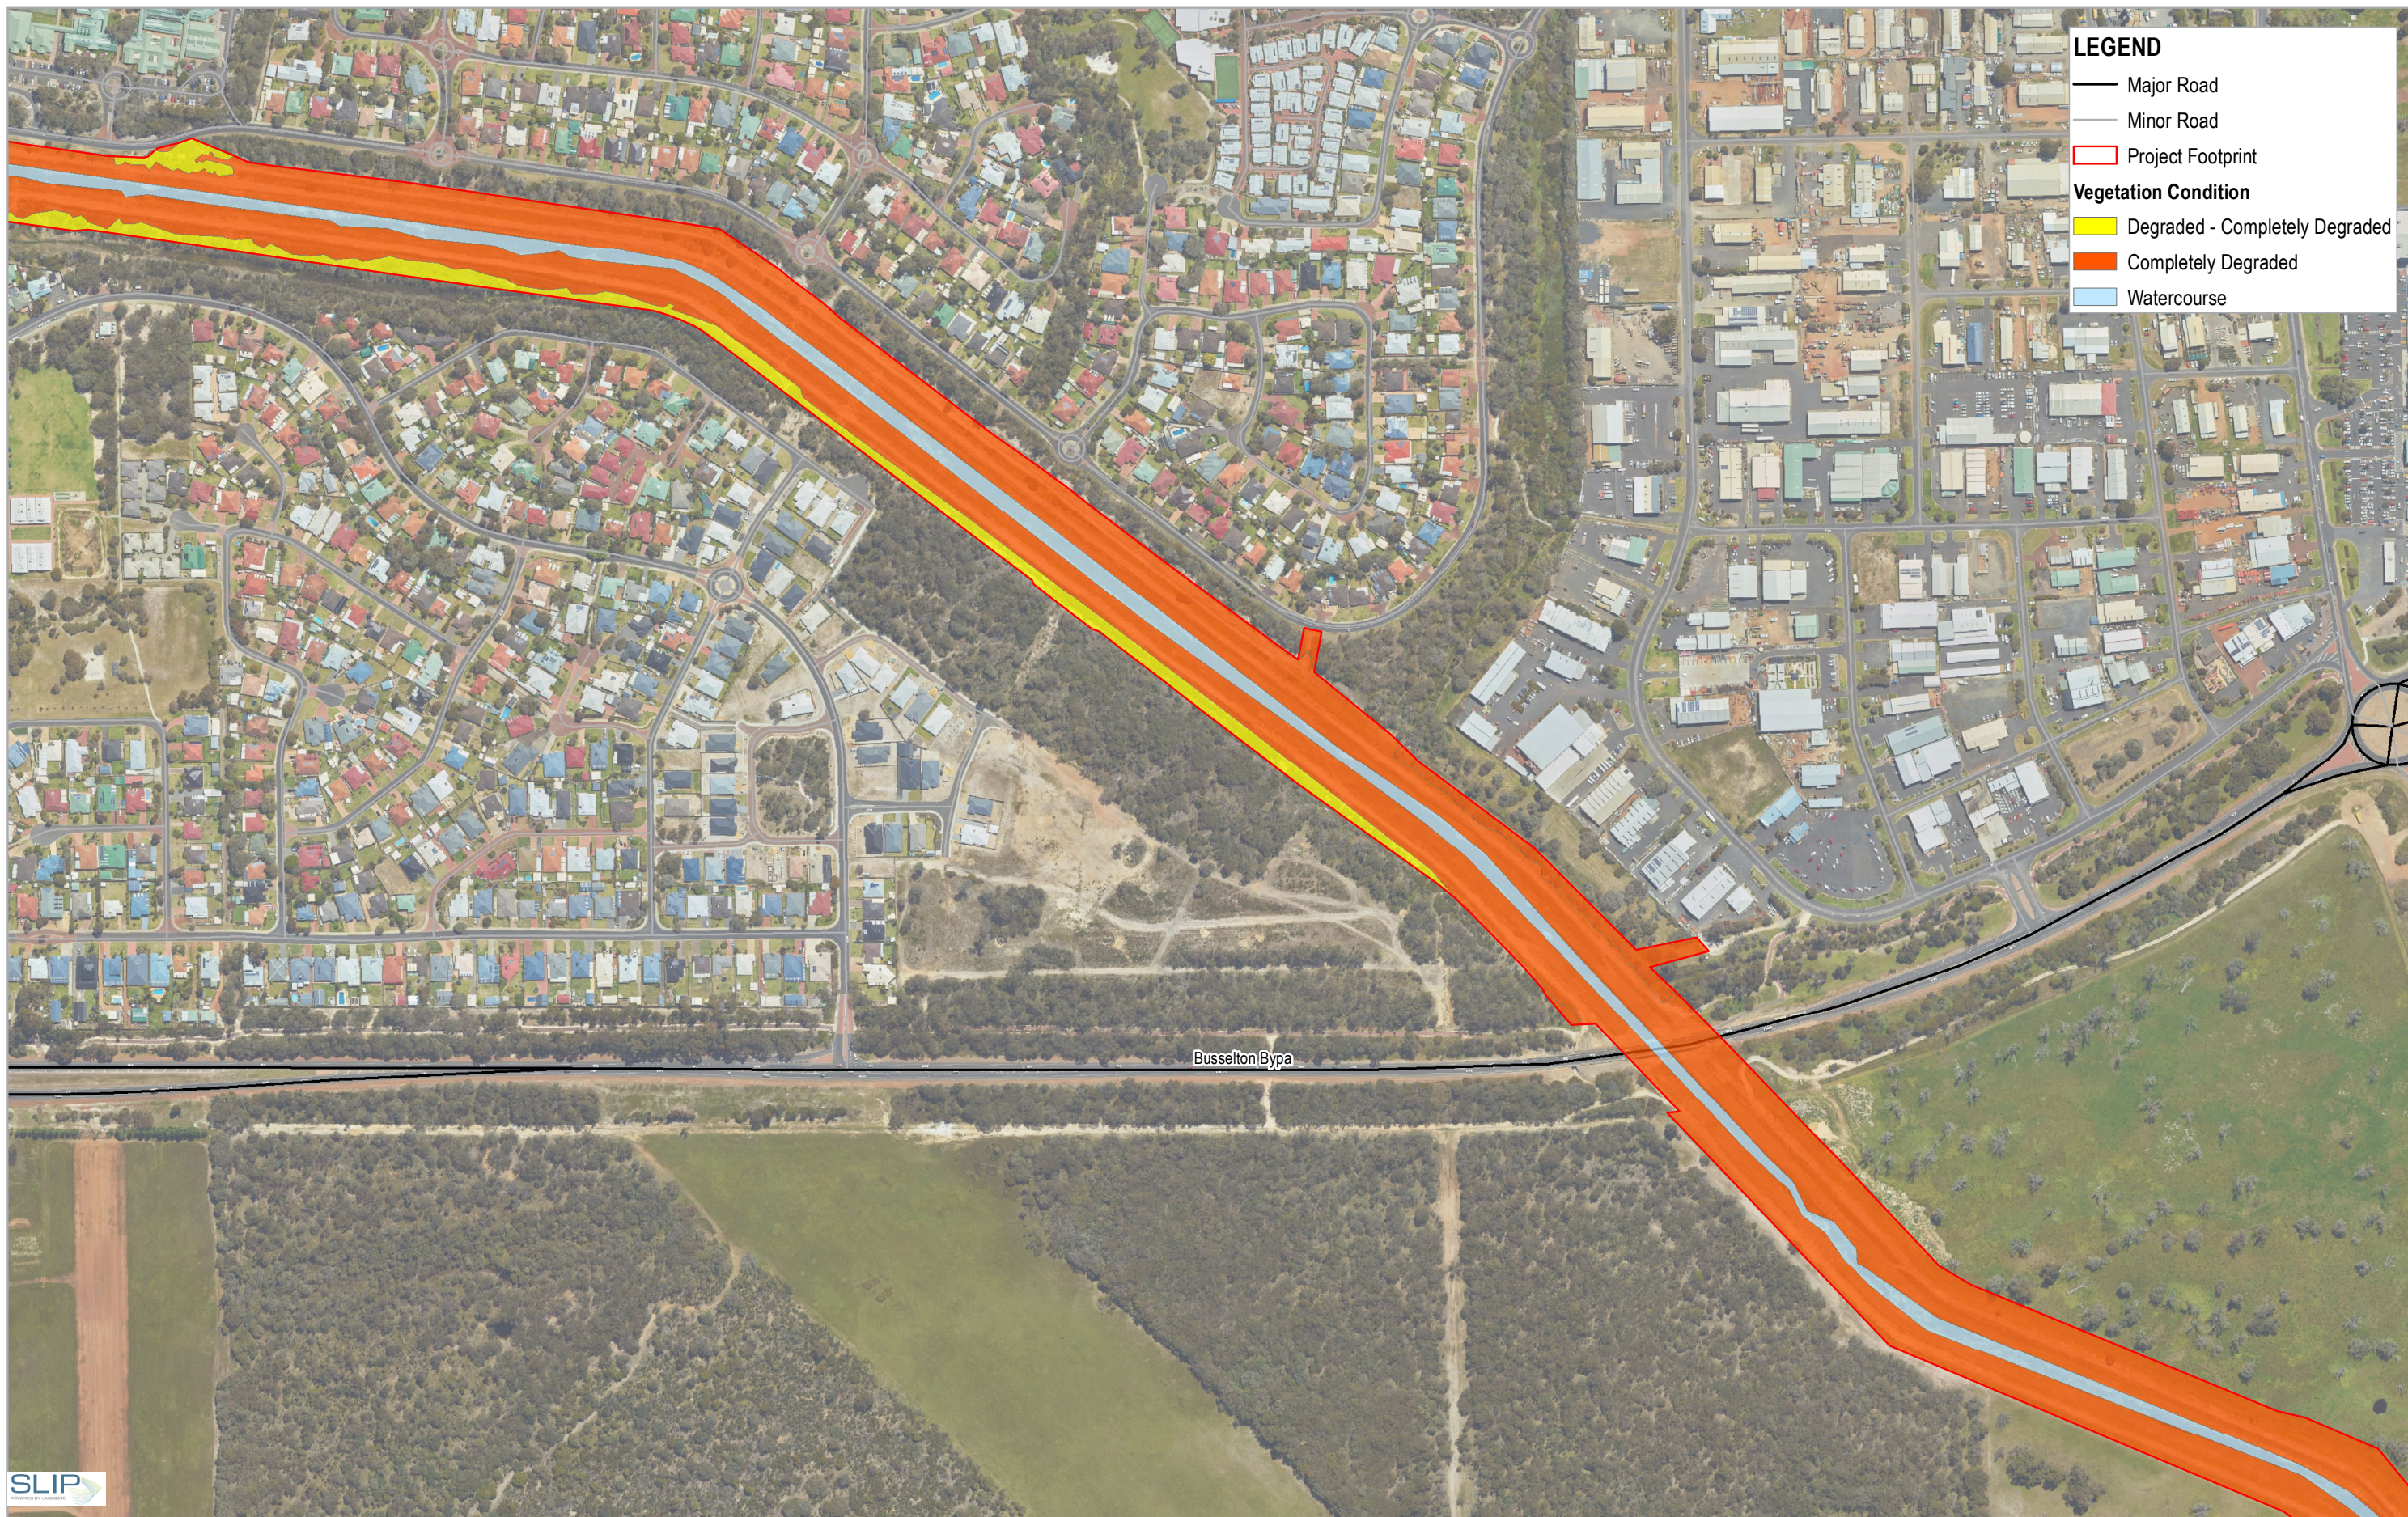
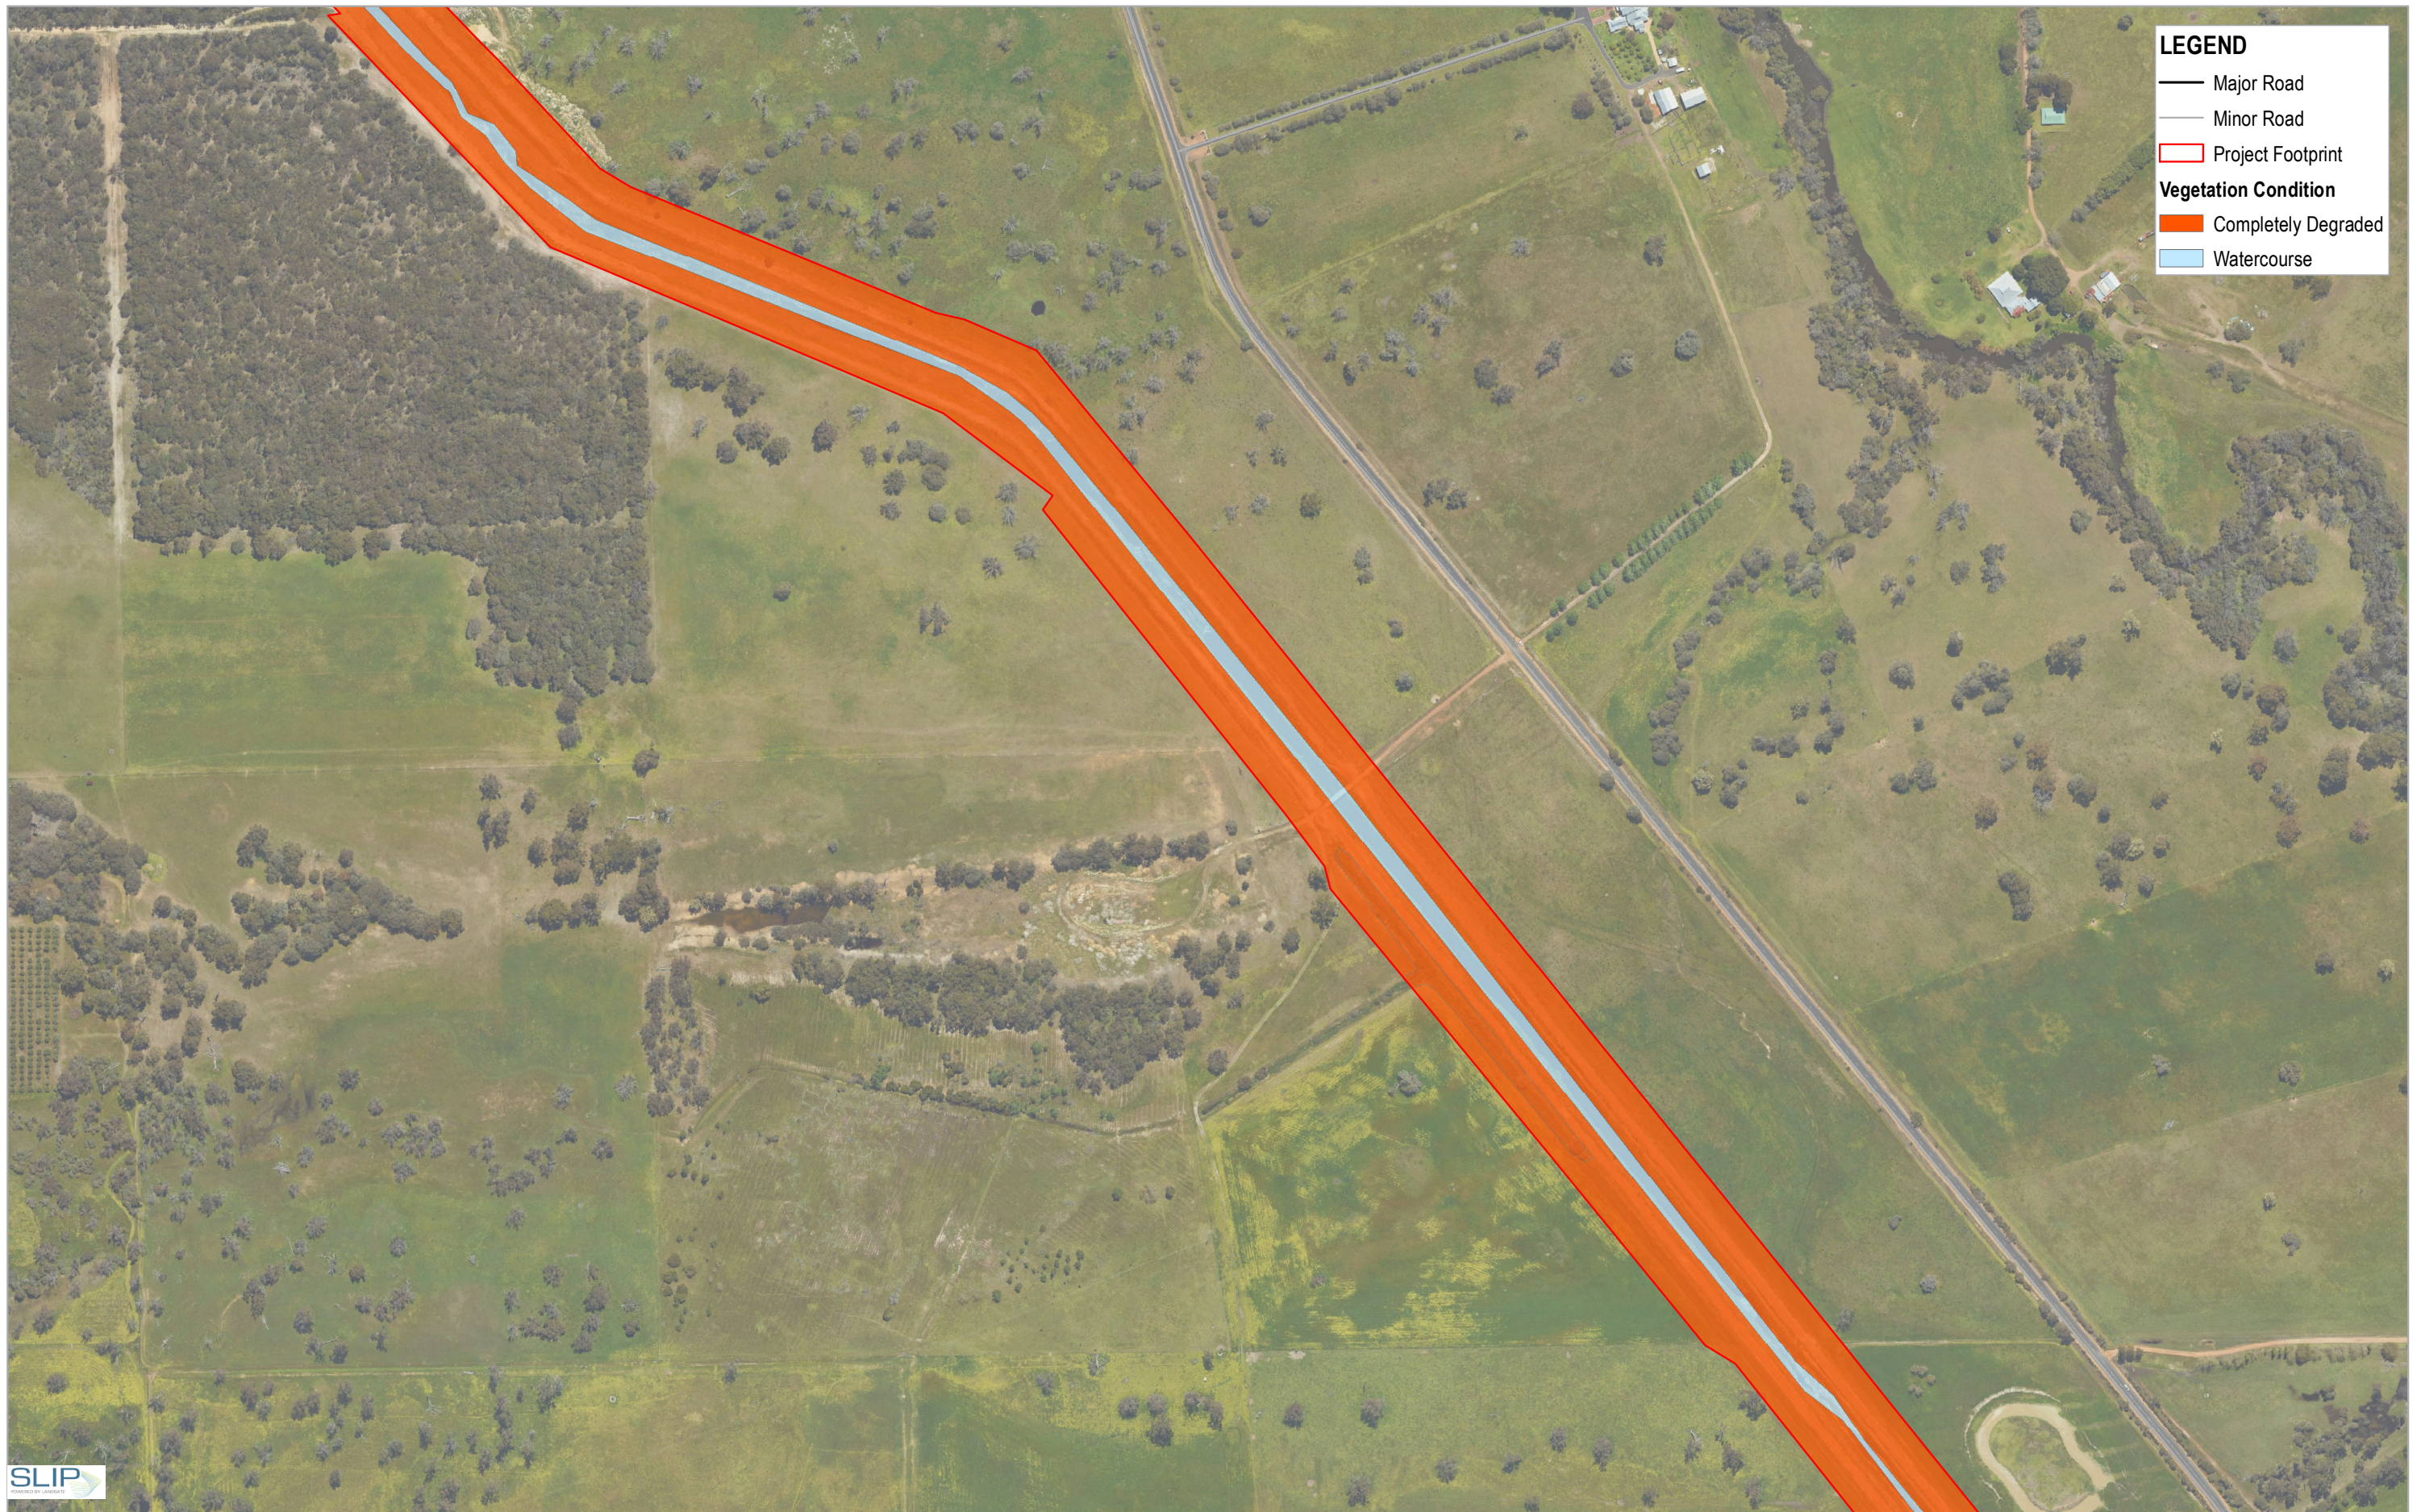
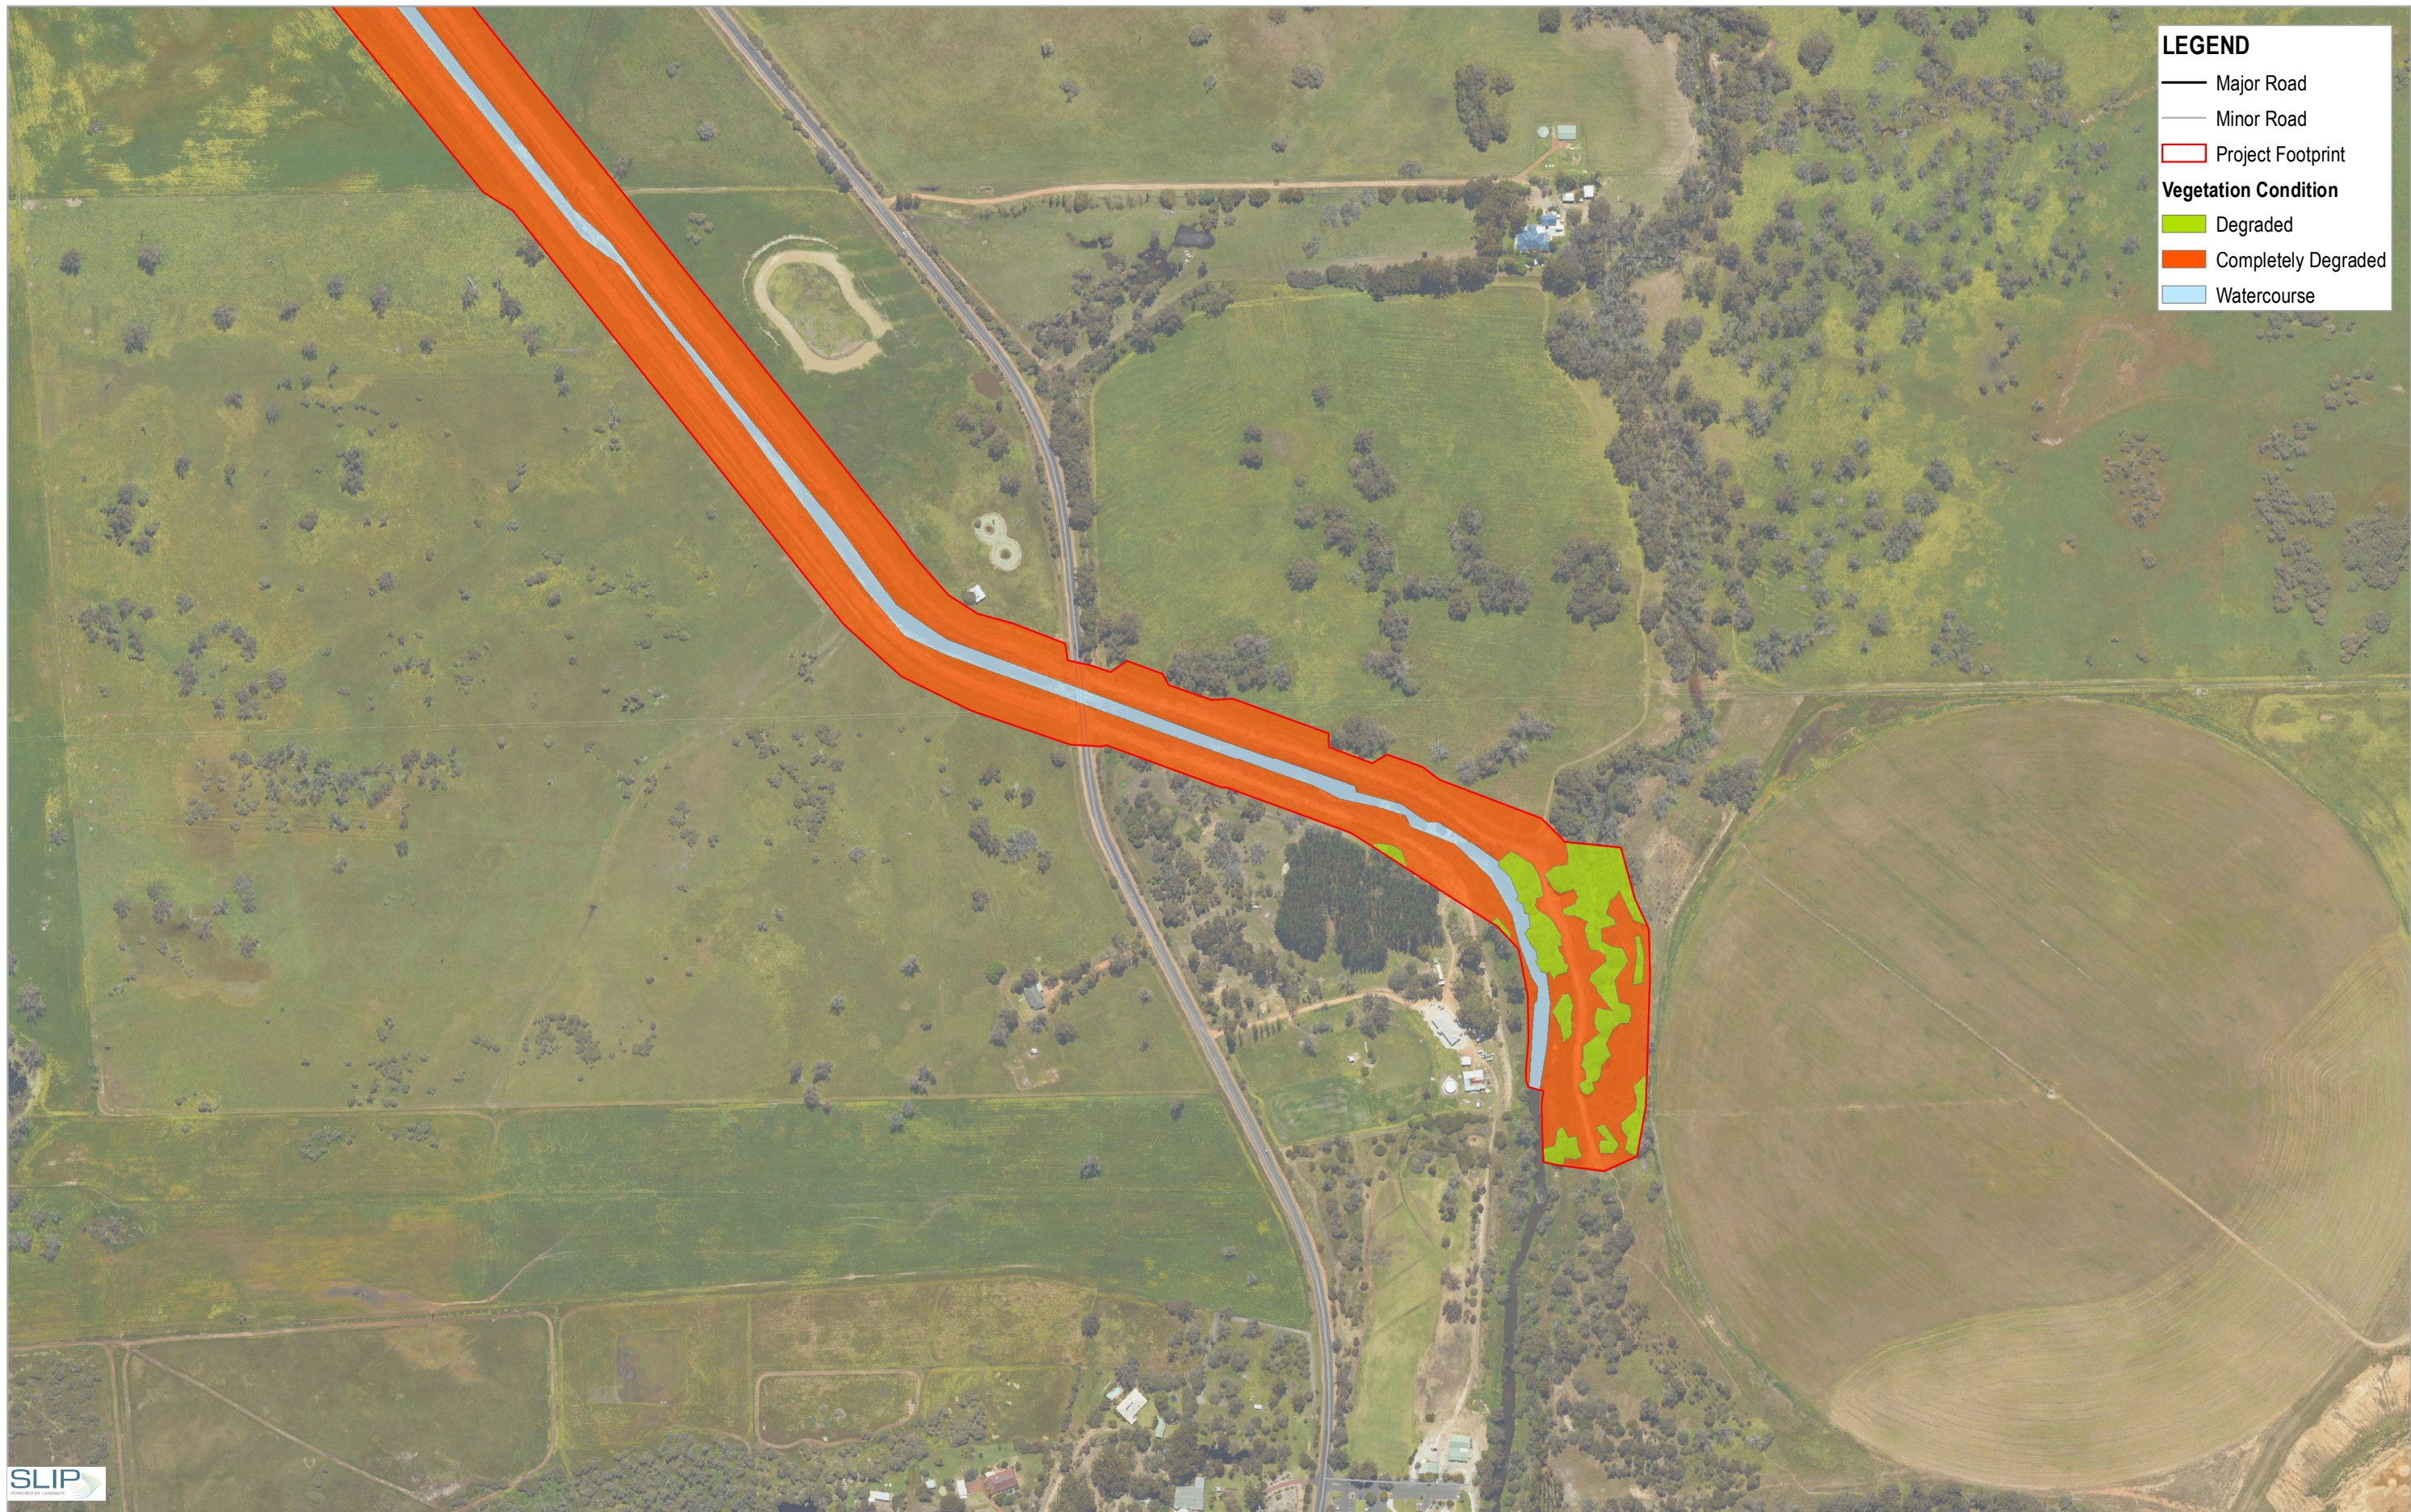
FIGURE 3

A summary of the vegetation condition rating mapped within the revised project footprint is provided in Table 3 with updated mapping provided in Figure 3, Appendix A.

Vegetation Condition

A large proportion of the project footprint has been mapped as completely degraded. The vegetation structure is severely impacted by disturbances such as historical clearing and weed invasion (GHD 2017c). There has been a very slight increase in the clearing of vegetation rated as Very Good to Good condition (0.02 ha) which is associated with the *Acacia* and Peppermint Shrubland.
