Water Corporation
Vasse Diversion Drain
Proposal Variation Summary Report

May 2018

Water Corporation
Vasse Diversion Drain Upgrade

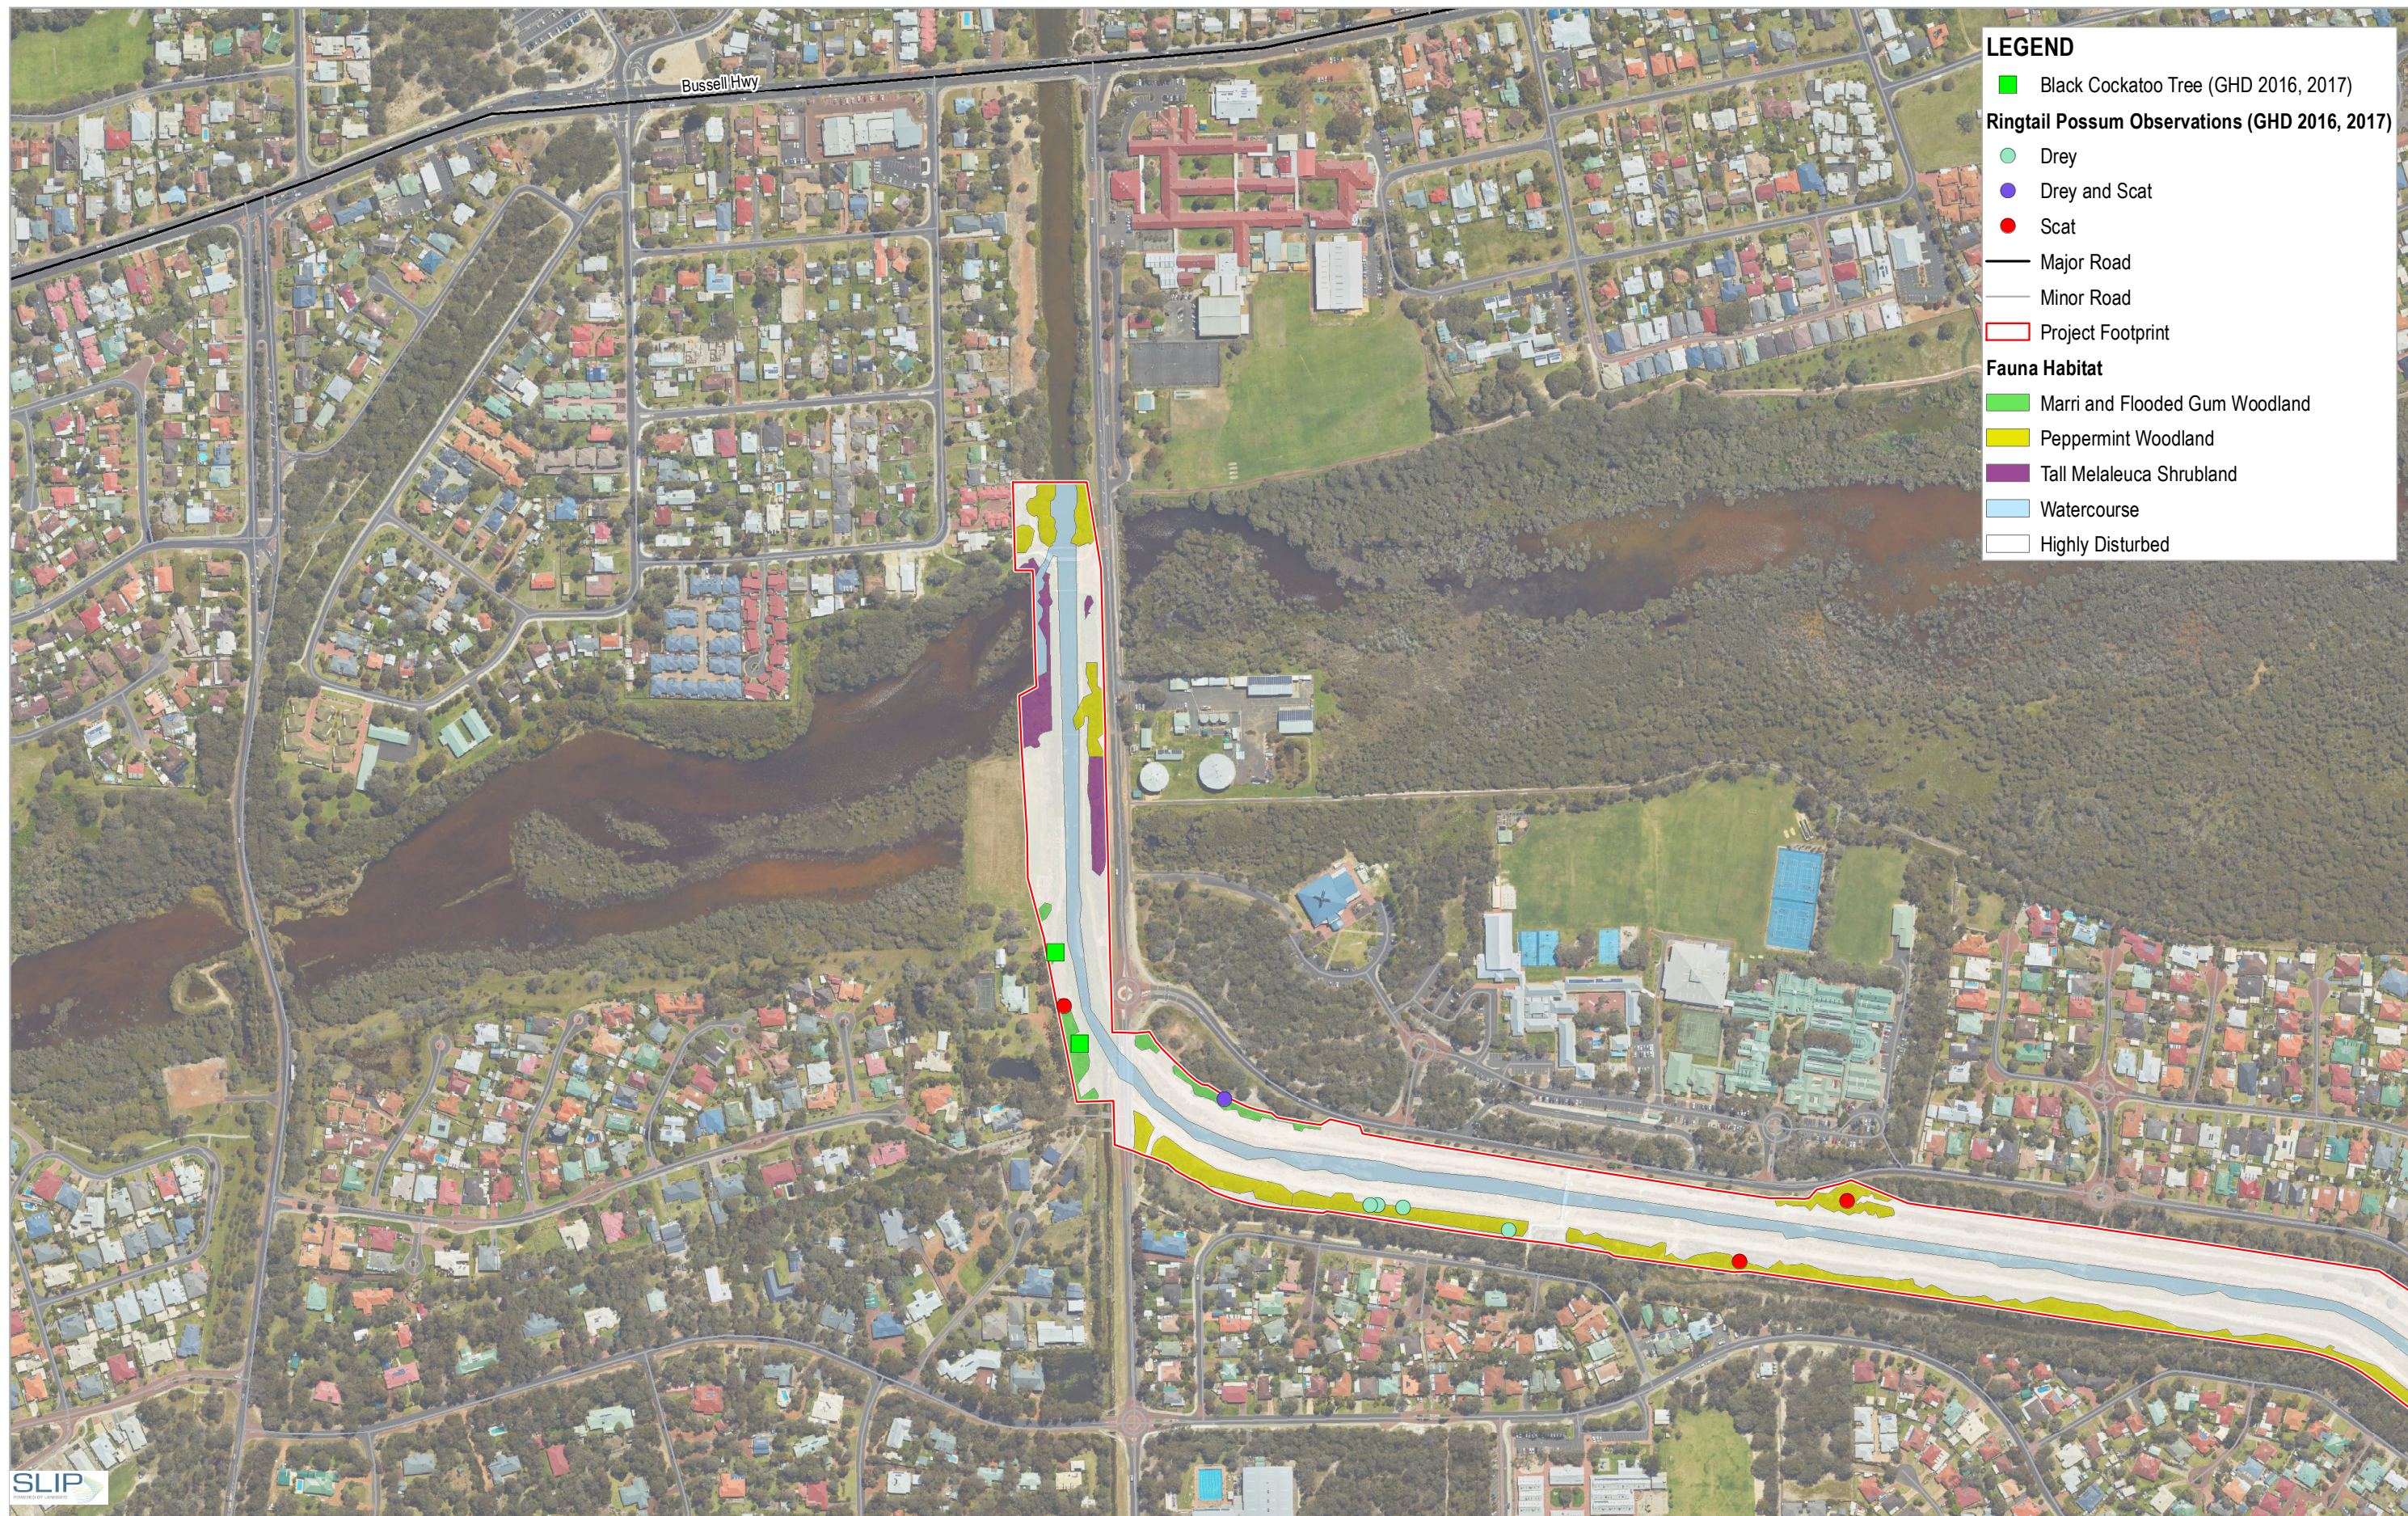
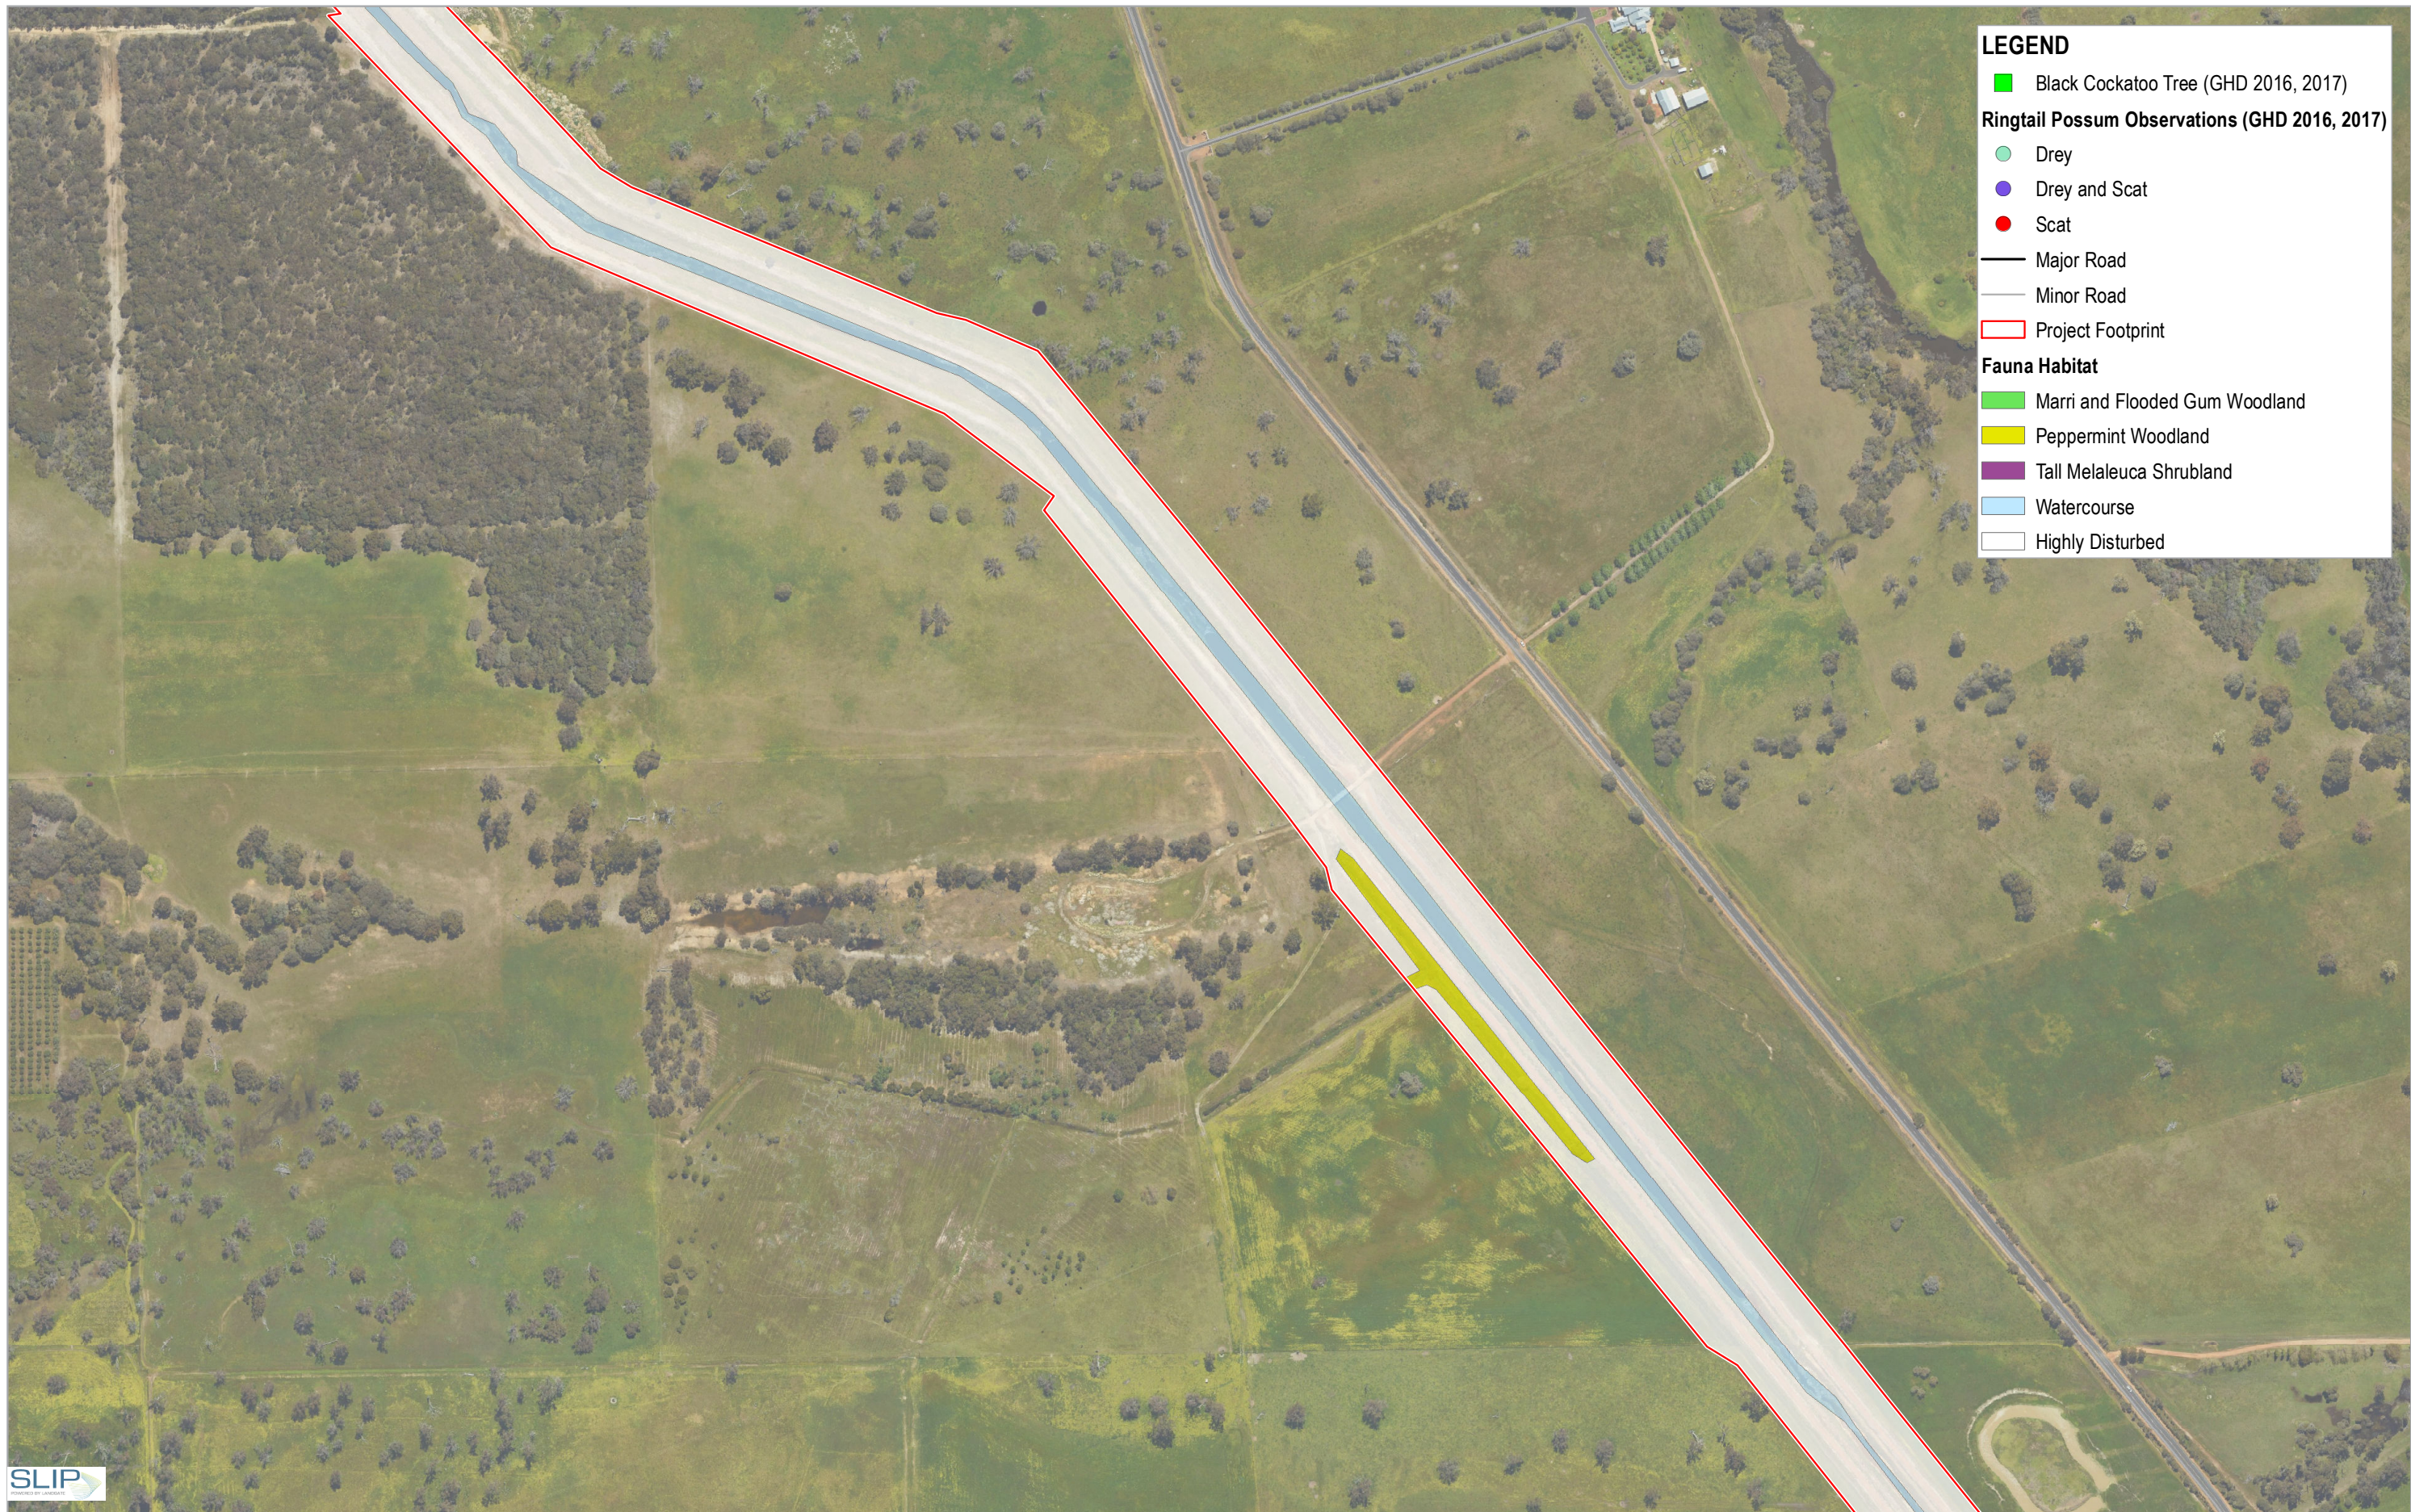
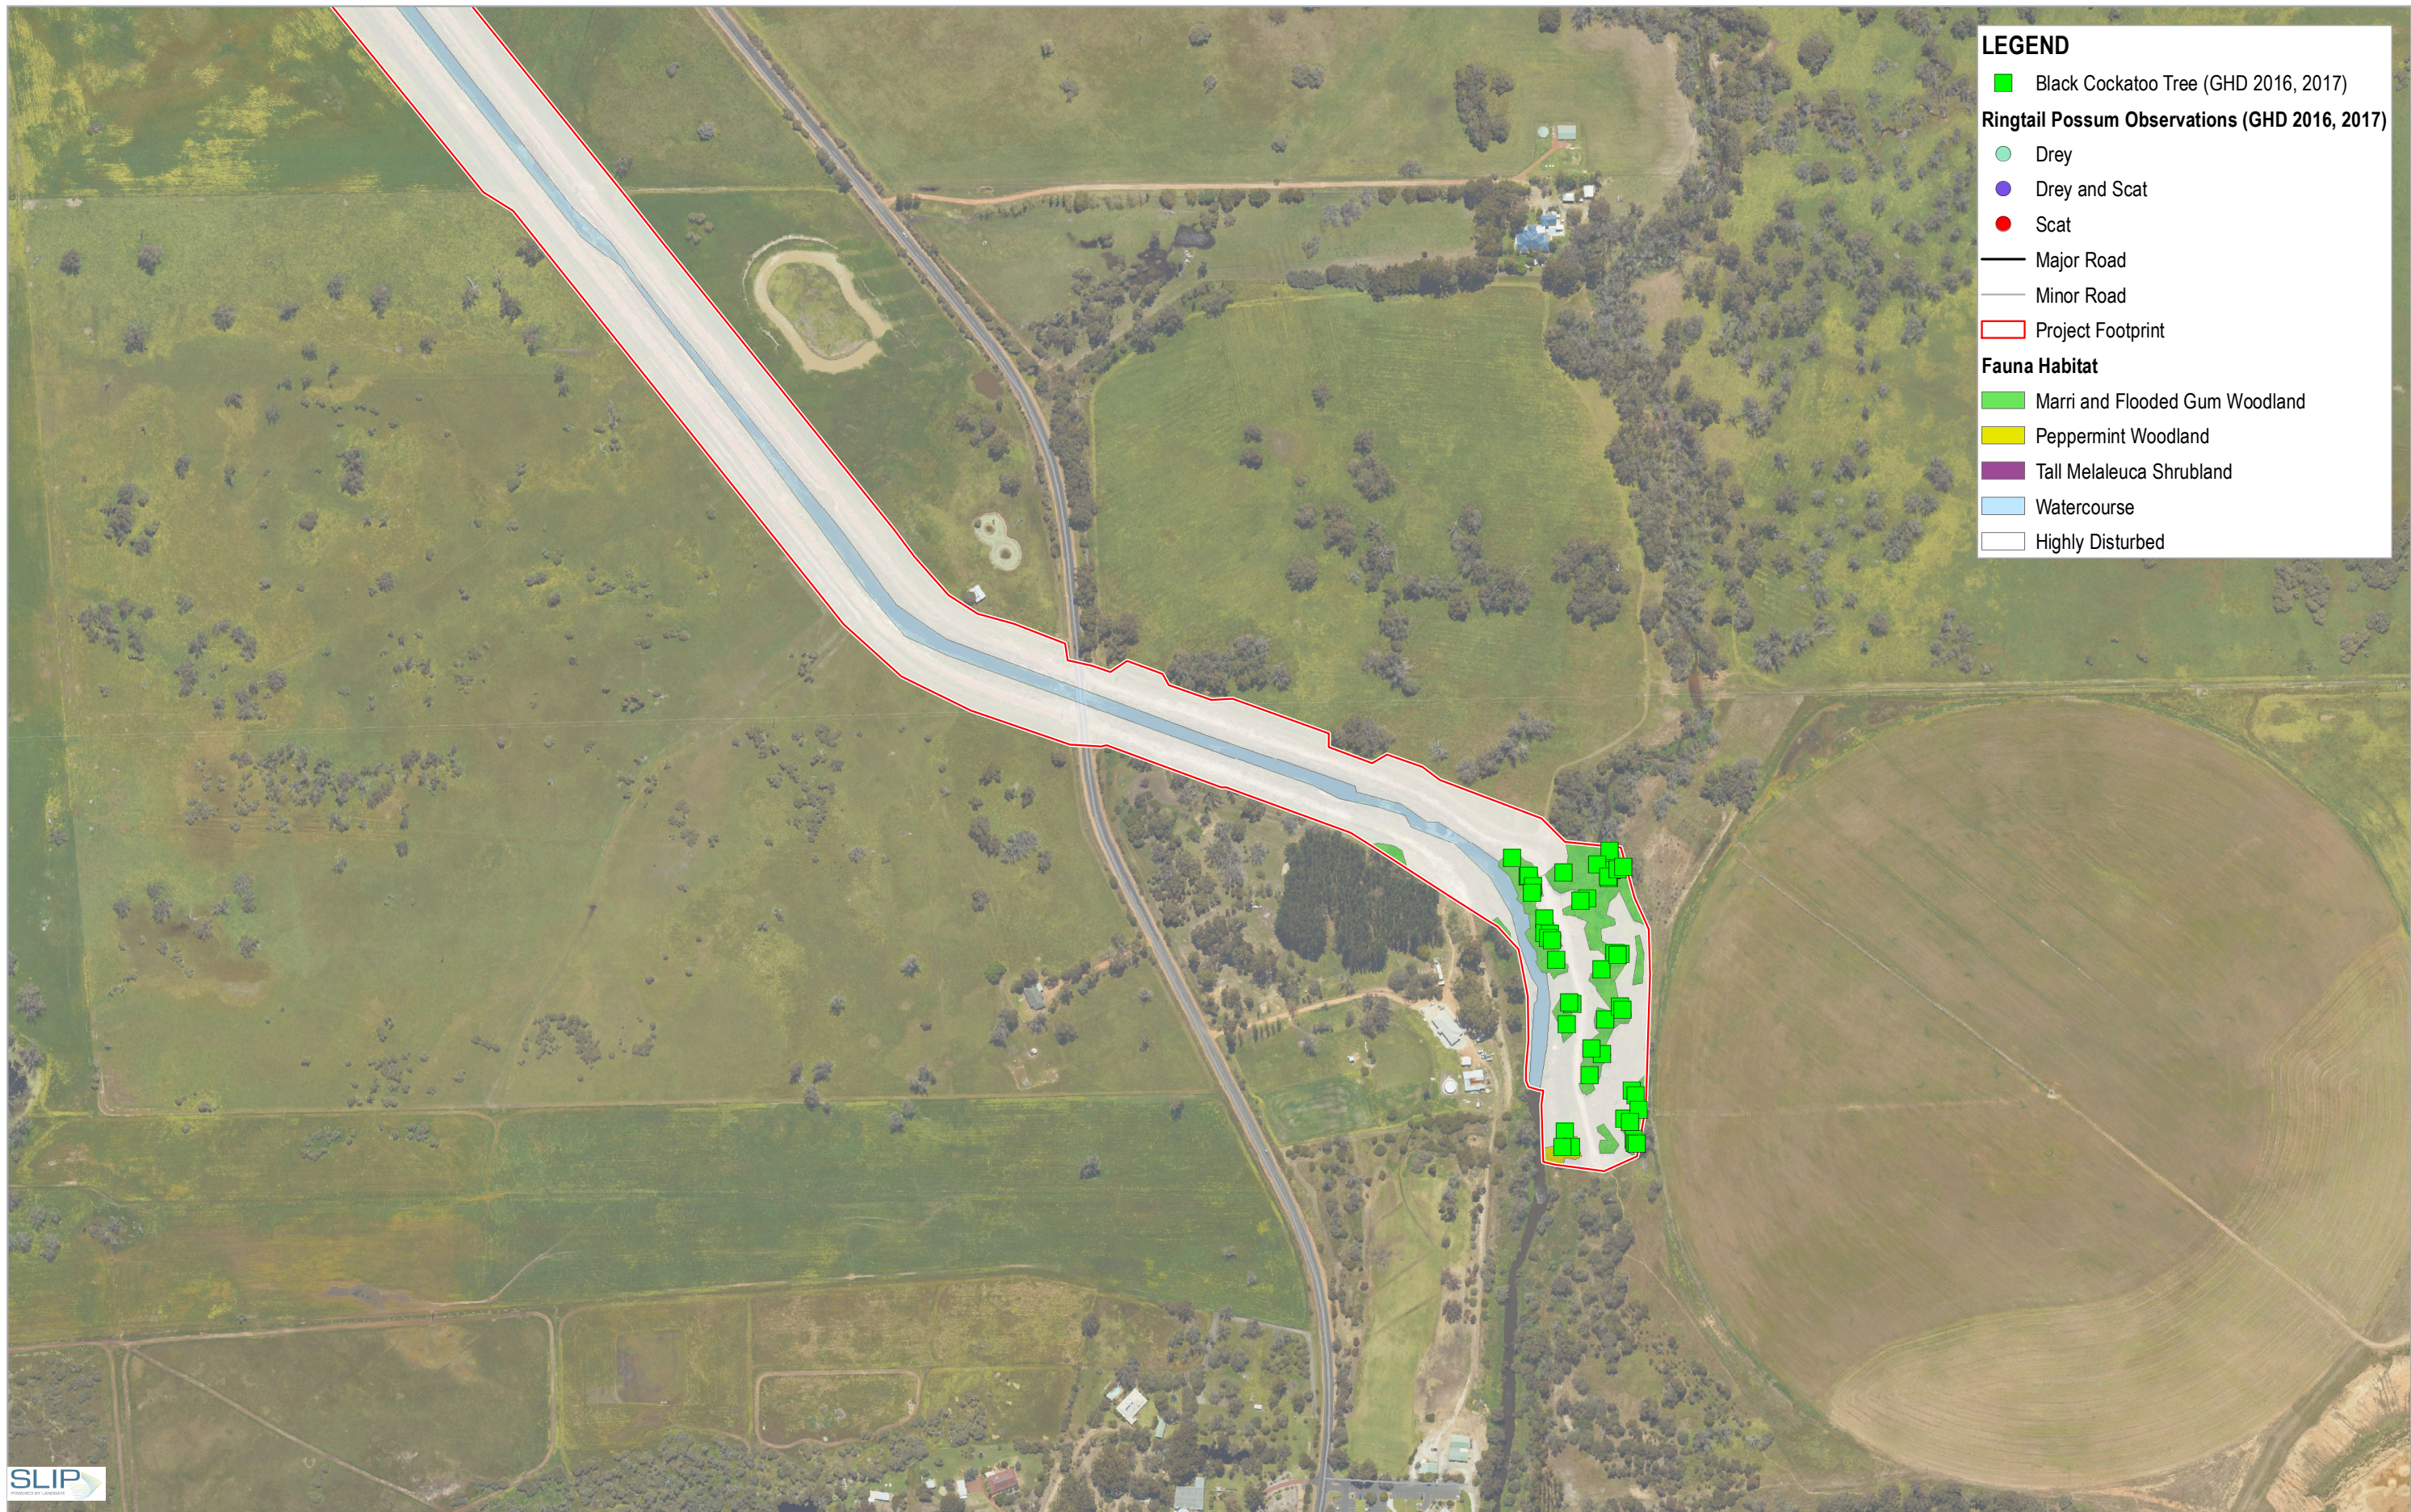
FIGURE 4

A summary of the habitat type extents for the revised project footprint is provided in Table 4 and mapped in Figure 4, Appendix A.

Fauna Habitats

The project footprint includes five habitat types, which are closely aligned with the vegetation types described within the project footprint.

Three threatened species of Black Cockatoo are known to occur in the project footprint, Carnaby's Black Cockatoo, Baudin's Black Cockatoo and Forest Red-tailed Black Cockatoo. Previous surveys have mapped the extent of Black Cockatoo foraging and roosting habitat and identified potential habitat trees within the previous project area. A description of the extent of habitat for these species within the total revised project footprint is summarised in Table 5 and mapped in Figure 5, Appendix A.

The Western Ringtail Possum has previously been recorded within the project footprint (GHD 2017b and 2017c). Scats were recorded throughout the project footprint in the Peppermint Woodland and Marri and Flooded Gum Woodland (GHD 2017b). Evidence of this species (scats and dreys) previously recorded by GHD have been mapped and provided in Figure 5, Appendix A. A summary of Western Ringtail Possum habitat within the revised project area is provided in Table 6.
