**2017/7932,
CPS 8191/1**

Vasse Diversion Drain Upgrade Variation 2

Supporting Documentation, March 2020 Submission

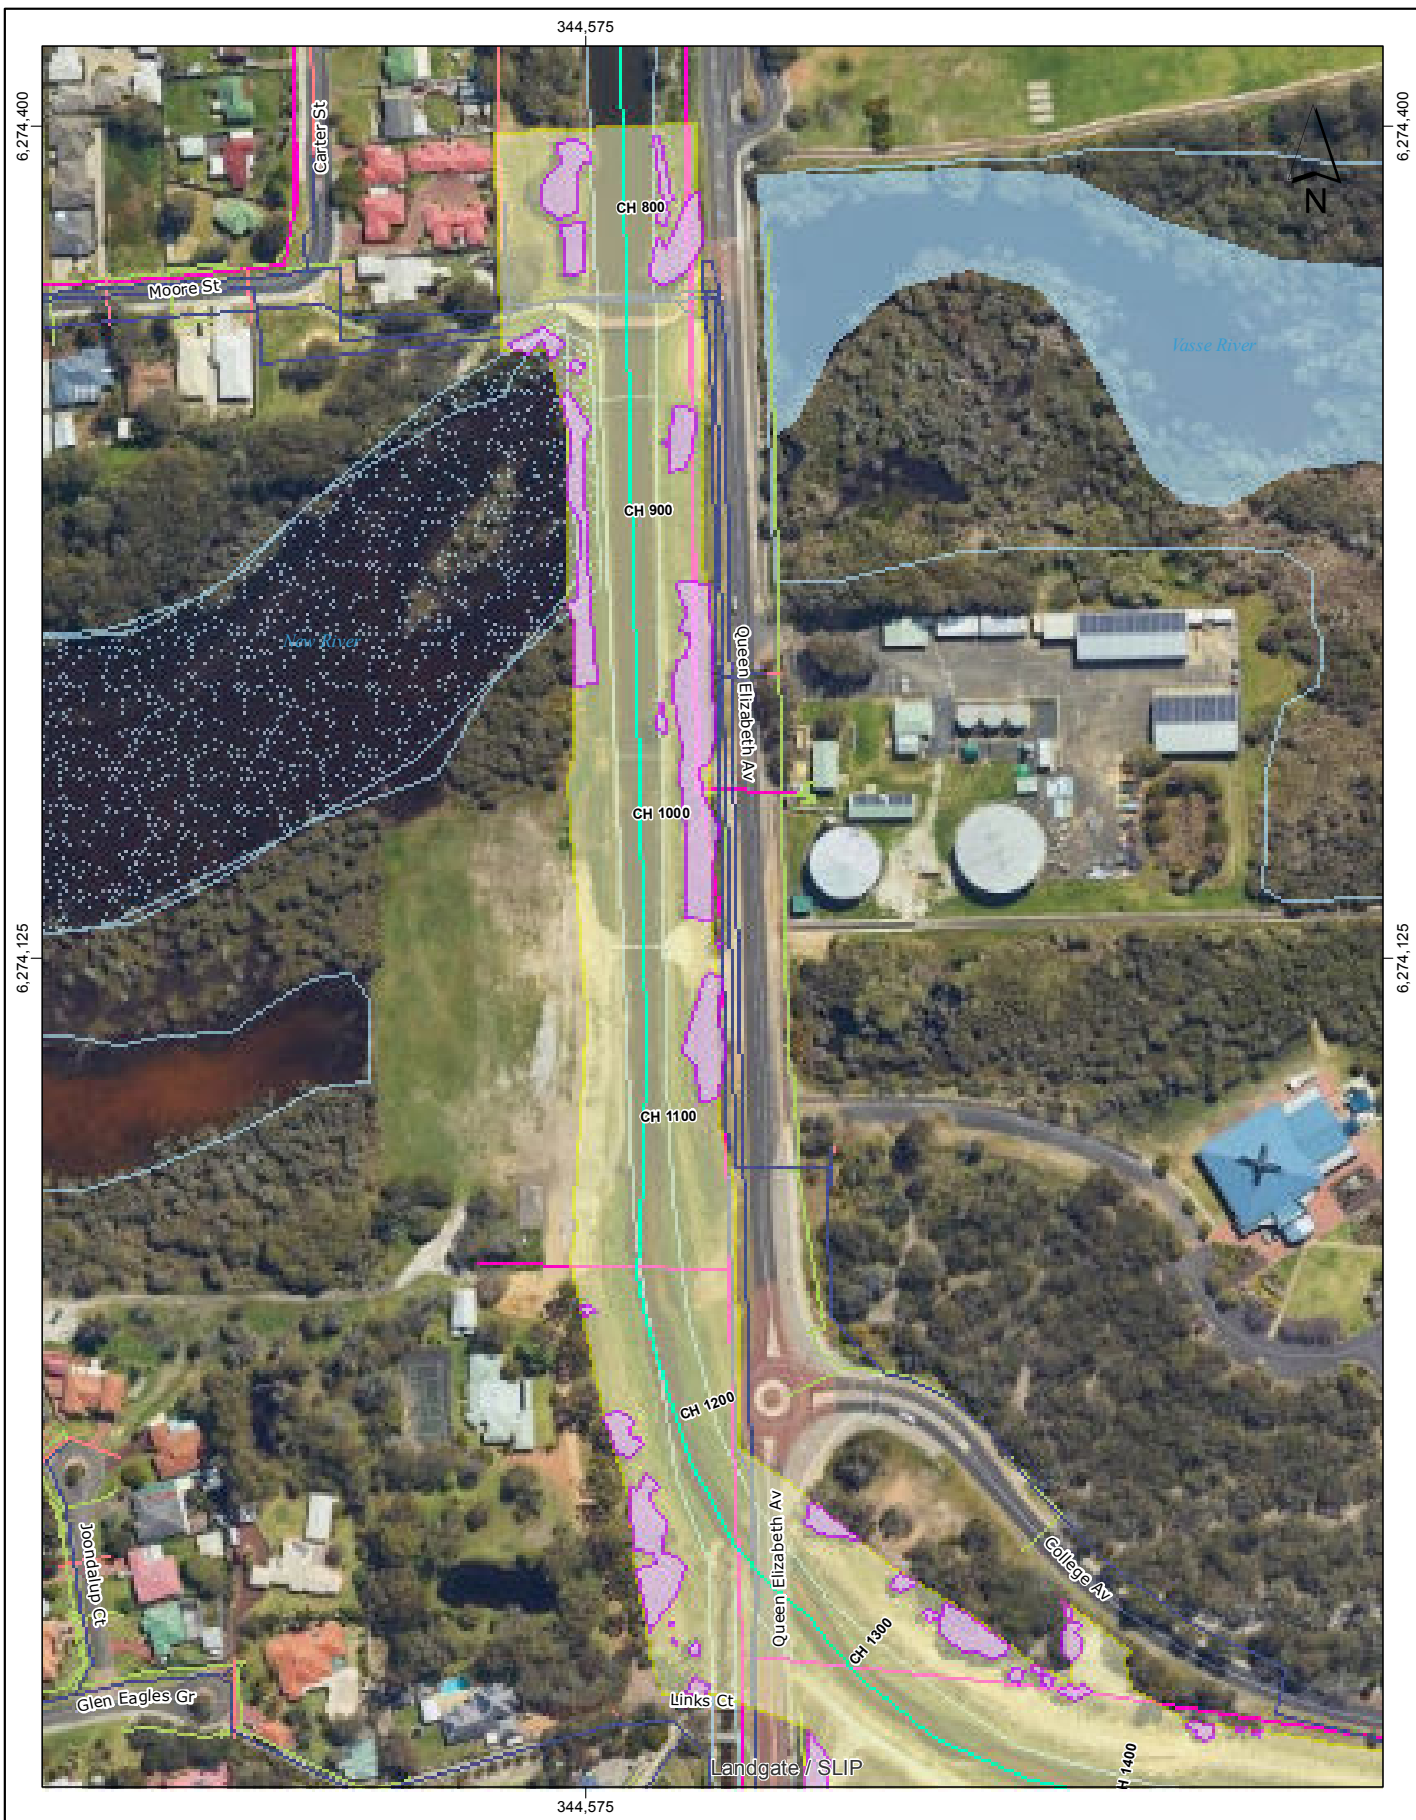
Figure 4: Chainage 5500 – Chainage 6200. South of Chapman Hill Road, reconstruction of the diversion dam and spillway will be undertaken. A number of large trees will require clearing, as the dam will require excavation of soil to allow for containment. Some modifications to the existing culvert and spillway is required, impacting on a section of the lower Vasse River (where it connects to the drain). Advice from DWER confirmed that the works did not require a Bed and Banks permit as the crossing is not located within a proclaimed surface water area under the RIWI Act (**Appendix B**).

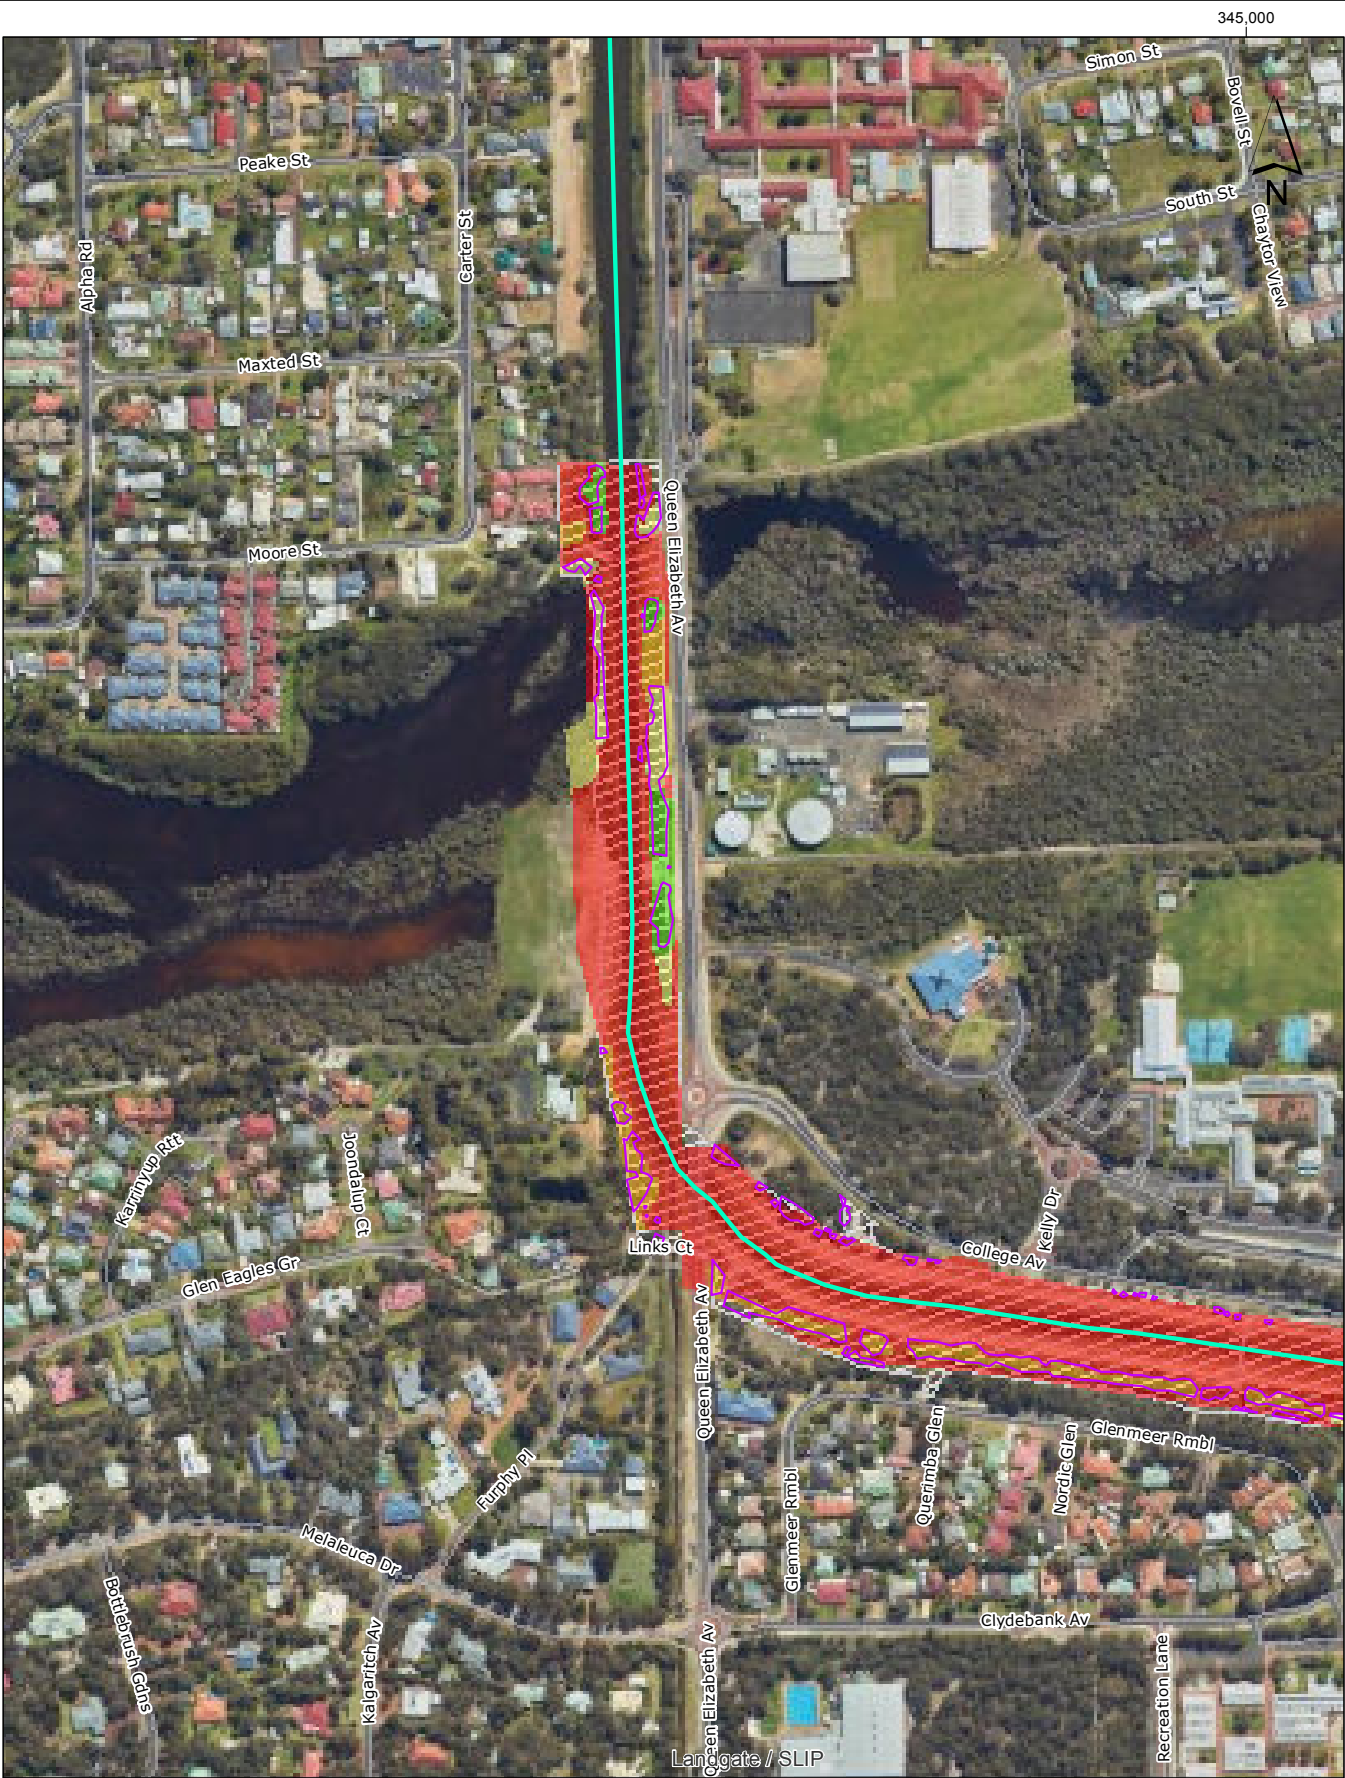
Table 8: Vegetation Condition by type EcoEdge (2019), Figure 7.

The proposal will result in the clearing of 2.16 ha, including the temporary clearing of 0.6 ha. 1.61 ha (74.5%) of the vegetation proposed to be cleared is in ‘*degraded*’ to ‘*completely degraded*’ condition, which is not, by definition, remnant vegetation according to COAG Standing Council on Environment and Water (2012).

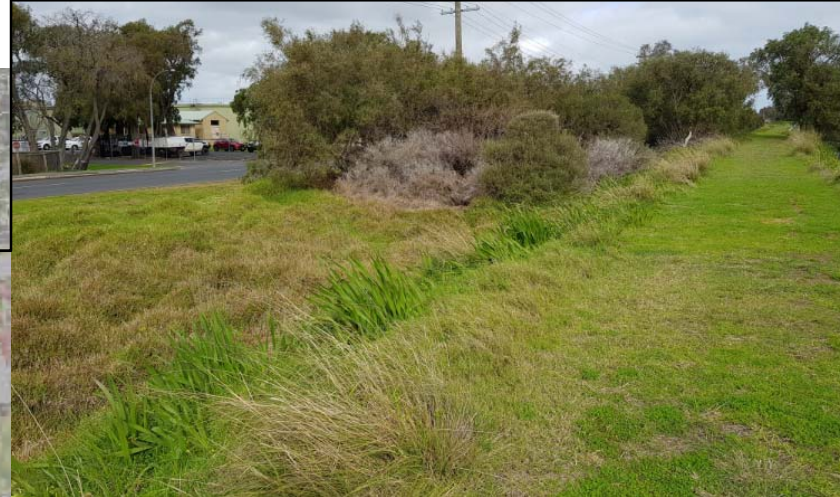
June 2018: Vegetation Unit D along QE Avenue City of Busselton S wale drain. R 41460, looking south

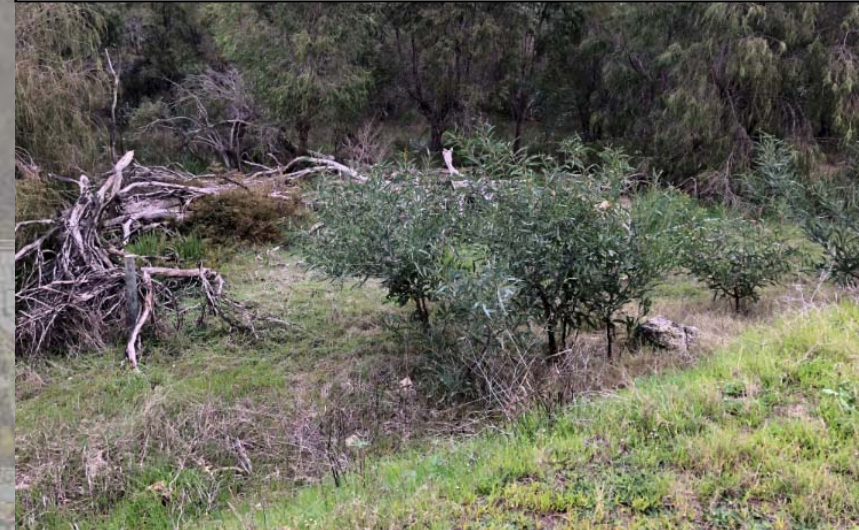
June 2018: Vegetation Unit A within P009868 56 looking sou-sou-west along the drain. Upstream of pedestrian bridge.

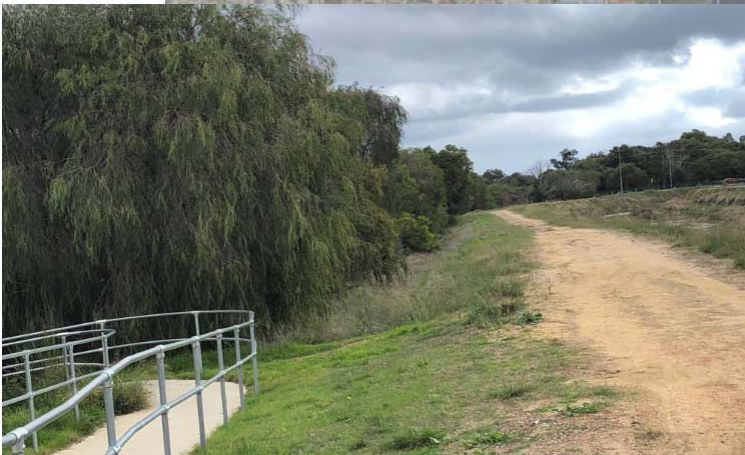
June 2019: Vegetation Unit A within P009868 56 looking west along the drain. downstream of pedestrian bridge.

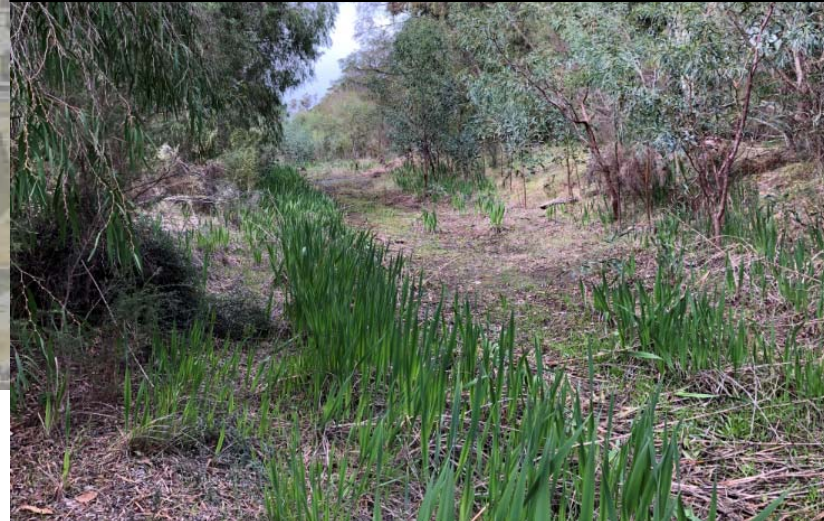
June 2019: City of Busselton swale drain (south-western) P020362 5067 (looking west)

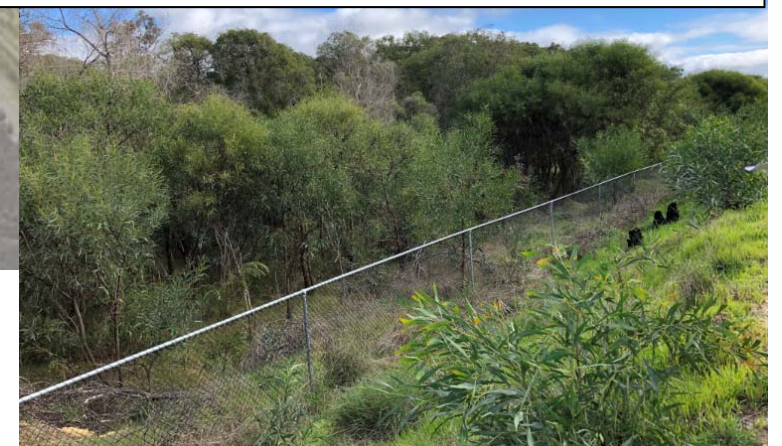
June 2019: Acacia saligna in City of Busselton swale drain (south-eastern) R 52132, Looking south-west along the drain)
