Busselton Eastern Link Project

Native vegetation clearing permit
application - supporting
documentation

Prepared for
City of Busselton
by Strategen

September 2018

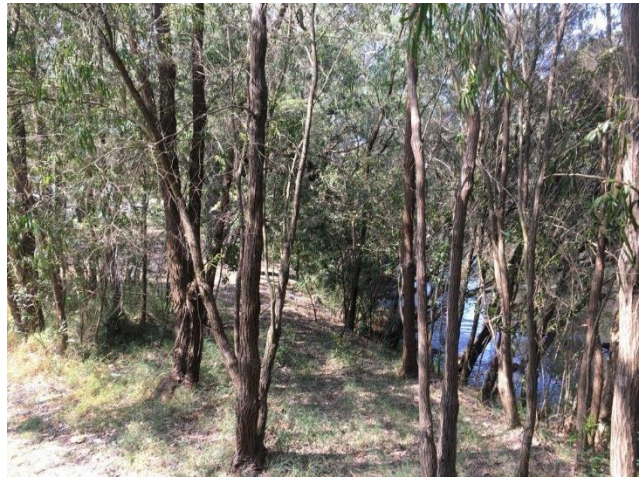
Figure 2 Eastern Link Vegetation Group 1

Vegetation Group	Description	Condition
Eastern Link 1	Low Woodland of Agonis flexuosa and Eucalyptus rudis over grasses (managed *Cynodon dactylon) (Figures 1 & 2)	Degraded on river edge to Completely degraded in parkland cleared area
Eastern Link 2	Low Woodland of Agonis flexuosa, E. rudis, E. cornuta, Melaleuca raphiophylla (& planted eucalypts), over open shrubland of Acacia littoralis, over closed grassland of Bolboschoenus caldwellii and assorted pasture grasses (*Cenchrus clandestinum) (Figures 3 & 4)	Degraded to Good

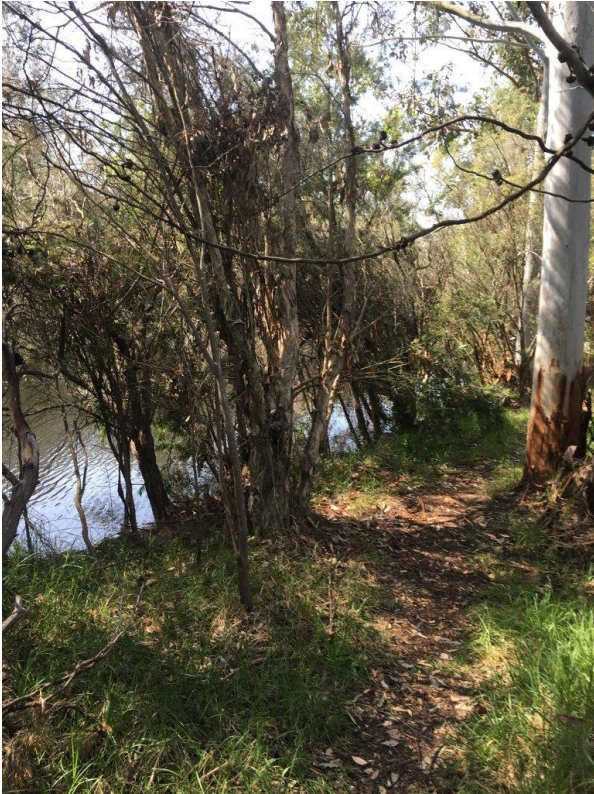
Figure 3 Eastern Link Vegetation Group 2

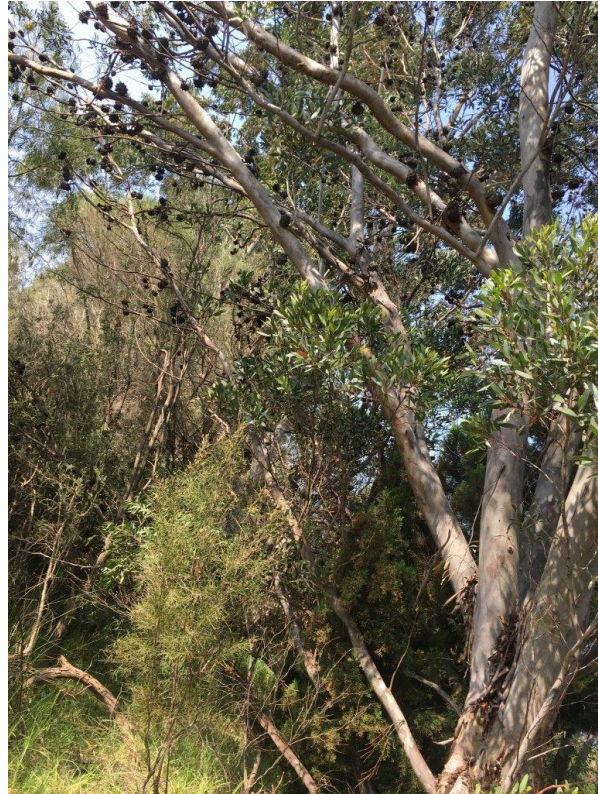
Figure 4 Eastern Link Vegetation Group 2

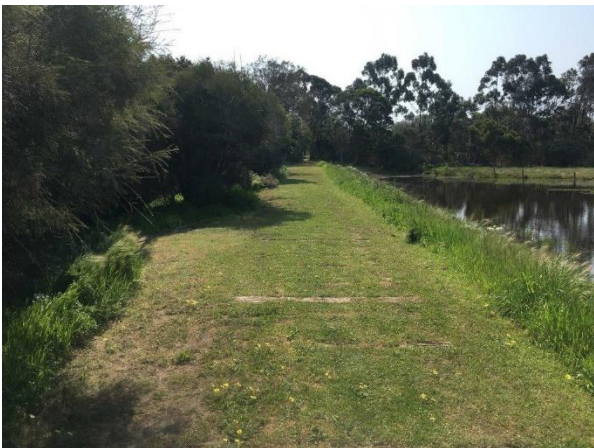
*Figure 5 Eastern Link Vegetation Group 3
(area to the left)*

Vegetation Group	Description	Condition
Eastern Link 3	Low Open Forest of <i>M. raphiophylla</i> , <i>M. preissii</i> , over Open Scrub of <i>M. viminea</i> , over pasture grasses (dominated by * <i>Cenchrus clandestinum</i> & * <i>Cynodon dactylon</i>) (Figure 5)	Degraded
Eastern Link 4	Closed sedge land of samphire species (predominantly <i>Sarcocornia quinqueflora</i> , though includes <i>Suaeda australis</i> and <i>Halosarcia indica</i>) and <i>Juncus kraussii</i> and <i>J pallidus</i> . incursions of introduced grasses (Figures 5 & 6)	Good - Very Good.

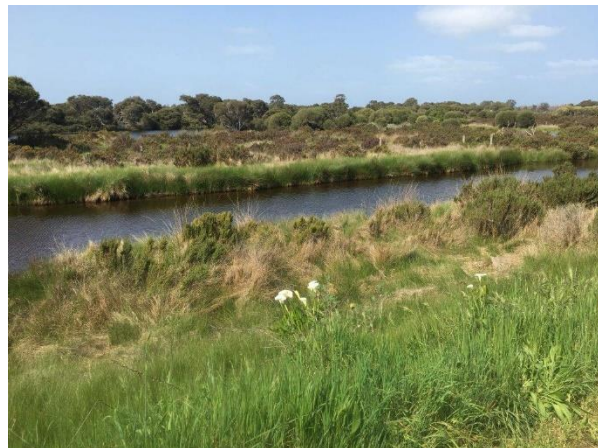
Figure 6 Eastern Link Vegetation Group 4

Vegetation Group 4 was dominated by samphire and is potentially subject to tidal influences of the Vasse Estuary (seen in Figure 6). Discussions with the Department of Biodiversity, Conservation and Attractions (DBCA) has confirmed that the species within of this association are consistent with the definition of the EPBC listed TEC (WA listed PEC) - Subtropical and Temperate Coastal Saltmarsh community (A. Webb, Regional Botanist SW DBCA, *pers comm* Sept 2017). Further investigations would be required to determine the specific extent of salt water inundation in this area to determine if the TEC is present.

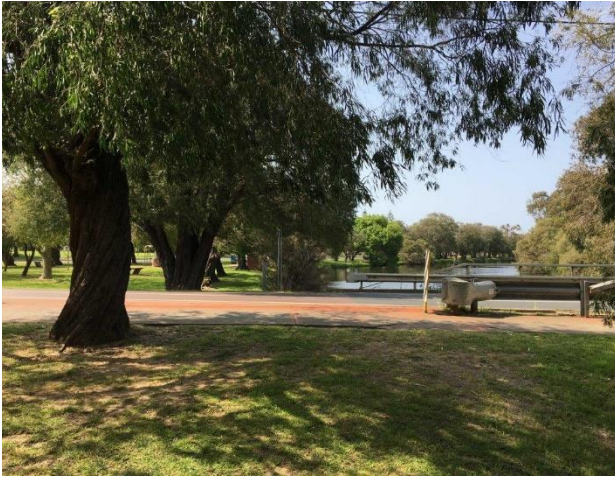
Figure 7 Causeway Vegetation Group 2

Vegetation Point	Description	Condition
Causeway 1	Low Woodland of <i>Agonis flexuosa</i> over managed grasses.	Completely Degraded - parkland cleared area
Causeway 2	Low Woodland of <i>Agonis flexuosa</i> , over sedgeland of <i>Juncus</i> spp on river with . managed grasses (Figures 7 & 8)	Degraded to Good on river edge
Causeway 3	Low Woodland of <i>E. rudis</i> , <i>M. raphiophylla</i> , <i>M. preissii</i> and <i>A. flexuosa</i> , Open sedgeland of <i>Lepidosperma gladiatum</i> , <i>J. pallidus</i> and <i>J kraussii</i> , with incursions of managed grasses. (Figure 9)	Degraded to Good on river edge.

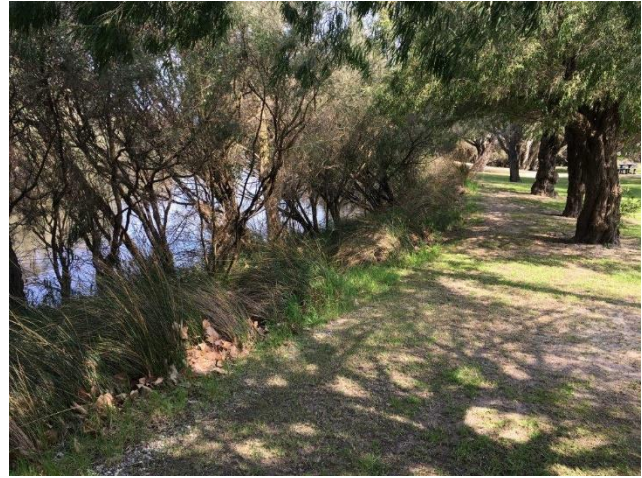
Figure 8 Causeway Vegetation Group2 - note good quality of vegetation along edge of river

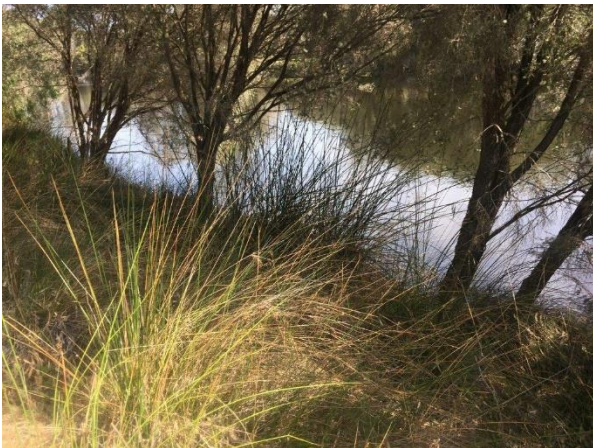
Figure 9 Causeway Vegetation Group 3

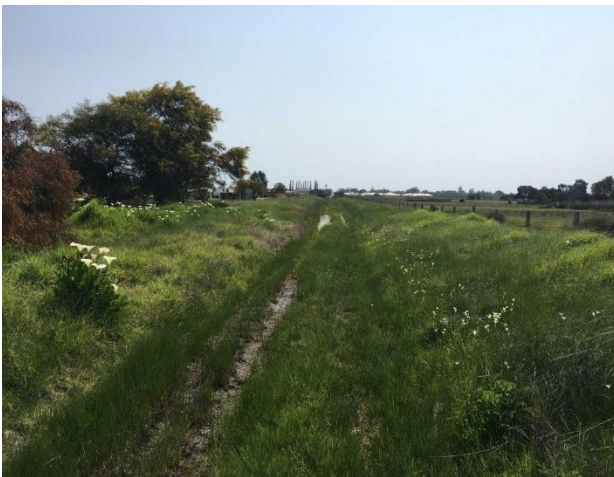
Figure 25 Ford Rd Vegetation Group 1

Ford Road is an unmade road reserve for the full length and this is dominated by annual grass weeds (Figures 25, 27 & 28).

Vegetation Group	Description	Condition
Ford Rd 1	Closed Grassland of introduced pasture grasses, *Trifolium spp, *Cenchrus clandestinum and *Cynodon dactylon with scattered *Zantedeschia aethiopica (Figure 25)	Completely Degraded
Ford Rd 2	Scattered Tall Trees of Eucalyptus gomphocephala over pasture grasses (Figure 26)	Completely Degraded
Ford Rd 3	Closed sedge land of samphire species (predominantly Sarcocornia quinqueflora, though includes Suaeda australis and Halosarcia indica) and Juncus kraussii and J pallidus. incursions of introduced grasses (Figure 27)	Good .
Ford Rd 4	Closed grassland of Typha orientalis with Scattered Melaleuca raphiophylla (Figure 28) .	Degraded to Completely Degraded
Molloy St - 1	Closed sedge land of samphire species (predominantly Sarcocornia quinqueflora, though includes Suaeda australis and Halosarcia	Good - Very Good.

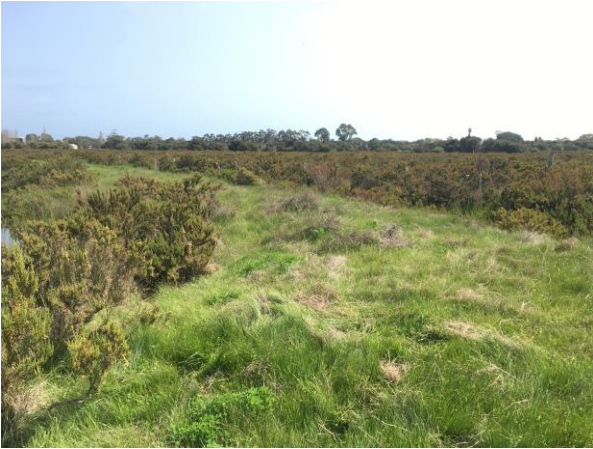
Figure 27 Ford Rd Vegetation Group 3

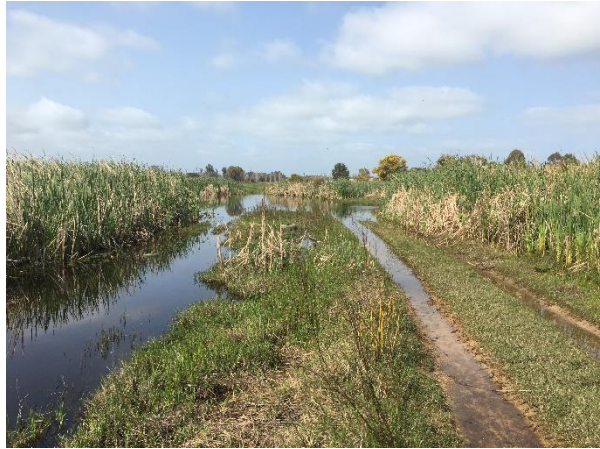
Figure 28 Ford Rd Vegetation Group 4

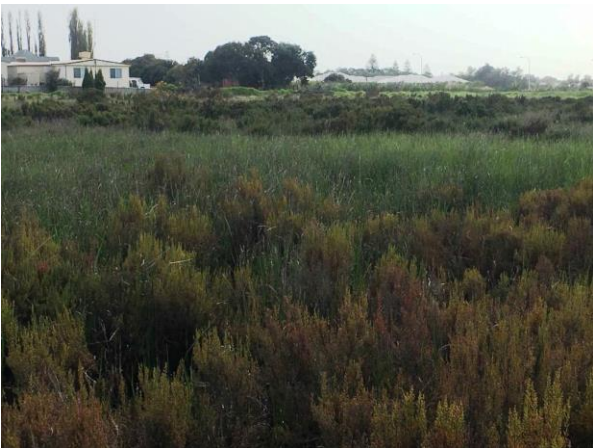
Figure 29 Molloy Vegetation Group 1

Vegetation Group	Description	Condition
	indica) and Juncus kraussii and J pallidus. incursions of introduced grasses and scattered *Zantedeschia aethiopica (Figure 29)	
Molloy St 2	Closed Grassland of Bolboschoenus caldwellii and assorted pasture grasses (*Cenchrus clandestinum, *Cynodon dactylon with scattered *Zantedeschia aethiopica (Figure 30).	Completely Degraded
Molloy St 3	Closed grassland of Typha orientalis with Scattered Melaleuca raphiophylla (Figure 31).	Degraded to Completely Degraded
Molloy St 4	Open Shrubland of Melaleuca raphiophylla and Acacia spp, over introduced grasses	Degraded

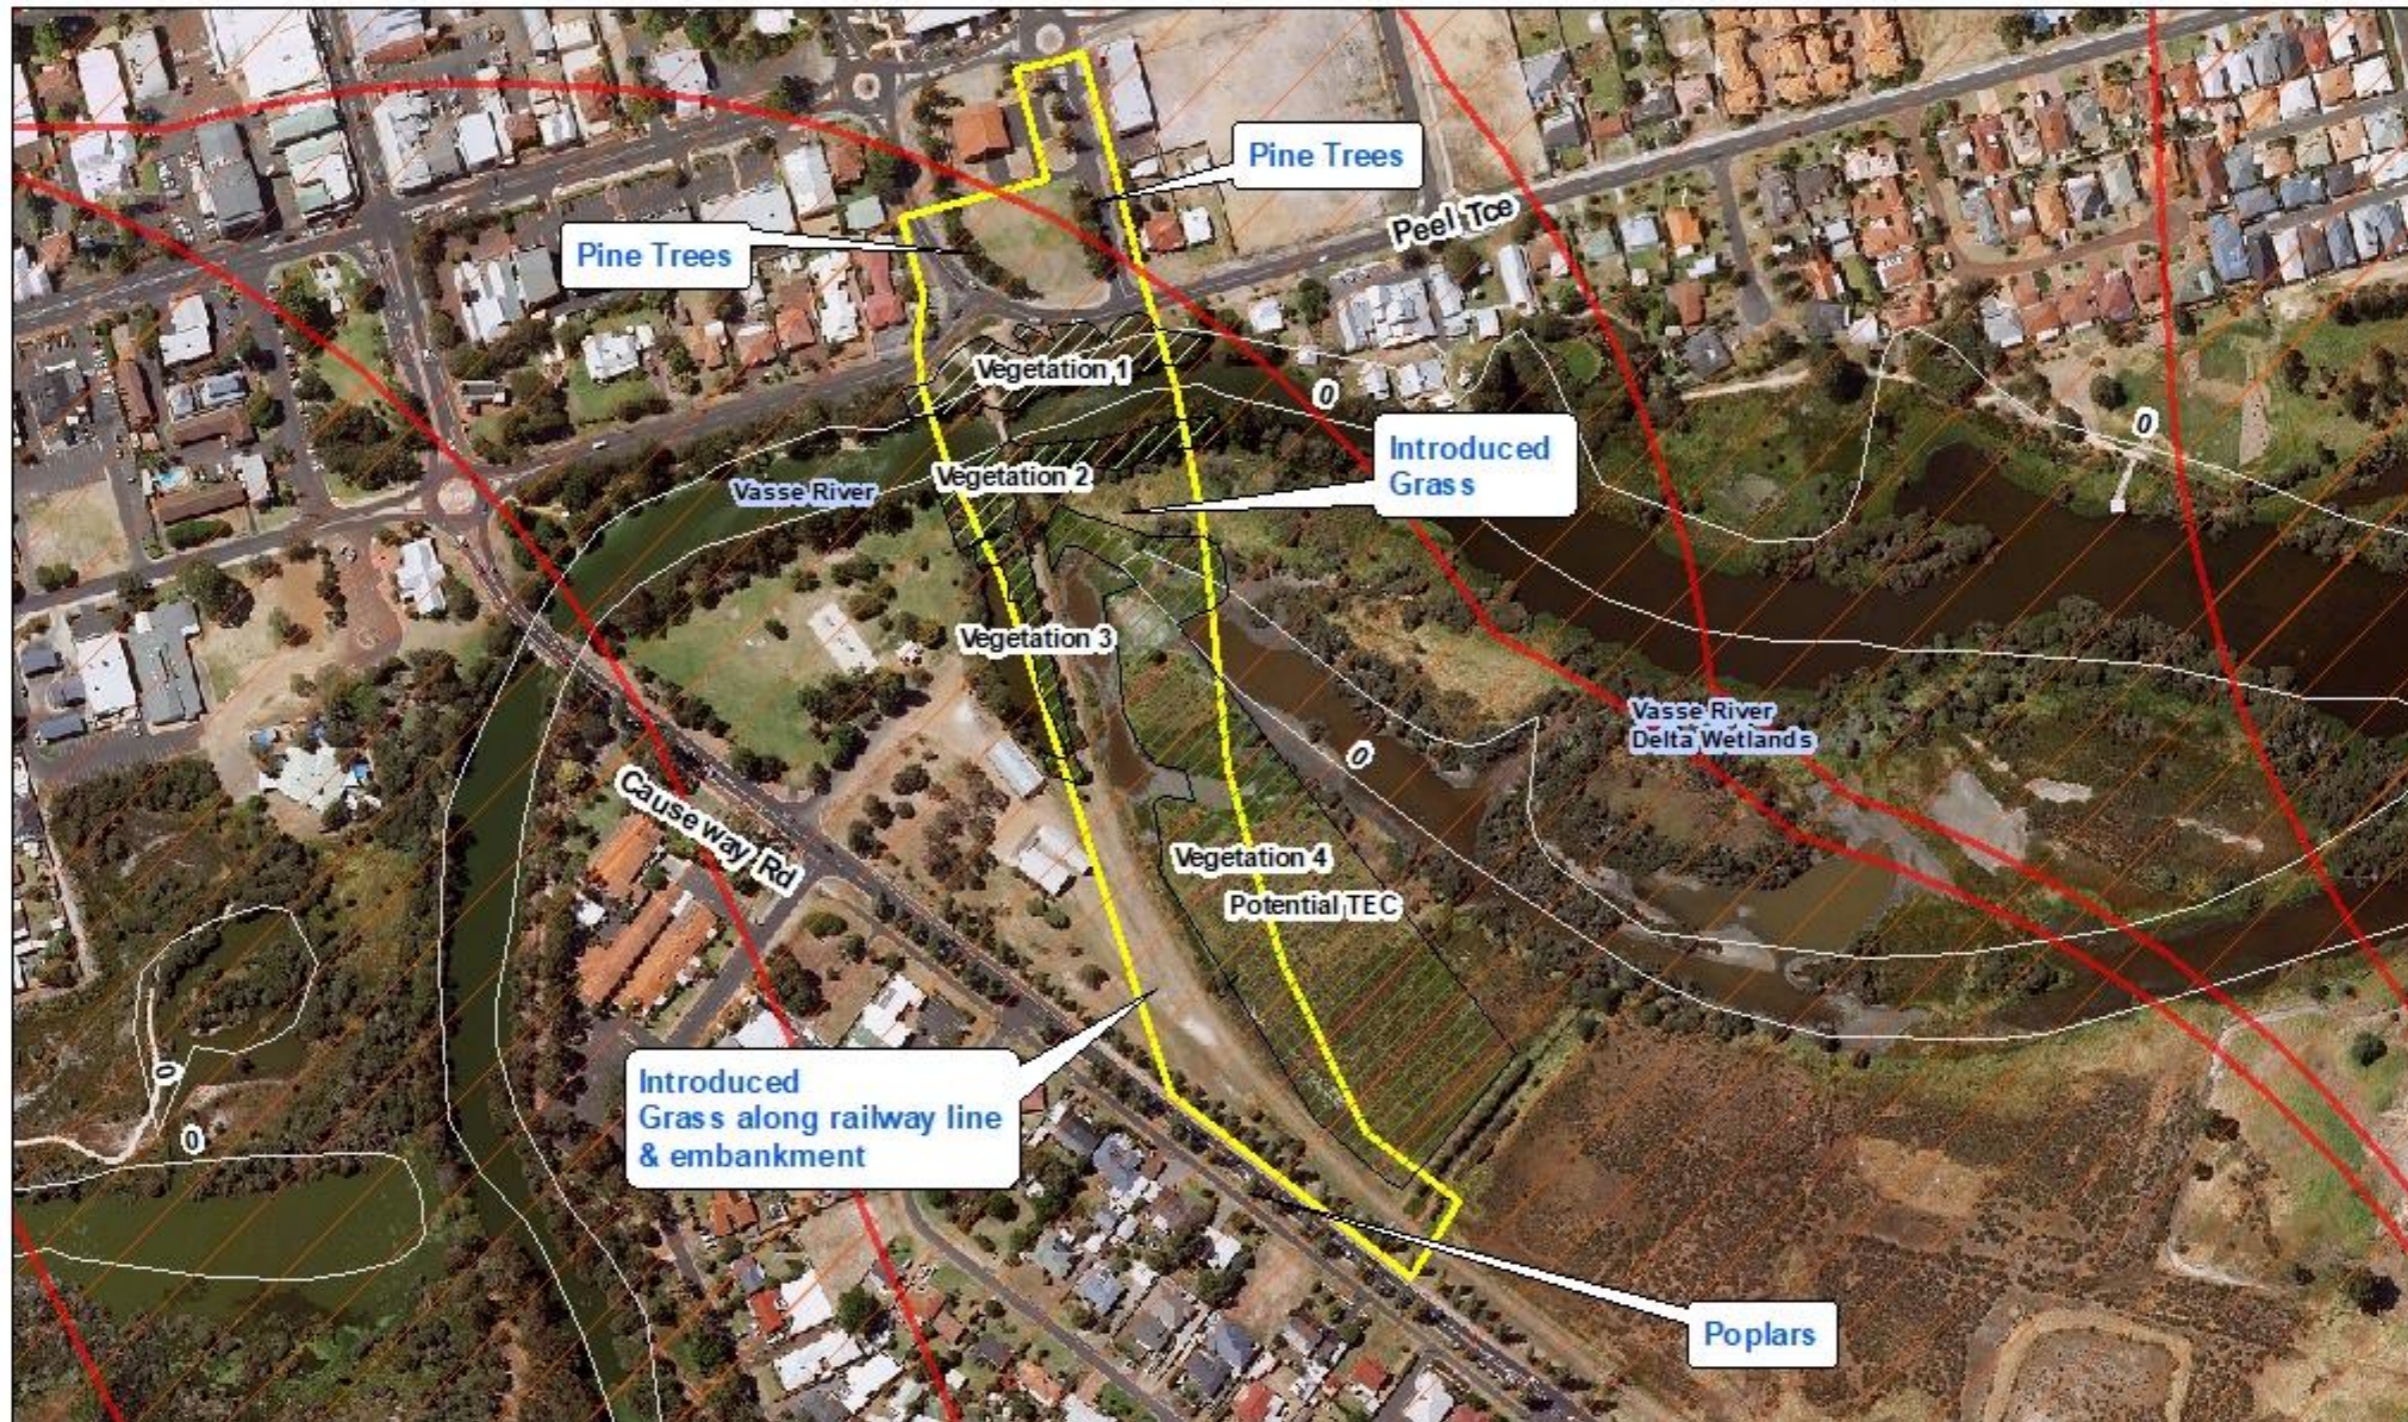
Map 2: Item A: Eastern Link Vegetation Groups

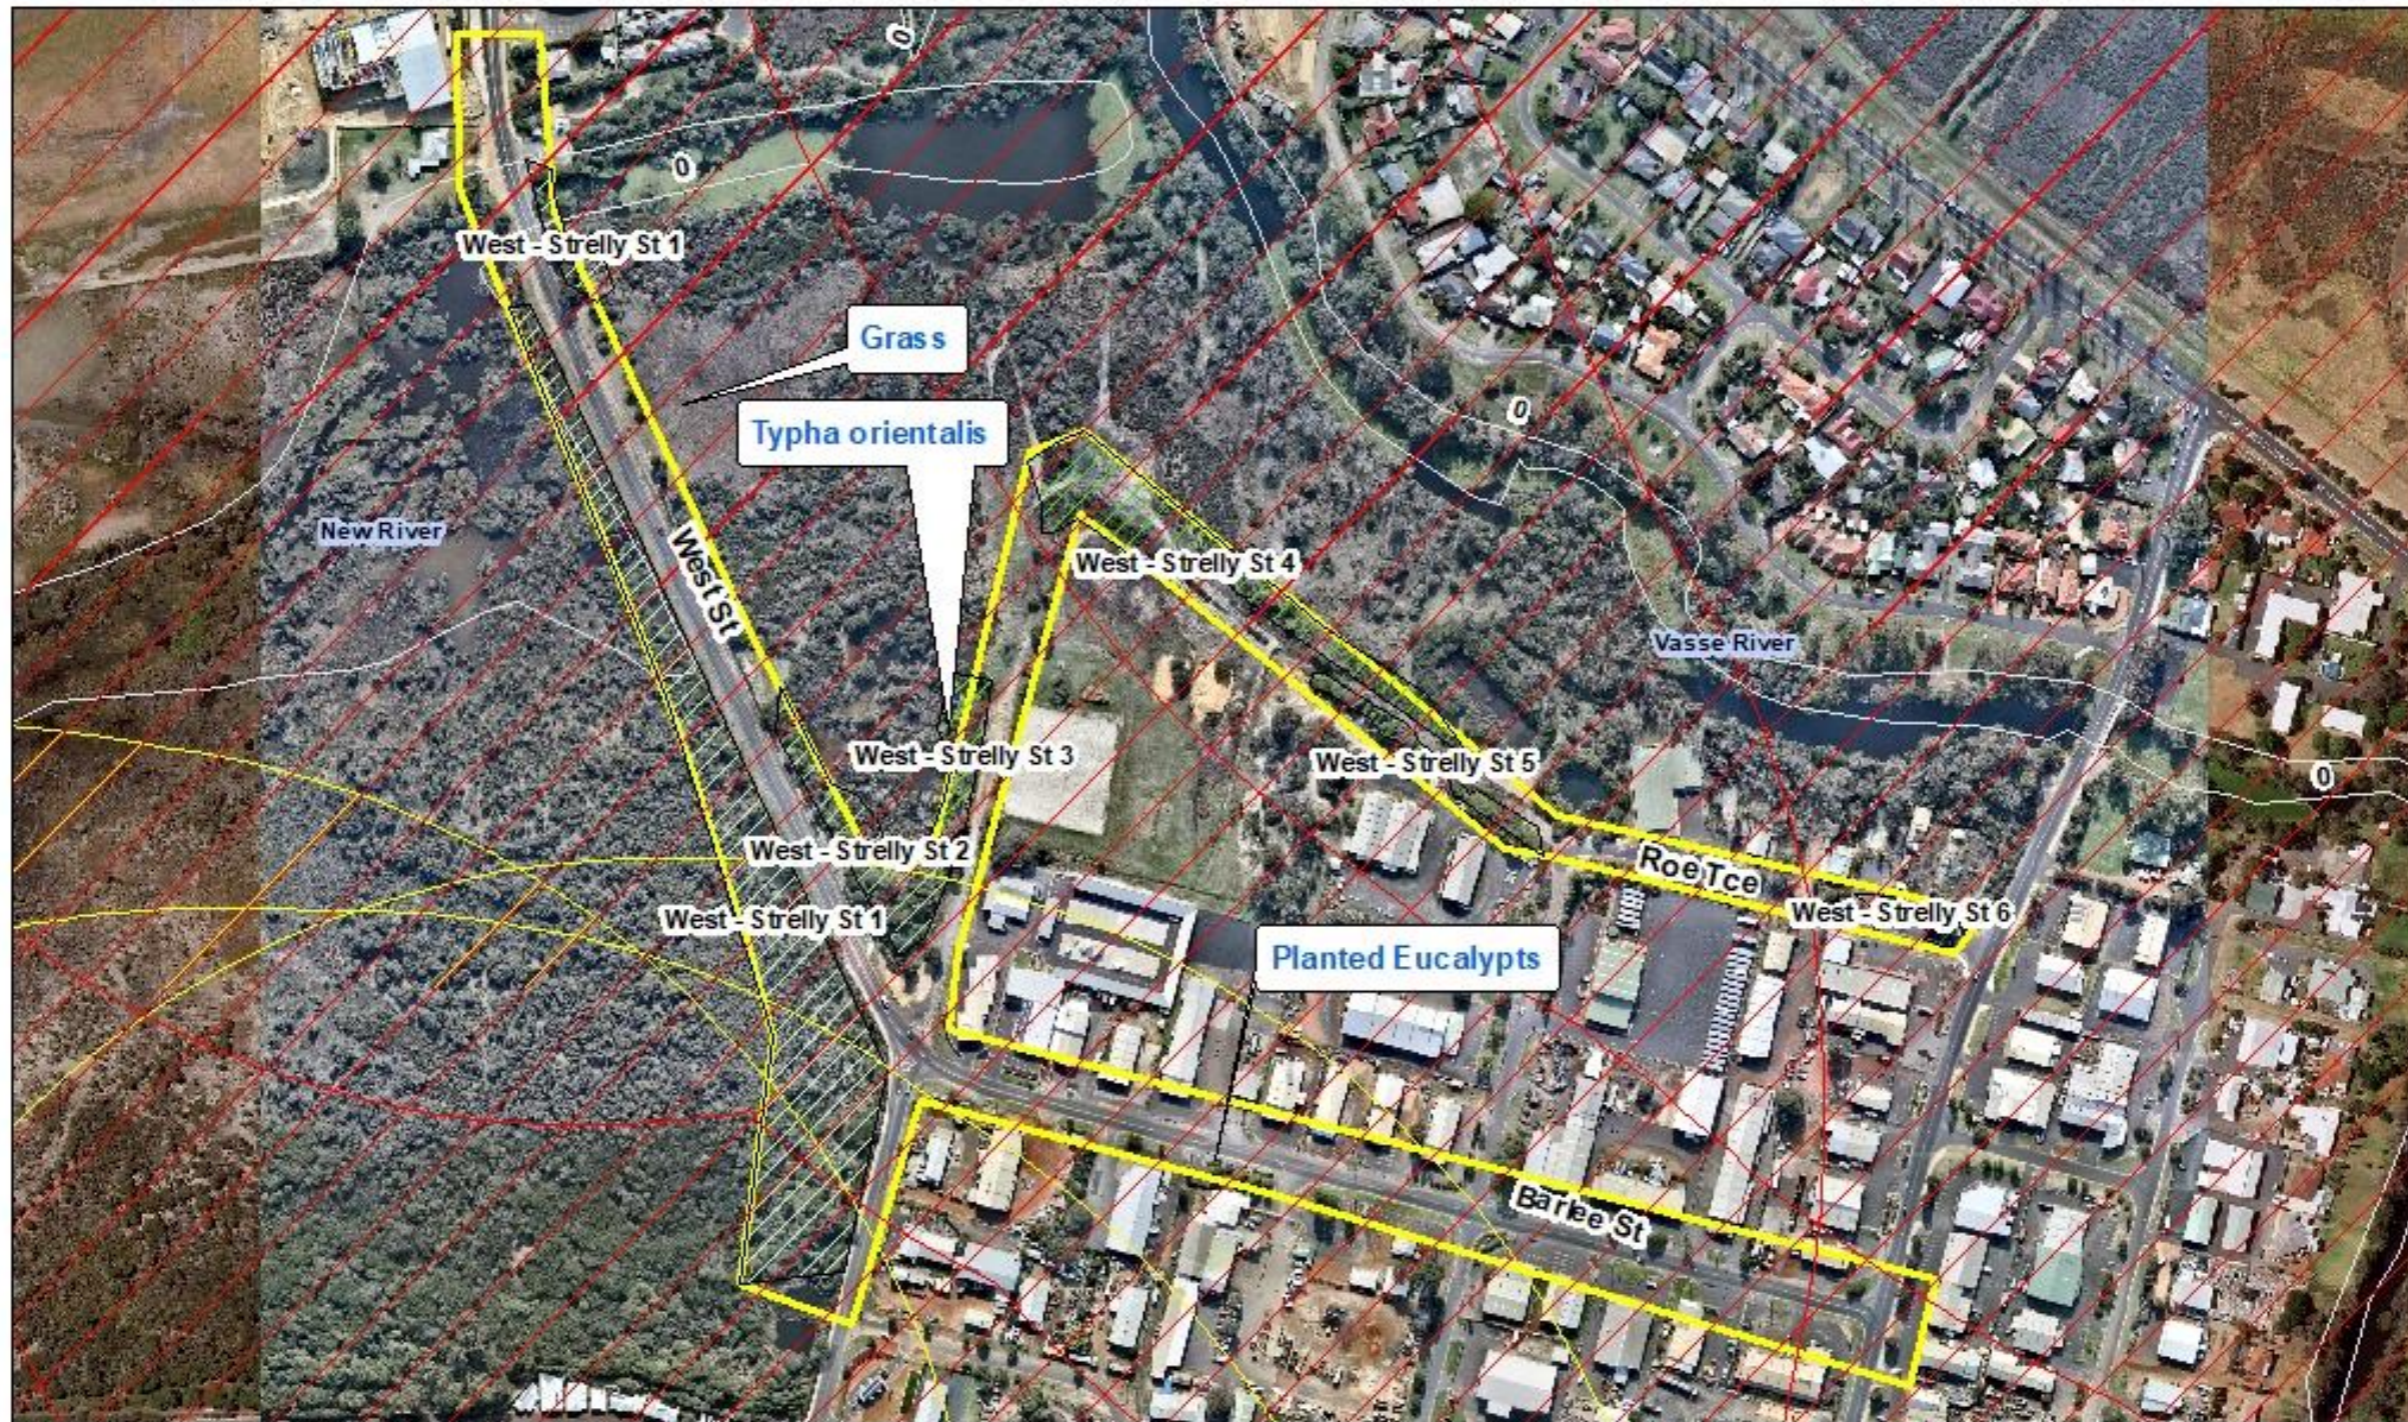
Map 4: Items C & D West-Strelly St Vegetation Groups **Project Address: City of Busselton**

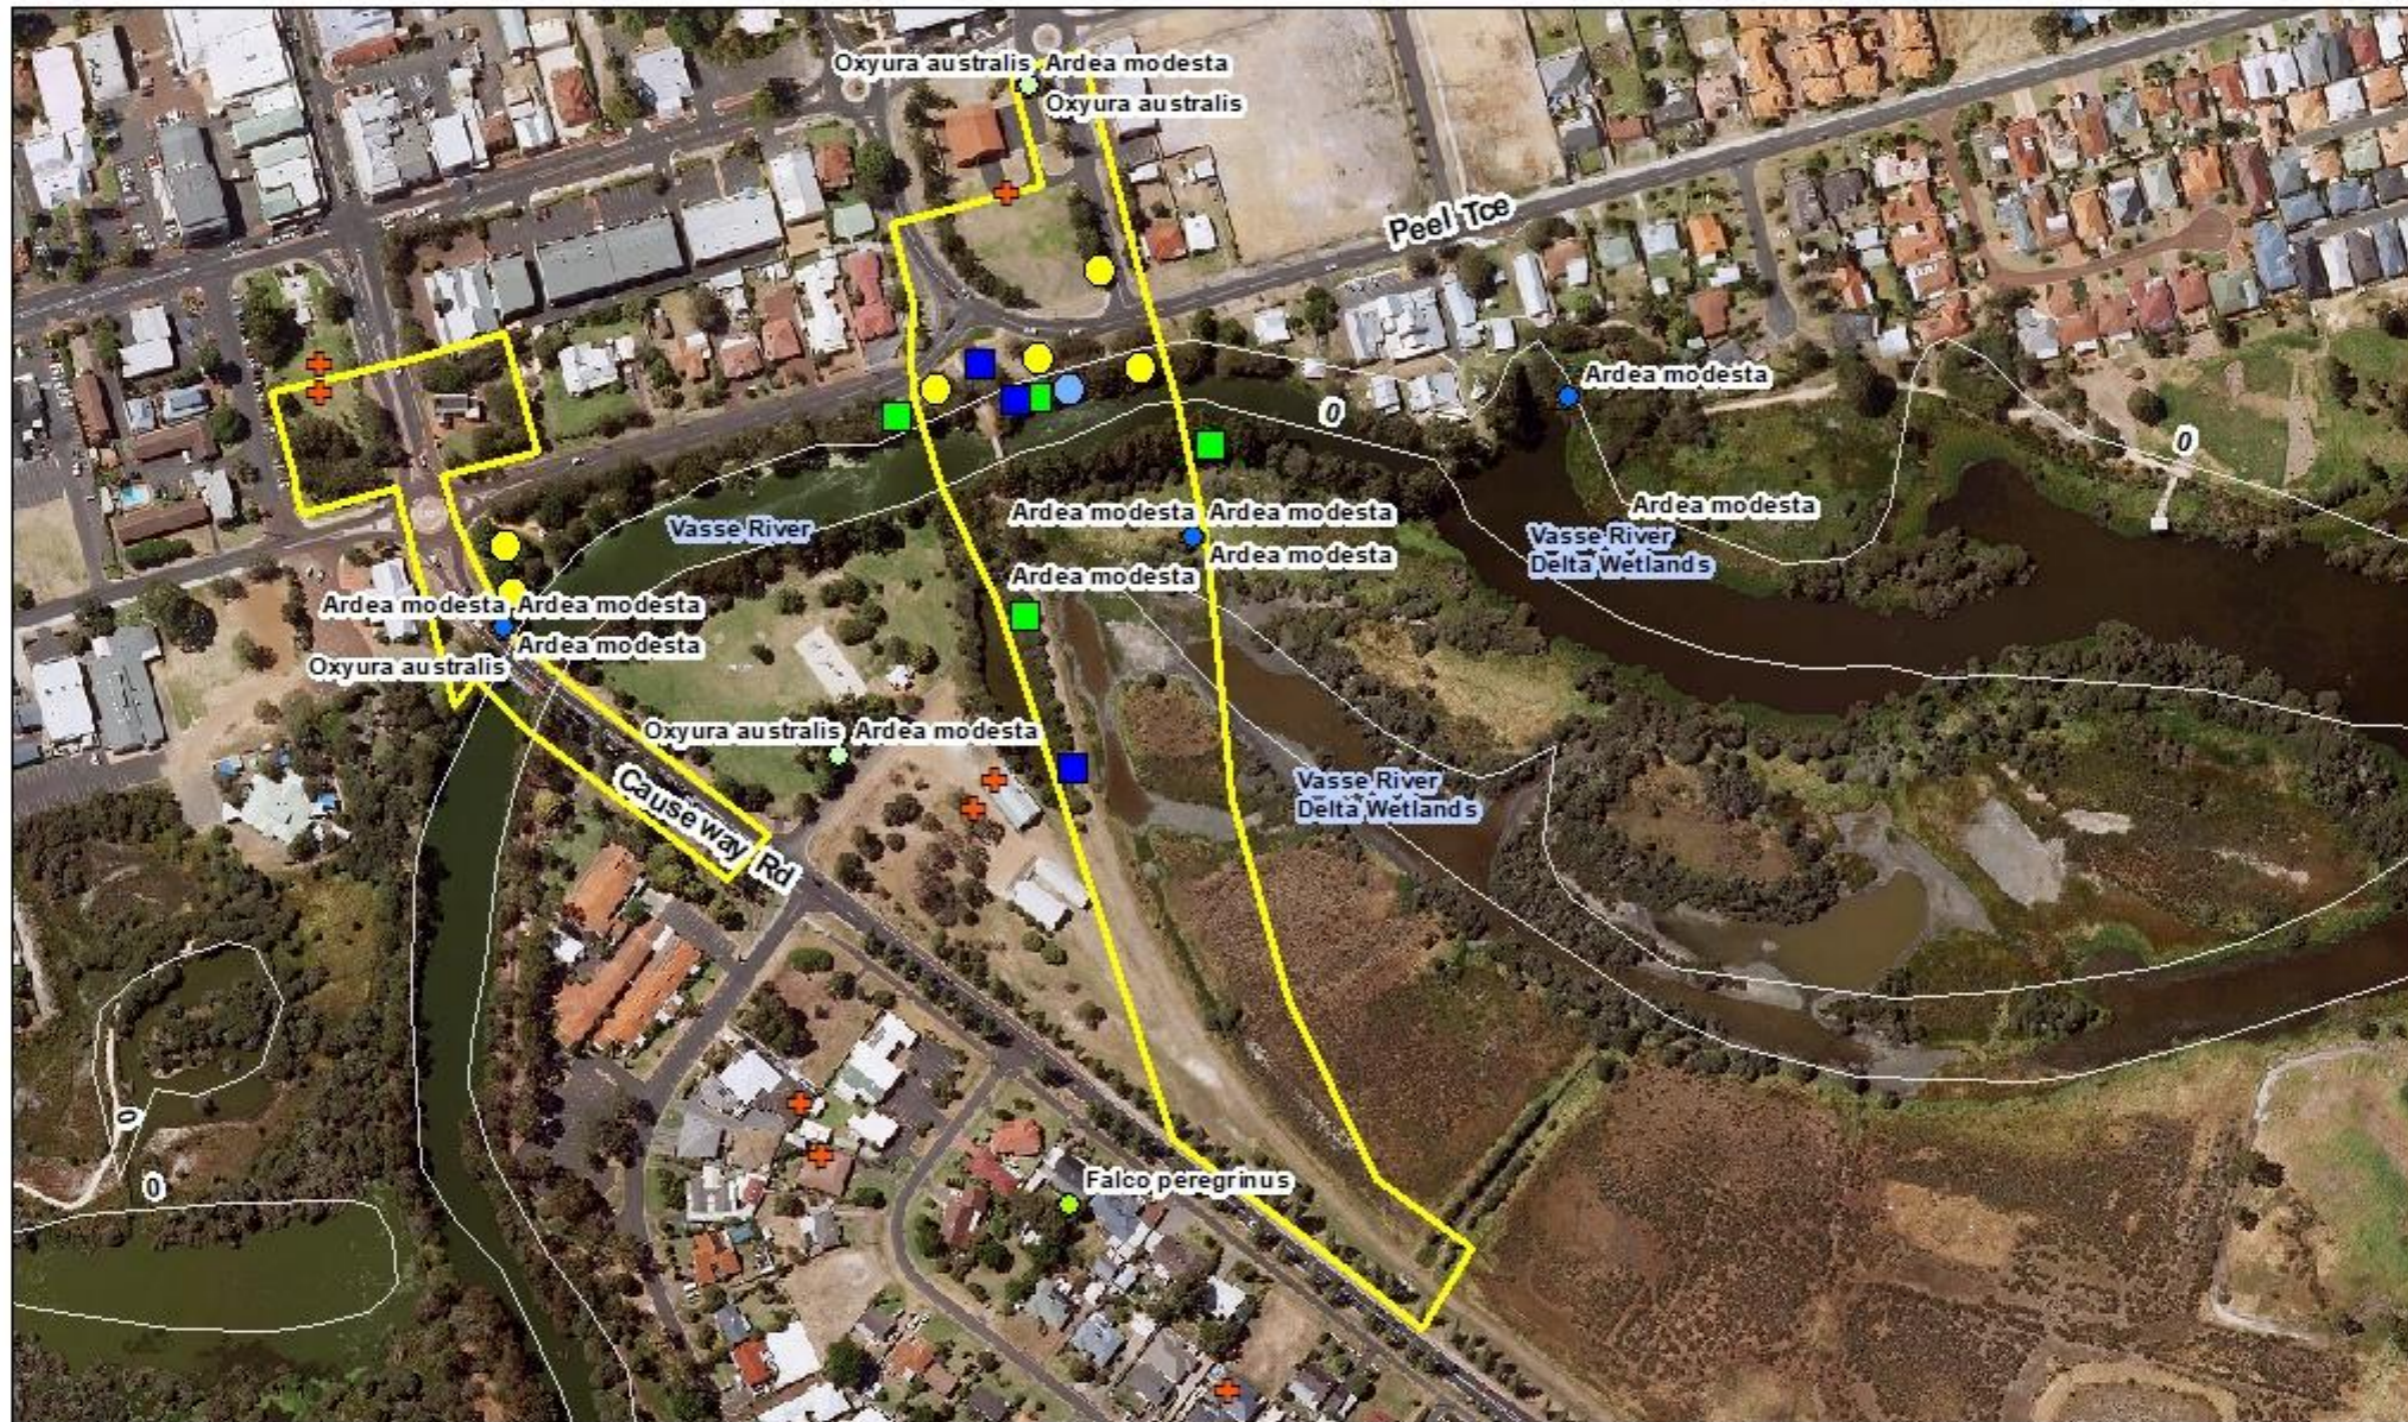
Map 9: Item A Eastern Link & Item B Causeway Bridge Fauna Survey Project Address: City of Busselton

The day time survey identified four areas of WRP scats and one drey observed within Vegetation Type 1 ('parkland cleared' Peppermint woodland) on the northern side of the river (Figure 5). The Peppermint trees in this area are mature and have potential gaps or hollows in their lees which would provide WRP habitat.

During the nocturnal surveys, four WRP were observed in Night 1 and three were observed in Night 2, within the areas of Vegetation Types 1 and 3 (Figure 5).

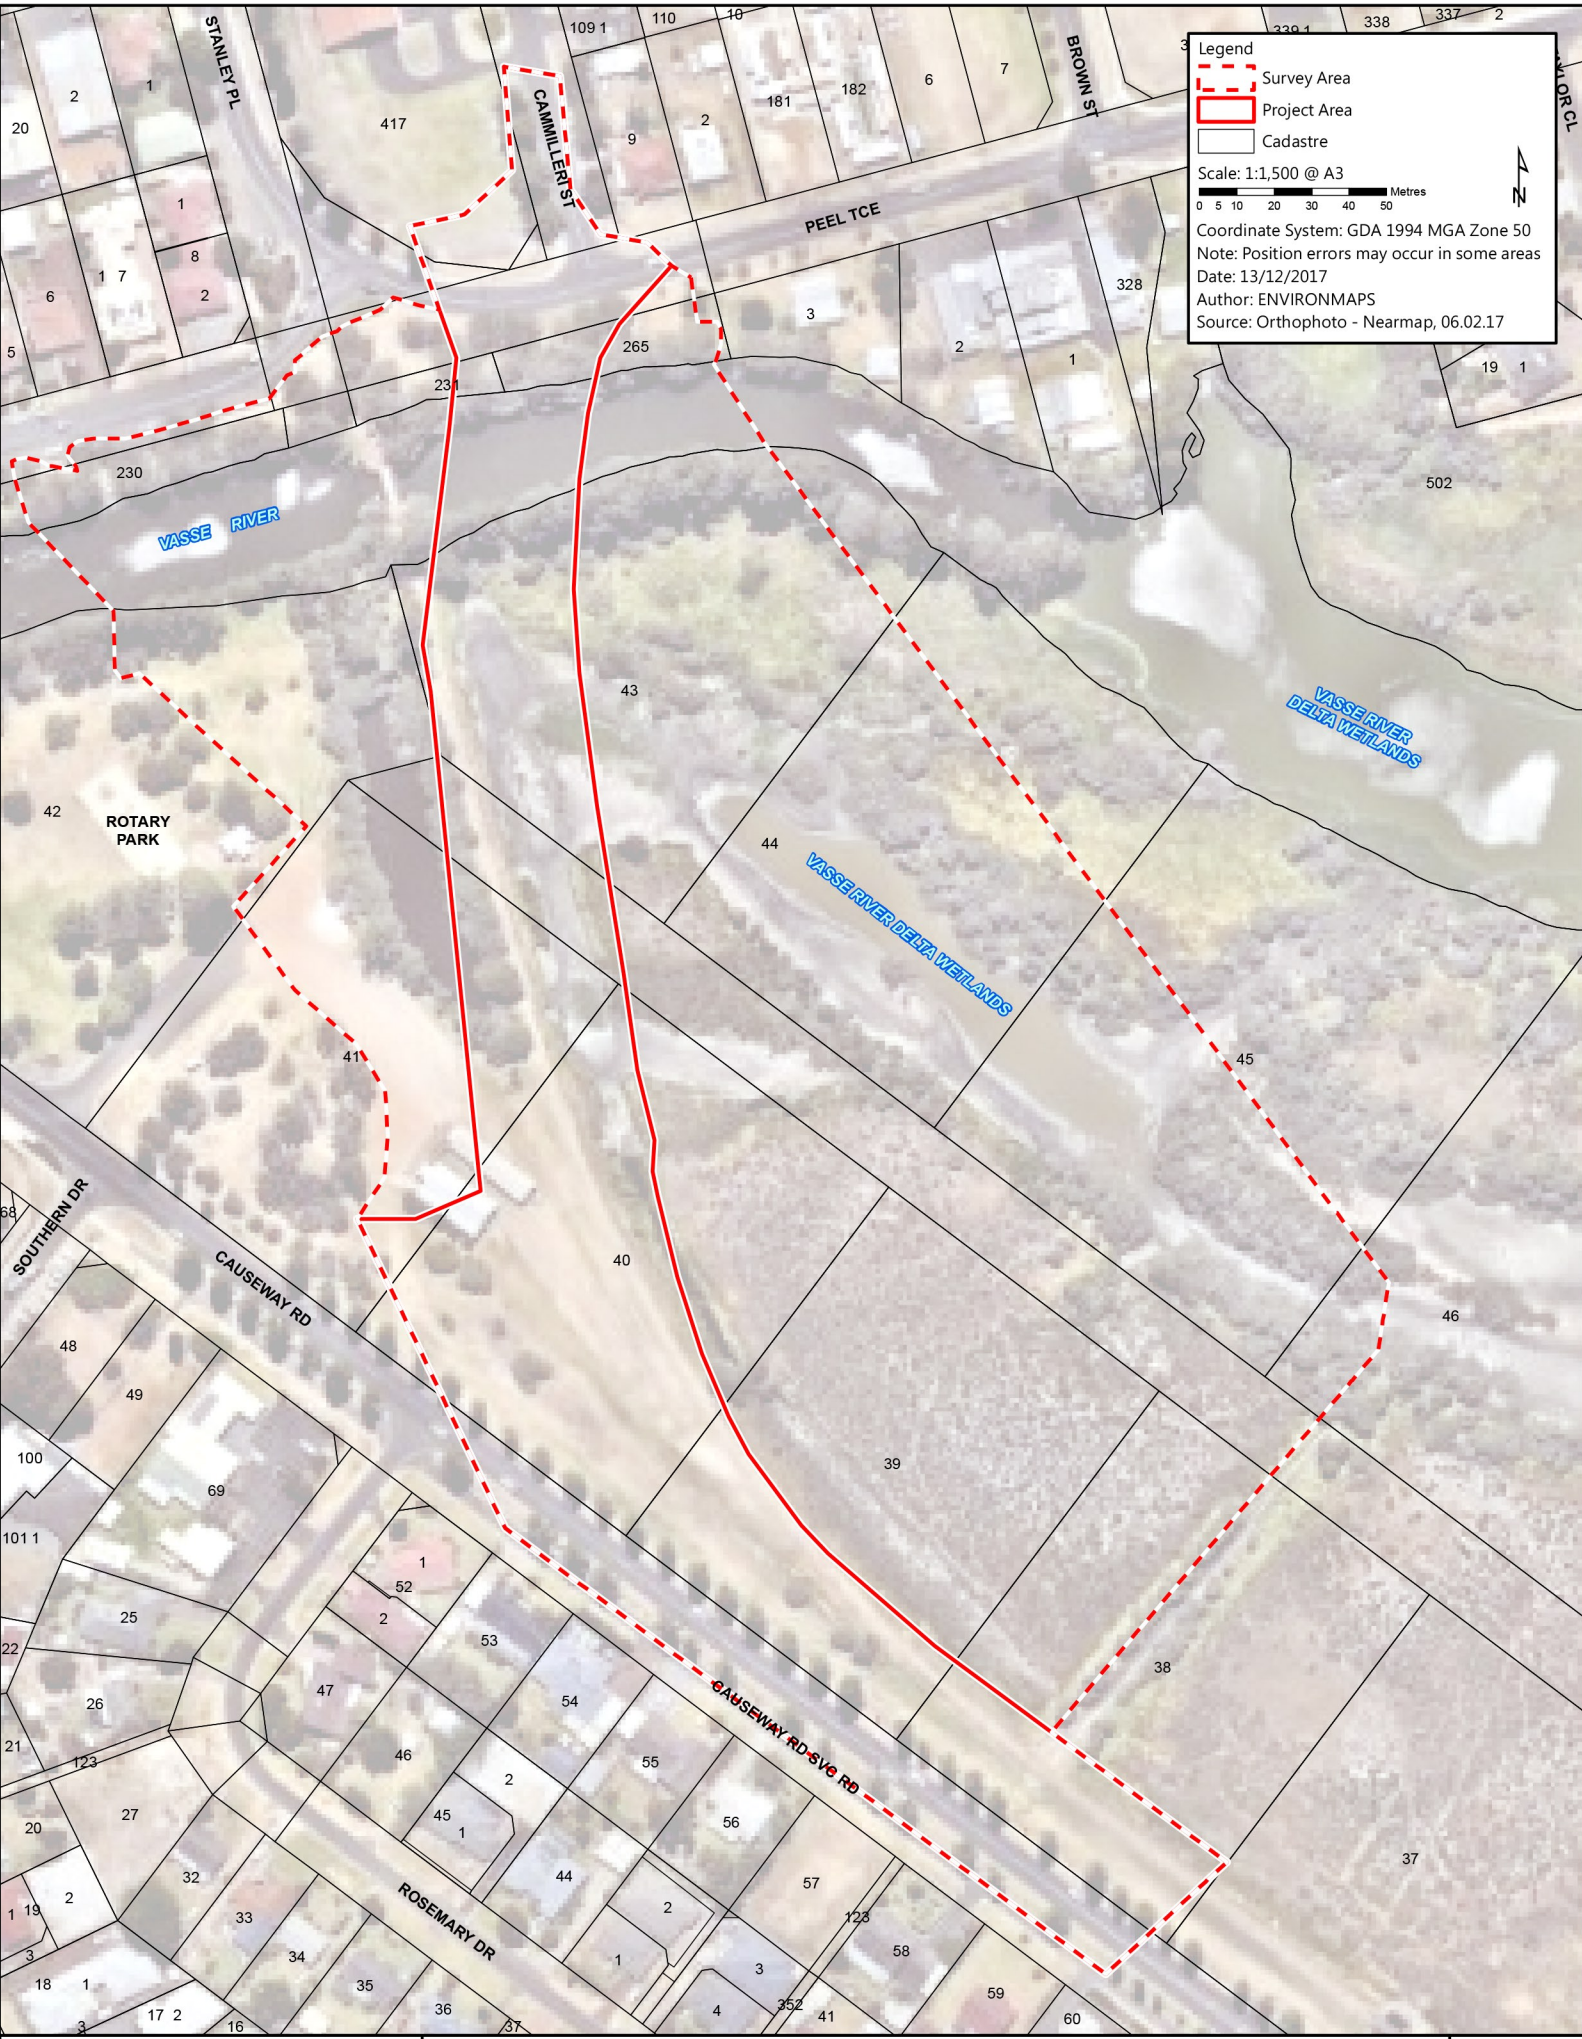
Figure
 1

Eastern Link Project – Detailed Flora and Vegetation Survey
 Survey Area and Project Area
