PRECINCTS 1 & 2 THOMAS ROAD, CASUARINA

ENVIRONMENTAL ASSESSMENT

Prepared for: Aigle Royal Developments
Report Date: 15 November 2017
Version: 1
Report No. 2017-326

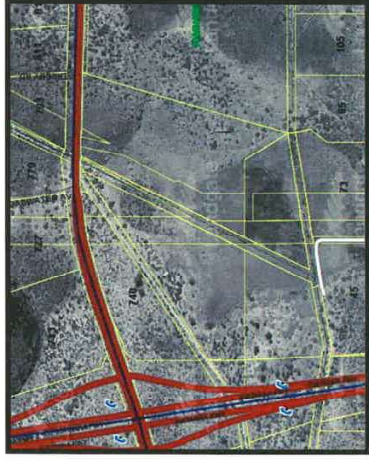
Plate 1: Historical aerial photograph from 1953 (Landgate, 2017)

In earliest available aerial photography in 1953 half of the site has been completely cleared and the other half contain scattered trees that appear in a range of condition from parkland cleared to an area in the north-west that is likely to have an intact understorey (Plate 1).

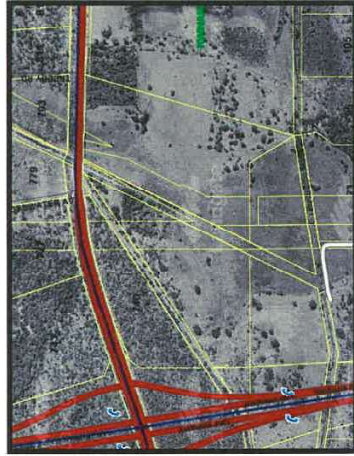
Plate 2: Historical aerial photograph from 1965 (Landgate, 2017)

Aerial photography from 1965 shows further clearing of the site in the south-west corner (Plate 2). The vegetation in the northwestern area remains as intact remnant vegetation.

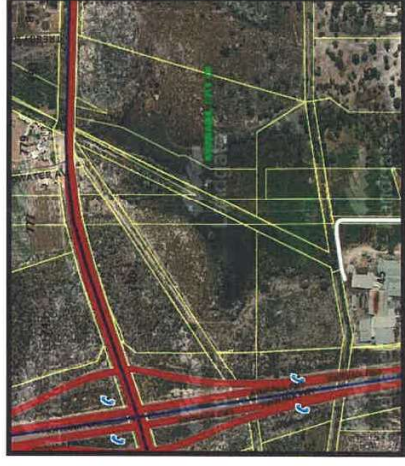
Plate 3: Aerial photography from January 2008 (Landgate, 2017).

The January 2008 aerial photography shows most of the site was burnt (Plate 3).

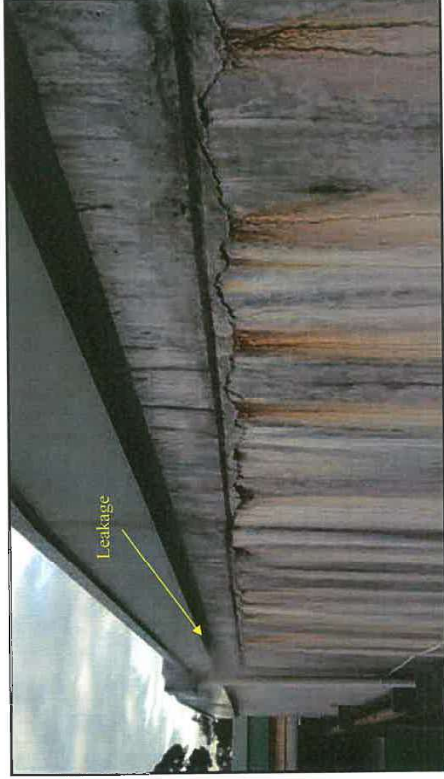
Figure 1 Example of leakage between concrete panels

- between the concrete cladding where the roof section abutted the tilt-up wall panels; and
- around the truck door seal.

The gaps in the concrete were inconsistent in size and there were substantial lengths where no emission (i.e. no gap) was apparent (see Figure 1).

It was observed that the volume of emission is much less than it was in 2012. In 2012, vertical gaps in the corners of the walls were in the order of a centimetre wide in places, and the resulting plume was visible well above the roof of the building.

Now, the emissions can only be observed by close inspection of the door and upper section of the walls. The emissions were through occasional very small gaps:

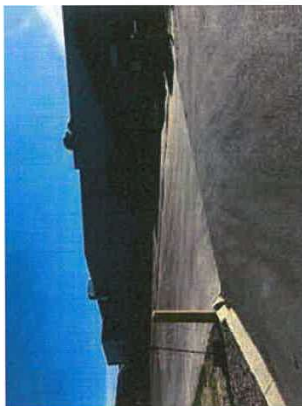
FIGURE 2 – LOGGER A – MUSHROOM EXCHANGE LOADING PAD NOISE MONITOR

Two locations were used for the continuous noise monitors, firstly the main compost loading / unloading area outside of the Tunnel building within the Mushroom Exchange facility. The second monitor was situated near to the boundary of the residential premise located at 73 Orton Road. Whilst not the closest noise sensitive premise, this site was chosen as from information provided, this was the main premise of concern in regard to noise. Monitor locations are shown in Appendix A.

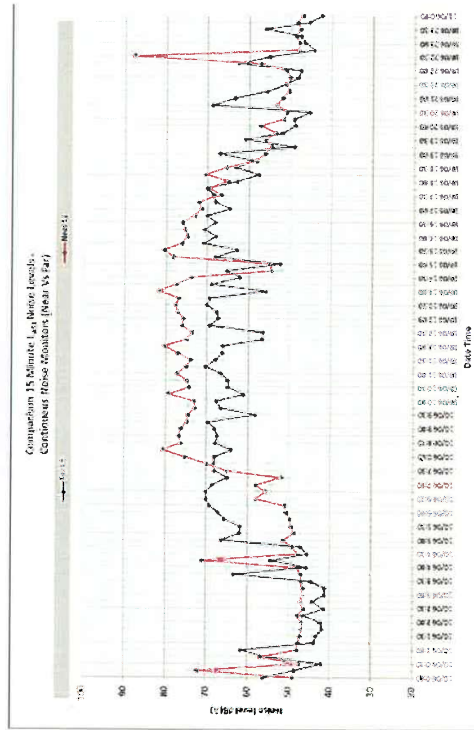
A Summarised comparison of the 15 minute noise levels for the L_{A10} , L_{A1} and L_{Amax} at both monitoring locations is shown in Figures 5 to 7. For the purpose of the summary, only Wednesday 10th June is detailed, with the entire monitoring period comparison contained in Appendix B.

FIGURE 6 – L_{Aeq} COMPARISON NOISE LEVELS WED 10th JUNE 2015

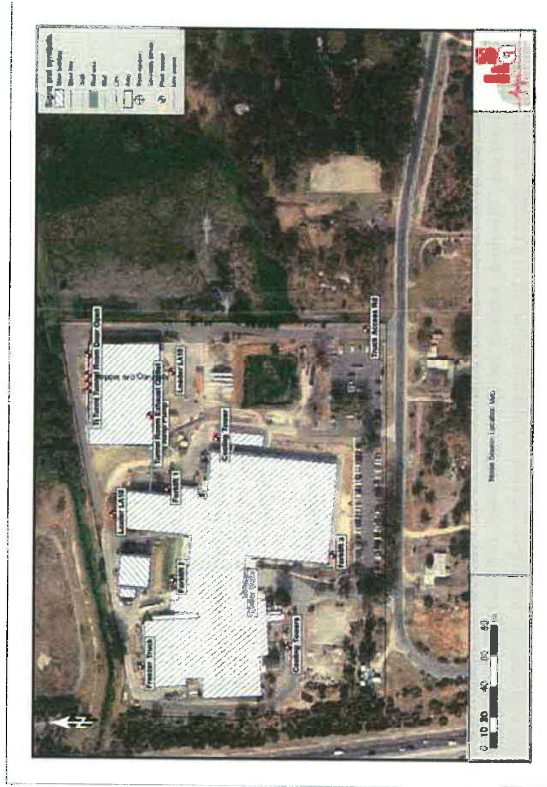
FIGURE 7 – SOURCE LOCATION MAP

- a) Supplied Drawings and source locations, shown in part in Figure 7.
- b) Sound Power Levels listed in Table 5.
- c) Ground Absorption of 0.65

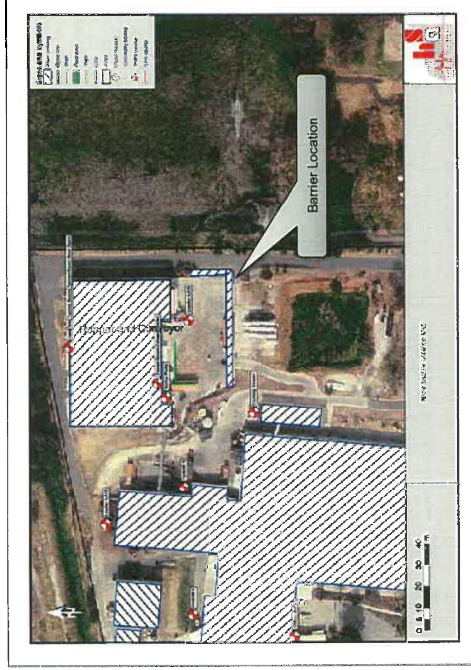
To provide an alternative to the enclosing of the loading equipment, modelling has been carried out to include a barrier 4.8m high along the southern end of the concrete loading area. The height of 4.8 m has been chosen as this is the same as two stacked sea containers. With the inclusion of this barrier, noise levels would be reduced at this location to a level where compliance would be achieved.

FIGURE 12 SHOWS THE LOCATION OF THE BARRIER REQUIRED FOR THE LOADING AREA
