PART LOT 650 THOMAS ROAD, CASUARINA

ENVIRONMENTAL MANAGEMENT PLAN

Prepared for: Aigle Royal Developments

Report No. 2017-323

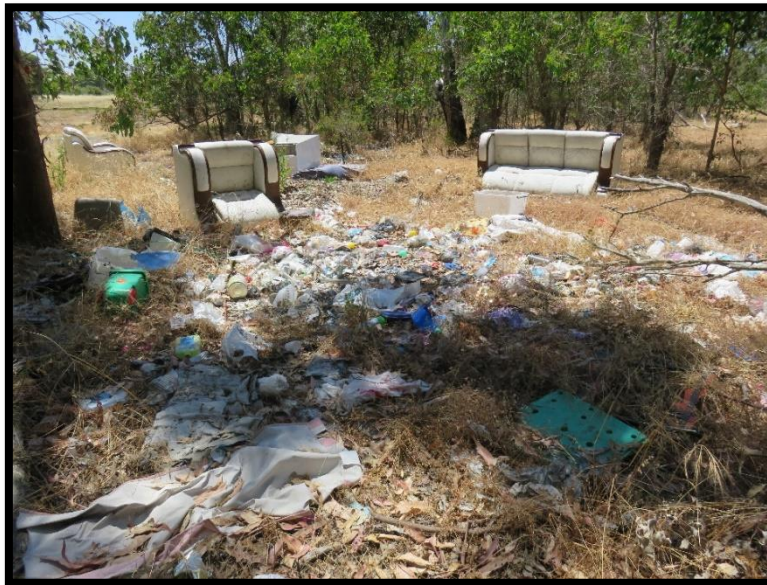
Plate 1: Dumping on the site

Approximately 3.2ha of the 5ha application area is currently completely cleared of native vegetation and was previously used for agricultural purposes. The native vegetation contains two distinct stands around 0.7ha and 1.1ha in size as well as some scattered native shrubs and trees (Figure 2). The site is no longer used for agricultural purposes. Some dumping of domestic rubbish has occurred on the site (Plate 1).

Prior to clearing the rubbish located on the site will be cleared. The rubbish will be disposed of will be as per all relevant legislation and protocols.

The site is not known to be contaminated, however there is dumped domestic rubbish which will be removed at the start of the operation. Caution should be used if there are any drums, car batteries or material that may be asbestos or other identified rubbish that is considered to present a risk. If during clearing potentially hazardous waste is encountered the management of the waste will be as per all relevant legislation and protocols.

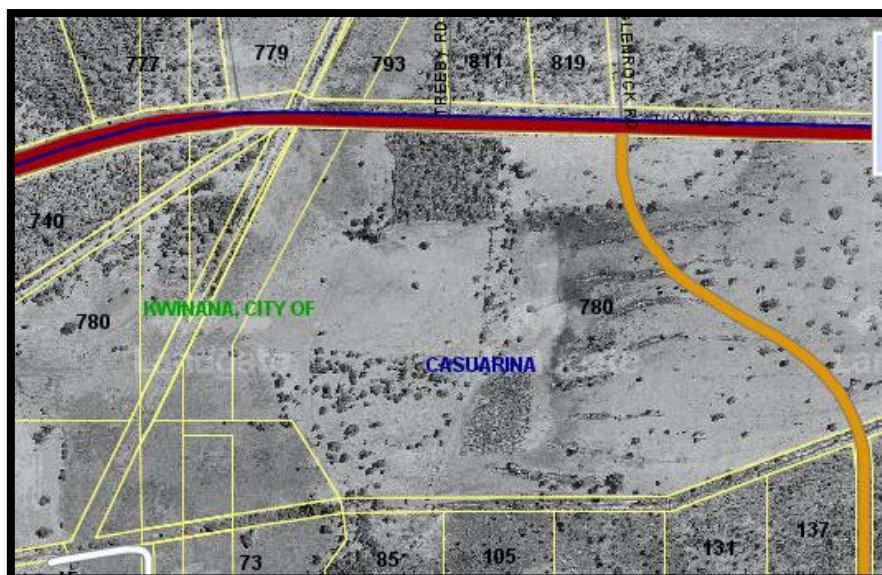
Plate 2: Aerial photography from 1965 (Landgate, 2017a).

Aerial photography from 1965 shows that more of the site was cleared in earlier years. The eastern portion of native vegetation that exists now was nearly completely cleared in 1965 (Plate 2). The vegetation in this area has regenerated from the few remaining trees.

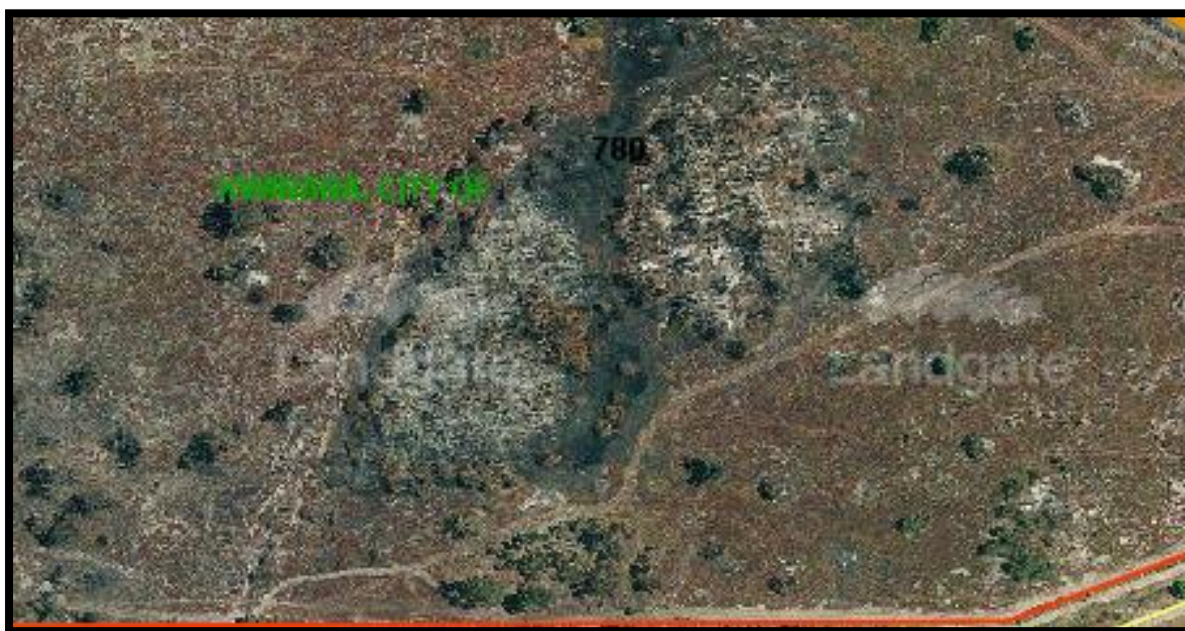
Plate 3: Aerial photography from January 2008 (Landgate, 2017a).

The January 2008 aerial photography shows both vegetated areas were burnt (Plate 3).

LPP1 defines a significant tree as one that has a diameter at breast height of greater than 50cm. The proposed stockpiling area has been partially cleared in the past and then more recently burnt (Plate 3). There are less than 10 Flooded Gums that meet the 50cm diameter criteria and those that do have been damaged by fire and would not be recommended to be retained.

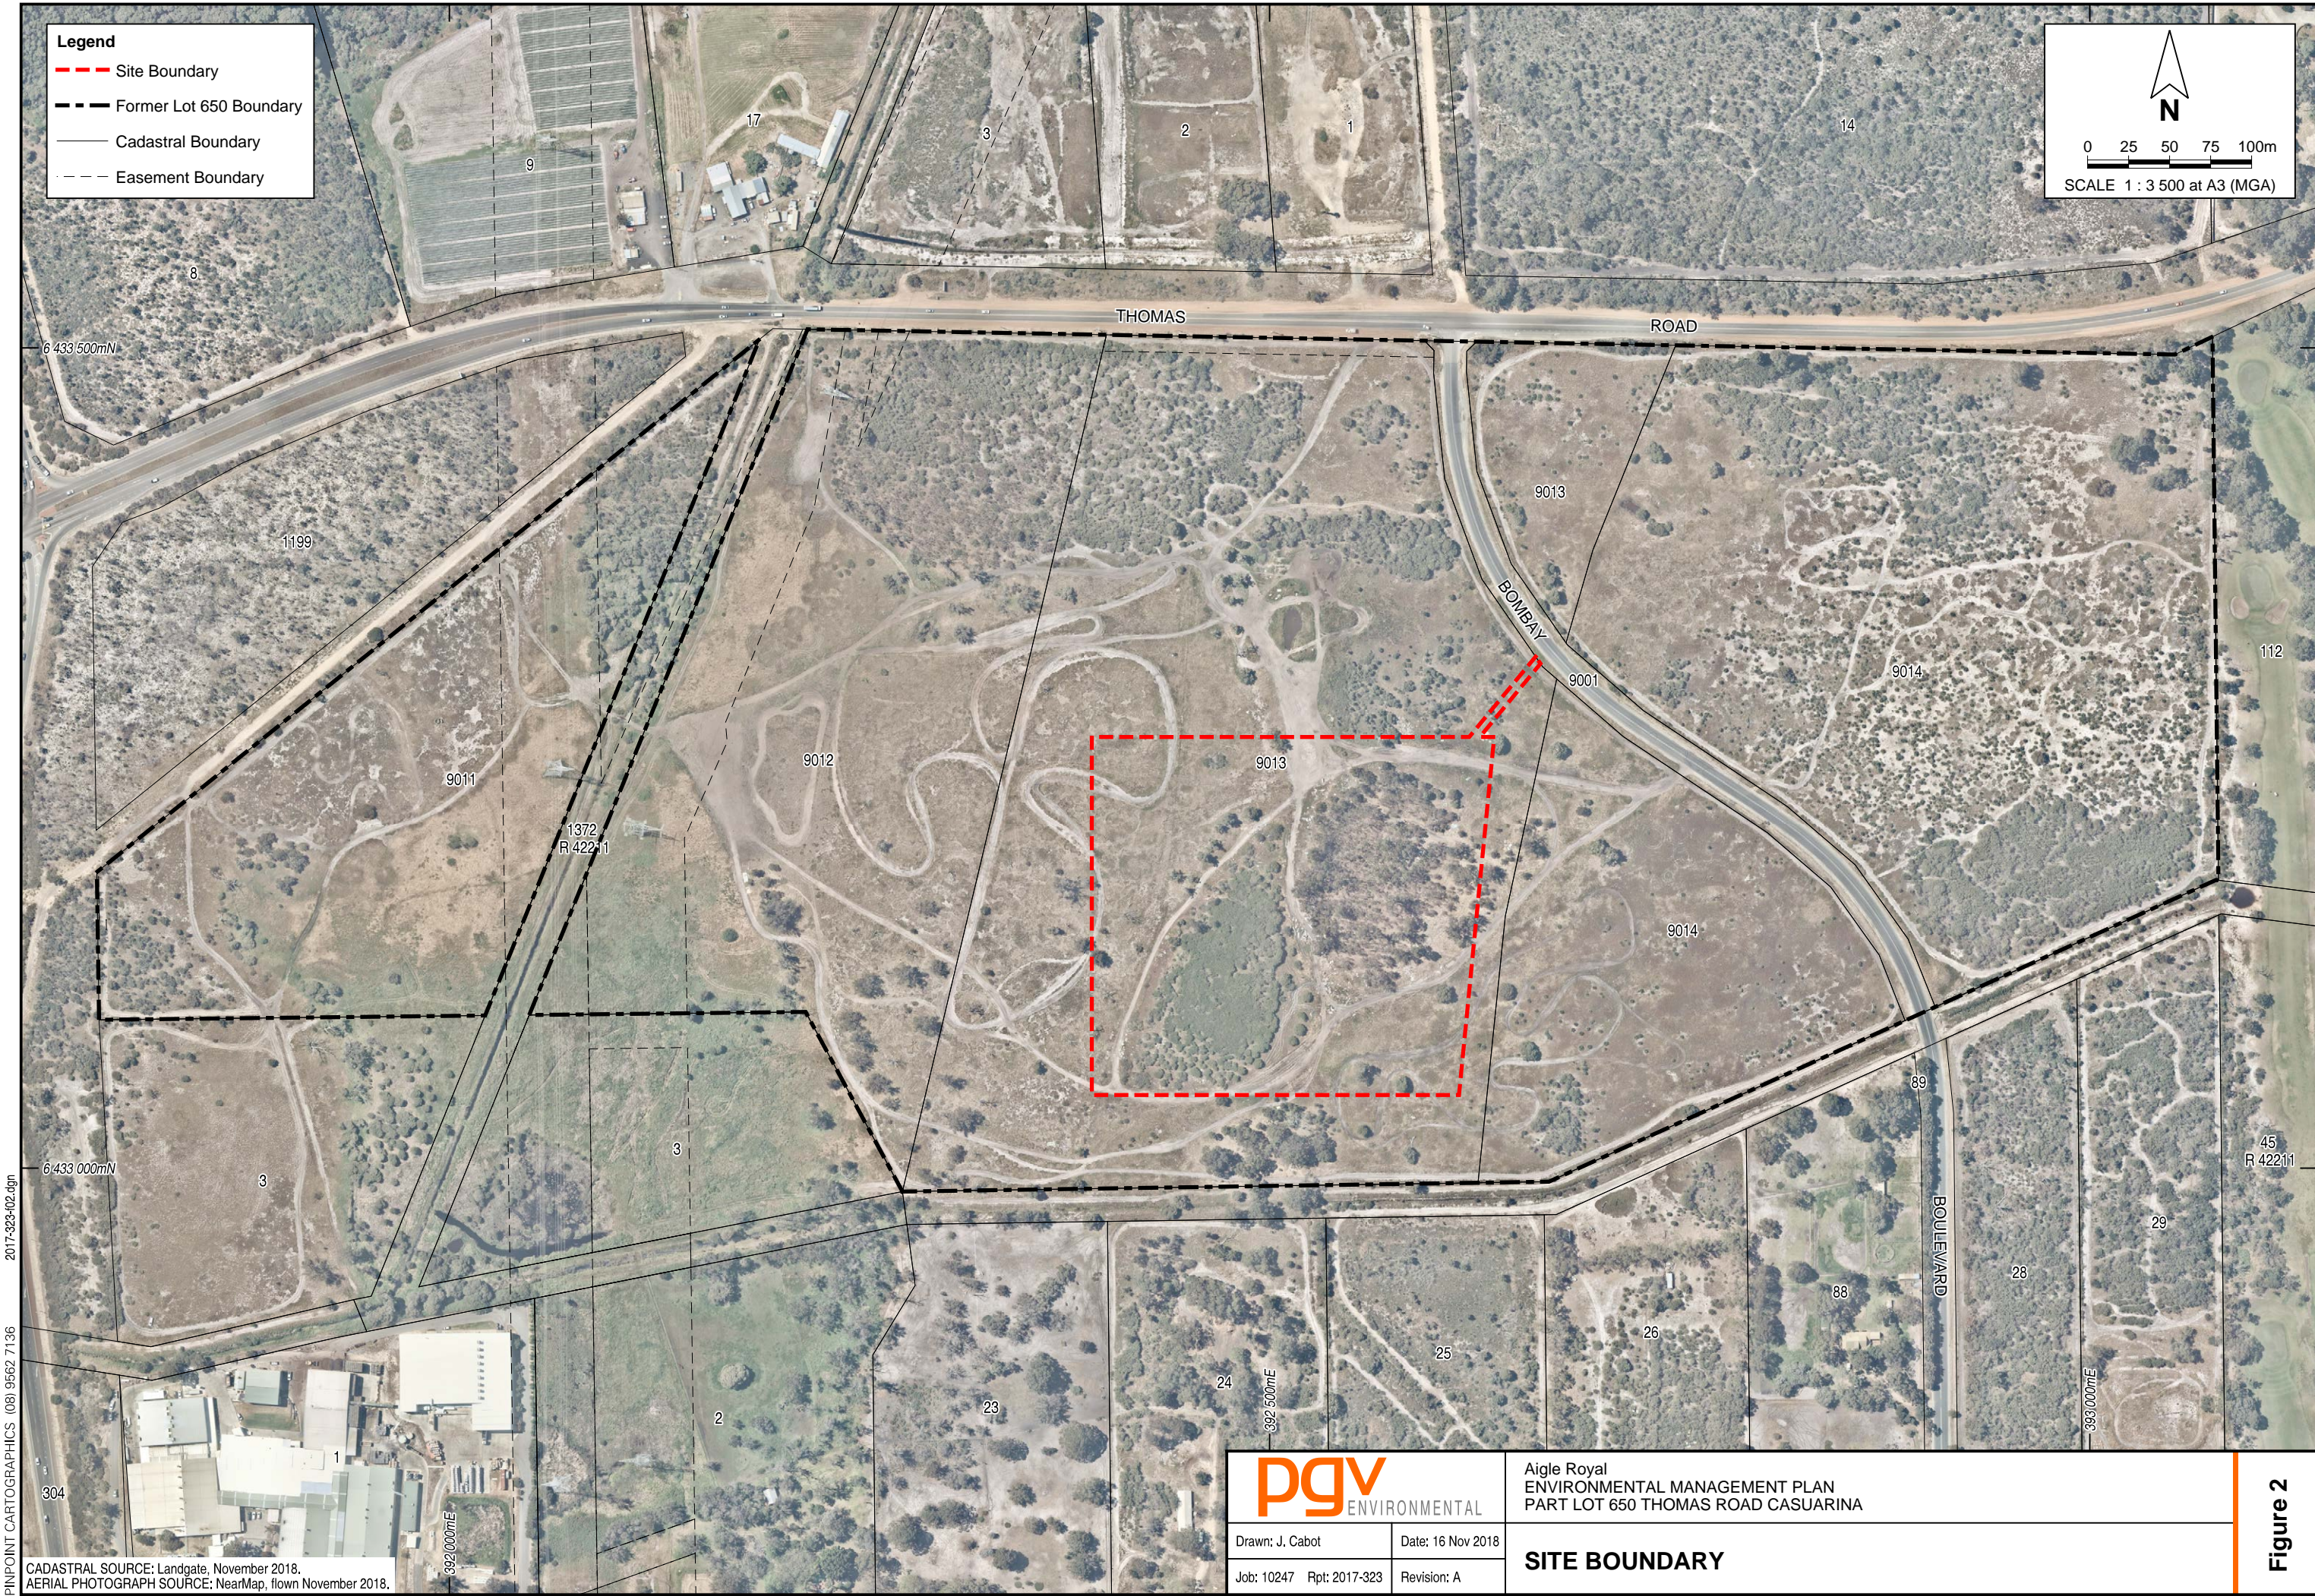
Figure 2

| | | SITE BOUNDARY | |

Aigle Royal Developments is proposing to stockpile sand on part of Lot 605 Thomas Road, Casuarina in preparation for future development on the 'Urban' zoned land. The site is located 30km to the south of the Perth Central Business District (Figure 1). The proposal is being submitted as a Development Application to the City of Kwinana. The footprint of the proposed stockpile site is 5ha (Figure 2).
