CLEARING PERMIT APPLICATION – BALANNUP ROAD UPGRADE

PROJECT	BALANNUP ROAD - HARRISDALE RAINFORD ROAD TO REILLY ROAD
DESCRIPTION	PROPOSED VEGETATION CLEARING AREA
DATE	10/11
SCALE	1:1000
PROJECT NO.	E17-133-SK6

Balannup Road Targeted Flora Survey

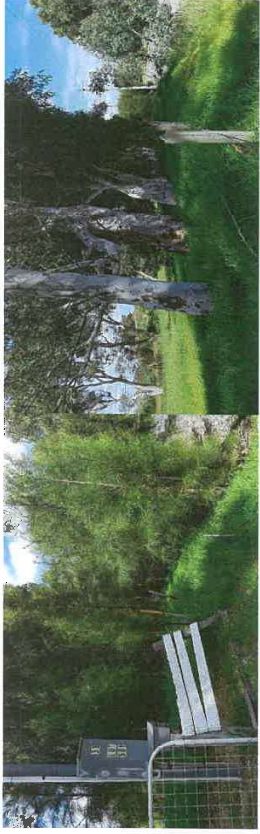
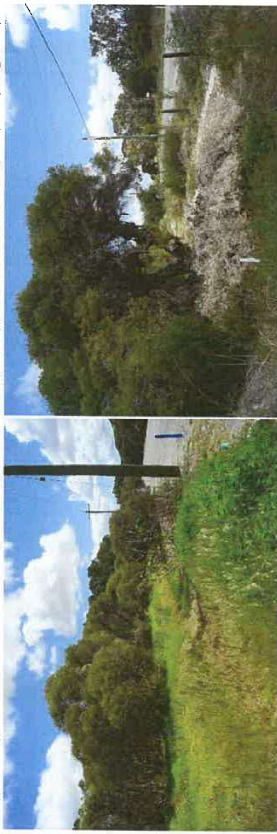
Figure 3: Vegetation types and condition

Foreign Eucalypt and Sheoak Woodland (Completely Degraded)

Meibomia raphiophylla Woodland (Completely degraded)

Meibomia praissiana Woodland (Very Good)

The field survey was undertaken on 02 October 2018 by botanist Harley Taylor. The soil types identified during the desktop survey were confirmed to be accurate. Vegetation condition ranged from Completely Degraded to Very Good, with the majority of the site in Completely Degraded condition (Figures 3 and 4). There were a high level of invasive weeds including species classified as Declared Pests under the *Biosecurity Management Act 2007* (WA):

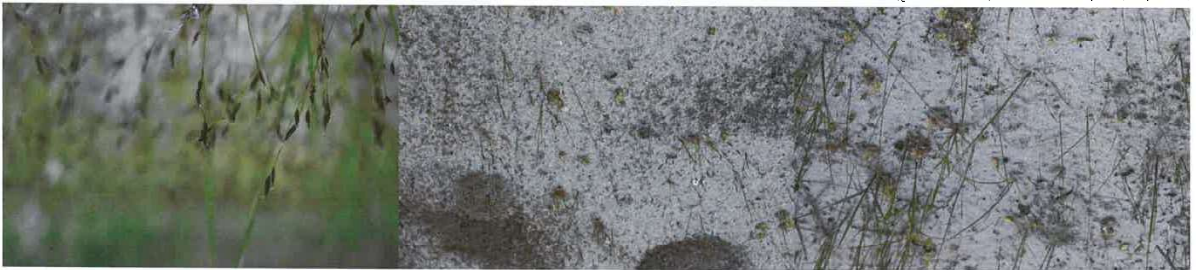
Figure 7: *Schoenus pennisetis* identification and densities

Schoenus pennisetis herbarium sample

Low density (app. 2 – 10 plants per m²)
Moderate density (app. 100 – 400 plants per m²)
High density (app. 600+ plants per m²)

One Priority 3 flora species was found during the survey, *Schoenus pennisetis*. The species was not identified during the site visit however a sample was taken (as it was identified to be a *Schoenus*) and the species identified at the Western Australian Reference Herbarium (Figure 7). A secondary site visit was undertaken on 8 October 2018 to map the population of the Priority species (Figure 8). Population was mapped in three densities: low, moderate and high (Figure 7 and 8). Permission was sought from the land owners to access the private property adjacent to the survey site to ensure the extent of the population was mapped. The population occurred almost exclusively in areas that have been cleared for the firebreak or other purposes (Figure 8).
