# Preliminary Site Investigation

Lot 500 on Plan 63577, Yilkari WA

Prepared for City of Kalgoorlie-Boulder

Project Number: TE18047

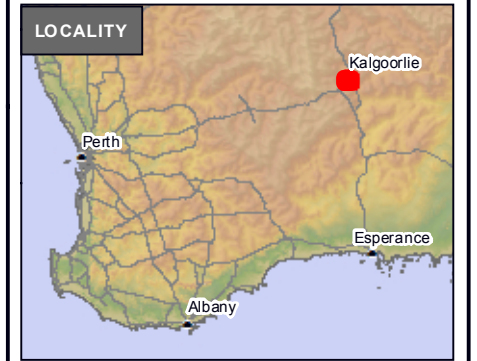
**EUROPEAN HERITAGE**

An online search of the Heritage Council of WA (HCWA) database using the inHerit portal found that the Site is not listed as European Heritage sites. The nearest listed site is the '*Goldfields Water Supply Scheme*' which is of '*National Heritage*' and is located directly to the north of the Site, as shown in Figure 6.

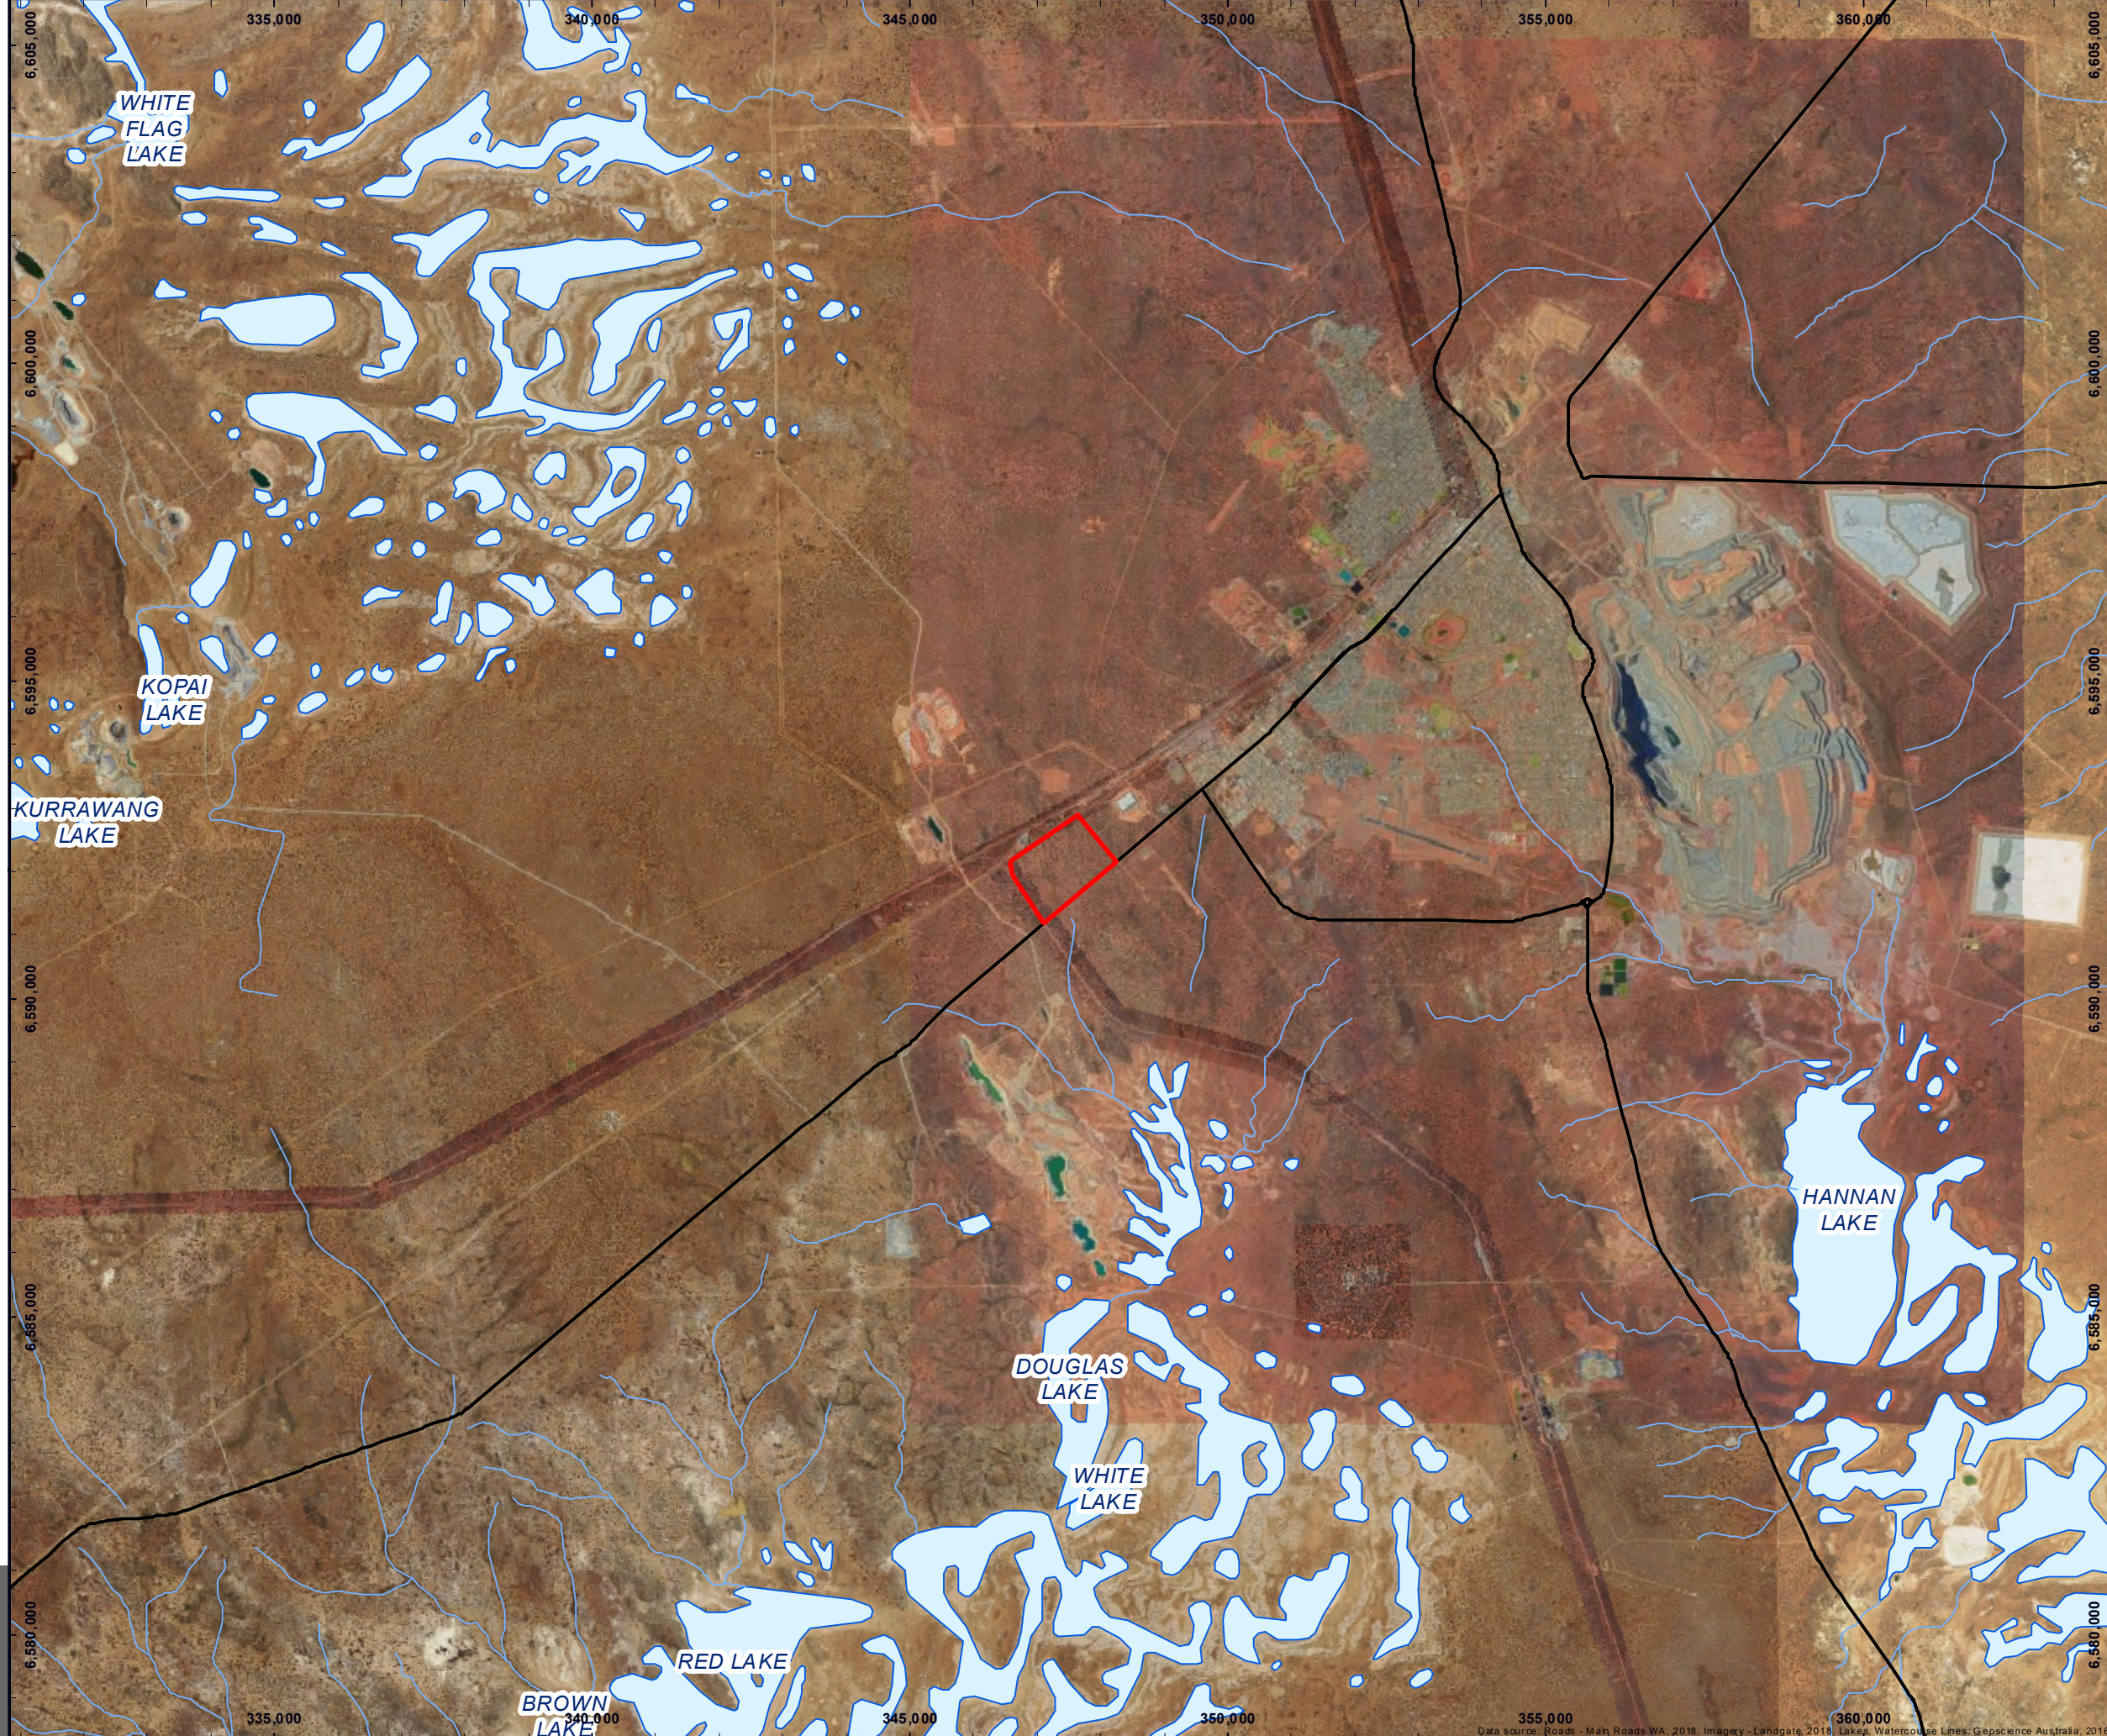
No surface water bodies were noted to be present at the Site. The nearest surface water body is an intermittent waterway, located approximately 120 m to the south of the Site; with a series of lakes located further to the south-east, approximately 2.5 km from the Site. These features are shown in Figure 10.

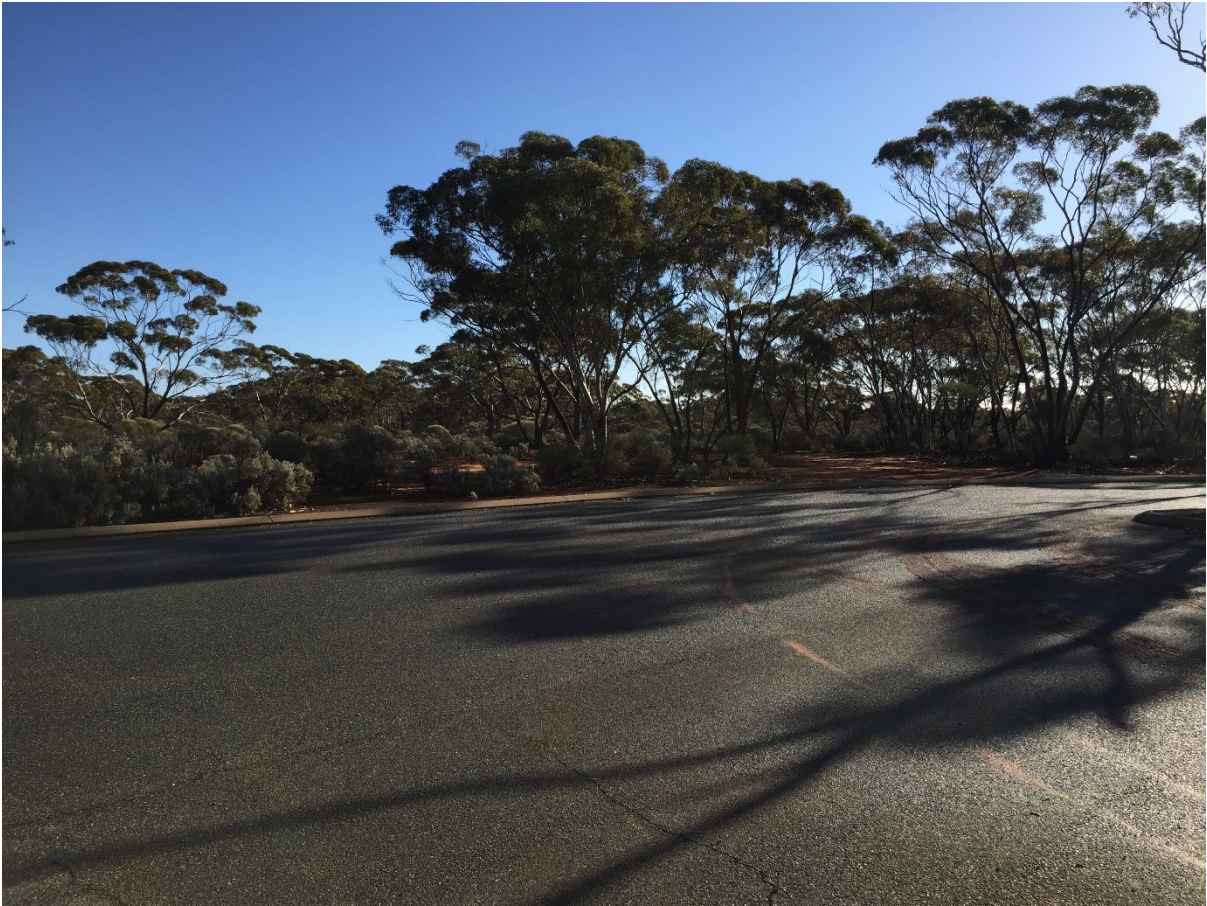
Photo 1: Parking area on southern boundary facing north.

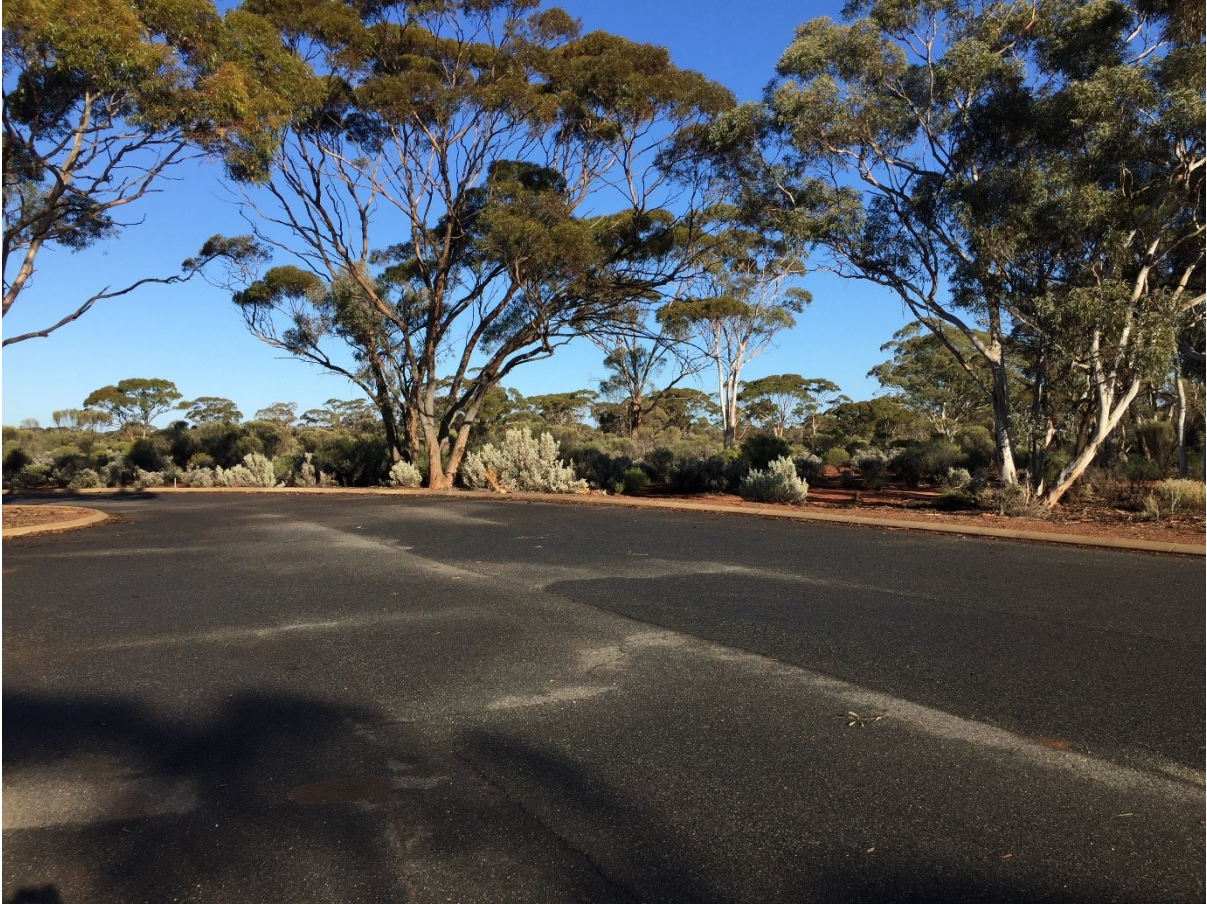
Photo 2: Parking area on southern boundary facing west.

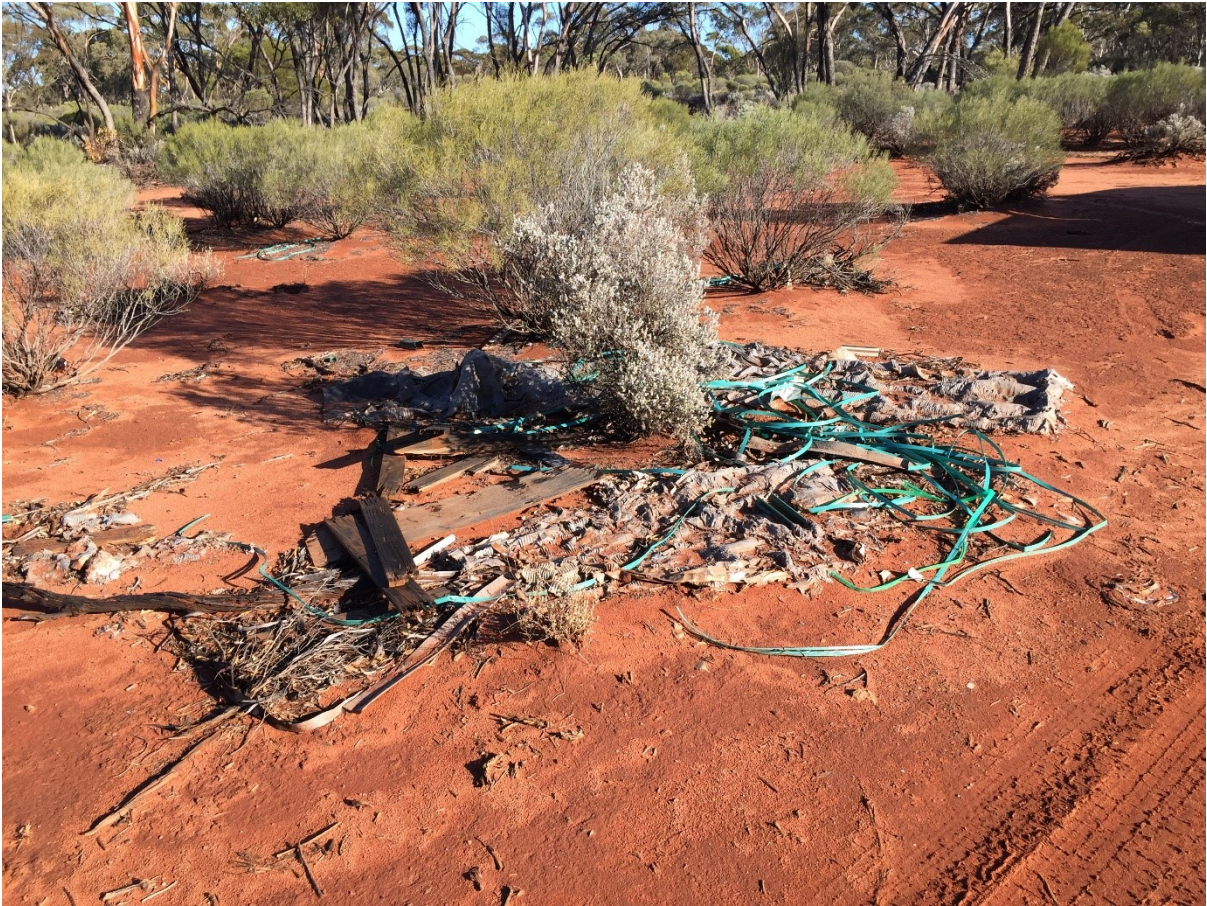
- Minor fly tipping was noted within the southern portion of the Site- close to the access via the rest stop area. Rubbish consisted of minor wood pallet scraps, cardboard, plastic straps, sheet metal and household whitegoods including washing machine and dryer;

Photo 3: Fly tipping of wood, cardboard, plastic straps and sheet metal facing west.

Based on the investigation undertaken, it is considered that the Site is suitable for use in a commercial/industrial land use setting. However, due to the presence of minor fly tipped waste material which was identified during the Site inspection, Talis recommends that this be removed and disposed off site to a licenced facility prior to development.

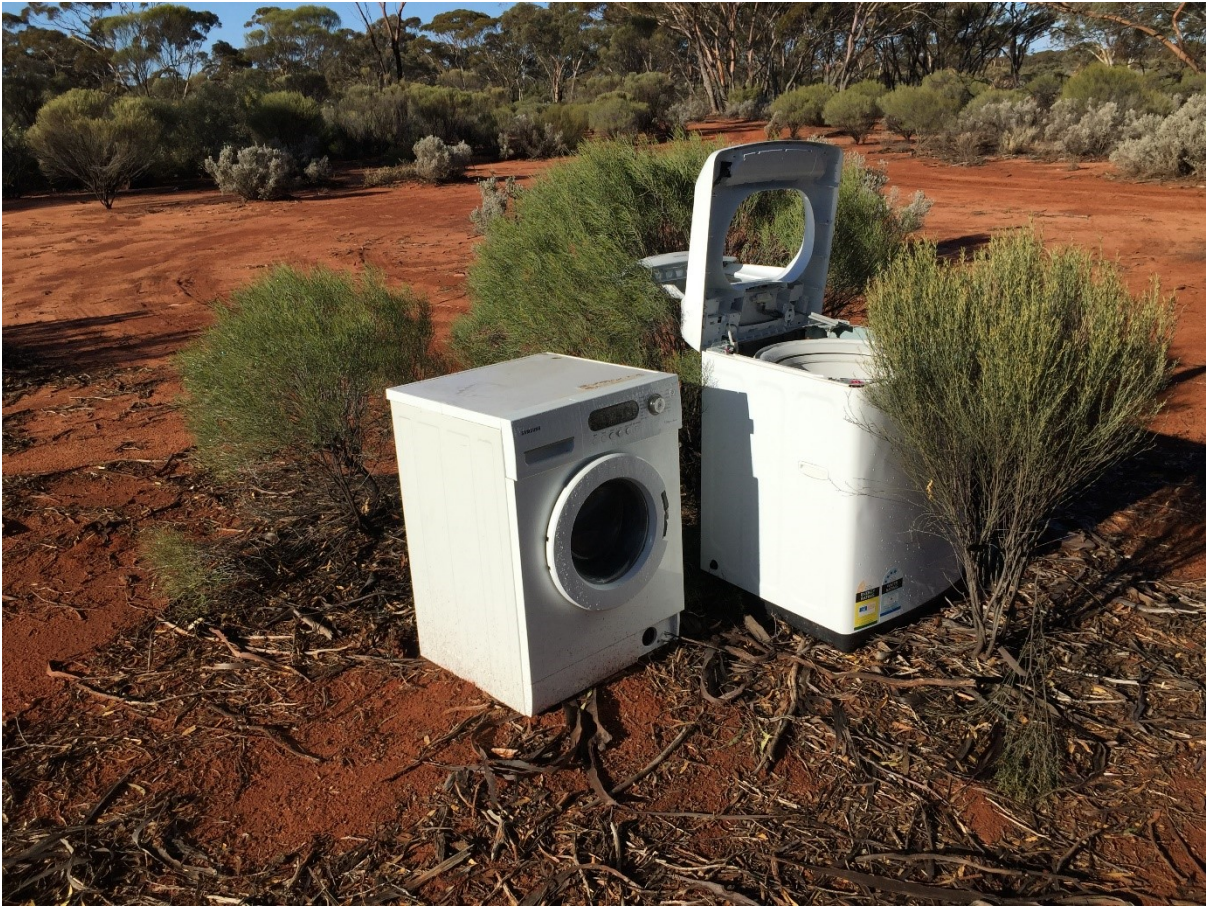
Photo 4: Fly tipping of a washer and dryer facing south.

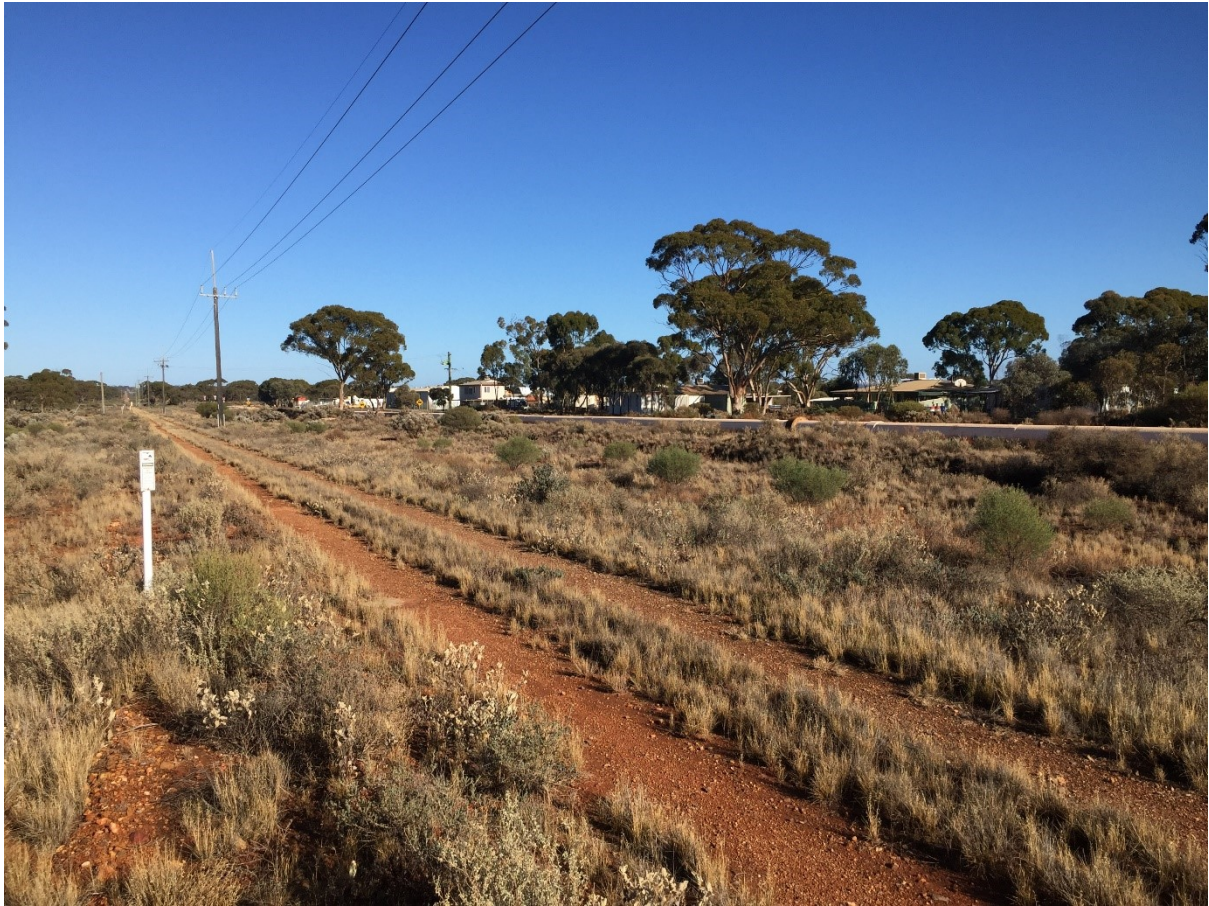
Photo 5: Service corridor along the northern boundary of the Site. Power lines and water pipeline visible. Freight and transport yards and workshops visible in background. Facing west.

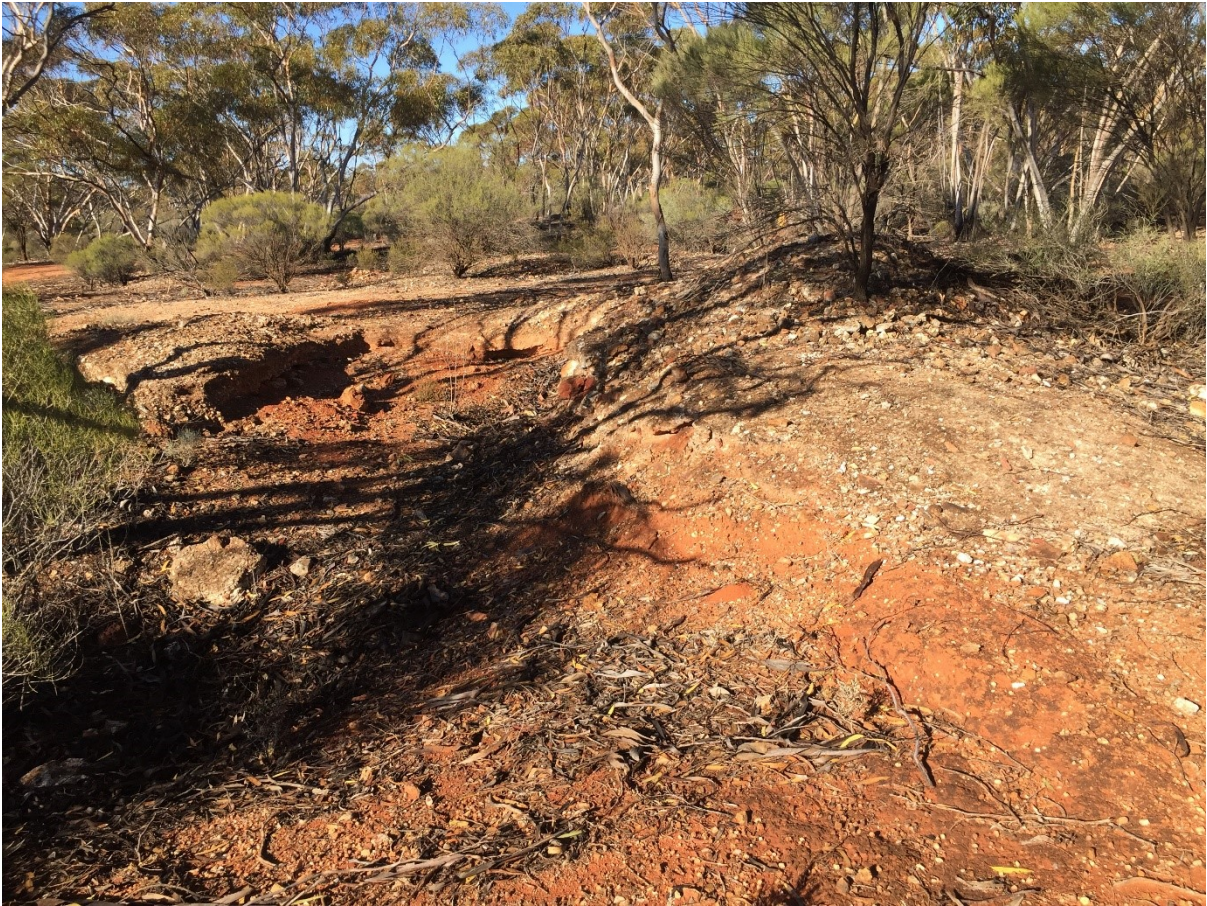
- Minor litter was observed around the rest stop;
- Areas in the north east of the Site have had ground disturbance, with minor trenches and stockpiles present. Some of this appears to be imported and dumped waste earth and rubble; and

Photo 6: Digging in the north east of the Site facing south west.

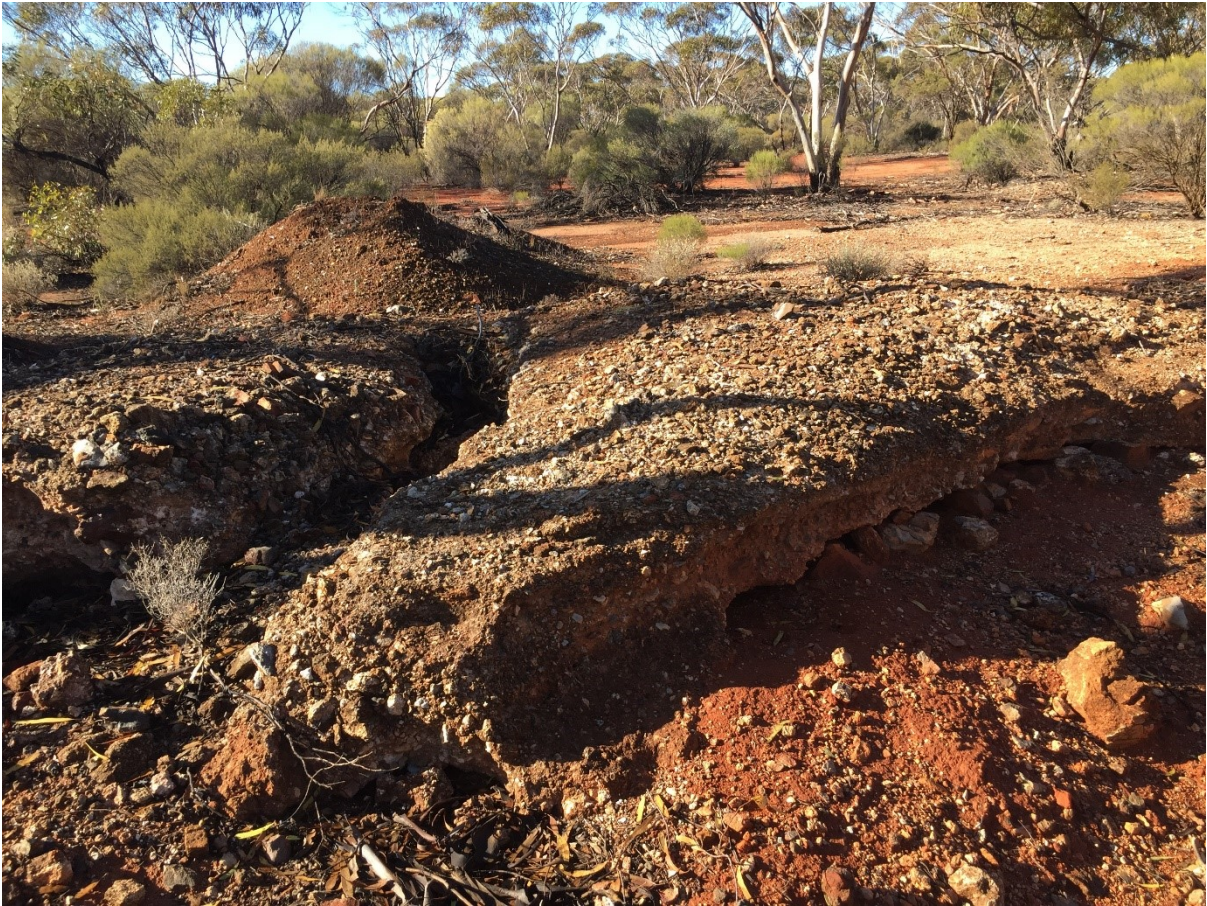
Photo 7: Diggings and soil piles in the north east of the Site facing south.

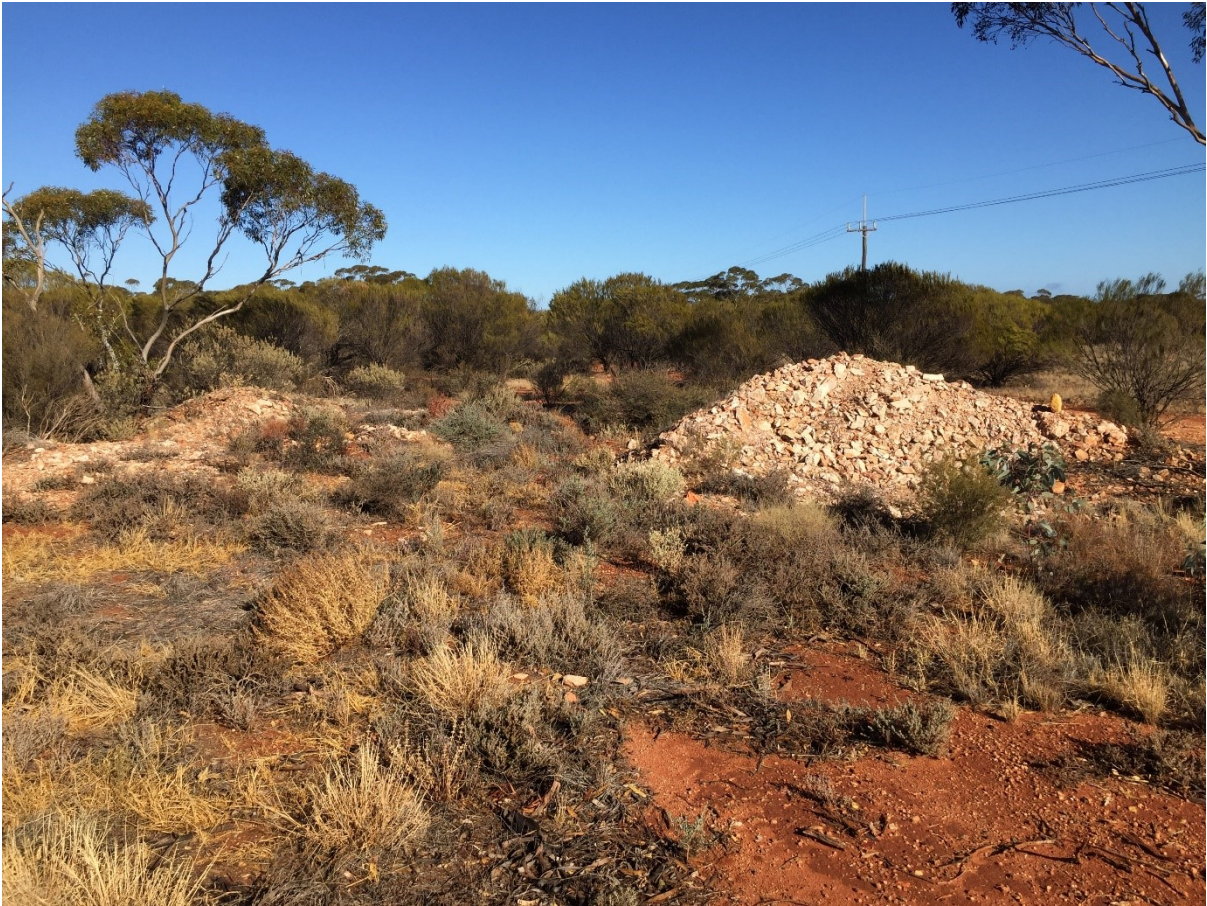
Phot 8: Soil and rubble pile in the north east of the site facing west.

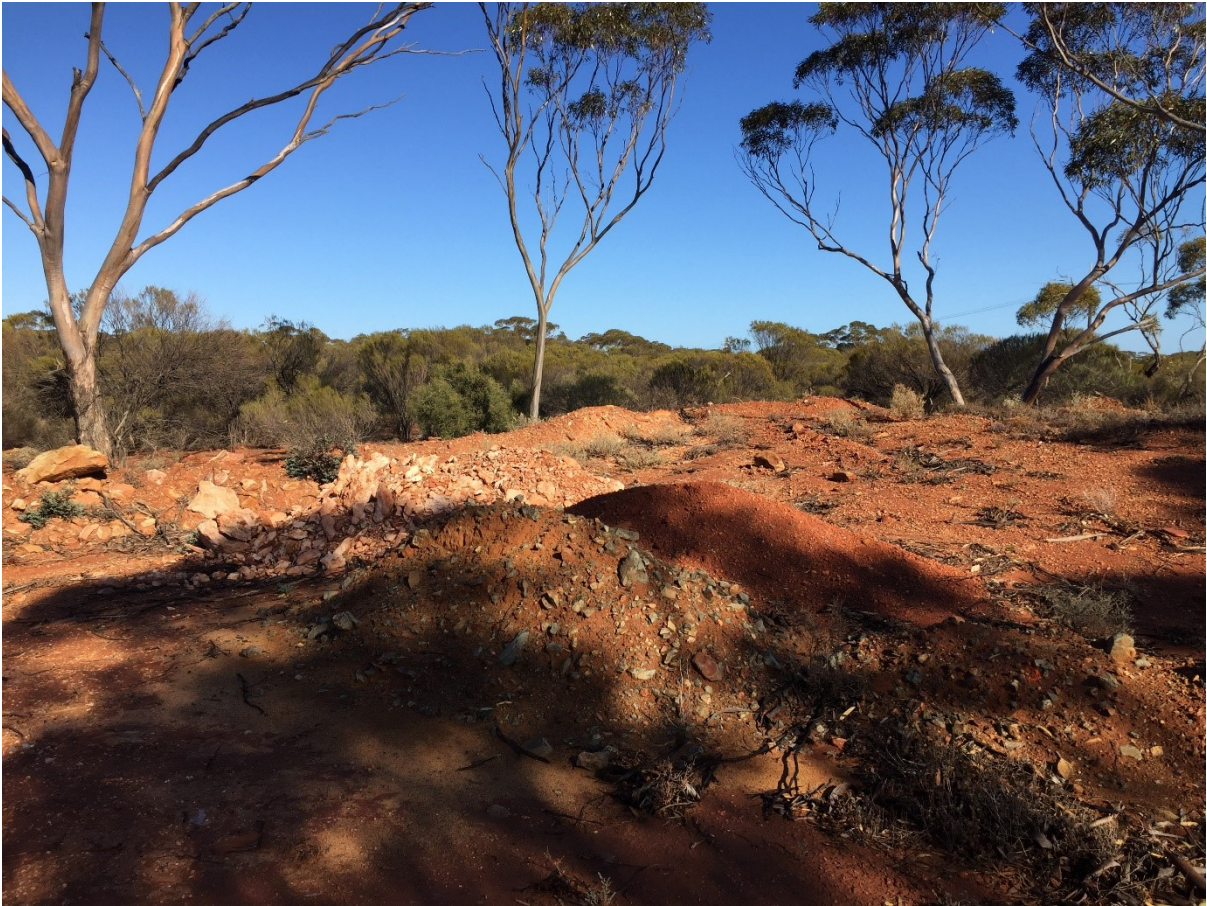
Photo 9: Piles of earth and rock rubble in the north east of the Site facing west.
