## VEGETATION SURVEY –ROAD UPGRADES

<b>Subject:</b>	Vegetation Mapping for Clearing Permit: Lee Road, Brown’s Road and Lake Saide Road Reserves, Youngs Siding, City of Albany.
<b>Introduction</b>	<p>A clearing permit is being sought to enable the creation of Lee Road and upgrade of Brown’s Road and Lake Saide Road at Youngs Siding in the City of Albany. The road upgrades are to facilitate the establishment of a lime pit on Lot 9000 Rock Cliff Road, Nullaki.</p> <p>The survey area was not included in the Albany Regional Vegetation Survey (Sandiford and Barrett, 2010).</p>
<b>Scope of Work &amp; Methodology:</b>	<p>The vegetation proposed to be cleared was mapped by Melanie Price of Aurora Environmental on 21 May 2019.</p> <p>To characterise the vegetation types and structures, the survey included:</p> <ul style="list-style-type: none"> <li>• Walking transects where no road was constructed; and</li> <li>• Driving along constructed road reserves.</li> </ul> <p>The survey did not include a full flora survey.</p> <p>A condition rating was assigned after Thackway and Lesslie (2006) and Keighery (1994) (Attachment 1).</p> <p>Vegetation types and conditions are illustrated in Attachment 2

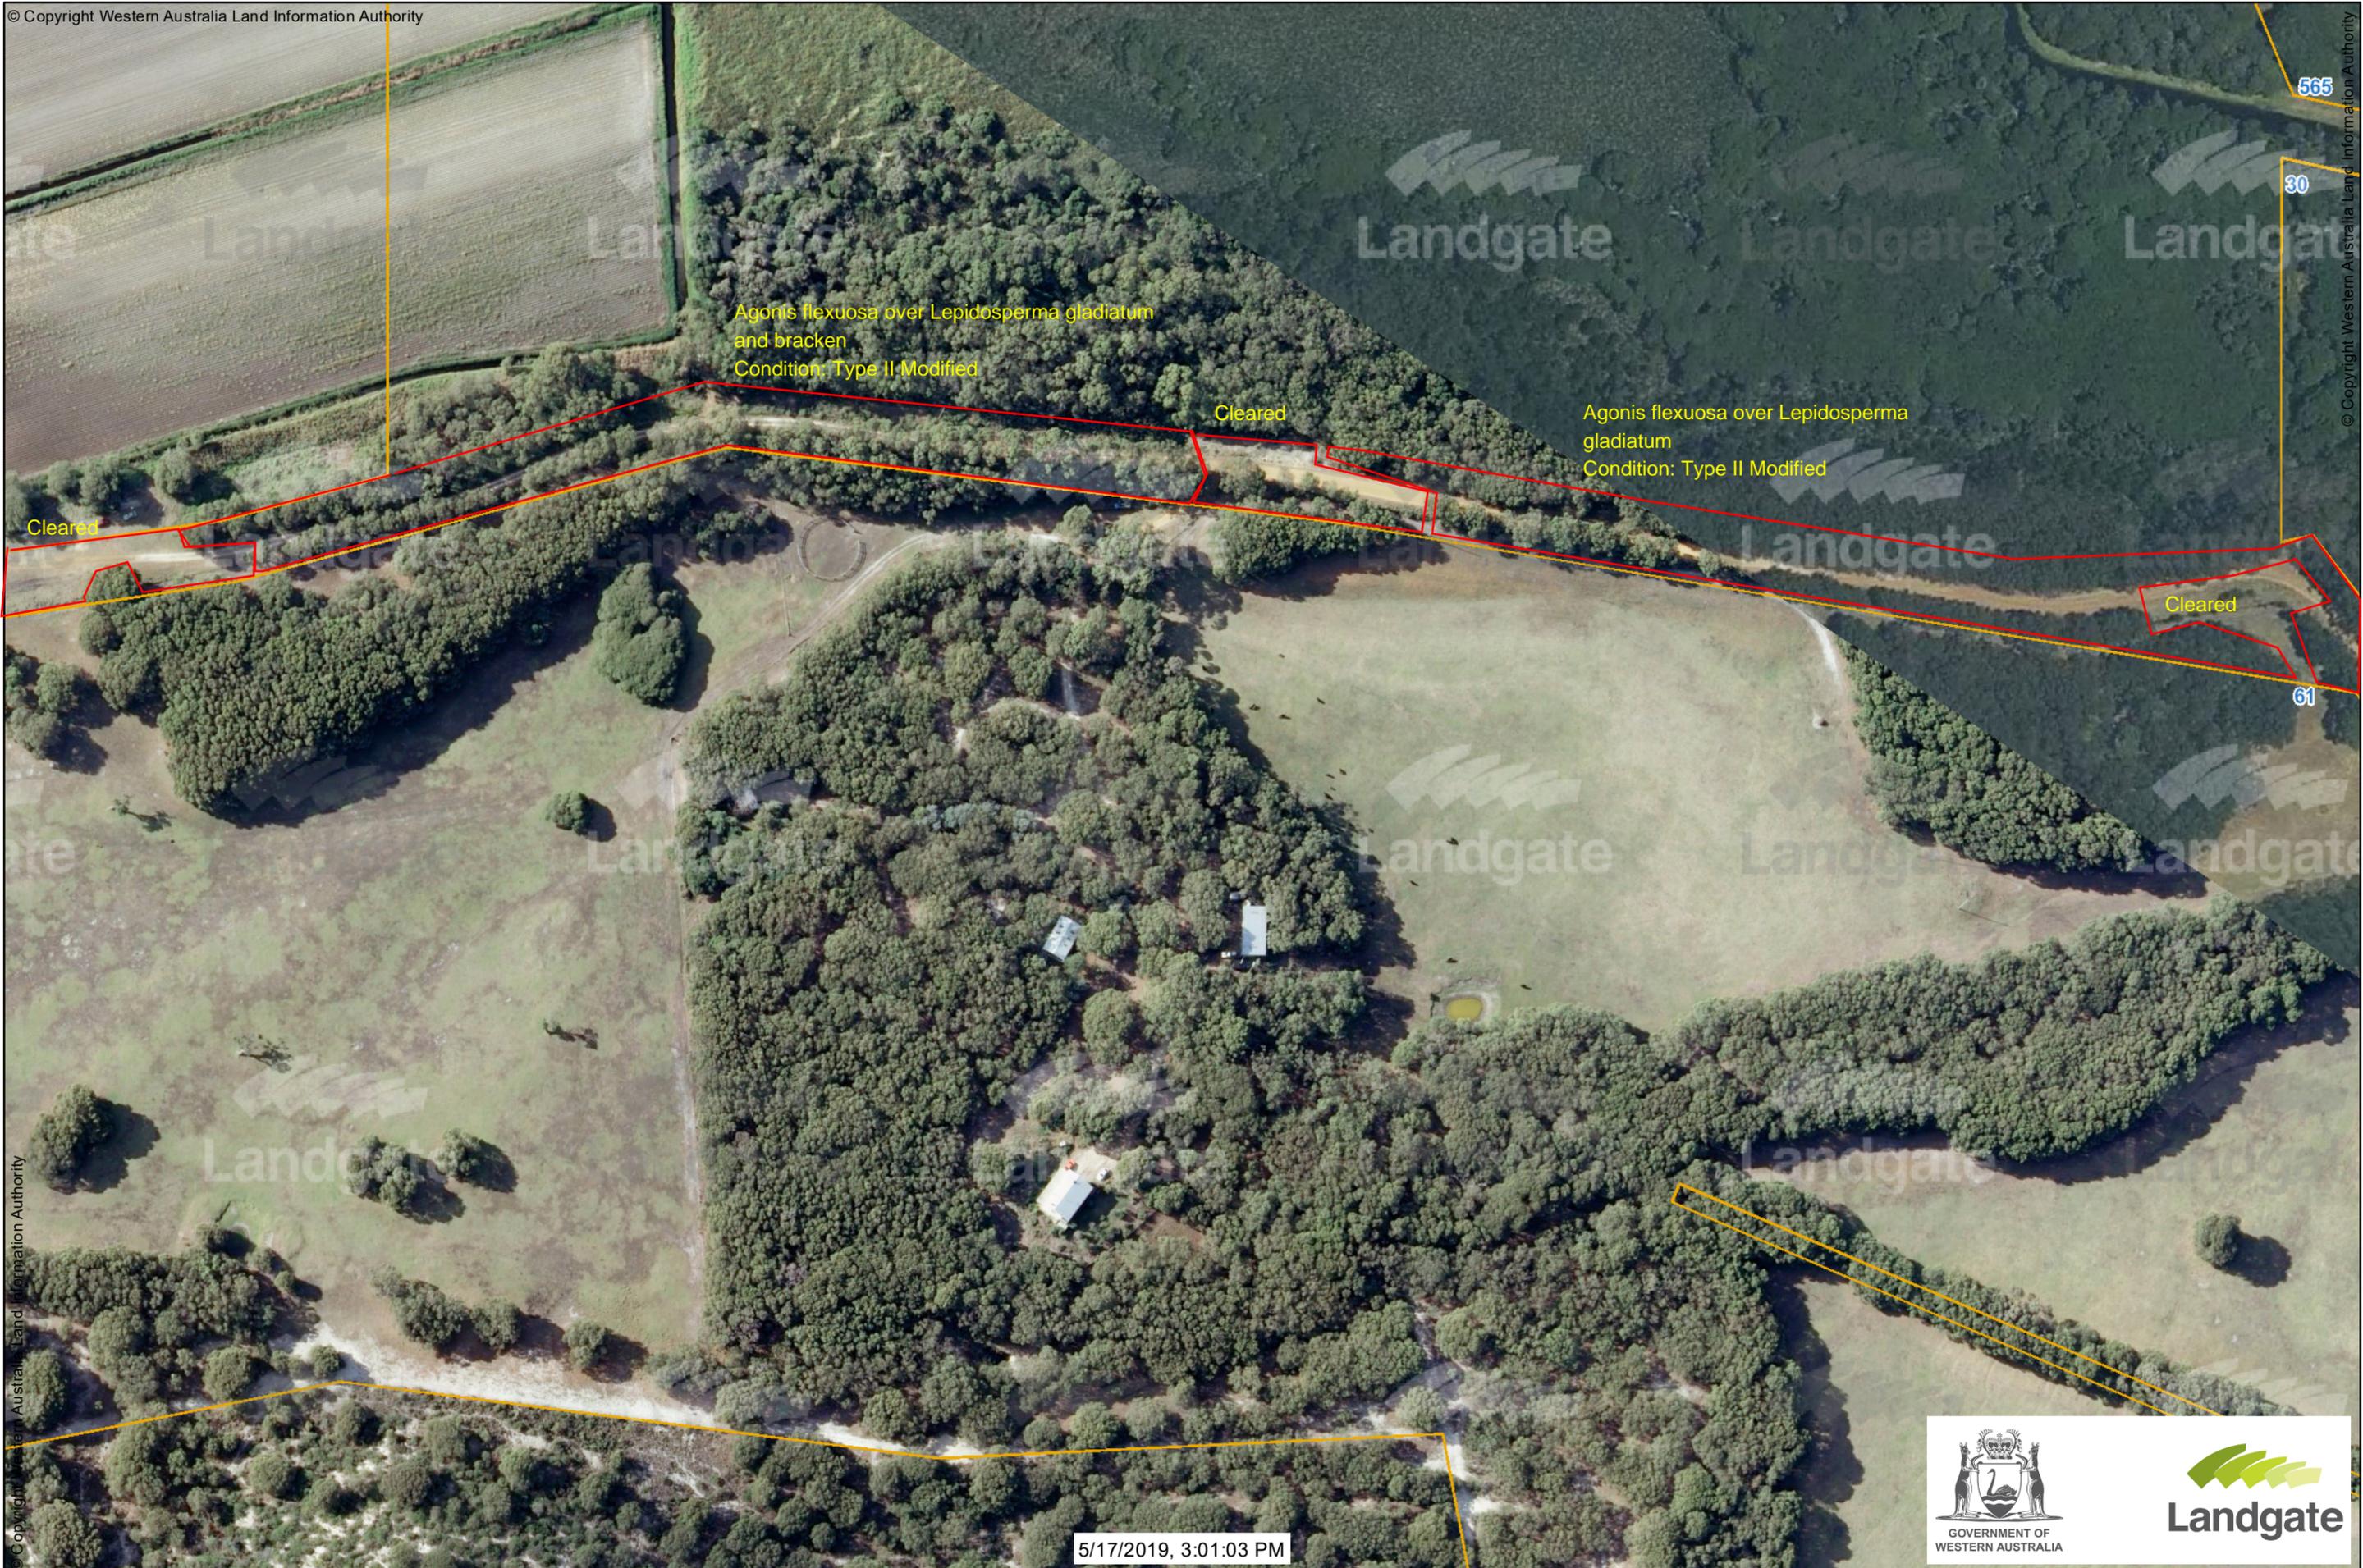
# Map 2

Agonis flexuosa over Lepidosperma gladiatum  
and bracken  
Condition: Type II Modified

Agonis flexuosa over Lepidosperma  
gladiatum  
Condition: Type II Modified

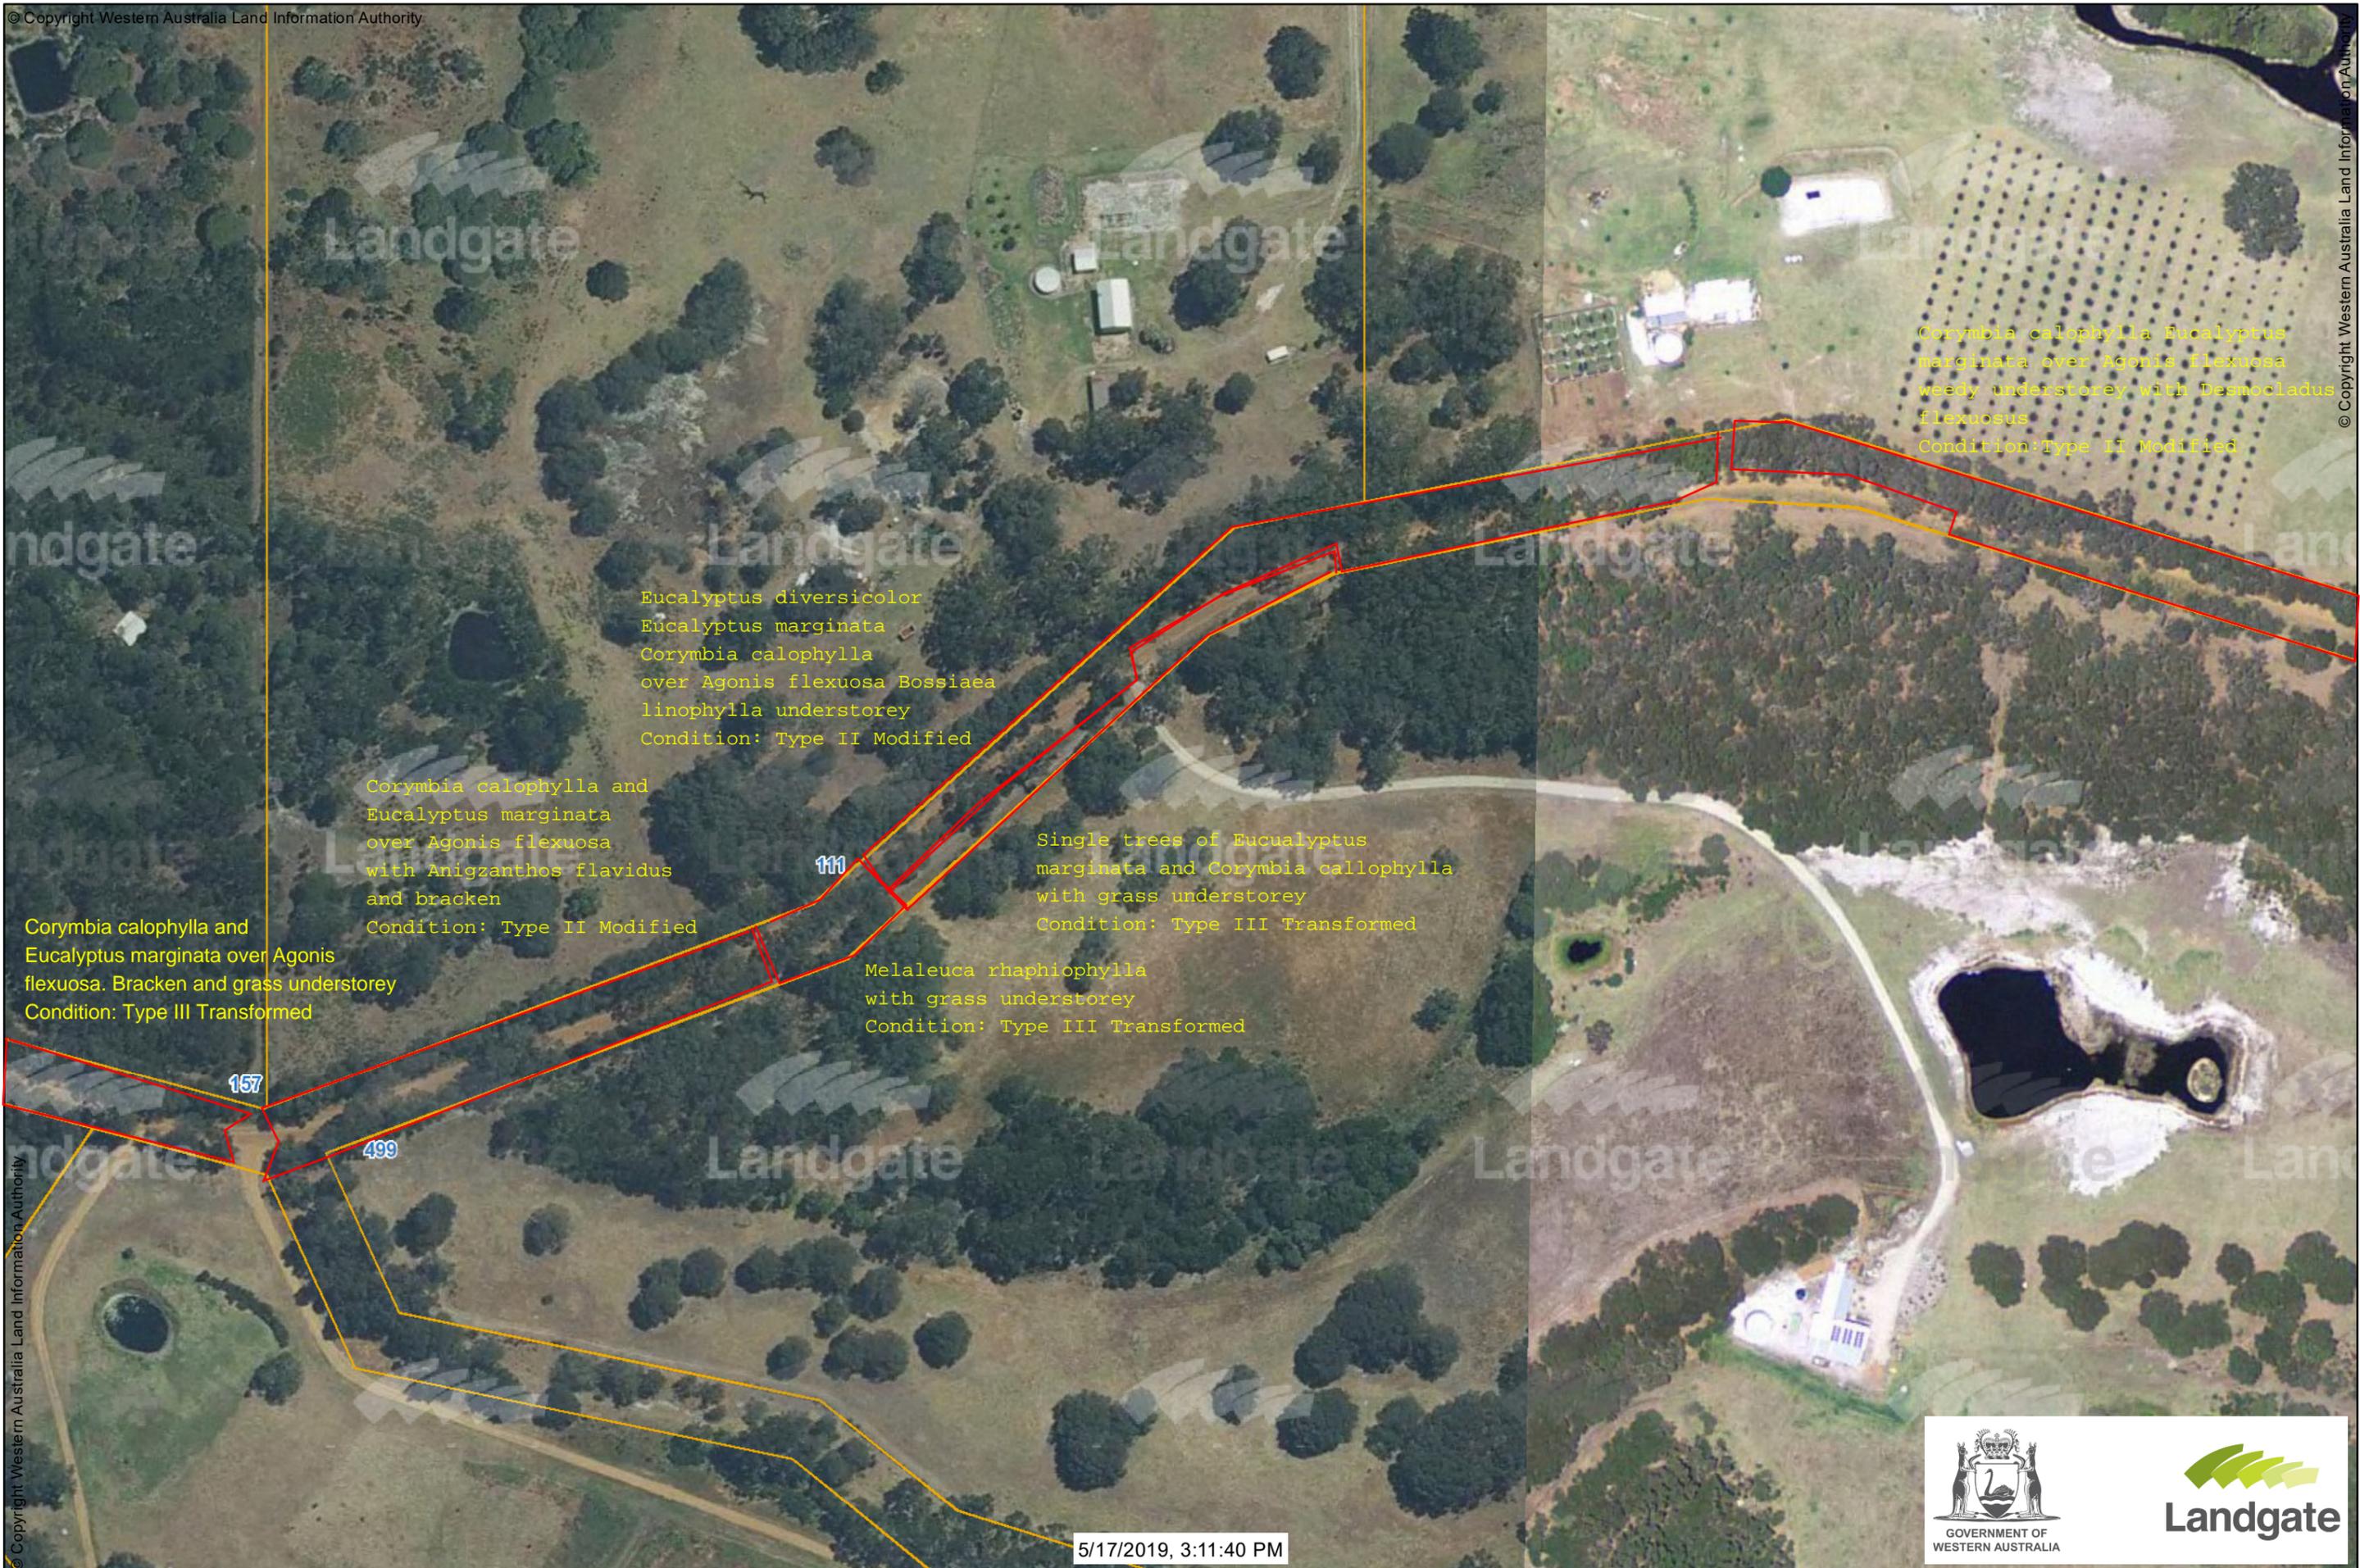
# Map 4

Corymbia calophylla Eucalyptus marginata over Agonis flexuosa weedy understorey with Desmodium flexuosus  
Condition: Type II Modified

Eucalyptus diversicolor  
Eucalyptus marginata  
Corymbia calophylla over Agonis flexuosa Bossiaea linophylla understorey  
Condition: Type II Modified

Corymbia calophylla and Eucalyptus marginata over Agonis flexuosa with Anigzanthos flavidus and bracken  
Condition: Type II Modified

Corymbia calophylla and Eucalyptus marginata over Agonis flexuosa. Bracken and grass understorey  
Condition: Type III Transformed

Single trees of Eucalyptus marginata and Corymbia calophylla with grass understorey  
Condition: Type III Transformed

Melaleuca raphiophylla with grass understorey  
Condition: Type III Transformed

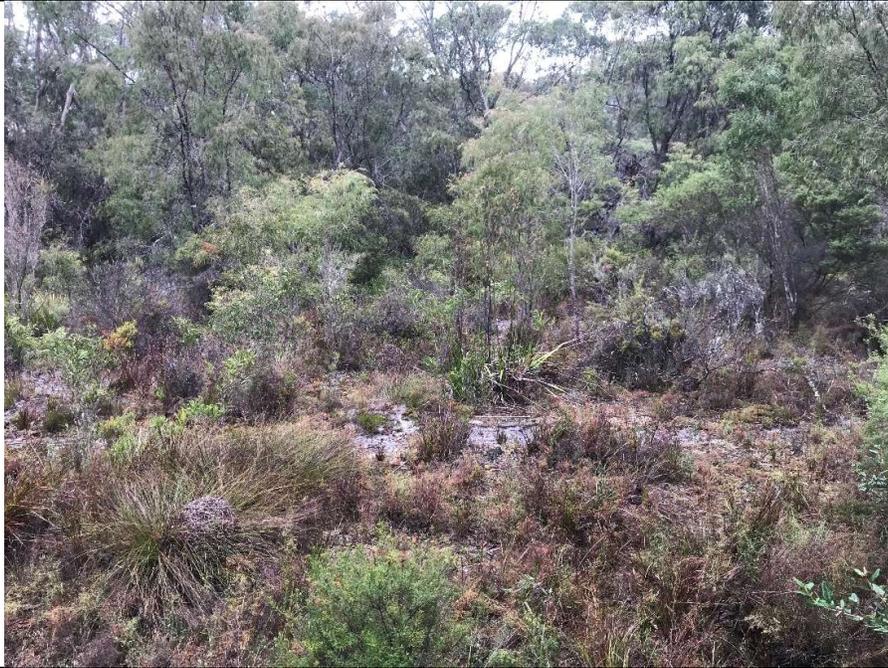
**Plate 1:** Open heath with *Agonis flexuosa*, *Spyridium globulosum* and *Rhagodia baccata* over *Desmocladius flexuosa*. Condition: Type I Residual

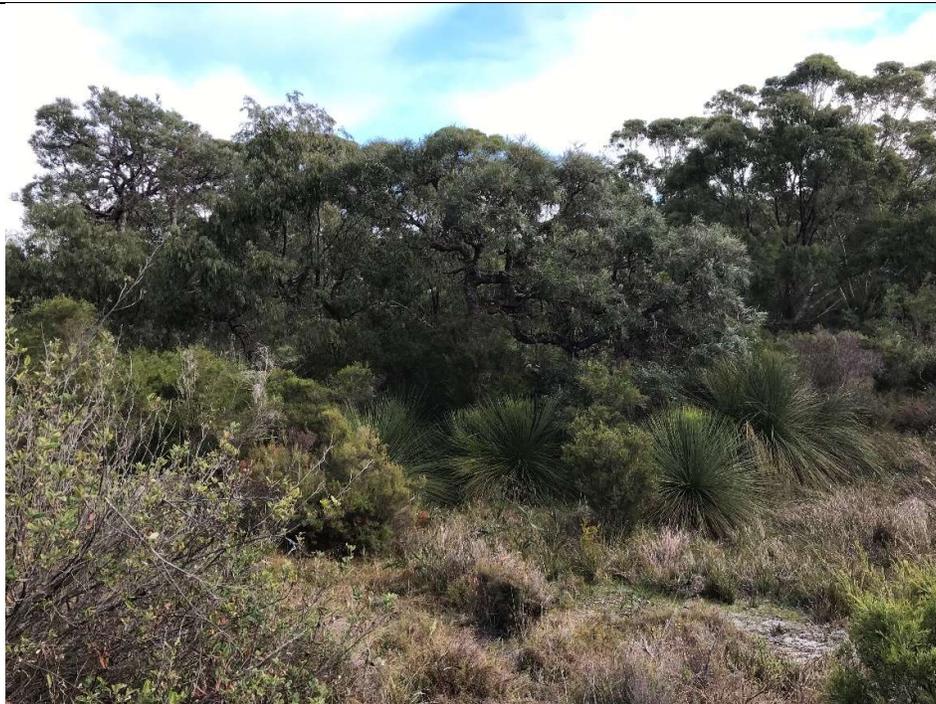
**Plate 2:** *Eucalyptus megacarpa* over *Agonis flexuosa* and *Banksia littoralis* with *Xanthorrhoea preissii*, *Rhagodia baccata*. Condition: Type I Residual

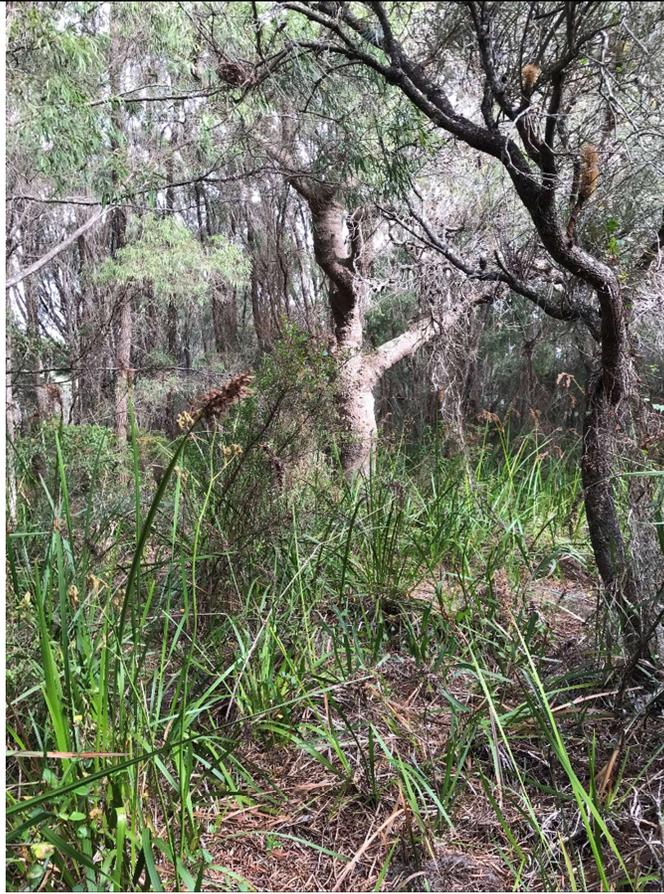
**Plate 3:** *Eucalyptus megacarpa* over *Agonis flexuosa* and *Banksia littoralis* with *Lepidosperma gladiatum*, *Xanthorrhoea preissii*, *Rhagodia baccata*. Condition: Type I Residual

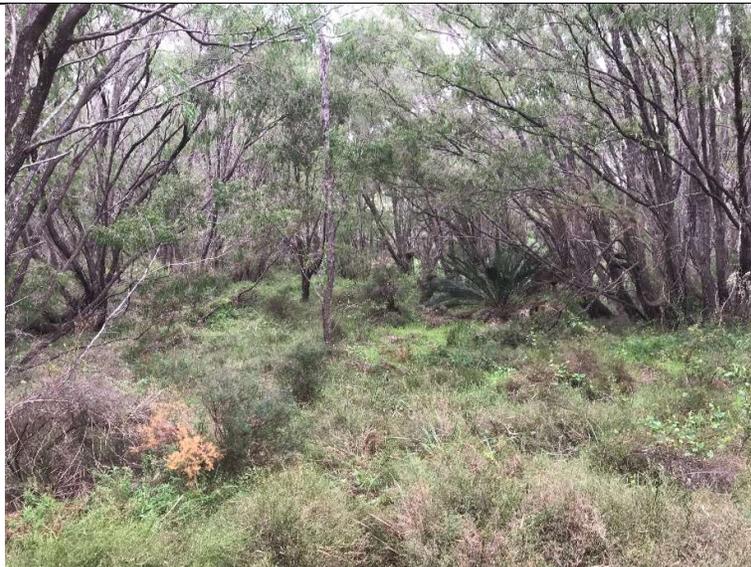
**Plate 4:** *Agonis flexuosa* over *Desmocladus flexuosus*, *Lepidosperma squamatum*. Condition: Type I Residual

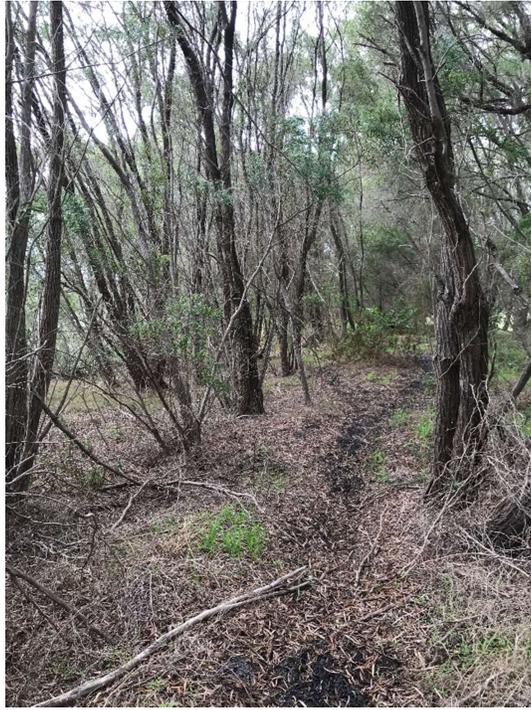
**Plate 5:** *Agonis flexuosa* with occasional *Eucalyptus megacarpa*. grass understorey. Condition: Type II Modified

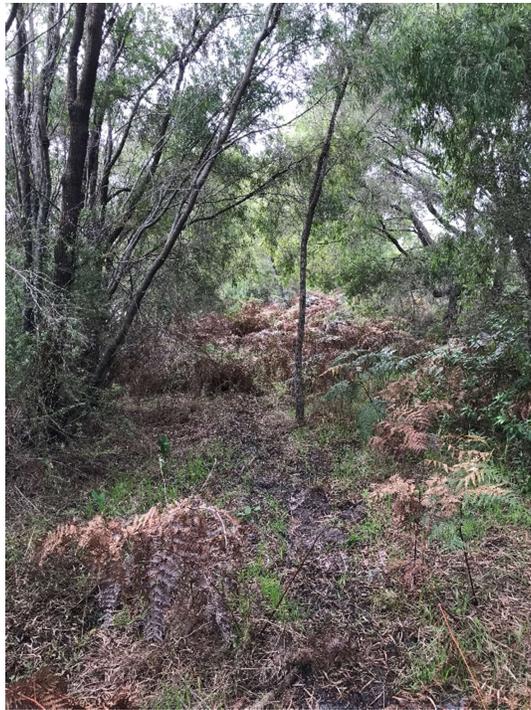
**Plate 6:** *Agonis flexuosa* with bracken and grass. Condition: Type III Transformed

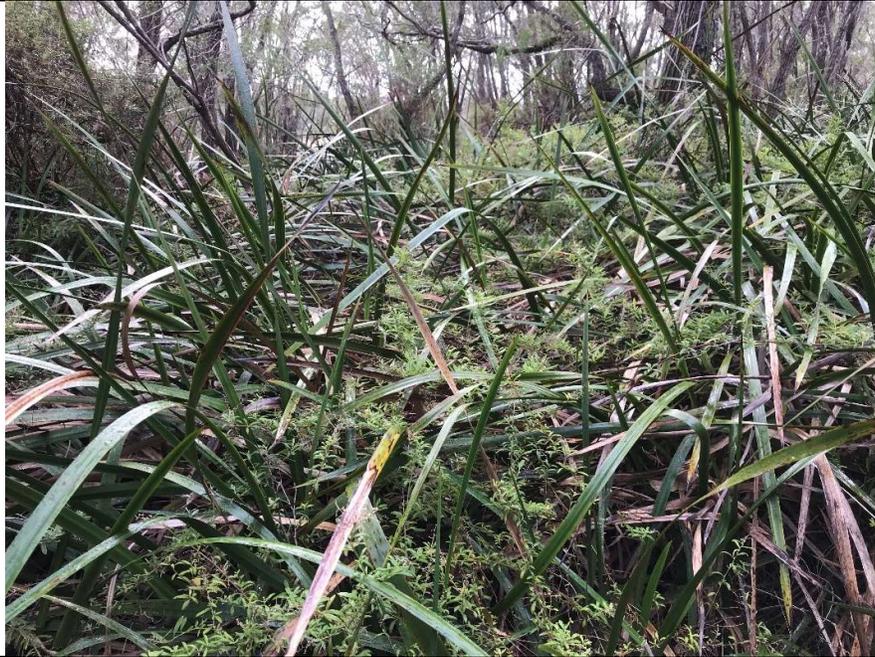
**Plate 7:** *Agonis flexuosa* over *Lepidosperma gladiatum* and bracken. Condition: Type II Modified

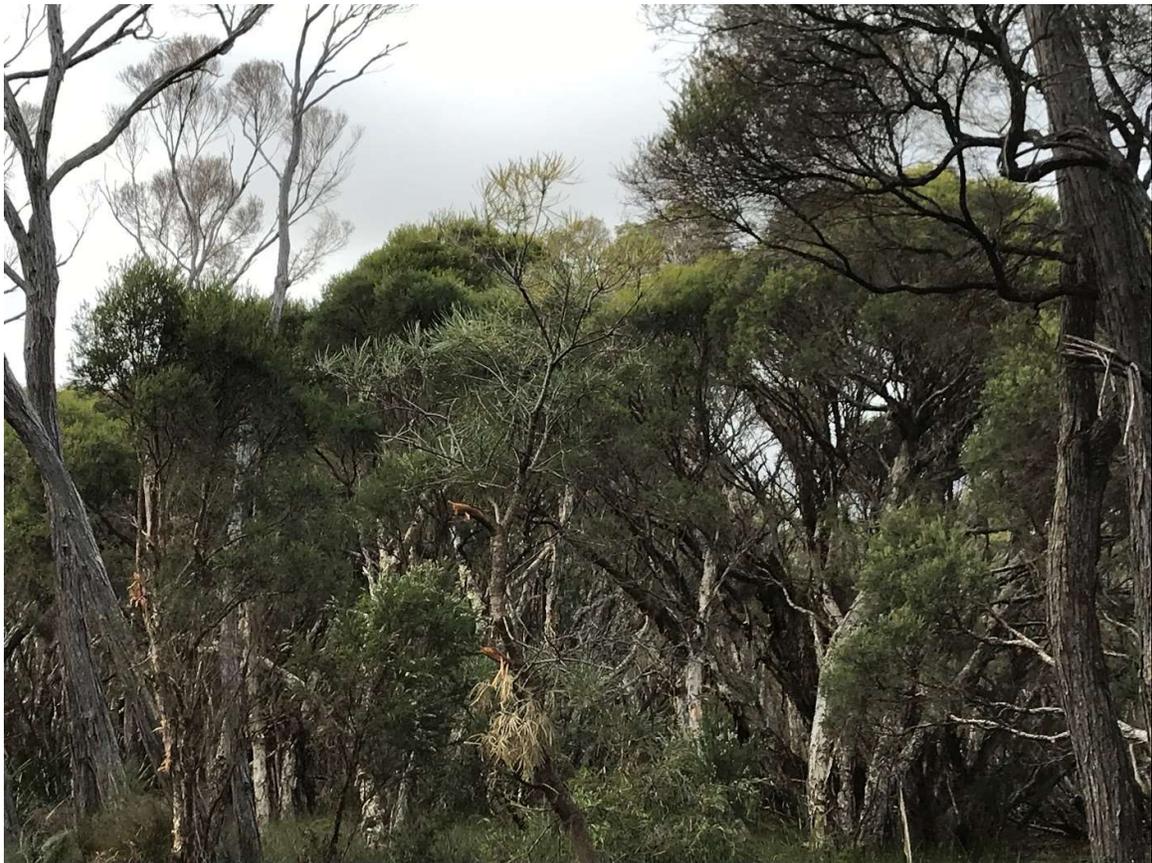
**Plate 8:** *Taxandria juniperina* over *Melaleuca sp* with *Lepidosperma gladiatum*. Condition: Type II Modified

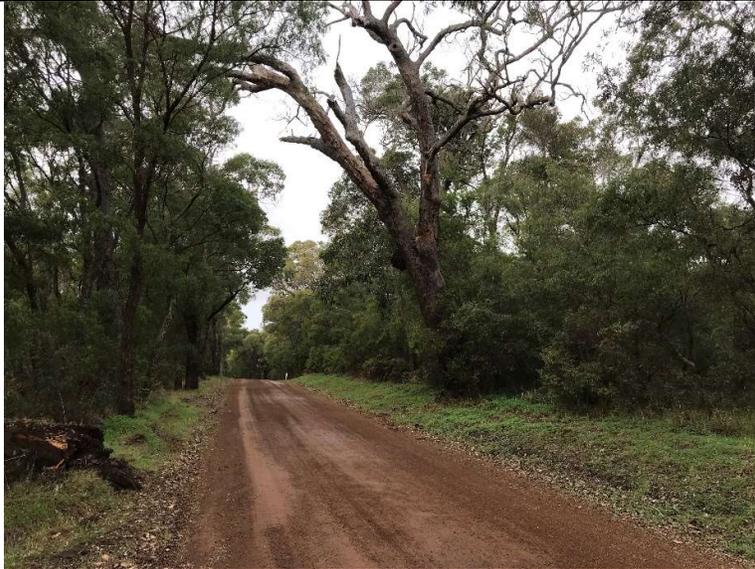
**Plate 9:** *Corymbia calophylla* and *Eucalyptus marginata* over *Agonis flexuosa*. Weedy understorey. Condition: Type II Modified

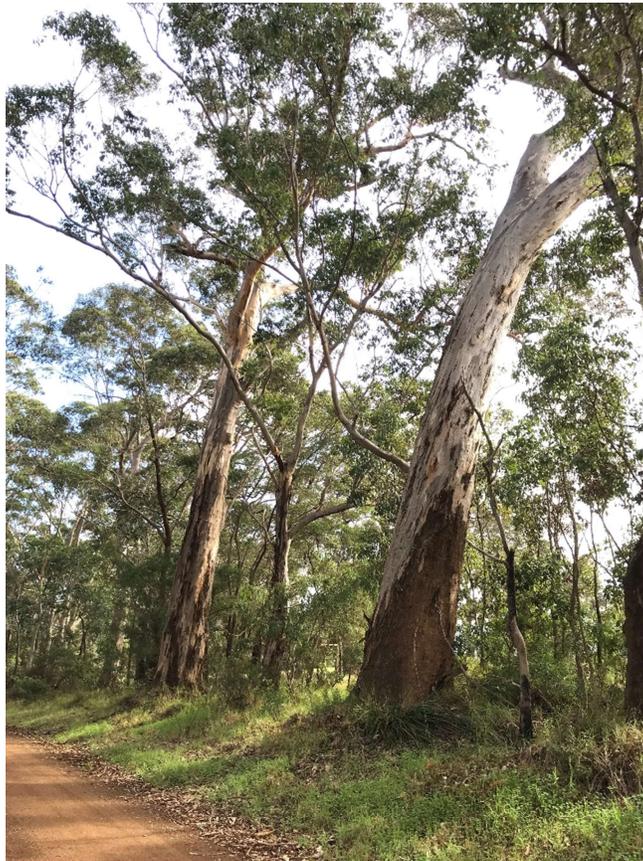
**Plate 10:** *Eucalyptus diversicolor*, *Eucalyptus marginata* and *Corymbia calophylla* over *Agonis flexuosa* and *Bossiaea linophylla* understorey. Condition: Type II Modified

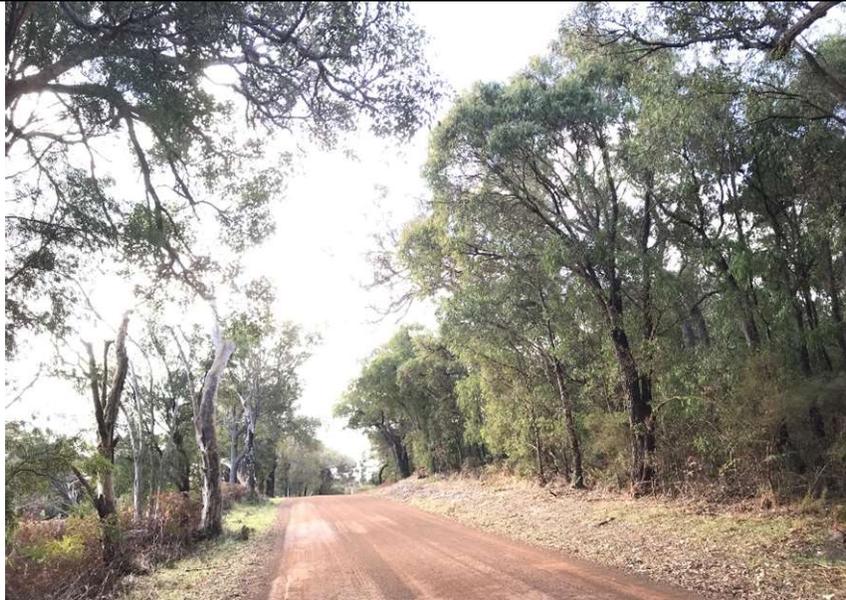
**Plate 11:** *Corymbia calophylla* and *Eucalyptus marginata* over *Agonis flexuosa*. Weedy understorey. Condition: Type II Modified

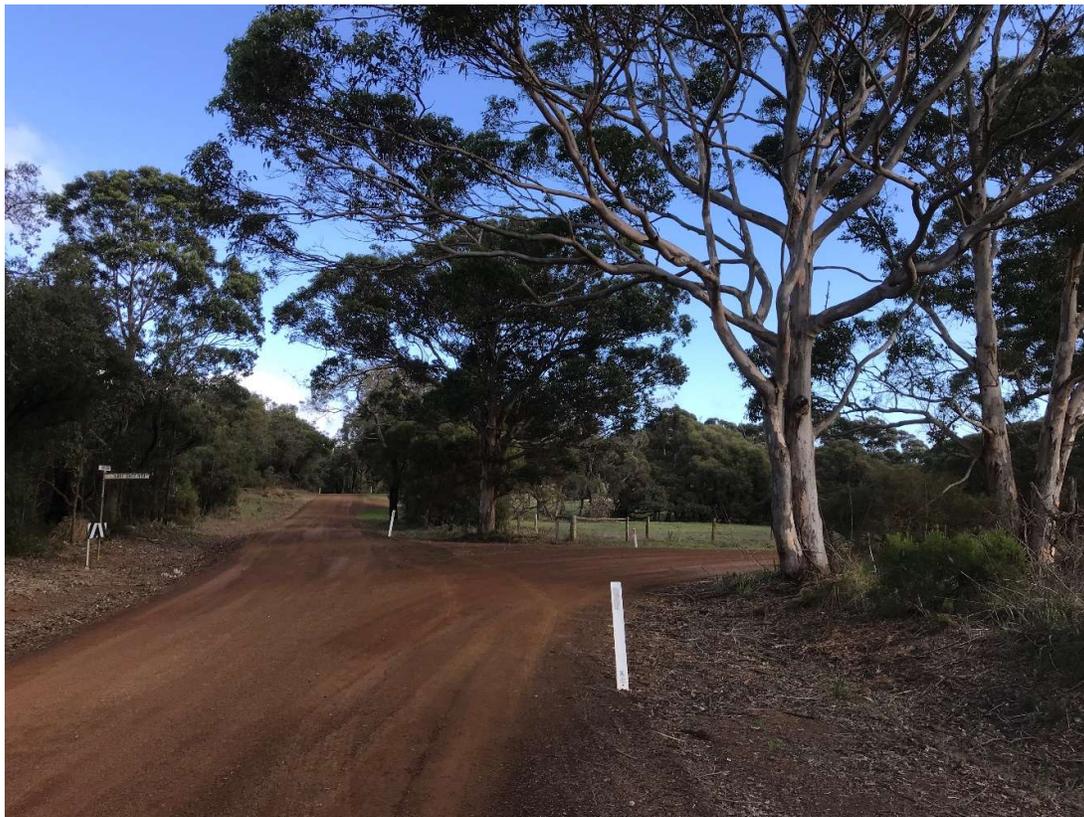
**Plate 12:** Single *Eucalyptus diversicolor* trees on the corner of Lake Saide and Thompson Roads. Condition: Type III Transformed
