Department of Infrastructure, Regional Development & Cities

Christmas Island Stormwater Remediation Works Clearing Permit Support Document

16 April 2019

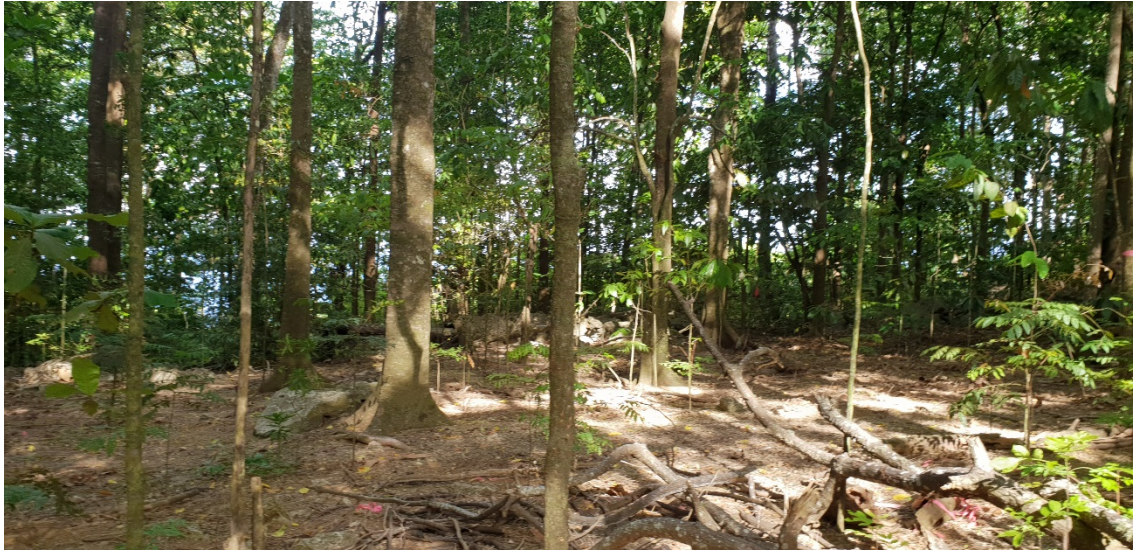
Photo 1 School site vegetation – southern section of the proposed basin looking north

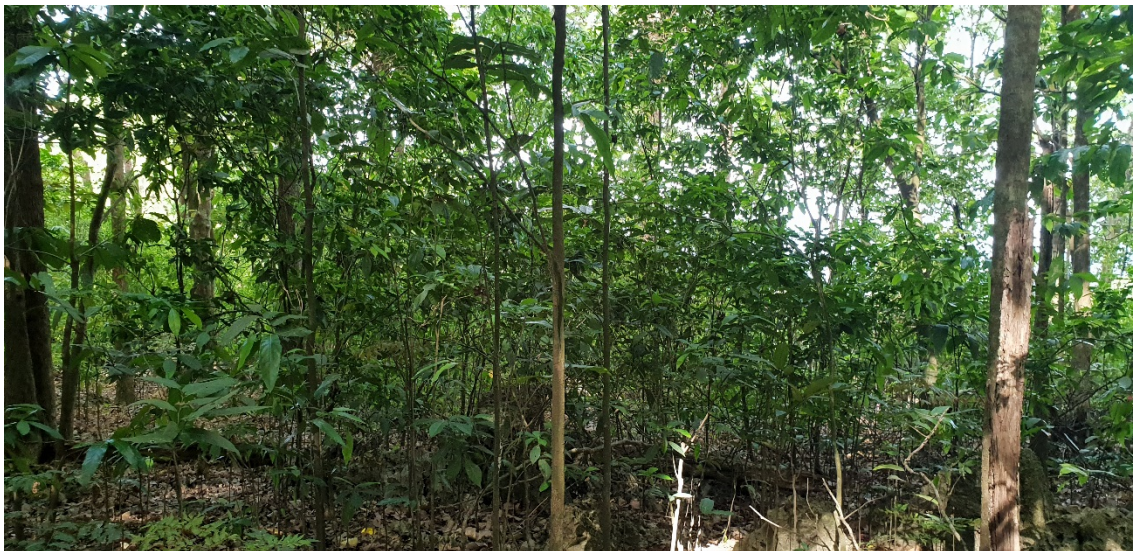
Photo 2 School site vegetation – northern section of the proposed basin looking north

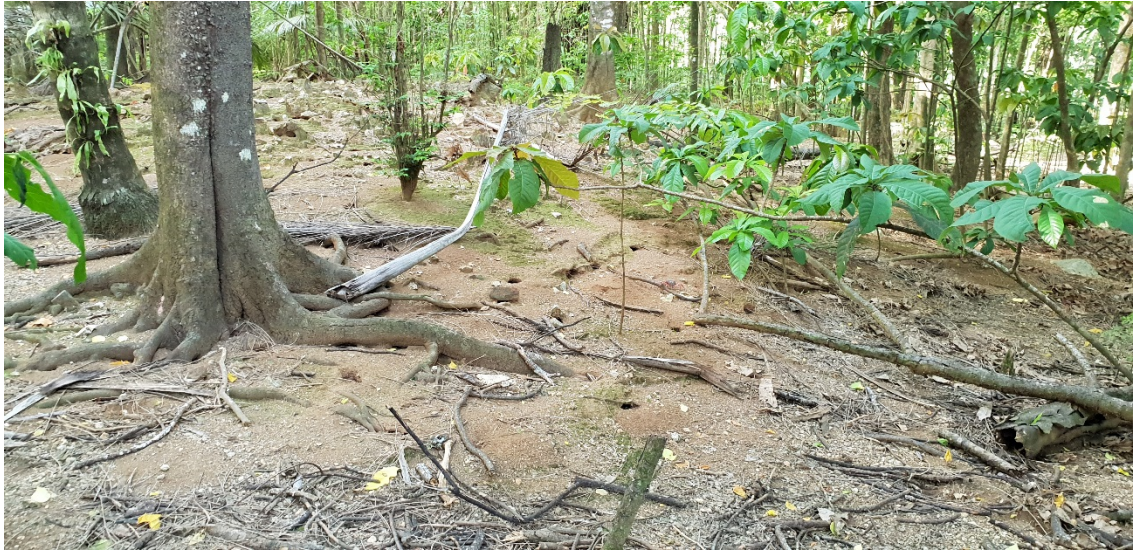
Photo 3 School site groundcover – middle of the proposed basin

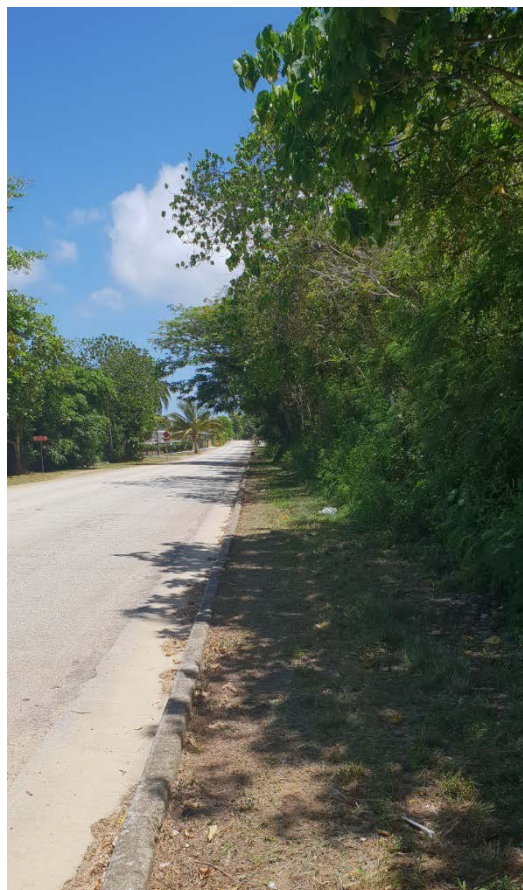
Photo 4 Vegetation along Murray Road looking east

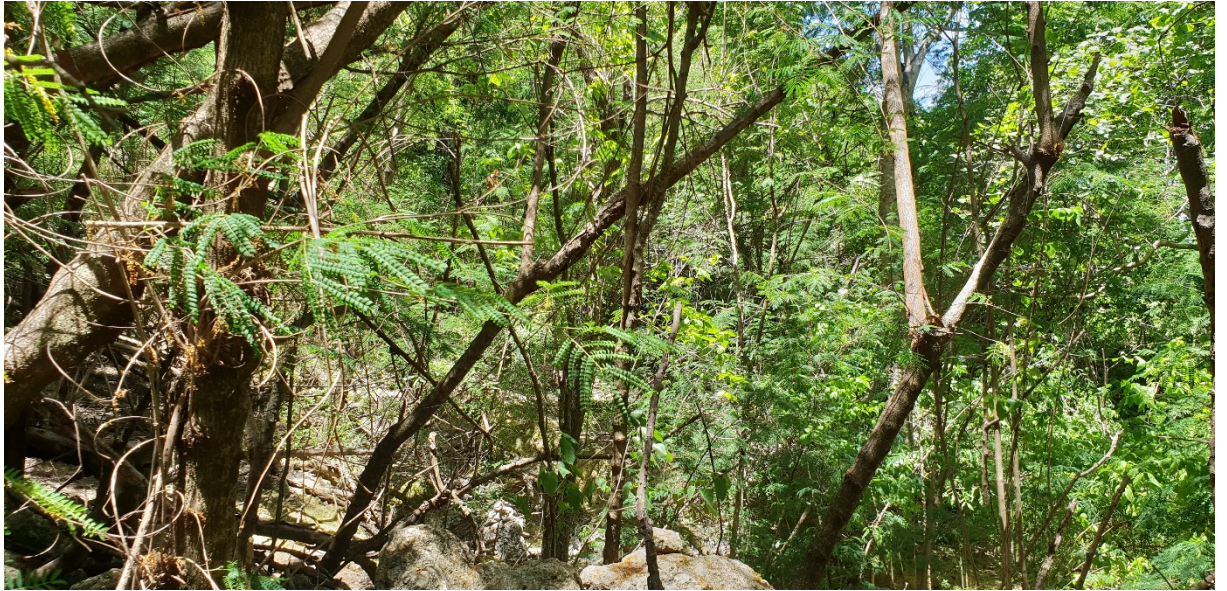
Photo 5 Silver City vegetation looking east

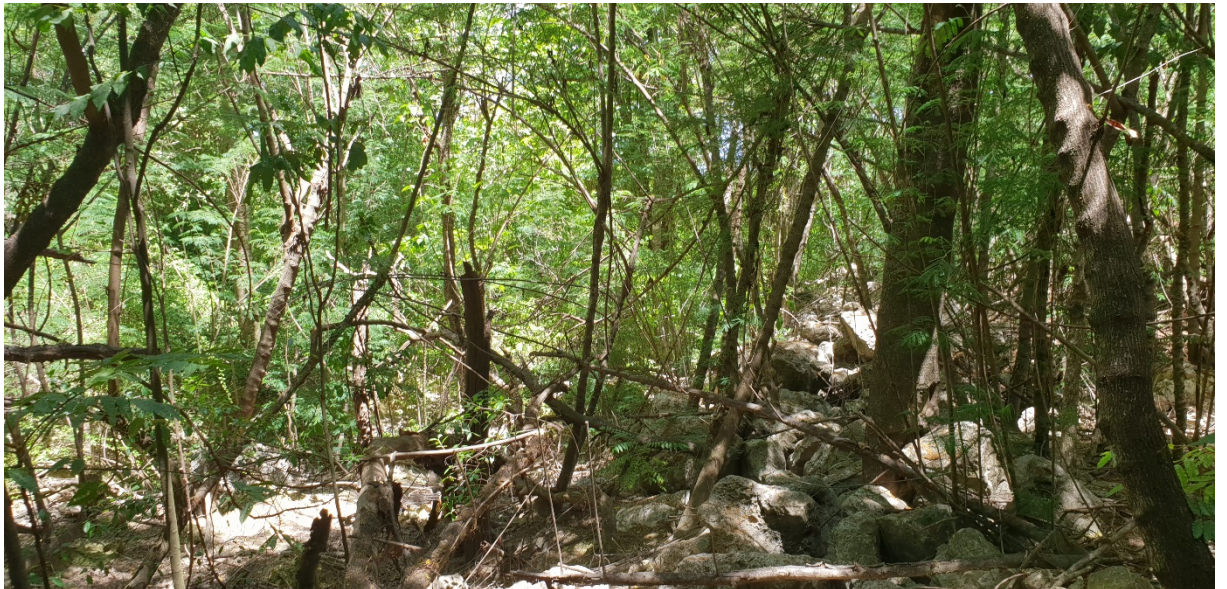
Photo 6 Silver City vegetation looking north

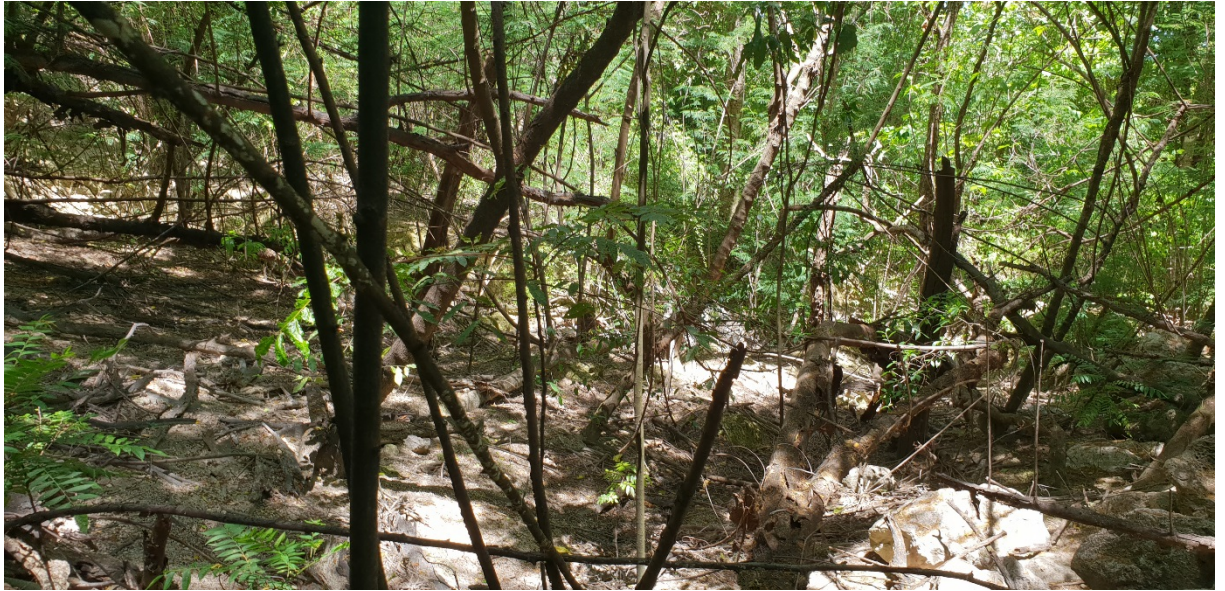
Photo 7 Silver City vegetation looking north

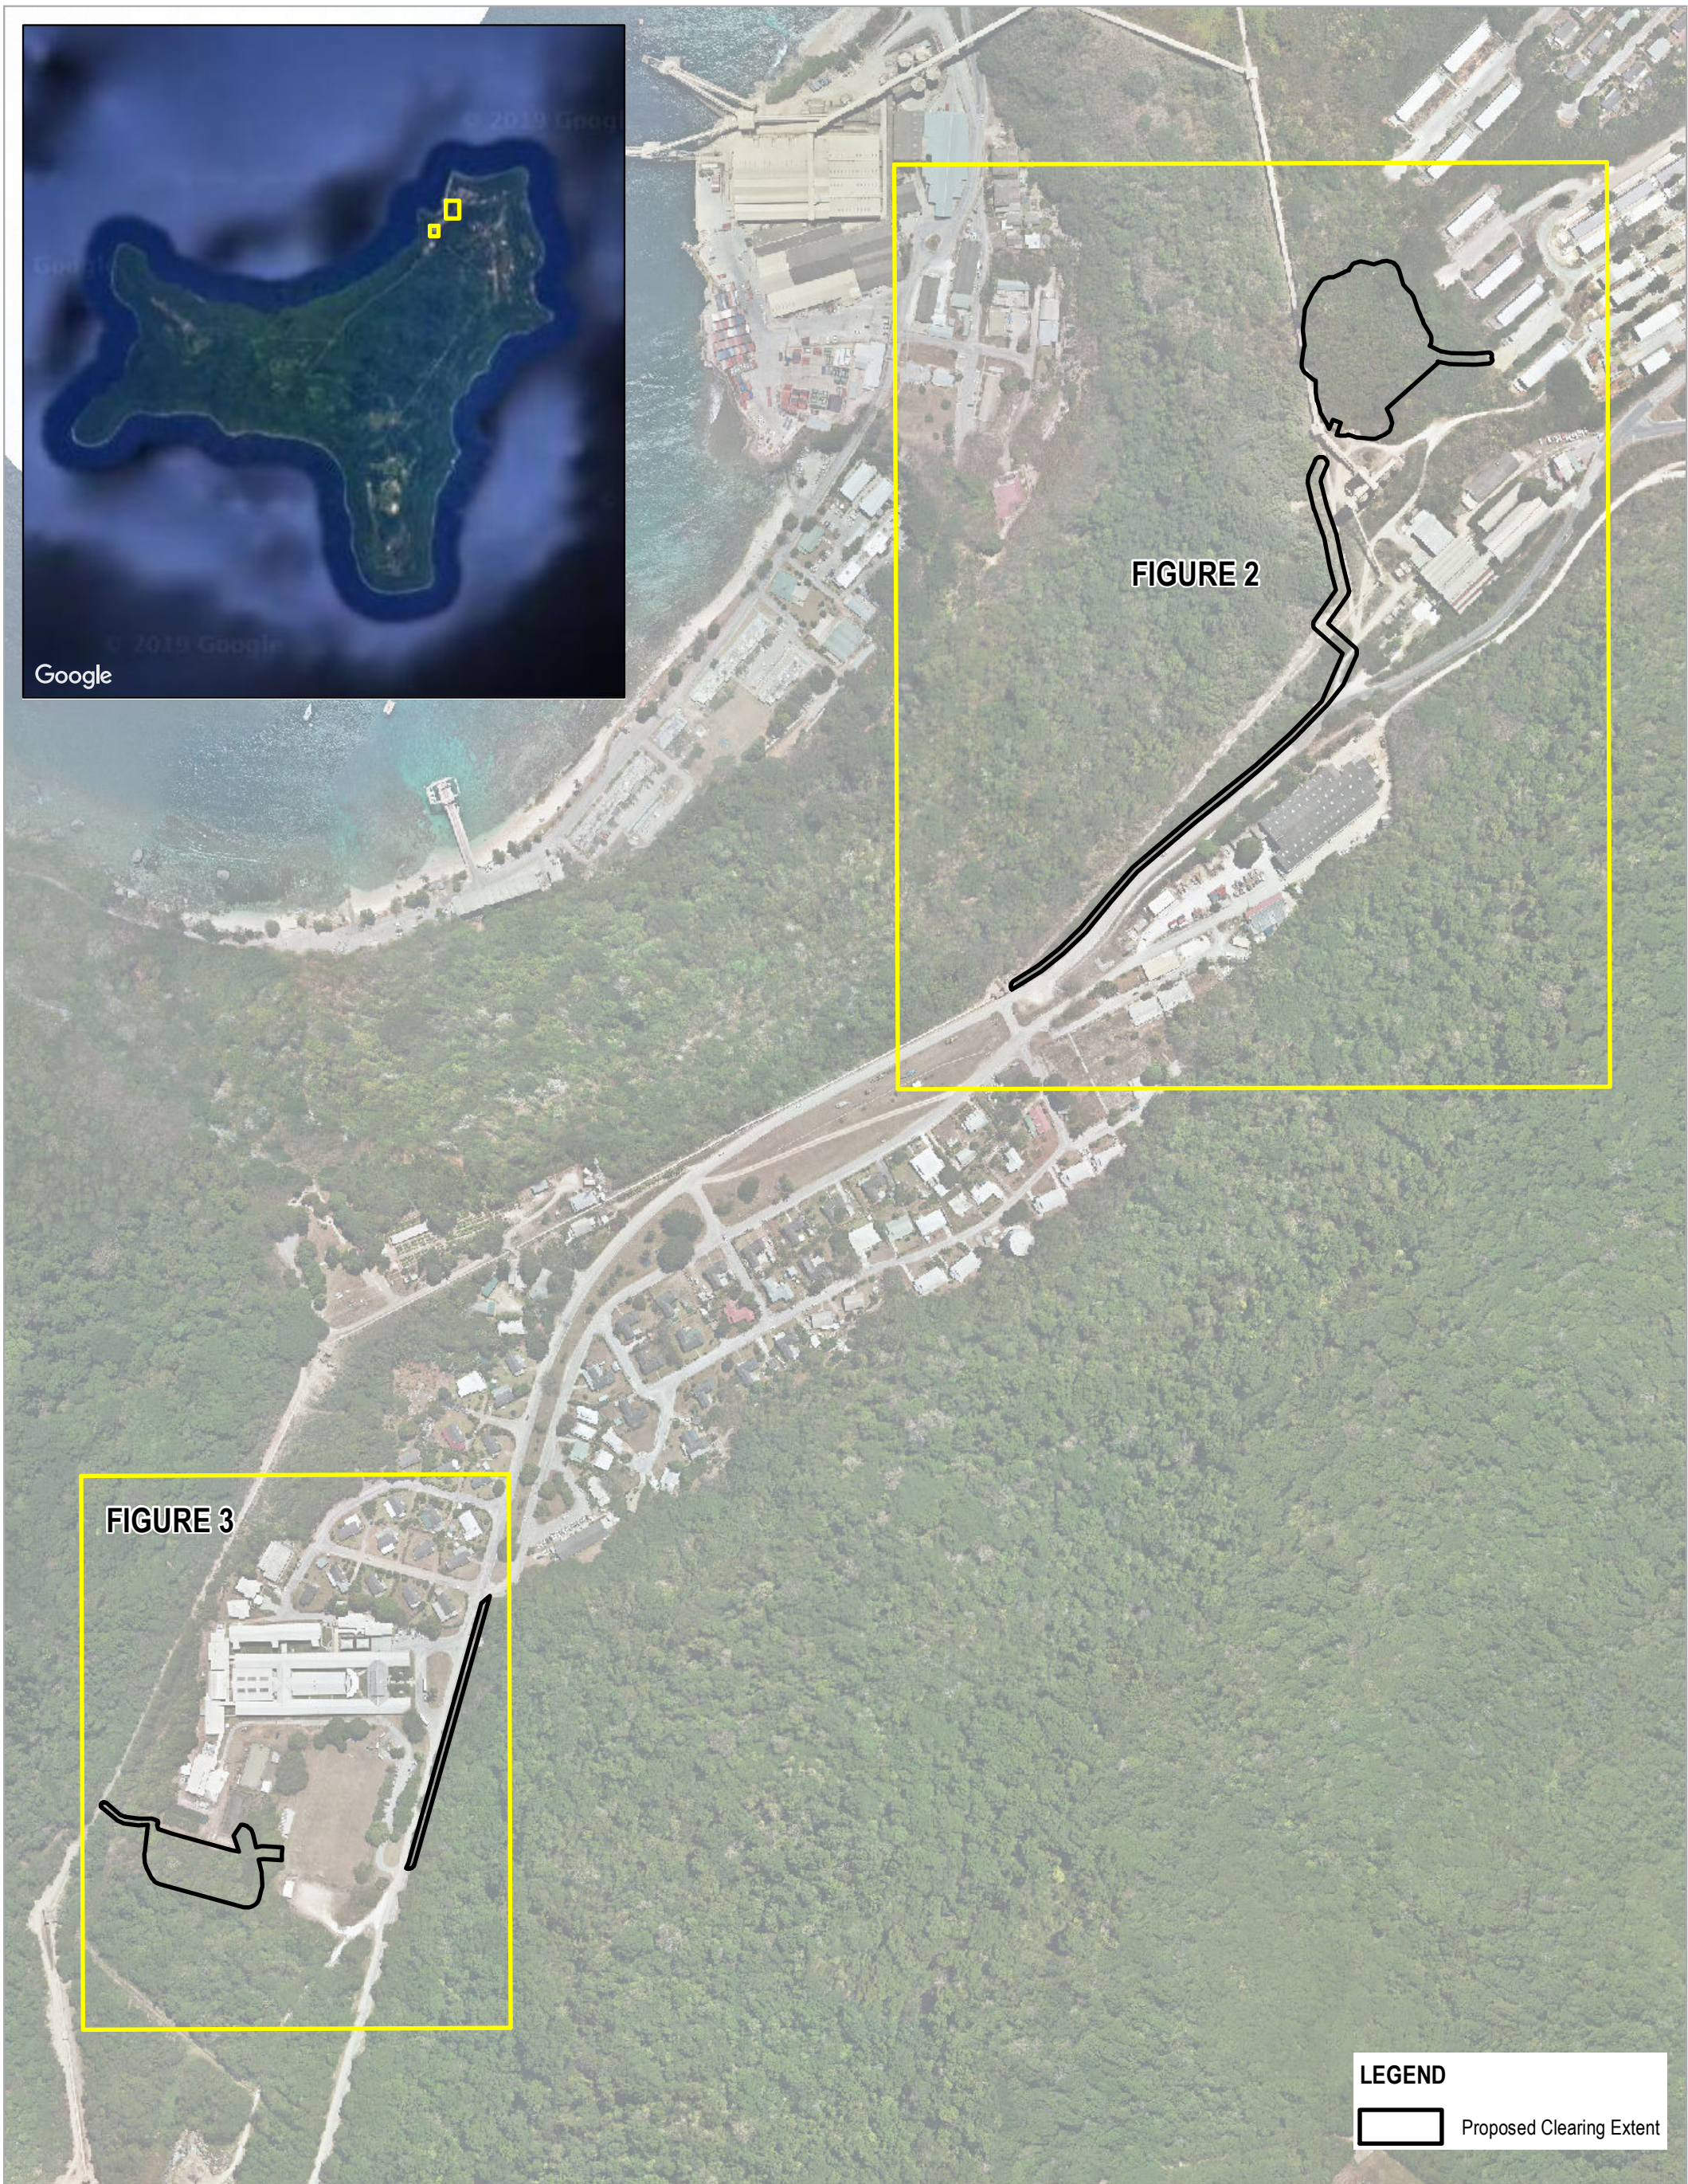
FIGURE 1

Overview
