CPS 8573/2 Revegetation Plan

Main Roads Western Australia

Bindoon Bypass – Northern Section

9 September 2022

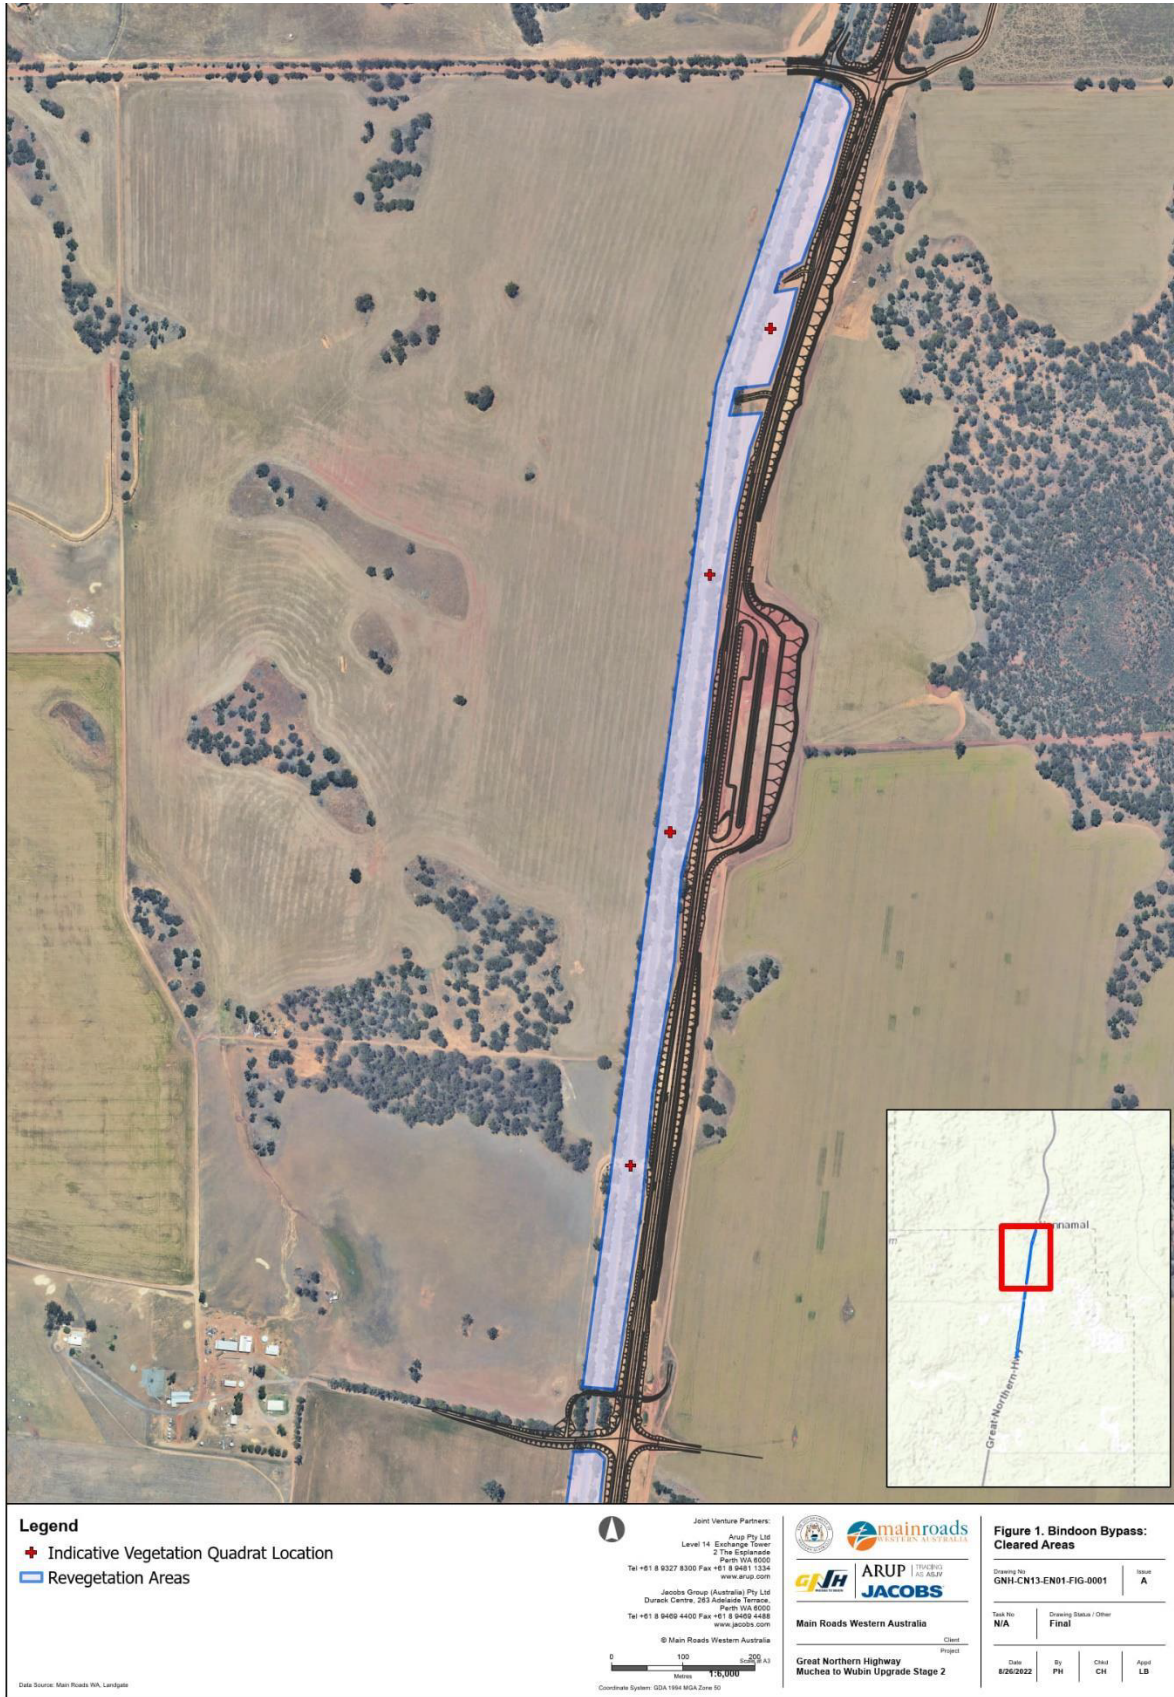
Figure 2-1 Location of Revegetation Patch 1 (SLK ~100.6 to ~98.7)

Locations of the proposed revegetation areas are provided within **Table 2-1** and **Figure 2-1**, **Figure 2-2** and **Figure 2-3**. A note is also included on the type of revegetation/rehabilitation that will be undertaken.

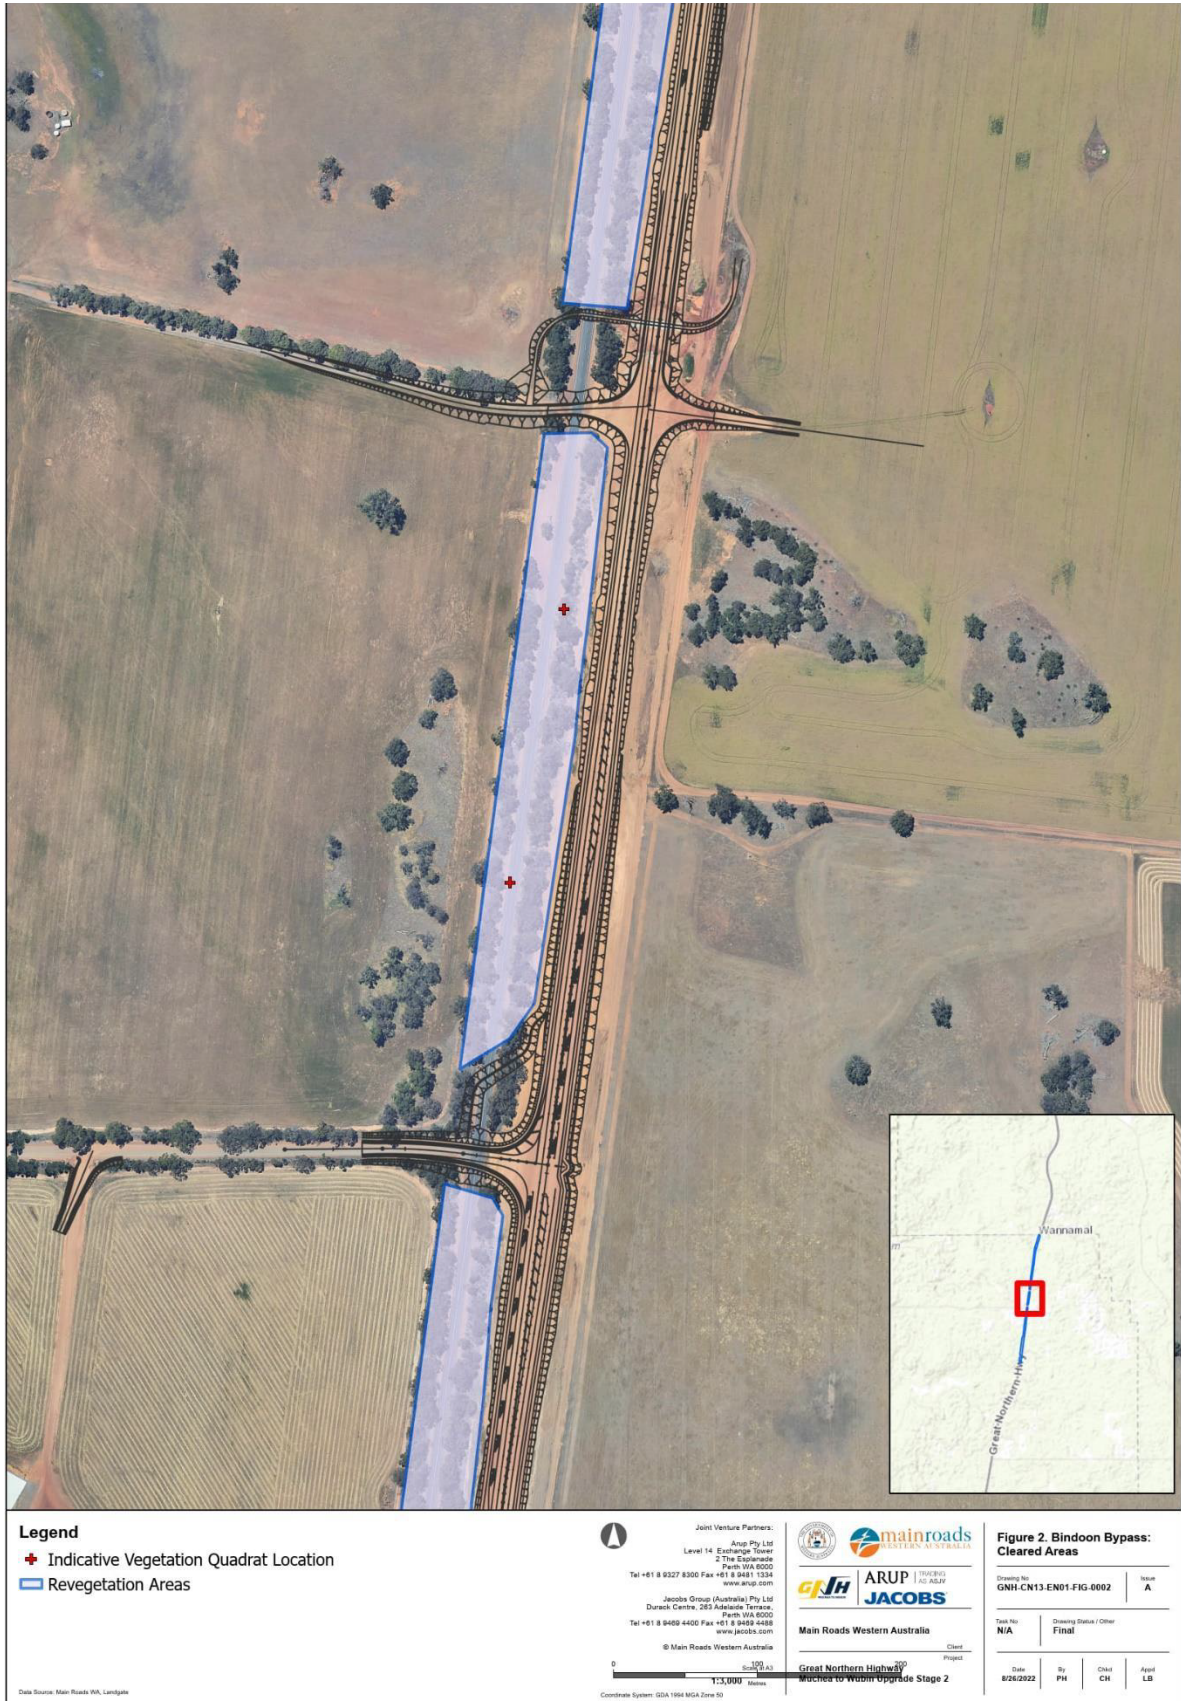
Figure 2-2 Location of Revegetation Patch 2 (Central Polygon) (SLK ~98.6 to ~98.2)

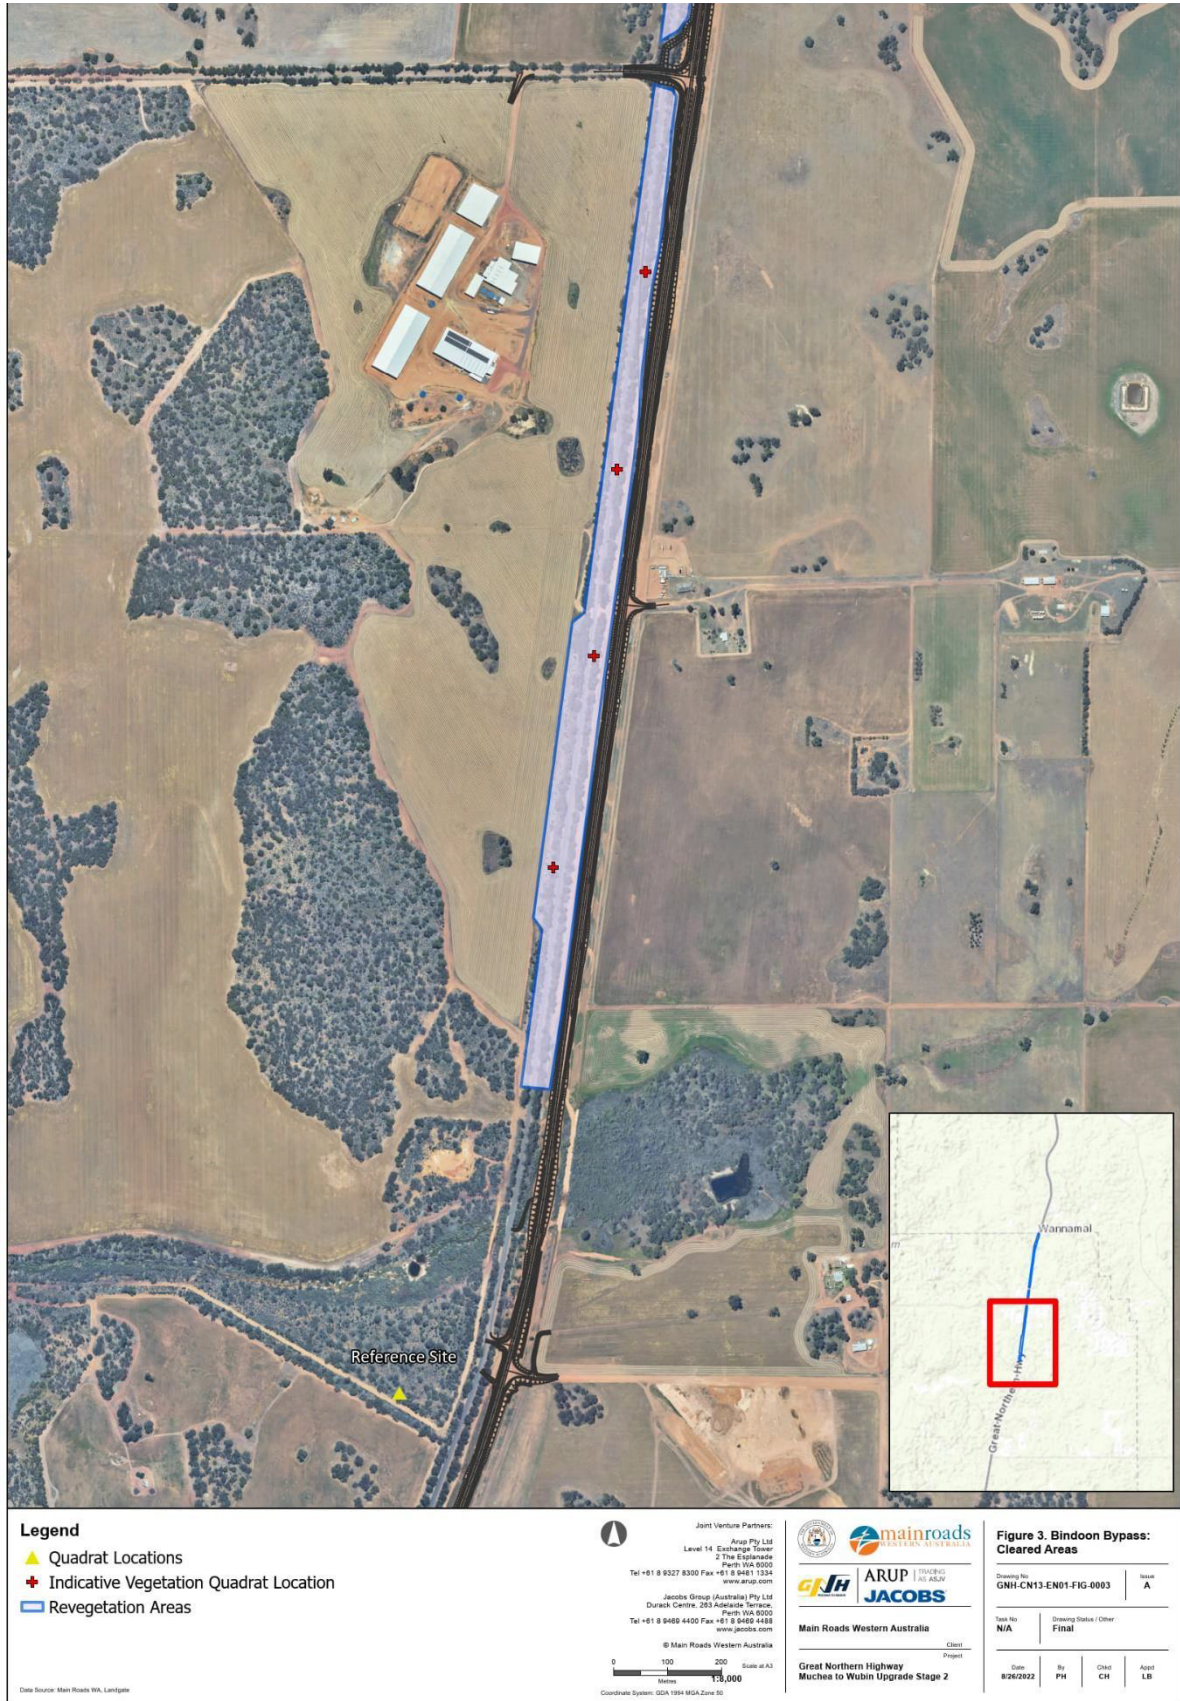
Figure 2-3 Location of Revegetation Patch 3 (SLK ~98.1 to ~96.2)

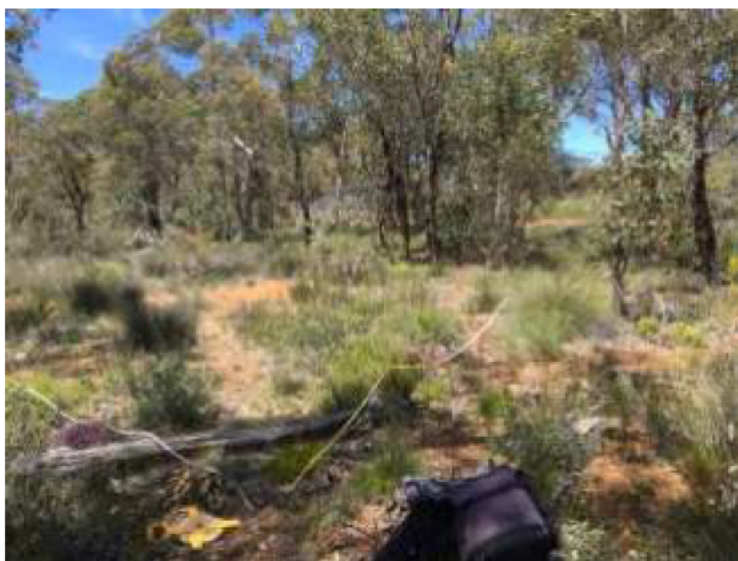
Figure 4-1 Low wandoo vegetation association within Reference Site

The reference site is situated within remnant roadside vegetation adjacent to the BBN and comprises medium woodland (wandoo), specifically Low *Eucalyptus wandoo* subsp. *wandoo* open woodland over *Allocasuarina humilis* and *Xanthorrhoea preissii* mid shrubland over *Mesomelana psuedostygia* and *Lepidosperma tenue* sedgeland (**Figure 4-1**). The site is in Excellent vegetation condition.
