Targeted Flora Survey Report

Howick Road North Construction Project CPS 7889/1 (Ridgelands Road to Parmango Road)

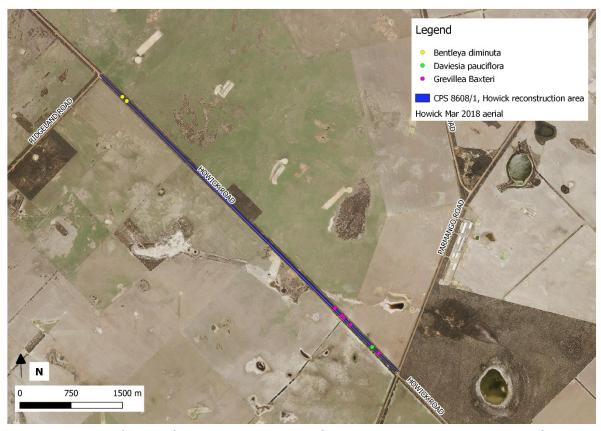
Figure 2. Location of Priority flora, *Bentleya diminuta*, *Grevillea Baxteri*, **and** *Daviesia pauciflora* on Howick Road North project area (Parmango to Ridgelands Rd), CPS 7889/1.

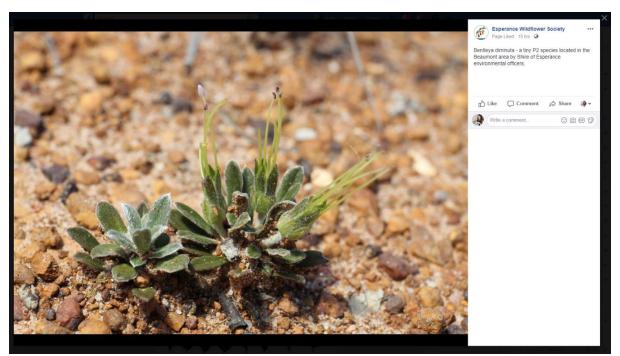
Figure 3. Confirmation of new population *Bentleya diminuta* (Priority 2) by local Esperance Wildflower Society.

Bentleya diminuta (Priority Two) was collected by Environmental Officers at the Shire of Esperance (Katie White – KW006; Appendix 7.3). The new population caused some excitement amongst the local Esperance Wildflower Society resulting in a field excursion confirming identification (Figure 3). It was collected by Ken Mills for WA Herbarium (KR Mills). Plants were located 600 m SE of Ridgeland Rd and Howick Rd intersection, over a 500 m section of road on both sides of the road reserve. It was growing directly on the road shoulder, along back slopes. No plants were present in undisturbed bushland behind road shoulders. The population contained up to 1000 ramets, however it is impossible to tell how many individual genetic individuals are present without genetic analysis. All plants discovered were located within clearing footprint area.

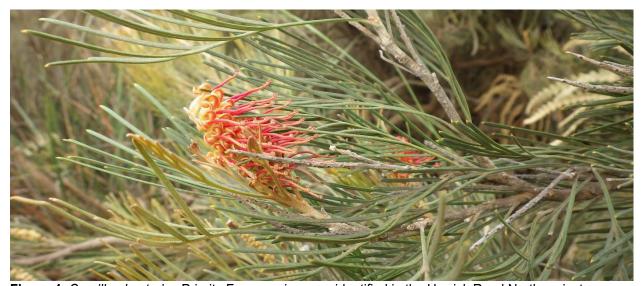
Figure 4. Grevillea baxteri, a Priority Four species, was identified in the Howick Road North project

targeted flora survey.

Two separate clusters of *Grevillea baxteri* (Priority Four) were located within CPS 7889/1 footprint, in the south east area of the permit (Figure 4). As these clusters were separated by 500 m, they have been treated as two separate populations. Two collections and priority forms therefore occurred. 'Population One' was located five km SE of Ridgeland/Howick Rd intersection on Howick Rd, with 11 plants present within a 350 m stretch of road. A specimen was collected by Katie White (KW005, Appendix 7.3). Six of the 11 plants will be removed if road widening occurs.

'Population two' had nine plants recorded within 150 m stretch of road. They were located one km NE of Parmango/Howick Rd intersection on Howick Rd. A specimen was collected by Katie White (KW004; Appendix 7.3). Four of the nine plants will be removed if road widening occurs. In total across the clearing permit area, 10 of the 20 *G. baxteri* plants identified if road widening under CPS 7889/1 occurs.

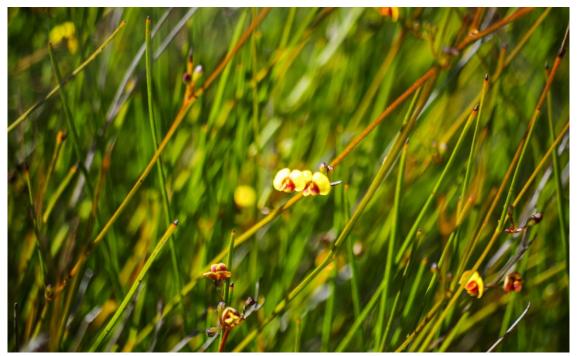
Figure 5. *Daviesia pauciflora*, a priority three species, present within the CPS 7889/1 (now CPS 8608/1) application area. Image demonstrates the indistinguishable characteristics of the species, showing how it is identification is cryptic outside of spring.

A priority three species *D. pauciflora*, was identified after the Spring 2018 flora survey, incidentally in October 2019. A specimen was collected (KW029, Accession 8178), and was confirmed by the WA Herbarium on 13/11/2019. No previous record was present from the spatial data from WA Herbarium, Esperance Threatened Flora and TPFL, meaning it was a new population discovered. One to three plants were present, which are all within the active clearing permit area and will be impacted upon.

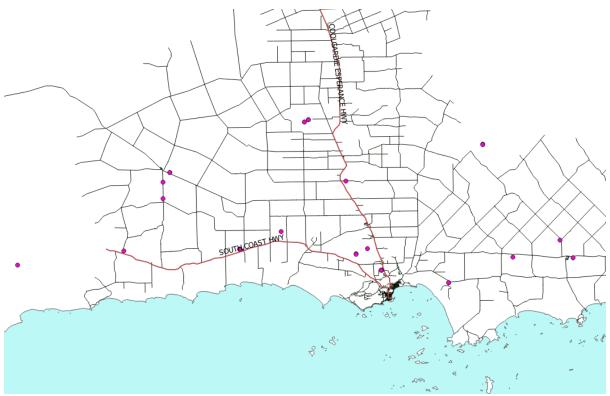
Figure 6. Map of all recorded locations of *Daviesia pauciflora* across the Esperance Shire, as obtained from Department of Biodiversity, Conservation and Attraction's WA Herbarium and Threatened and Priority Reporting spatial databases.

It is believed that this species is under-represented in total known populations in the spatial databases. As DBCA does not actively manage low priority species, it is highly likely many records have not been prioritized being entered into the database or have simply never been reported. Additionally, *D. pauciflora* is cryptic in identification, looking extremely non-descript and similar to many other common species outside of flowering time in spring. It is therefore likely that many populations remain undiscovered due to being unidentifiable for 11 months of the year. It is described as growing over a vast array of sandplain habitats and vegetation communities. This is supportive by personal experience, where plants have been observed in mallee shrubland to thick Banksia coastal shrubland. Lastly, it covers a large distribution and is not geographically restricted. It has been recorded across 230 km latitude and 70 km longitude area of the Esperance Shire (Figure 6).

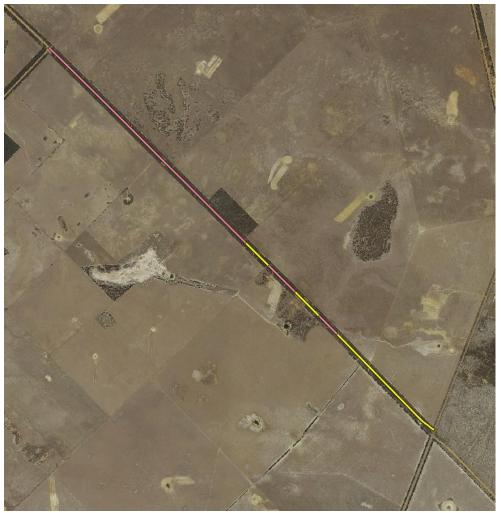
Figure 7: Yellow indicates location of 'Proteaceae Dominated Kwongkan Shrublands of the Southeast Coastal Floristic Province of Western Australia' TEC within project area (Pink). This consists of 37% of the project area.

The vegetation mapping conducted in January 2018 for 'Vegetation, Flora, Fauna and Environmental Considerations report' was confirmed during the targeted flora surveys. 37% of the project area meets the Environment Protection and Biodiversity Conservation Act (1999) listed 'Proteaceae Dominated Kwongkan Shrublands of the Southeast Coastal Floristic Province of Western Australia' Threatened Ecological Community (TEC) diagnostic characteristics and condition thresholds. This was mostly located in the southern half of the 7889/1 project area. The Shire of Esperance plan to use banked Environmental Offsets to compensate for the loss of habitat and Kwongkan TEC. A separate offset proposal will be submitted.
