NATIVE VEGETATION CLEARING PERMIT APPLICATION

BROOME TOWN BEACH GROUYNE UPGRADE AND JETTY PROJECT

AUGUST 2019

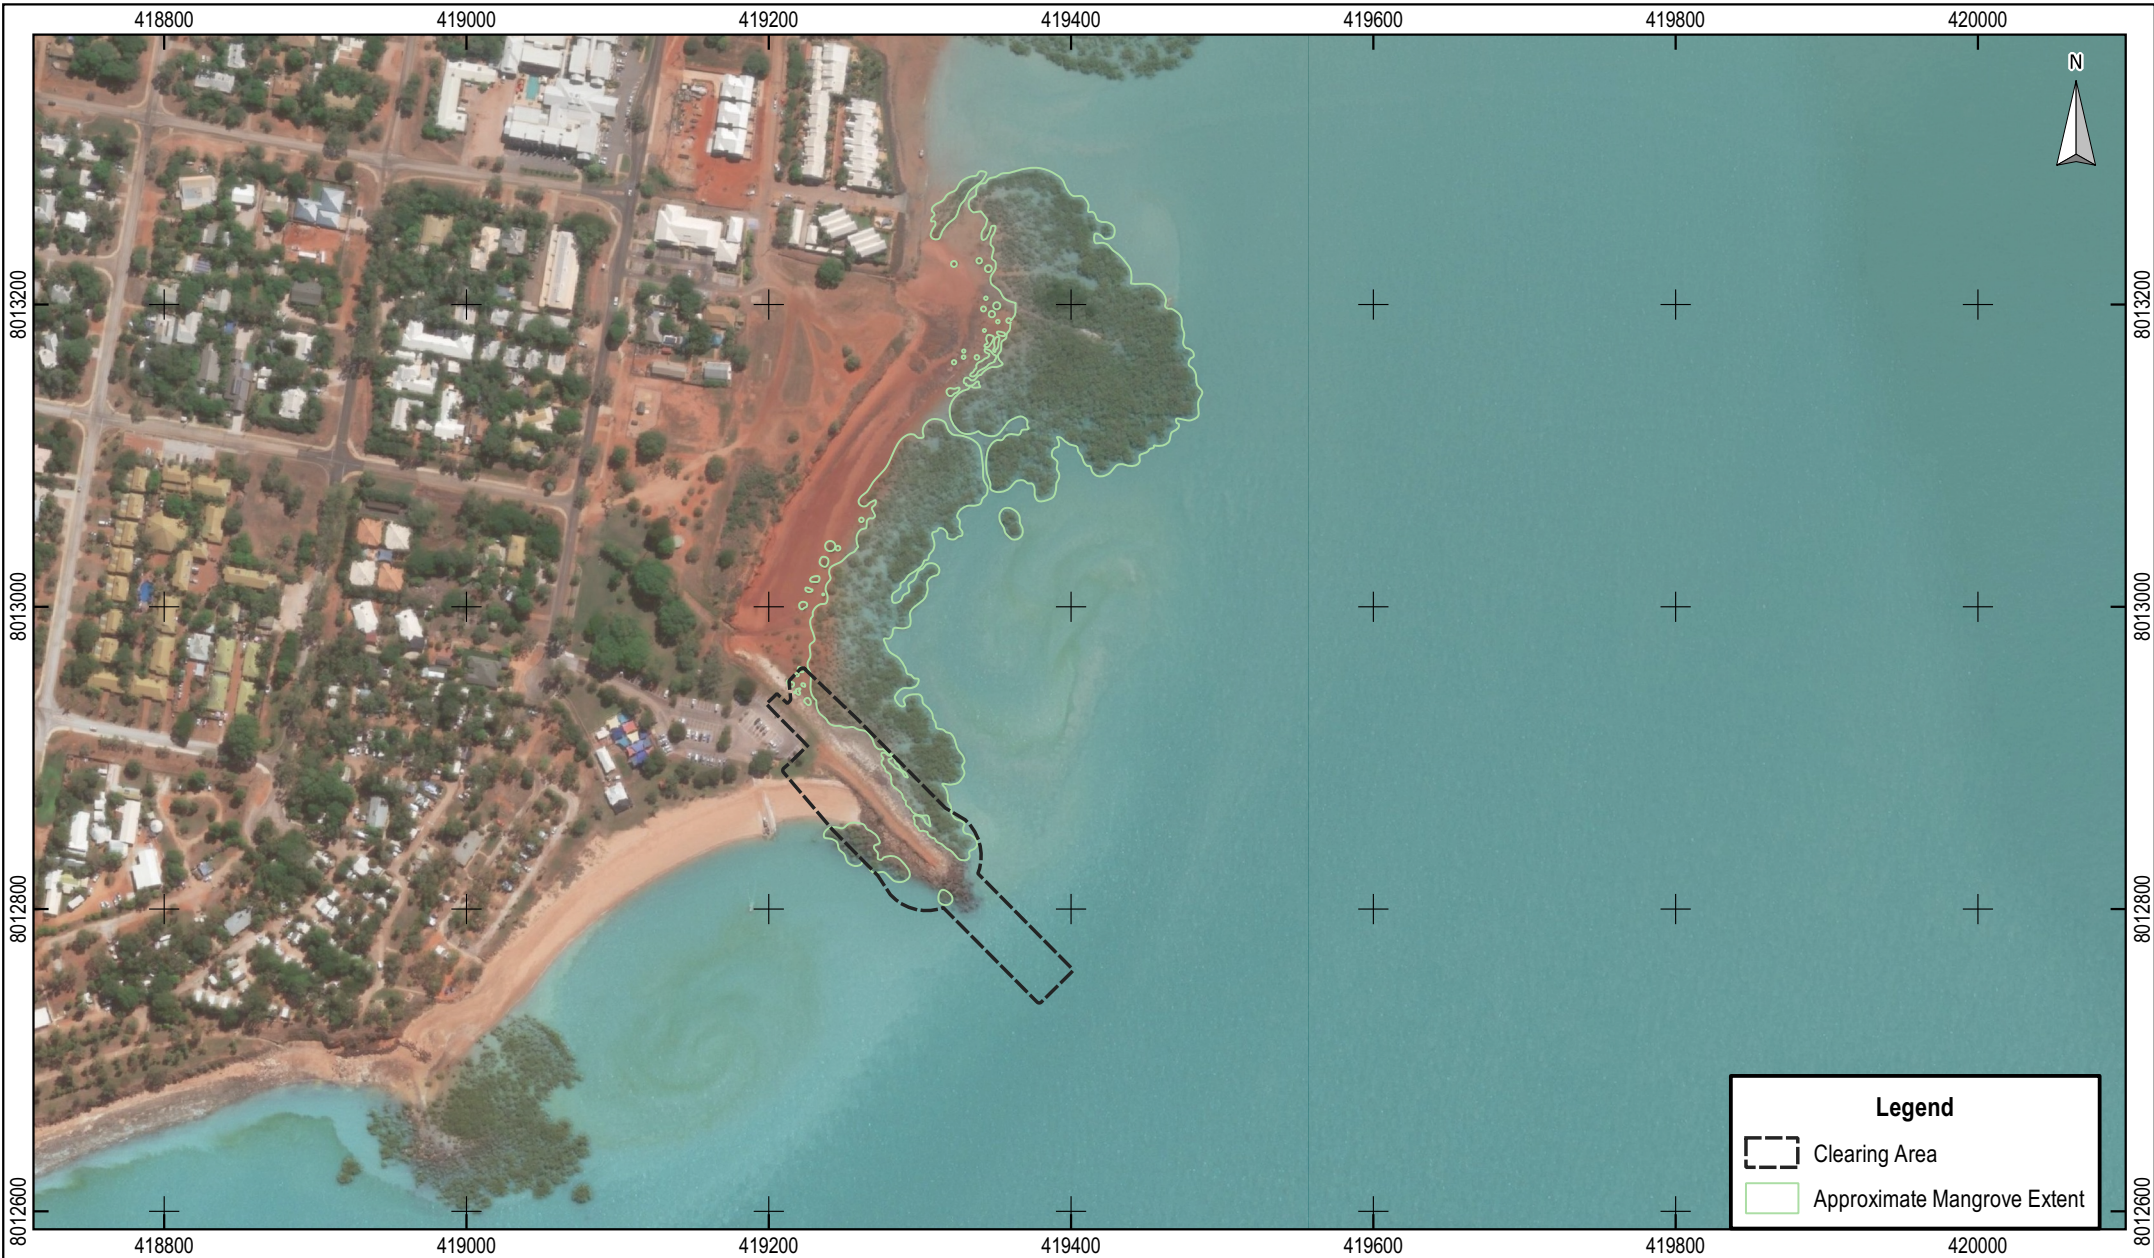
Figure 2

Clearing Area in Relation to Mangrove Habitat

The Proposal involves upgrades to the historic Town Beach Jetty, present as a groyne structure and in a state of disrepair, with erosion ongoing (Plate 2). The remains of a previous jetty structure occur to the west of the groyne structure. The groyne upgrades require the clearing of mangroves immediately adjacent to the Town Beach Jetty (Figure 2).

Grey mangroves (*Avicennia marina*) occur adjacent to the existing groyne (Plate 1, Figure 2). Beyond the clearing area, to the north and south, and around the eastern shoreline of Roebuck Bay, are larger areas of mature mangrove habitat including the Grey mangrove (*Avicennia marina*) and the Stilted mangrove (*Rhizophora stylosa*).

The clearing will impact up to 0.28 ha of mangroves or up to 7.7% of the locally mapped extent, refer Figure 2. Extensive mangroves occur across the local area and more regionally (refer Section 2.6.3).
