Wetland Assessment

Shire of Dardanup

October 2019

Version 2

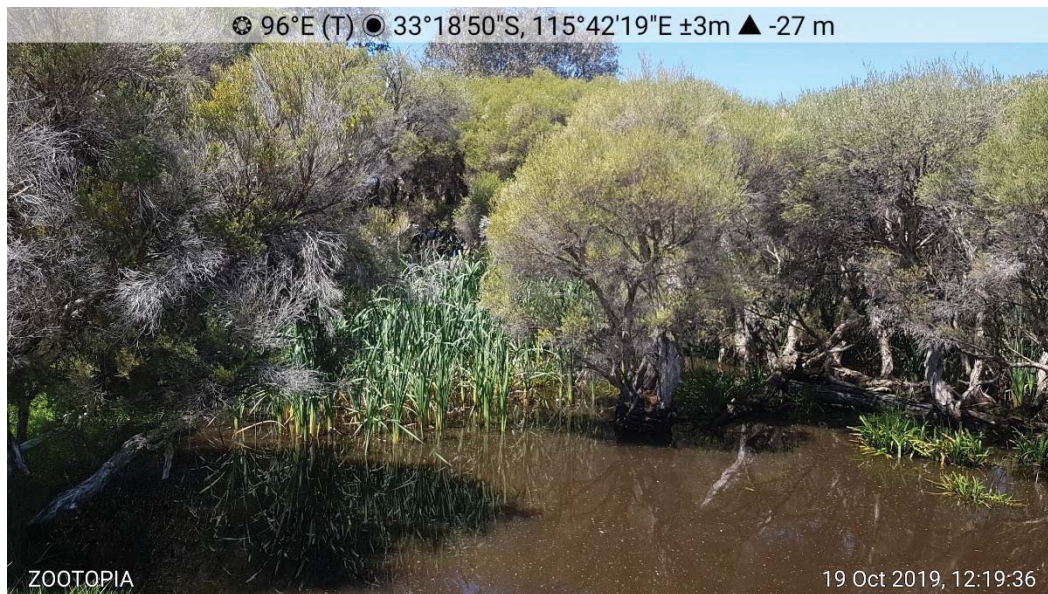
Plate 1: Bulrush Infestation - Eagle Wetland Reserve

This wetland is largely covered by a dense low closed forest of paperbark (*Melaleuca* spp.) and flooded gum (*Eucalyptus rudis*) with fringing peppermint (*Agonis flexuosa*) over a closed sedgeland and weeds. The reserve has a total area of approximately 2.8 ha (Figure 2). An infestation of bulrush was observed at the northern end of the reserve (see Plate 1). The infestation has a total area of about 1,000 m².

The management methods that will be used at each location is yet to be finalised but it should be noted that any actions employed at some locations may impact on fauna, in particular waterbird roosting and nesting habitat. It is therefore recommended that a management plan be formulated and implemented that aims to minimise any possible impacts that may occur during bulrush removal/control.

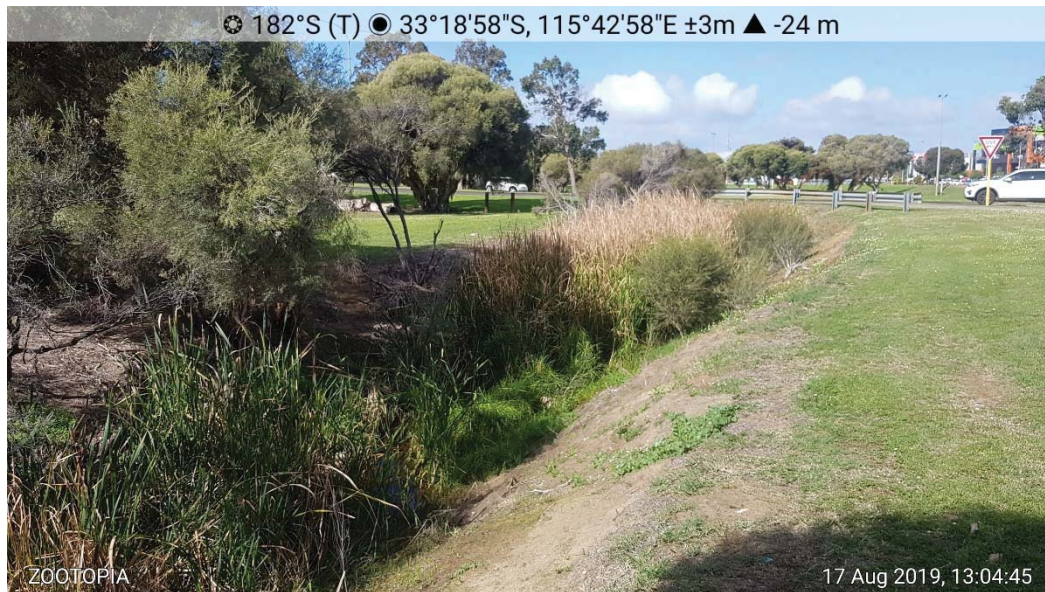
Plate 2: Bulrush Infestation - Hands Avenue Reserve

This small reserve (~0.31 ha) contains a drainage channel which possibly represents a historically modified natural water course which ultimately drains into the Collie River. The drain is bordered by a woodland of marri (*Corymbia calophylla*) and paperbark (*Melaleuca* spp.) along its north western half. The south eastern end of the drain, which is only bordered by grassland and a few scattered paperbarks, contains an infestation of bulrush with a total area of about 168 m². Some small infestations are also present further downstream to the north east (Figure 3).

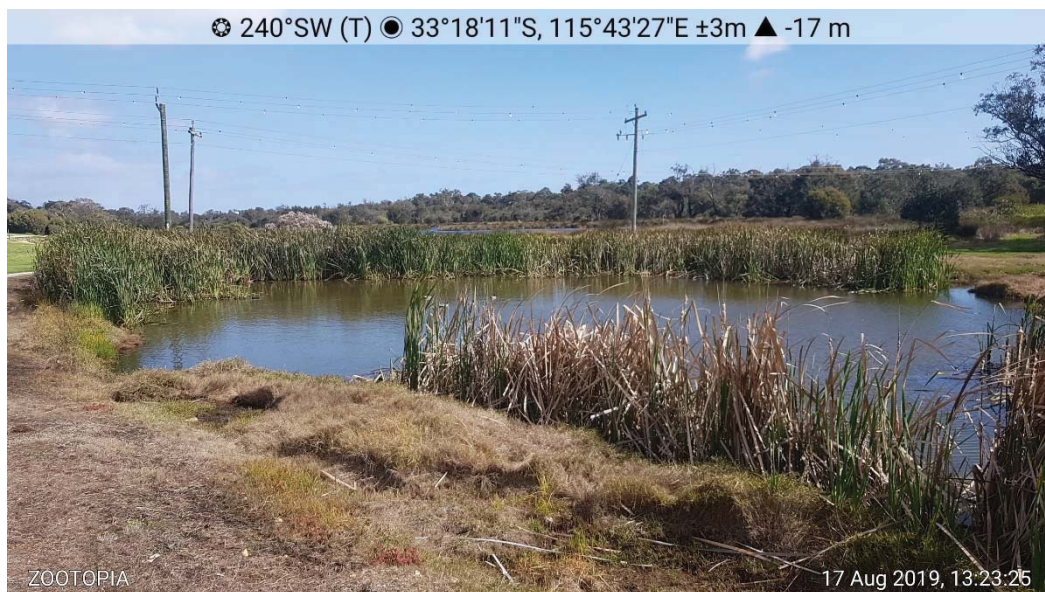
Plate 3: Eastern Bulrush Infestation - Leicester Wetland Reserve

Leicester Wetland Reserve has a total area of about 9.6 ha and is characterised by having a large area of open water bordered by sedgeland. To the south, vegetation is represented by areas of dense low closed forest of paperbark (*Melaleuca* spp.) and flooded gum (*Eucalyptus rudis*). The north end of the of the reserve contains four smaller bodies of open water which have been subject to considerable historical disturbance with natural vegetation being highly modified or removed. Two small infestations of bulrush were observed having a total area of about 621 m² (Plate 3 and Figure 4).

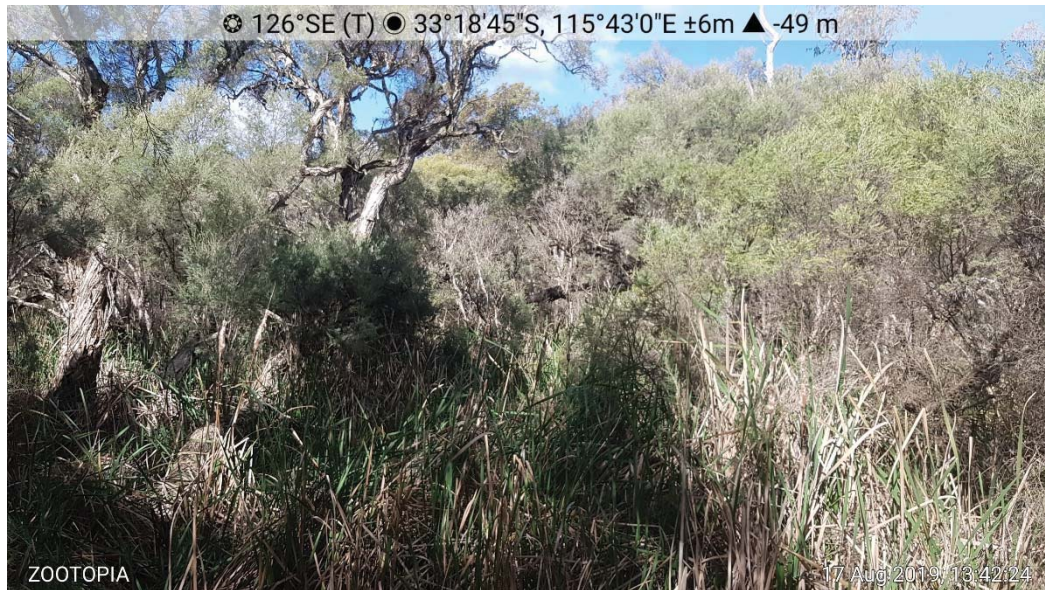
Plate 4: Bulrush Infestation - Watson Reserve

This wetland has a total area of about 5.6 ha and is largely covered by a dense low closed forest of paperbark (*Melaleuca* spp.) and flooded gum (*Eucalyptus rudis*) with fringing peppermint (*Agonis flexuosa*) over a closed sedgeland and weeds. The wetland doesn't appear to have any open water areas. An infestation of bulrush was observed along the access track into the reserve (see Plate 4) however the full extent could not be determined due to the dense nature of the vegetation making access to centre areas difficult (Figure 5).

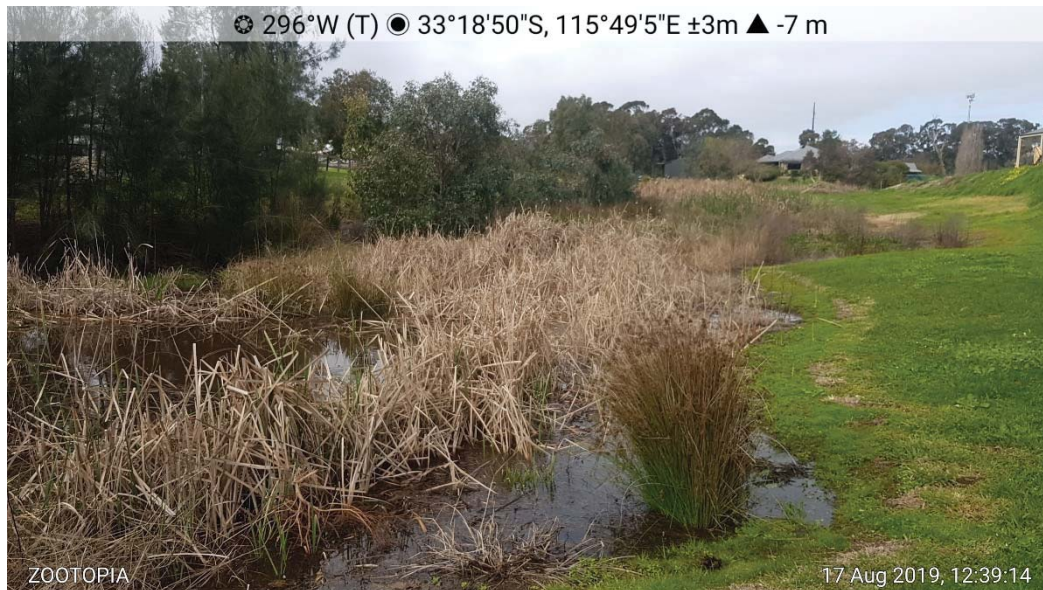
Plate 5: Bulrush Infestation - Shier Rise Reserve

The Shier Rise Reserve has a total area of about 2.7 ha. The wetland has been modified from its original form (a seasonal creekline) by the construction of a narrow weir in the centre of the reserve. This results in flooding upstream of this point in winter which forms an elongated lake. Downstream of the weir the creekline is bordered by a woodland dominated by marri (*Corymbia calophylla*). Upstream of the weir vegetation bordering the wetland is generally sparse having been cleared as parkland. The vegetation that is present consists of sheoak (*Allocasuarina* spp.) and flooded gum (*Eucalyptus rudis*) with the wetland itself containing sedges and a considerable infestation of bulrush particularly in the southern upstream section of the reserve which in total covers about 1,985 m² (Plate 5 and Figure 6)

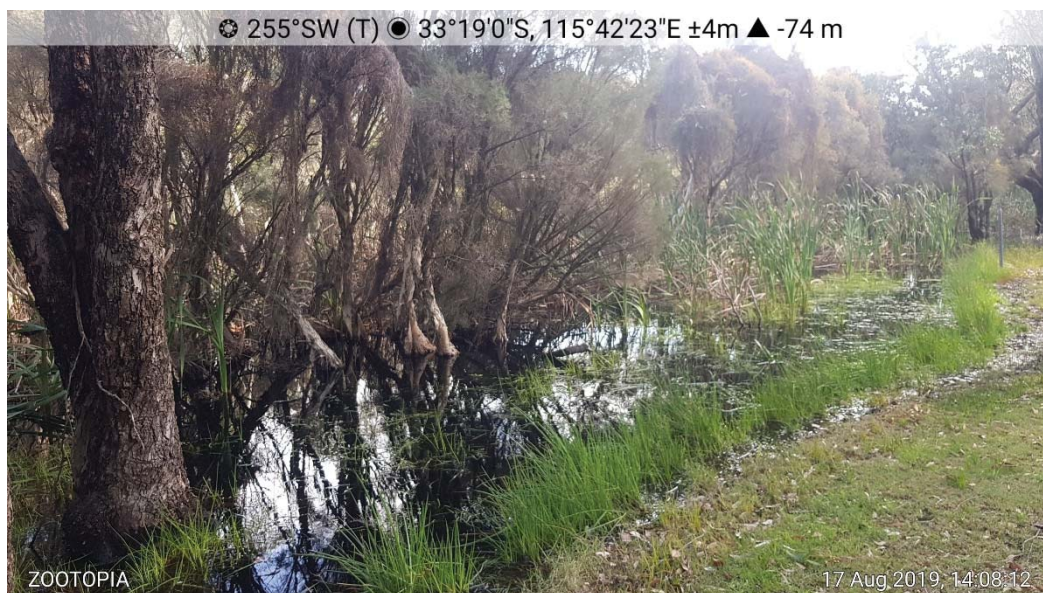
Plate 5: Bulrush Infestation – Duck Wetland Reserve

The Duck Wetland is a small reserve of about 1.9 ha. The wetland is largely covered by a dense low closed forest of paperbark (*Melaleuca* spp.) and flooded gum (*Eucalyptus rudis*). The central section of the wetland would have originally been open water but is now infested with about 2,030 m² of bulrush (Plate 6 and Figure 7)

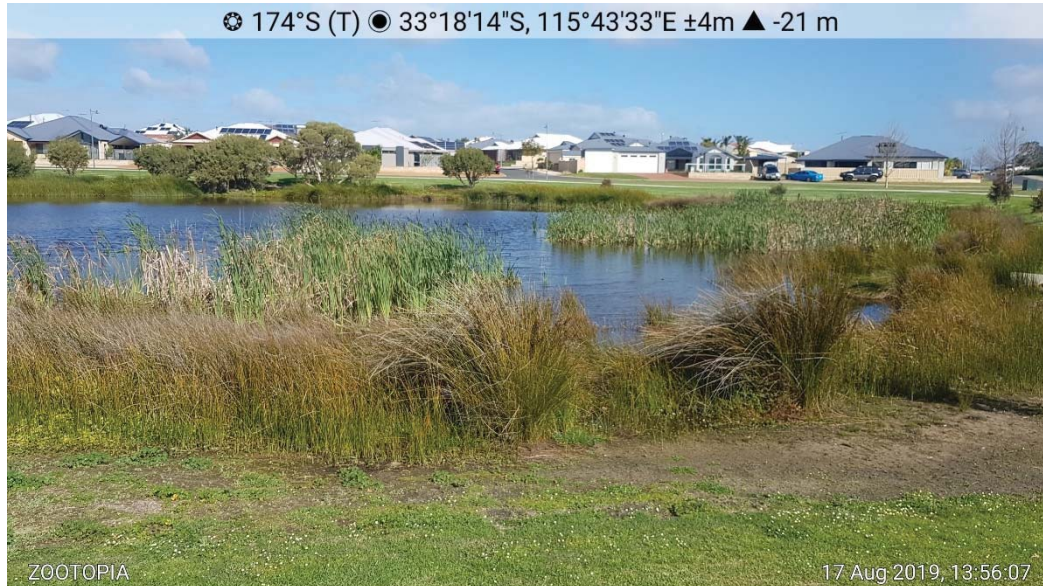
Plate 7: Bulrush Infestation – Peninsular Lakes Park

The open water wetland within the 0.9 ha Peninsular Lakes Park has been highly modified with most of the vegetation originally bordering the lake having been removed. The wetland itself contains areas of sedges and several small infestations of bulrush totalling about 610 m² (Plate 7 and Figure 8).

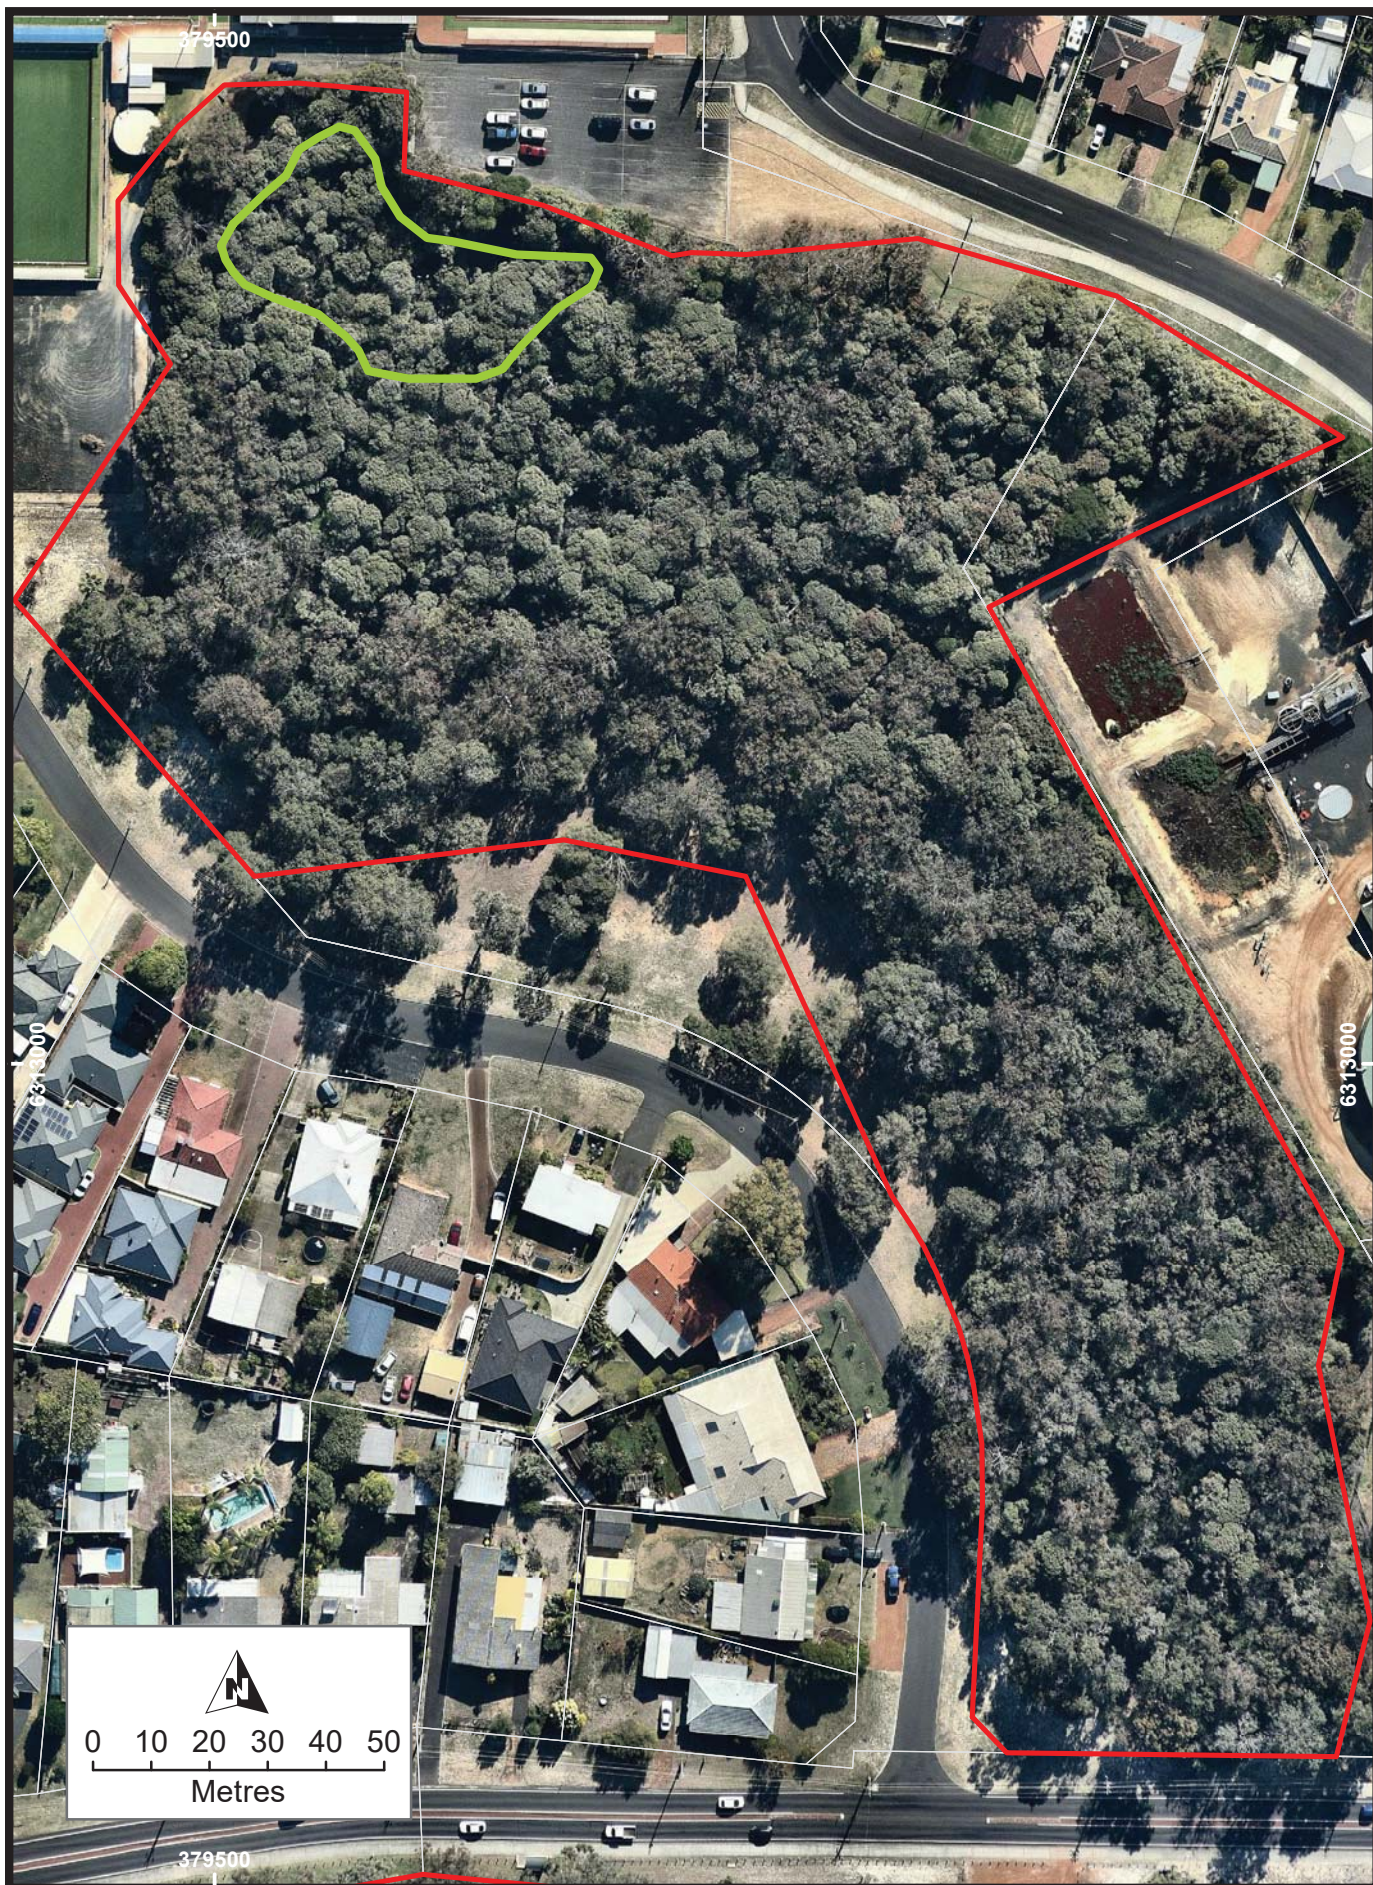
Figure: 2

Eagle Wetland Reserve

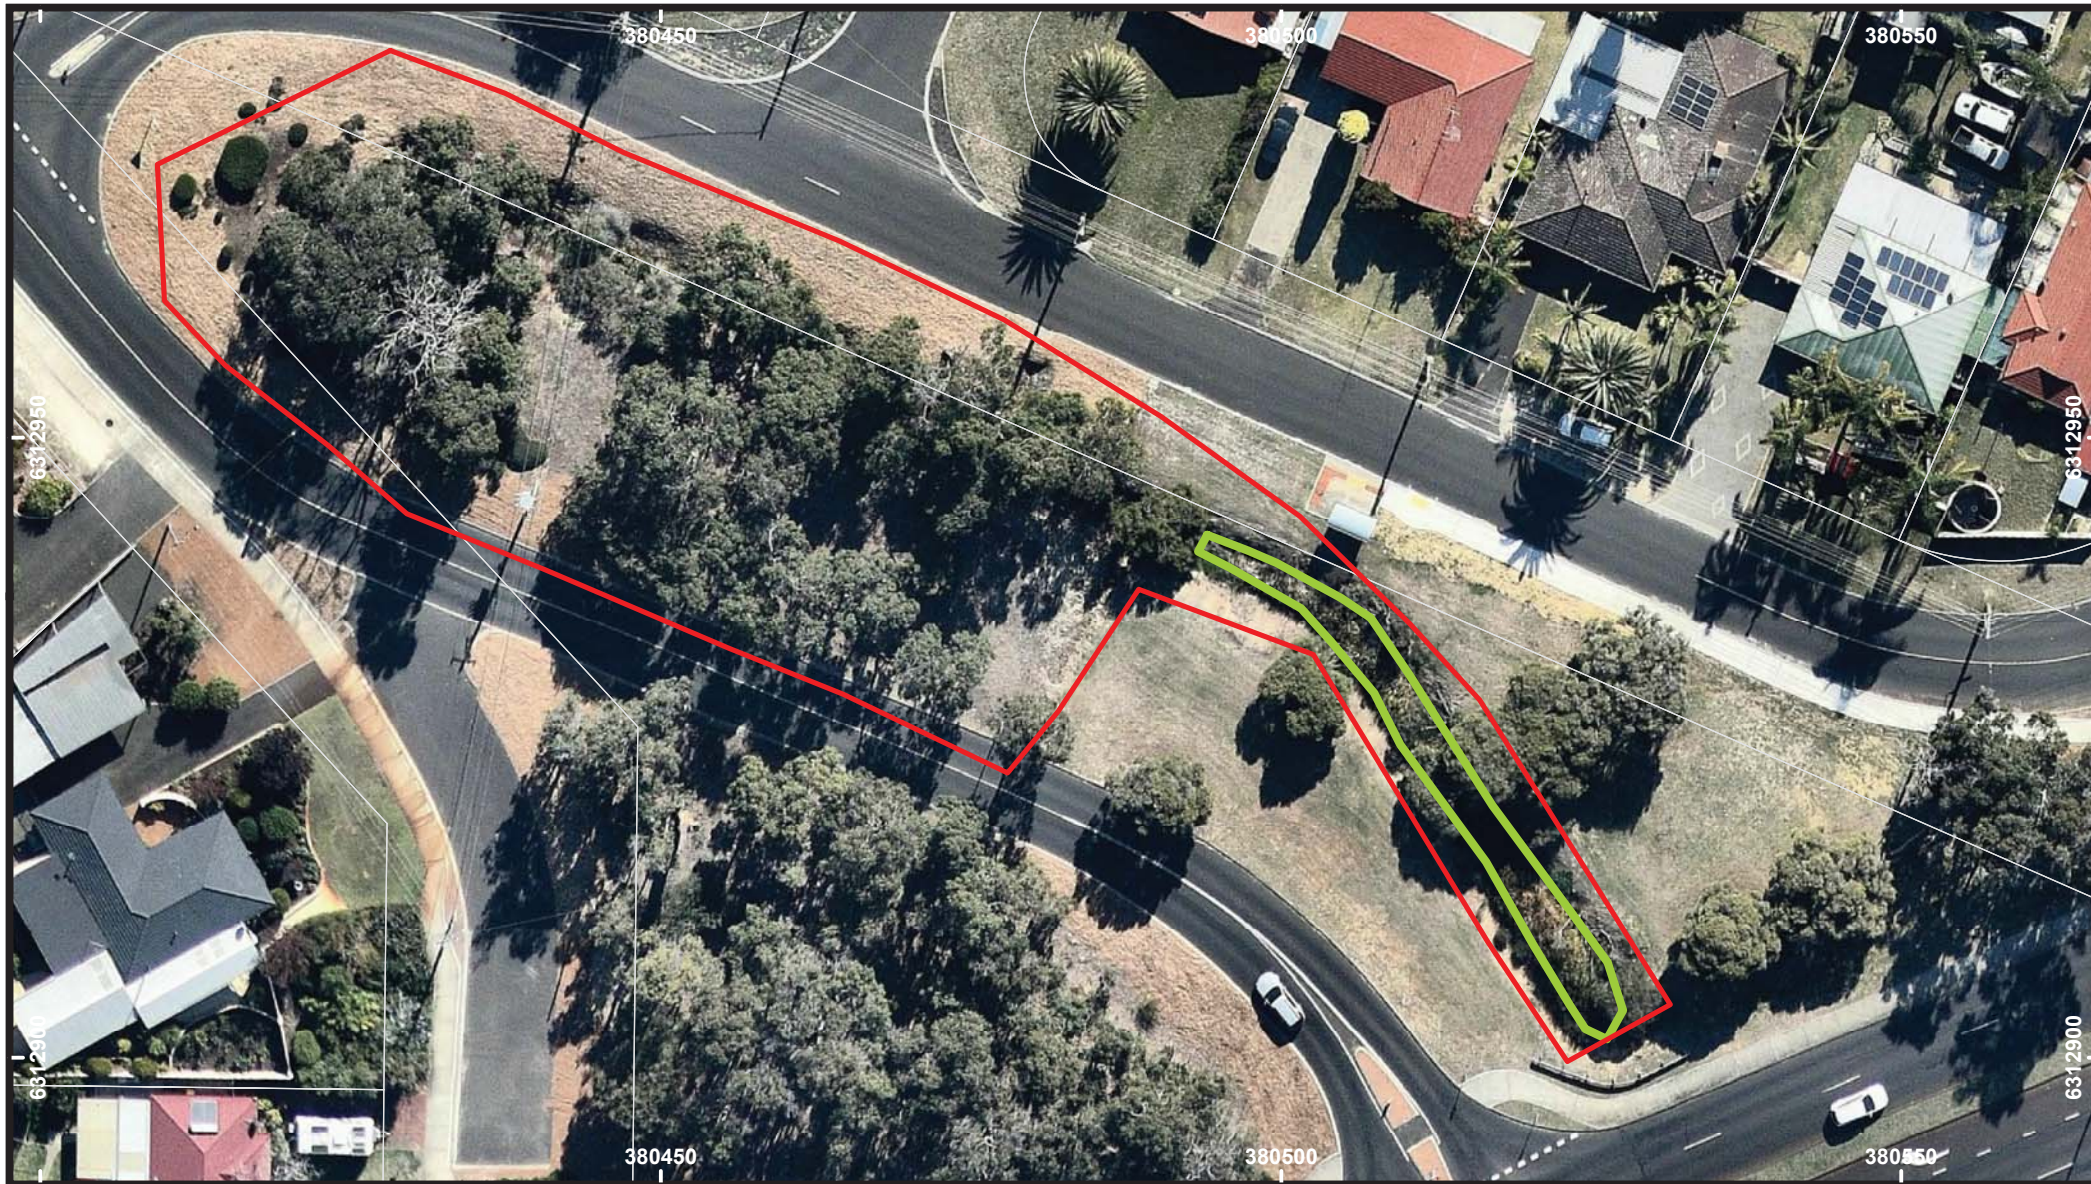
Figure: 3

**Hands Avenue
Reserve**

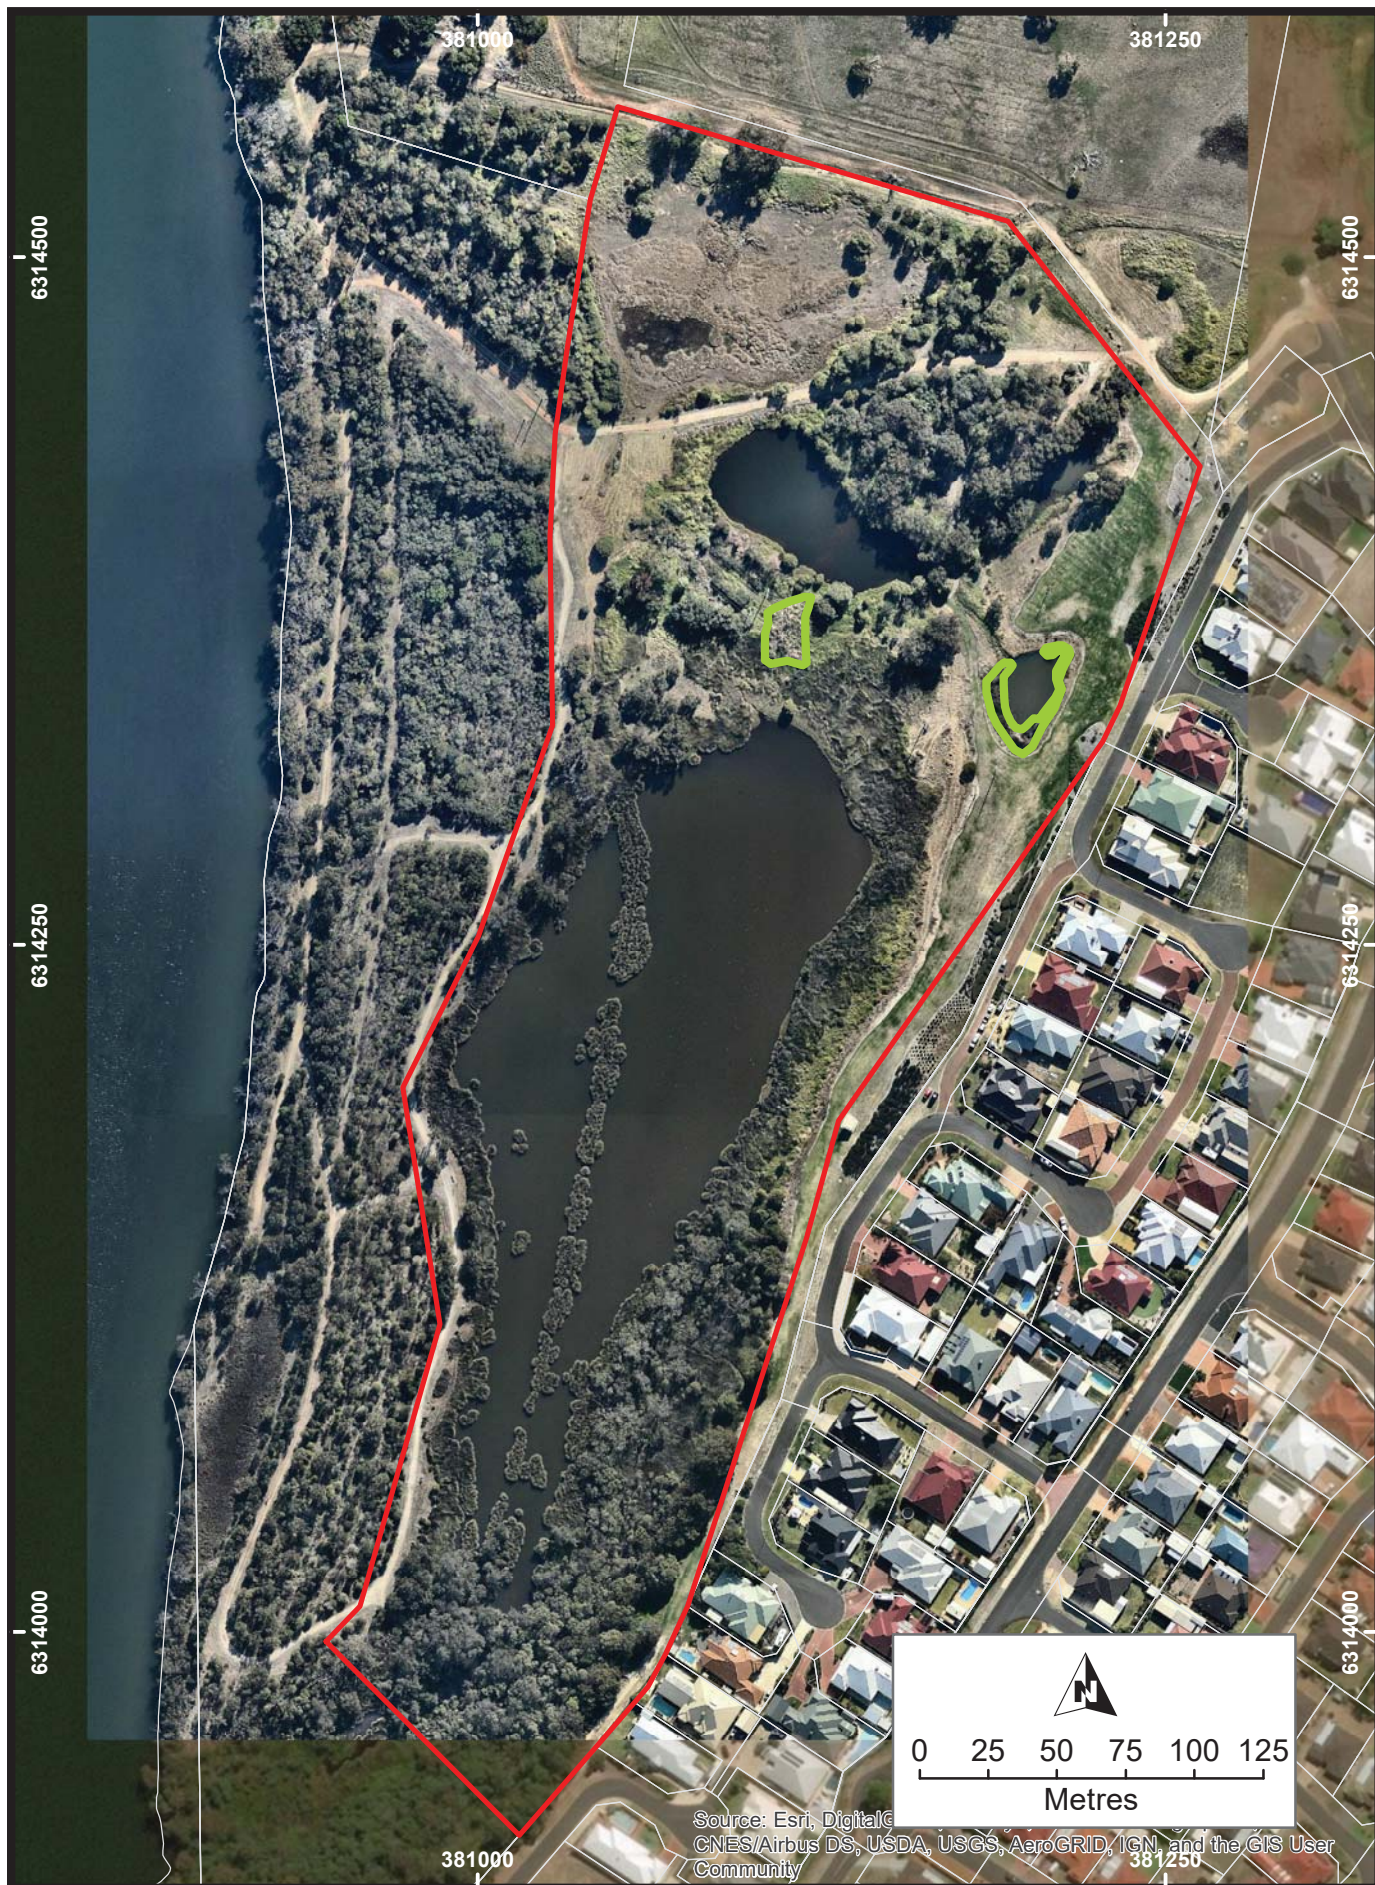
Figure: 4

Leicester Wetland Reserve

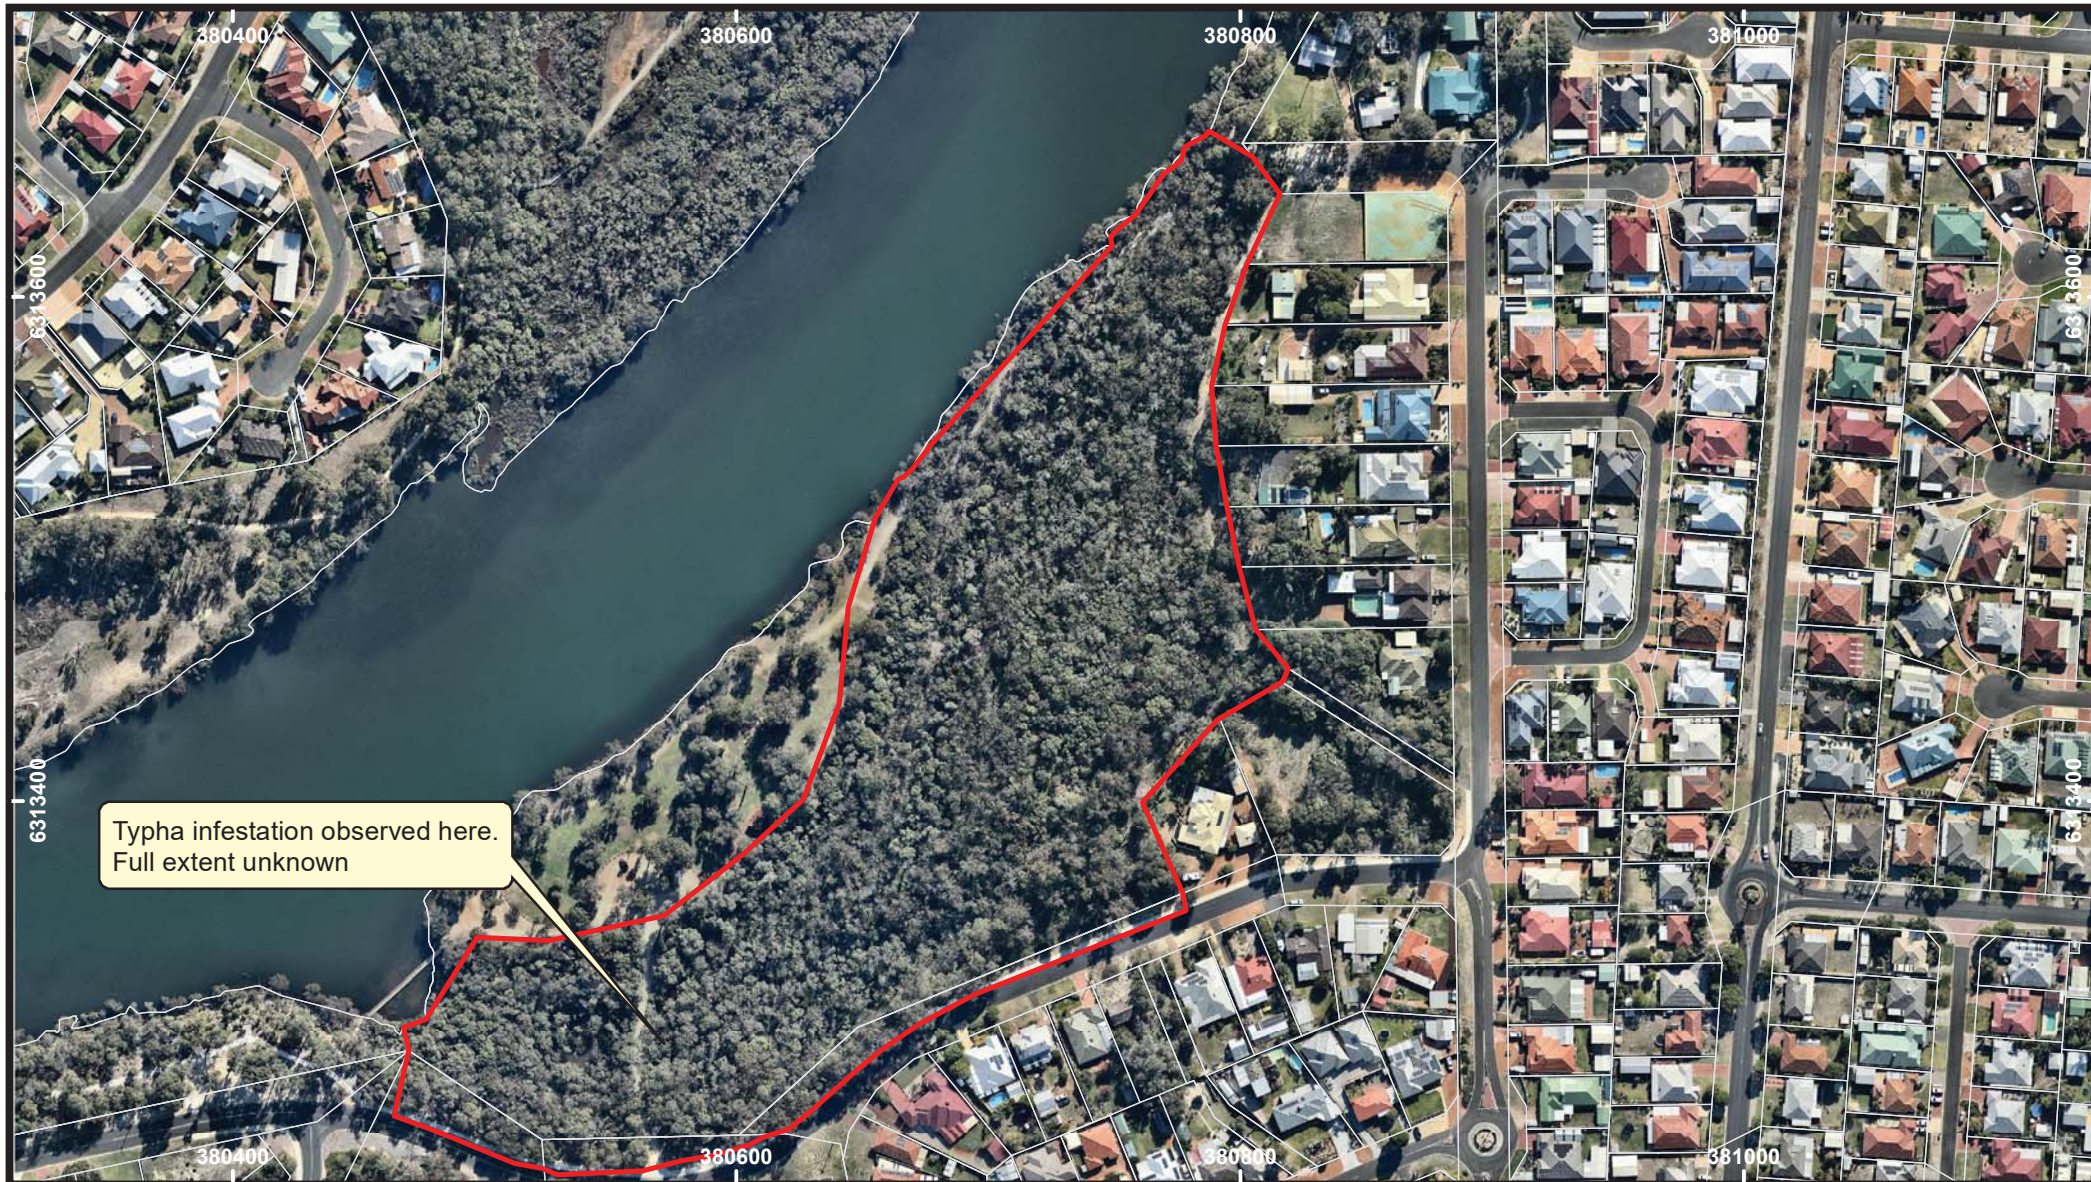
Figure: 5

Watson Reserve

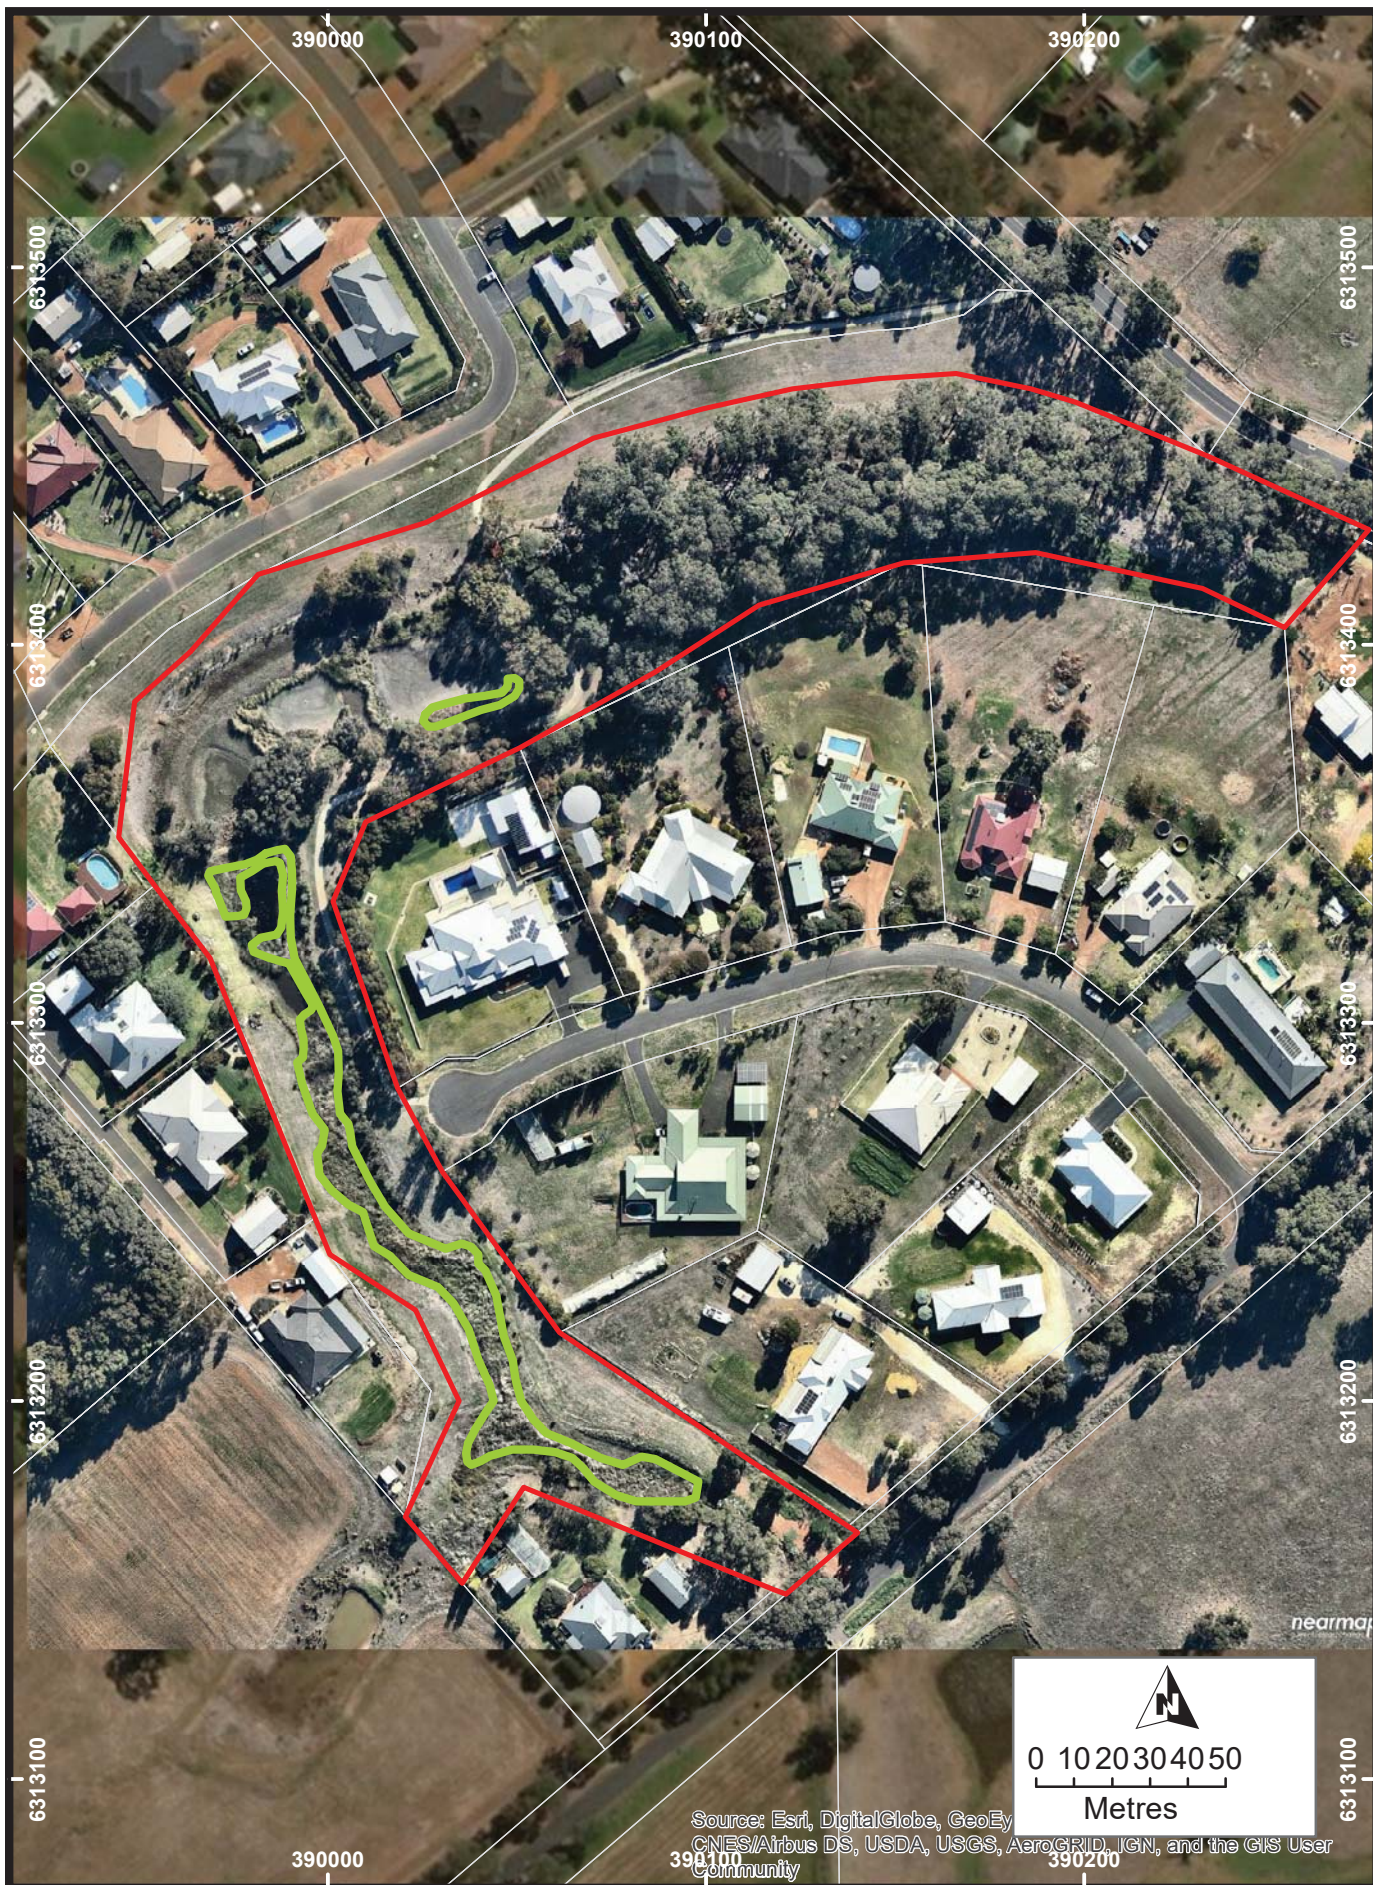
Figure: 6

Shier Rise Reserve

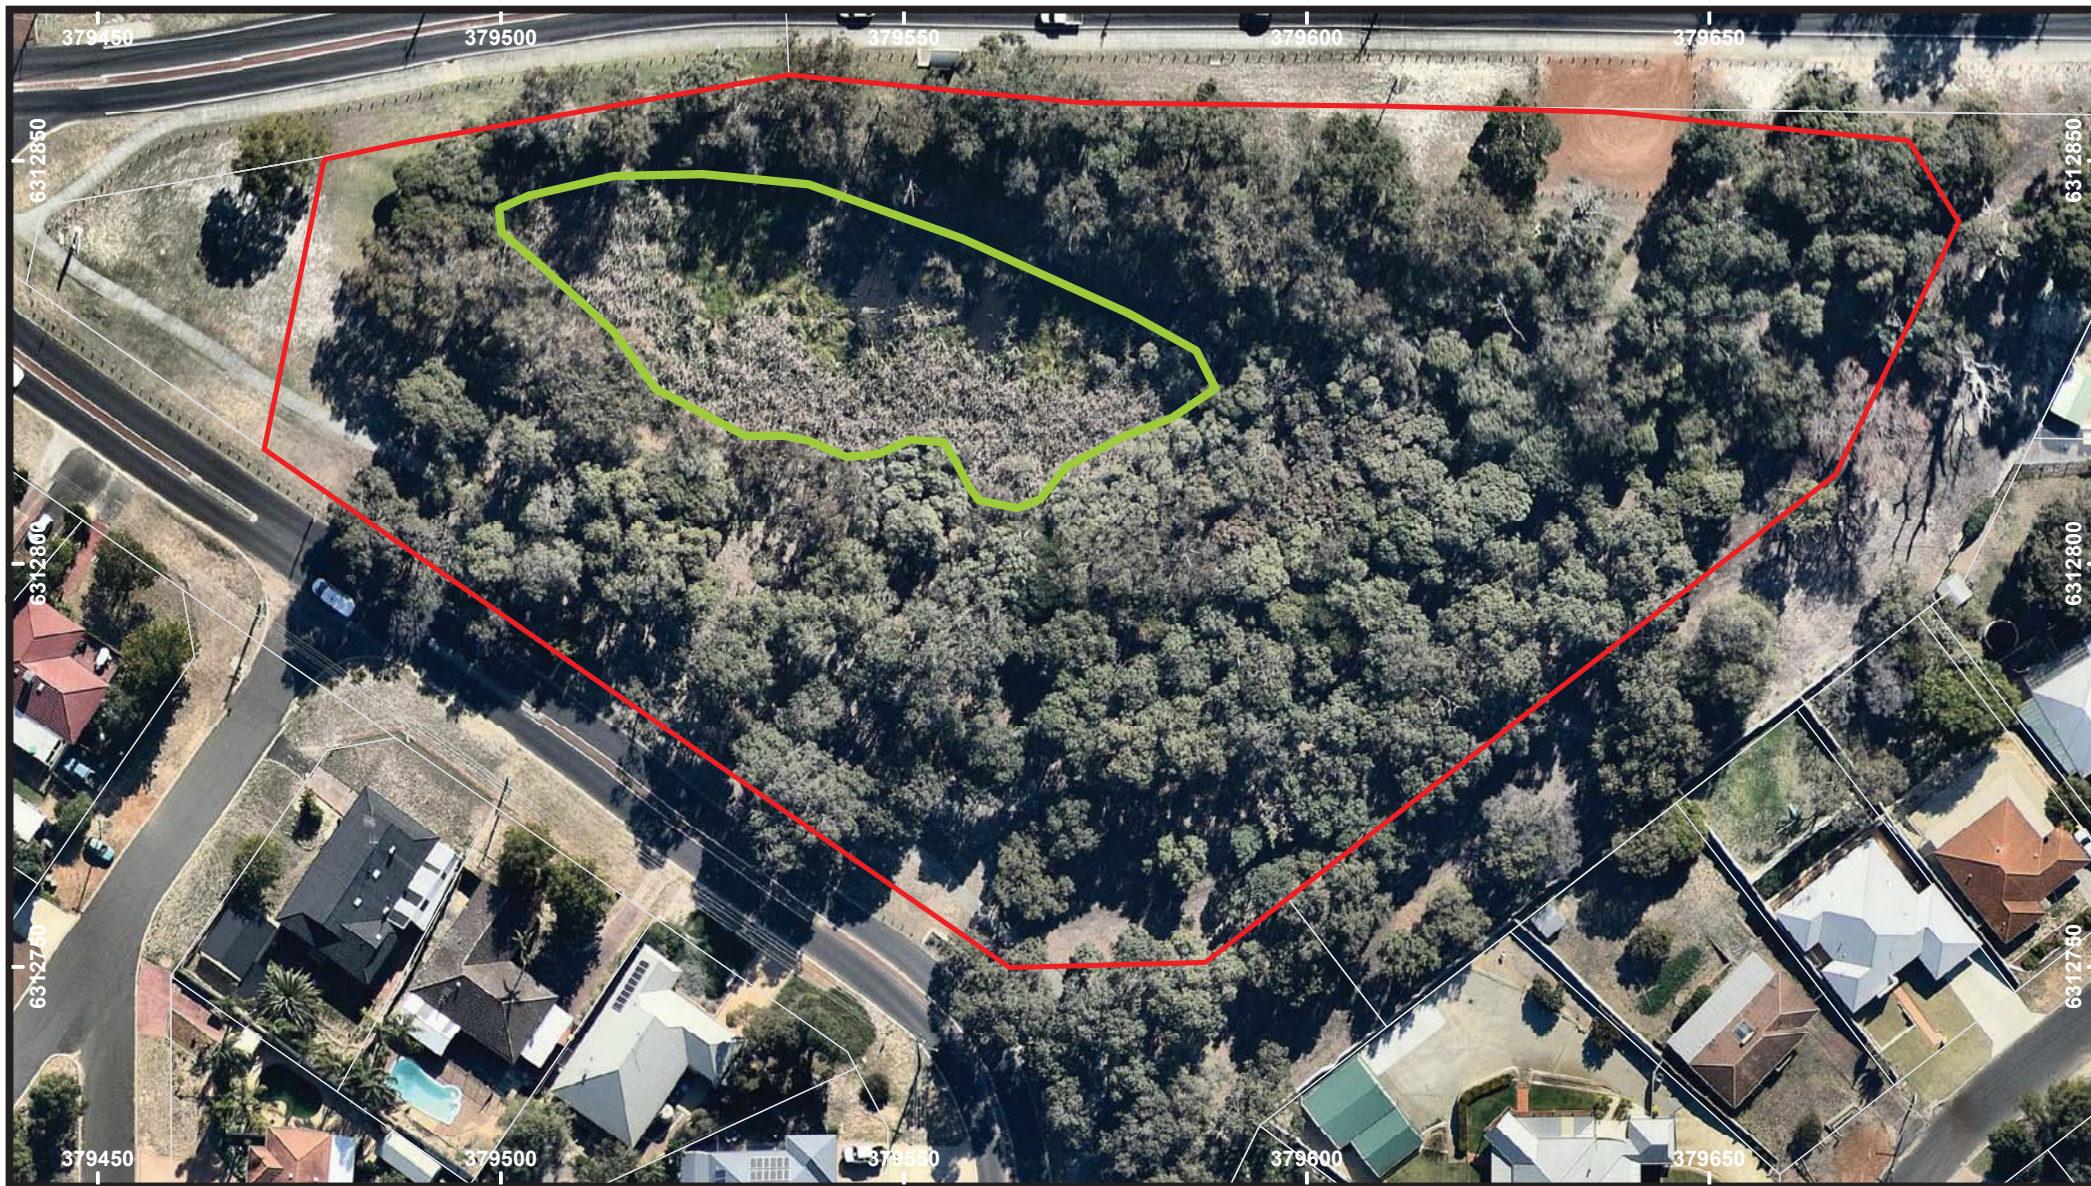
Figure: 7

Duck Wetland Reserve
