Wetland Assessment

Shire of Dardanup

October 2019

Version 2

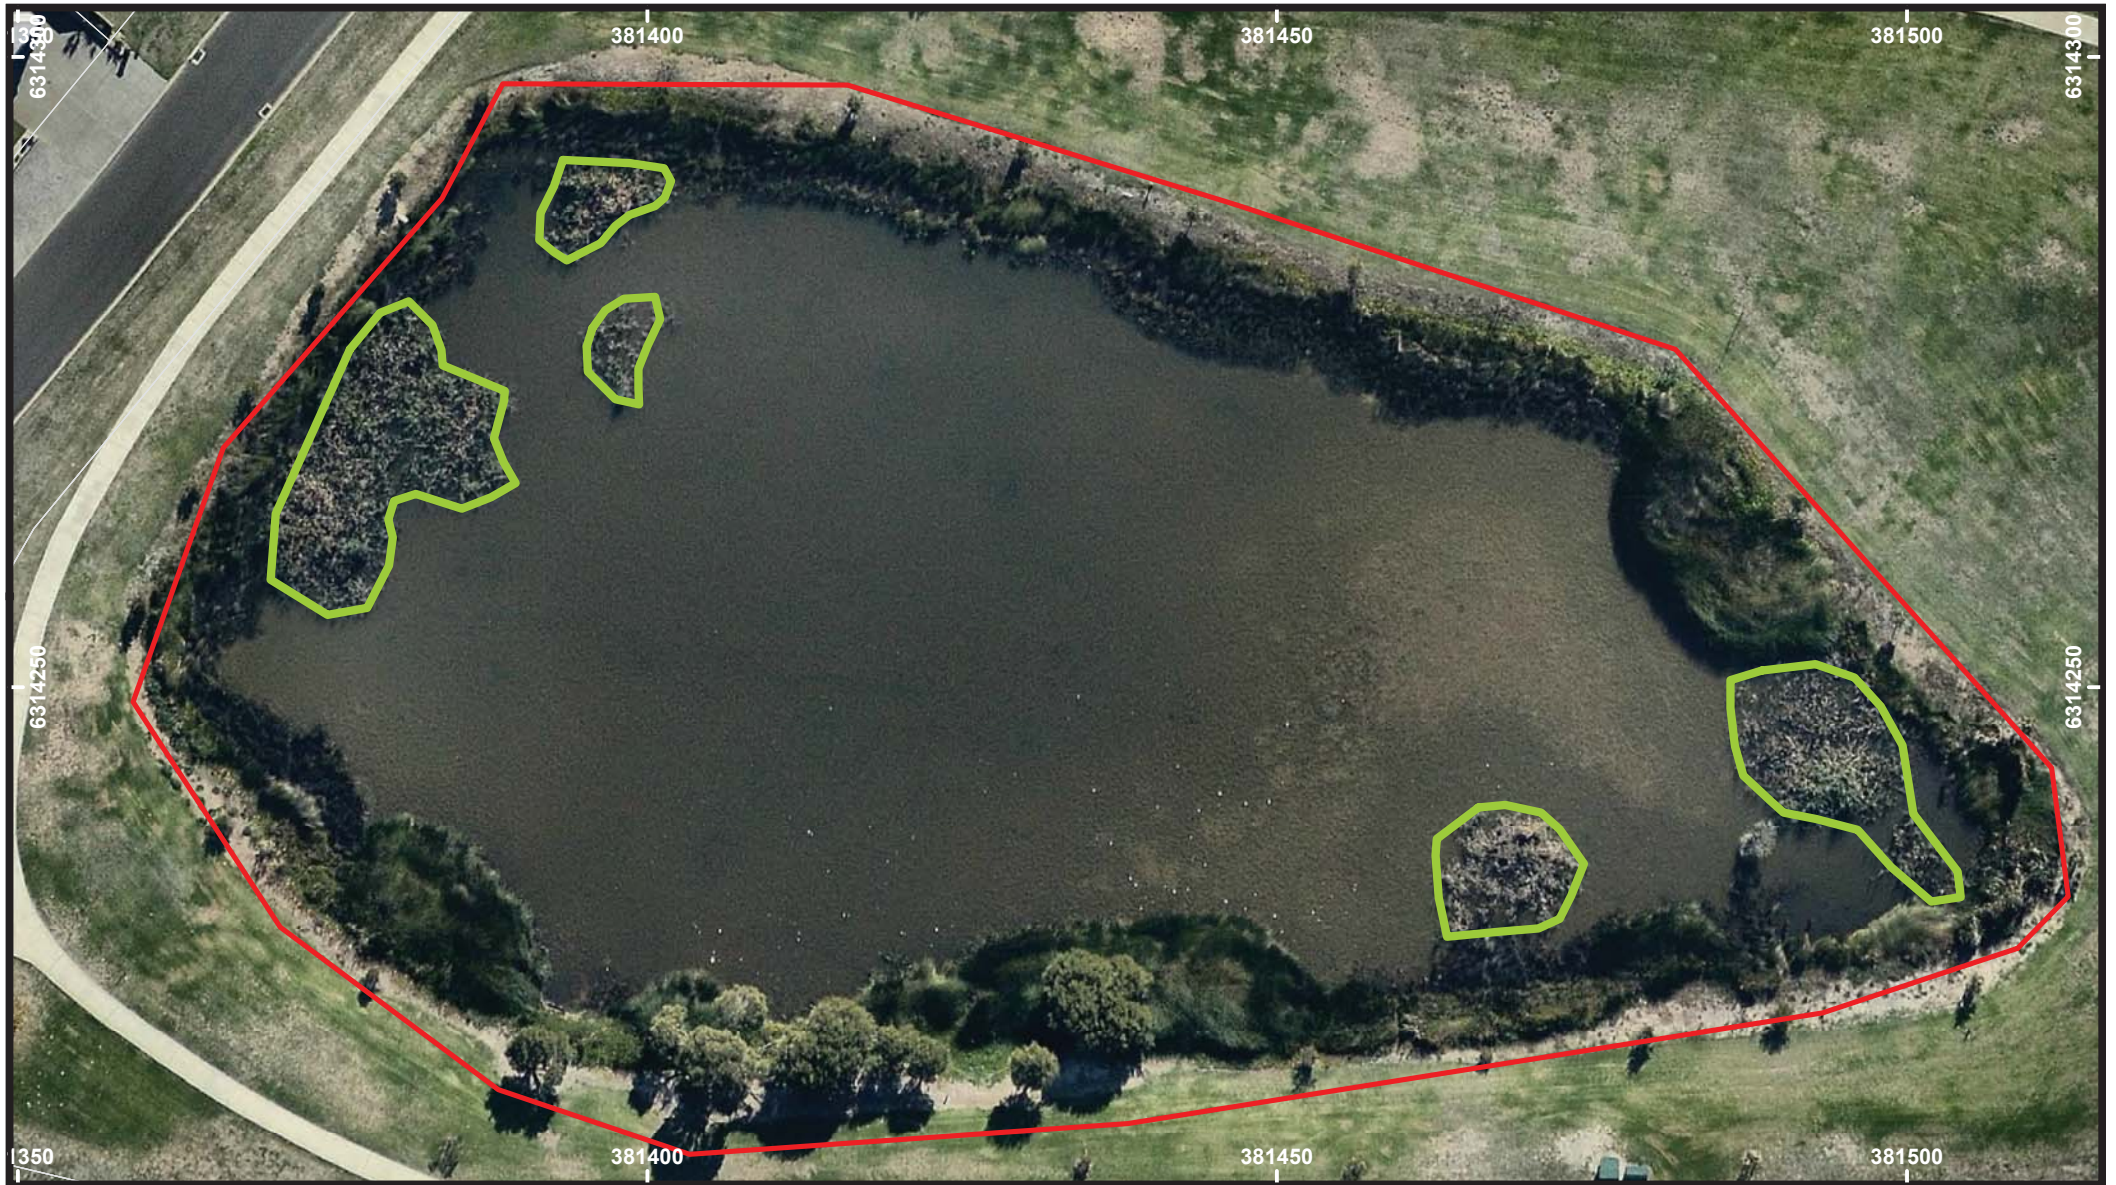
Figure: 8

The open water wetland within the 0.9 ha Peninsular Lakes Park has been highly modified with most of the vegetation originally bordering the lake having been removed. The wetland itself contains areas of sedges and several small infestations of bulrush totalling about 610 m² (Plate 7 and Figure 8).

Peninsular Lakes Park
