Document Reference: EP19-105-(22)--012

CLEARING PERMIT (PURPOSE PERMIT) APPLICATION FOR PART LOT 103 GREAT NORTHERN HIGHWAY, MIDDLE SWAN- BRICK STORAGE AREA

Emerge Associates (Emerge) has been engaged to provide environmental consultancy services to support a future hard stand storage area within part Lot 103 Great Northern Highway, Middle Swan (the 'application area').

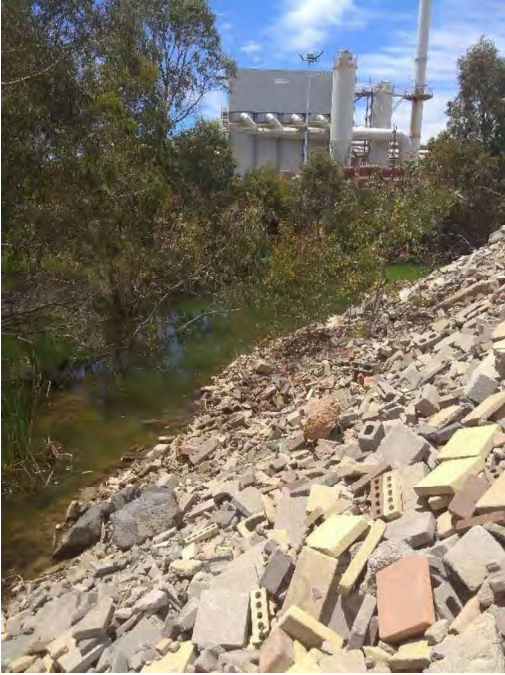
Plate 1: Illustration of material historically used to infill the clay pit. Photograph taken from within the application area, close to the northern boundary, facing east.

Review of historical images available from 1965 (Landgate 2019) onwards indicates the majority of the application area was historically cleared of native vegetation for industrial land uses associated with the Midland Brick site. As such, the application area has been subject to long term repeated historical disturbance. The application area was used for extraction and quarrying purposes until 1977, after which the clay basin was decommissioned and became inundated. From 1977 until present, the clay basin has changed shape several times due to areas being reclaimed/backfilled; an illustration of the type of material used, in addition to the current inundated clay basin and brick storage area is presented in **Plate 1 to Plate 3**.

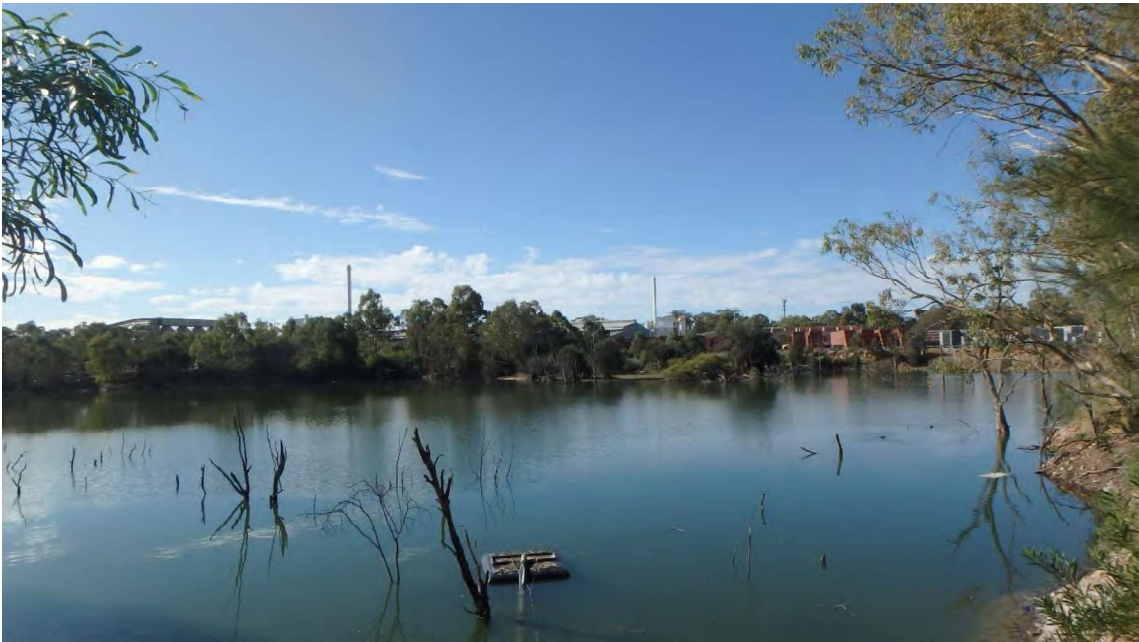
Plate 2: inundated clay basin within the central portion of the application area.

As is illustrated in the aerial photography shown in **Plate 1 to Plate 4**, the mapped lake coincides with the location of the inundated clay basin which is not considered to be representative of a wetland or watercourse due to its artificial formation and highly modified hydrology. In addition, the vegetation surrounding the clay basin was not identified as riparian vegetation and is instead considered to comprise predominately non-native species with scattered native plants in a ‘completely degraded’ condition.

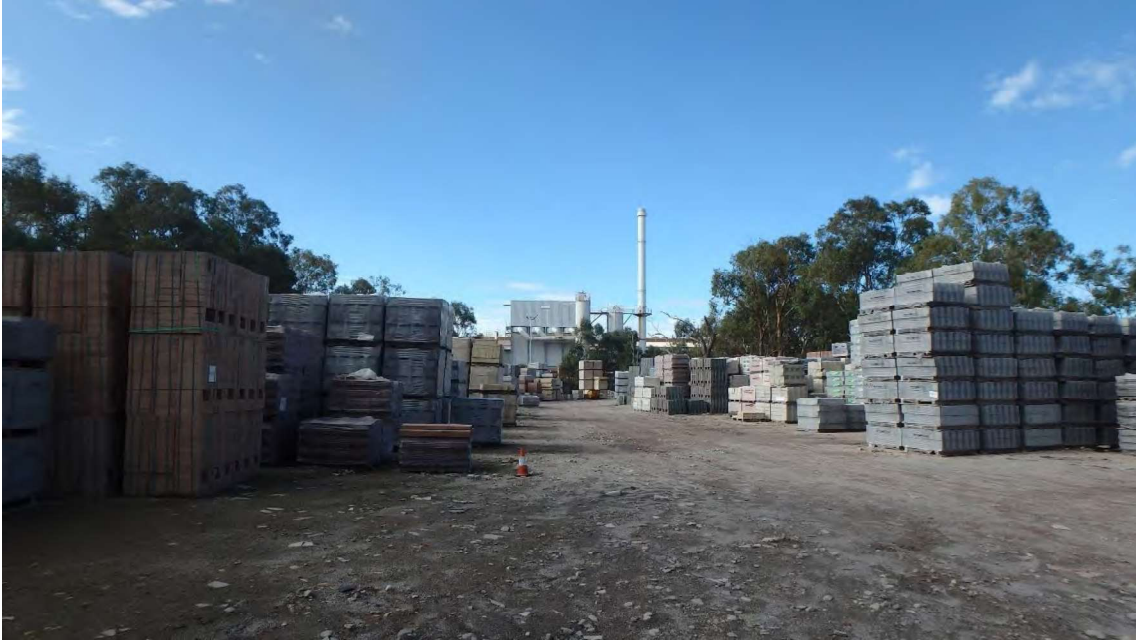
Plate 3: bituminised brick storage area within the northern portion of the application area.

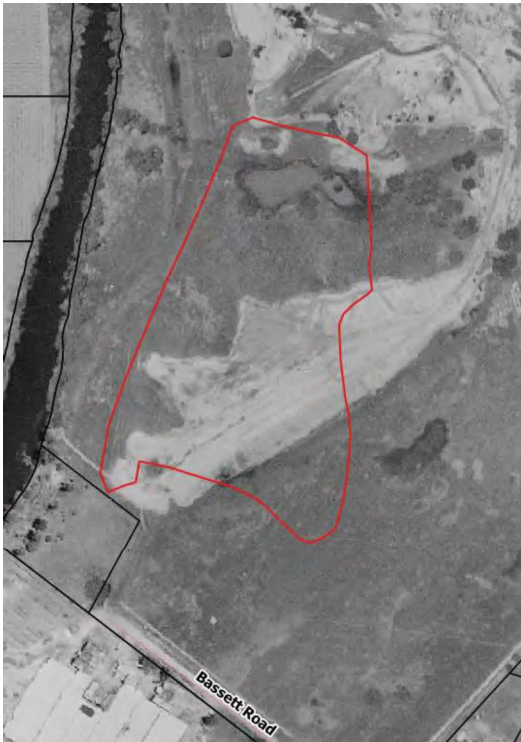
Plate 4: Aerial photograph of the application area in 1965 showing historical land clearance (WALIA 2019).

Scattered vegetation surrounding the clay basin and the northern portion of the application area is present circa 2000, and it is uncertain whether those areas have been planted or regenerated naturally. The northern portion of the application area was converted to hard-stand circa 2016, for the purposes of brick storage. Refer to **Plate 4 to Plate 7** for examples of historical aerial imagery.

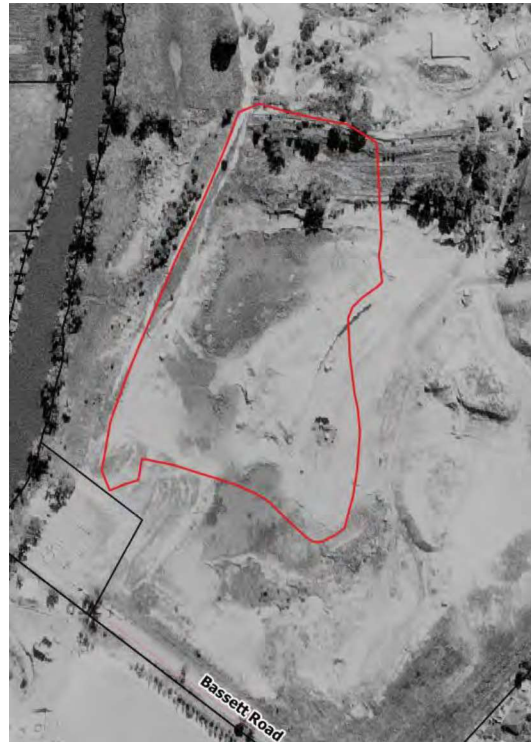
Plate 5: Aerial photograph of application area in 1974 showing historical land clearance (WALIA 2019).

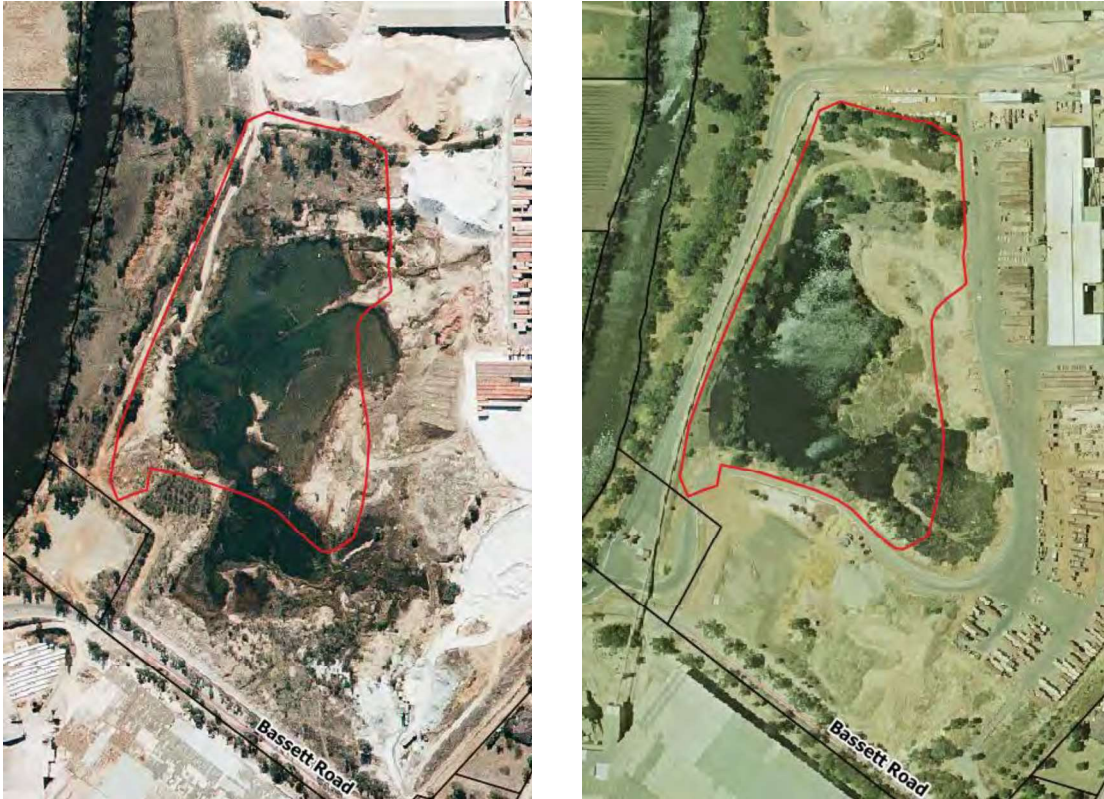
Plate 6: Aerial photograph of the application area in 1983, Plate 7: Aerial photograph of the application area in 2001, showing water retention within the clay basin (WALIA 2019). showing vegetation regrowth and basin realignment (WALIA 2019).

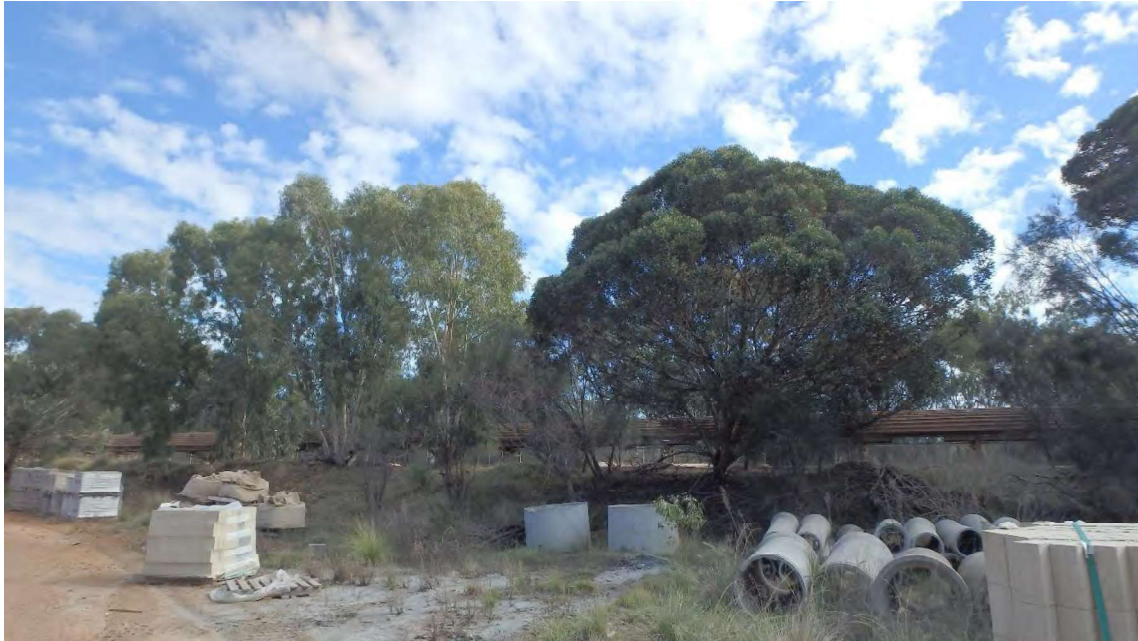
Plate 8: Plant community non-native/cleared in 'completely degraded' condition, showing native Casuarina obesa trees (right).

The application area has been subject to long-term disturbance and modification, and as such only one plant community '**non-native vegetation**' was identified within the application area which was not considered representative of an intact plant community. This community was described as 'heavily disturbed areas comprising planted non-native trees and shrubs over non-native herbs and grasses, with occasional native shrubs and forbs', extending over 3.14 ha as shown in **Figure 2**. Given the plant community was not considered intact, a comparison to regional floristic community types (FCTs) could not be undertaken. Therefore, the plant community was not determined to be representative of a threatened or priority ecological community. Representative photographs of the plant community '**non-native vegetation**' are provided in **Plate 8** and **Plate 9** below.

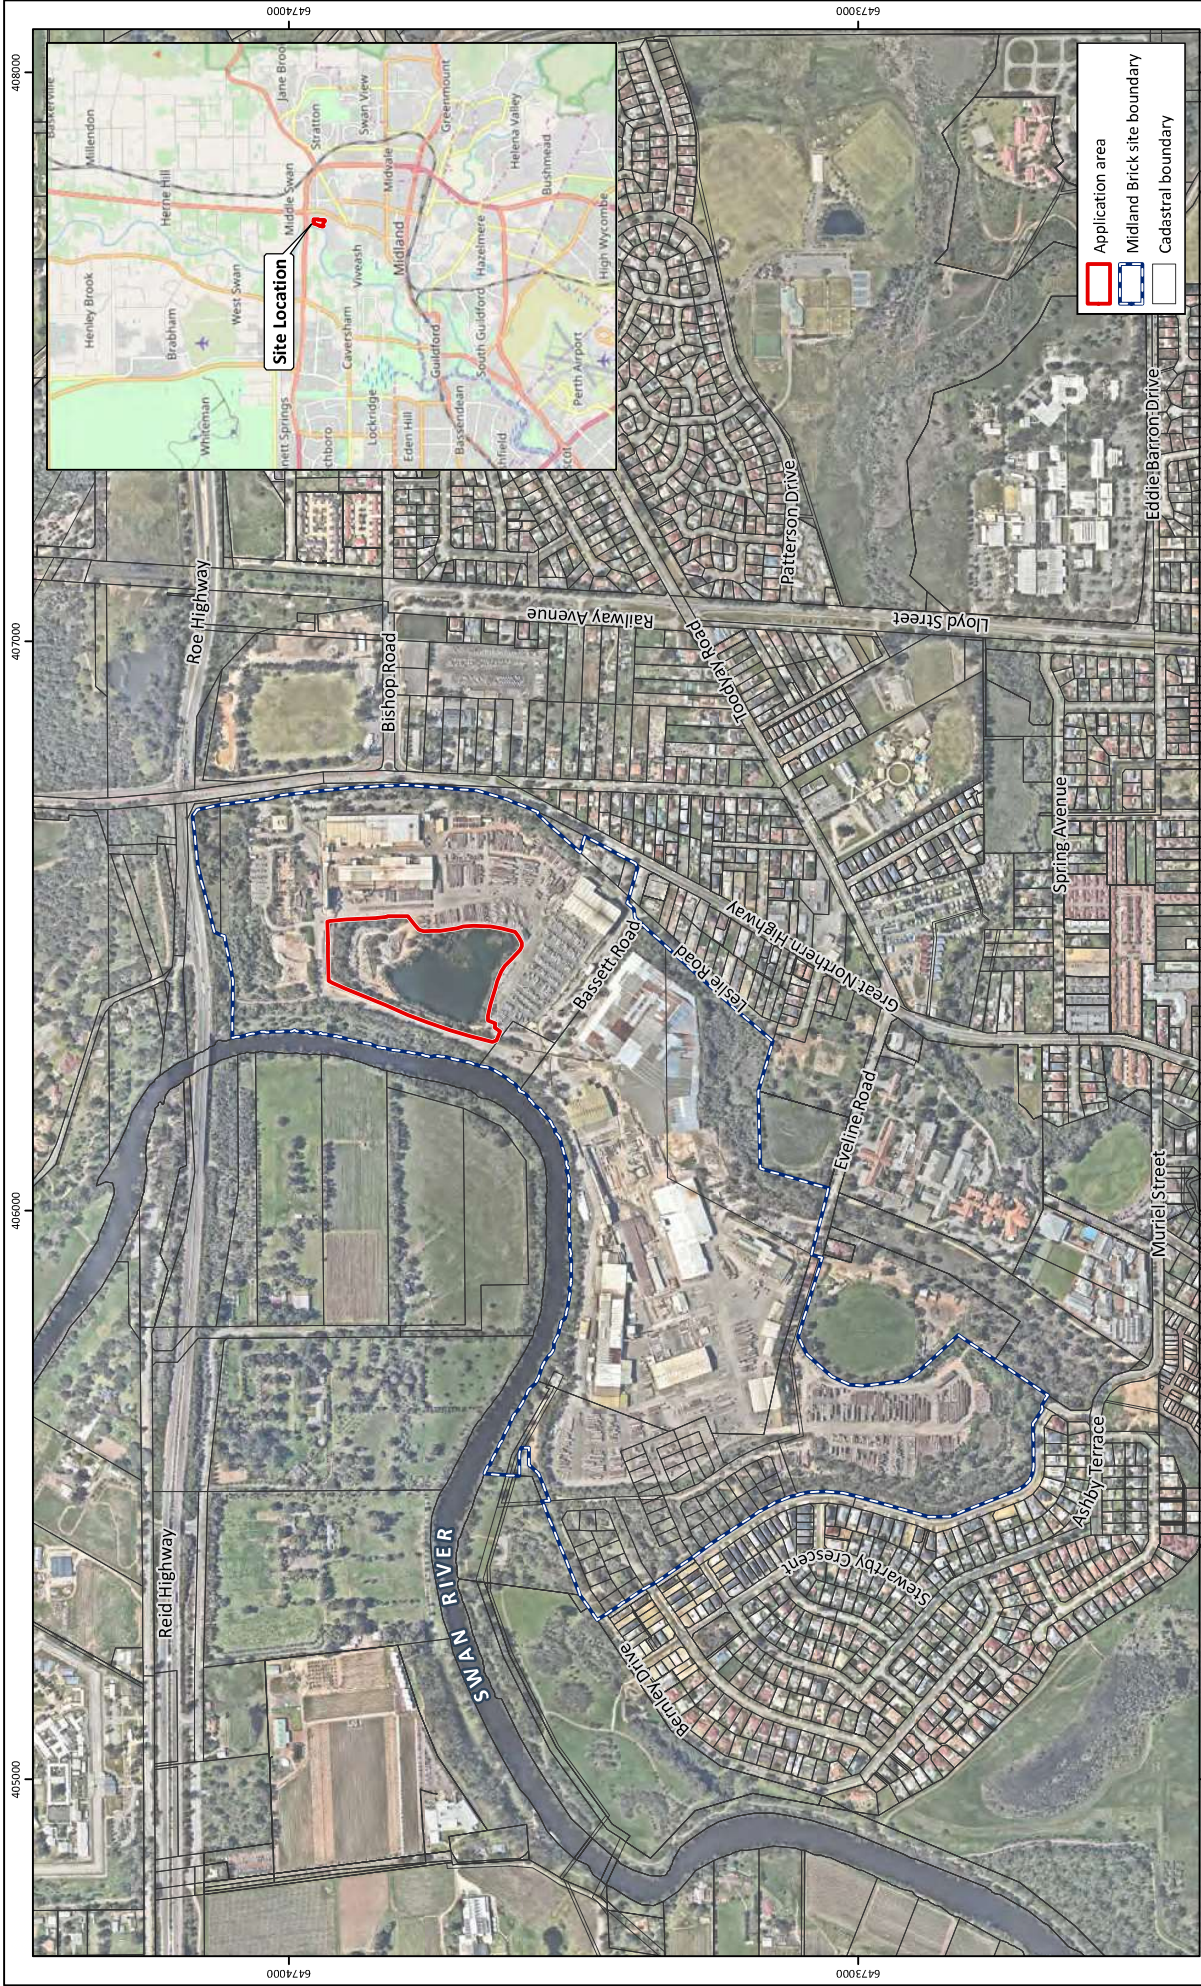
Figure 6: Hydroglogical Features

The *Geomorphic Wetlands of the Swan Coastal Plain* dataset does not identify any mapped wetlands within the application area. The locations of mapped hydrography features in and near the application area is shown in **Figure 6**.

Examination of the Department of Water and Environmental Regulation (DWER) hydrography dataset (DWER 2018) shows a perennial lake occurring in the central portion of the application area, as well as a major drain in the south east of the application area (**Figure 6**).

A review of the *Perth Groundwater Map* (DWER 2018) indicates that the depth of ground level to the water table is between 0.8 m within the centre of the clay basin, to 7.5 m within the northern portion of the application area. The application area is not mapped as occurring within a floodplain area (DWER-003), and no wetlands are located within the application area, as shown in **Figure 6**.

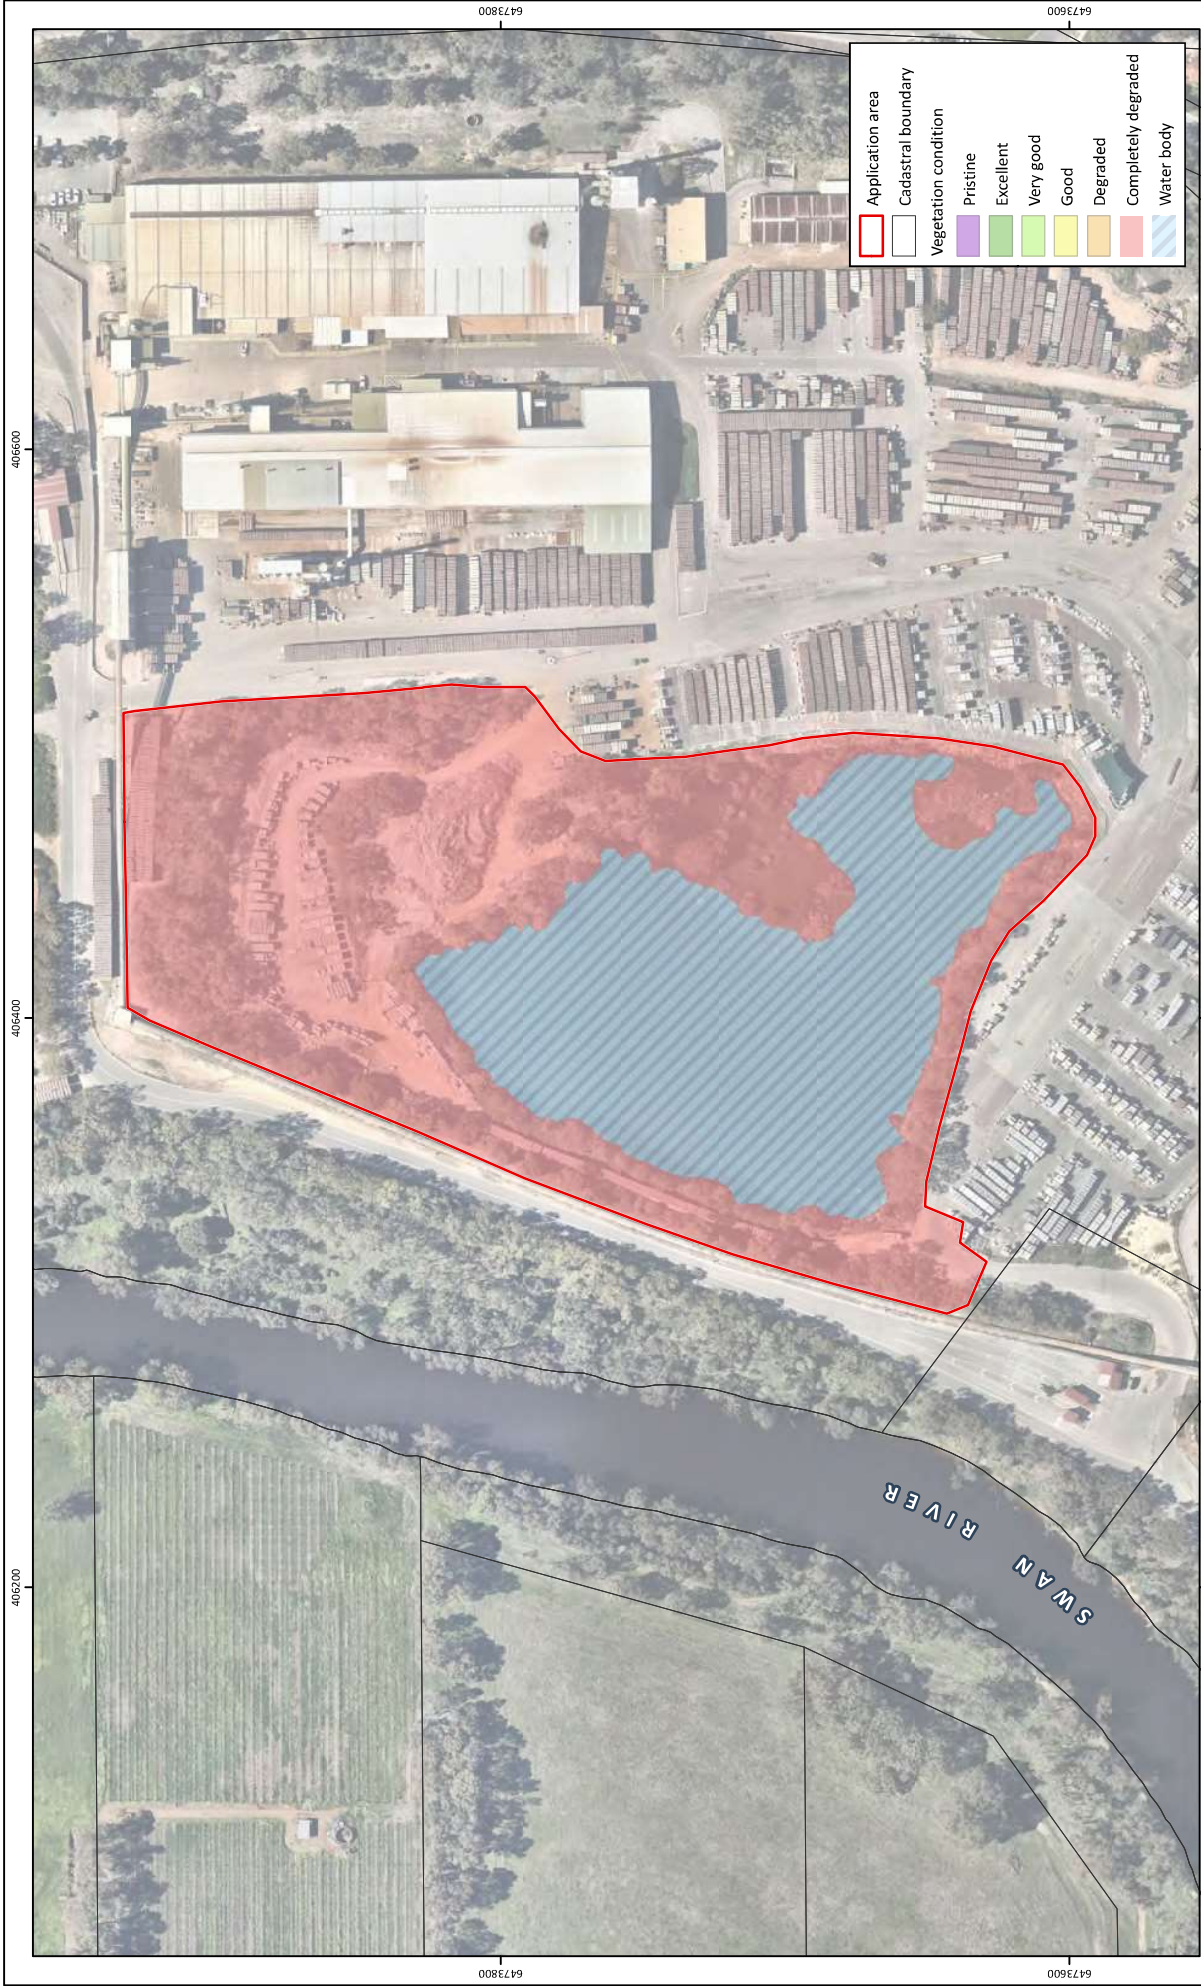
Figure 3: Vegetation Condition

Vegetation condition

- Pristine
- Excellent
- Very good
- Good
- Degraded
- Completely degraded
- Water body

Vegetation condition within the application area was assessed by Emerge as 'completely degraded' using methods from Keighery (1994). All vegetation within the application area was determined to be in a 'completely degraded' condition due to the intensive historical and ongoing disturbance from the Midland Bricks industrial land uses in the area. Vegetation condition mapping across the application area is provided in **Figure 3**.
