COTERRA Environment

Tamala Park Regional Council

Botanical Assessment of Proposed Access Roads from Catalina to the Beach

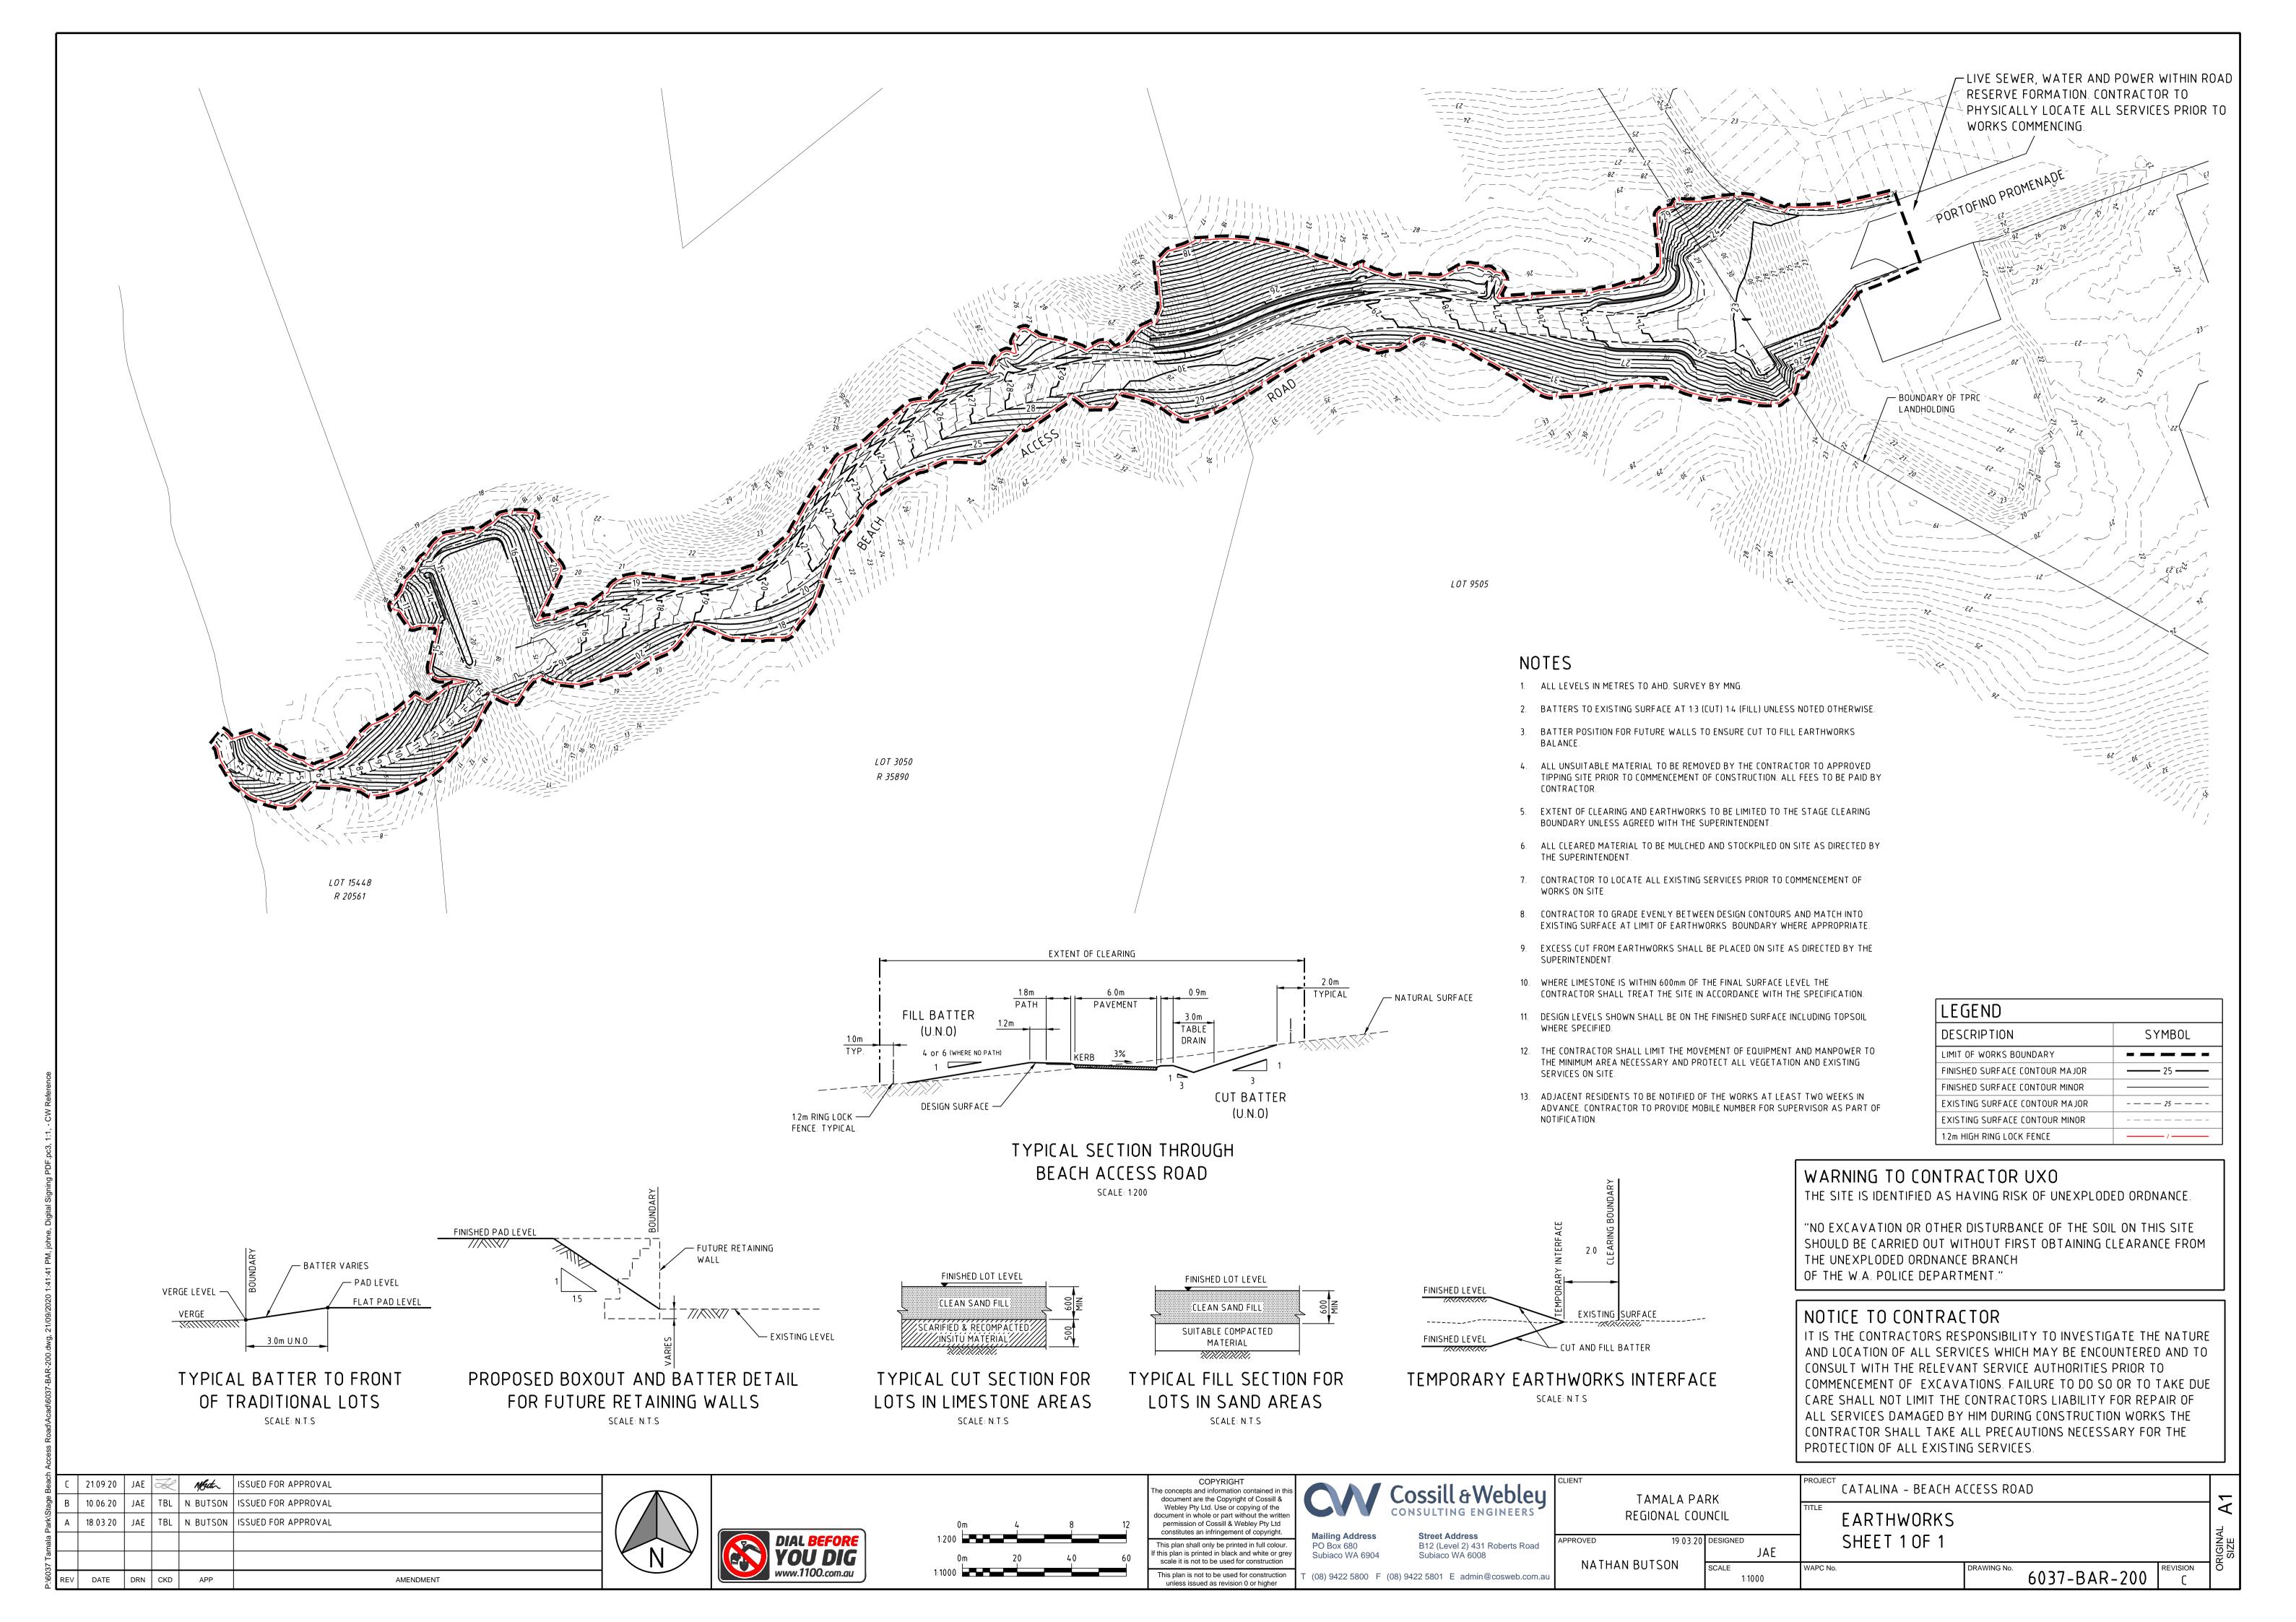
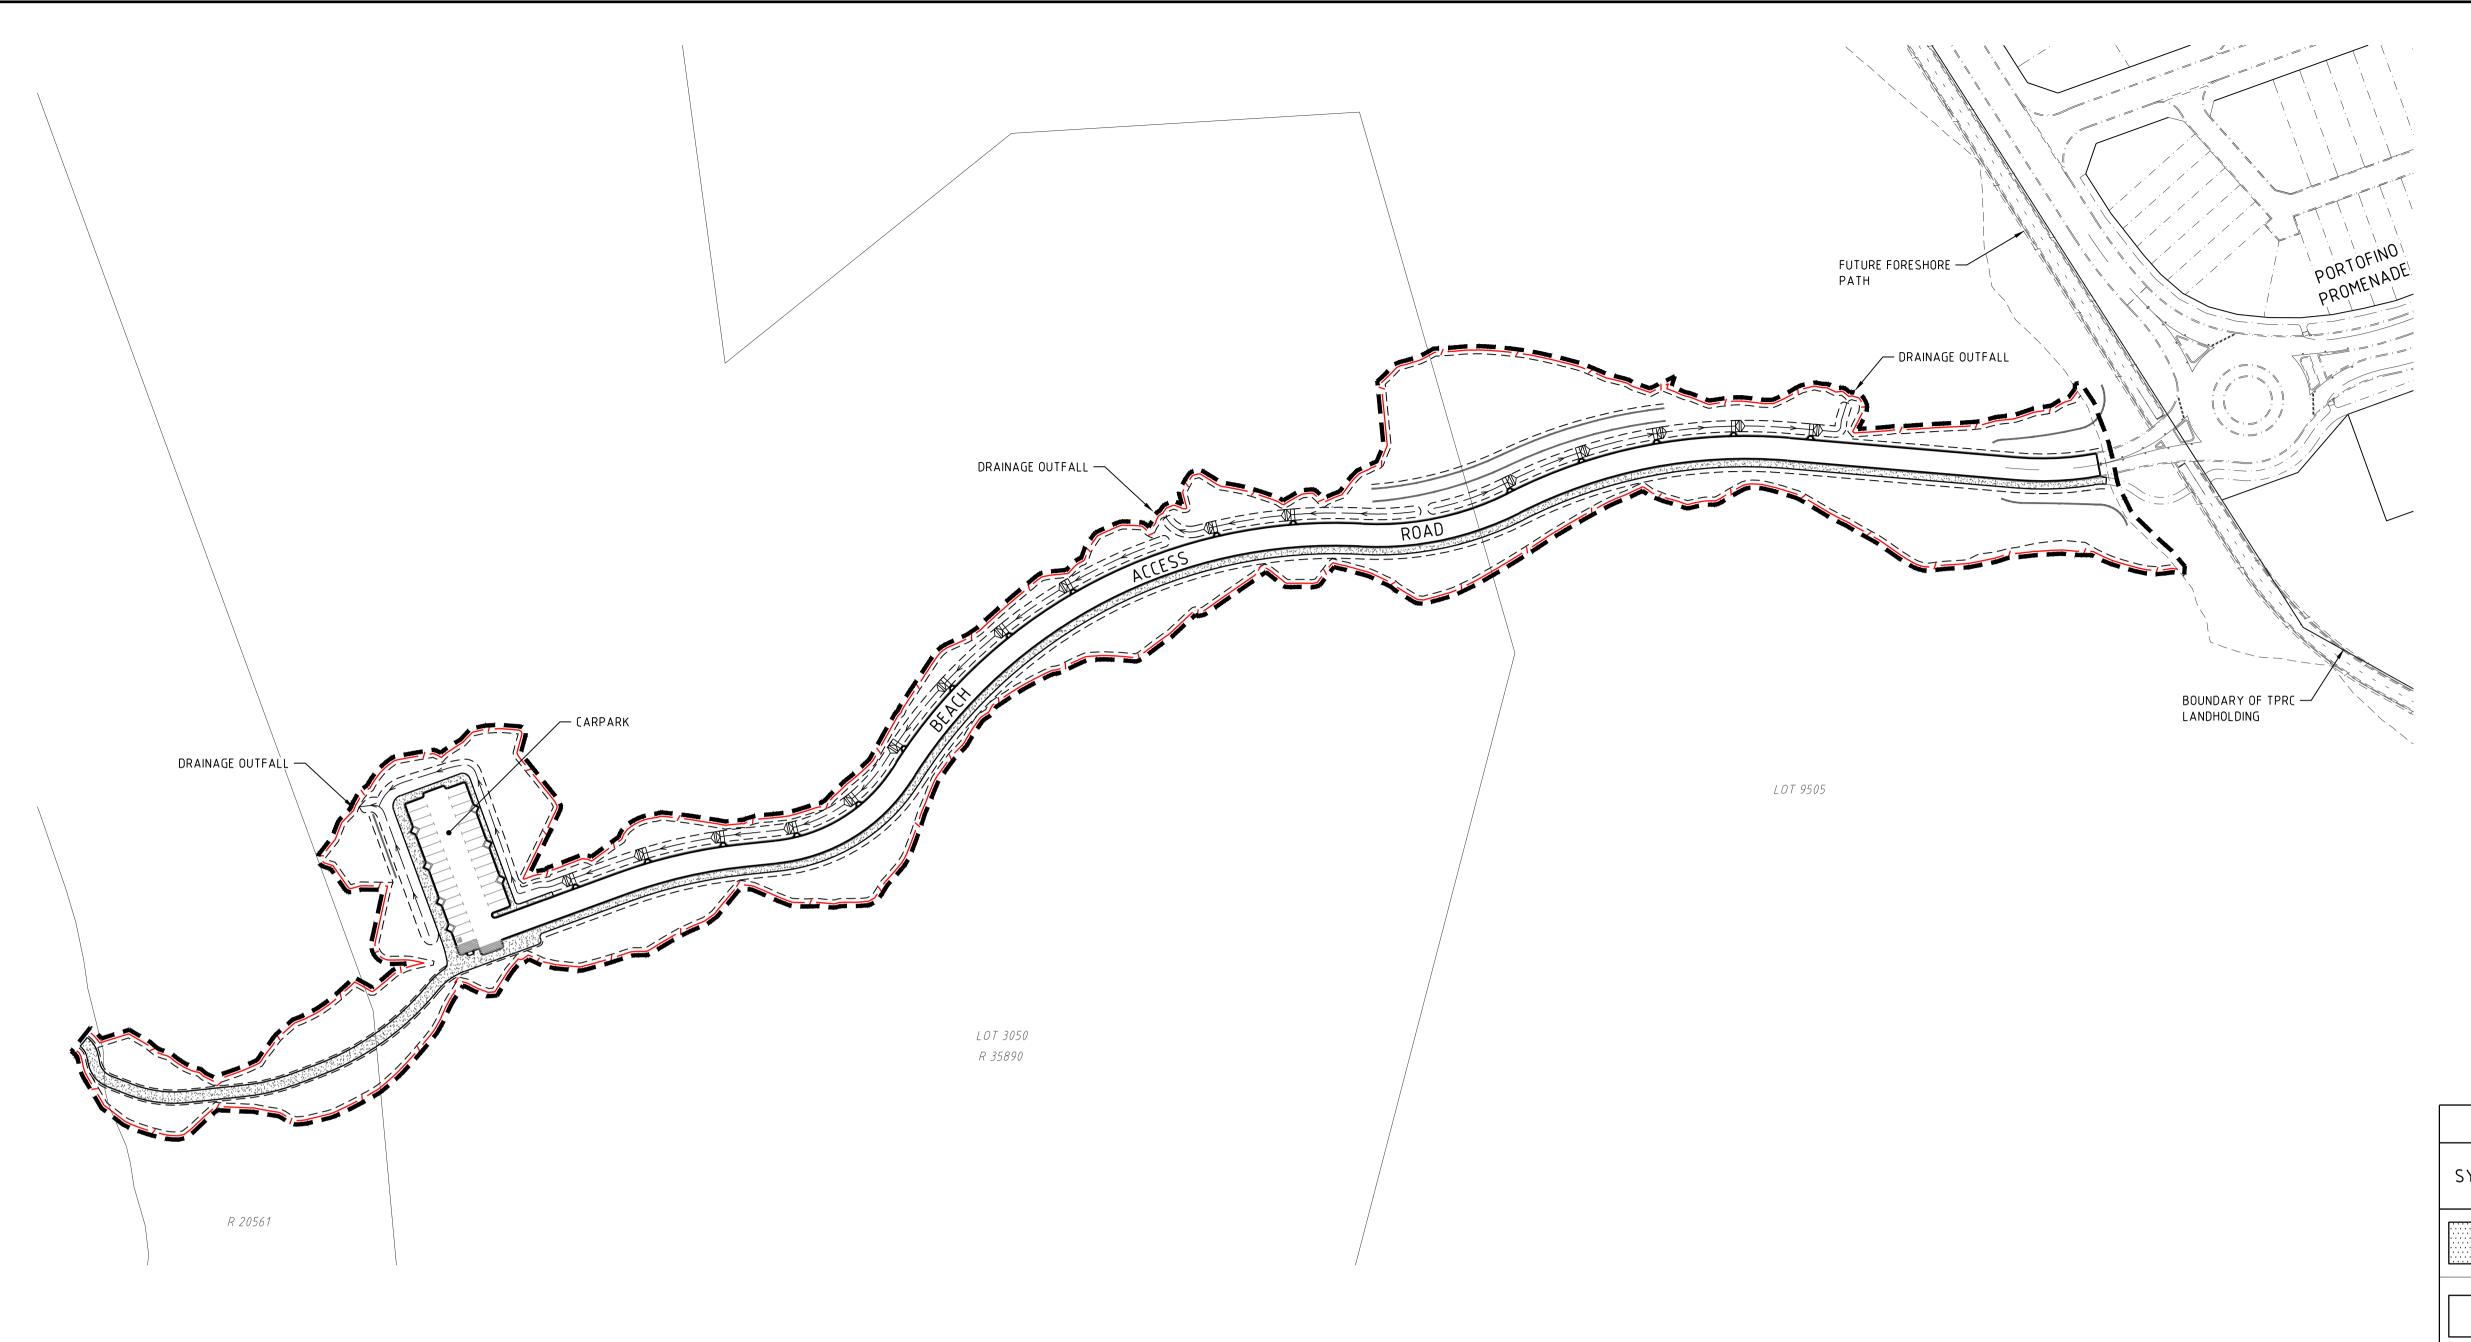
Appendix 1 Coastal Access Infrastructure Engineering Plans

Engineering plans for the coastal access infrastructure are provided in Appendix 1. The infrastructure traverses the following three reserve lots:

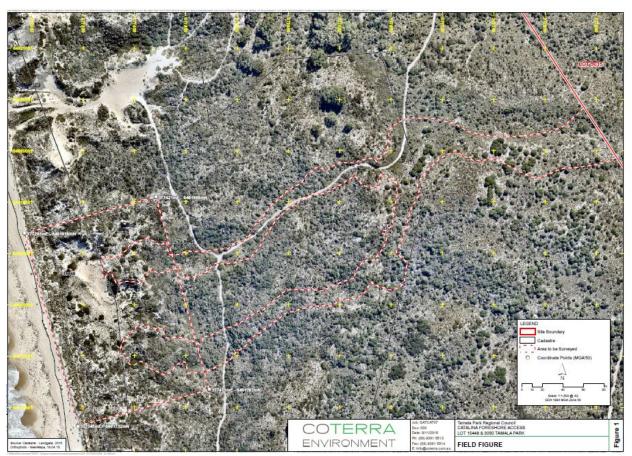
Diagram 1. Study area outlined in red/white lines. The white area indicates current tracks and the red line at the top right hand corner is where the current expansion will terminate.

Both of the tracks in Diagram 1 end in a rectangular area where it is proposed to construct a car park.

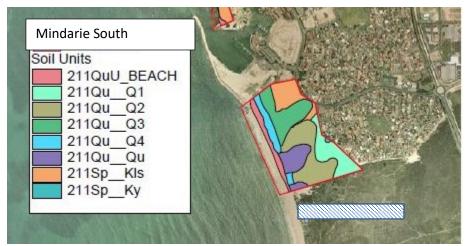
Diagram 2. Soils and Landforms described for Mindarie South including the cross hatched current study area.

From Diagram 2 it can be inferred that the current study area includes following the soil units: which are described as:

- 211QuU Beach = Beach;
- 211Qu_Qu = Presently unstable sand;
- 211Qu_Q4 = the youngest Quindalup phase of irregular dunes with slopes up to 20%, consisting of loose pale brown sand with no soil profile development;
- 211Qu_Q2 = the second Quindalup phase consisting of a complex pattern of dunes with moderate relief. These sands have organic staining to a depth of about 20cm, passing into pale brown sand with some cementation below 1m;
- 211Qu_Q1 = the oldest Quindalup phase of dunes or remnants with low relief, consisting of calcareous soils with organic staining to 30cm, overlying pale brown sand with definite cementation below 1m.

Although the current study area was not included in this detailed dune analysis some soil units can be inferred. Diagram 2 is a section of this study showing Mindarie which is just north of the survey area and the dune system recorded there.

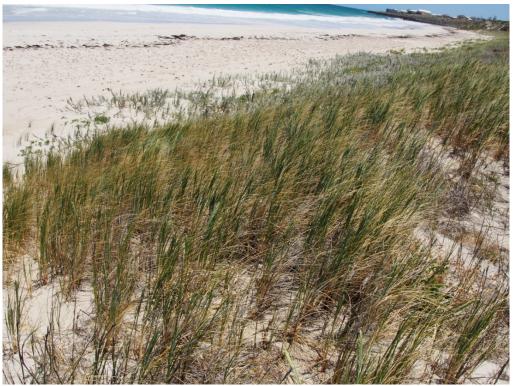
Marram grass (*Ammophila arenaria) was established in amongst Spinifex longifolius plants above the strand. The Marram plants were all relatively young so it was uncertain if they had been planted or if they had established from rhizomes which had come down on the current from Mindarie.

Photograph of Marram Grass established above the strand line.

It is important that native species in particular *Spinifex longifolius* and *Spinifex hirsutus* be planted in preference to Marram Grass close to the strand line and in the foredunes.
