COTERRA
ENVIRONMENT

**Native Vegetation Clearing Permit
Application Supporting Information**

Catalina Coastal Access Infrastructure

December 2019

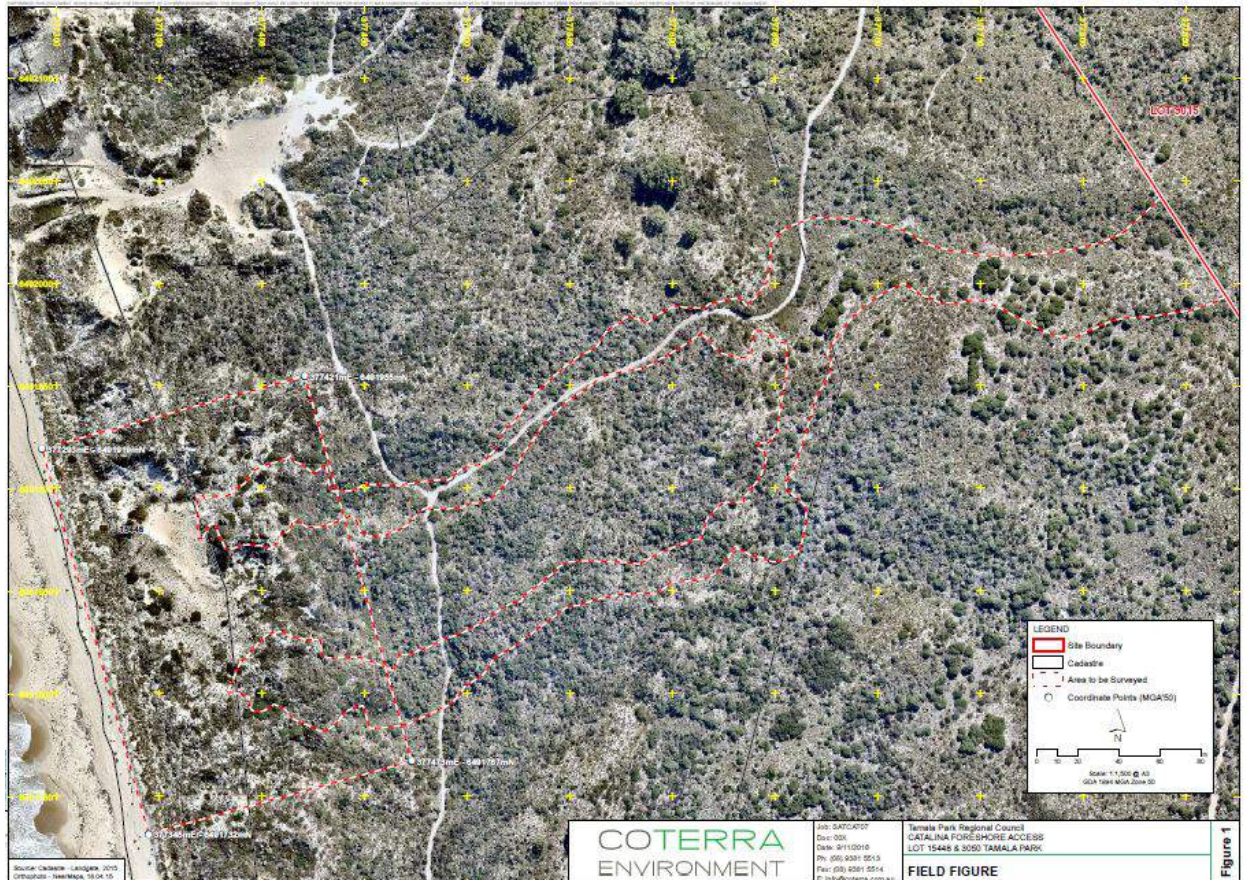
Diagram 1. Study area outlined in red/white lines. The white area indicates current tracks and the red line at the top right hand corner is where the current expansion will terminate.

Bennett Environmental Consulting Pty Ltd was commissioned by Coterra Environment to undertake a Level 2 assessment of two alternate routes proposed for a hard surfaced road from the new extension of the Catalina housing development to the beach. The development at Catalina commenced in 2012 and a new section is currently being prepared for additional housing.

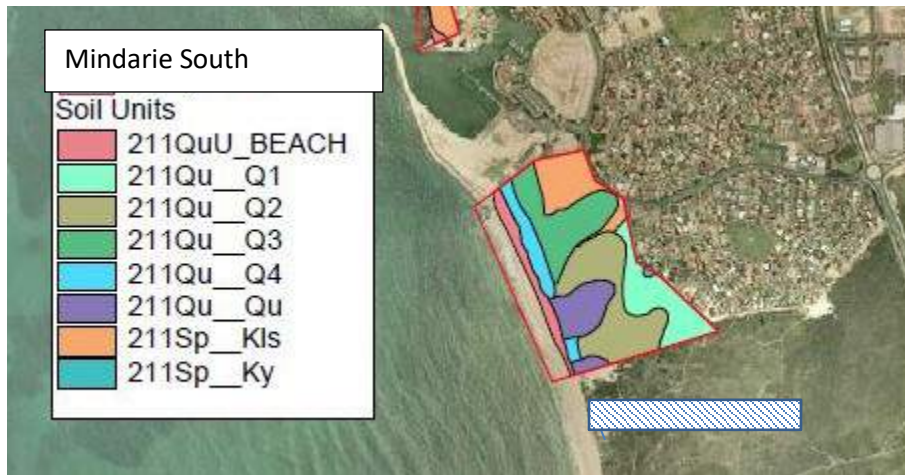
Diagram 2. Soils and Landforms described for Mindarie South including the cross hatched current study area.

Although the current study area was not included in this detailed dune analysis some soil units can be inferred. Diagram 2 is a section of this study showing Mindarie which is just north of the survey area and the dune system recorded there.

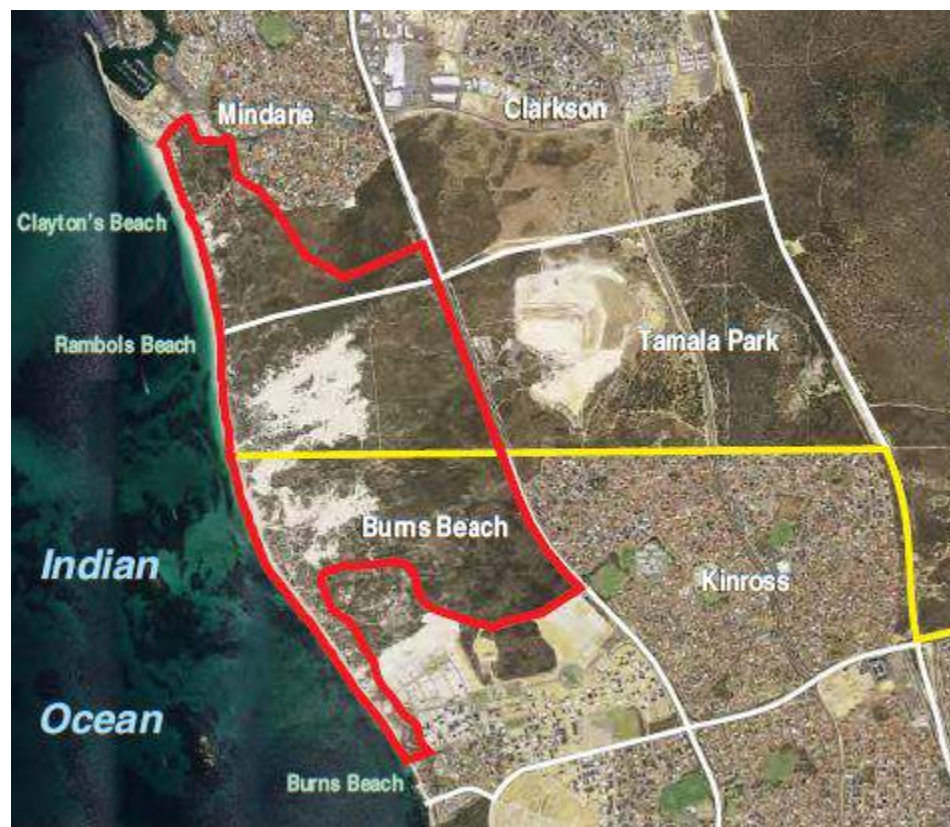
Diagram 3. Area outlined in red proposed as Tamala Conservation Park.

3. In March 2012 a Tamala Conservation Park was proposed and an establishment plan prepared (Western Australian Planning Commission, 2012). The area under consideration is outlined below in Diagram 3 and it can be seen that it includes the current survey area. This was proposed to be managed by the Department of Environment and Conservation (now Department of Parks and Wildlife). The Establishment Plan did not include a timetable for creation of the Conservation Park as it is understand that part of the land covered remains in private ownership. The Tamala Conservation Park has three broad zones of usage, conservation and protection, natural environmental use and recreational use (Western Australian Planning Commission, 2012). With conservation and protection the primary management concern is to ensure no further disturbance to the bushland ensuring that public access is restricted and only via walk paths. Access to the beach has been poorly managed with off road vehicle tracks crossing the bushland.

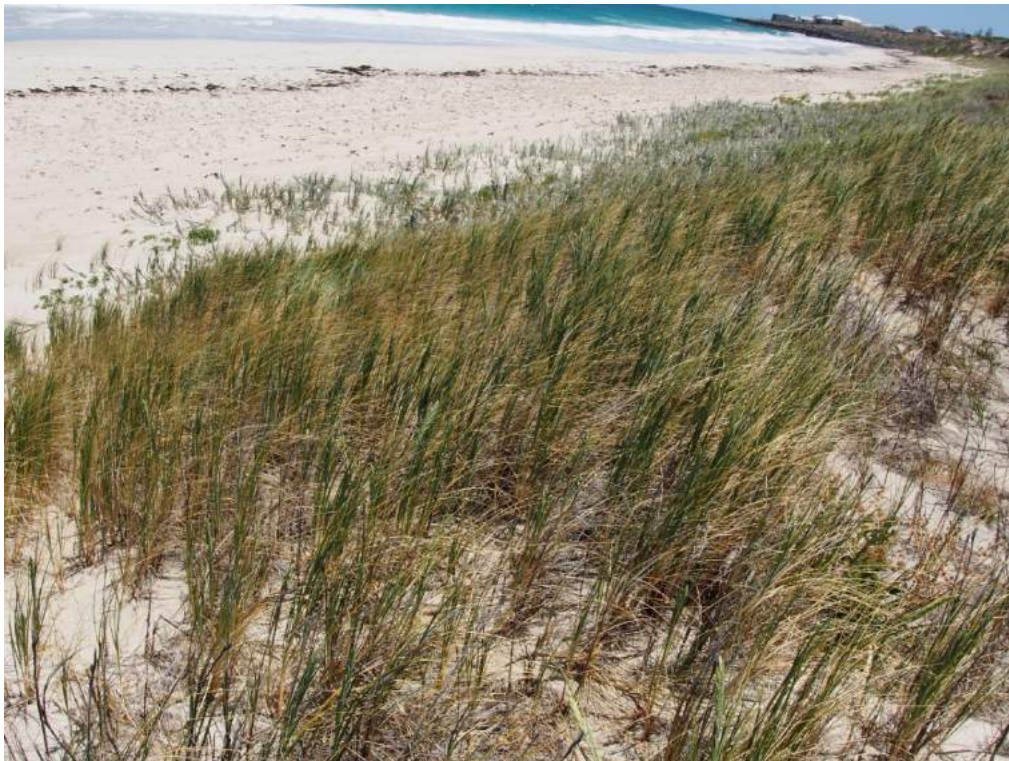
Photograph of Marram Grass established above the strand line.

Marram grass (**Ammophila arenaria*) was established in amongst *Spinifex longifolius* plants above the strand. The Marram plants were all relatively young so it was uncertain if they had been planted or if they had established from rhizomes which had come down on the current from Mindarie.

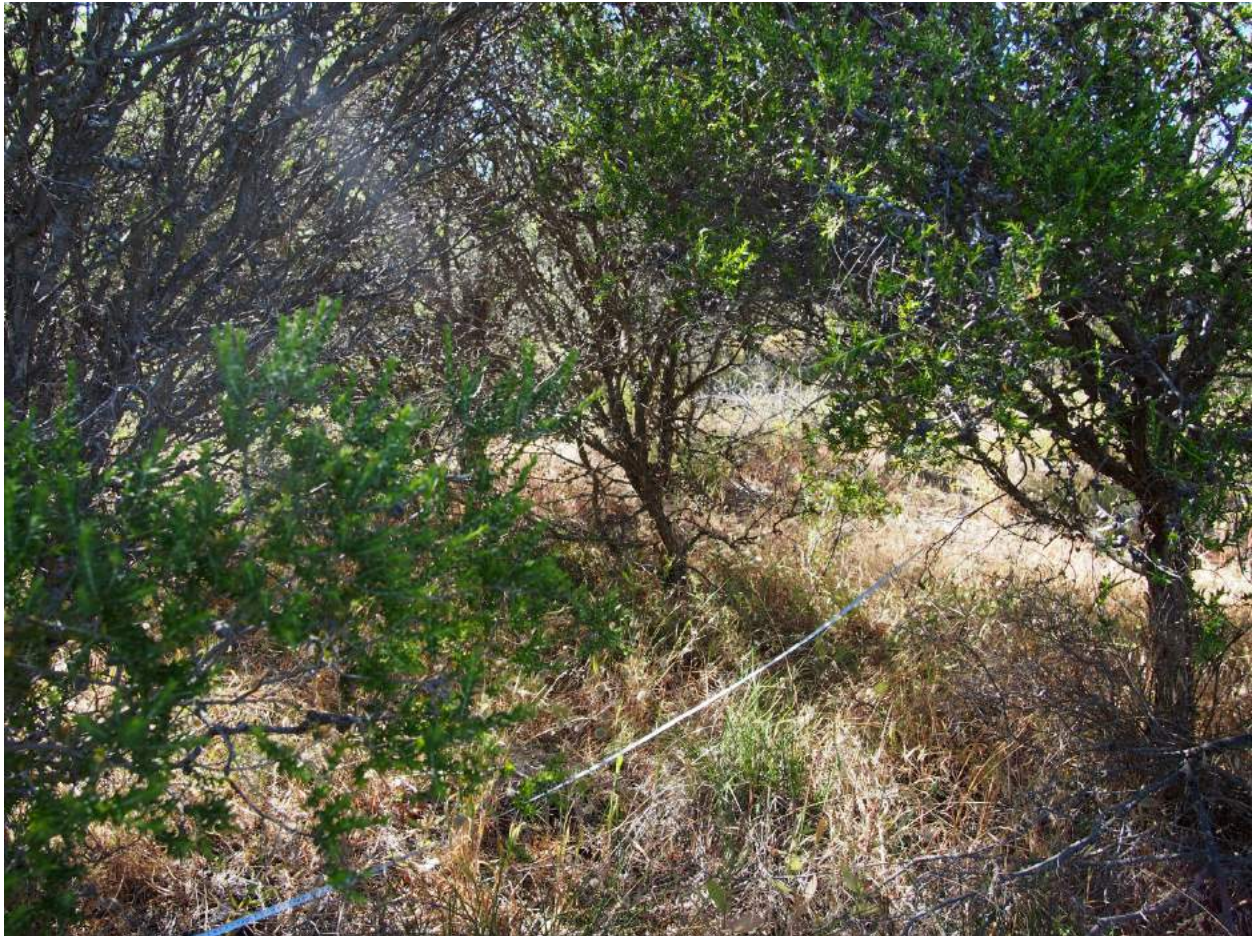
QUADRAT caq1**GPS (WGS84):** 377775E; 6492000N**Location:** Most eastern section of the proposed road**Topography:** Upper slope to crest of sand dune**Soil:** Grey sand**Litter:** Branches 10%; Leaves 20%**Vegetation Description:** Open Heath of *Melaleuca cardiophylla* over Very Open Grassland dominated by **Ehrharta longiflora* over Herbland dominated by **Raphanus raphanistrum*, **Crassula glomerata* and **Petrorhagia dubia* over Sedgeland dominated by *Lomandra maritima* and *Desmocladius flexuosus***Vegetation Condition:** Good to very good**Notes:** Numerous weeds

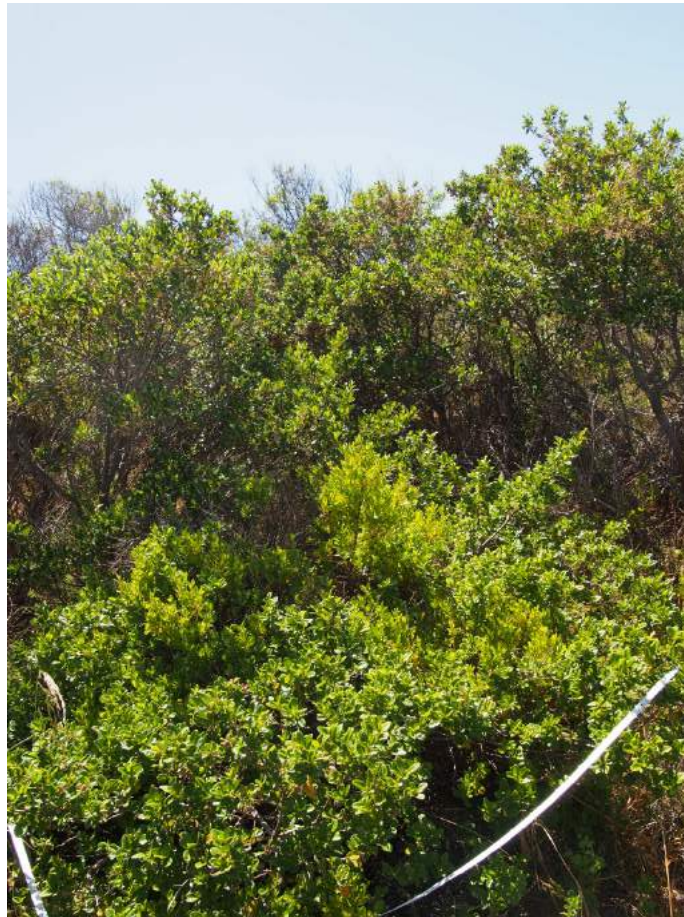
QUADRAT caq2**GPS (WGS84):** 377550E; 6491850E**Location:** Southern proposed track**Topography:** Middle slope**Soil:** Grey sand**Litter:** Branches 5%; Leaves 25%**Vegetation Description:** Tall Open Scrub of *Acacia rostellifera* and *Spyridium globulosum* over Low Shrubland of *Melaleuca systena* over Open Grassland dominated by **Ehrharta longiflora* over Open Herbland dominated by **Lysimachia arvensis* over Very Open Sedgeland of *Lomandra maritima* and *Desmocladius flexuosus***Vegetation Condition:** Good**Notes:** Very occasional *Xanthorrhoea preissii* recorded opportunistically

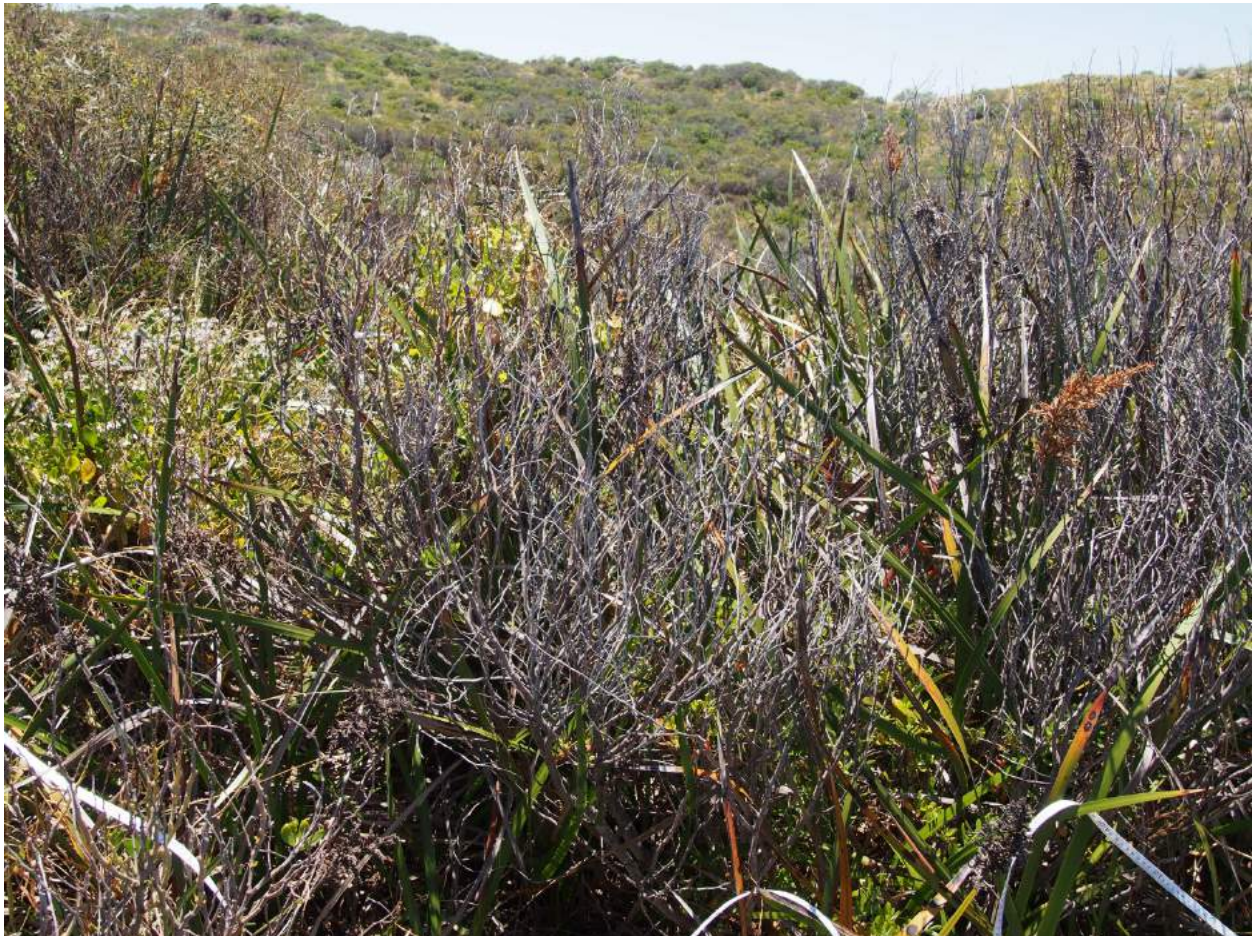
Vegetation Condition: Very Good

Notes: Valleys between the dunes had dense cover (>75%) of *Lepidosperma gladiatum*

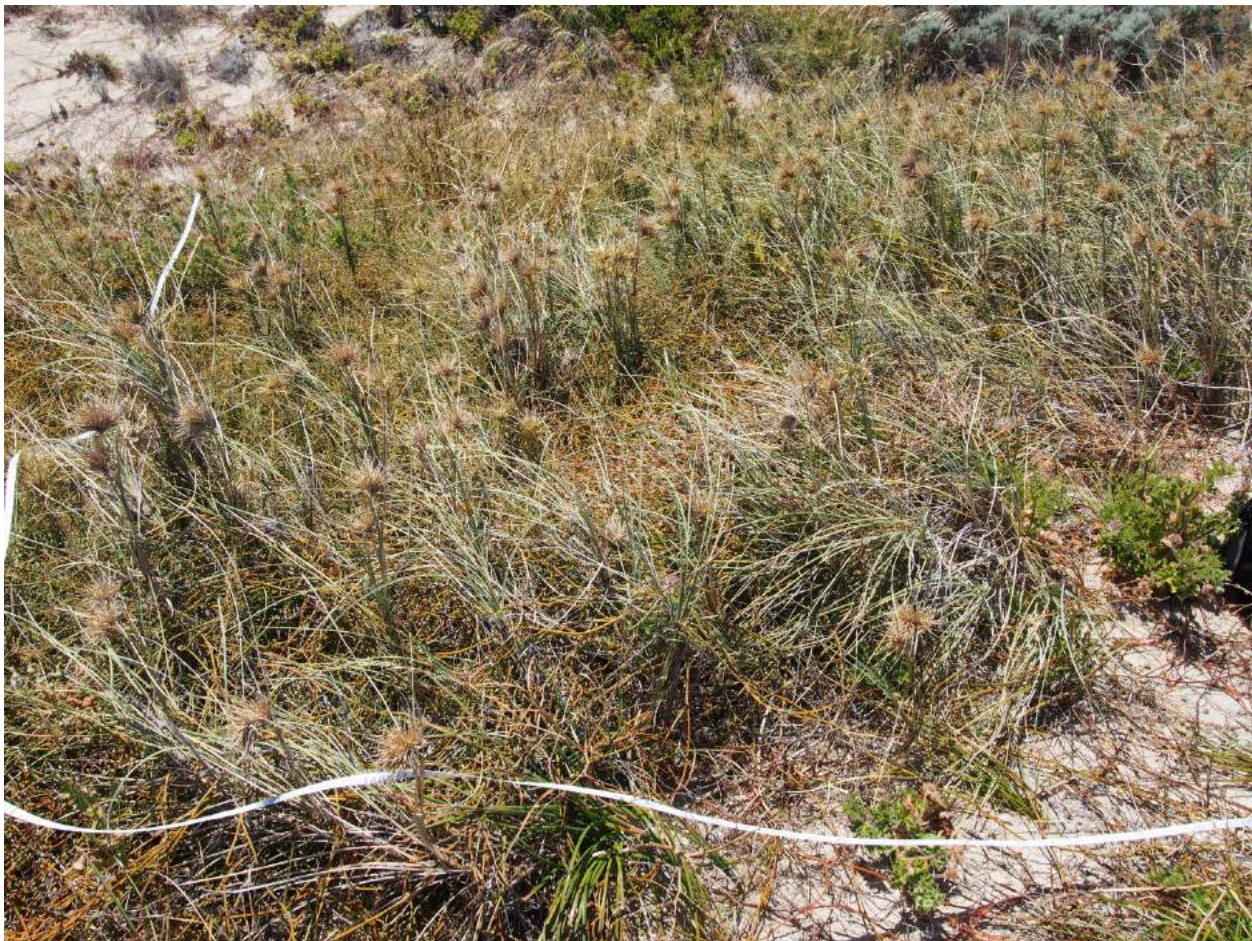
QUADRAT caq4**GPS (WGS84):** 377325E; 6491875N**Location:** Just back from the beach**Topography:** Fore dune**Soil:** Pale grey/white sand**Litter:** Leaves 5%**Vegetation Description:.** Low Open Shrubland of *Olearia axillaris*, *Scaevola crassifolia*, **Pelargonium capitatum* and *Rhagodia baccata* subsp. *dioica* over Grassland dominated by *Spinifex longifolius* over Very Open Herbland dominated by **Trachyandra divaricata***Vegetation Condition:** Good to very good**Notes:** Just before the drop down to the water there was a belt about 5m wide where young Marram grass (**Ammophila arenaria*) was dominant and growing between the plants of *Spinifex longifolius*. Many of the plants recorded a dense infestation of the native parasitic twiner *Cassytha flava* If the infestation is very heavy it has the capacity to kill plants

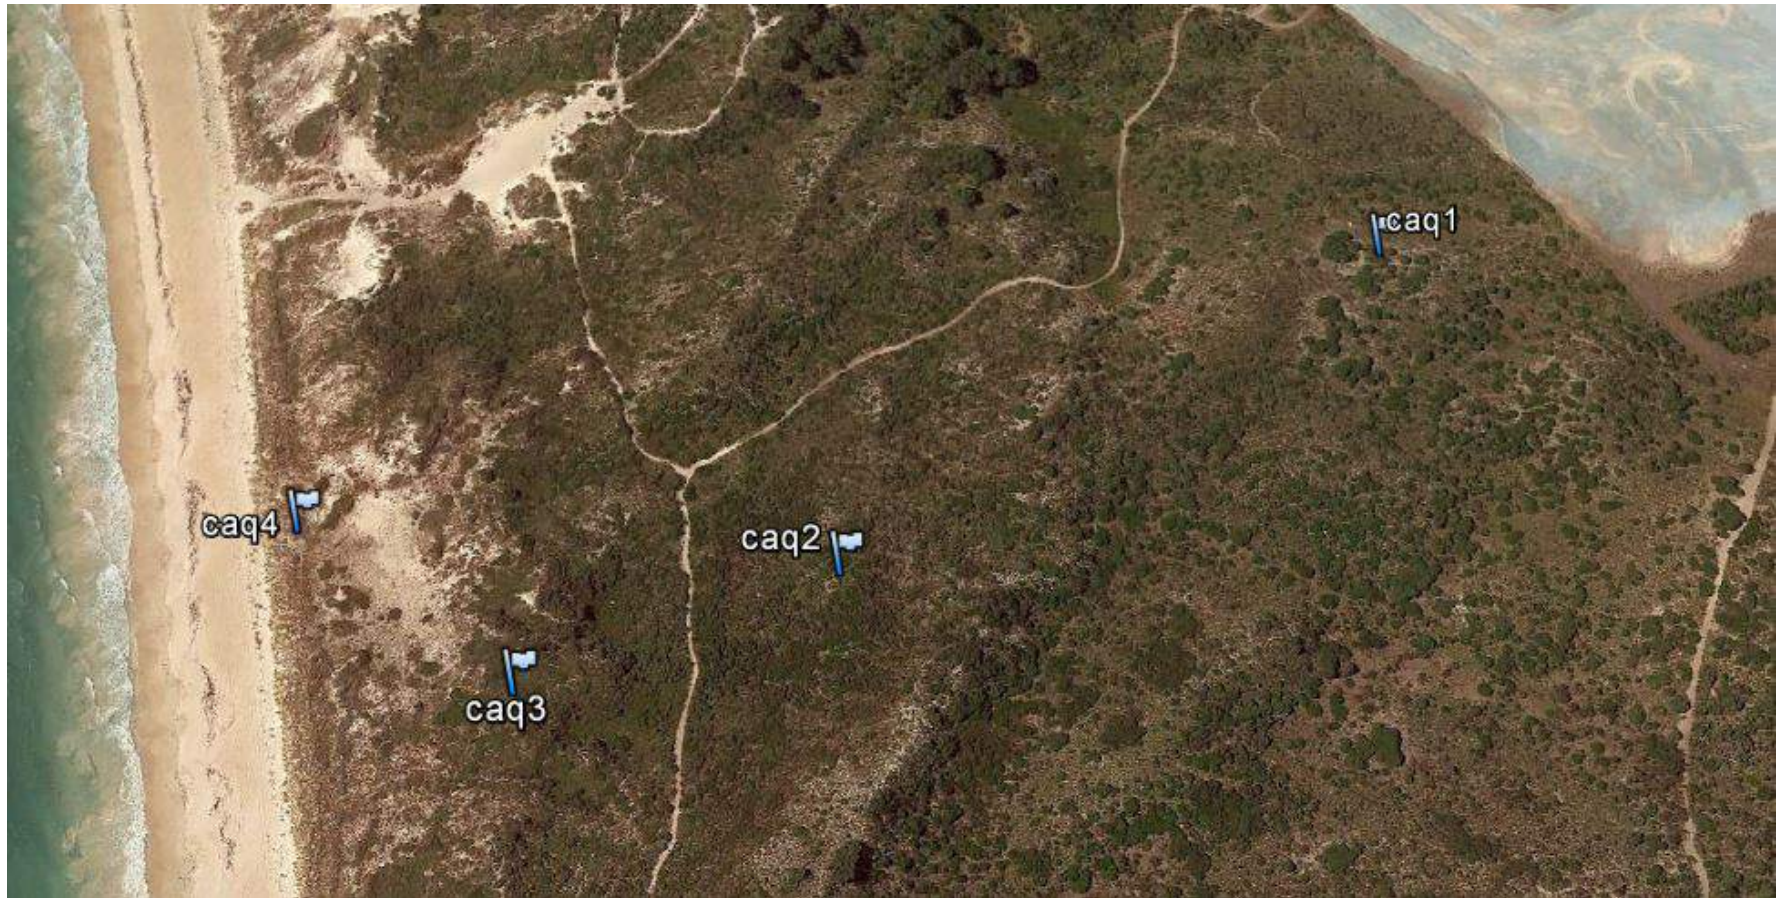
Map 1. Location of quadrats

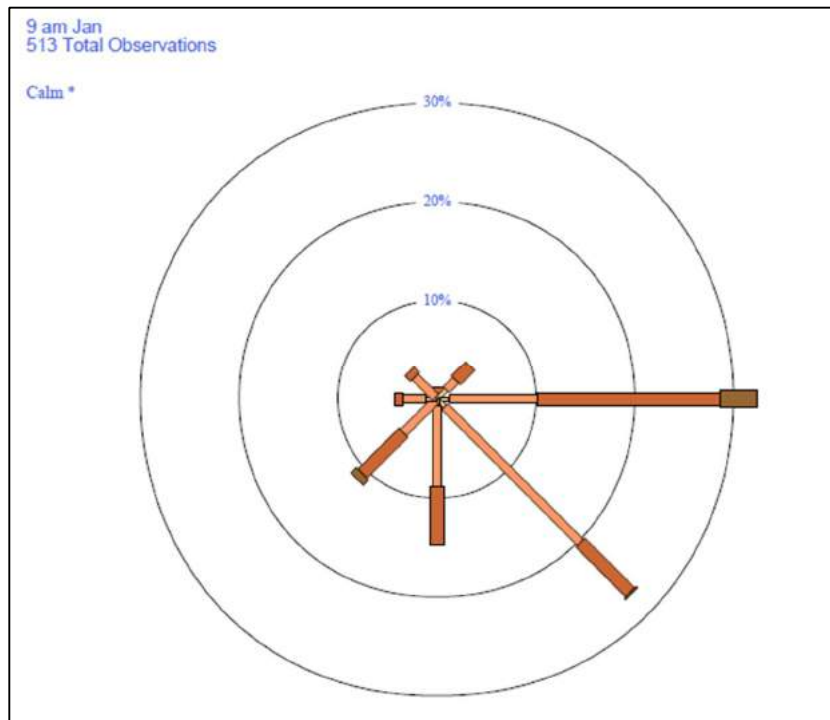
Plate 1: Wind rose (Swanbourne) - 9 am January Observations (BOM, 2016)

The weather in the Perth metropolitan area tends to be Mediterranean in nature, with hot, dry summers and cool, wet winters. The nearest coastal weather station is at Swanbourne (Site No. 9215) which lies ~30 km south of the foreshore area (BOM, 2016). The mean annual rainfall in Swanbourne is 721.2 mm (over 20 years between 1993 and 2016). Wind speed and direction averages (January and July, 9 am and 3 pm) are provided in Plates 1 to 4 below. The trend in summer is mostly morning easterlies, with strong and predictable south-westerlies in the afternoons, whilst the winter trend is for morning easterlies and variable wind patterns in the afternoons, slightly trending to westerlies / north-westerlies / south westerlies.

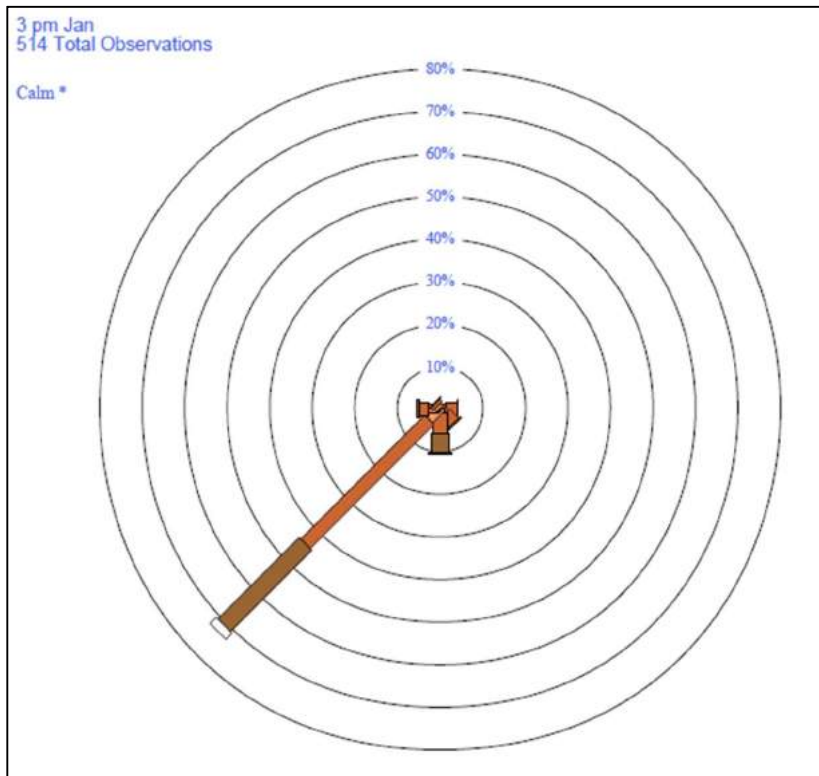
Plate 2: Wind rose (Swanbourne) - 3 pm January Observations (BOM, 2016)

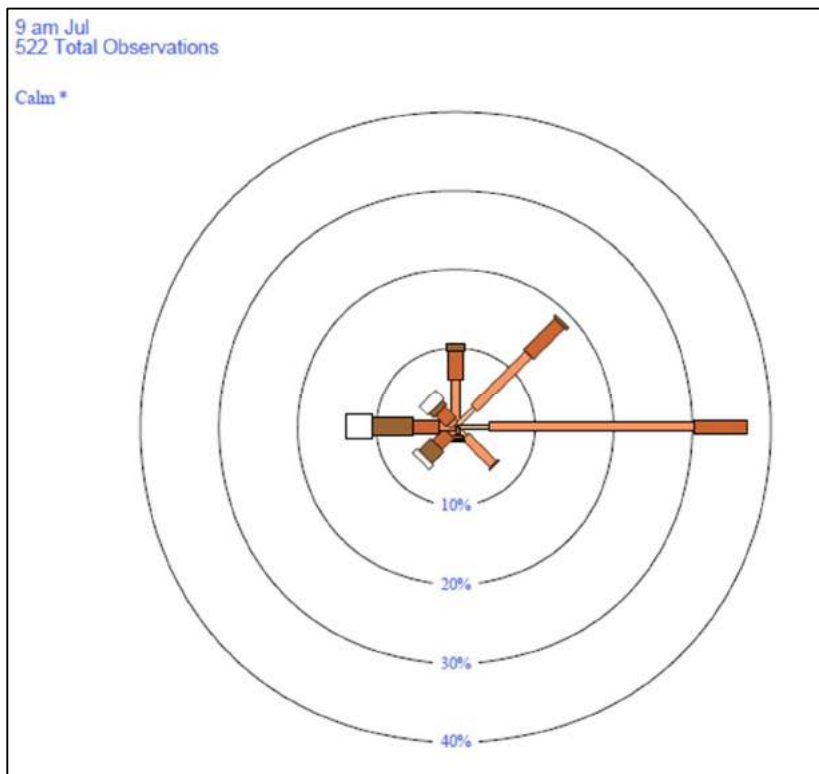
Plate 3: Wind rose (Swanbourne) - 9 am July Observations (BOM, 2016)

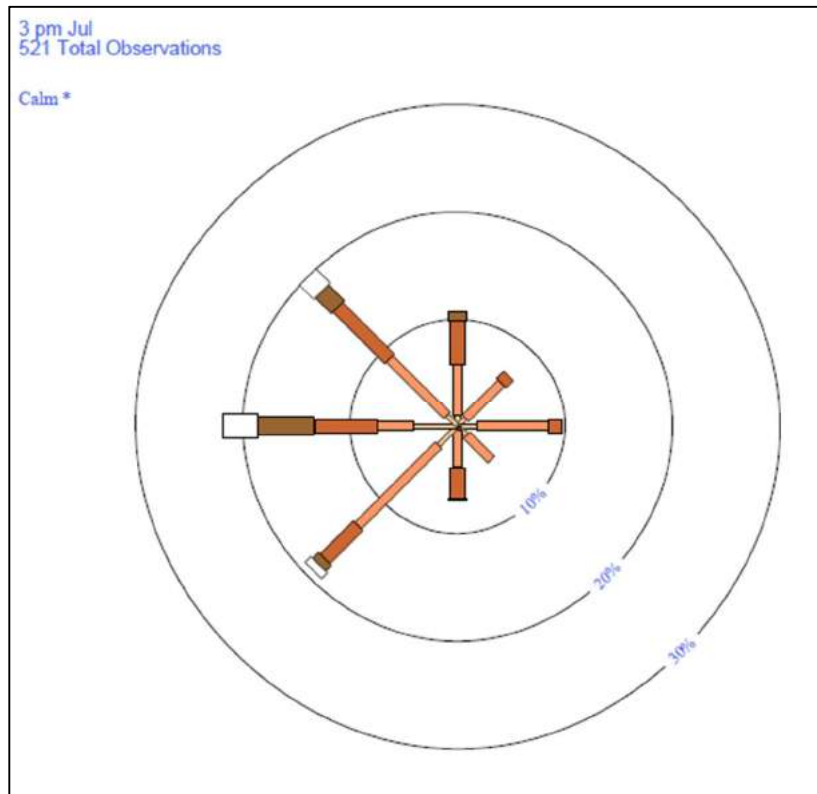
Plate 4: Wind rose (Swanbourne) – 3 pm July Observations (BOM, 2016)

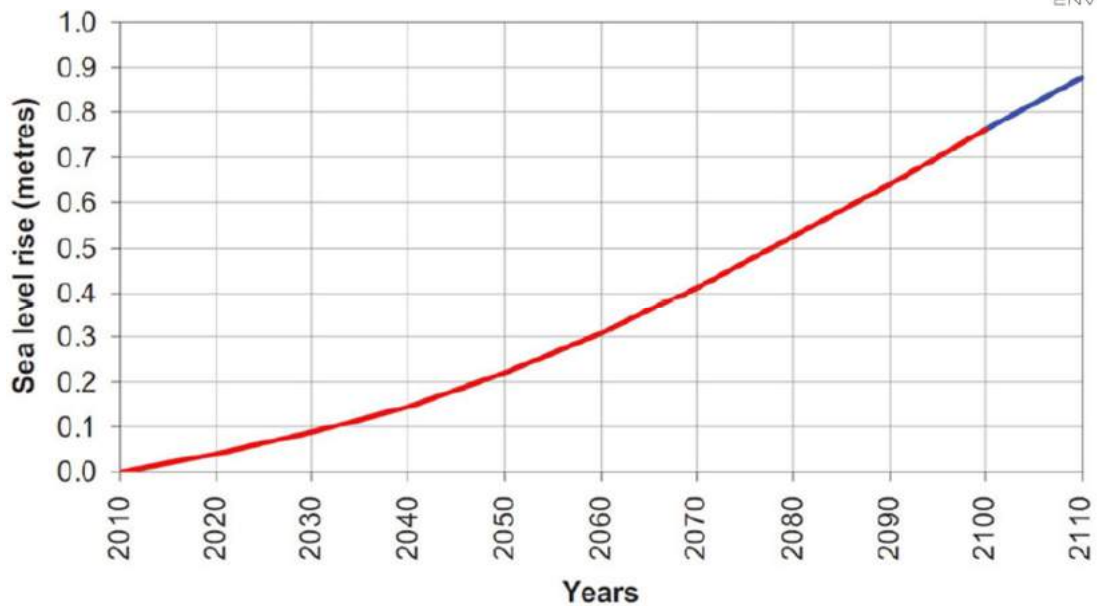
Plate 5: Recommended sea level rise scenario for coastal planning in WA (DoT, 2010)

Sea level rise attributed to the various scenarios of climate change has been modelled for the next 100 years, by the Intergovernmental Panel on Climate Change (IPCC). Increases in the global sea level are likely to lead to accelerated vulnerability (i.e. beach erosion), and various formulas have been employed to quantify the likely impacts (MP Rogers, 2015 and 2019). DoT (2010) completed an assessment of the potential increase in sea level that could be experienced on the Western Australian coast in the coming 100 years, the results of which have since been adopted by the WAPC for use in coastal planning in Western Australia (including SPP 2.6). This sea level rise scenario is provided in Plate 5.

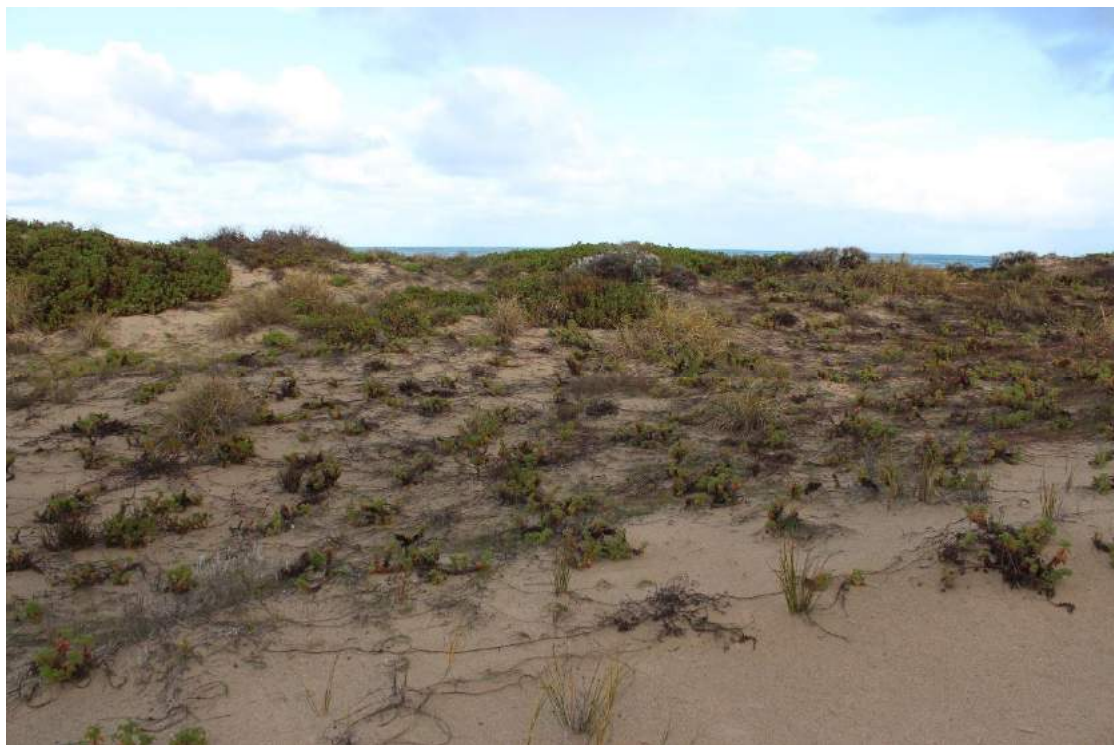
Plate 6: Foredune over which an access track will be constructed to provide pedestrian and maintenance vehicle accessway to the beachfront (photo taken facing west)

The accessway will be installed as part of the construction program associated with the development application for the project.

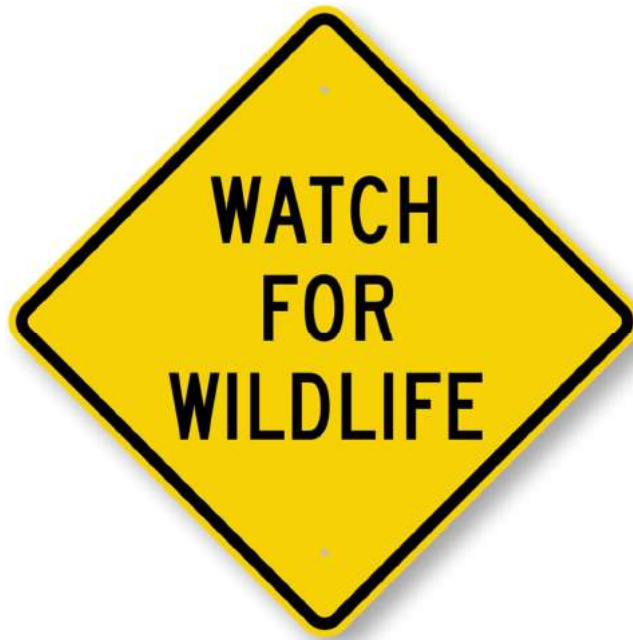
Plate 7: Example wildlife road awareness sign

To improve awareness of facility users, wildlife crossing signage shall be installed at both entrance points to the access road. Examples of signage are provided in Plate 7.

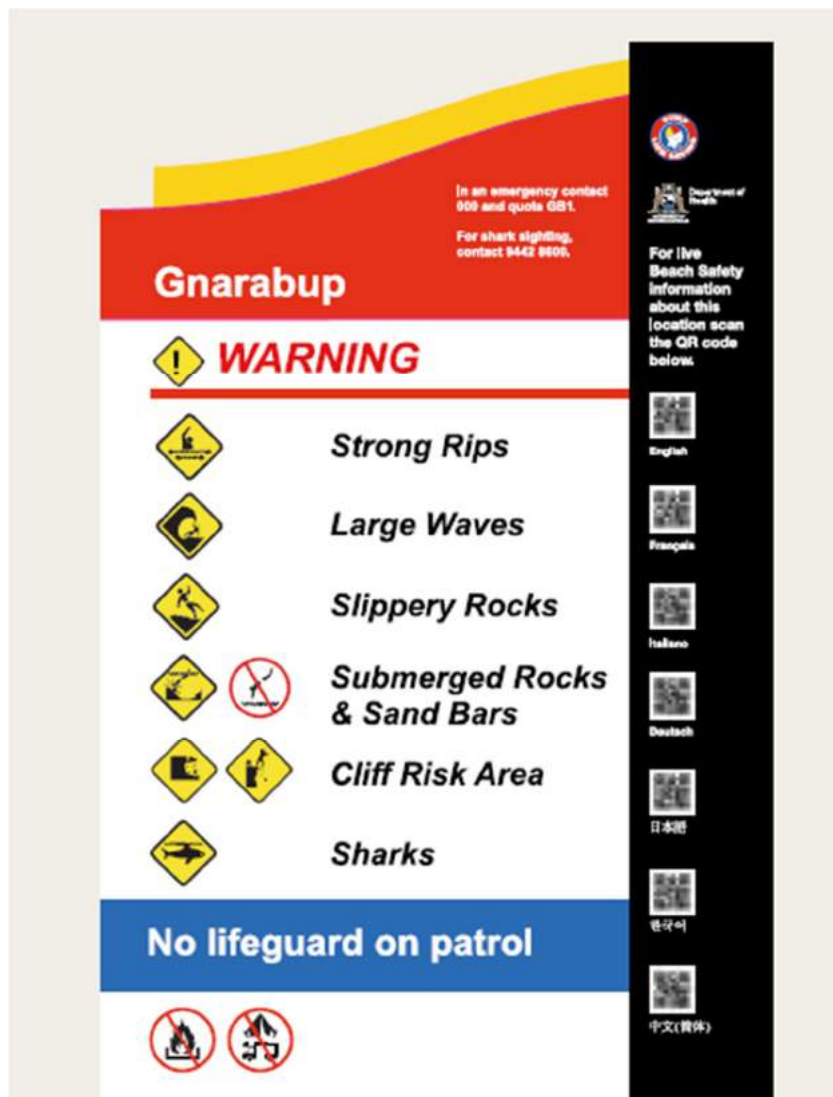
Plate 8: Example of recommended safety signage

Appropriate coastal hazard signage is recommended to be installed at the beach access carpark outlining the hazards of the area and encouraging awareness and vigilance, as part of a greater education and awareness program (SLSWA, 2014). An example of this type of signage is provided in Plate 8. In this case, QR code signs are used to enable those with smart phone technology to access the beachsafe.org website for live and local beach conditions in a number of foreign languages. Generally this is an initiative assisted by the Department of Health and the Surf Life Saving Association of WA through local government recommendations (SLSWA, 2014).

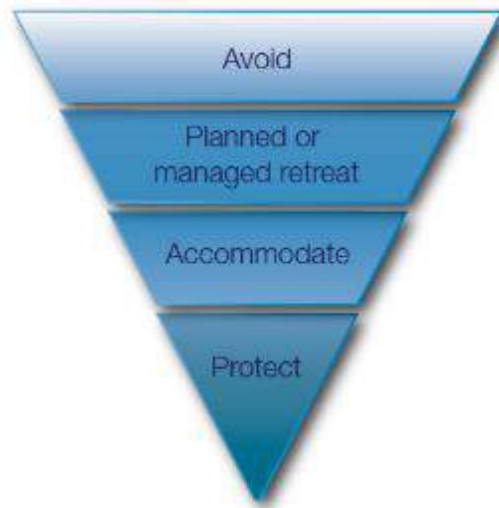
Figure 7.1 Risk Management & Adaptation Hierarchy

SPP2.6 outlines a hierarchy of risk adaptation and mitigation options, where options that allow for a wide range of future strategies are considered more favourably. This hierarchy of options is reproduced in Figure 7.1.

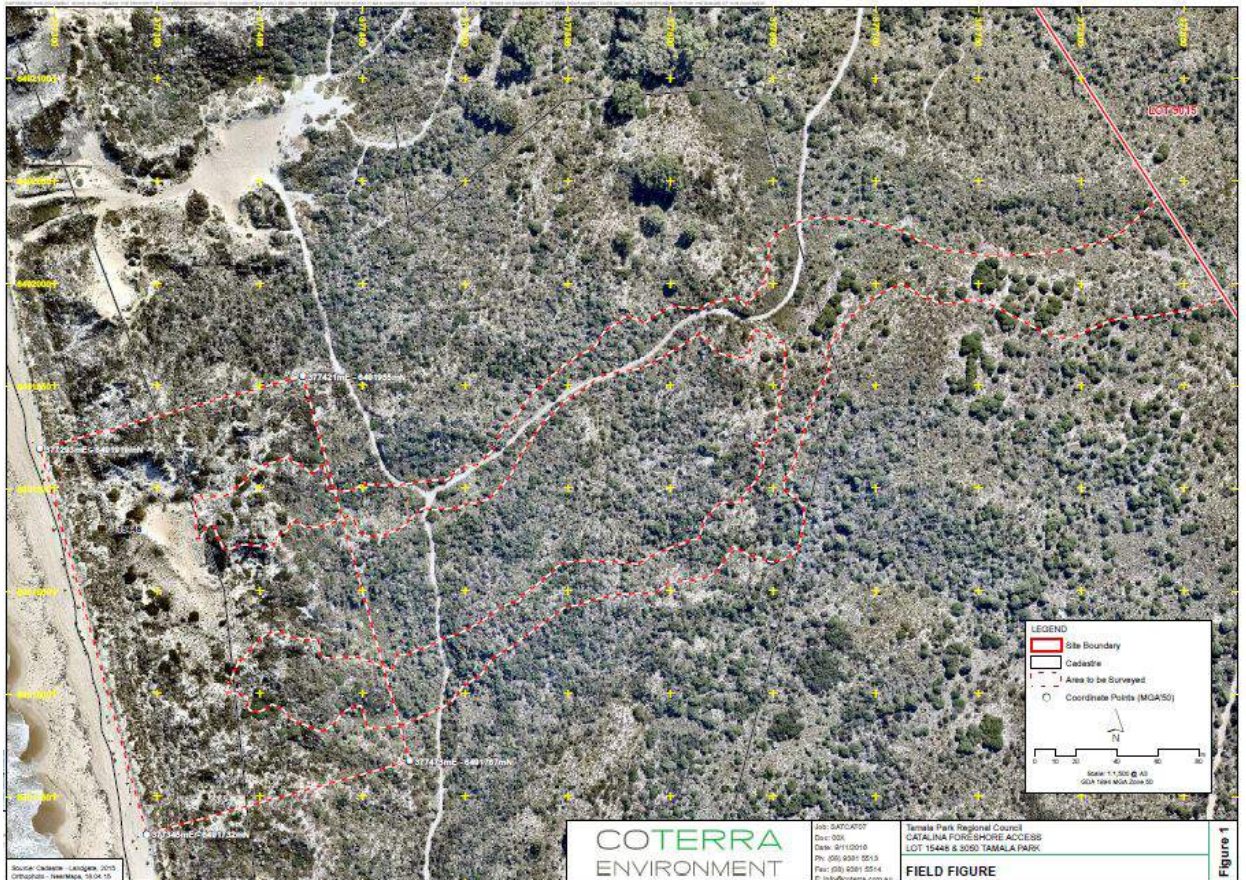
Diagram 1. Study area outlined in red/white lines. The white area indicates current tracks and the red line at the top right hand corner is where the current expansion will terminate.

Both of the tracks in Diagram 1 end in a rectangular area where it is proposed to construct a car park.

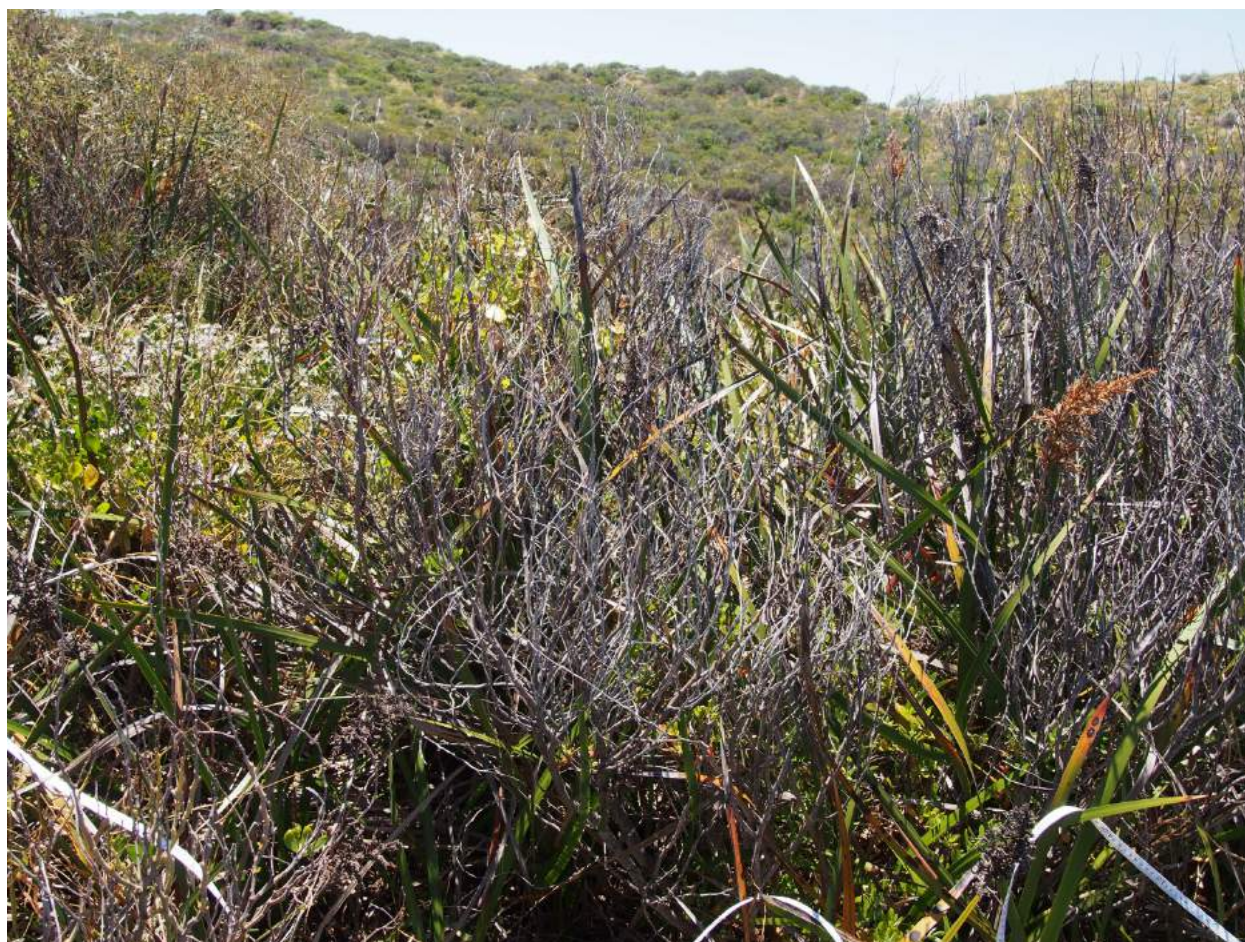
Vegetation Condition: Very Good

Notes: Valleys between the dunes had dense cover (>75%) of *Lepidosperma gladiatum*
