CLEARING PERMIT

Granted under section 51E of the Environmental Protection Act 1986

Area Permit Number: 8802/1
File Number: DWERTV5307
Duration of Permit: 3 June 2020 – 3 June 2030

Railway Parade Road Reserve (PIN 11727298), Bullsbrook

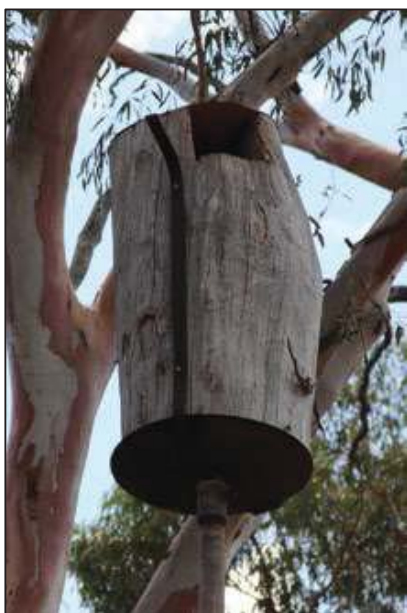
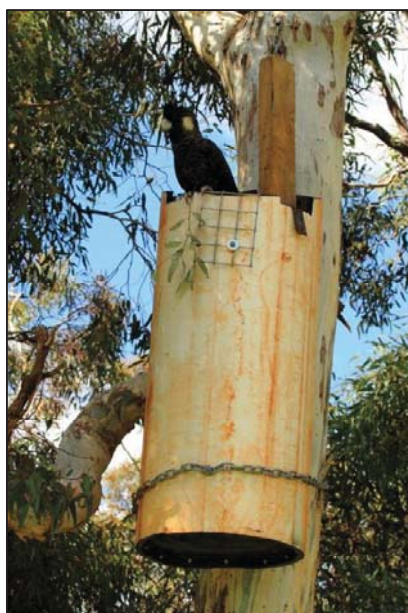
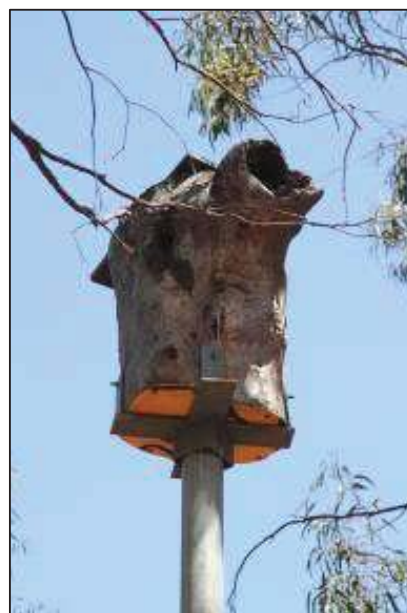
Below are three examples of successful artificial hollows used by Carnaby's cockatoo for nesting. Artificial hollows made from a natural log with cut side entrance (left), white industrial pipe with top entrance (centre) and natural log with natural side entrance (right).

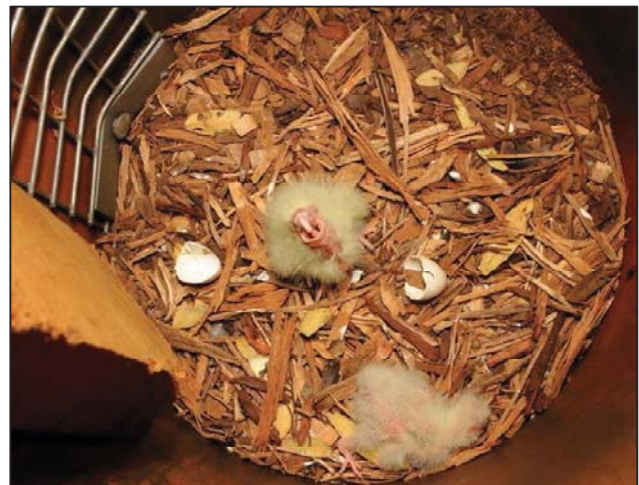
Bottom of an artificial hollow showing ladder that is fixed to the wall and a chewed sacrificial post which is 200 mm from the floor.

It is recommended that at least two posts are provided. Posts 70 x 50 mm have been used, but require replacing at least every second breeding season when the nest is active. Birds do vary in their chewing habits and therefore the frequency at which the chewing posts require replacement will also vary.

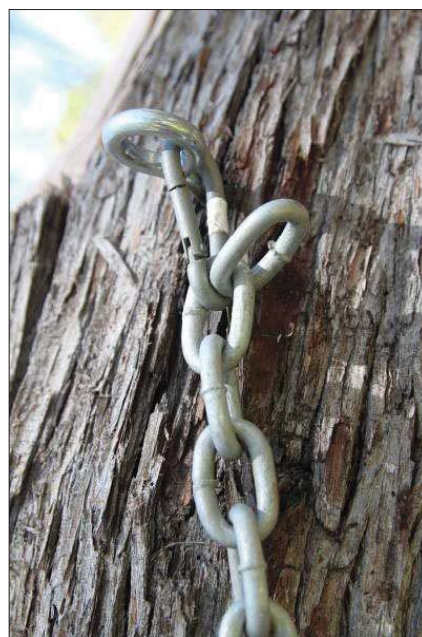
Example fixing for artificial hollow
Photo by Christine Groom

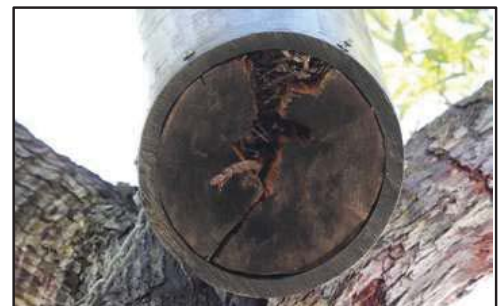
Artificial hollow base needing repair.
Photo by Christine Groom

Any problems identified during maintenance checks should be addressed, and any repairs required done, as soon as possible. If breeding is currently occurring, maintenance may need to be delayed if it is likely to disturb the parents or nestling. Likely maintenance needs include replacement of chewing posts (frequently) or nest bases (occasionally) and repairing of any cracks (infrequently). Maintenance concerns regarding the security of attachment points or the stability of the tree or pole should be addressed as a priority for safety reasons.

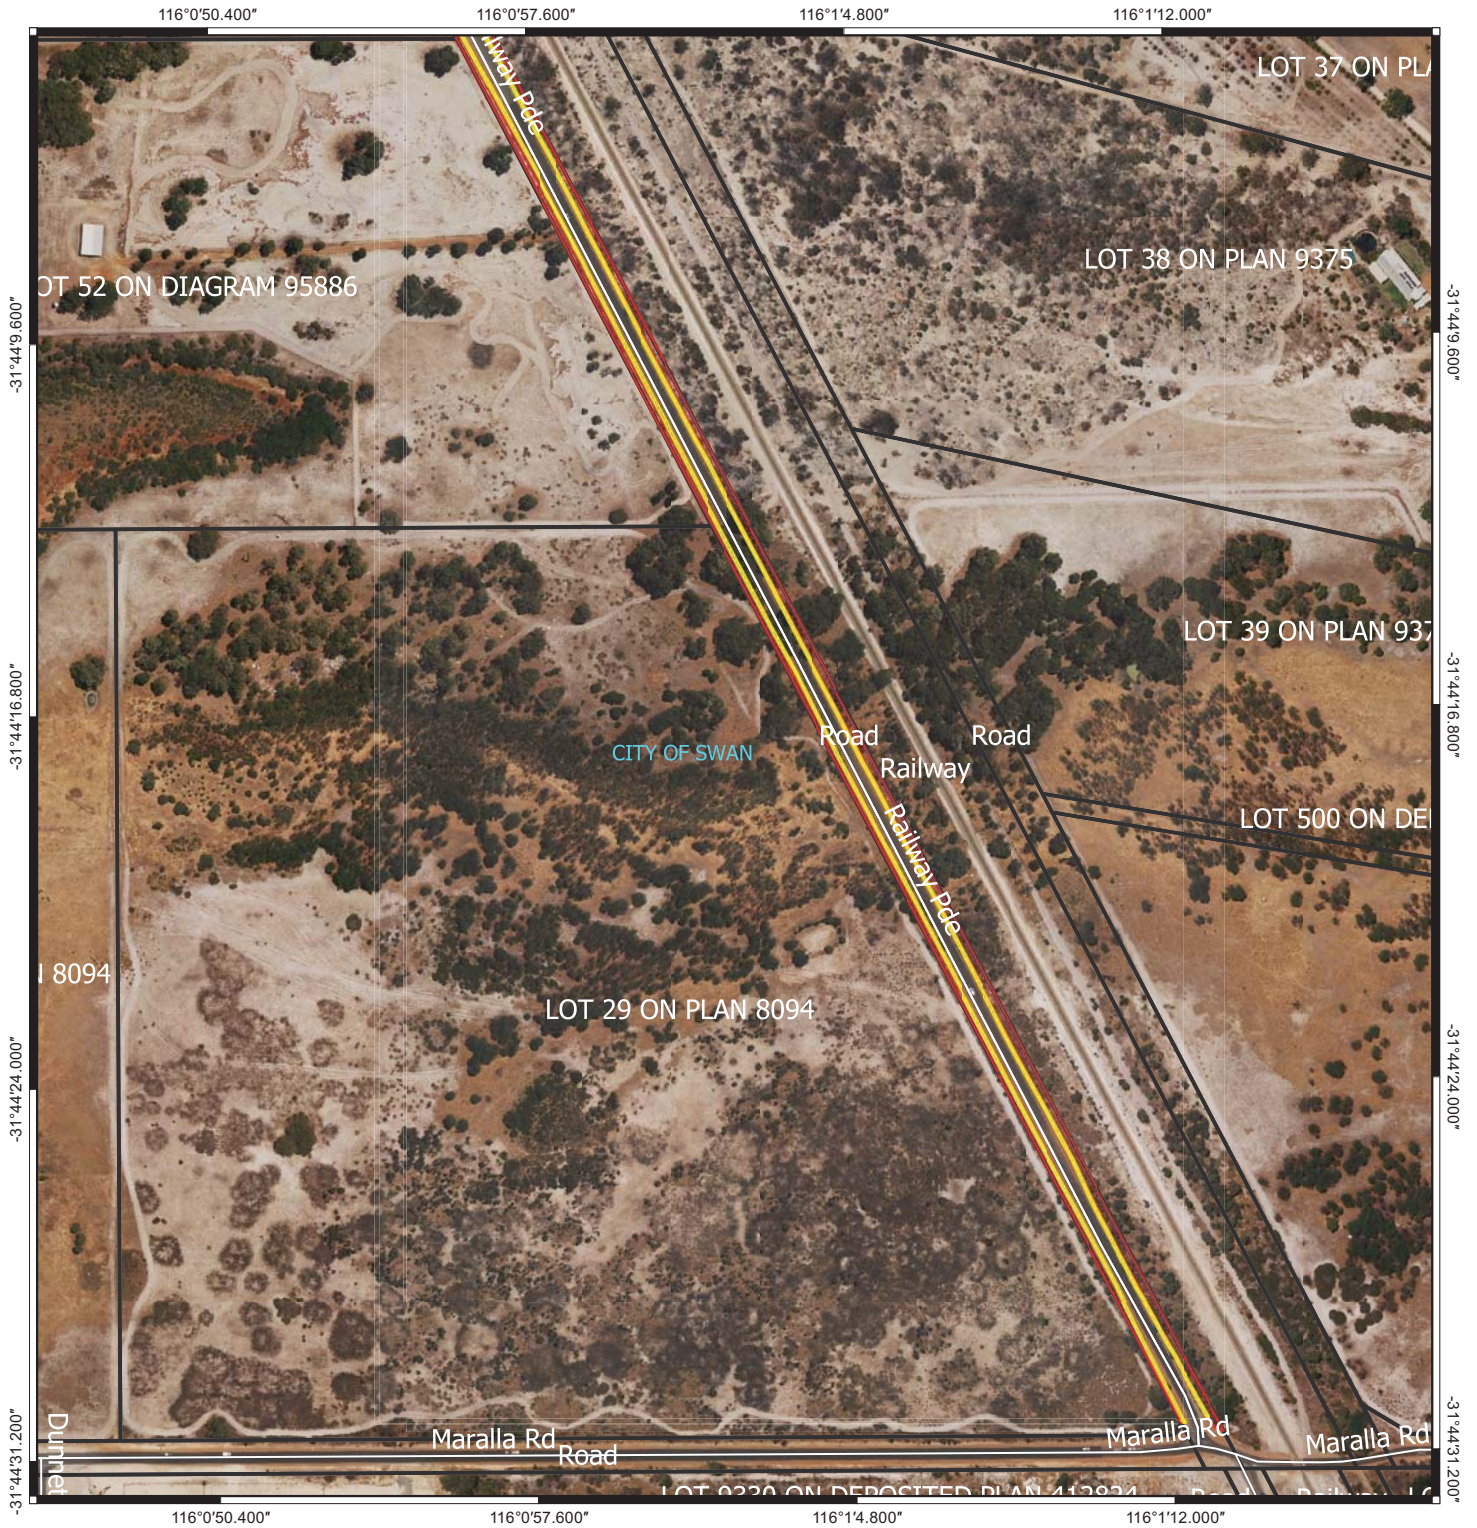
Plan 8802/1a

The Permit Holder shall not clear more than 0.7609 hectares of native vegetation within the area cross-hatched yellow on attached Plan 8802/1a, Plan 8802/1b, Plan 8802/1c and Plan 8802/1d.

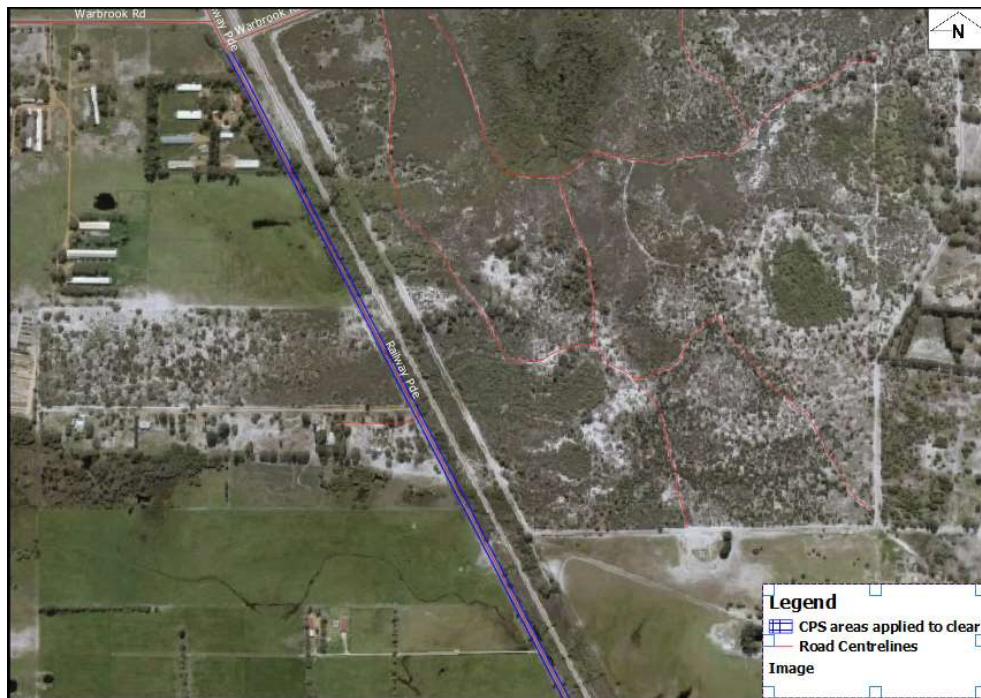
Figure 1a Northern section of the application area cross-hatched blue

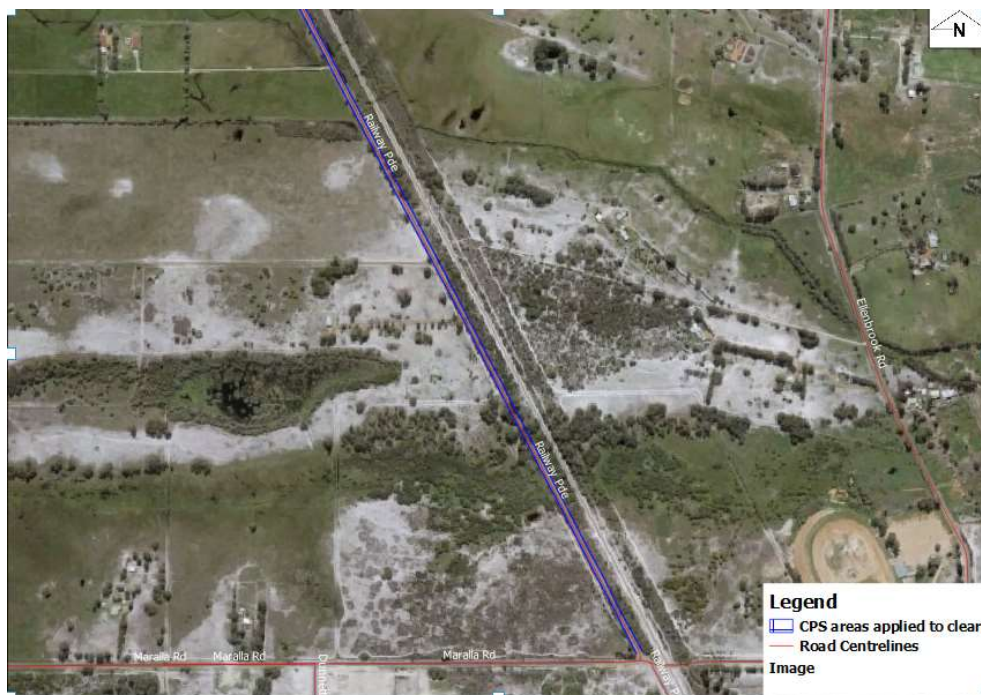
Figure 1b Southern section of the application area cross-hatched blue

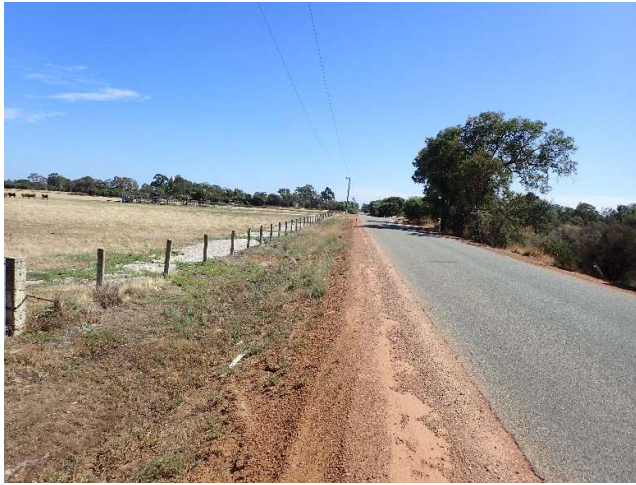
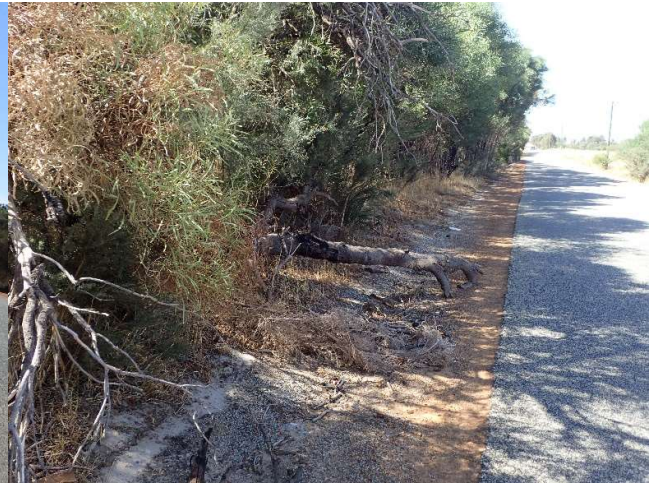
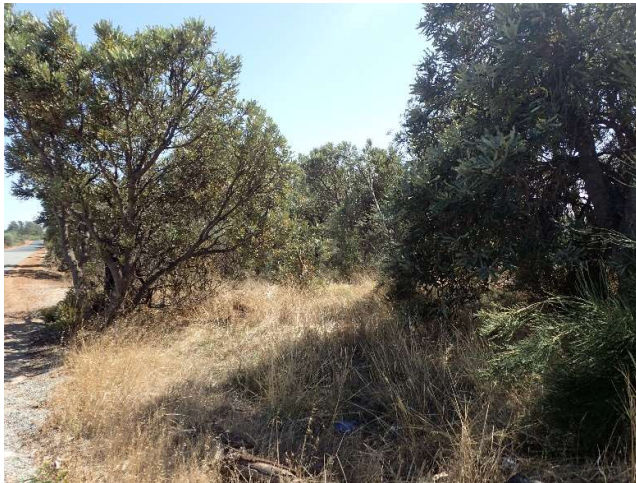
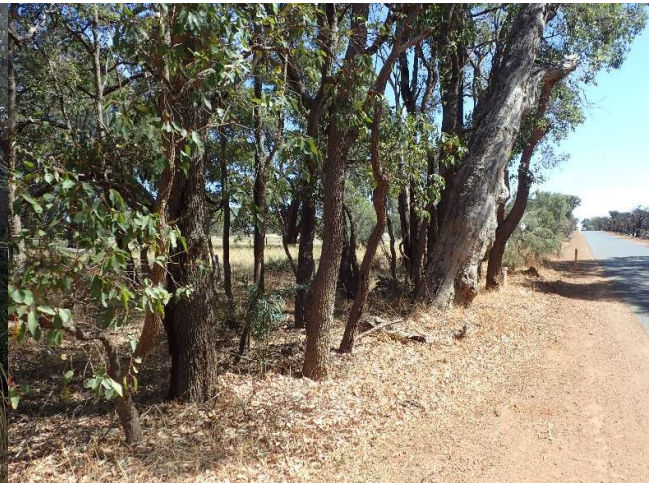
Figures 2a-d: Representative photos of the vegetation within the application area (DWER, 2020).

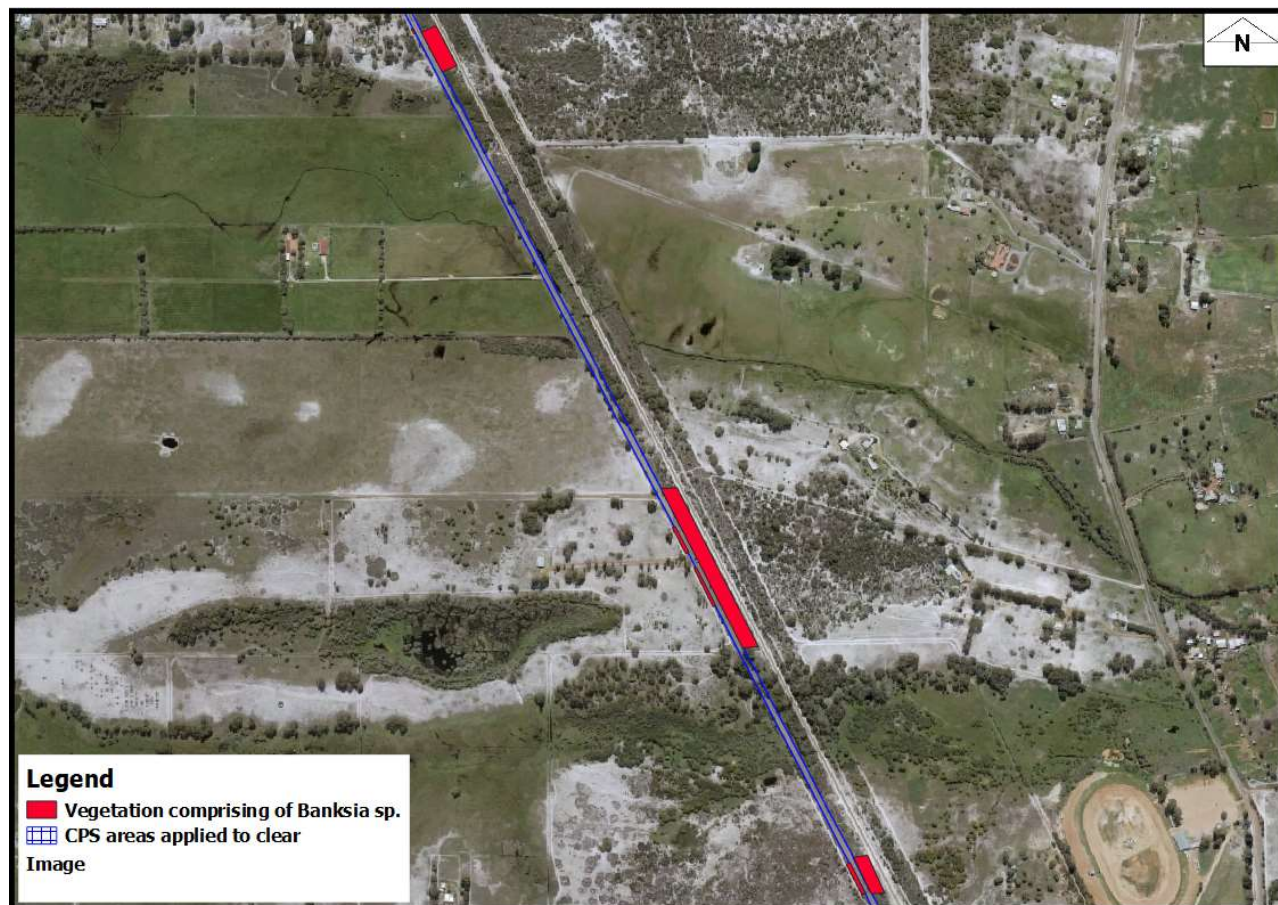
Figure 3 Areas of vegetation comprising of Banksia sp.

The site inspection (DWER, 2020) observed a number of patches of vegetation within the road reserve and adjacent railway reserve (Figure 3), that appeared to be representative of 'Banksia Dominated Woodlands of the Swan Coastal Plain', listed as 'Priority 3(iii)' ecological community (PEC) by Department of Biodiversity, Conservation and Attractions (DBCA), and as an 'Endangered' threatened ecological communities (TEC) under the *Environment Protection and Biodiversity Conservation Act 1999* (EPBC Act). The combined area of this vegetation is approximately 0.186 hectares, with less than 0.099 hectares being in the application area.

Three sections located in the centre of the Figure 3 have been impacted by a recent fire, and therefore, the vegetation condition could not be determined. However, based on the observation of the unburnt vegetation, the vegetation condition in these areas is in a degraded (Keighery, 1994) condition with a weedy understorey. The remaining sections of the potential Banksia woodland TEC were in degraded (Keighery, 1994) condition with weedy understorey. Considering this and the key diagnostic characteristics of the Banksia Woodland, which include minimum patch size and condition thresholds, the vegetation does not meet criteria to be classified as the Banksia Woodlands TEC.

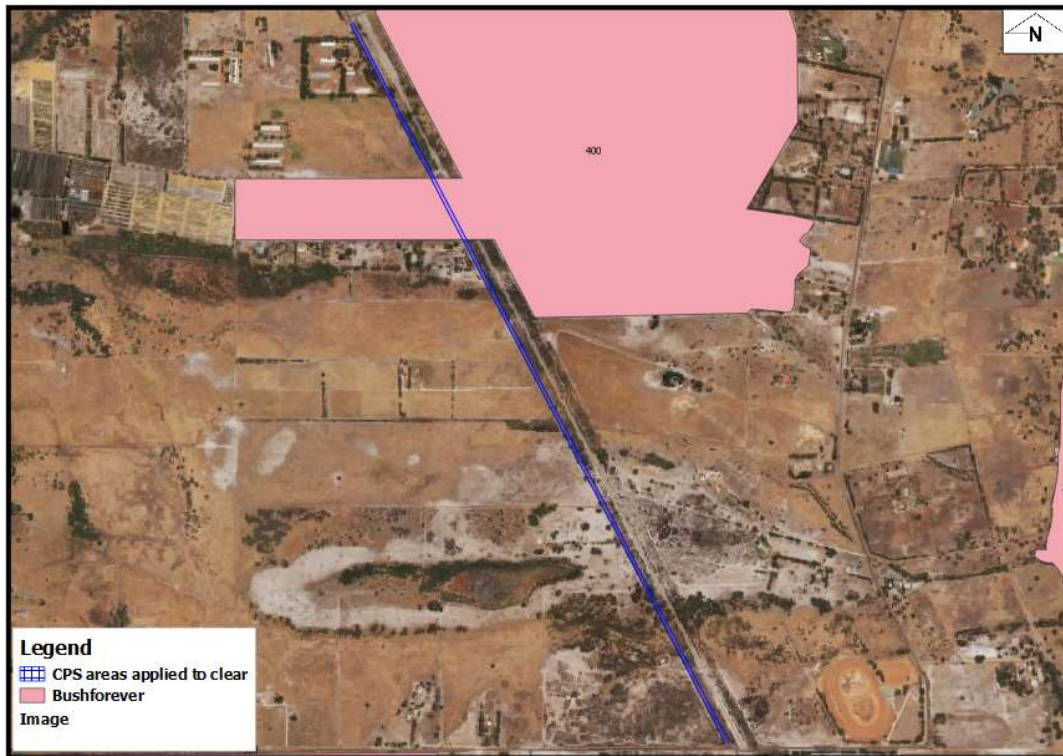
Figure 5 Location of the application area in relation to Bush Forever Site 400

Approximately 0.06 hectares of vegetation in the application area is mapped within Bush Forever Site 400 (Twin Swamps Nature Reserve and adjacent bushland, Bullsbrook) (Figure 5). Noting the condition of the vegetation within the application area, its small size and that most of the application area has undergone historical disturbance, the proposed clearing is not likely to directly impact on the environmental values of this conservation area. However, the disturbance caused by the proposed clearing may indirectly impact on the Bush Forever Site via the introduction and spread of weeds and dieback. Weed and dieback management practices will assist in mitigating this risk.
