Vegetation, Flora, Fauna and Environmental Considerations, and Targeted Flora Report

Site E – Neds Corner Road Reconstruction
– North of Cascade Rd

Written by Environmental Officers,
Julie Waters – BEnvSc (Hons)
& Katie White – BSc (Hons)

March 2020

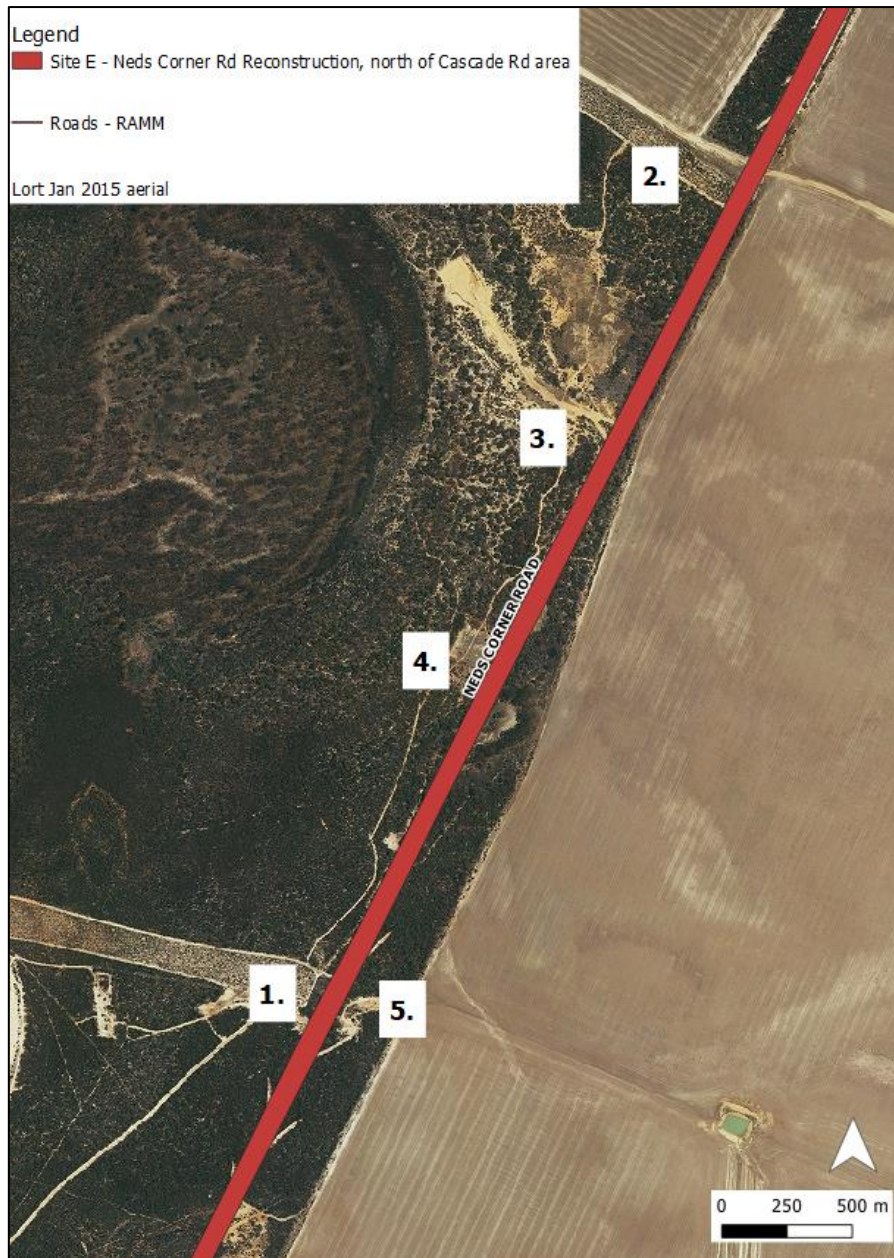
Figure 3. Strategic fire breaks intersecting (Site 1 and 2), and evidence of historical material extraction (Site 3, 4 and 5), within 'Site E – Neds Corner Rd Reconstruction, north of Cascade Rd'.

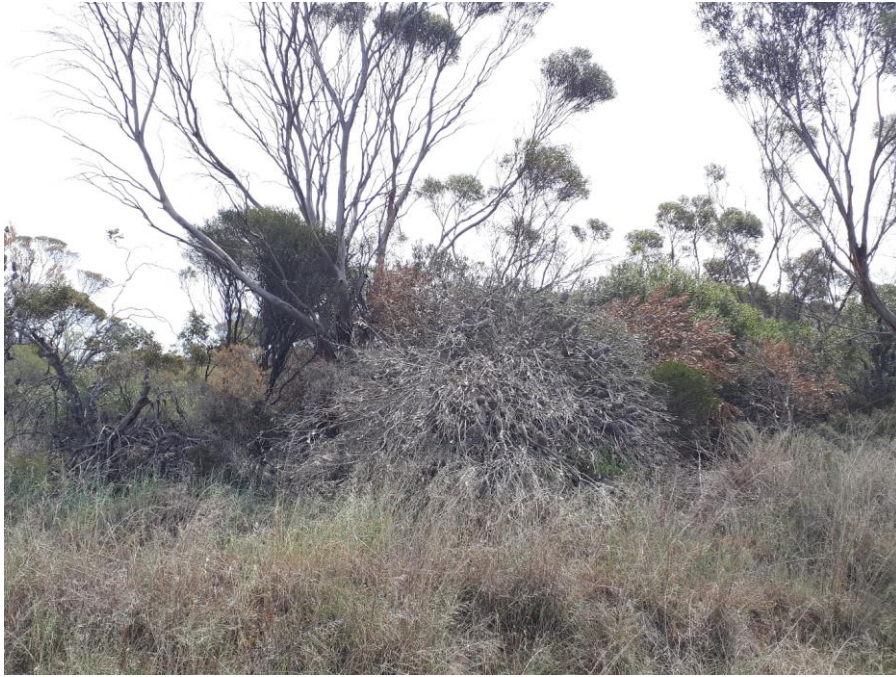
Vegetation types two, six and eight contain large amounts of vegetation that is *Phytophthora cinnamomi* Dieback susceptible, most notably dominated by Proteaceae species. Very limited data collection on the presence of *Phytophthora cinnamomi* Dieback has been conducted on roadsides in Western Australia. No positive or negative sample points are collated on the Dieback Information Delivery and Management System (DIDMS; GAIA Resources, State NRM & SCNRM 2020). However, during the field survey, a plant pathogen most likely to be *P. cinnamomi* Dieback was observed in vegetation type six and eight, as indicated by multiple dead *Banksia media* plants throughout the area (Figure 4). Appropriate hygiene measures will be employed to limit introduction of infection, including clearing in dry conditions and clean down of machinery. This aims to limit the likelihood that *P. cinnamomi* Dieback will spread, but there is always a possibility that introduction will occur during proposed activities.

Figure 4. Dead *Banksia media* plants within vegetation type six of 'Site E – Neds Corner Rd Reconstruction, north of Cascade Rd', potentially indicating *Phytophthora cinnamomi* Dieback.

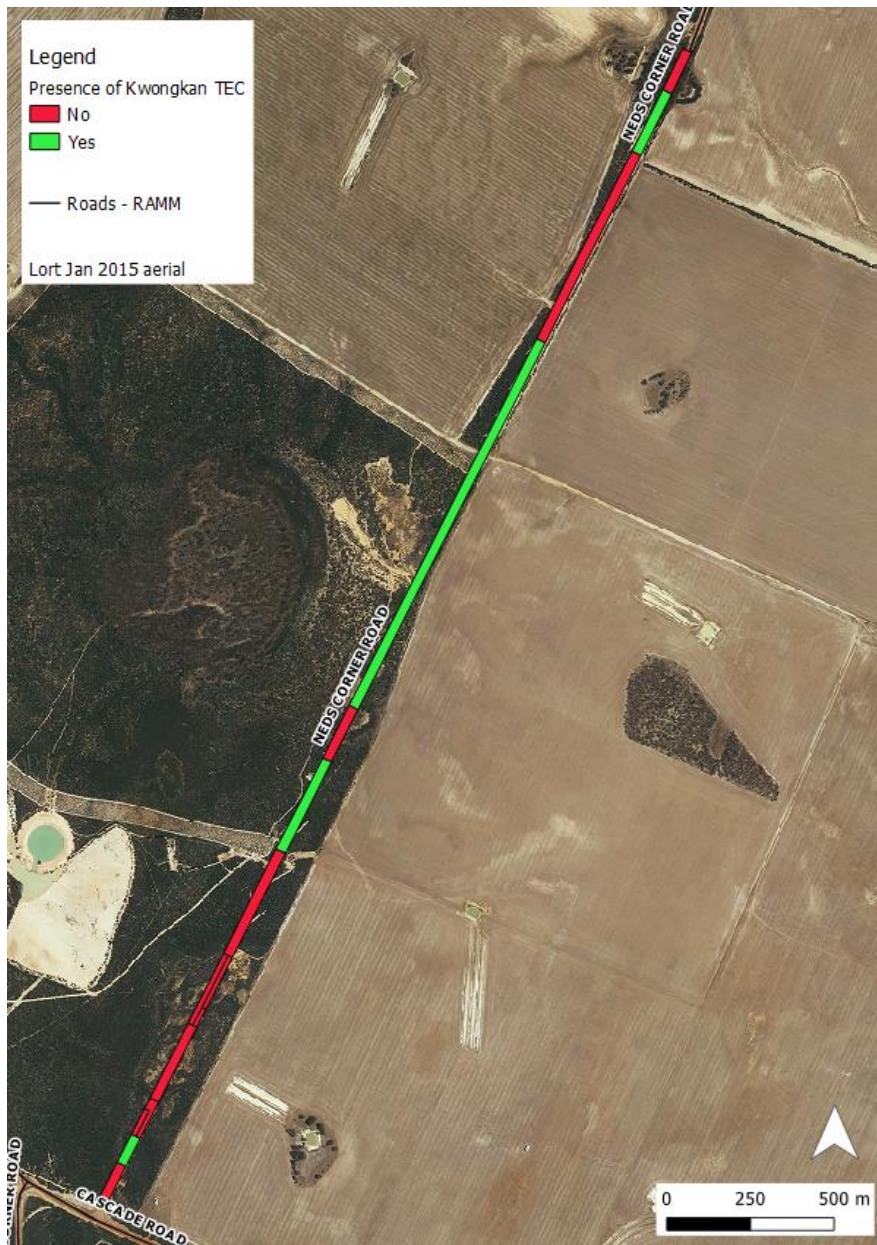
The desktop study indicates a 390 m section at the northern end of the site is mapped as 'likely to occur' for the Environmental Protection and Biodiversity Conservation (EPBC) Act 1999 listed threatened ecological community (TEC) 'Proteaceae Dominated Kwongkan Shrubland of the Southeast Coastal Floristic Province of Western Australia (Kwongkan)' (DBCA 2019j). There were no other occurrences of the PECs or TECs within the 20 km buffer of the site. The field survey confirmed the presence of Kwongkan TEC over a different geographic area (Figure 5; Table 1). In total 1.64 ha of native vegetation within a 5.36 ha area of 'Site E - Neds Corner Rd Reconstruction, north of Cascades Rd' met the criteria for the Kwongkan TEC, all in very good condition.

Figure 5. Vegetation within the 'Site E - Neds Corner Road, north of Cascades Road' meeting the threatened ecological community (TEC), 'Proteaceae Dominated Kwongkan Shrubland of the Southeast Coastal Floristic Province of Western Australia' thresholds.

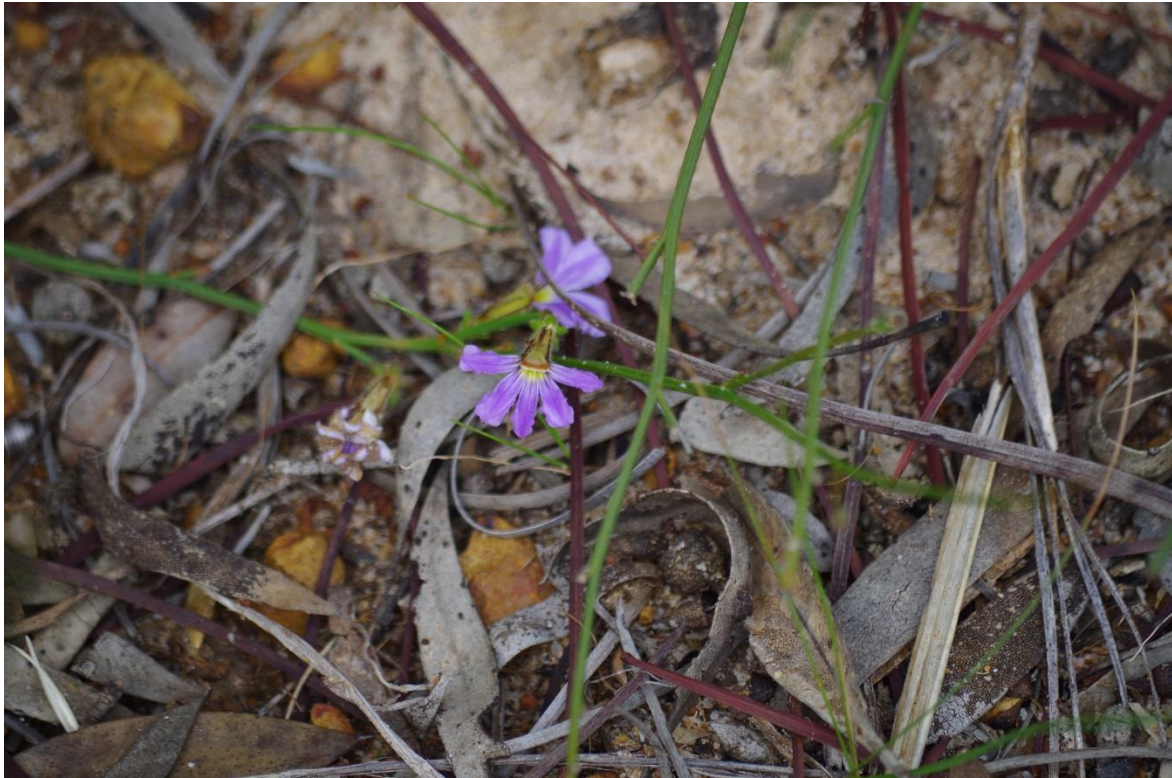
Figure 7. Priority one species, *Scaevola archeriana*, plant growing within 'Site E – Neds Corner Rd Reconstruction, north of Cascade Rd'.

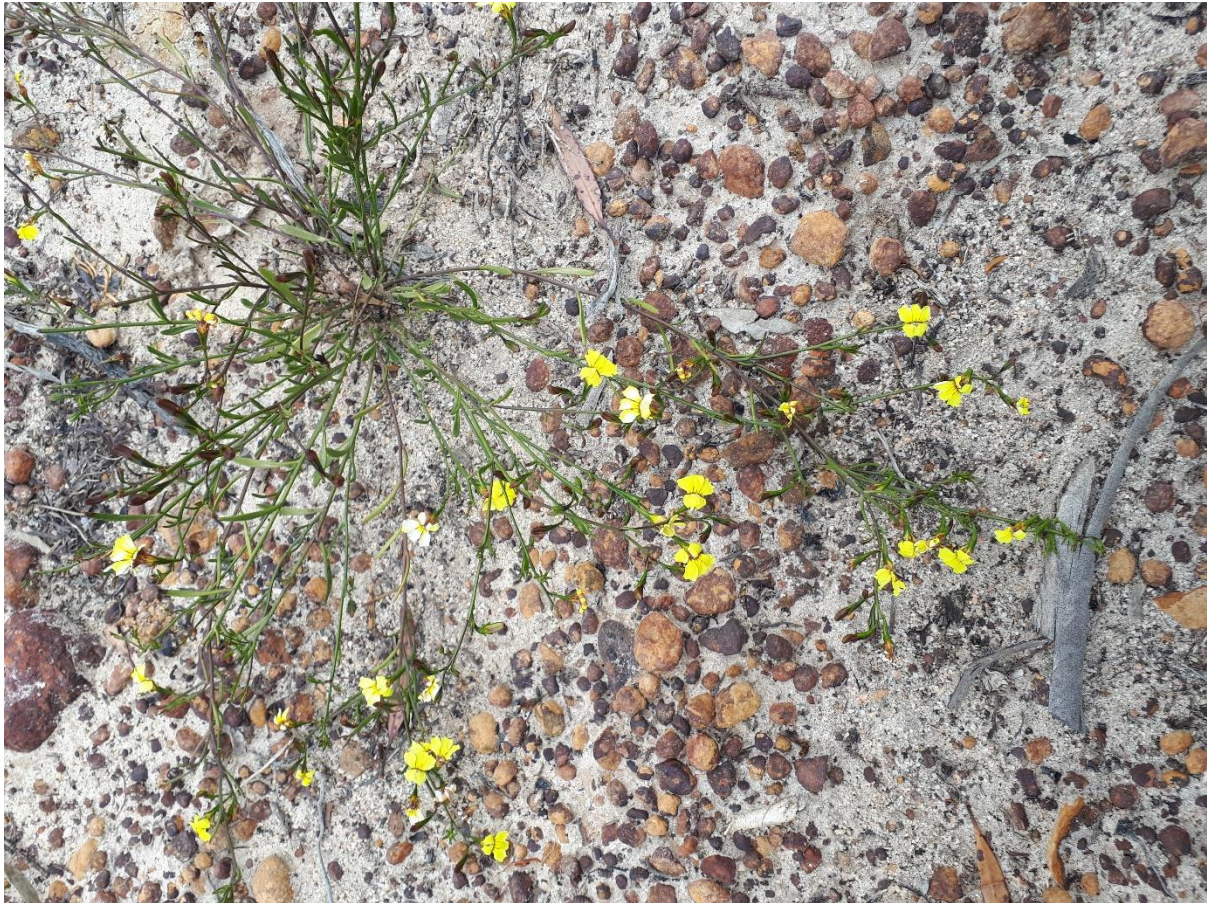
Figure 12. Priority three species, *Goodenia laevis* subsp. *laevis*, plant growing within 'Site E – Neds Corner Rd Reconstruction, north of Cascade Rd'.

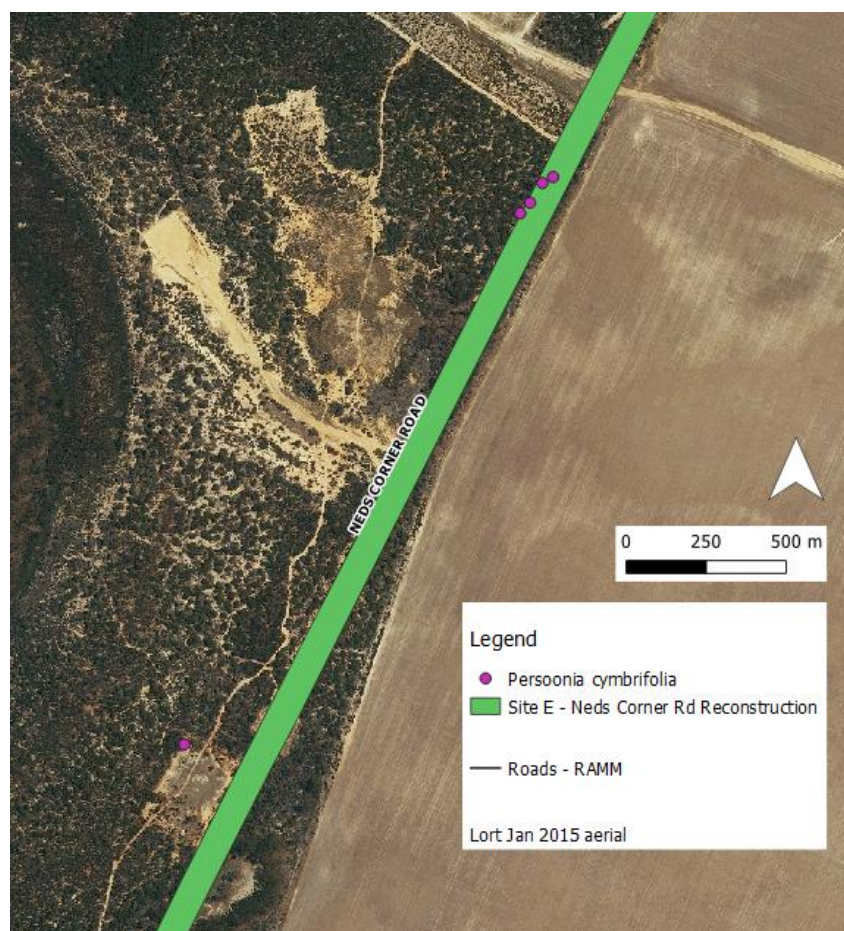
Figure 13. Location of priority three species, *Persoonia cymbifolia*, within the 'Site E – Neds Corner Rd Reconstruction, north of Cascade Rd' area.

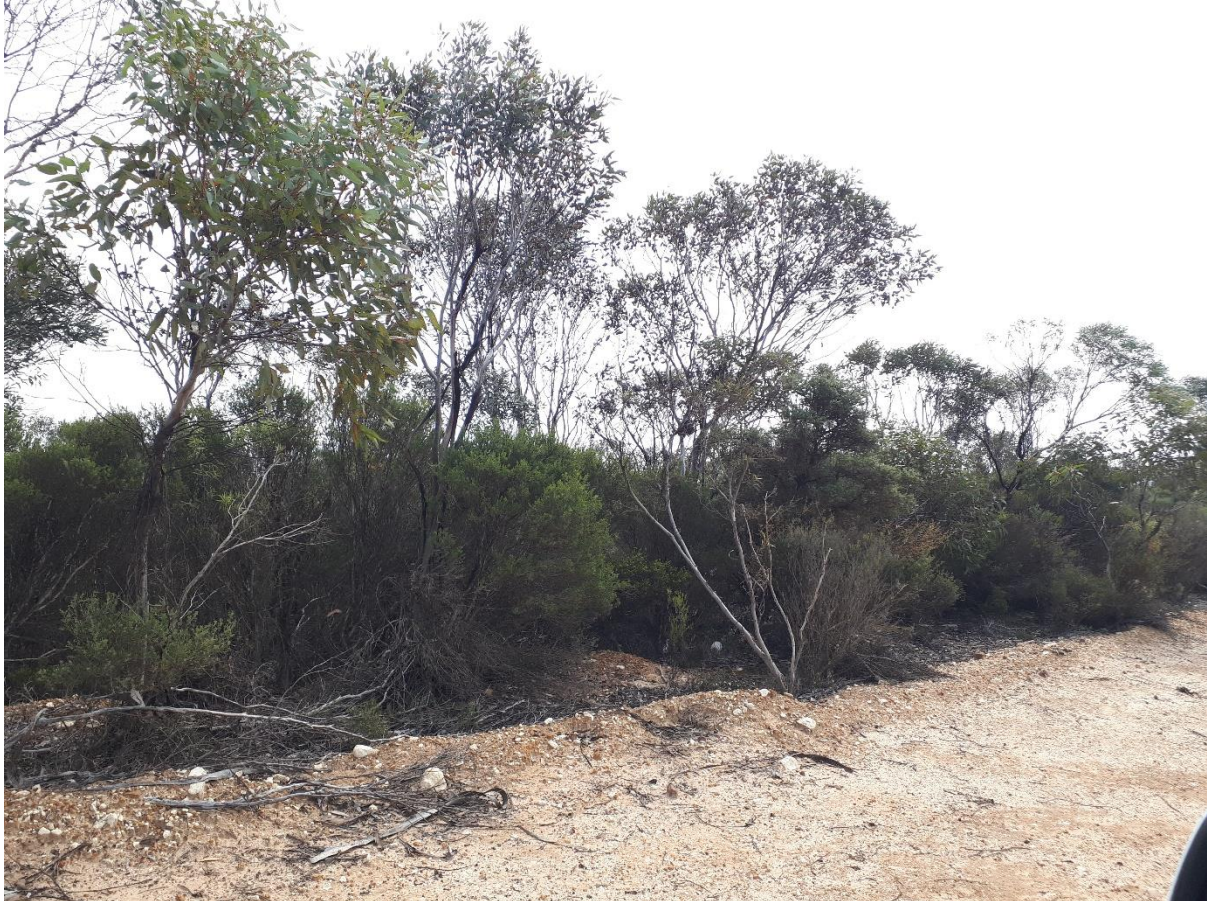
Figure 15. Vegetation type one within 'Site E – Neds Corner Rd Reconstruction, north of Cascade Rd', described as mixed Mallee Eucalyptus with low diversity, dense Melaleuca shrubland.

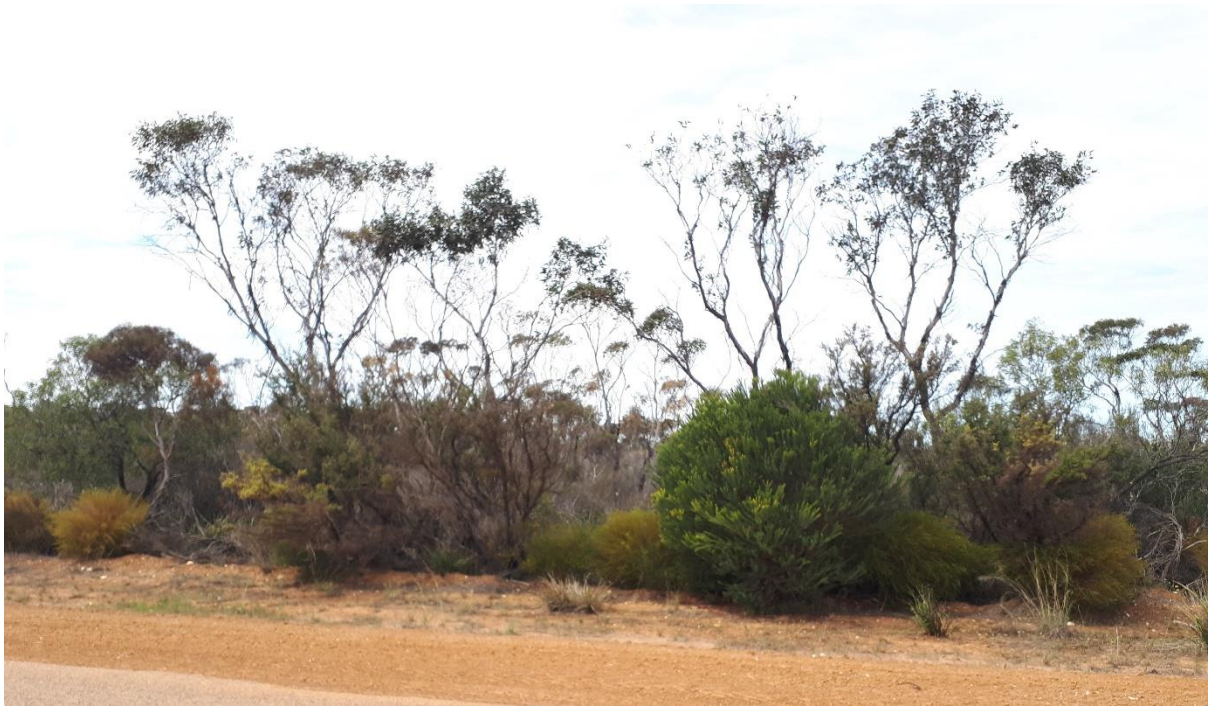
Figure 16. Vegetation type two in 'Site E - Neds Corner Rd Reconstruction, north of Cascade Rd', described as highly diverse shrubland, with scattered Acacia and Eucalyptus understorey. Mixed understorey of *Santalum acuminatum*, *Calothamnus quadrifidus*, *Leptospermum erubescens* and *Hakea marginata*.

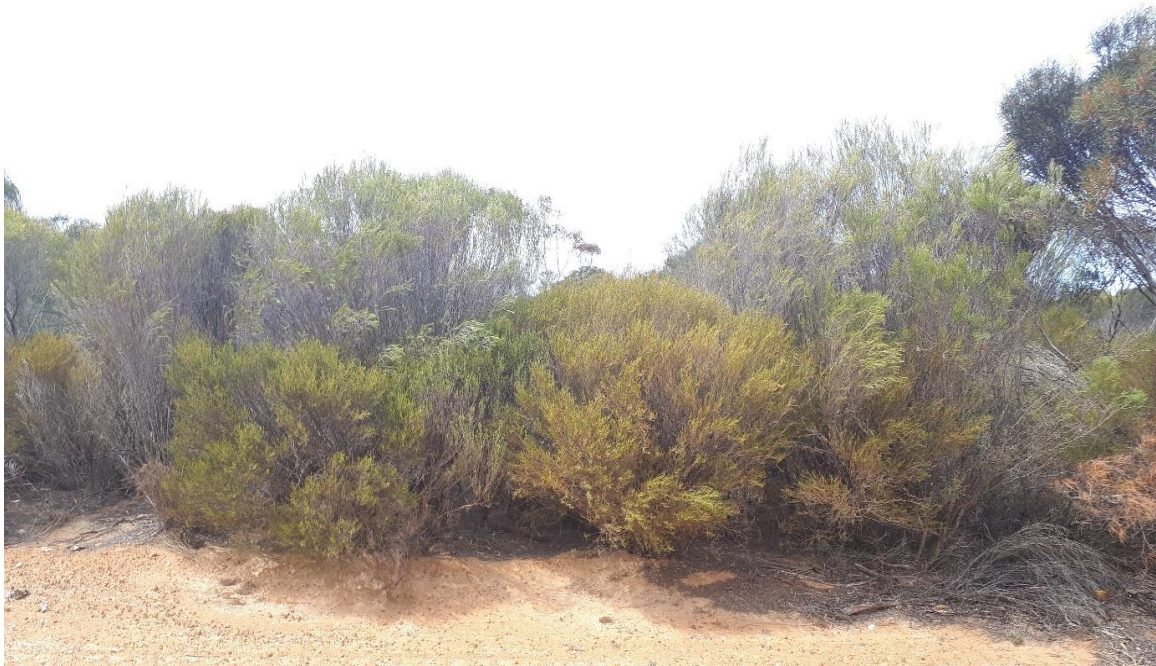
Figure 17. Vegetation type three in 'Site E - Neds Corner Rd Reconstruction, north of Cascade Rd' area, described as Acacia Shrubland, with *Melaleuca hamata*, Broom Bush.

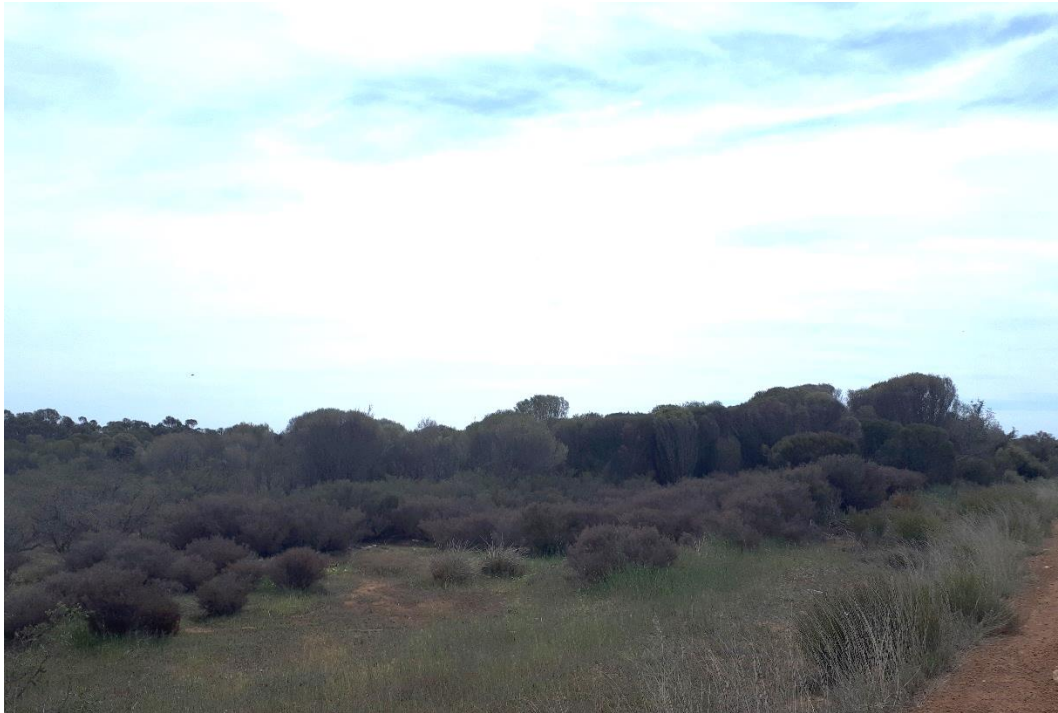
Figure 18. Vegetation type four in 'Site E - Neds Corner Rd Reconstruction, north of Cascade Rd' area, described as mixed granite shrubland. The periphery of road reserve has a Cape Weed and African lovegrass infestation.

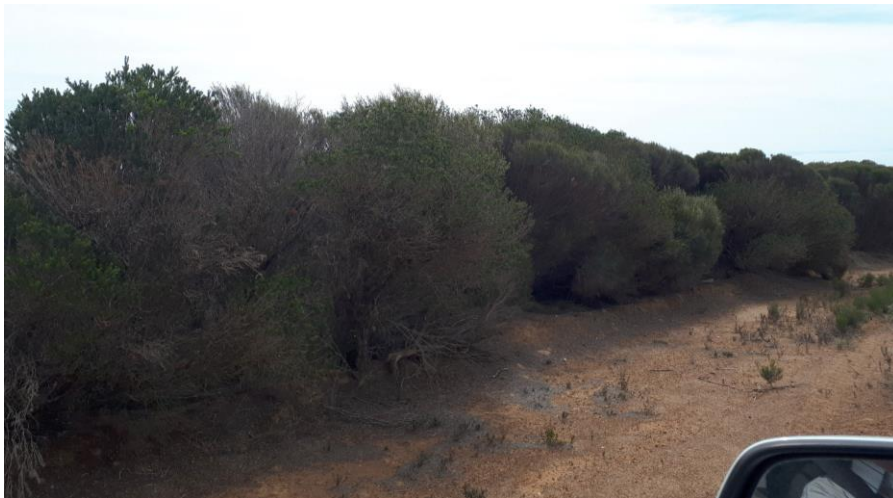
Figure 19. Vegetation type five in 'Site E - Neds Corner Rd Reconstruction, north of Cascade Rd' area, described as Closed shrubland of *Melaleuca hamata* and *Calothamnus quadrifidus*.

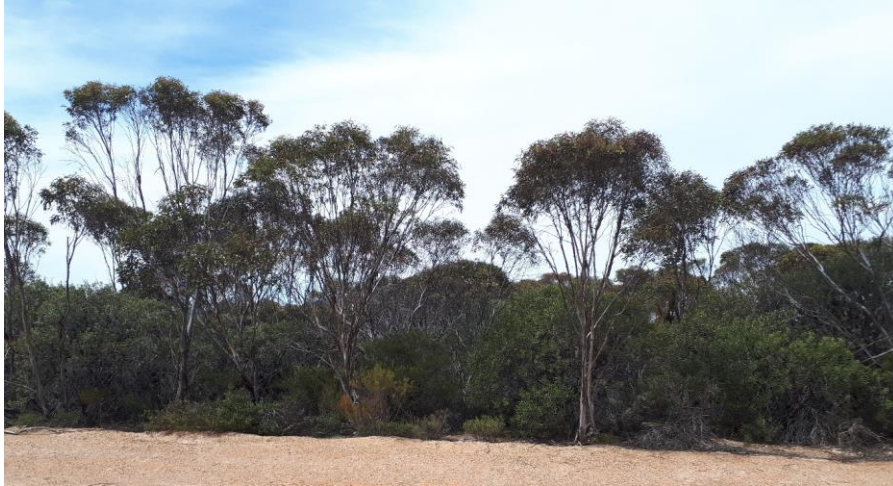
Figure 20. Vegetation type six of 'Site E – Neds Corner Rd Reconstruction, north of Cascade Rd', described as mixed Mallee Eucalyptus with low diversity, dense Melaleuca shrubland, and dominant *Banksia media* mid-story.

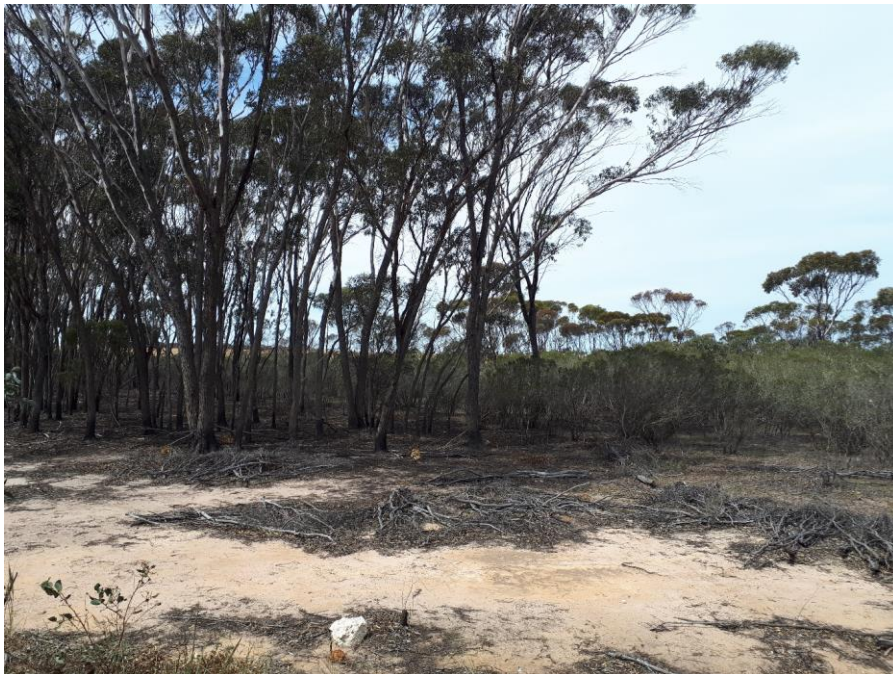
Figure 21. Vegetation type seven within 'Site E – Neds Corner Rd Reconstruction, north of Cascade Rd', described as a Yate Swamp.
