Rehabilitation Plan
Site A – Fisheries Road, near Daniels road, Sandpit
CPS 8884/1

October 2020

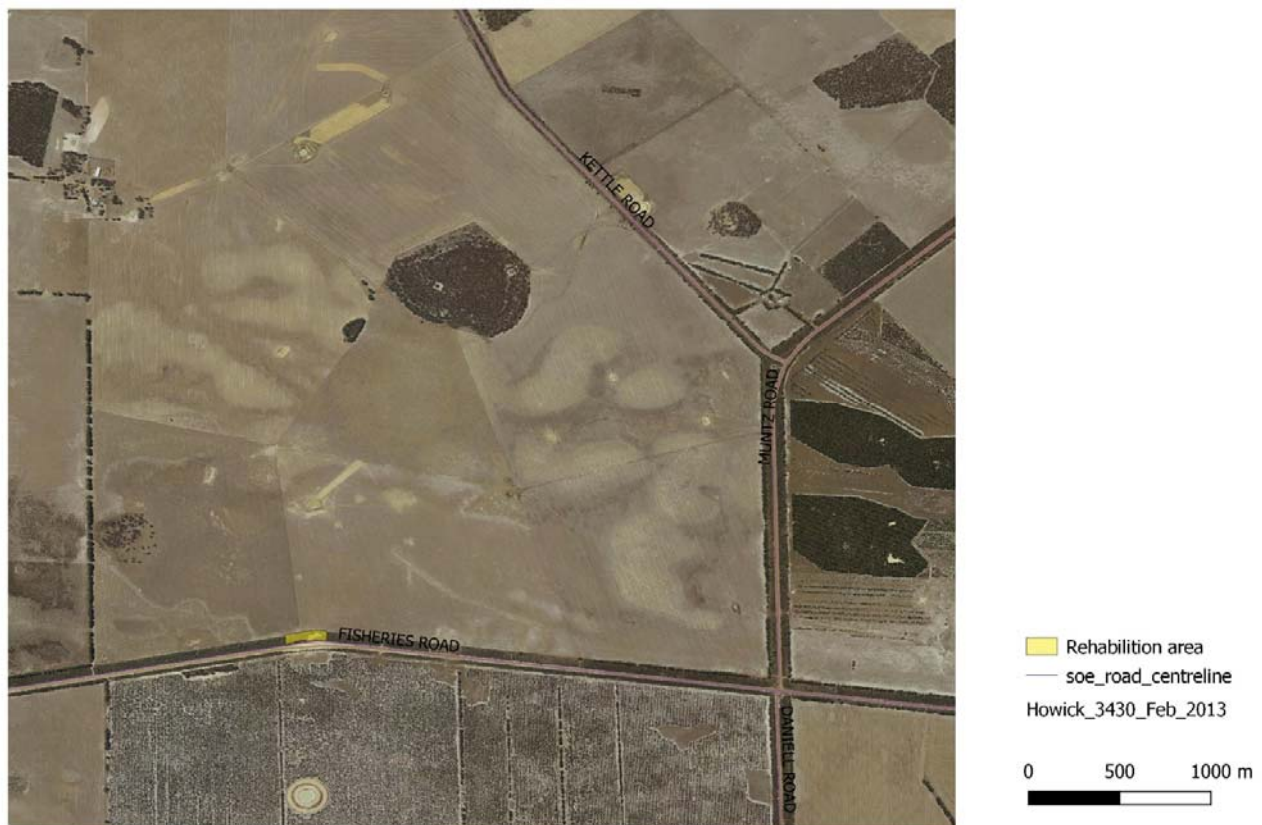
Figure 1. Location of 'Site A – Fisheries Rd, near Daniels Rd, Sandpit' revegetation area CPS 8884/1

'Site A – Fisheries Rd, near Daniels Rd, sandpit' is located ~70 km east of Esperance and 10.8 km east of the Condingup town-site, located within Shire of Esperance managed road reserve. Specifically, it is located on Fisheries Rd, 2.1 km west of Daniels Rd, at straight line kilometre (SLK) 75.40 (Main Roads 2020). A point within the rehabilitation area is -33.747551 S, 122.641850 E (GDA94). The rehabilitation area includes both CPS 8884/1 'Site A – Fisheries Rd, near Daniels Rd, sandpit' as well as the historic sand extraction area enclosed by this application.

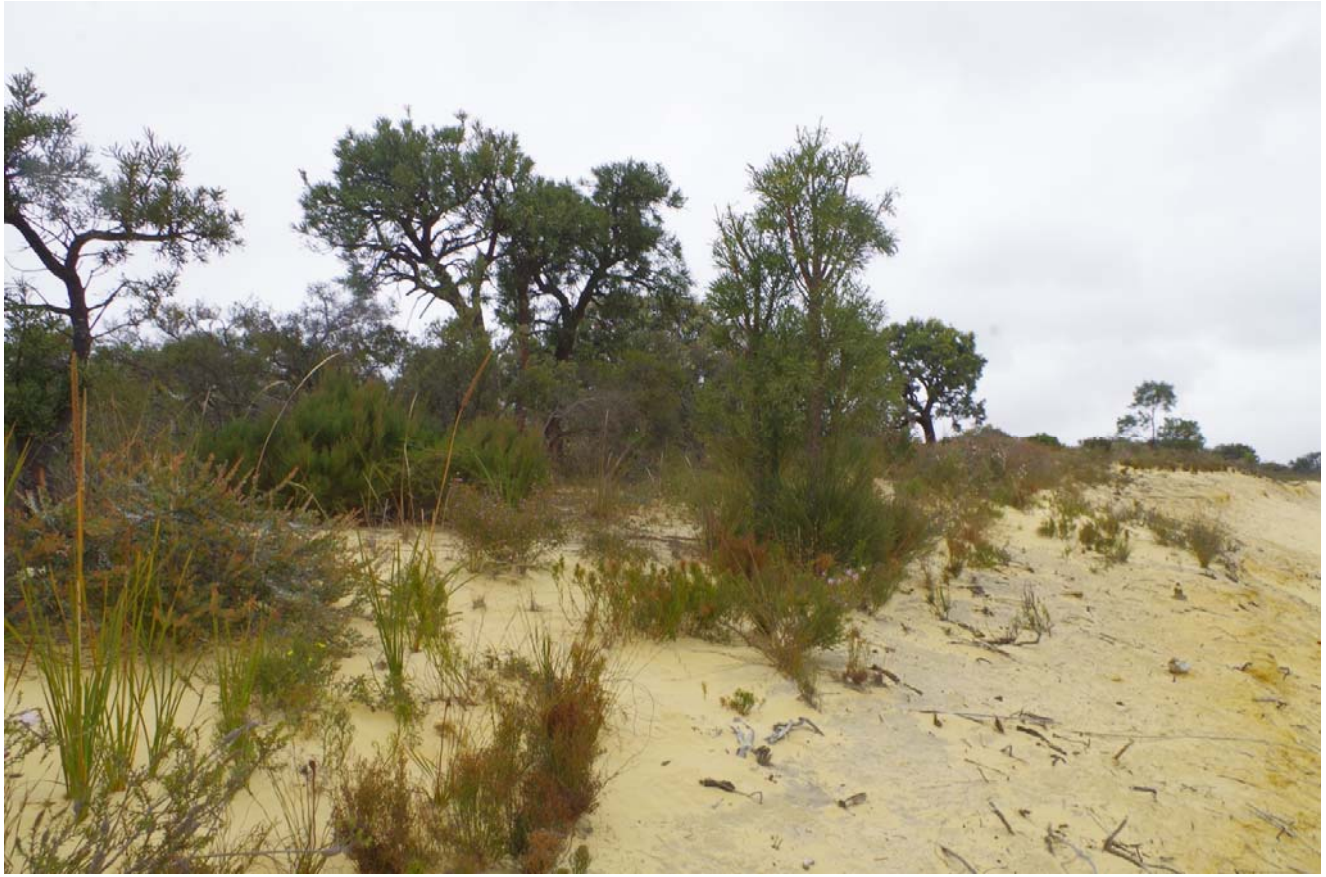
Figure 2. Preclearing vegetation of 'Site A – Fisheries Rd, near Daniels Rd, Sandpit'

The site was surveyed on 01/10/2019 by Shire of Esperance's Environmental Officer's Julie Waters and Katie White. Results of this survey are in the previously submitted 'Vegetation, Flora, Fauna and Environmental Considerations Report, Site A – Fisheries rd, near Daniels Rd sandpit (2020)'. Vegetation structure and composition was described during the field survey as *Nuytsia floribunda* and *Banksia speciosa* dominated over-story, *Melaleuca striata*, *Allocasuarina humilis* and *Adenanthos cuneatus* dominated mid-story, and *Caustis dioica* and *Anarthria scabra* dominated under-story (Figure 4). It is believed that the Beard (1973) vegetation association 6048 is an appropriate match for the observed vegetation community (Section 2.6). The targeted flora survey recorded a total of 83 species (Appendix 7.1). This shows the site and vegetation community is characterized by high diversity.

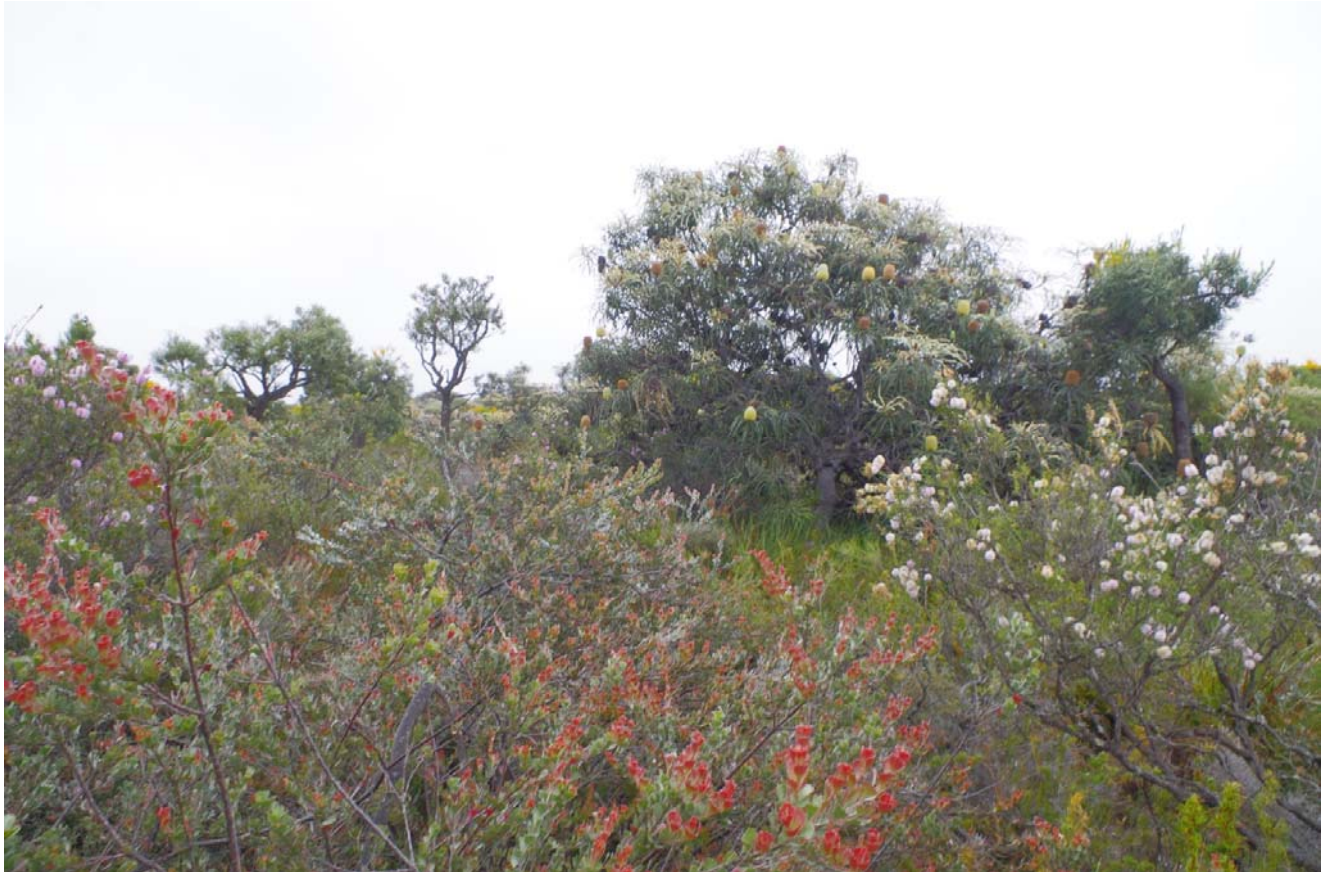
Figure 3. Preclearing vegetation of 'Site A – Fisheries Rd, near Daniels Rd, Sandpit'
