Fenix Resources Ltd

Iron Ridge Project

Clearing Permit CPS 8891-2

Annual Report

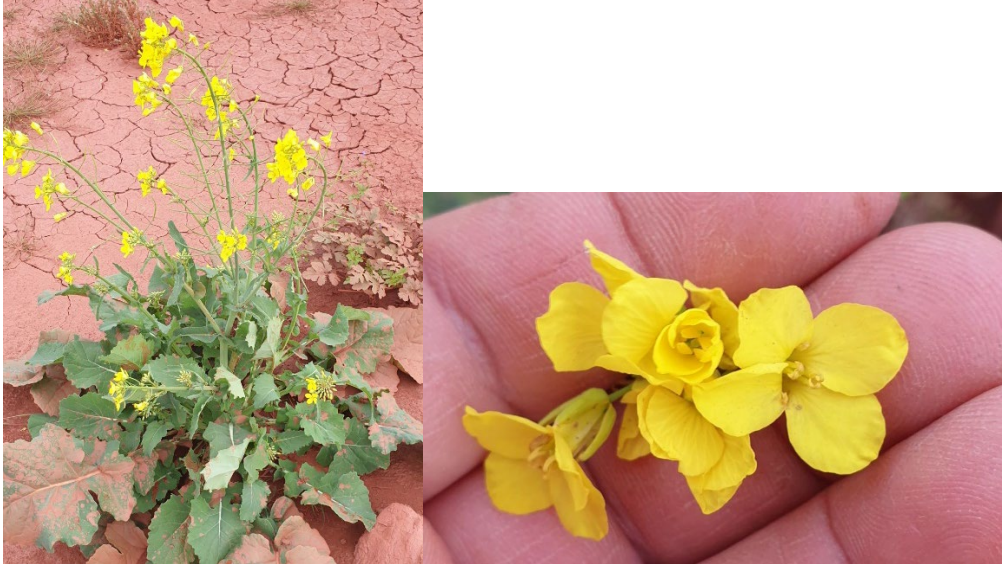
Two canola plants (*Brassica napus*) were found alongside the main road train haul route onto the ROM. The species is seen occasionally along the Berringara-Cue Road and is commonly and prolific along road verges further south in the Wheatbelt. It is likely the seeds have been gradually blown along the road or transported in mud picked up by vehicles on the public roads. The species is not particularly invasive, generally short-lived and readily controlled with glyphosate. The plants observed on site were manually removed.

Weed species	Location	Photograph
Canola <i>Brassica napus</i>	Road side on approach to ROM

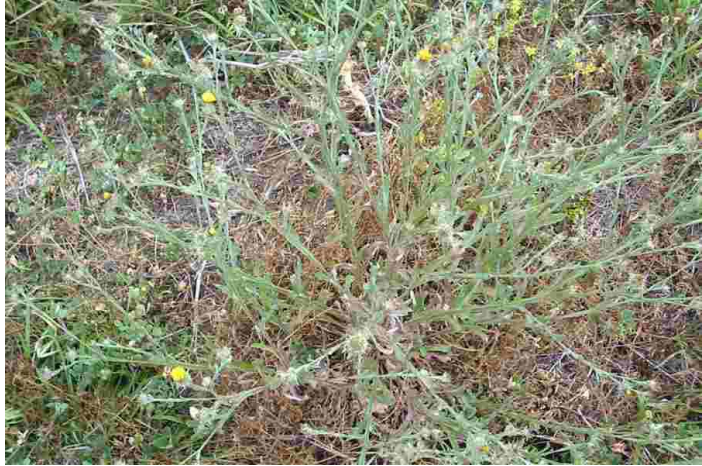
A few maltese cockspur (*Centaurea melitensis*) individuals were observed at one location in the sprayfield. This species is generally spread by wind and is typically associated with disturbed areas with higher soil-moisture content. It is found throughout Western Australia. The species is difficult to control although does not appear to compete with native species in established vegetation.

Maltese cockspur <i>Centaurea melitensis</i>	WWTP sprayfield

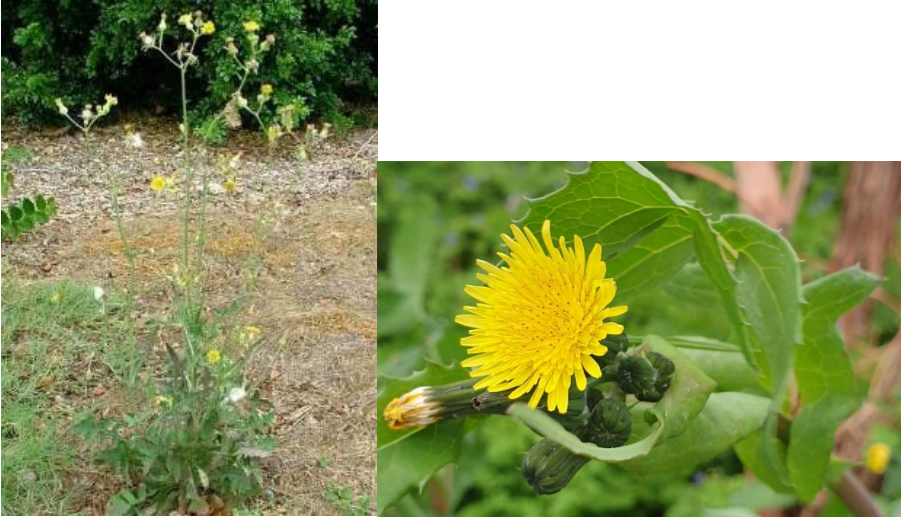
Common sow thistle (*Sonchus oleraceus*) and milk thistle (*Sonchus asper*) were found in relatively low numbers in the waste water treatment plant spray field, around the camp and in low-lying areas near the mine site office. The plants in the sprayfield were restricted to the radius of the sprinklers and were sprayed with herbicide at the time of the inspection although, with the sprinklers coming on regularly, it is not known whether the treatment will be effective. Individuals near the office were removed manually. Those around the camp have not been sprayed or removed. Both species are common and widespread throughout Western Australia and are spread via wind, water flow and grazing animals. Neither species is invasive however can become prolific in damper areas such as drains, berms of waste dumps and waste water treatment facilities. *Sonchus* species are generally readily controlled with glyphosate and broad leaf herbicides such as Dicamba.

<p>Common sow thistle <i>Sonchus oleraceus</i></p>	<p>WWTP sprayfield, camp</p>

- Inspect the ruby dock plant (located near centre sprinkler, northern/back row) in the next few days. If it is not showing any indication of being affected by herbicide it should be manually removed before it produces seed.
- Undertake weed control around the camp as soon as possible to eradicate the low numbers of thistle (*Sonchus asper* and *S. oleraceus*) before they set seed.
- Communicate the weed species present on site with relevant site personnel and encourage reporting of any sightings, particularly ruby dock.
- Continue annual weed inspections.
- Undertake weed control as necessary.

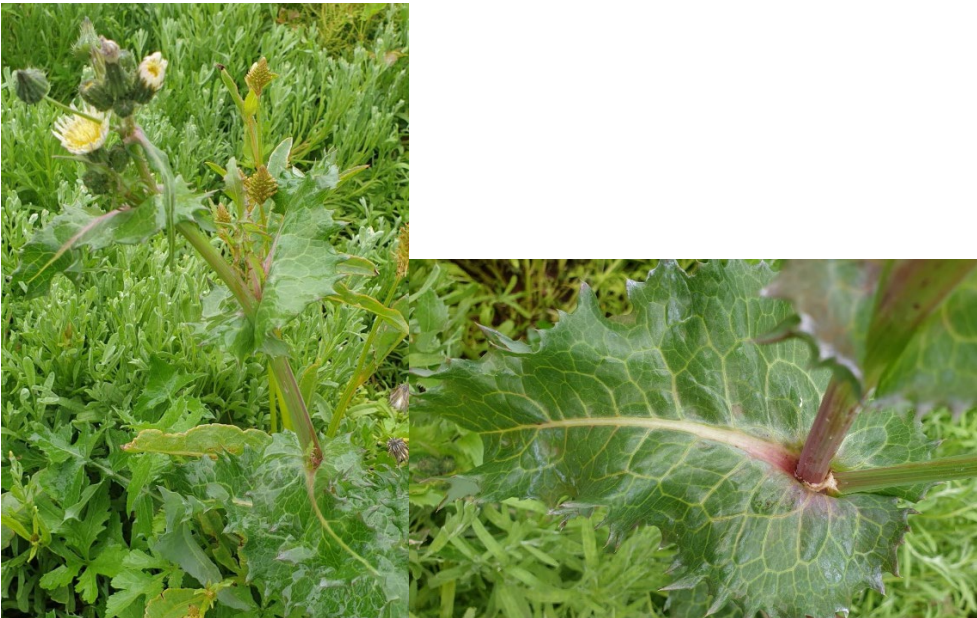
<p>Milk thistle; Prickly sow thistle <i>Sonchus asper</i></p>	<p>WWTP sprayfield, camp</p>

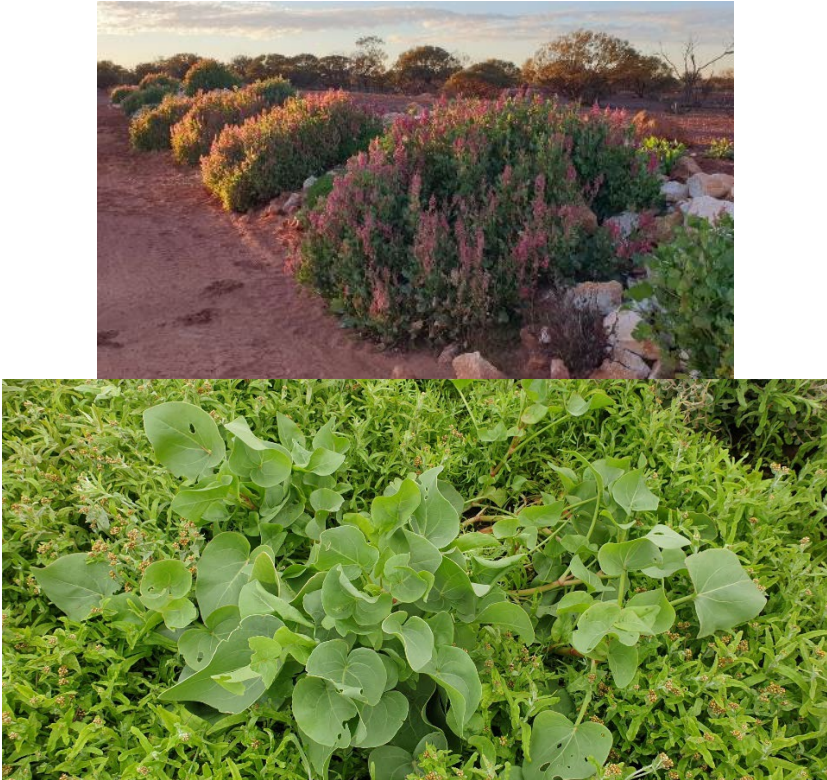
Ruby dock (*Rumex vesicarius*) was again observed in abundance along the Berringara-Cue Road and the Great Northern Highway while travelling to site. A single plant was found in the sprayfield and sprayed with herbicide however, with the sprinklers coming on regularly, it is not known whether the treatment will be effective. Seeds are likely to have been transported to site by being blown along the roadside by vehicle movement or in mud picked up by vehicles along the public road route to site. Ruby dock is an invasive species and can have a significant impact on the success of mine site rehabilitation. It is best controlled with glyphosate and a penetrant such as Pulse. Addition of a broad leaf specific herbicide such as Dicamba can also be useful where glyphosate resistance has developed. Vigilance is required for this species as it is a prolific seed producer with seed able to remain dormant in the soil for many years.

<p>Ruby dock <i>Rumex vesicarius</i></p>	<p>Verges and drains of the public roads used to access the site.</p> <p>One plant located in the WWTP spray field.</p>

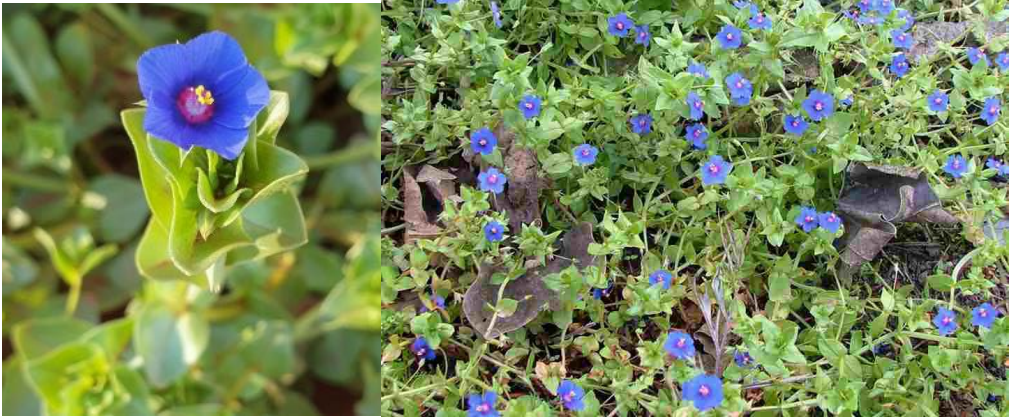
Pimpernel (*Lysimachia arvensis*) was found in a few locations and has been recorded throughout undisturbed areas in the original flora surveys conducted prior to commencement of operations. It is common and widespread, and is typically abundant following good winter rains. It is not invasive and generally no control measures are necessary.

<p>Pimpernel <i>Lysimachia arvensis</i></p>	<p>Numerous locations throughout the undisturbed areas surrounding the mine site.</p>
