CLEARING PERMIT

Purpose Permit number:	CPS 8909/1
Permit Holder:	Department of Transport
Duration of Permit:	2 November 2020 to 2 November 2025

Clearing Permit Decision Report

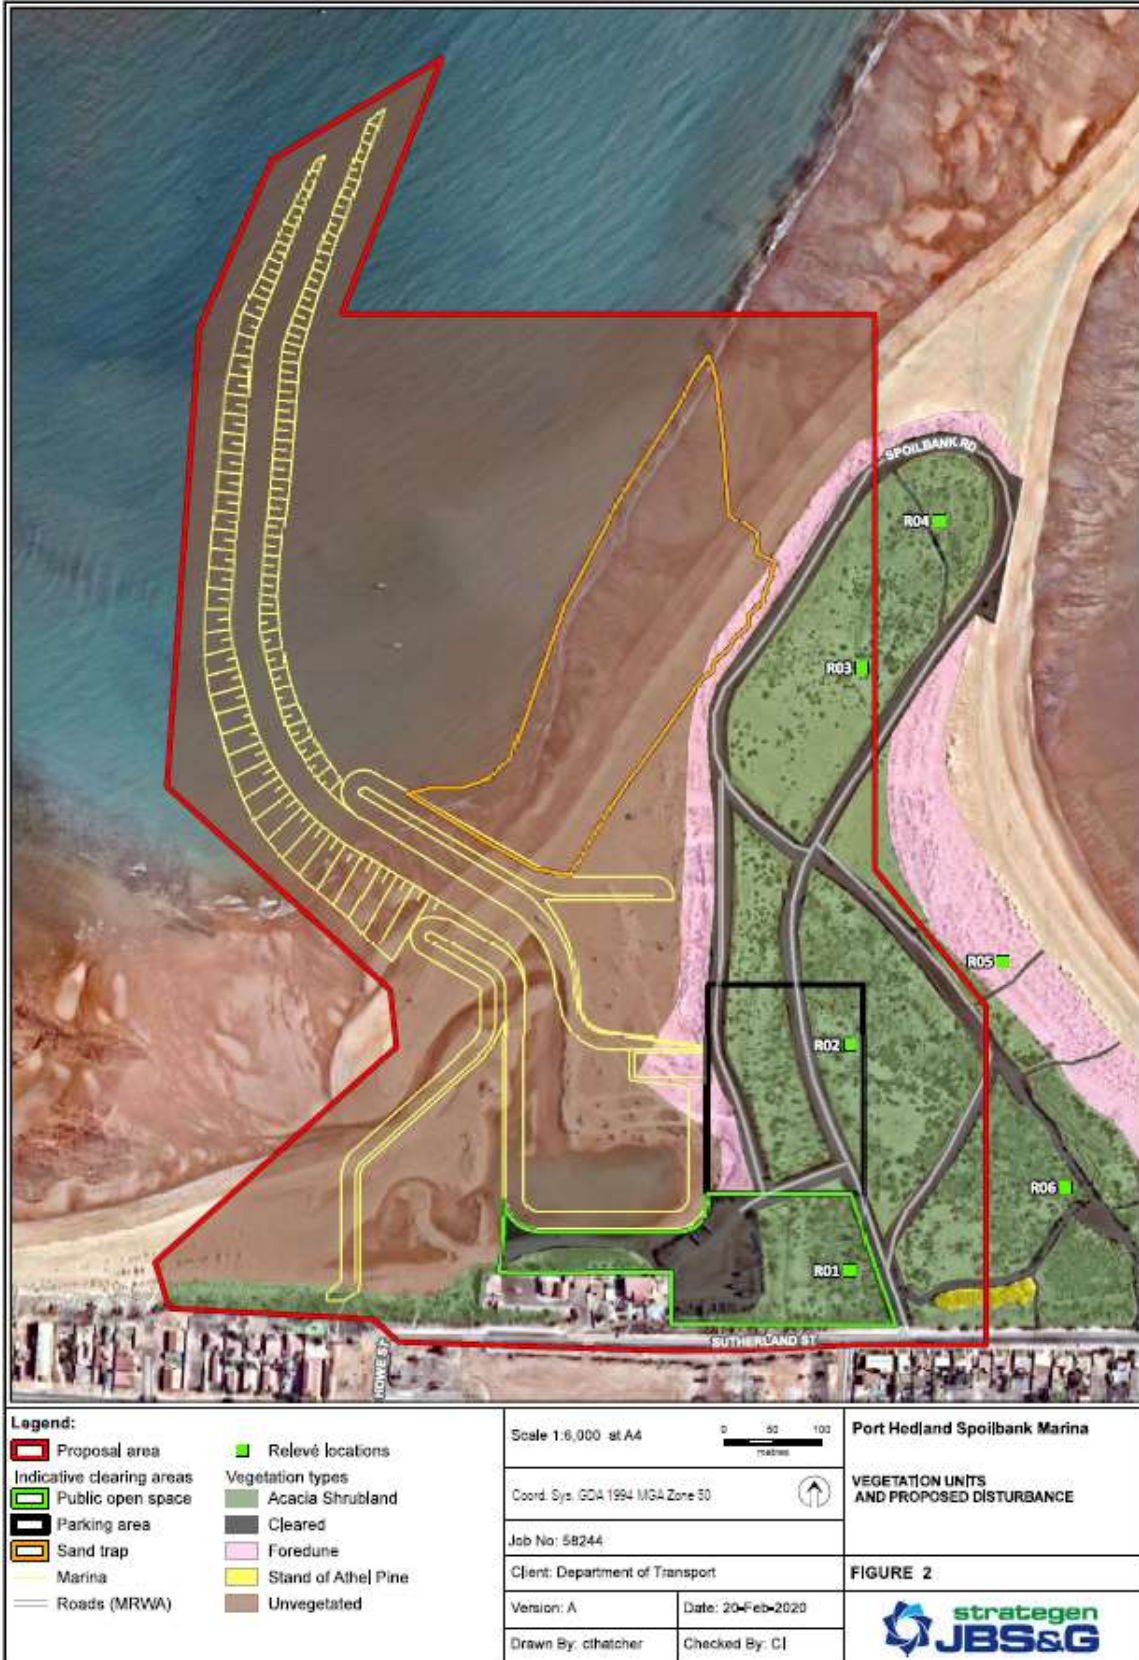
Figure E-1 – Vegetation mapping within the terrestrial portion of the application area (Strategen, 2020b)

Site characteristic	Details
Vegetation description	<p>A flora and vegetation reconnaissance survey conducted of the terrestrial portion of the application area in February 2020 (Strategen, 2020b) found that vegetation within the application area consisted of:</p> <ul style="list-style-type: none"> • Acacia shrubland: Open shrubland, primarily of Acacia species, over grasses and Fabaceae species, which gradually decreased in species richness closer to the western coast of the application area; • Fore-dune: Areas of <i>Spinifex longifolium</i> and <i>Ipomoea pes-caprae</i> closest to the western coast. Aerial photography at different scales demonstrates that dune and coastline locations of the Spoilbank peninsula fluctuate over time due to tidal levels coastal erosion, and as such the position of fore-dune vegetation is likely to fluctuate accordingly; • Athel Pine: A small area of athel pine (<i>Tamarix aphylla</i>, a declared pest) was present in the south-east of the application area near Sutherland Street; • Unvegetated: A large portion of the south-west application area consisted of unvegetated bare ground; and • Cleared: Areas of roads and buildings cleared of vegetation (refer to Figure E-1, Appendix E). <p>39 flora species were identified within the terrestrial portion of the application area, of which 11 were introduced and five were pending identification confirmation (refer to Figure E-2, Appendix E). No threatened or priority flora were identified, and the five unidentified species were not considered to be of conservation significance based on their attributes. Vegetation present in the application area did not meet criteria for any threatened or priority ecological community listed as occurring in the Pilbara.</p> <p>Vegetation in the waterbody within the terrestrial portion of the application area has not been surveyed (Strategen, 2020b and O2 Marine, 2020b), however sediment samples collected within this waterbody did not contain any biota (O2 Marine, 2019a).</p> <p>Mapping of Pre-European vegetation (Shepherd et al, 2001) is only present for a small portion of the south-western application area, likely because the majority of the application area is an artificially created landform (see Soil description below for more details), and is mapped as Abydos Plain 117: Hummock grassland, <i>Triodia</i> spp. Both shrubland and fore-dune areas mapped by Strategen (2020b) are largely inconsistent with this vegetation mapping.</p> <p>When surveyed by O2 Marine (2019b), the marine portion of the application area contained 12.6 hectares of mixed assemblage (coral, macroalgae, sponges and hydrozoan) benthic communities without seagrass and 2.3 hectares of mixed assemblage communities with "very sparse" (typically <1% cover (O2 Marine, 2020b)) seagrass (<i>Halodule</i> species) (O2 Marine, 2019b) (refer to Figure E-6, Appendix E). The remainder of the marine portion of the application area is described as bare substrate, with no benthic community habitat or occasional isolated sparse macroalgae (O2 Marine, 2019b). Macroalgal species present within the application area were not specified by O2 Marine (2019b), except for <i>Halimeda</i> sp. noted to be present at one location.</p> <p>Of the areas of mapped benthic communities described above, approximately 3 hectares of mixed assemblage communities and 1.1 hectares of mixed assemblage communities with seagrasses are present within the dredging area, with the remainder of these areas within a zone of modelled "irreversible loss". This area of "irreversible loss" was modelled upon predicted coral mortality sedimentation tolerance limits for corals in clear water (and are considered conservative for corals in naturally turbid areas and also for seagrasses) and a dredge plume impact assessment (O2 Marine 2019b).</p>

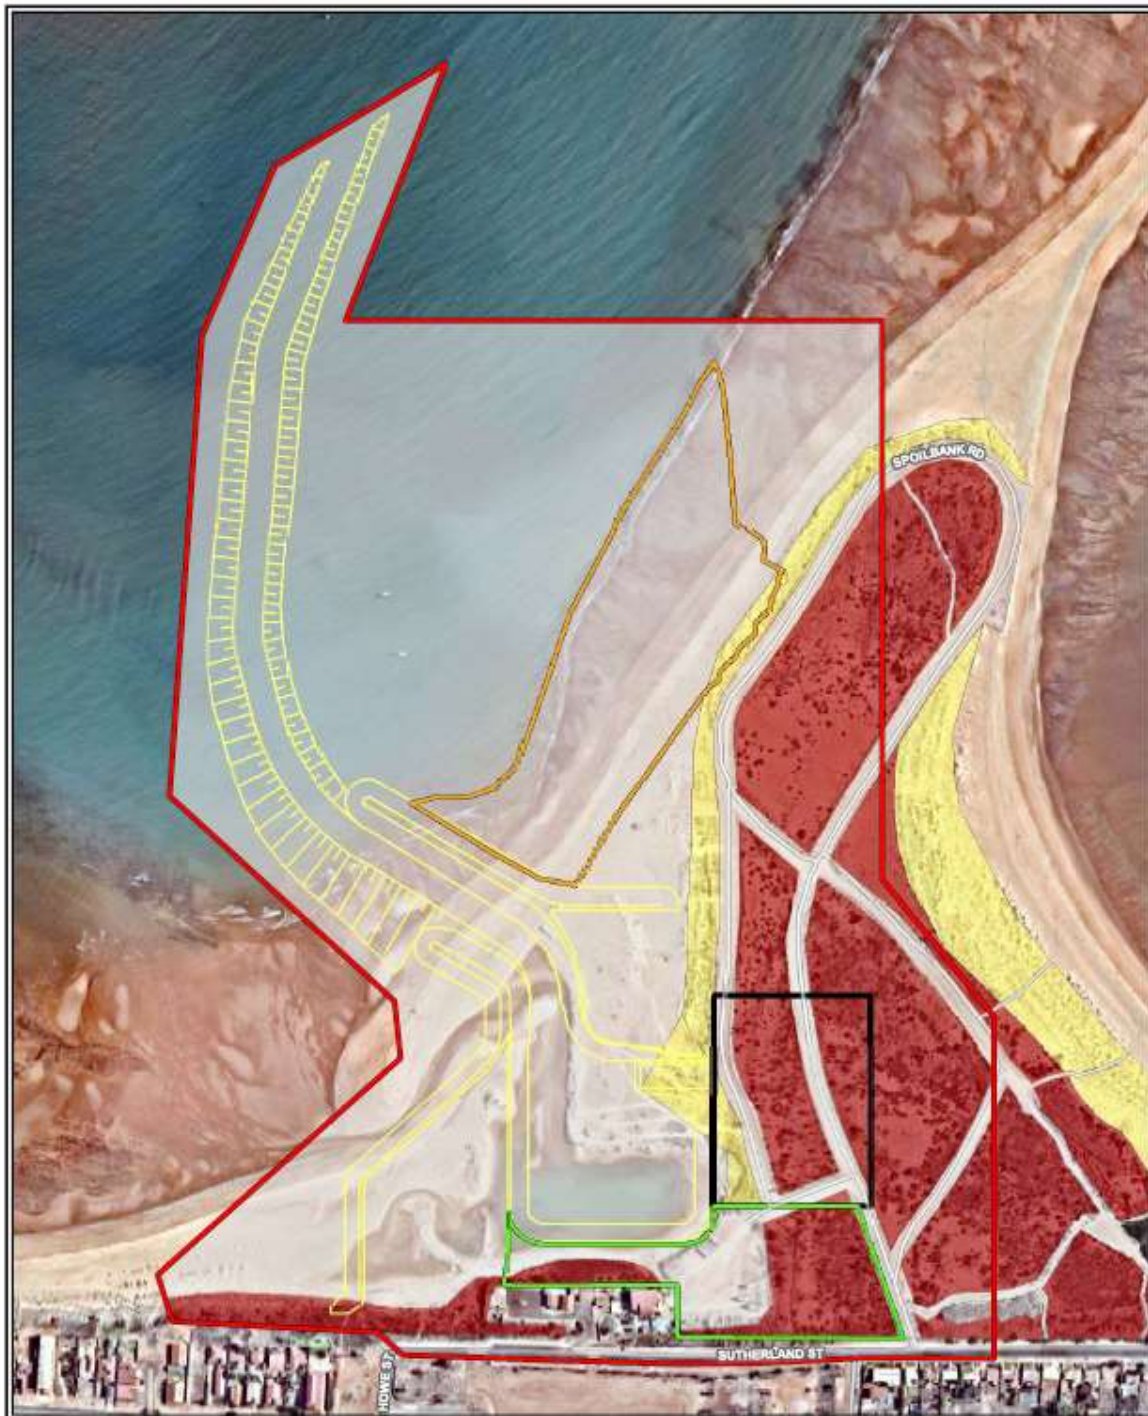
Legend: Proposal area Public open space Parking area Sand trap Marina Roads (MRWA)		Vegetation condition Good Degraded Completely Degraded n/a		Scale 1:6,000 at A4 Coord. Sys. GDA 1994 MGA Zone 50 Job No: 58244 Client: Department of Transport Version: A Date: 20-Feb-2020 Drawn By: cthatcher Checked By: CI	Port Hedland Spoilbank Marina VEGETATION CONDITION AND PROPOSED DISTURBANCE FIGURE 3
-------------------------------------------------------------------------------------------------------------	--	-------------------------------------------------------------------------------	--	-------------------------------------------------------------------------------------------------------------------------------------------------------------------------------------------------	---------------------------------------------------------------------------------------------------------------------

Figure E-3 – Vegetation condition mapping within the terrestrial portion of the application area (Strategen, 2020b)

Vegetation condition	<p>Strategen (2020b) indicated that vegetation within the terrestrial portion of the application area was in (refer to Figure E-3, Appendix E):</p> <ul style="list-style-type: none"> • Very Poor (Trudgen, 1991) (described by Strategen as Degraded) condition in the majority of the application area: <ul style="list-style-type: none"> ○ Vegetation was dominated by <i>Cenchrus ciliaris</i> (buffel grass, an aggressive weed widespread throughout the Pilbara region). The area

Site characteristic	Details
	<p>was fragmented by many four-wheel-drive tracks and showed signs of extensive human use for dog walking and off-road and four-wheel motorbikes. Earthworks had been undertaken in many places throughout the application area, with earth pushed up into piles which contained rubble (Figure E-4, Appendix E). It was considered that site some portions of the site which had low species diversity may be subject to periodic storm surges (Strategen, 2020b). There was also a patch of vegetation in the south-east of the reserve which was dead, with no apparent cause, although speculated to be due to herbicide or a storm surge (Figure E-5, Appendix E).</p> <ul style="list-style-type: none"> • Poor (Trudgen, 1991) (described by Strategen as Good) condition in areas of vegetation closest to the coast: <ul style="list-style-type: none"> ○ Although largely consisting of only two species, vegetation within these areas had a lack of weeds. • Completely Degraded (Trudgen, 1991) condition in area cleared for buildings and roads. <p>The full Trudgen condition rating scale is provided in Appendix E, below.</p>

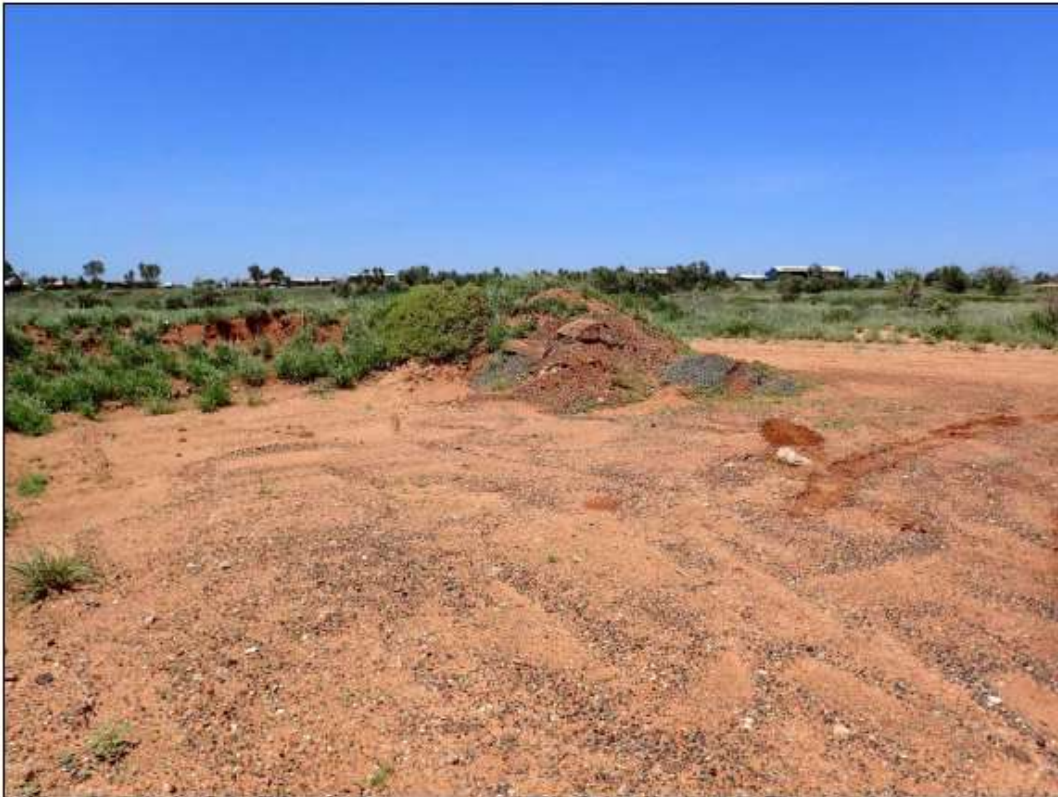
Figure E-4 – Photograph of soil disturbance from earthworks within the terrestrial portion of the application area (Strategen, 2020b)

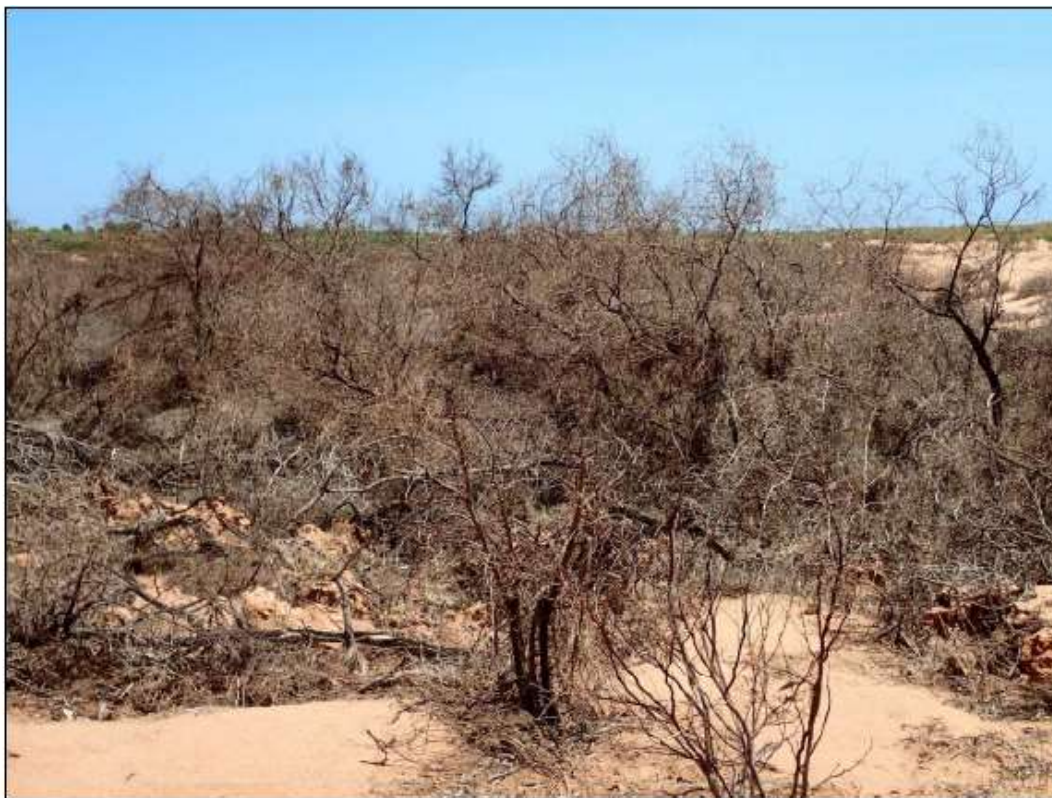
Figure E-5 – Photograph of dead vegetation within the terrestrial portion of the application area (Strategen, 2020b)

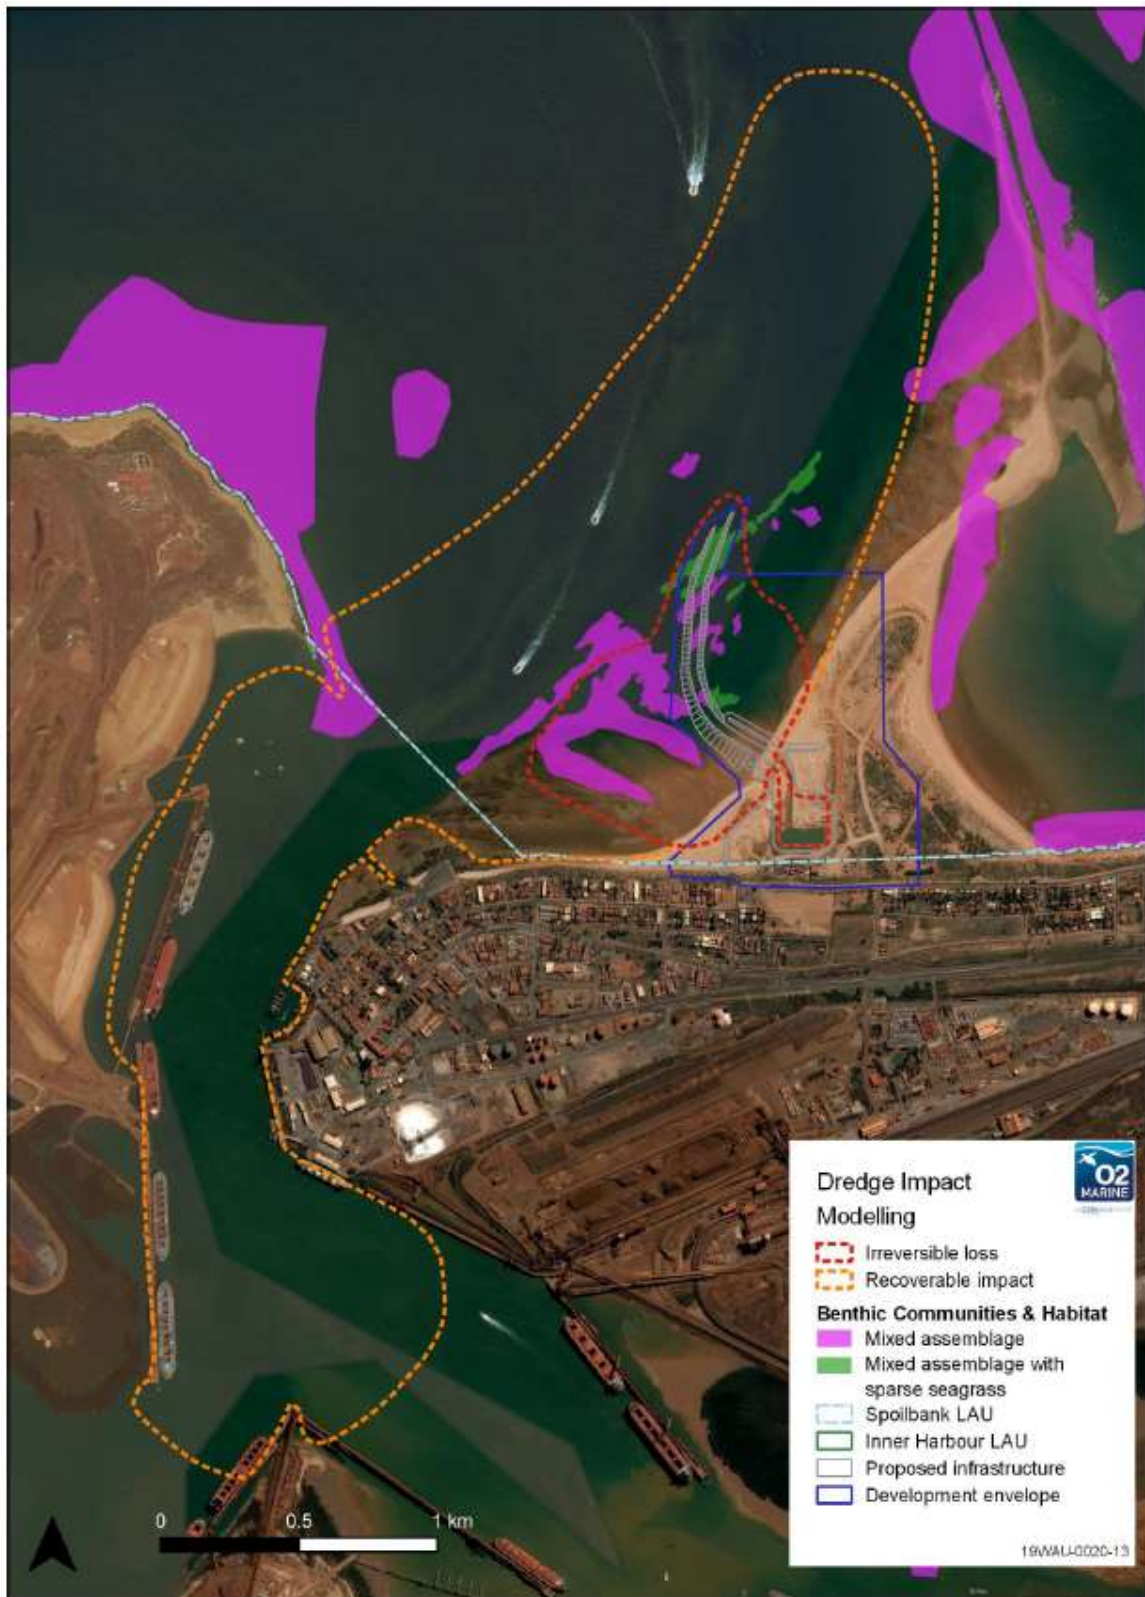
Figure E-6 – Dredge impact modelling and benthic habitat mapping within the marine portion of the application area (O2 Marine, 2020b)

The initial application area footprint only encompassed the terrestrial portion of the application area (Department of Transport, 2020a) however the application area footprint was revised twice during the assessment process to add the dredging area and area of irreversible benthic habitat loss (see Appendix A for further details).

Applicant increased the application footprint from 45.08 hectares to 97.82 hectares to include the entirety of the areas mapped as irreversible areas of habitat loss by O2 Marine (2019b) to ensure that both areas of direct and indirect seagrass loss were included within the application area (Department of Transport, 2020d).	The application area footprint was amended and the application re-advertised for 7 days.
