Native Vegetation Clearing Permit Supporting Documentation

Hamersley Road Upgrade

May 2020

100-AE-EN-002

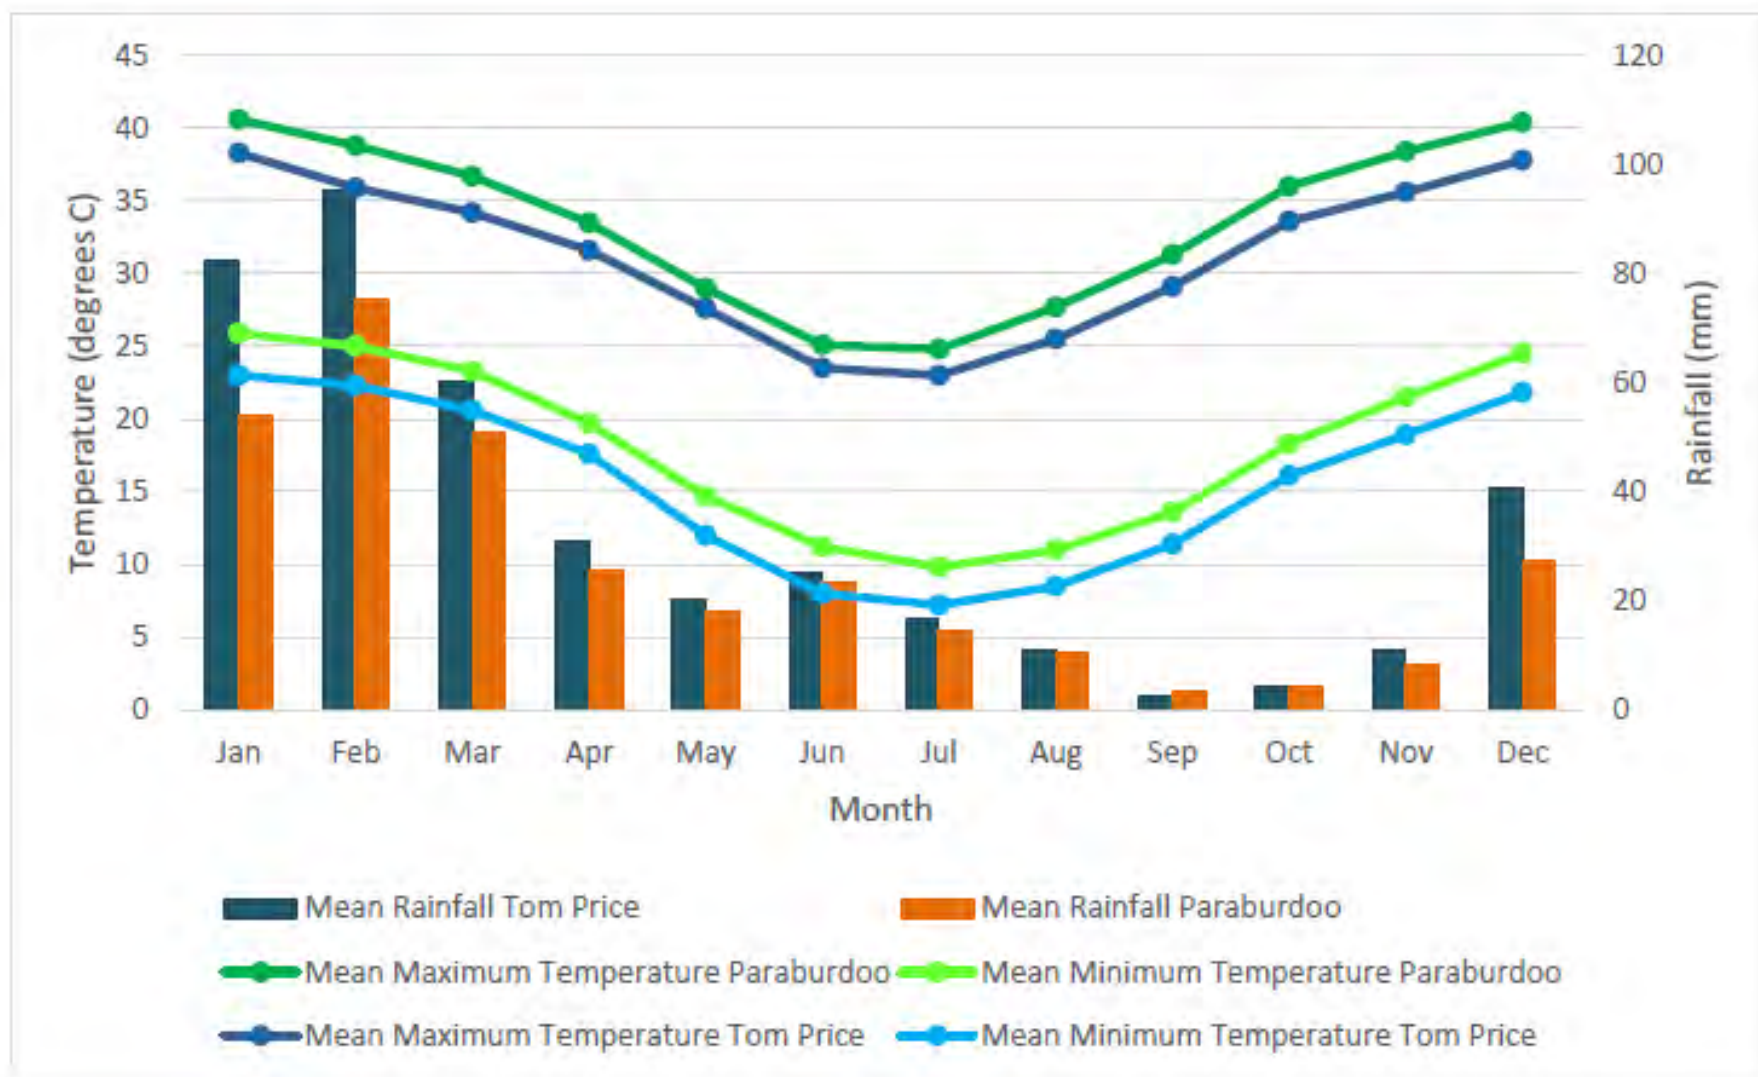
Figure 3: Climate Averages

The monthly rainfall and temperature averages for the Tom Price (BoM, 2017a) and Paraburdoo (BoM, 2017b) Bureau of Meteorology (BoM) stations, located 50 km and 103 km south of the Proposal area, respectively are shown in Figure 3.

Monthly maximum temperatures range from an average of 23°C in July to 41°C in January, whereas minimum temperatures range between 7°C in July and 26°C in January (BoM 2017a; 2017b).

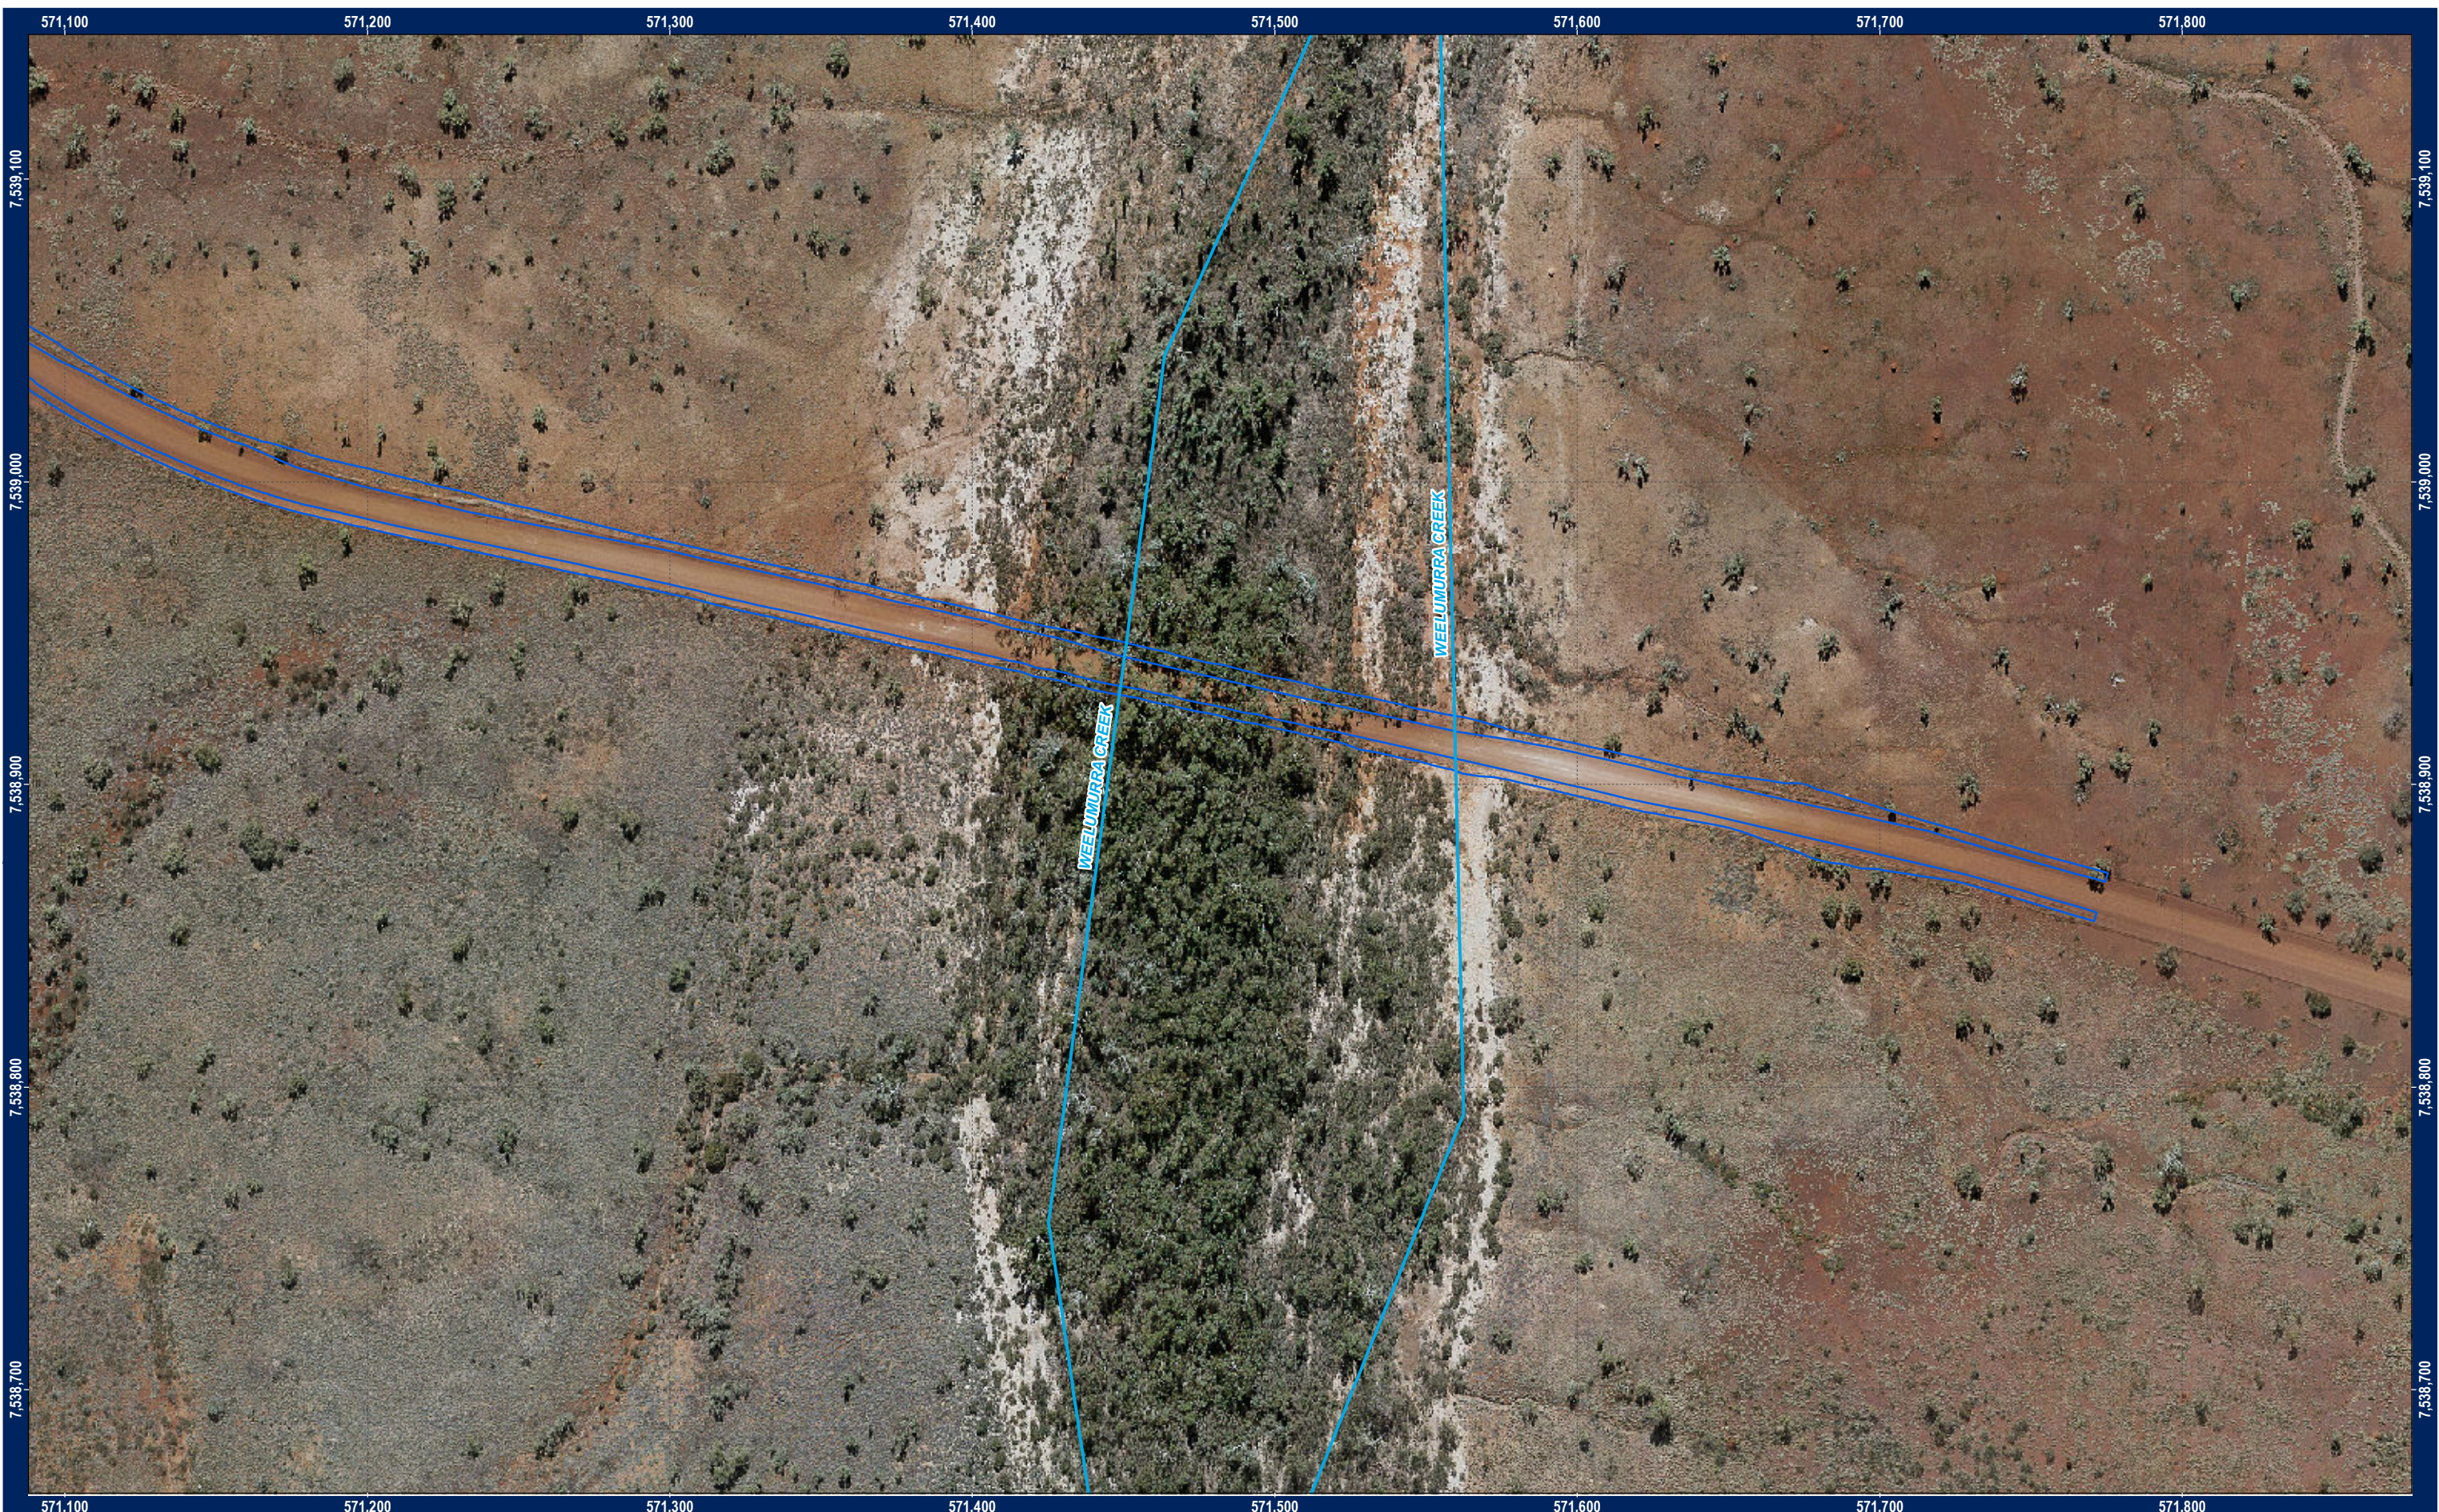
Figure 9
Weelumura Creek

The majority of the application area occurs within the Lower Fortescue sub catchment (Figure 9), a tributary of the Lower Fortescue River. Weelumurra Creek intersects with the permit envelope and in this area, there will be some road upgrade required (Figure 9). In fact, Hamersley Road narrows significantly at this point and this is one reason for the proposed upgrade.
